CENTRAL MALTING, NEW ROAD, WARE,  
HERTFORDSHIRE

HISTORIC BUILDING APPRAISAL

Authors: Matthew Williams MA MSc Lee Prosser BA PhD	
NGR: TL 3603 1433	Report No. 3149
Parish: Ware	Site Code: AS 1163
Approved: Claire Halpin MIFA	Project No. 3260
Signed:	Date: September 2008

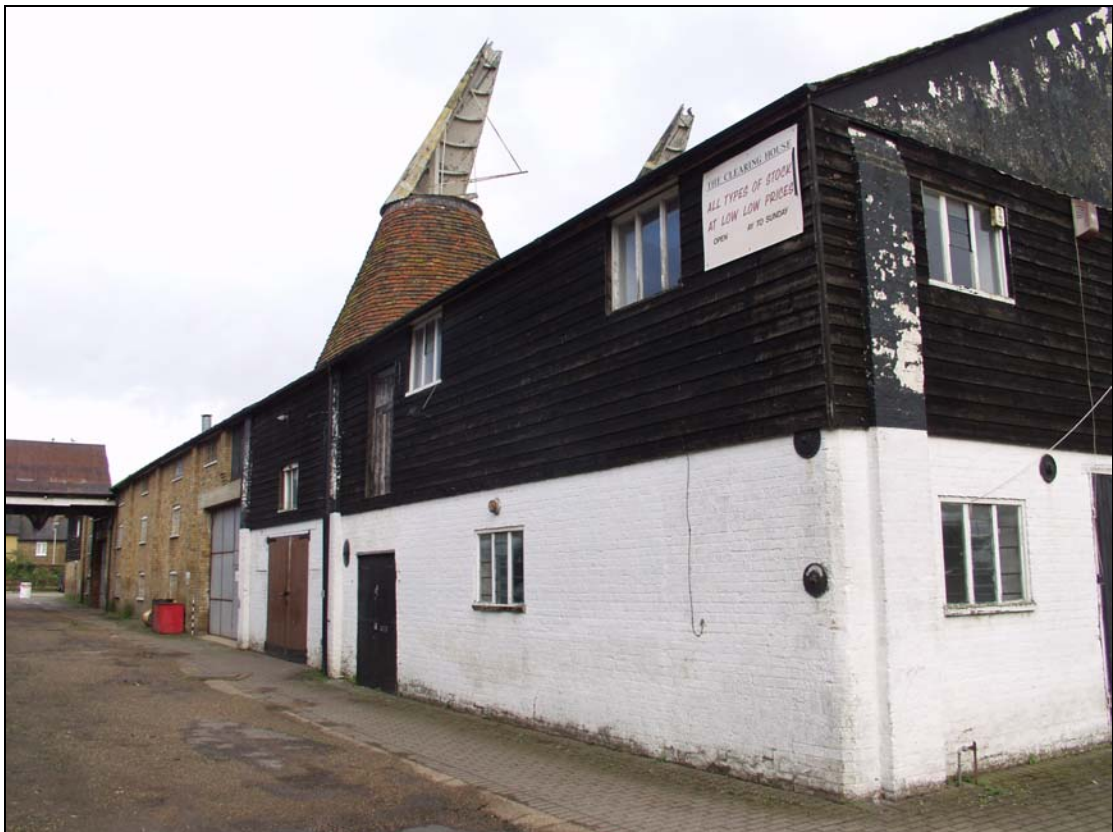
2 Southern elevation taken from the south-east (3)

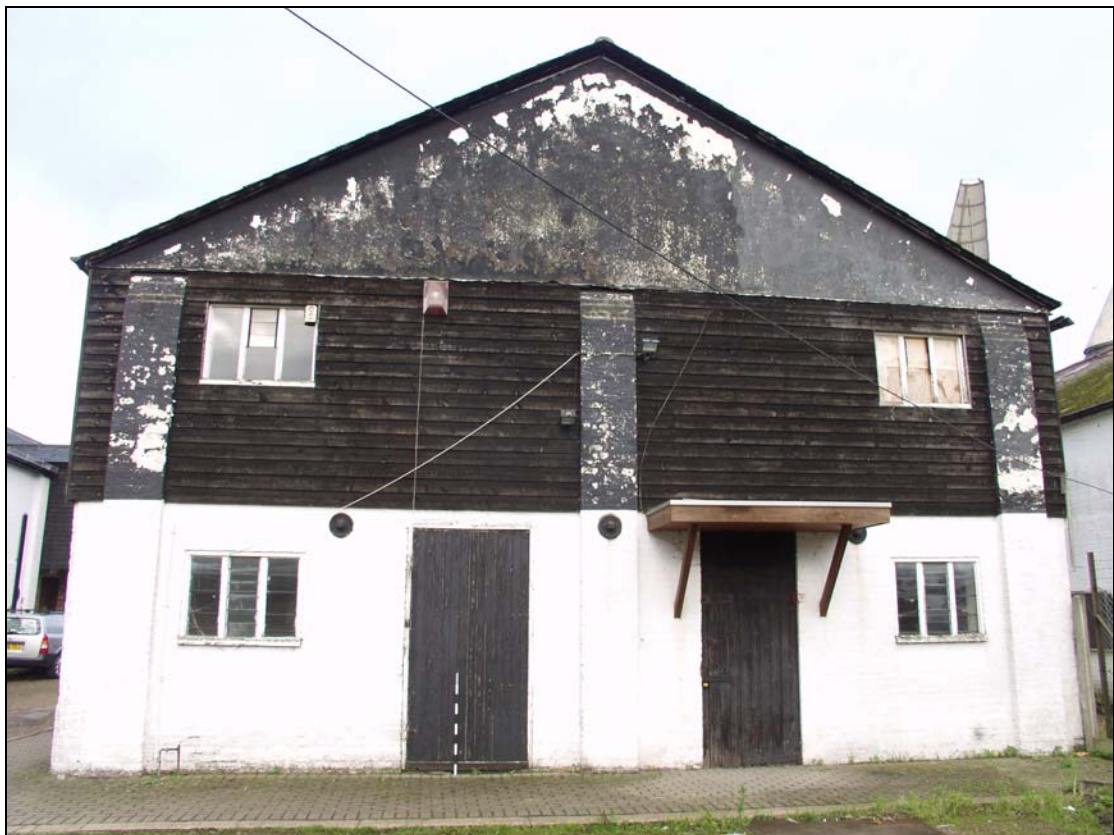
6 Eastern elevation taken from the east (4)

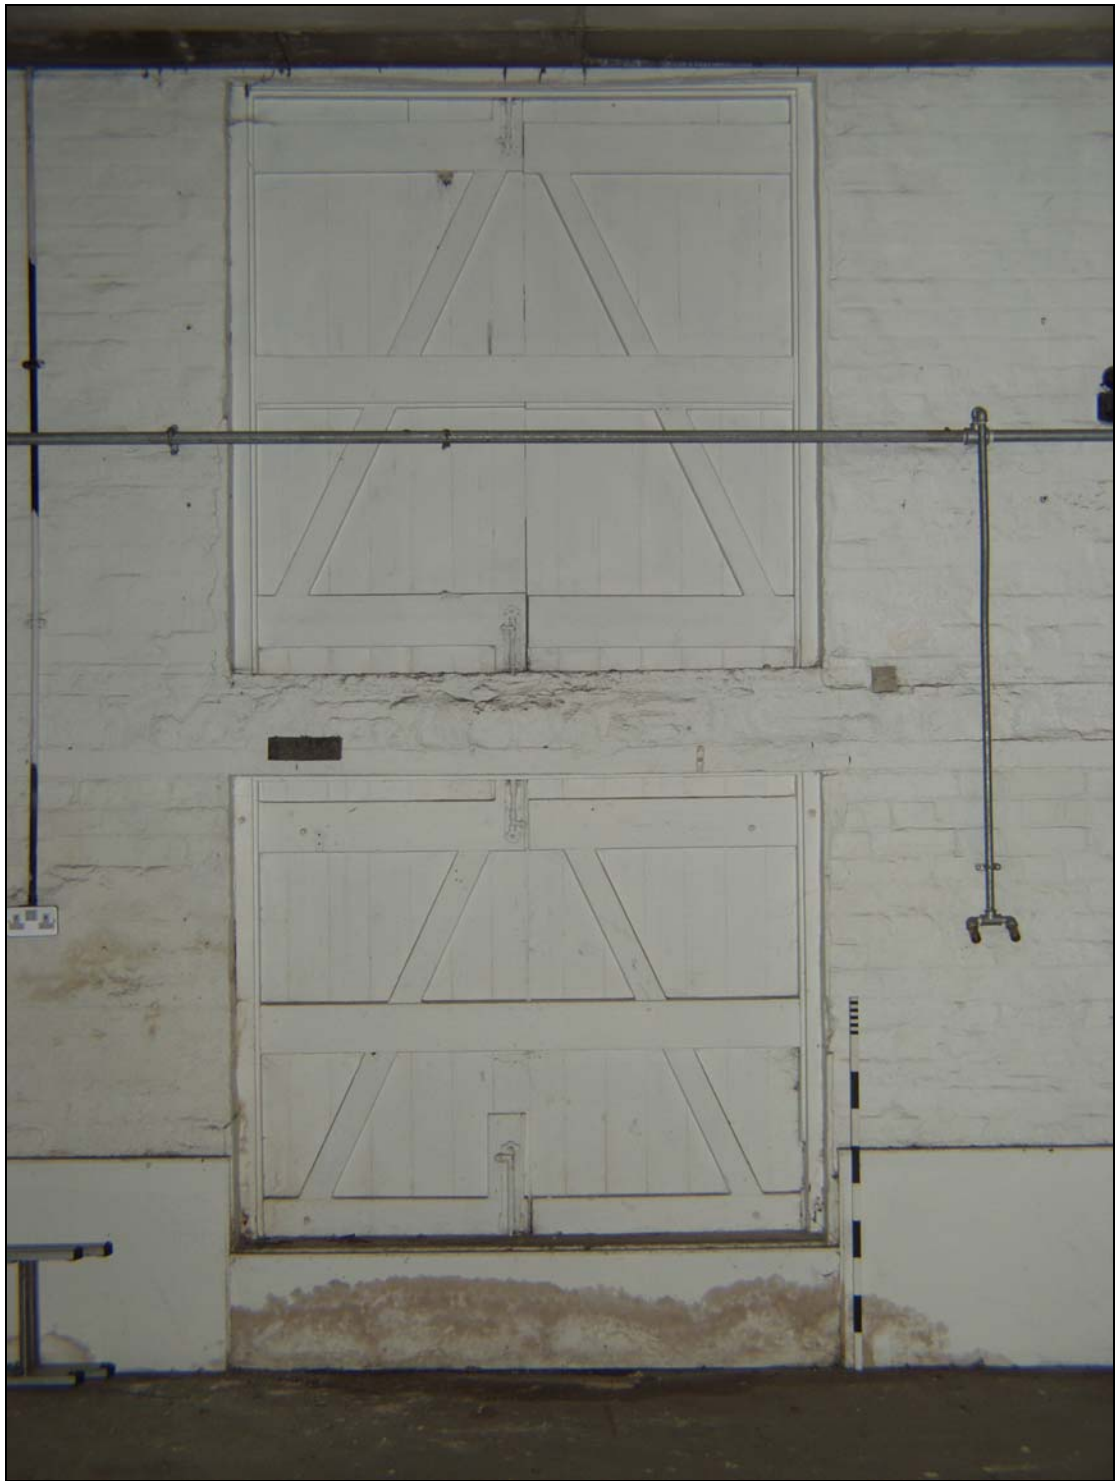
5.2.6 The north elevation remains the best preserved, retaining original loading doors, but displaying minor modification of windows etc, noted above.

9 Loading doors to central section, taken from the south (40)

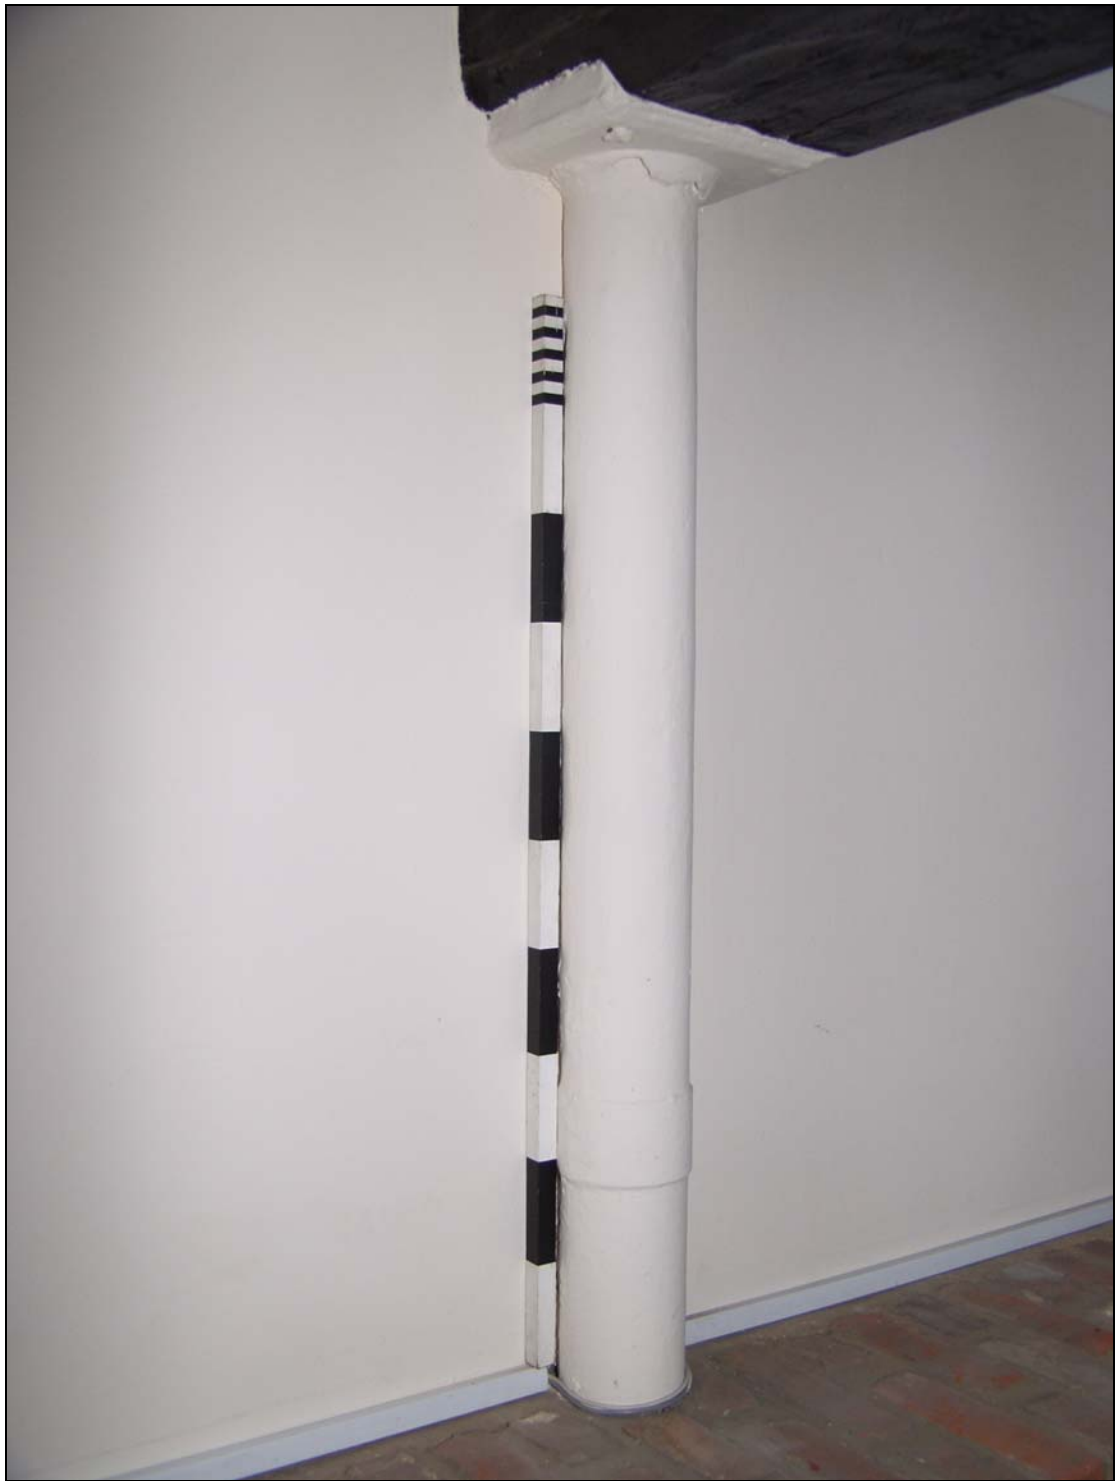
13 Detail of surviving iron stanchion (42)

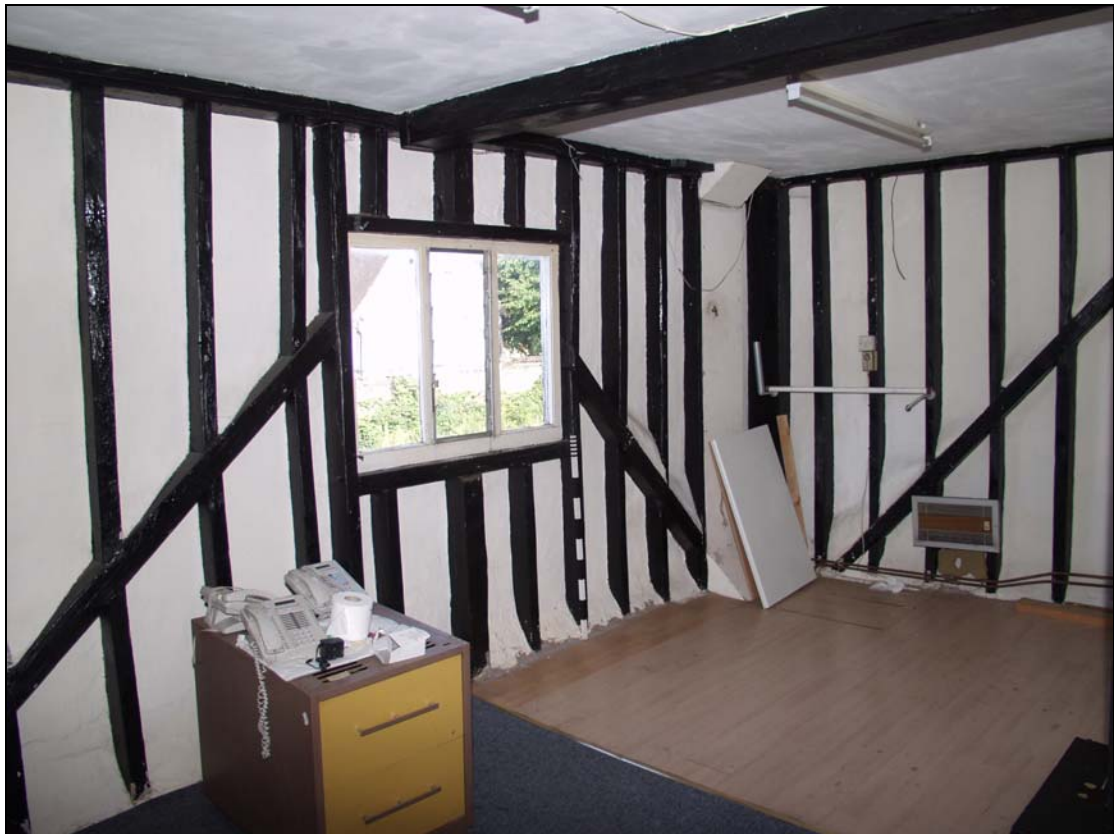
16 North-west office on first floor of western section, taken from the south-east (19)

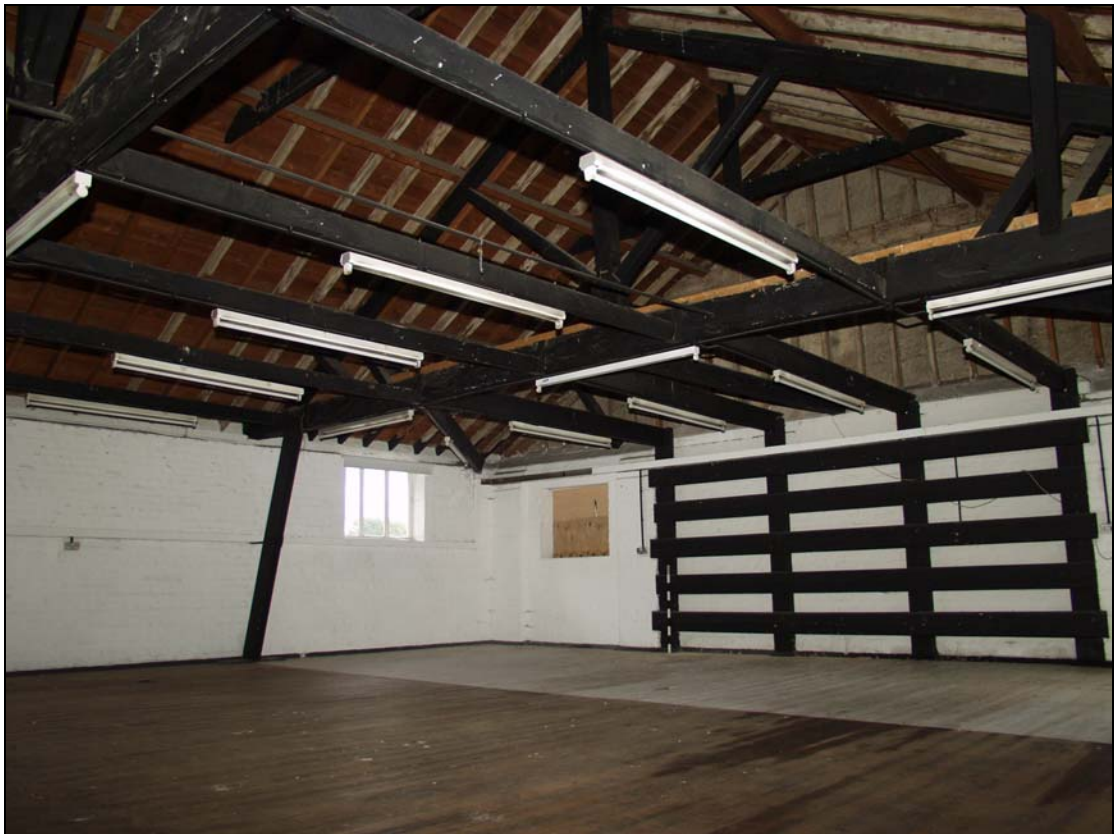
21 Main studio of first floor of eastern section taken from the south-west (29)
