**BARNS AT WOODS FARM, WOOD ROW,
HATFIELD BROAD OAK, ESSEX**

HISTORIC BUILDING RECORDING

Authors:	Tansy Collins BSc Lee Prosser PhD Charlotte Davies BA Kathren Henry Kate Higgs BA	
NGR: TL 5365 1824		Report No. 3260
District: Uttlesford		Site Code: HBWF09
Approved: Claire Halpin MIFA		Project No. 3397
Signed:		Date: March 2009

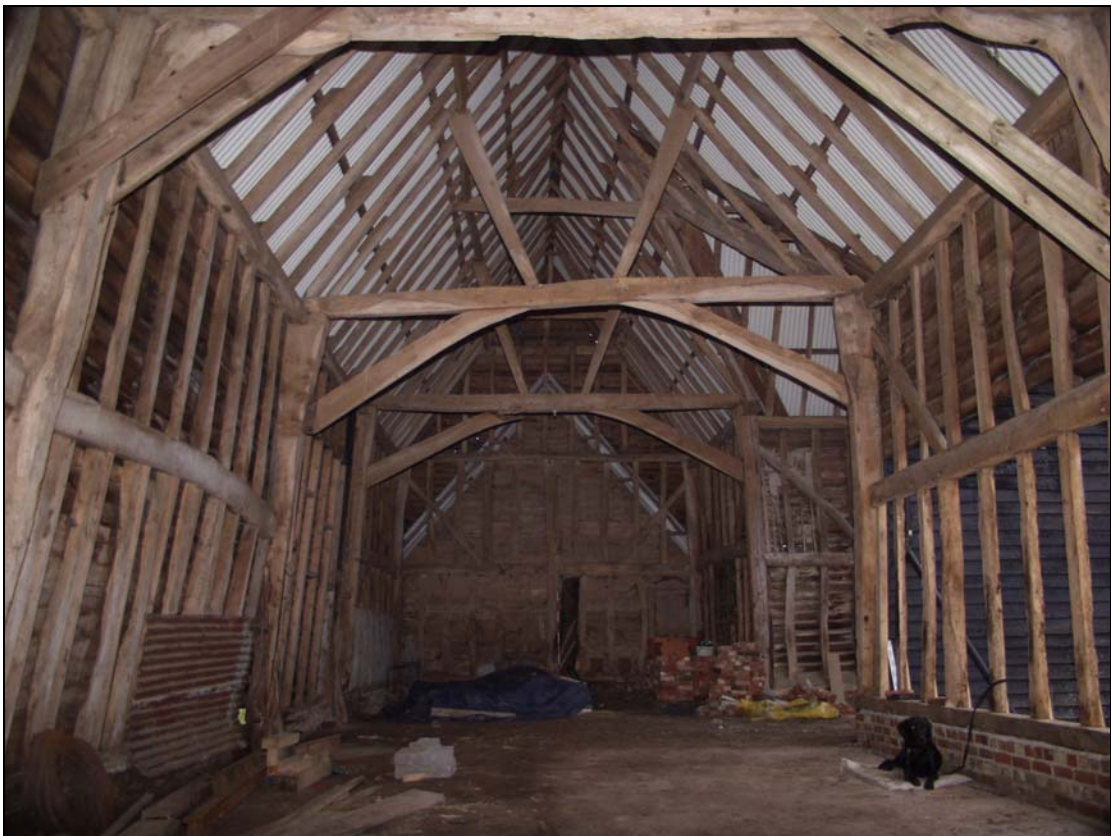
Plate 2 Interior of Building 1, taken from the south (25)

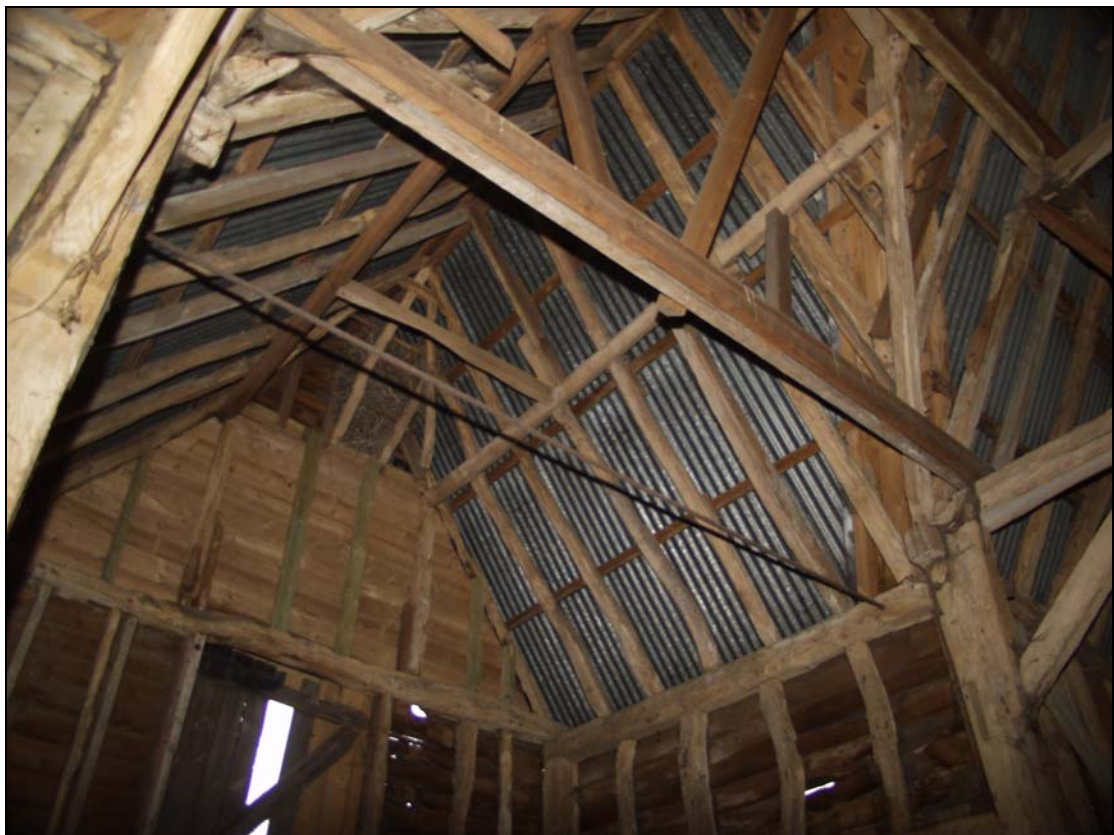
5.3.3 The five bays are numbered from west to east in the description below, with the contemporary porch on the north side of Bay 3 (Plate 7). The floor is a disturbed mixture of earth and concrete, while at the west end of the barn and within the porch, the lower framing is obscured by corrugated sheet metal cladding. The oak frame displays a mixture of good quality squared timber for the principals with fairly waney wood elsewhere, particularly at roof level.

Plate 7 Interior of Building 2, taken from the west (49)
