**THE BARN, OLD PARK FARM, PERRY GREEN, MUCH
HADHAM, HERTFORDSHIRE**

HISTORIC BUILDING RECORDING

Authors:	Tansy Collins BSc Lee Prosser PhD Matthew Williams MA MSc Charlotte Davies BA Kathren Henry	
NGR: TL 44299 16773	Report No: 3233	
District: East Hertfordshire	Site Code: AS 1182	
Approved: Claire Halpin	Project No: 3296	
Signed:	Date: December 2008

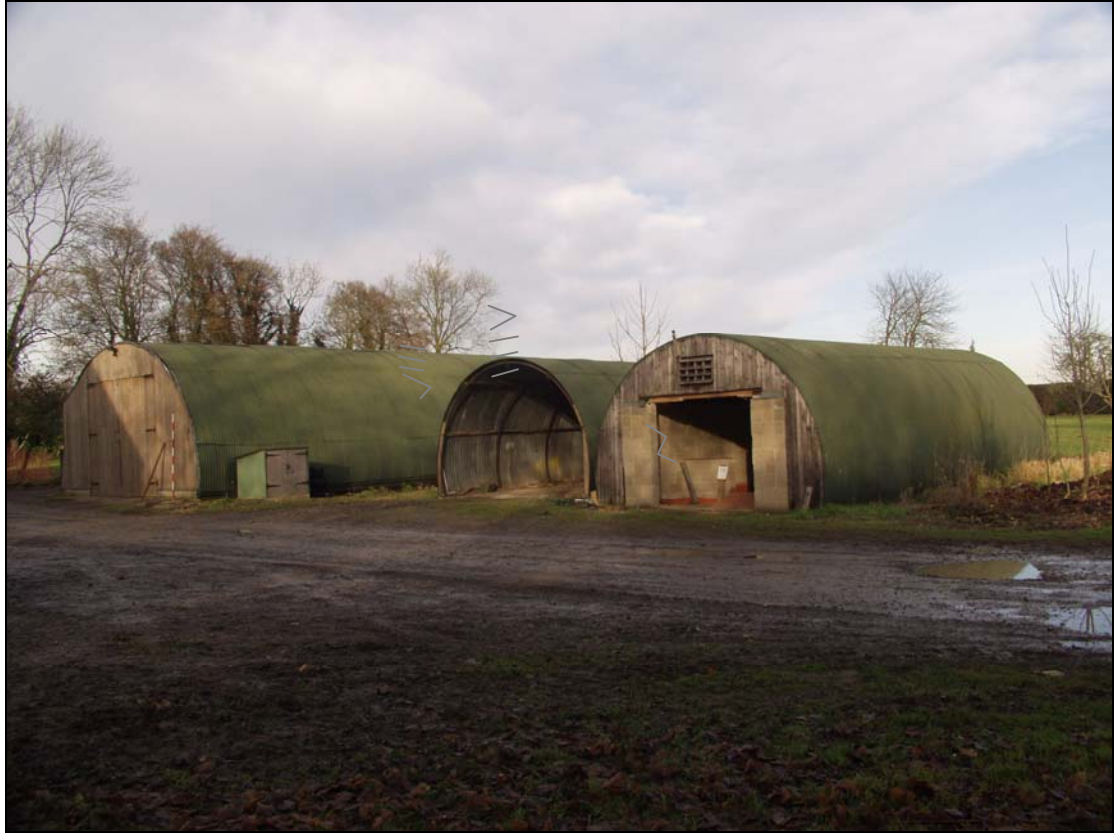
Plate 7 Exterior view of Buildings 2-4, taken from the south (1)
