**OUTBUILDINGS SHEERING HALL, BAMBER GREEN,
TAKELEY, ESSEX**

**HISTORIC BUILDING RECORDING AND ARCHAEOLOGICAL
MONITORING AND RECORDING**

Authors:	Tansy Collins BSc Lee Prosser PhD Matthew Adams BA Peter Thompson MA Kathren Henry	
NGR: TL 5760 2288		Report No: 3480
District: Uttlesford		Site Code:
Approved: Claire Halpin		Project No: P3310
Signed:		Date: February 2010

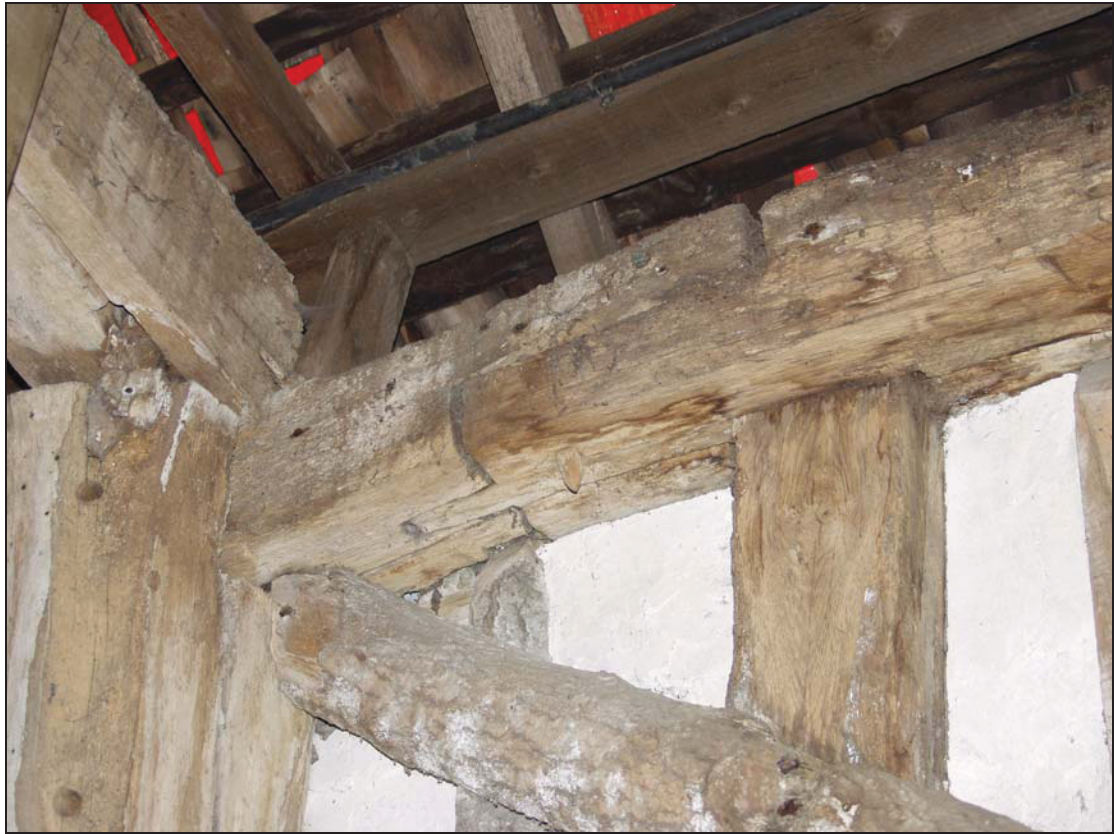
Plate 5 Detail of edge-halved and bladed scarf joint in the west wall-plate of Building 1, Bay 7, taken from the north-east (DP 85)

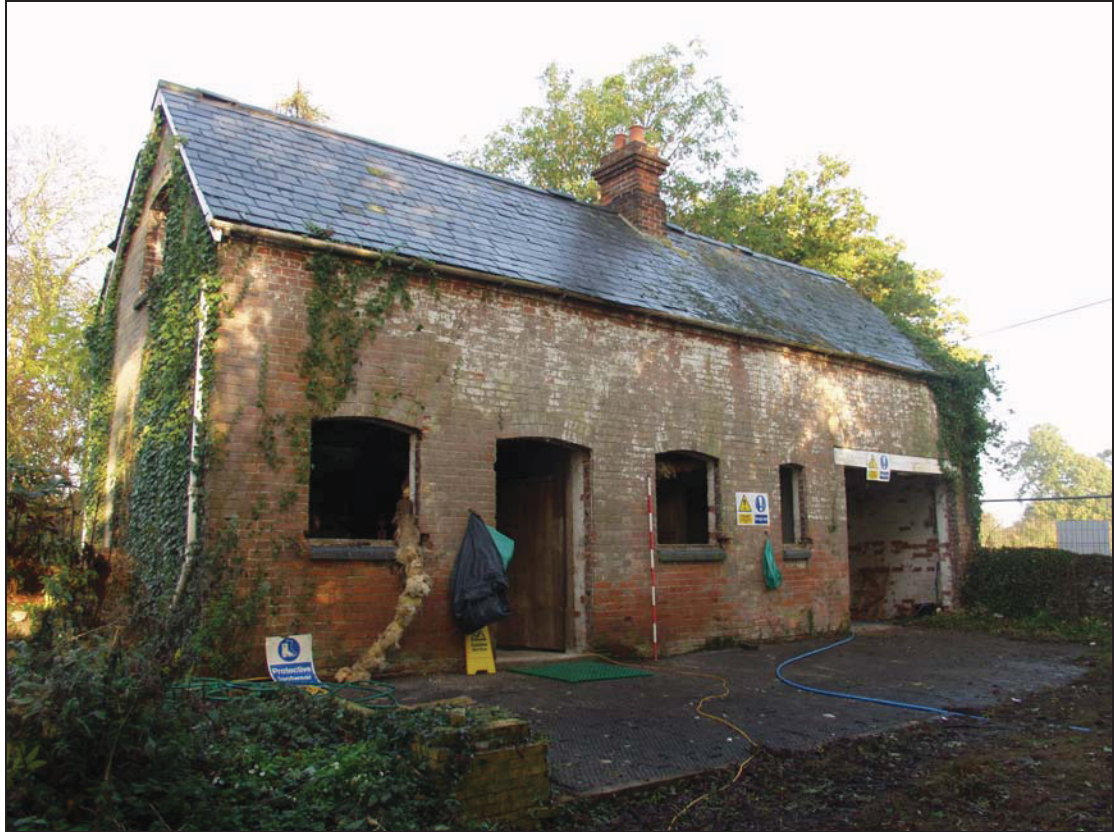
6.6.2 The only surviving historic elements of the principal range include the south gable wall and a number of *ex-situ* roof trusses (Plate 16). The south wall is constructed of brick with a timber bearer at tie-beam level. There are five roof trusses of identical form to that seen in both Buildings 3 and 5, all with chiselled assembly marks. Evidence of strapping can be seen.

Plate 16 South and west sides of Building 6, taken from the south-west (DP 11)

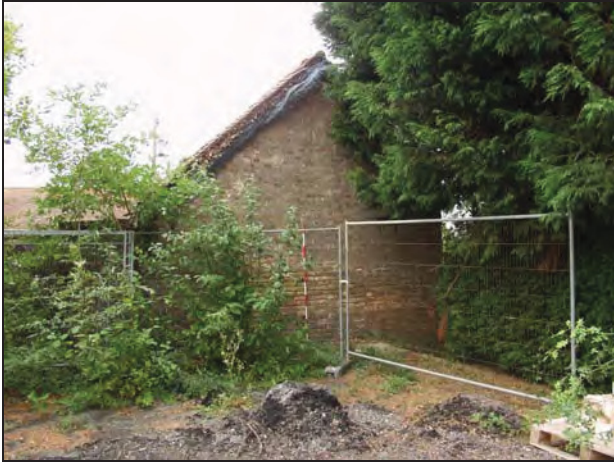
6

View of partially demolished Building 6, taken from the south-east

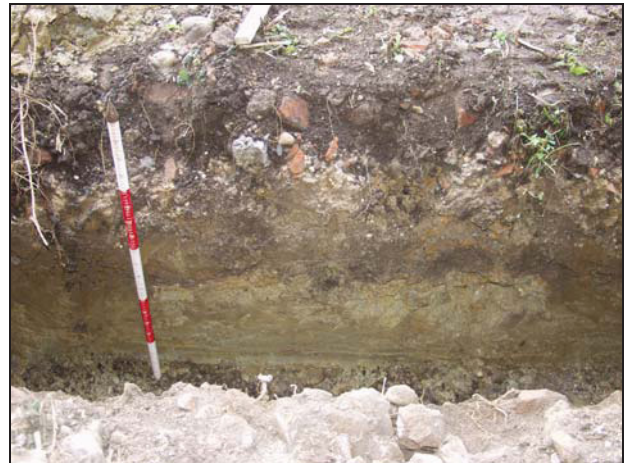
144

Detail of foundation trench on the south side of Building 5 showing sample section 5, taken from the east

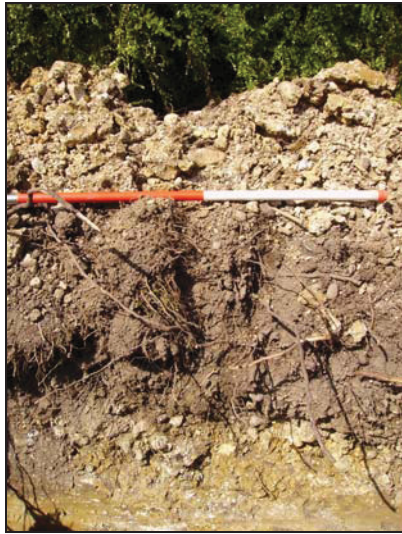
145

Detail of foundation trench on the south side of Building 5 showing sample section 6, taken from the north
