FARM BUILDINGS AT SIBLEYS FARM, CHICKNEY ROAD, HENHAM, ESSEX

HISTORIC BUILDING RECORDING

Authors: Lee Prosser BA PhD	
Lisa Smith BA	
Kathren Henry	
NGR: TL 565 297	Report No. 3514
District: Essex	Site Code: SFHN10
A survey of Olaina I lake in	Ducie et Ne. 2040
Approved: Claire Halpin	Project No. 3816
MIFA	Data: March 2010
	Date: March 2010
Signed:	
Ũ

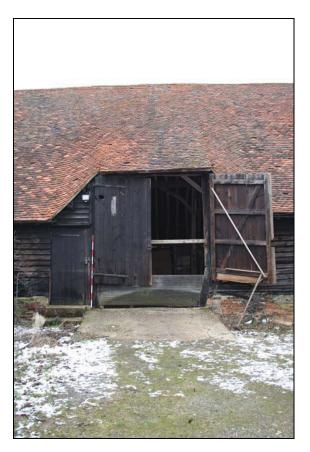
Plate 4 The barn, trusses 2 and 3, taken from the south-west (DP 37)

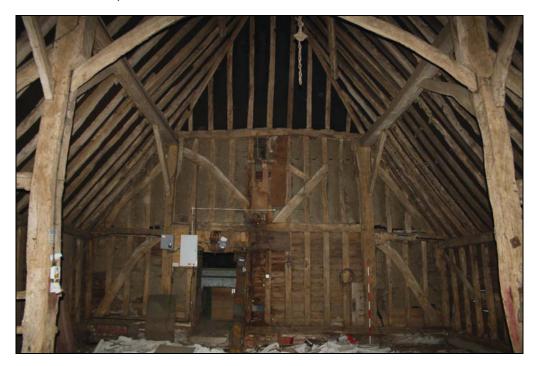
Plate 6 The barn, truss 1, taken from the east (DP 26)

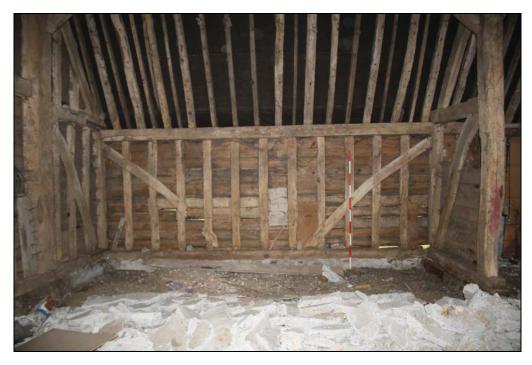
Plate 7 The barn, wall panel, bay 1, taken from the south (DP 32)

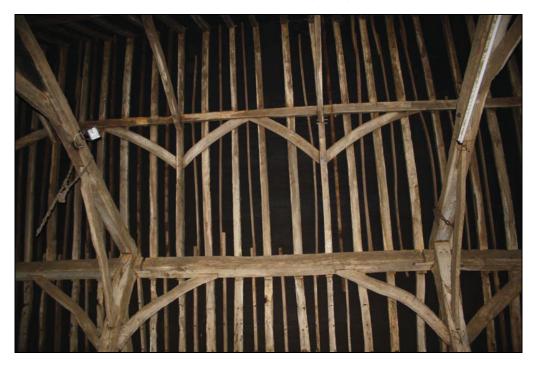
Plate 10 The barn, bay 2, roof structure, taken from the south (DP 13)

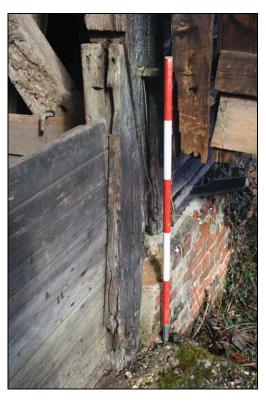
Plate 12 The barn, threshing leap, eastern jamb of main entrance, taken from the south-west (DP 40)

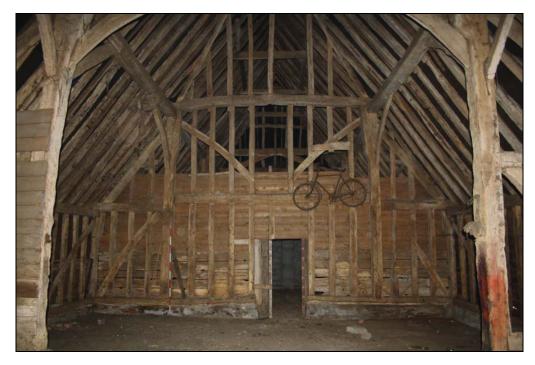
Plate 13 The barn, truss 4, taken from the west (DP 25)

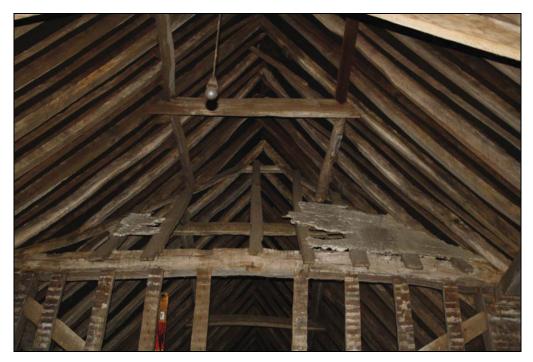
5.26 The eastern façade of the truss remains partially clad with a mixture of wide hand-sawn oak and elm boarding with later machine-cut additions, but these probably relate to the internal configuration of the later 17th extension. Some patches of plasterwork remain in the upper framing. The dwarf wall retains some 16th century brickwork to the south; to the north the wall has been rendered. At roof level, the original hip rafters survive with only one loss (Plate 14).

Plate 14 The barn, truss 4, original roof structure, taken from the west (DP 24)

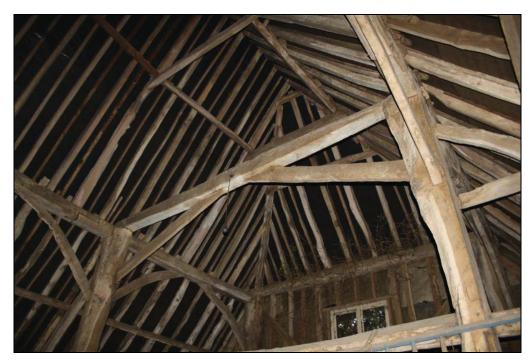
5.30 The bays are divided by waney arcade posts which have shallow, but not well expressed jowls (Plate 16). These are braced to the tie-beam and flanking arcade plates as before. The south post sits on an aisle plate over a heavily eroded brick dwarf wall but its companion to the north is set directly on the ground surface, with no evidence for a wall or aisle plate.

Plate 16 The barn, truss 5, taken from the south-west (DP 18)

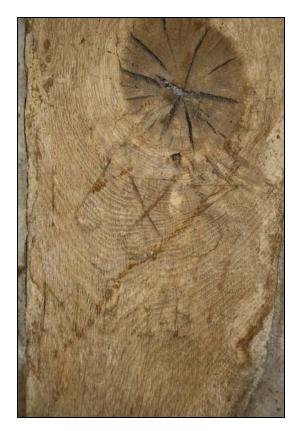
5.36 The gable end has been heavily modified with little surviving fabric at lower level, but the mid-rail survives with eight redundant peg-holes for original studs. The arcade posts have been partially truncated and embedded in modern block work. The northern post is inscribed with the date of 1683 and initials 'M.B.' and 'I.B' (Plate 17).

Plate 17 The barn, graffiti carved into a post imbedded into the eastern gable end (Truss 6), 1683 M.B.I.B, taken from the south-west (DP 34)

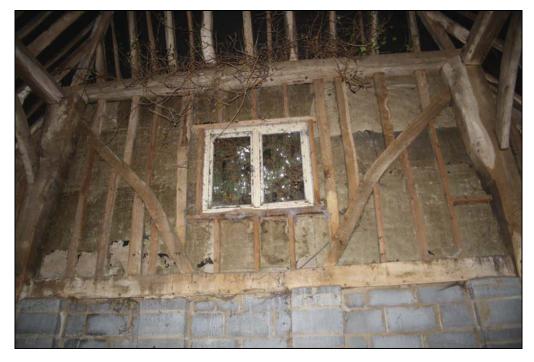
5.37 The upper framing is also much altered, retaining only two cranked braces extending from the posts to the mid–rail. Many of the studs have been truncated to accommodate a fixed two-light window and lesser modern members have been added (Plate 18). Vegetation has invaded the internal framing.

Plate 18 The barn, interior, truss 6, upper register, taken from the west (DP 42)

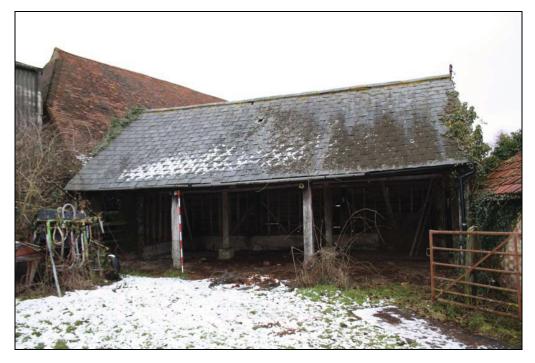
5. 41 The cart shed is timber-framed and weather-boarded, standing to the south of the barn and aligned north-west and south-east. It is laid out on a simple plan of three by two bays, open-fronted to the south-west, constructed of oak and elm with a slate roof (Plate 19). The external boarding is probably original, good quality hand-sawn oak and elm boards with very little modern replacement. Internally, the frame is highly regular and systematic, having primary-braced wall panels of seven studs per bay, with even scantling extending throughout, though the lower elements have been replaced with cement or embedded in concrete, which has caused some decay (Plate 20).

Plate 19 The cart shed, western elevation, taken from the west (DP 5)

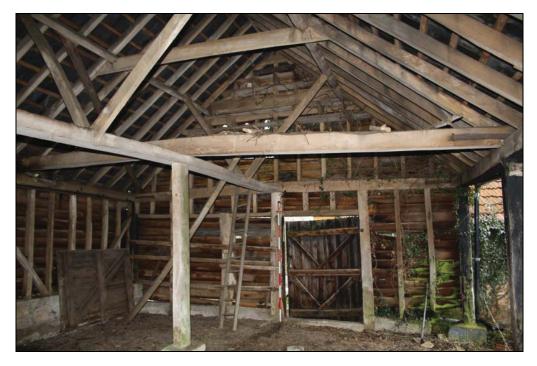
5. 43 Most of the studwork of the south-east end wall has been truncated to accommodate an aperture, since infilled with waney, nailed-on timber. To the west of the central post a large doorway framed by two robust jambs is filled by a bead-moulded, vertically-boarded ledged and braced door. The gable is filled with evenly-spaced studs carrying a rudimentary set of braced shelves and partitions for nesting boxes added at a later date (Plate 22).

Plate 22 The cart shed, internal, southern elevation, taken from the north-west (DP 11)
