**DOWN GREEN HOUSE, HARPENDEN ROAD
WHEATHAMPSTEAD**

HISTORIC BUILDING APPRAISAL

Authors: Dr Lee Prosser BA PhD Tansy Collins Bsc	
NGR: TL 1657 1378	Report No. 3435
District: St. Albans	Site Code: AS 1256
Approved: Claire Halpin	Project No. 3350
MIFA	Date: November 2009
Signed:

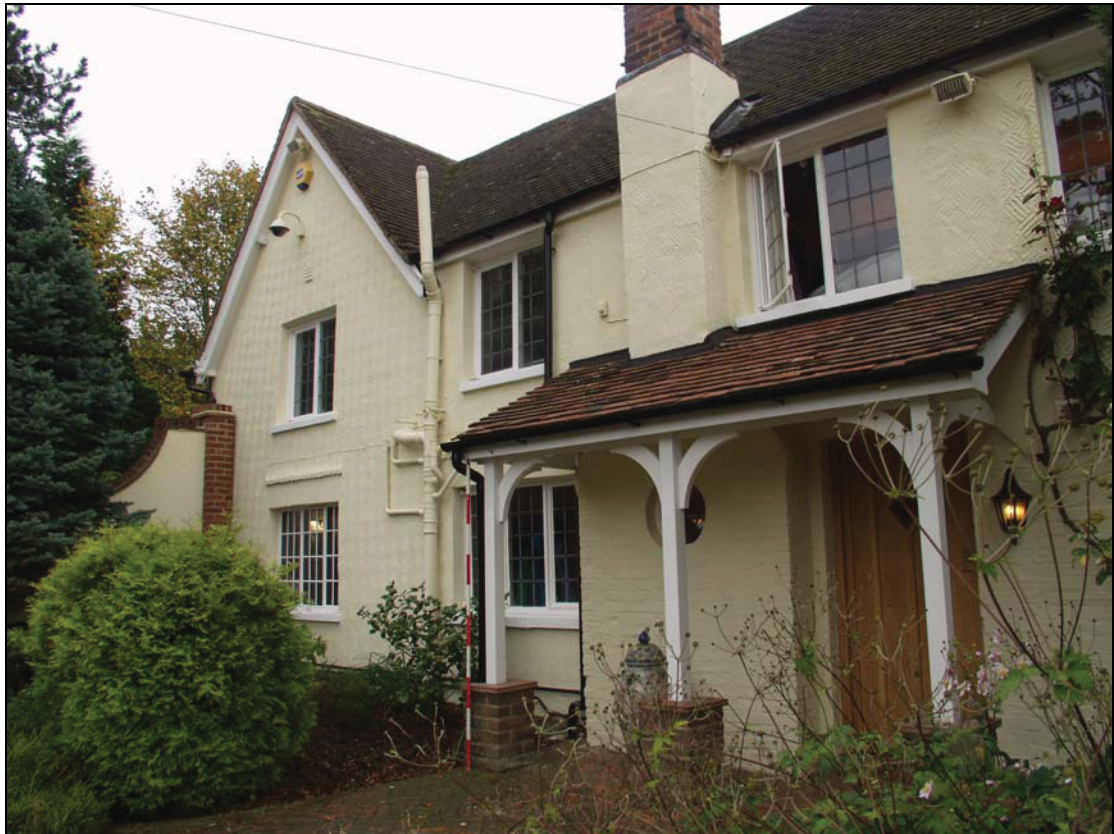
4.1 Down Green House comprises a north – south range with a cross-wing extending to the rear at the south end and various further extensions to the property. The house is now given access from a long drive extending parallel to Harpenden Road with the main entrance on the east side (Plate 1). This, however, comprises a relatively recent alteration and historically the south side of the building, principally the cross-wing was the principal façade and entrance. The building has suffered varying degrees of modification which obscures much of the original detail.

Plate 1 East façade of the building showing the entrance and gable at the south end, taken from the north-east (DP 10)

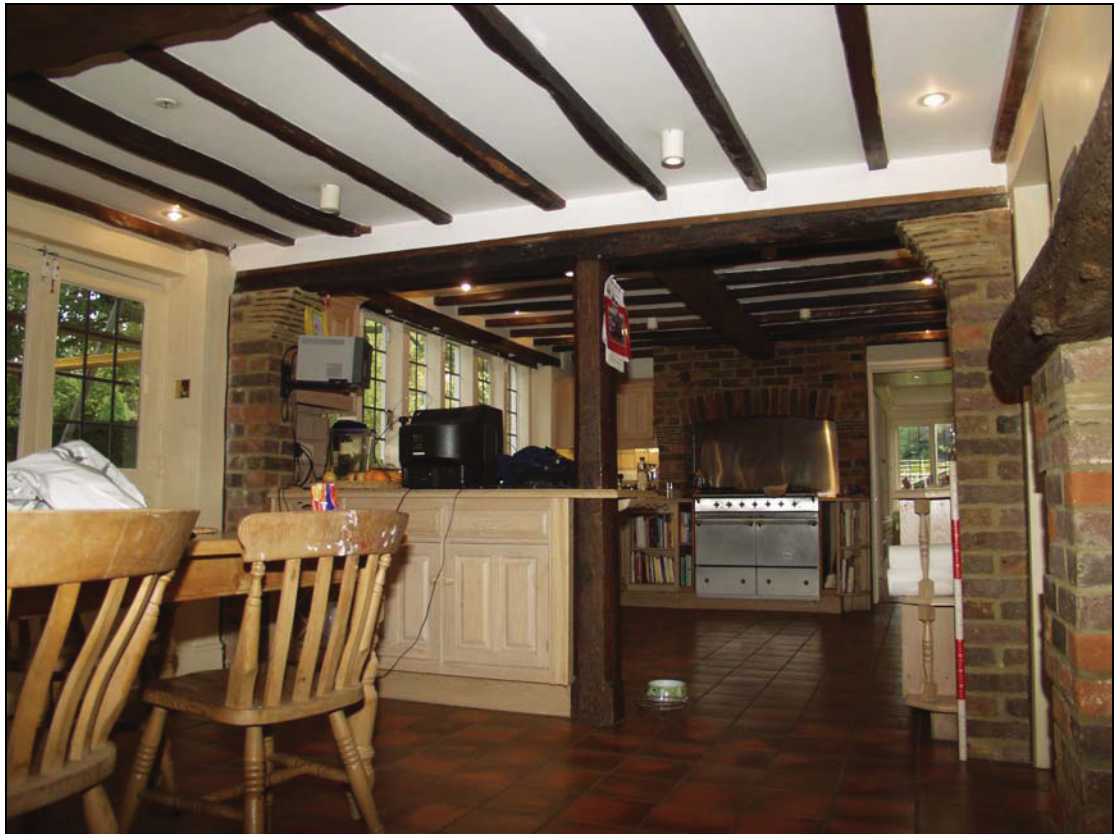
4.25 At low level the timberwork is not particularly coherent although the general layout can be discerned. The westernmost bay (Room 5) comprises a dining room (Plate 7), which is now open-plan with the adjoining kitchen (Room 6) situated in the 19th century addition. Little historic fabric is visible. A central post expresses the division between the two rooms, formerly an external wall, with a joist resting on corbelled out tiles at both ends. This is the only feature which is perhaps original, as it retains mortices for lower studwork. The ceilings of both rooms comprise large central joists with exposed common joists of waney mechanically-sawn oak, all of which are modern replacements with the principals crudely chamfered and ‘roughed up’ in an attempt to convey authenticity. Beyond the kitchen a number of 19th century pine doors survive, now stripped of their original paint.

Plate 7 Room 5 (historic core) now open-plan with Room 6, taken from the south (DP 41)

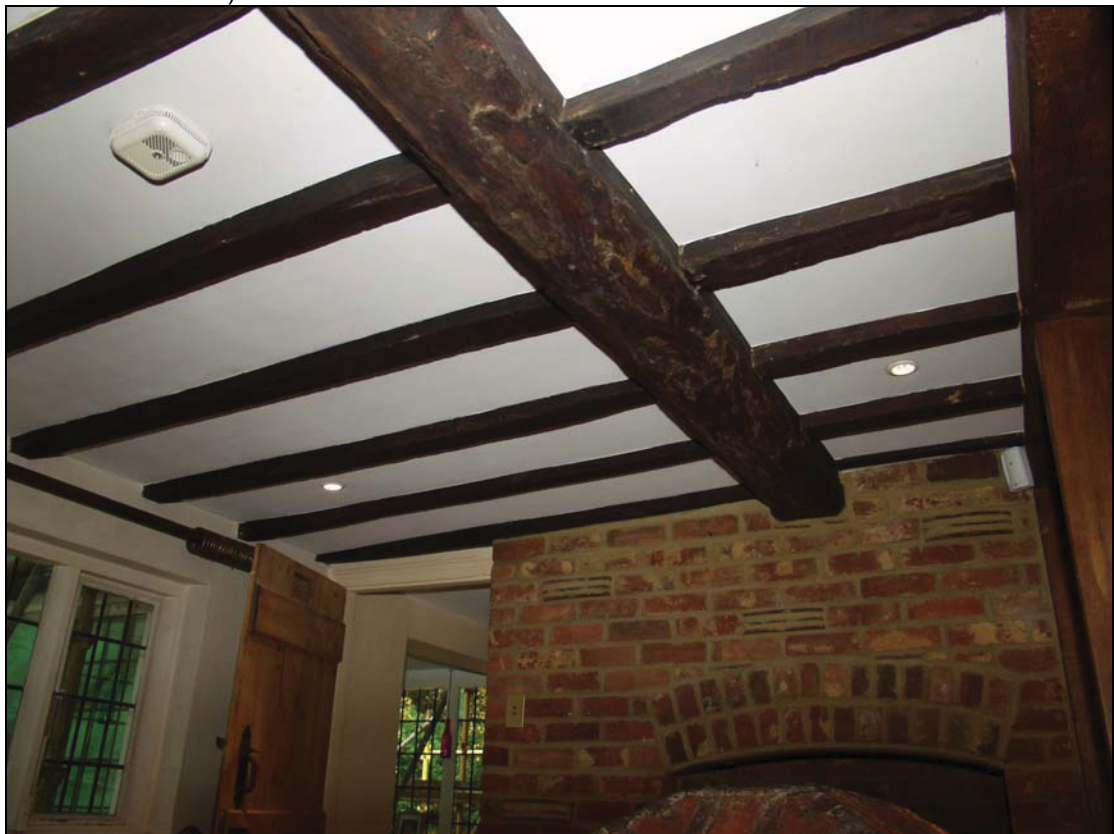
4.27 The east bay (Room 7) has a greater level of timber-framing exposed. This room retains fairly waney corner posts, the south-east member embedded in the wall, although the south mid-rail is well-preserved with an even pattern of peg-holes for upper studwork. Traces of lower peg-holes are visible. The north wall studwork can also be seen in Room 4. This side presents an outline of extremely close-spaced studs, as opposed to the wider spacing at upper level visible from the exterior, of such tight dimensions that the spaces between the studs are almost of the same width as the studs themselves (approximately 12¼" (310mm)). This framing is pierced by a small doorway, later blocked. An exposed timber ceiling comprises a central bridging joist with in-line commons on both sides. The bridging joist is chamfered on both sides, with a crude stop on the east and two wide stops on the west end. This timber is perhaps original although the common joists may not be so in every instance (Plate 8).

Plate 8 Exposed ceiling joists in Room 7, historic core, taken from the north-east (DP 12)

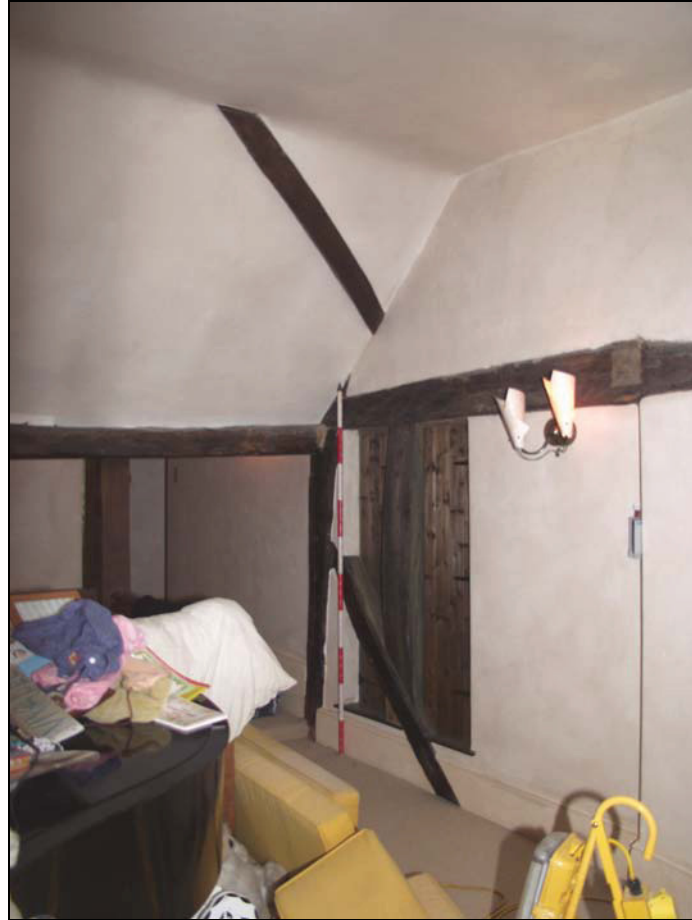
4.29 Much of the end gable is visible in the east bay (Room 8) expressed with corner-posts and tie-beam, while on the north side the external face of the former wall-plate is visible. The corner posts of the east gable swell to a jowl and preserve a thin downward tension brace to the mid-rail (Plate 9). There is a lateral mortice for a further downward brace on the corresponding corner. The tie-beam is well-preserved. It displays side-axing marks and retains peg-holes for regularly-spaced

Plate 9 North-east side of Room 8 (historic core), taken from the south-west (DP 24)

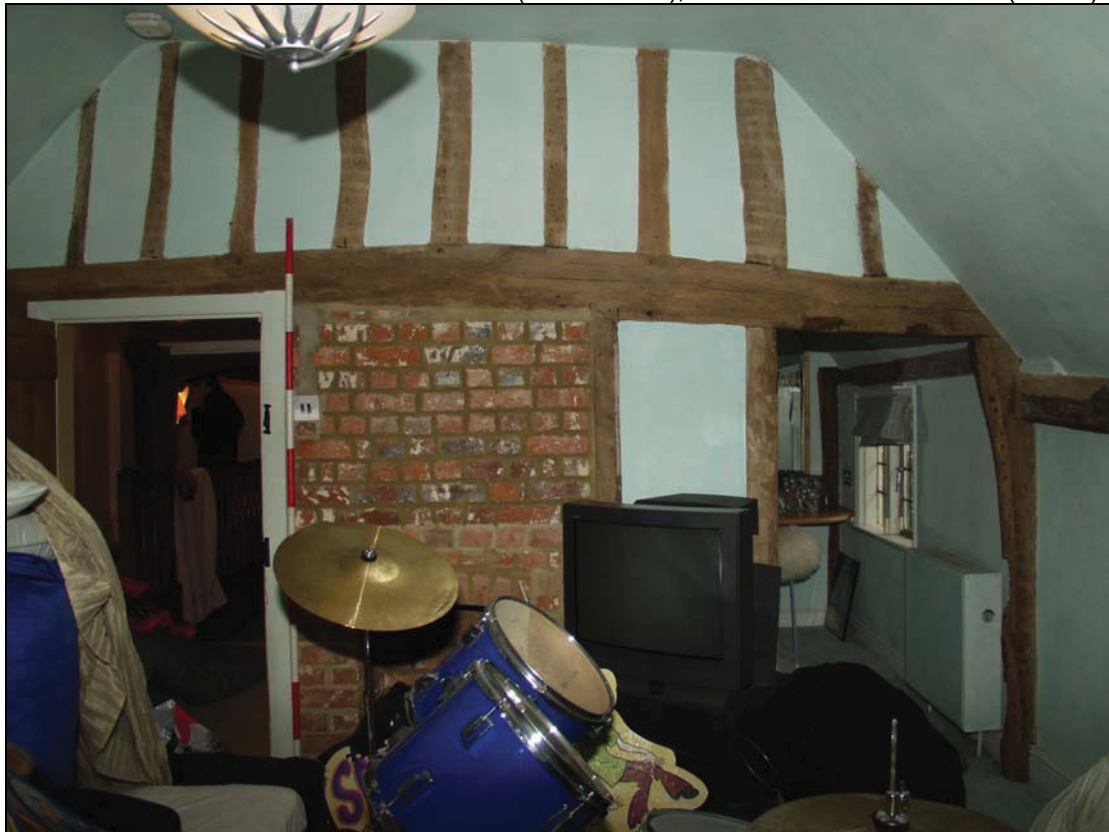
4.30 The south side of the chimney bay is reached from the west bay (Room 9) and now encloses a walk-in closet. Fairly wide-spaced external studs are visible. Room 9 preserves some timber-framing although much is obscured. The west gable tie-beam is visible and on the east adjoining the chimney bay, the tie-beam and outer jowled posts frame the two doorways and a section of chimney stack. The principal posts retain mortices for lateral downward tension braces. Above tie-beam level ten studs are visible; the base of alternate studs pegged (Plate 10).

Plate 10 East side of Room 9 (historic core) adjoining the chimney bay, taken from the west (DP 28)

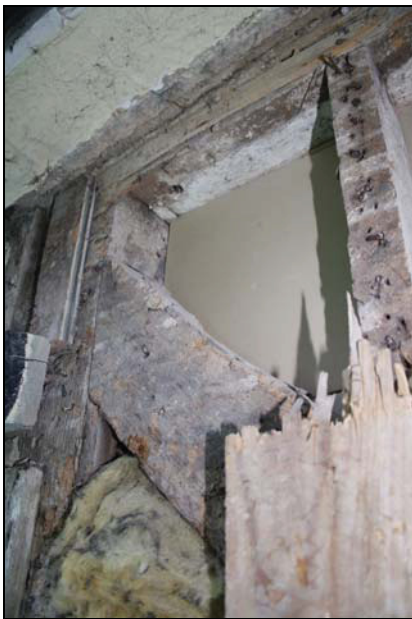
DP 38

4.14 In the west bay (Plate 3) the wall-plate is mostly visible, jointed into the post of the chimney bay to the east, apart from the area above the existing window. In the soffit of the wall-plate we see a pattern of mortices indicating a series of robust studs flanked by staves or wattle poles with a further intermediate wattle pole. This is a characteristic also seen on the opposite side, now internal, and noted below. Occasional original studs survive, pegged at the head, although very degraded at the base where the mid-rail has been lost with the bricking-in of the lower facade. The west section of the bay is primary-braced as on the west gable, along with a reconfiguring or insertion of secondary studs. Again we see the redundant wattle holes in the soffit of the wall-plate, confirming the secondary nature of the primary-bracing (Plate 4). Some of these timbers perhaps reuse members from the earlier framing.

Timber-framing of the west bay at upper level, south side of the historic range, taken from the south-west

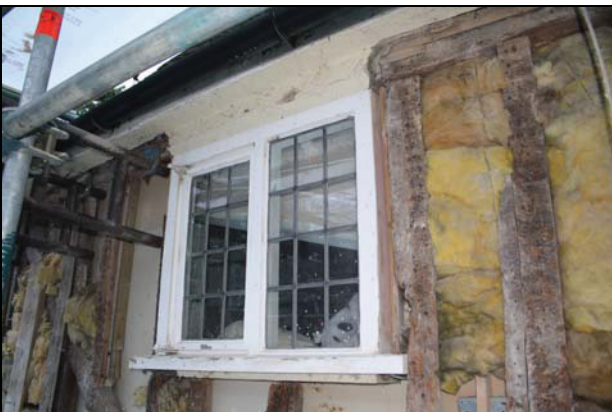
DP 40

Mortise for the sill piece of an original window in the west bay of the upper floor, south side of the historic range, taken from the south-west

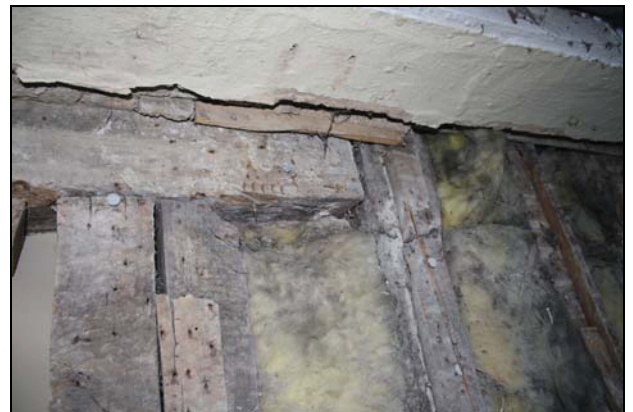
DP 41

Existing window in the west bay at upper level, south side of the historic range, taken from the south-east

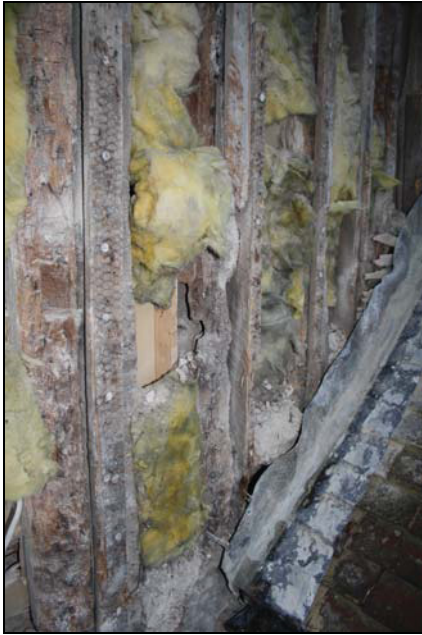
DP 42

Junction between the west bay and the chimney bay at wall-plate level, south side of the historic range, taken from the south

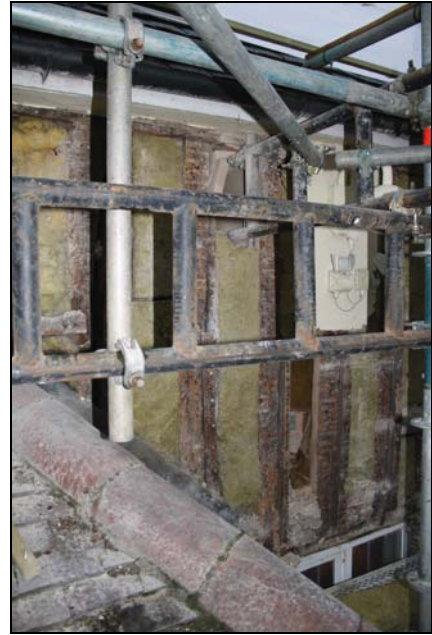
DP 43

Detail of through mortice in the west post of the chimney bay at upper level, south side of the historic range, taken from the west

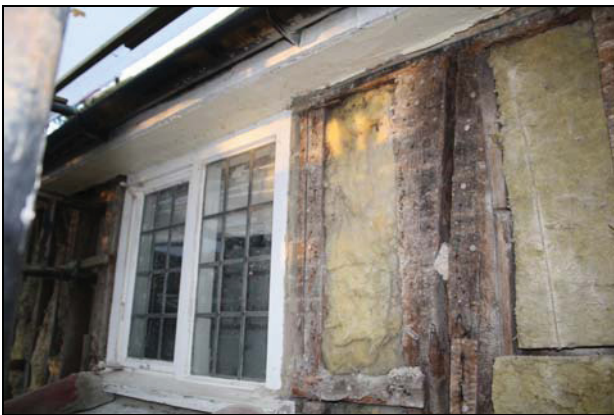
DP 44

East side of the chimney bay at upper level, south side of the historic range, taken from the south-west

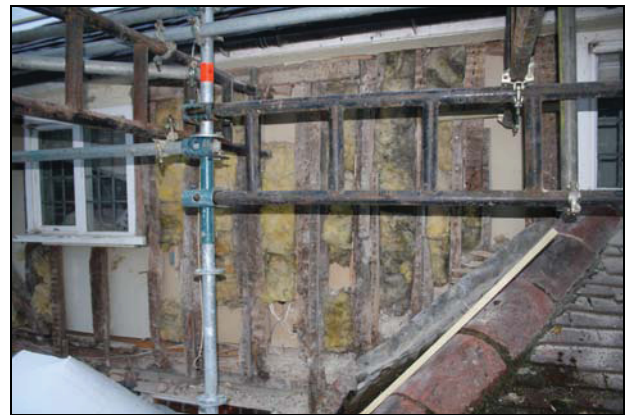
DP 45

Robust post between the chimney bay and the east bay at upper level, south side of the historic range, taken from the south-east

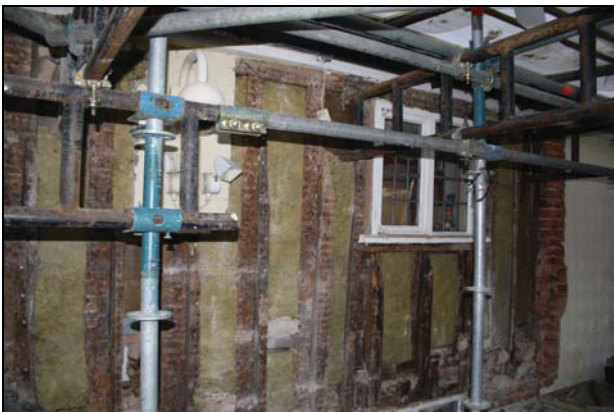
DP 46

Timber-framing at upper level of the junction between the west bay and chimney bay, south side of the historic range, taken from the south

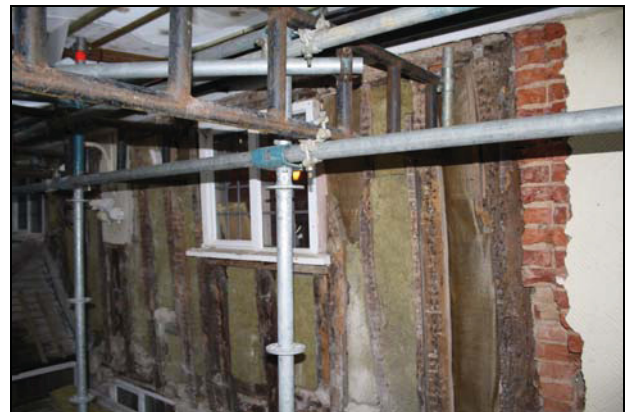
DP 47

Timber-framing of the east bay at upper level, south-side of the historic range, taken from the south-west

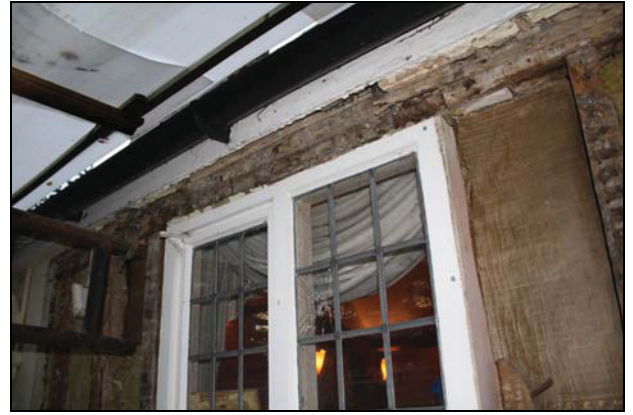
DP 49

Base of studs in the east bay at upper level showing fragmentary mid-rail, south side of the historic range, taken from the south-east

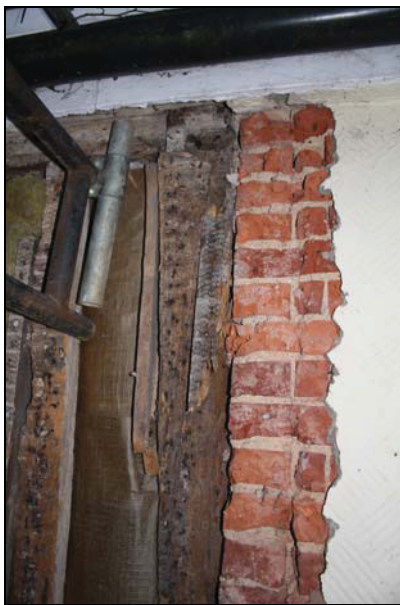
DP 50

Wall-plate of the east bay showing existing window and pegs in the wall-plate, south side of the historic range, taken from the south-east

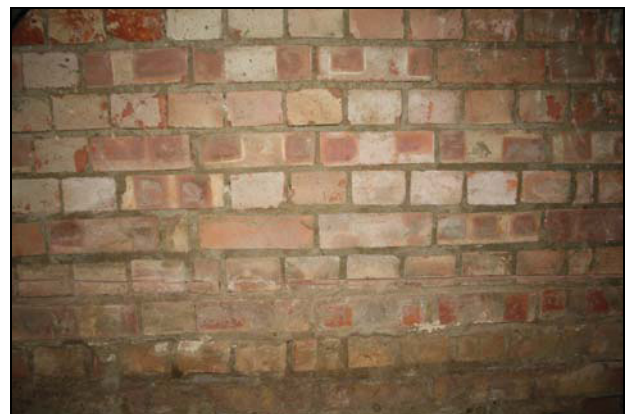
DP 53

Detail of brickwork at ground floor level in the east bay, south side of the historic range, taken from the south

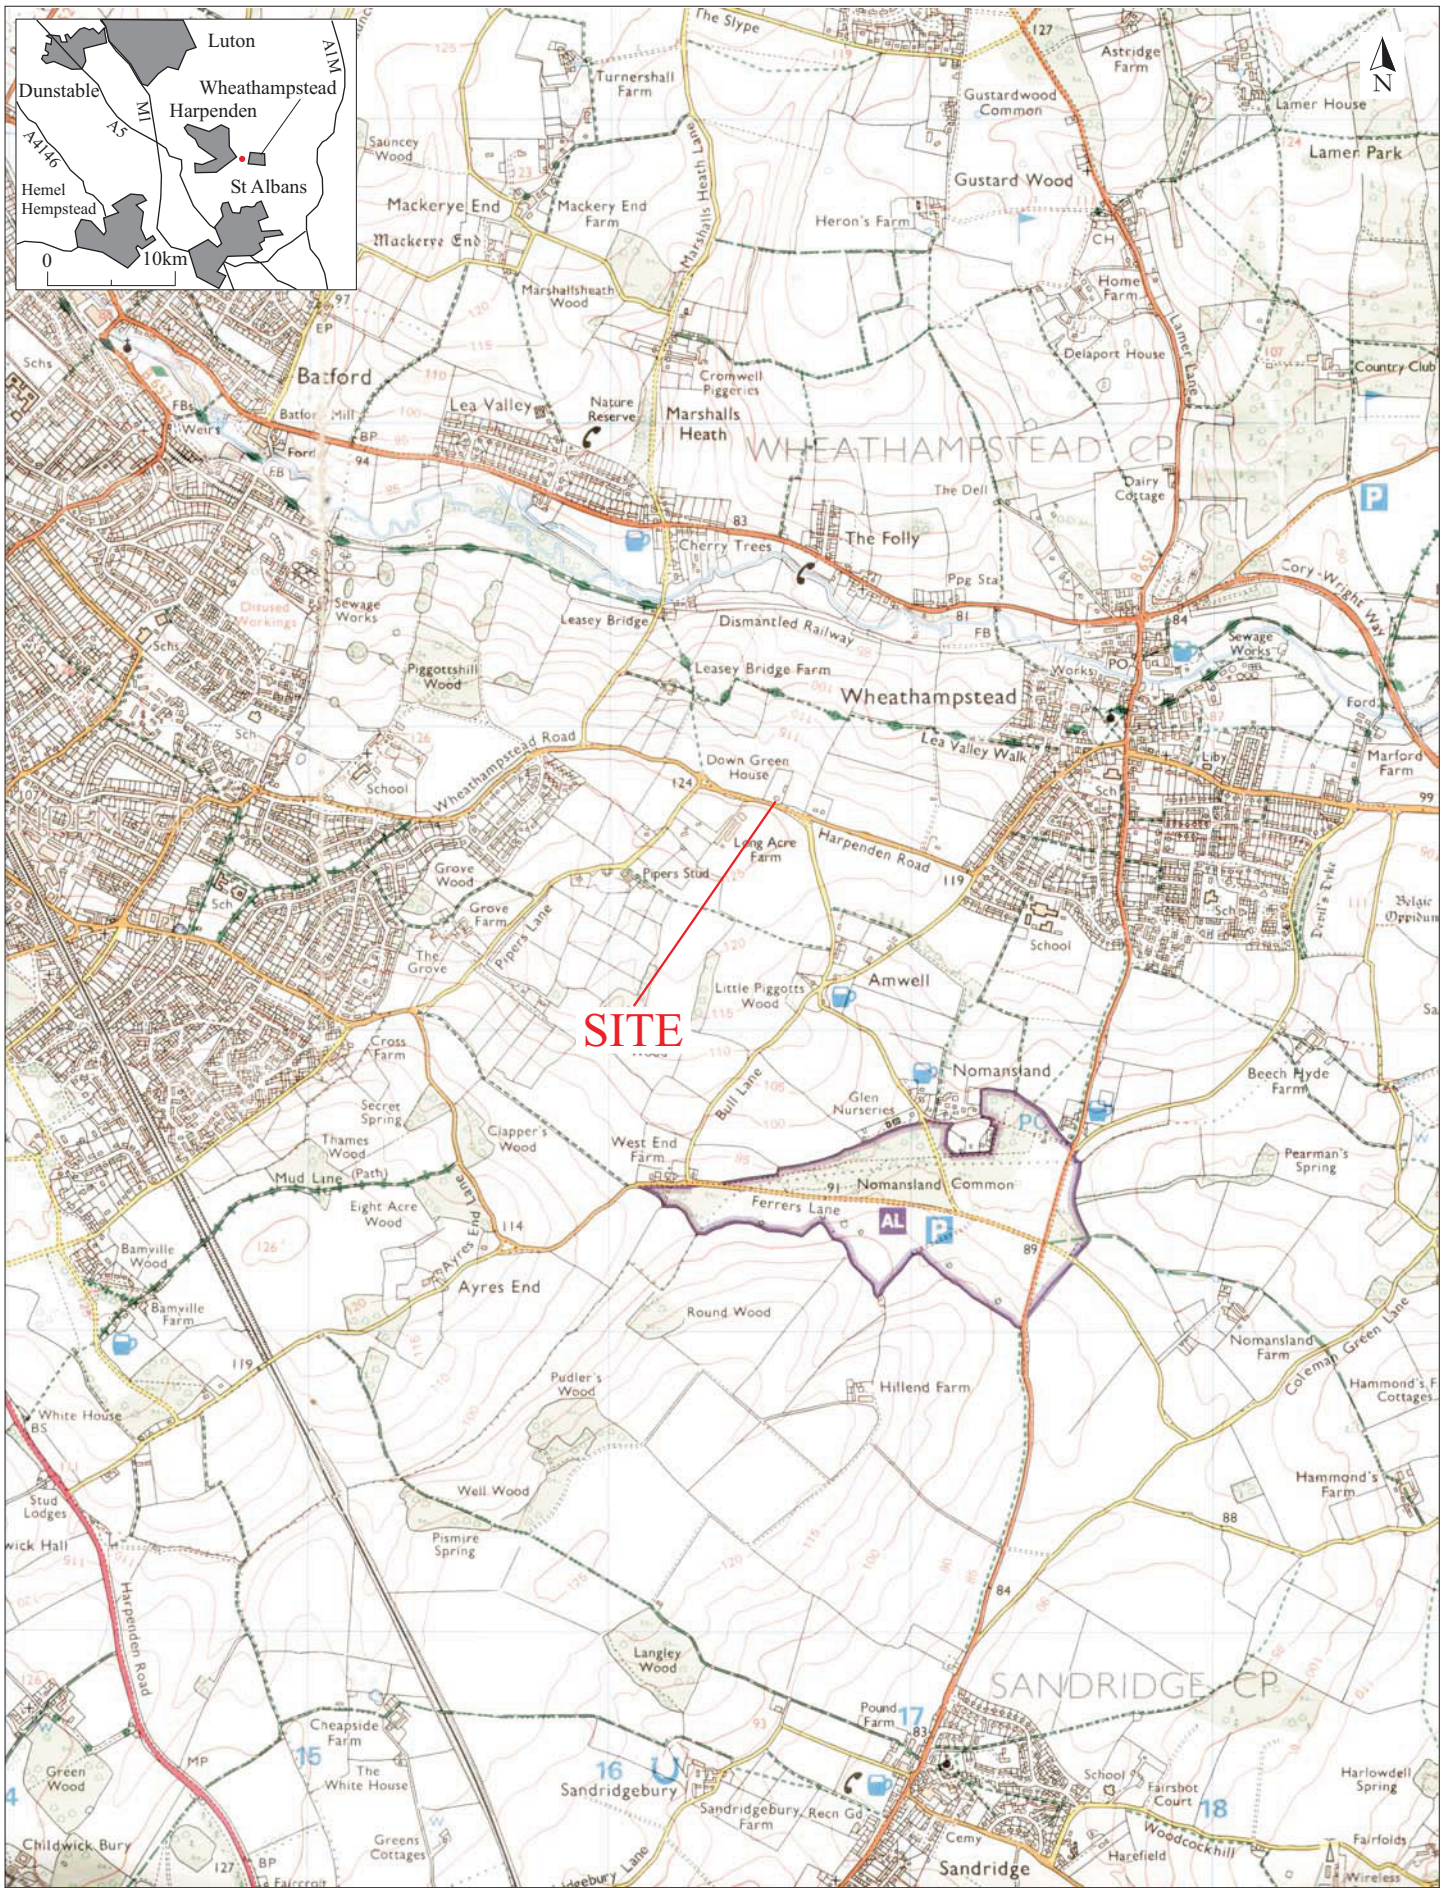
DP 54

Detail of the brickwork of the porch on the south side, taken from the south
