**BUILDINGS ON LAND OFF FOLLY ROAD,
GREAT WALDINGFIELD, SUFFOLK**

**An Archaeological Desk-Based Assessment and
Historic Building Recording**

Authors: Peter Thompson MA Lisa Smith BA	
NGR: TL 9080 4349	Report No: 3515
District: Babergh	Site Code: WFG 041
Approved: Claire Halpin	Project No: 3325
Signed:	Date: March 2010

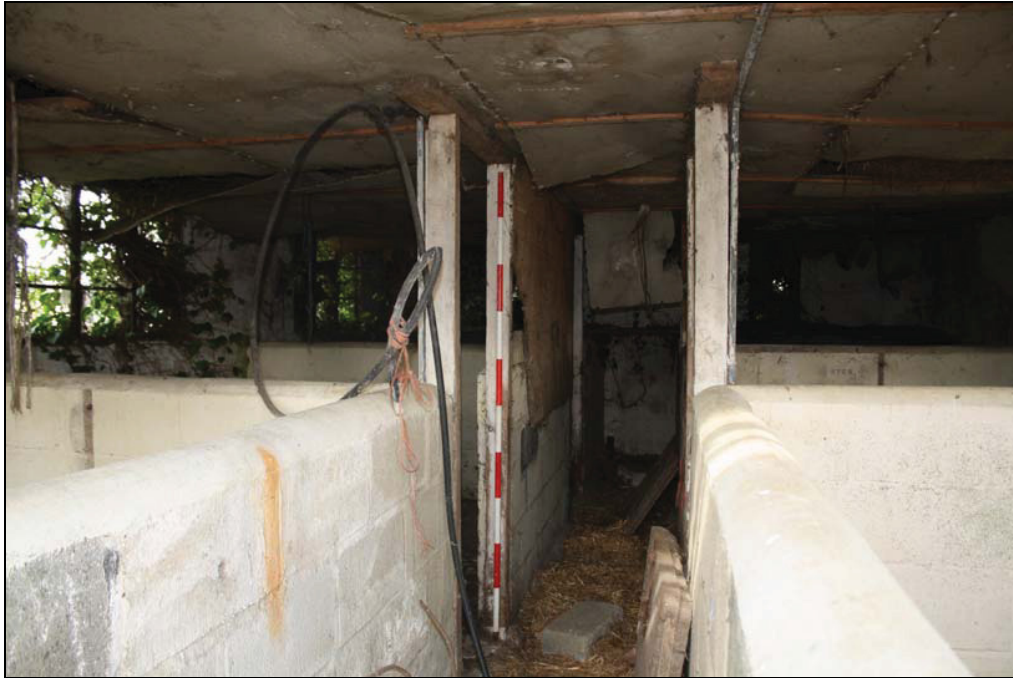
6.24 Internally the building has been completely altered to accommodate animal stalls inline with its later agricultural role and retains no evidence for its original function (Plate 5). Six stalls defined by four courses of modern white-washed block work flank a central concrete walkway leading to a blocked doorway in the northern gable end. The entrance to each stall is framed by timber uprights carrying lateral members providing additional support to a flimsy ceiling. A single small vertically boarded door remains *in situ* hung from the timber jamb by modern strap hinges. Others have been removed and now lie scattered throughout the building. Metal water drinking bowls attached to the dividing walls and glazed concrete feeding troughs feature in each of the stalls. The two northern most stalls are occupied by semi-circular metal framed pens clad in corrugated iron with sheet metal doors.

Plate 5 The airmen's latrines, interior, divided into animal pens taken from the south (DP 19)

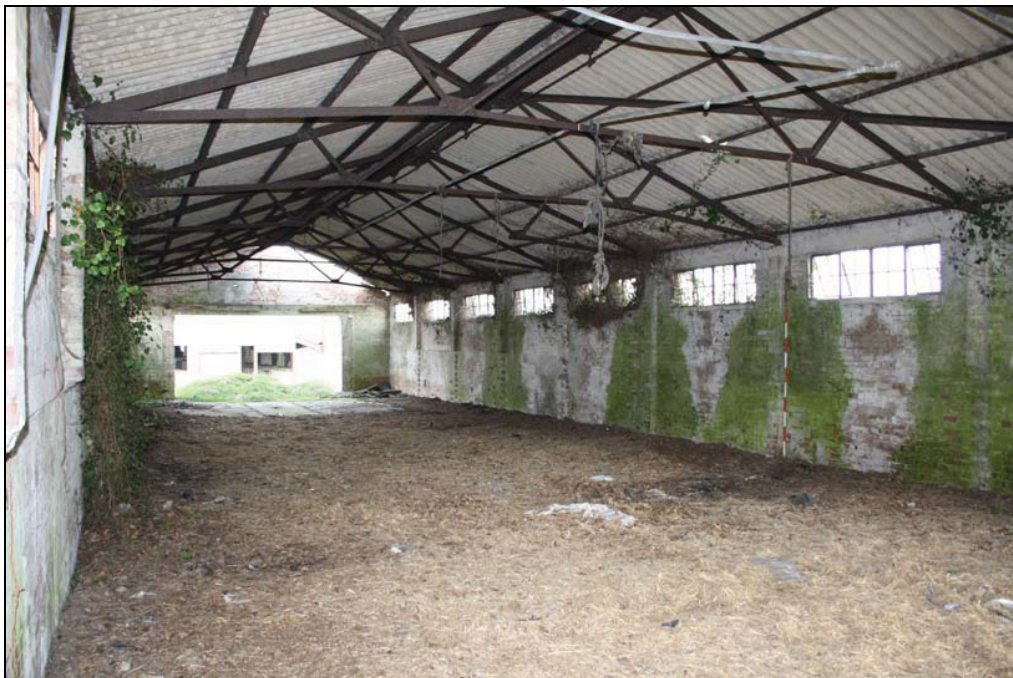
6.37 The walls rise in white washed stretcher bond divided at regular intervals by buttresses consistent with the external pattern each supporting a metal roof truss. A regular arrangement of windows, rusted with all glass now removed occupies the upper areas of each bay (Plate 8). Six wide doorways framed by concrete lintels and blocked with brickwork pierce the elevations. These doorways can be seen in the second, fifth and eighth bays of the north-east facing elevation and in the second, fourth and eighth bays of the south-western elevation leading into the south-western range. Many of these blocked openings are not visible from the exterior suggesting that the building was rendered after they were bricked up.

Plate 8 The gymnasium, interior, taken from the south-east (DP 39)

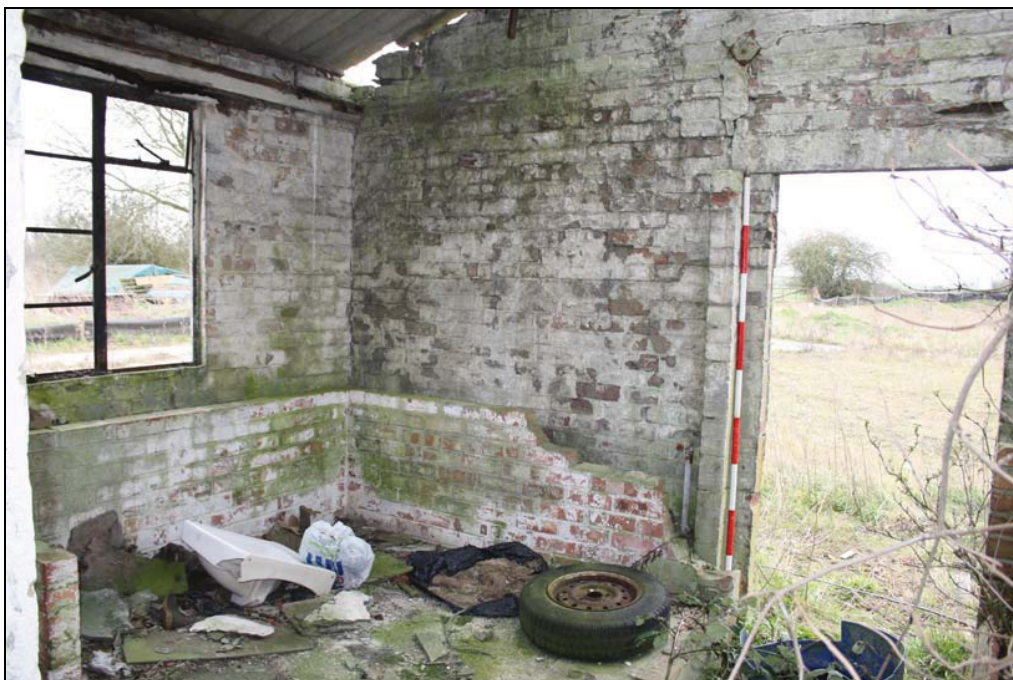
Plate 12 The meat and ration store, interior, bay 1, taken from the north-west (DP 77)
