**MALLOWS GREEN FARM BARNs,
MANUDEN, ESSEX**

HISTORIC BUILDING RECORDING

Authors: Dr Lee Prosser Lisa Smith BA Kathren Henry Kate Higgs BA	
NGR: TL 472 266	Report No. 3591
District: Uttlesford	Site Code: MAMG10
Approved: Claire Halpin MIFA	Project No. 3926
Signed:	Date: July 2010

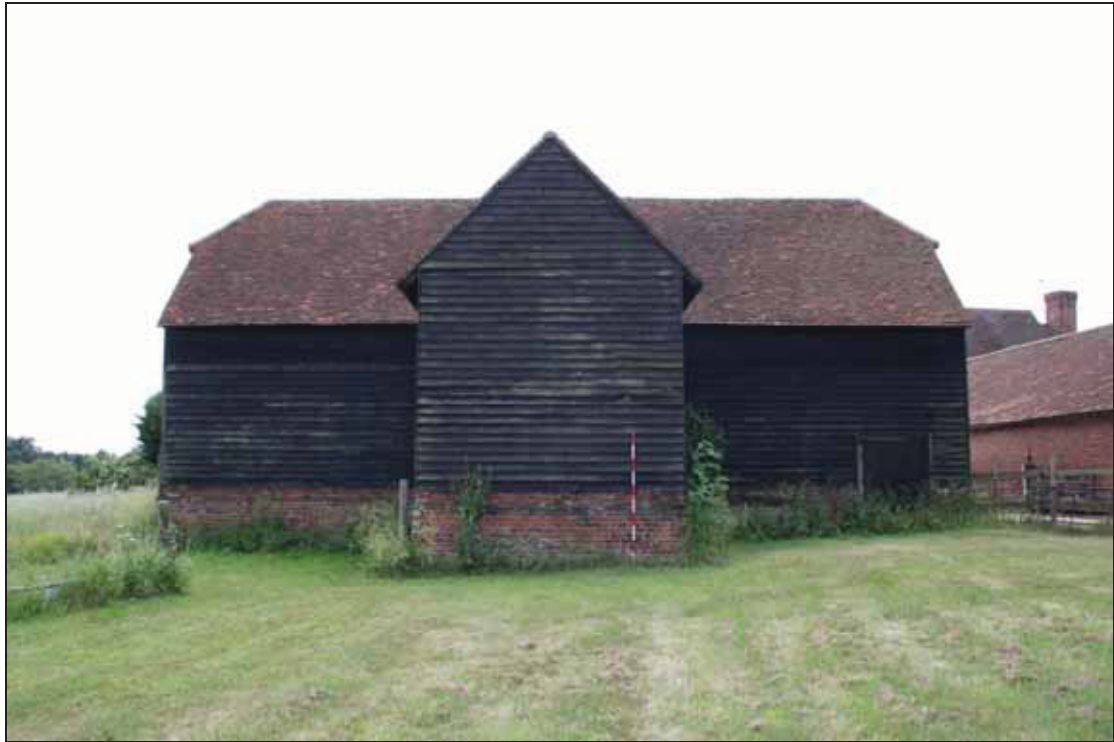
Plate 1 Building 1, northern elevation, taken from the north (DP42)

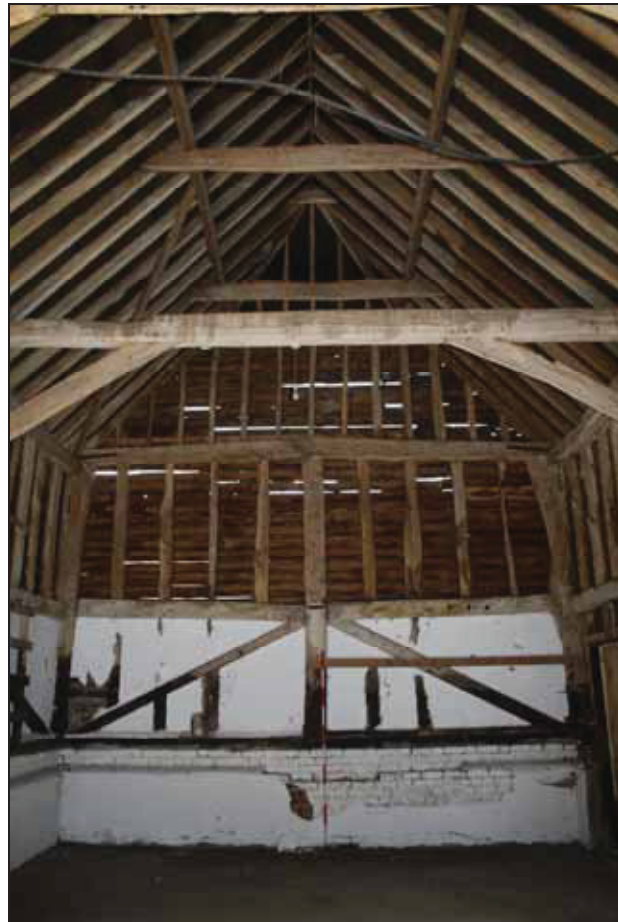
6.34 The western gable has a central prick post with in-line mid-rails on either side (Plate 4). The lower register retains its later applied diagonal braces over a rendered surface with a few studs visible behind. The upper register has four studs in each panel; three are original and retain notches for downward corner bracing. The tie-beam is slightly curved and supported with iron strapping. Above the tie-beam slender studs extend to a collar clasping purlins to the rafters.

Plate 4 Building 1, interior, truss 6, western elevation, taken from the east (DP 16)

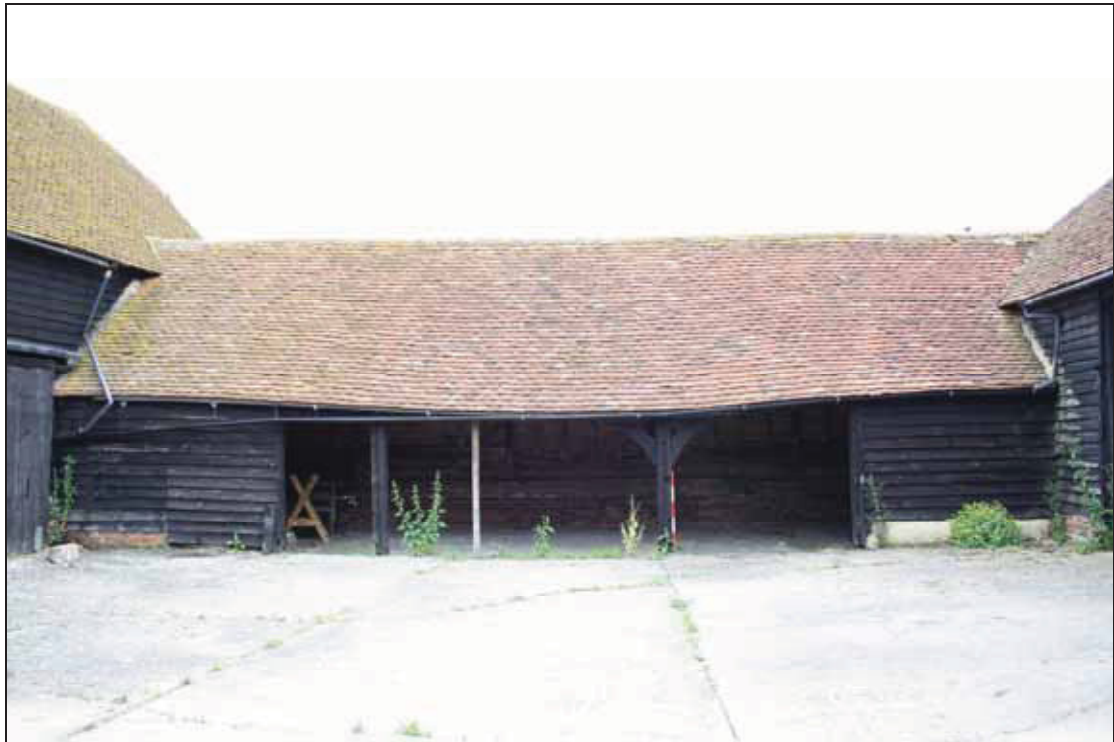
6.38 Building 2 is a five-bay timber-framed and weather-boarded cart shed standing a low brick dwarf wall which has been rendered at the south-western end. The three central bays are open to the courtyard and framed by robust posts, but only one original survives with short curved braces (Plate 5). The rear elevation is weather boarded as before; the roof is peg-tiled.

Plate 5 Building 2, western elevation, taken from the west (DP 45)

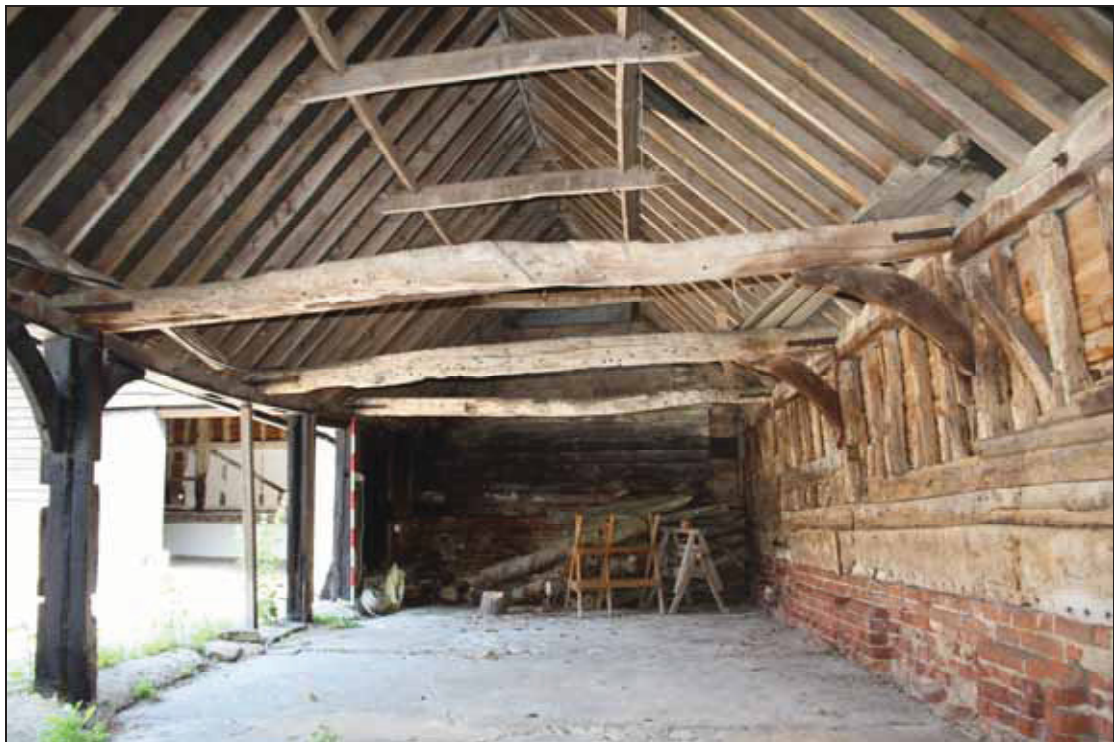
6.39 The building is constructed with a mixture of oak and softwood elements in distinct phases, suggesting a comprehensive refurbishment at some stage (Plate 6). The building was formerly used for livestock, indicated by wide nailed-on boards of immense width (one measuring 21") which may indicate the presence of a manger or feeding trough extending along the eastern wall. A brick plinth in the same form and fabric as the main barn is visible on three sides, but not well preserved. The concrete floor preserves marks for stall divisions, now removed.

Plate 6 Building 2, interior, taken from the south (DP 18)

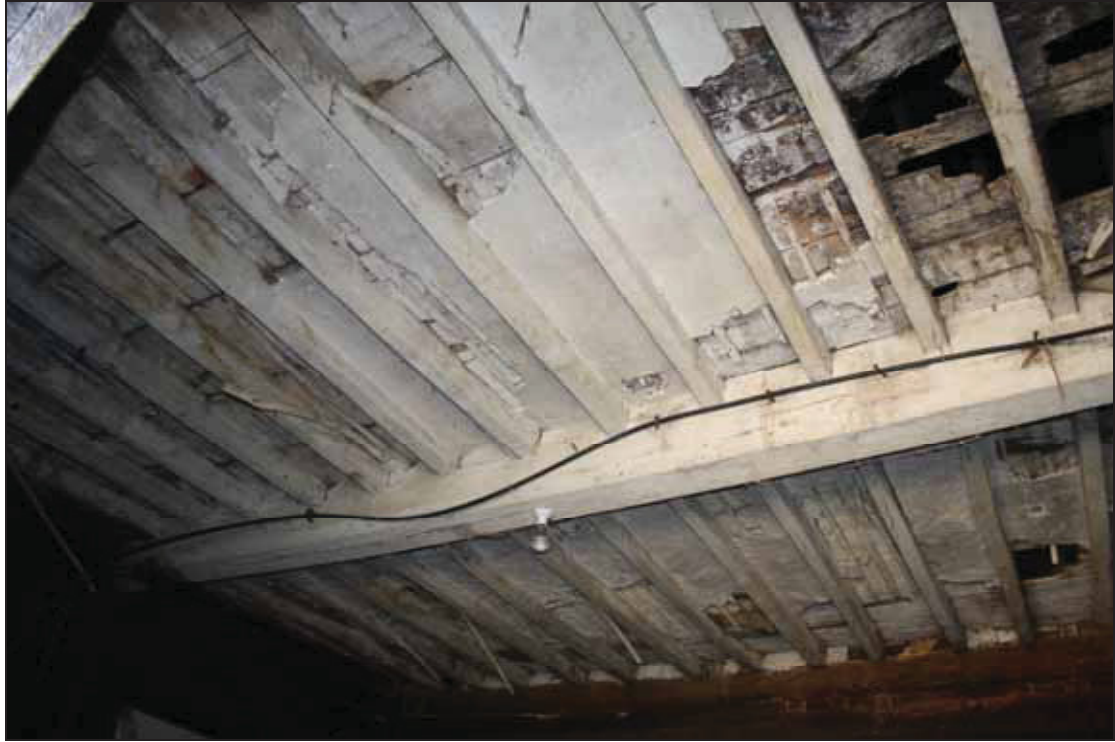
6.61 The ceiling within both chambers is exposed and supported by large principal joists, chamfered on both sides with lambs-tongue stops at both ends. Wide-spaced common joists are jointed to the main beam with diminished haunches and pendant soffits (Plate 9). These are ceiled from above with lath and plaster over which wide upper boarding has been laid. The decoration of the main joisting lies at odds with plain supporting posts, suggesting that they were not meant to be seen. In the west chamber, two joists have been removed and a trimmer inserted for a ladder stair giving access to the loft above (Plate 10). The stair does not survive.

Plate 9 Building 4, interior, ground floor ceiling, taken from the north-west (DP 26)

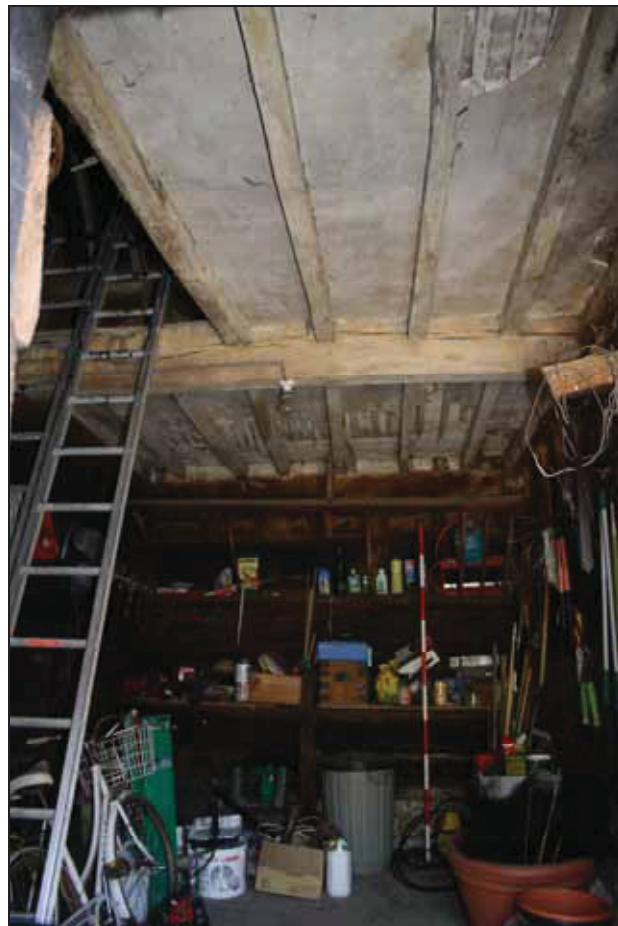
Plate 10 Building 4, interior, ground floor, taken from the north (DP 27)

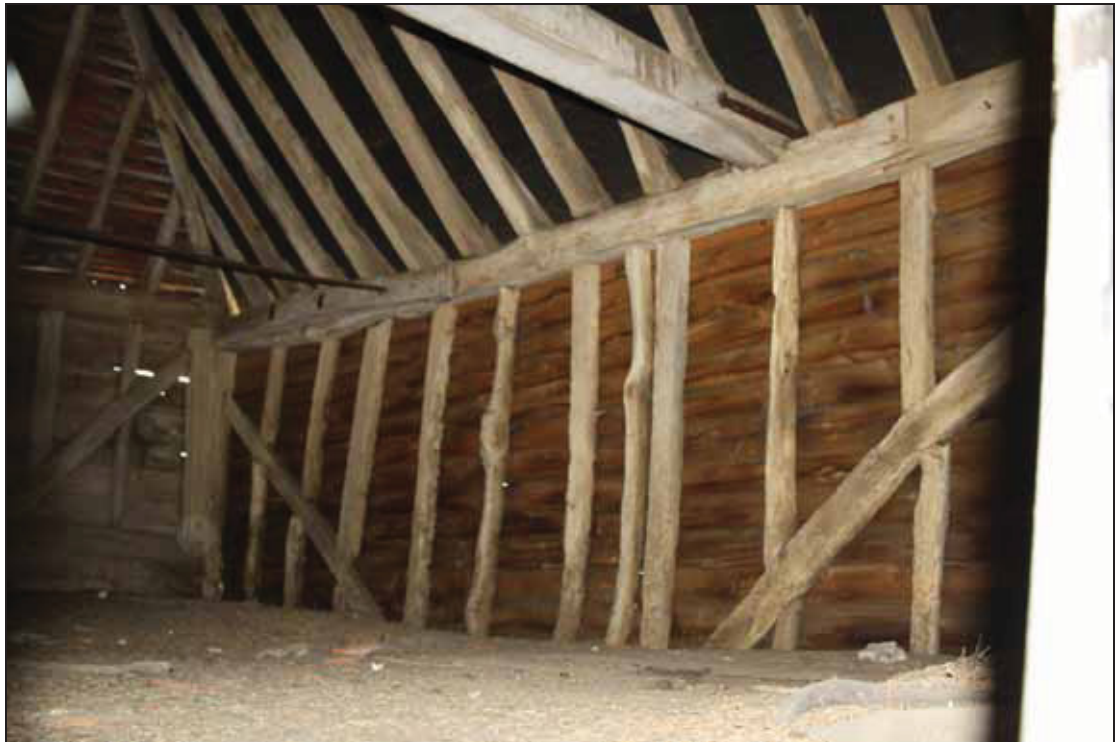
6.62 The upper chamber was considered too hazardous to explore and so was viewed from the vantage point of the former stair aperture only. Un-boarded wall-framing is visible all round, with gently swelling jowled corner posts and plain principals above their lower counterparts. The bay panels however seem to differ from those below; here they are primary-braced from the corner posts as well as central members with a regular arrangement of studs (Plate 11). The studwork in the north-eastern corner has been replaced. The wall-plate is of good quality scarfed in places and given some assistance by bolted-on cleats and other members. A rudimentary balustrade rail frames the opening.

Plate 11 Building 4, interior, first floor, southern elevation, taken from the north-west (DP29)

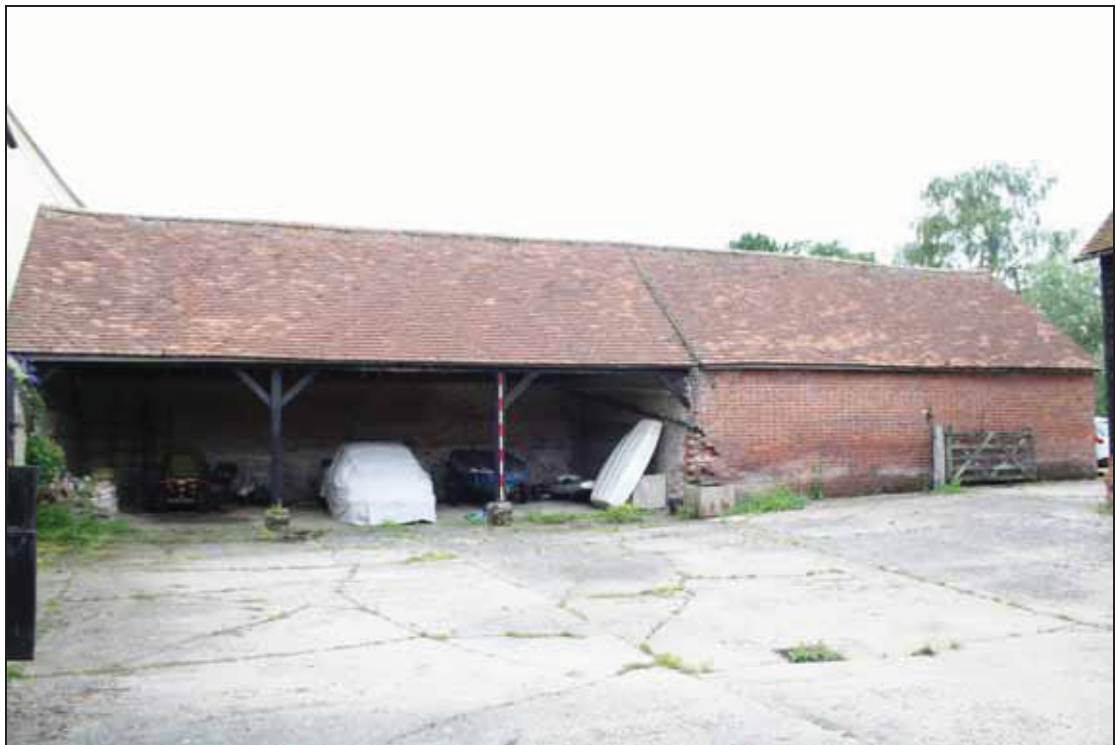
6.66 The building consists of two units: a three bay cart shed open to the courtyard and an enclosed brick unit to the north, given access from the west and presenting only a blank brick wall to the east (Plate 12). The south gable end incorporates an existing garden wall with the remaining elevations constructed of homogenous 19th century unfrogged brickwork, measuring 8¾" x 2 3/8" x 4 1/8" laid in Flemish bond with ¼" buff-colour flinty lime mortar

Plate 12 Building 5, eastern elevation, taken from the south-east (DP 48)
