**CHURCH OF ST BOTOLPH,
IKEN, SUFFOLK**

HISTORIC BUILDING RECORDING

ARCHAEOLOGICAL SOLUTIONS LTD

Authors:	Tansy Collins BSc Lee Prosser PhD Peter Thompson MA Kathren Henry	
NGR: TM 0265 6235		Report No: 3592
District: Suffolk Coastal		Site Code:
Approved: C Halpin MIFA		Project No: 3499
Signed:		Date: July 2010

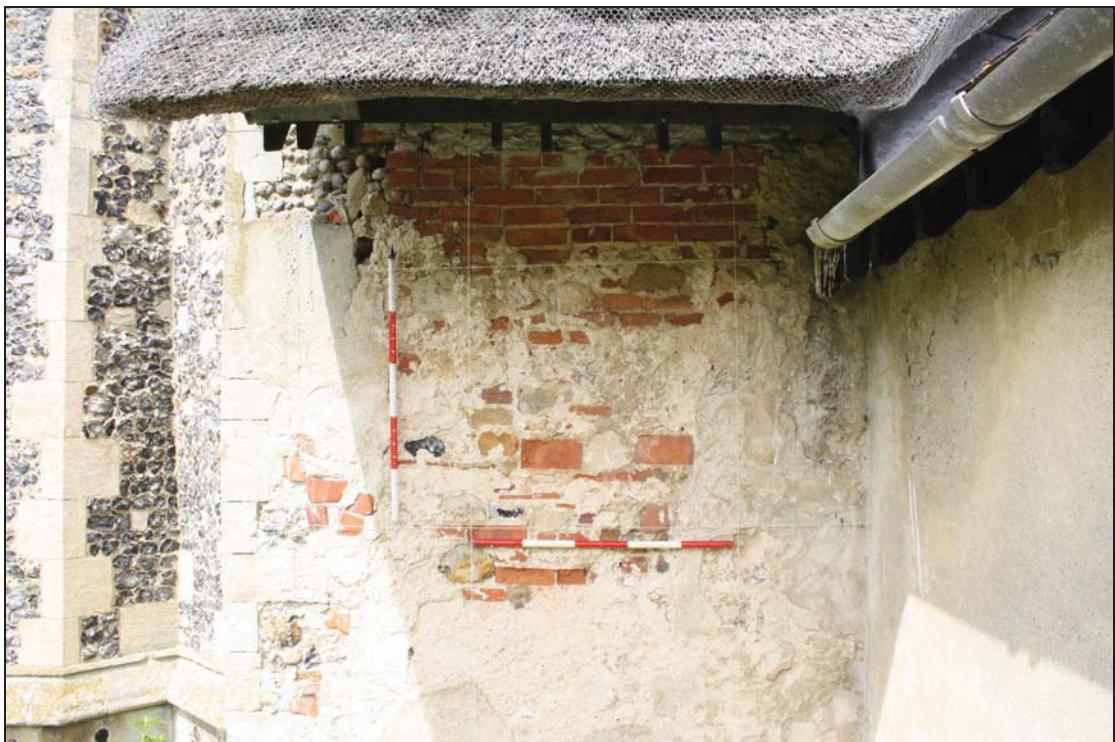
5.23 This is a final short section of the nave terminating at a ragstone buttress contemporary with the chancel. Only c.1m of the wall fabric survives at lower level (Plate 9) as the upper area has been entirely replaced with 20th century pink Fletton bricks laid in stretcher bond immediately behind the former rood stair, which survives within the church. The lower courses are of

9 North nave wall, lower Bay 4, taken from north (01)

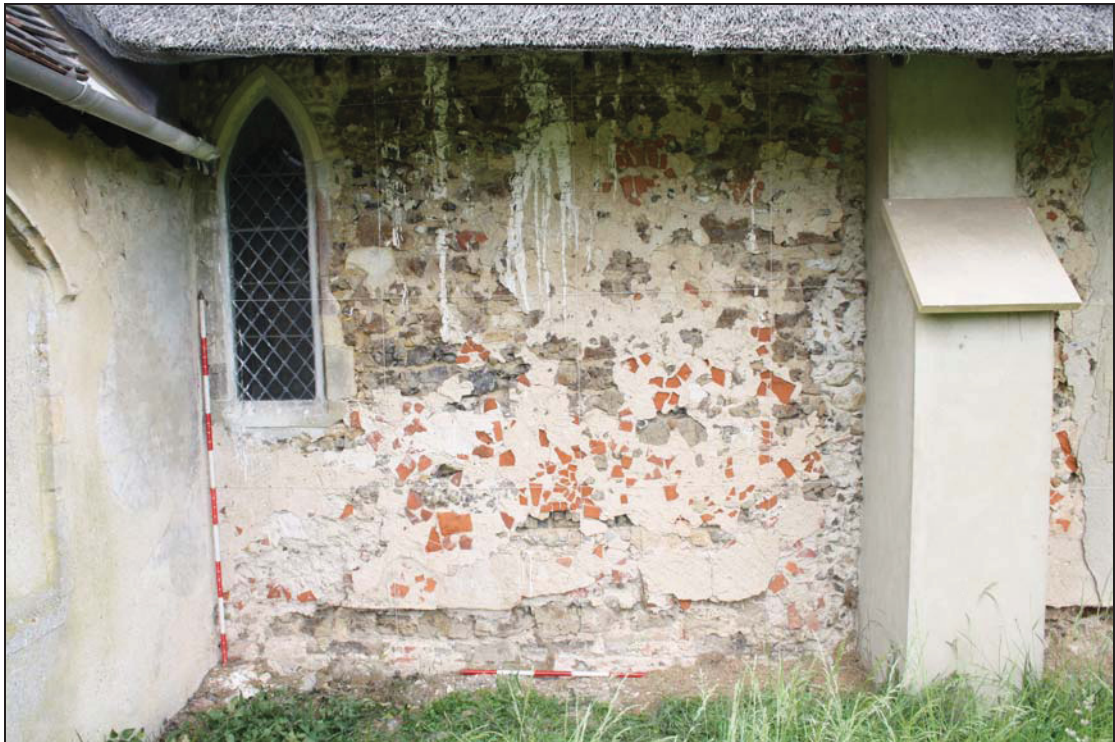
10 Detail of south nave wall, Bay 1, taken from the south (14)

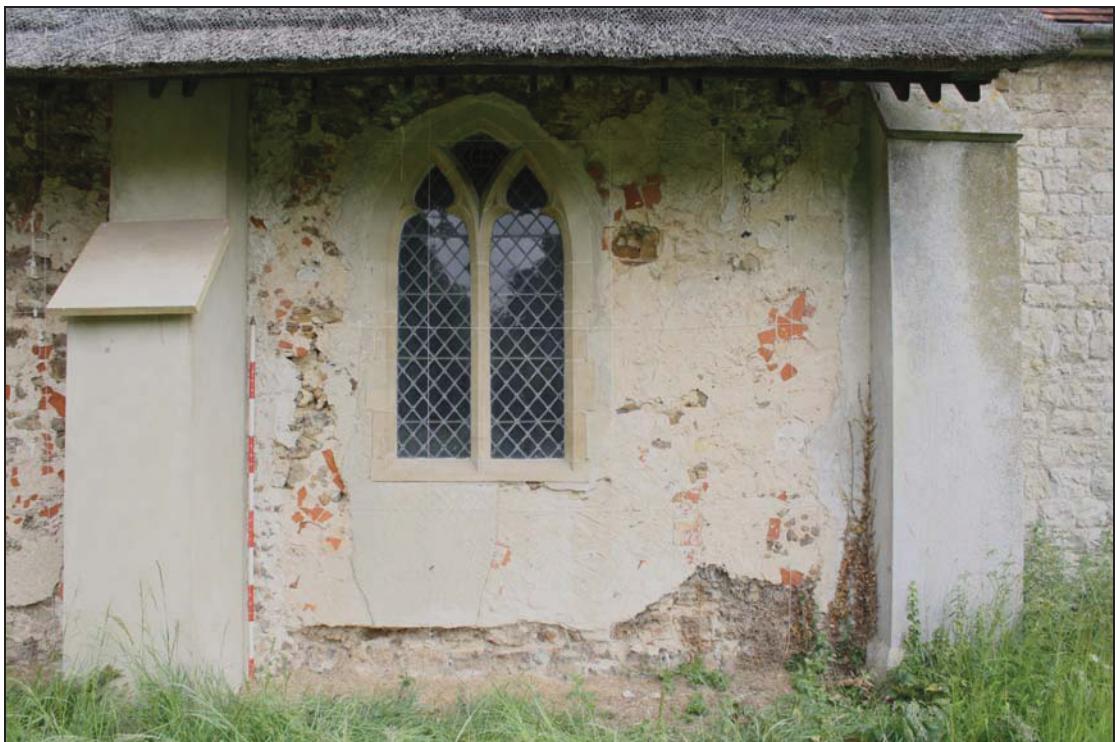
11 South nave wall, Bay 3, taken from the south (15)

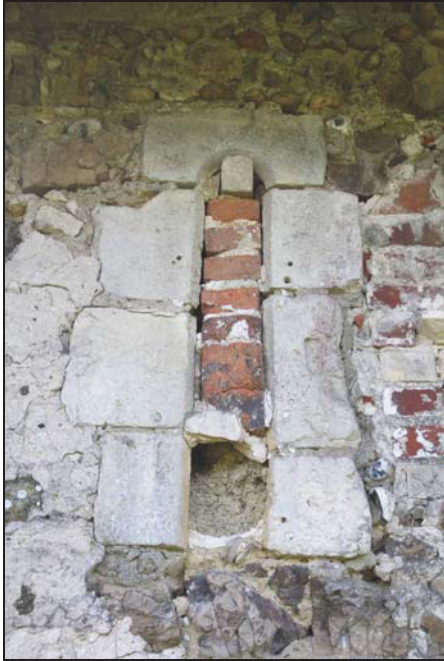
42

Possible putlog hole (P1) in Bay 3, north nave wall, taken from the north
