**BARN AT TILE KILN FARM, A1017,
SIBLE HEDINGHAM, ESSEX**

HISTORIC BUILDING RECORDING

Level 3

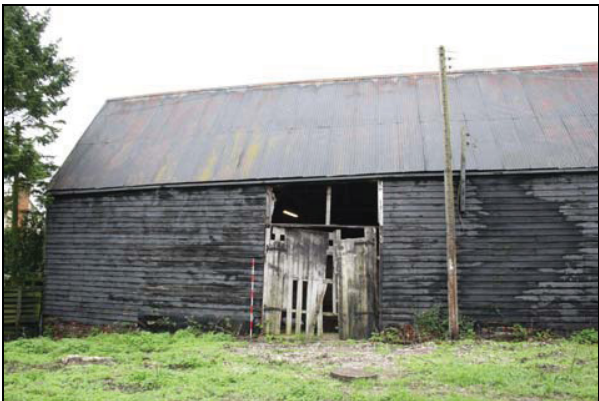
1

6.1 The barn stands in a dilapidated state on a small plot of land including a yard with modern farm buildings associated with the farm house (Plate 1). It is orientated north-west to south-east, but for ease of description, is considered to be east-west in the description below. The building has five bays with a central porch on the north and an adjoining outshut to its west, all weather-boarded (Plate 2). A large central entrance on the south now forms the principal access. The original roof has been replaced with corrugated

Barn, Tile Kiln Farm, south-western elevation, taken from the south-west

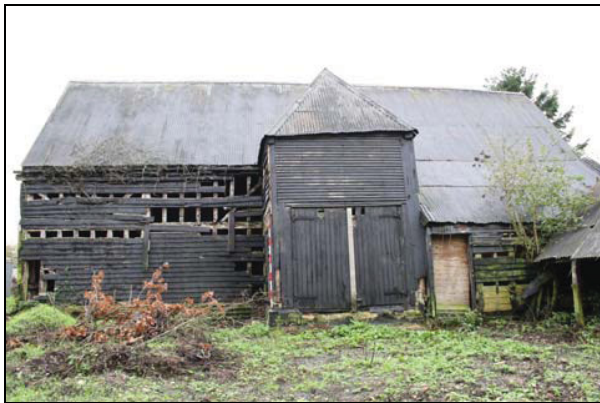
4

Barn, Tile Kiln Farm, north-eastern elevation, taken from the east

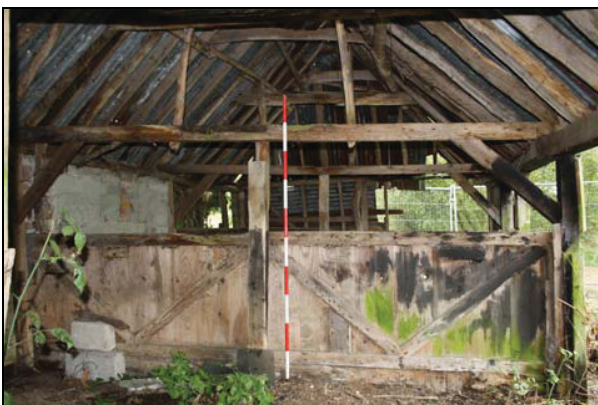
11

6.31 The animal byre abuts the outshut and is partly ruinous, but it remains open-fronted on the east with much modification elsewhere. Internally it retains fragments of a coherent five-bay structure, probably of 19th century date, with a fairly slender frame of oak and softwood, especial care having been taken to use the best timber for the wall-plates and principal posts (Plate 9). The rear wall panels are in poor condition. Two have partially collapsed while a third has been replaced by brick and concrete. One panel is complete, and has slender, primary-braced slender studwork. Internal stall partitions with horizontal boarding survive and are most probably original.

Stall partition, animal byre, interior, taken from the south-west

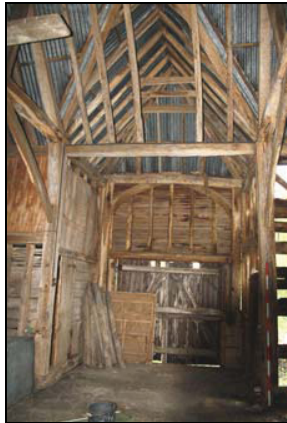
13

6.15 The porch (Plate 6) is clearly original to the frame, as the tie-beams at the bay division sail over the principal posts to become wall-plates and are scarfed to short pieces completing the wall. The area preserves sole-plates and mid-rails on both sides. On the west, two studs have been removed to insert a later door to the outshut, though this is probably of late 17th or early 18th century date, with bead-moulded softwood boards, ledged to the rear and hung on an upper strap-hinge with a pintle and a lower conventional strap

Porch interior, taken from the south-west

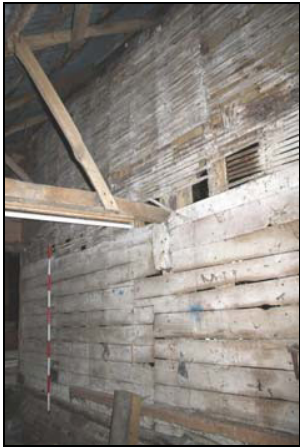
19

6.26 The addition of the outshut has been beneficial in preserving some original external cladding to the main barn (Plate 8). This follows the traditional East Anglian pattern of upper plasterwork with lower weatherboarding. The existing boards are hand-sawn oak or elm but applied as butted boards and not overlapped as proper weather-proofing, suggesting that the outshut is contemporary. The upper plasterwork has mostly been removed, though the laths survive extensively.

Upper laths and lower weather boarding, original external barn elevation seen in the outshut, taken from the north

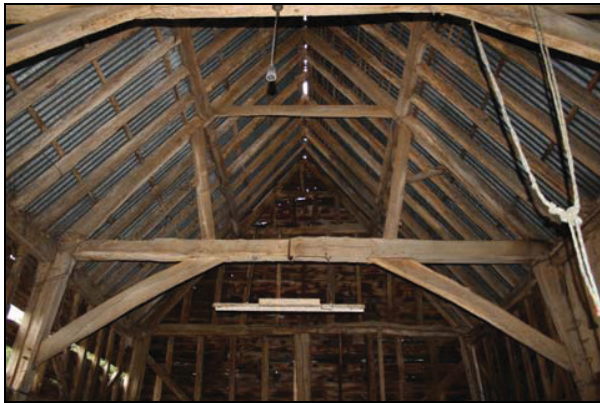
21

6.4 The five bay division trusses are identical and comprise slightly splay-cut, jowled principal posts with long, slender braces to tie-beams and raking queen struts rising to principal rafters (Plate 4). A collar is also preserved above a series of butted side purlins which have a regular arrangement of common rafters in two flights pegged to the purlins. Slender straight wind braces are present in the end bays on the south side only.

Truss and roof structure, taken from the north-west

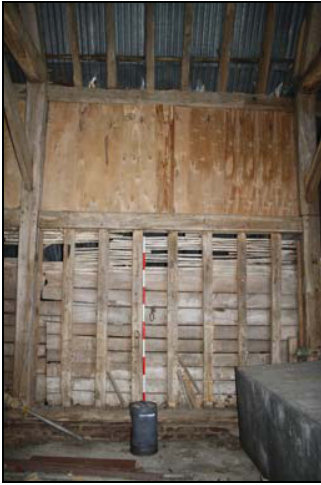
25

6.11 All members on the north side of bay 2 are original, with seven lower common studs (some re-used) and obscured upper studs, probably primary-braced and in-line as indicated by peg holes (Plate 5). The wall-plates are joined with face-halved and bladed scarfs, double-pegged and additionally strengthened by a coach bolt.

Bay 2, north-eastern panel, taken from the south-west

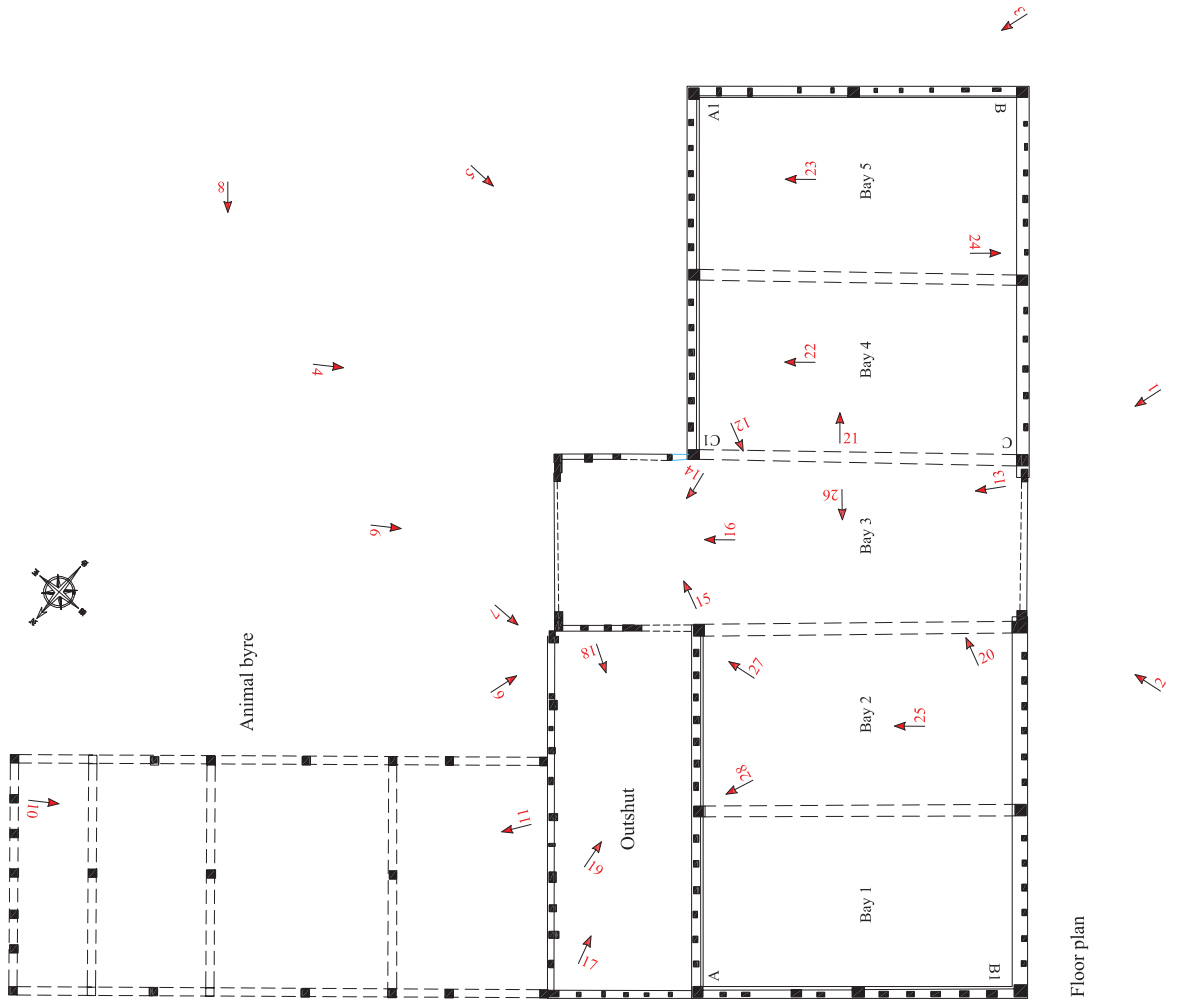
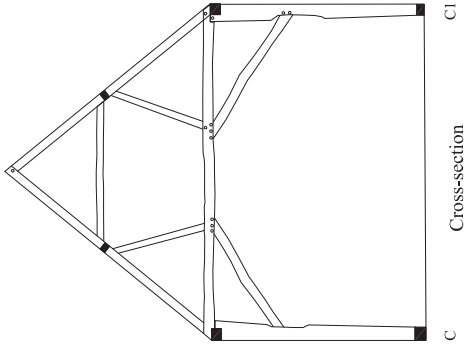
Archaeological Solutions Ltd
Fig. 8 Floor plan & section
 Scale 1:100 at A3

6 THE BUILDING (Fig. 8 & 9)
