Archaeological Observation
Investigation and Recording
at
122 Strensall Road
Huntington
York

Planning Reference: 06/01020/FUL National Grid Reference: SE 6027 5713 Site Code: WB2006.072

Watching Brief Report Number: 946 August 2007

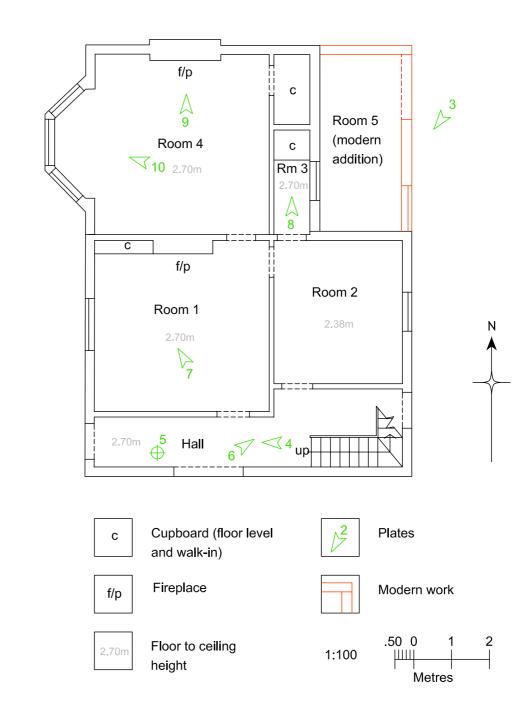
Figure 3 Ground-floor plan of the farmhouse (Ilford House)

The straight joint in the west elevation of the farmhouse and the overlapping of the bathroom window by a subsequent wall point to the house having been built in two phases (*Figures 3 and 4*). However, given the stylistic integrity of the two halves of the house and the very similar nature of the brick, it is most probable that the second phase was initiated very shortly after the completion of the first during the later 19th century.

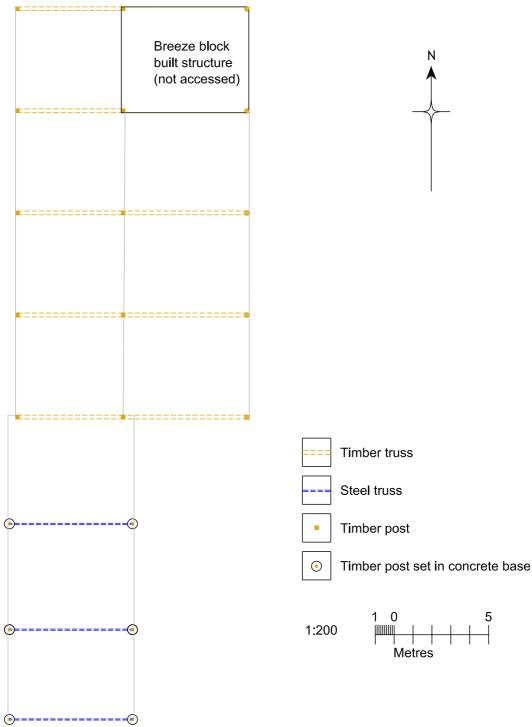
Figure 6 Plan of the open-sided barn

and set in *in-situ* cast concrete bases 0.53m across (*Figure 6*). The southern part had three mild steel trusses supported by round-section timber posts some 0.15m across, and set in the same size concrete bases described above. The roofing material appeared to be cast iron sheeting throughout. The southern part was probably a later addition.

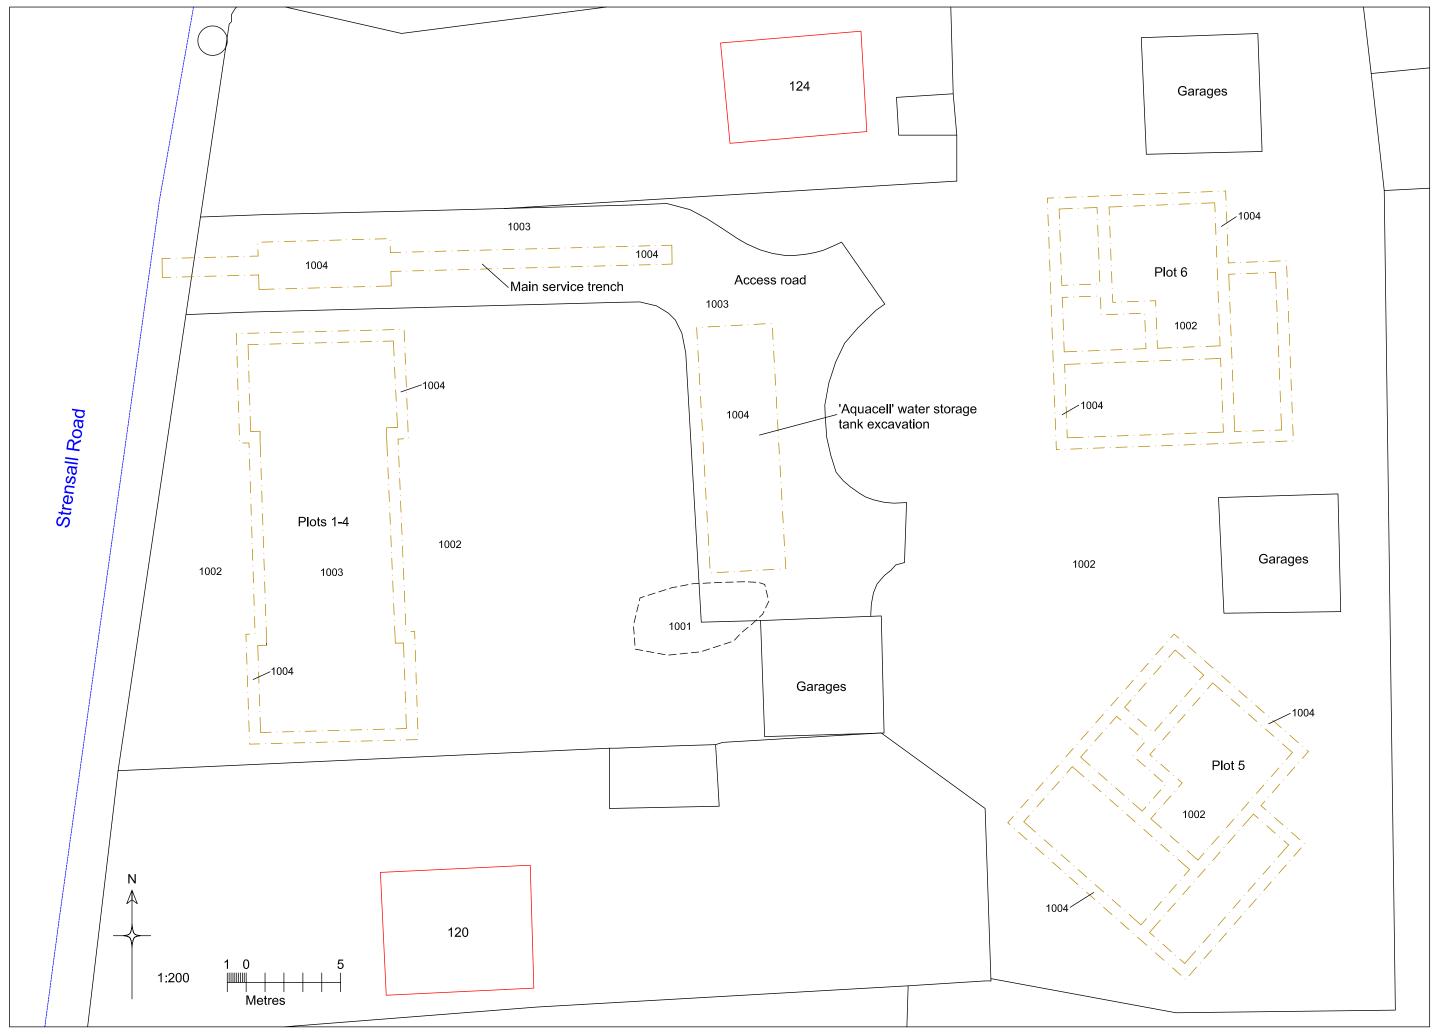
Figure 7 Plan showing the location of the foundation and other trenches within the development

The main service trench for the site was observed open for a length of around 27m, running east to west along the centreline of what would be the access road to the new dwelling (*Figure 7, Plate 22*). The trench was 1m wide, except for an area some 7m by 2.50m, intended to accommodate two manholes, and was generally around 2m deep. Throughout the base of the trench was a layer at least 1.50m thick of a firm yellow brown clay, that was largely free of inclusions (1004). Above this there was a 0.30m thick layer of a mid brown silt clay subsoil (1003) and a 0.20m thick layer of dark greyish brown topsoil (1002). No archaeological features were observed.

The 'Aquacell' water storage tank (*Figure 7, Plate 23*) was accommodated in an excavation some 13m long, 4m wide and up to 2.15m deep. The stratigraphy observed was as above, save that the (1004) was up to 1.65m thick and there was, within the (1002), a spread (1001) of especially contaminated topsoil containing ceramic building material and other demolition debris, together with a substantial number of ceramic and glass bottles and jars (see **5. Finds**).

The foundation trenches for plots 1-4 covered an area measuring 21.5m from north to south and 9m from east to west (*Figure 7, Plate 24*). This area was stripped of topsoil (1002) and subsoil (1003) to a depth of around 0.50m. The foundation trenches were up to 2m deep and contained the stratigraphy observed for the main service trench, with the (1004) at least 2m thick. No archaeological features were observed.

The foundation trenches for plots 5 and 6 both measured up to 13.50m by 12.50m (*Figure 7, Plate 25*). They were generally around 0.90m deep, with a layer of (1004) at least 0.40m thick in the base of the trenches. Above the (1004) was a 0.30m thick layer of a very dark charcoal grey silt that was largely free of inclusions (1005) (*Plate 26*). This in turn was covered by a 0.20m thick layer of (1002) that was heavily contaminated with demolition debris. No archaeological features were observed in either plot.

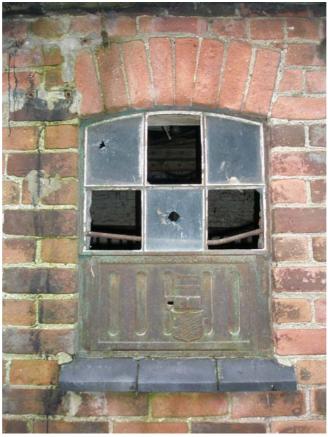
Plate 14 Window detail in east wall of stable (loose box)

Like the small building housing the vacuum pump for the milking machinery (see above), this was a 20th-century addition to the buildings. It had a slate covered monopitched roof and was built in the same muted orange/brown brick as the vacuum pump house, the brick being laid in an English Garden Wall Bond (*Plate 13*). There was a row of ventilation slots and a heck (split) door in the north elevation and an unusual window in the east elevation. This was small and with a segmental brick arch. It had a 6-pane upper portion and a lower part comprising a cast iron sliding grill bearing the caption, 'The Desideratum Sliding Granary Window. Tomlinson-Walker Iron Works. York' (*Plate 14*). The south elevation was featureless with the exception of a row of ventilation slots
