**Dale Gap Farm, Barrow Hill,
Rocester, Staffordshire**

Building Recording

Site Code: DGR18/78

May 2018

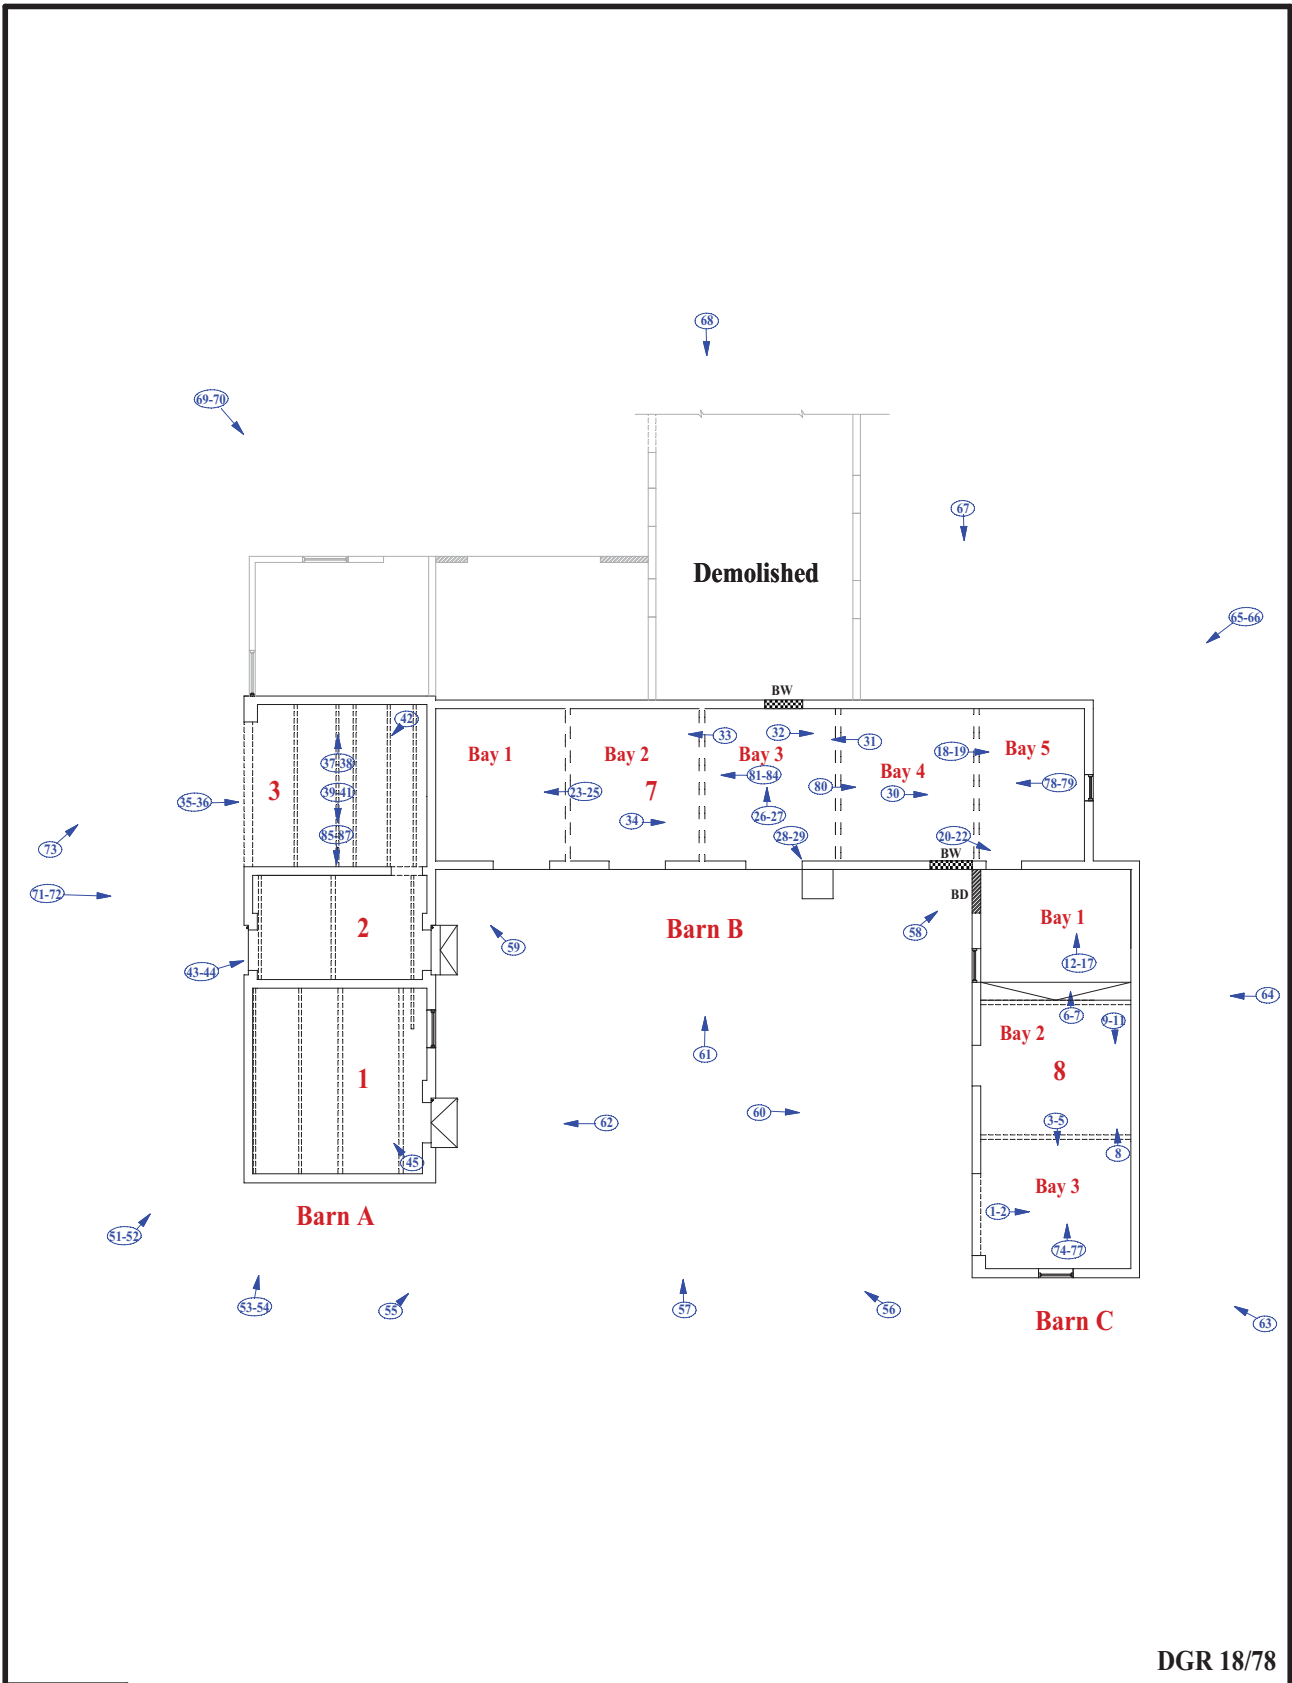
Figure 7. Ground Floor Plan.

Ground Floor (Fig. 7)

Internal (Fig. 7)

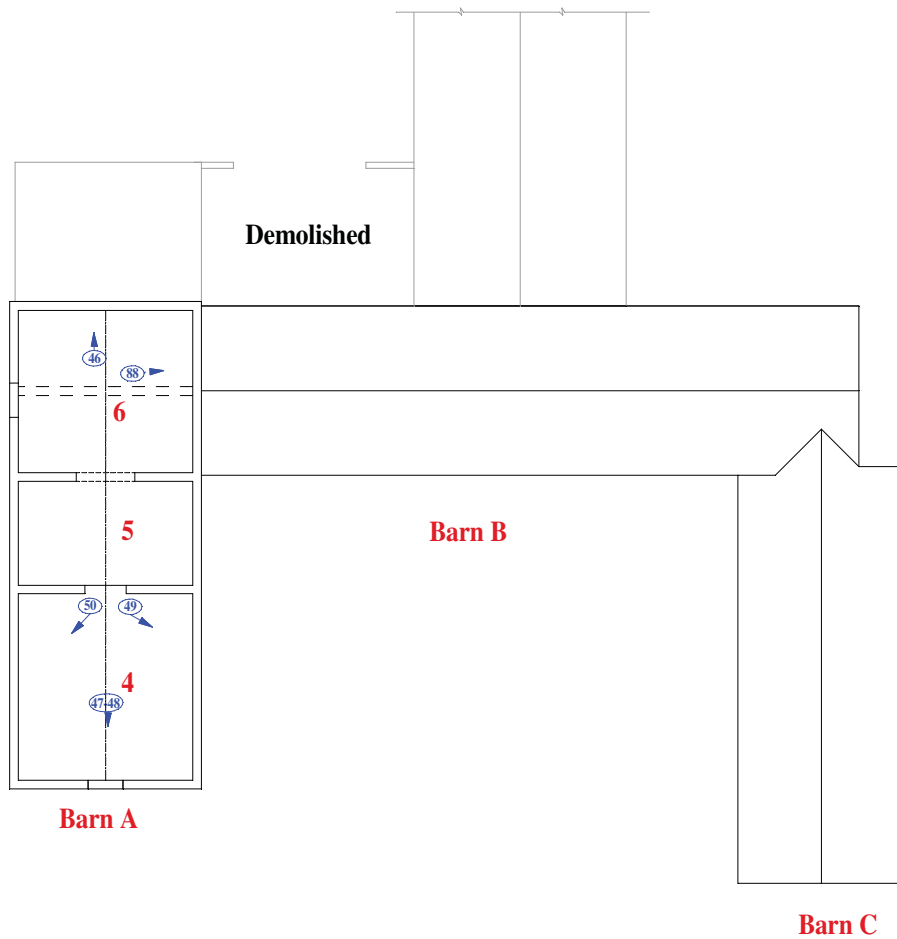
Figure 8. First Floor Plan

First Floor (Fig. 8)

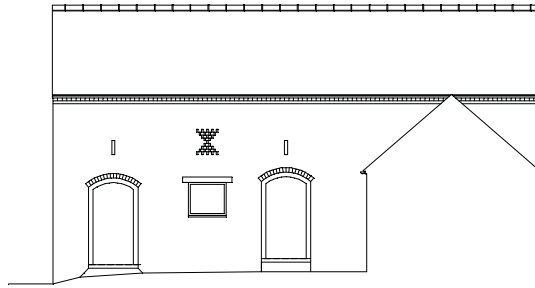
North-east elevation (courtyard)

The main, farmyard side entrance is located on the north-east side (Pl. 1, Fig. 9). This elevation consists of a pair of doorways on the ground floor with a window between, and a pair of unequal sized slits on the first floor with lattice brickwork in between, arranged in the shape of an hour-glass. The two door openings are each set beneath a curved arch in rowlock bond with a recessed second skin of brickwork to form a sealed door. Set within this recessed brickwork, on both sides are dressed stone blocks. The window is situated beneath a plain timber lintel containing three equally spaced peg-holes. The wall has been painted white.

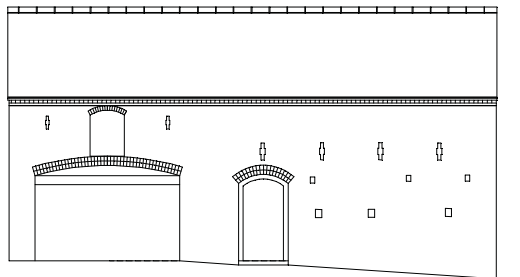
South-west elevation

The south-west facing elevation (Pl. 3, Fig. 9) contains a central doorway and a larger arched opening at the north-west end. Each is set beneath a double curved brick arch, with the doorway having the same recessed brick and stone structure as on the north-east elevation. Once again no door is present, though the upper part of the large opening has been squared off with two timber planks, infilling the curve of the arch. To the south-east of the doorway are three square ventilation holes holding a ceramic vent. Above these are three small ventilation slits, above which are a further four cross-shaped ventilation slits, with the most easterly over the doorway. Above the large opening is a further opening beneath a single curved brick arch with a small crossed ventilation slit on either side.

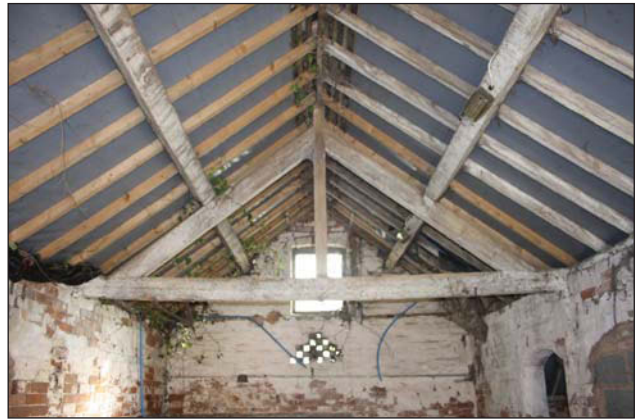
Plate 20. Barn B, interior, roof detail, looking south-east.
