**Archaeological Standing Building  
Recording**

**Lodge Hill Farm**

**Whitby, North Yorkshire**

**July 2021**

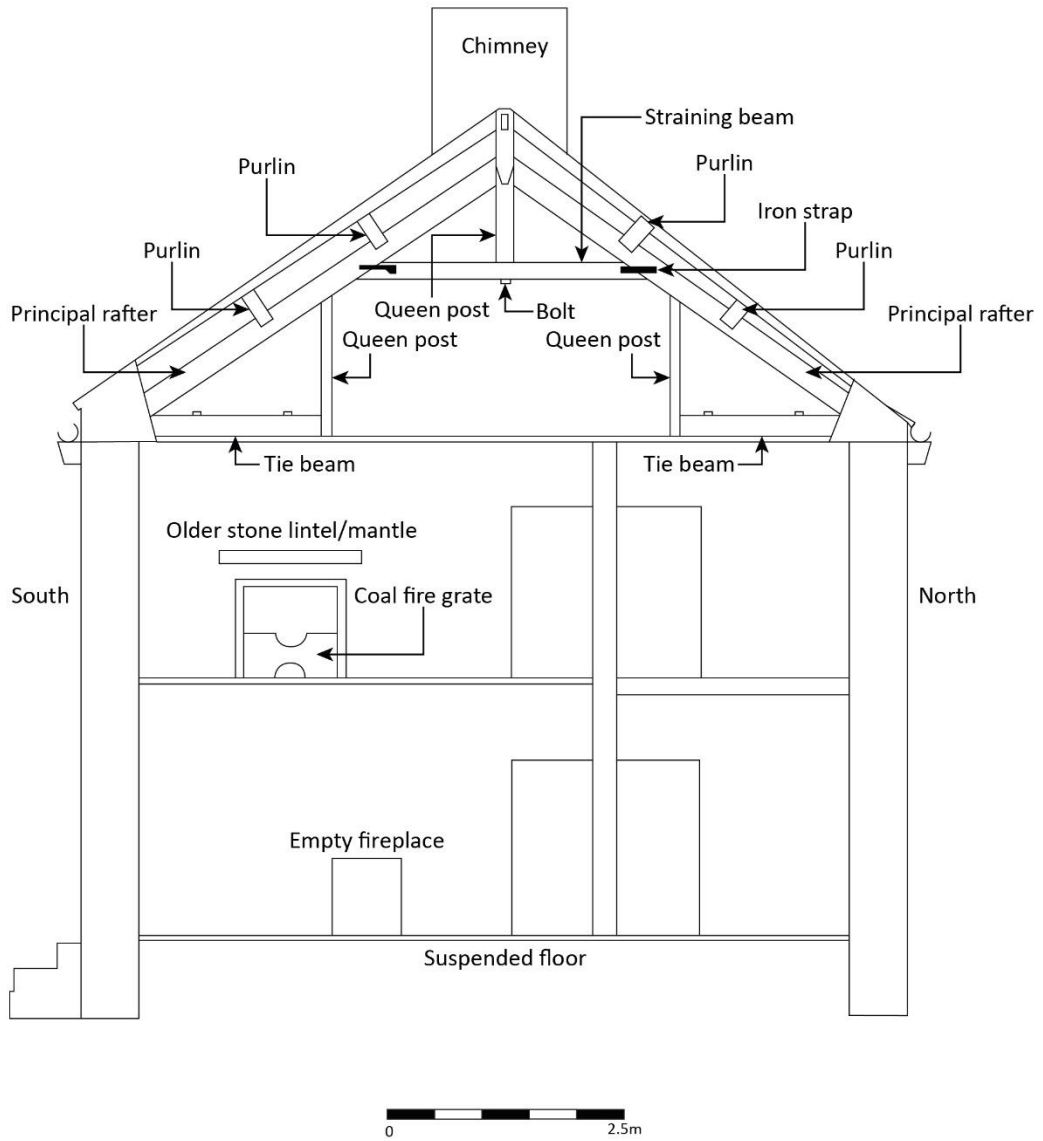
Fig: 11	
Drawing Name:	Building 1: Cross-section showing roof structure
Site:	Lodge Hill Farm
Project type:	Archaeological Standing Building Recording
© borderarchaeology

A straight staircase from the first-floor central hallway gave access to a three-bay open-plan attic (*Plates 87-88; Fig. 3*) with a planked floor and a pair of exposed roof trusses (*Plates 87-94; Fig. 11*). Squared, machine-cut timbers used both for the trusses and common rafters suggest the roof is probably not original (*Plates 90 & 93*). The trusses are of modified queen-post type with a pair of vertical queen struts connecting two tie-beams to the principal rafters at floor-level. The principal rafters are in turn linked by a vertical straining beam, a third strut in the centre of the beam connecting it to the apex of the truss. A pair of trenched purlins are keyed-into the principal rafters and the straining beam has been further reinforced with iron straps tying the beams to the principal rafters.

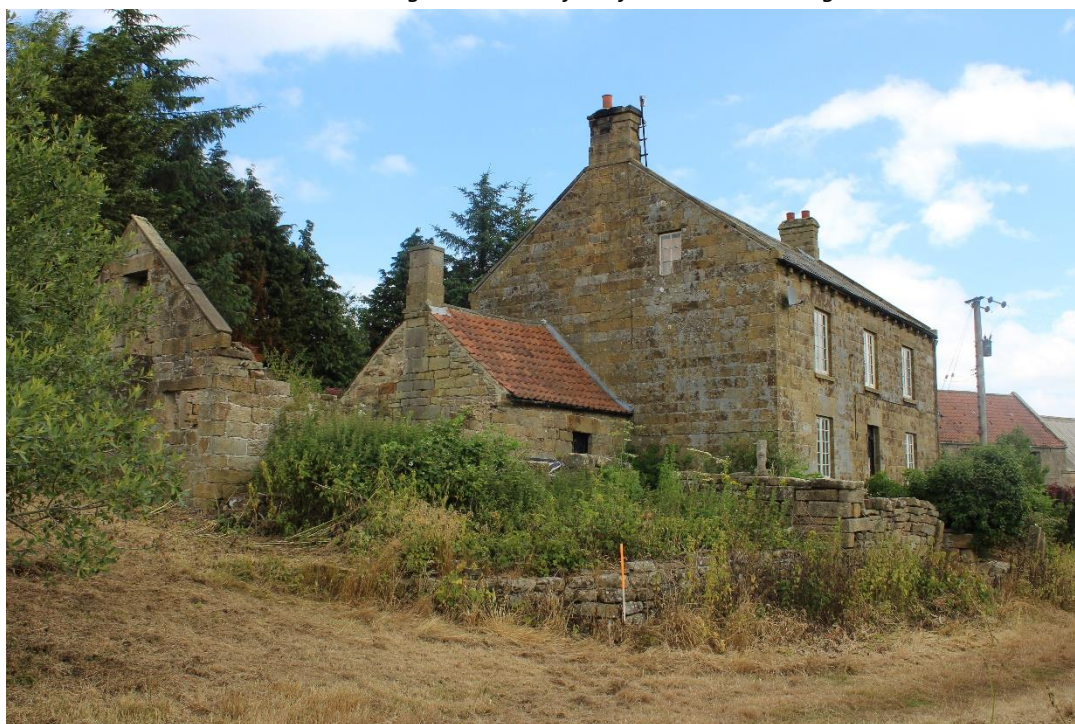
*Plate 4: View NE showing S facing elevation of the farmhouse Building No.1, with derelict pigsty (foreground) and outbuilding (middle foreground)*

The farmhouse (*Figs. 2, 6 & 7*) is a two-storey gabled building (with attic) of three bays, aligned ENE-WSW, with a single-storey outhouse and derelict two-storey pigsty at the W gable end. The building is set slightly into a bank to the N with a gradual slope to the S, away from the house. The house itself is of dressed sandstone blocks under a slate roof with rectangular chimneystacks attached to the gable walls (*Plate. 3*). The outhouse and pigsty are similarly of dressed sandstone construction but the outhouse has a pantile roof and square chimneystack in its W gable end (*Plate 95*) and the pigsty is derelict, with no surviving roof structure (*Plate 4*).

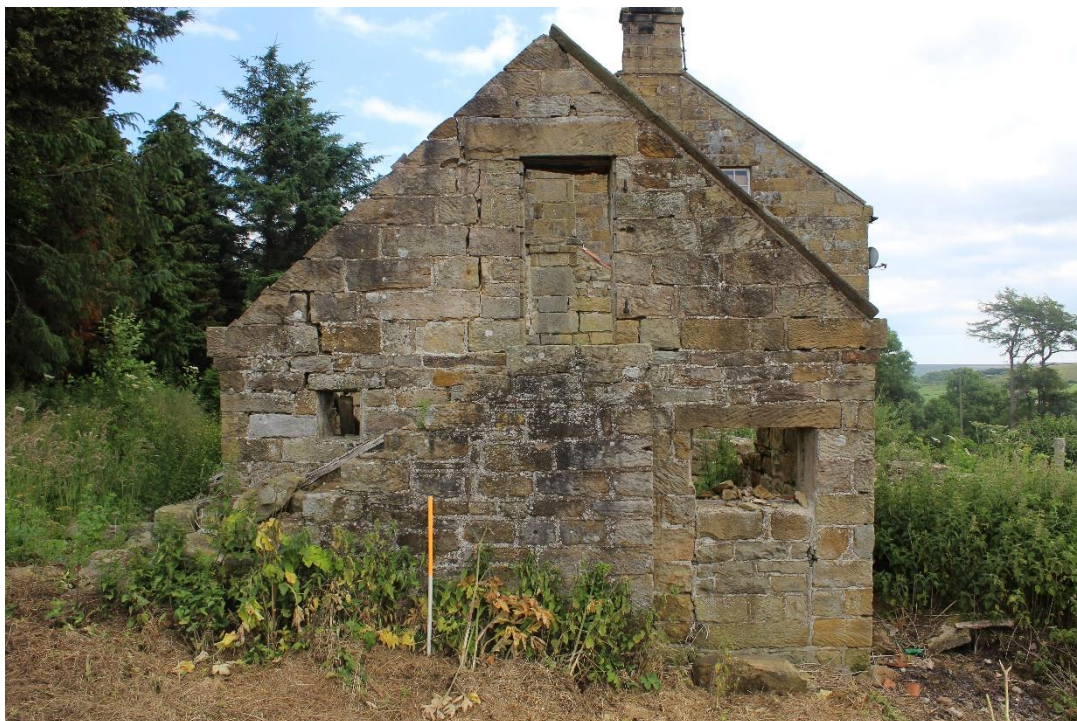
*Plate 6: View ENE showing close of W facing elevation of the pigsty (Building No. 1)*

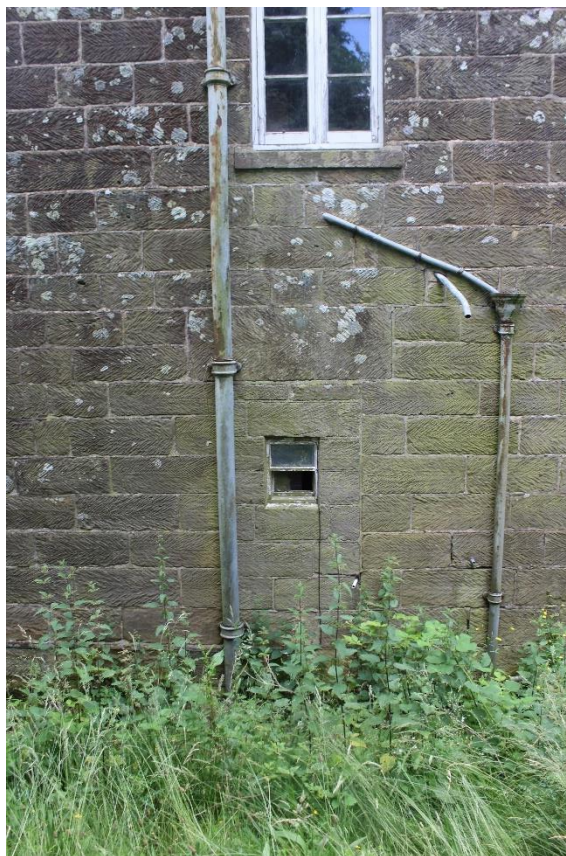
doorway (*Plate 10*) incorporating a small, single-light sash window with a pair of evenly spaced two-light casements set either side and three matching windows aligned above at first-floor level. Guttering repeats the arrangement of stone corbels and metal brackets seen in the S-facing elevation. The connecting outhouse to the W (*Fig. 9*) has a doorway at its eastern end and a small single-light sash window to the right. The N-facing elevation of the pigsty is more complete than its S-facing counterpart (*Plate 10*) with a doorway at the E end and modern air bricks at roof height towards the W end.

*Plate 10: View SSE showing blocked central door within N facing elevation of the farmhouse (Building No. 1)*

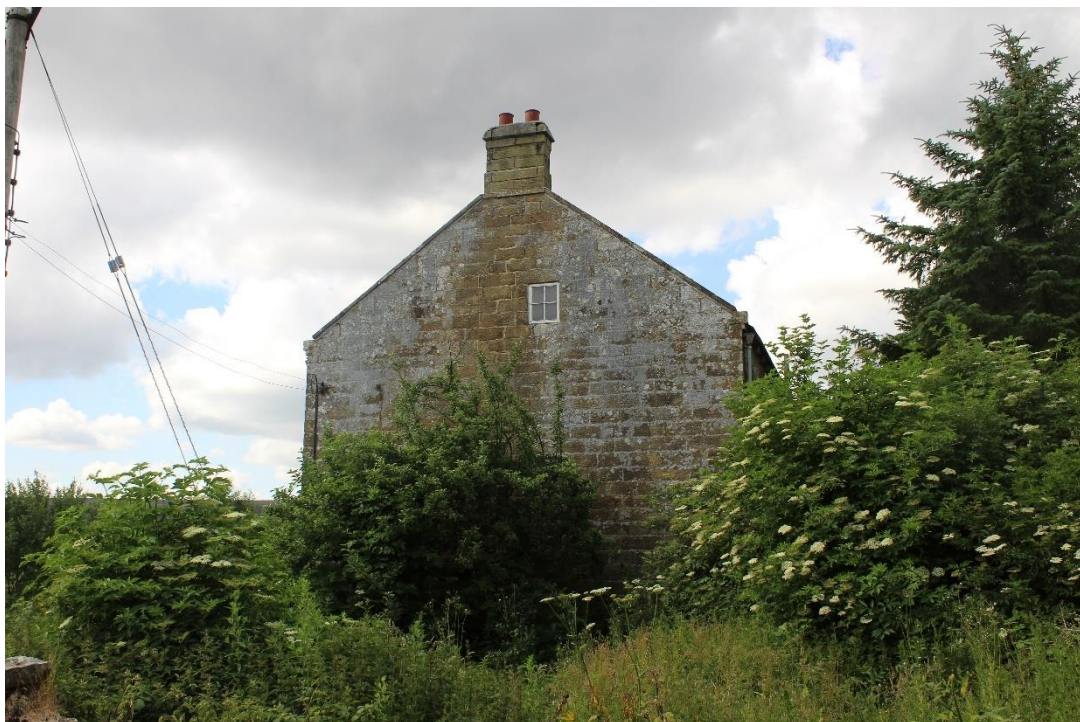
The E-facing gable-end of the farmhouse (*Plate 12*) is devoid of features apart from a single-light casement at attic level. It is positioned off centre, to the right of assumed position of the central chimney flue.

*Plate 12: View WSW of E gable end of the farmhouse (Building No. 1)*

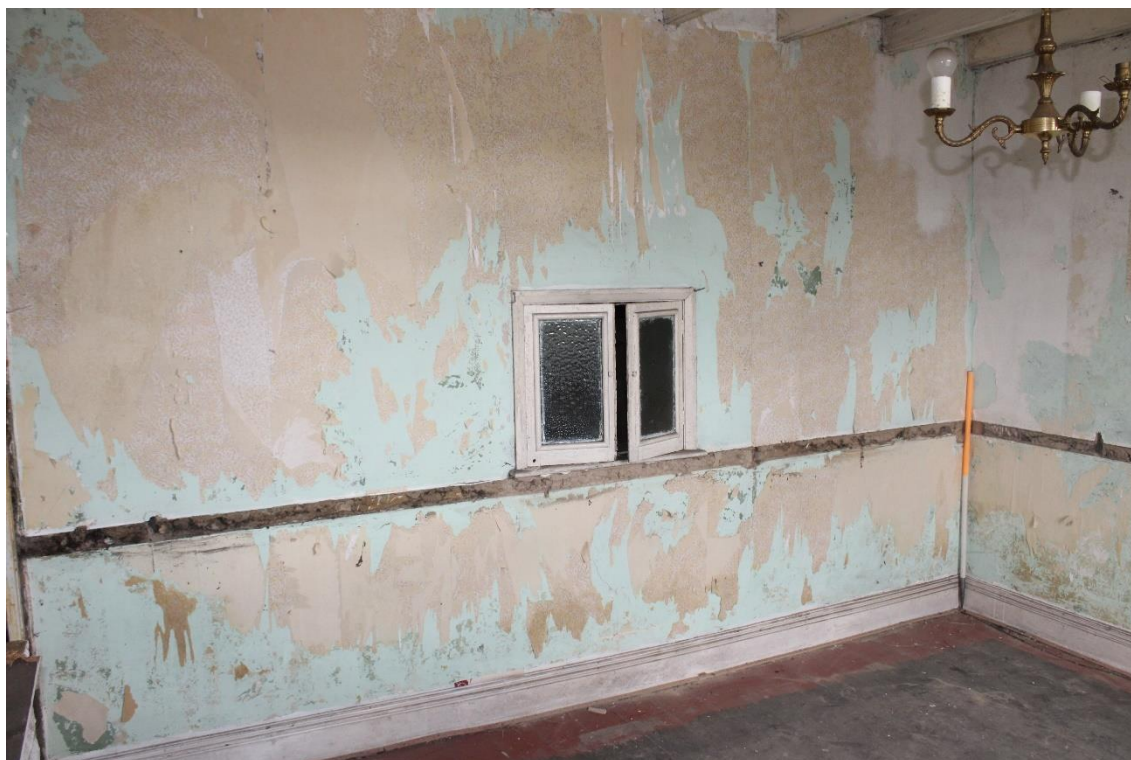
The first sitting room open W from the central hallway (*Plates 20-24*) and has wooden floorboards, plastered walls and exposed chamfered ceiling beams; the underside of the first-floor floorboards is again visible (*Plate 24*). The room is lit by a two-light casement set into the southern wall (*Plate 23*) and the W wall contains a central coal-grate with mid-20<sup>th</sup> century fire surround (*Plate 20*). Alcoves beside the chimney breast have been converted into cupboards and the N wall contains a service-hatch through to the kitchen (*Plate 22*).

*Plate 22: internal view ESE within ground floor living room showing service hatch through to the kitchen – Building No. 1*

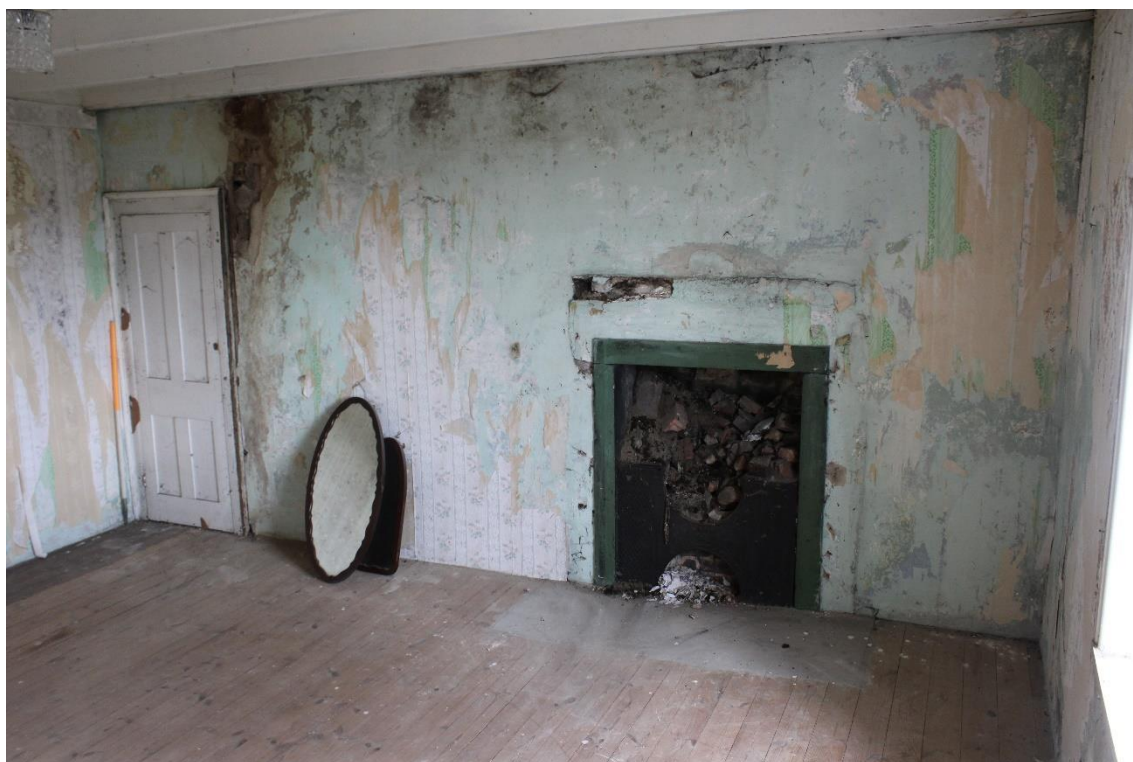
two-light casement in the N wall (*Plate 81*). An off-centre fireplace in the E wall has a cast iron coal insert and stone slab surround (*Plates 82 & 86*) with the remains of an older stone lintel or mantel above it. An alcove in the N corner of the E wall is likely to have been used for storage but the door was nailed shut (*Plates 82-83*).

*Plate 82: Internal view NE of 1<sup>st</sup> floor fourth bedroom showing fireplace and locked storage alcove– Building No.1*

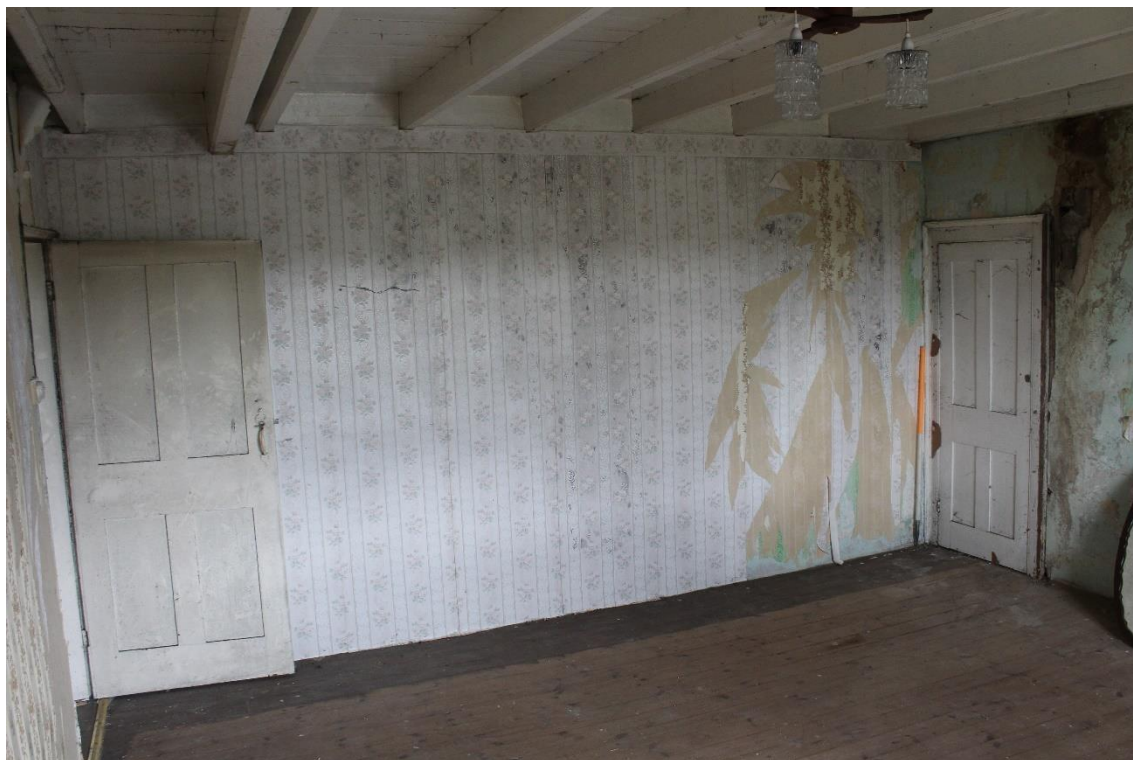
*Plate 83: Internal view NNE of 1<sup>st</sup> floor fourth bedroom showing locked storage alcove – Building No.1*

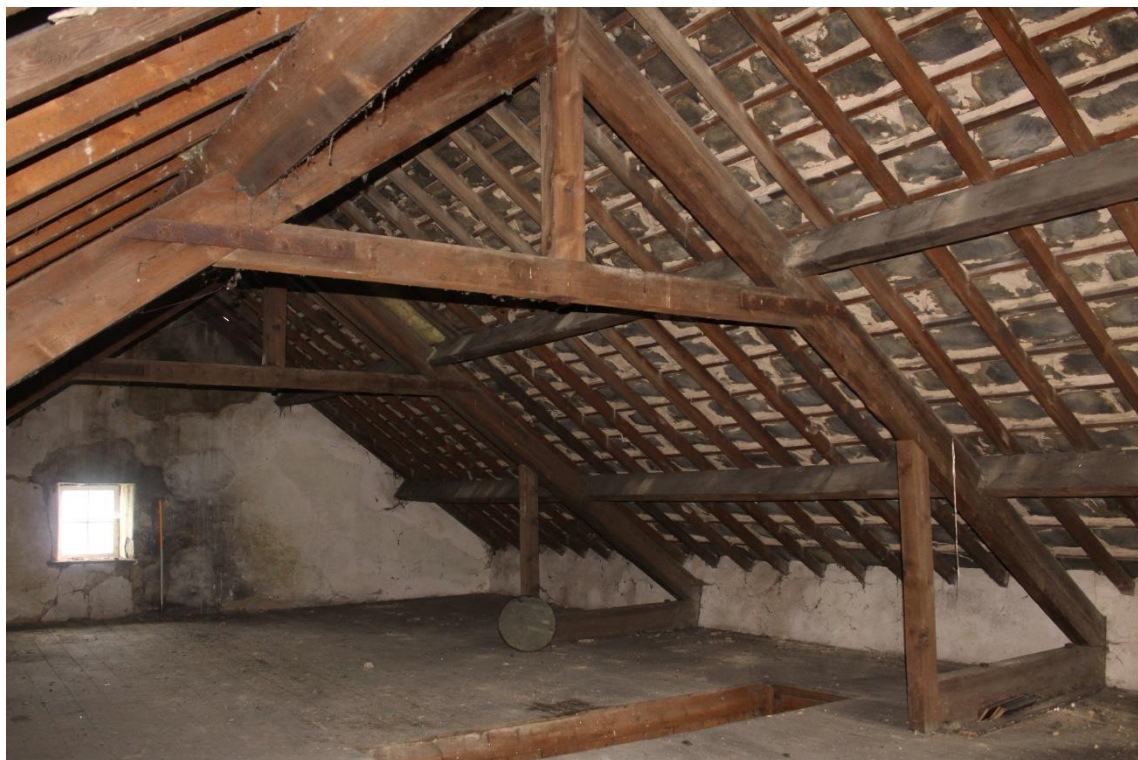
*Plate 90: Internal view E of attic/roof space showing roof trusses – Building No.1*

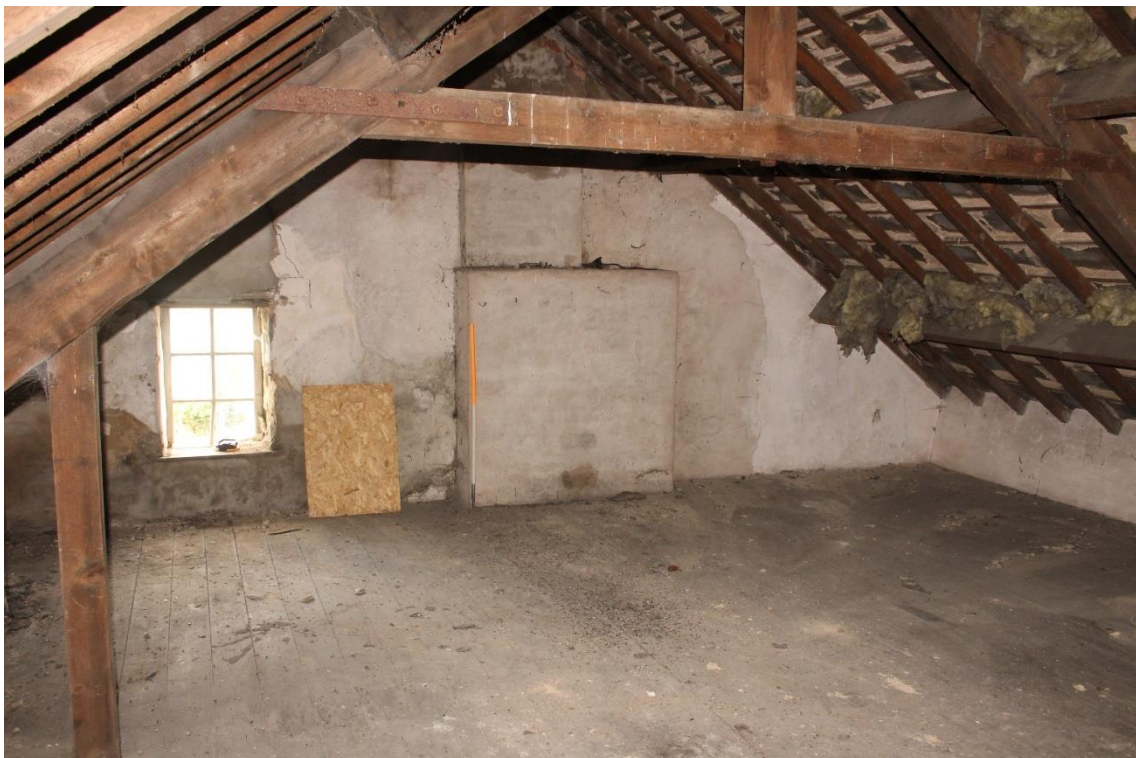
The two single-light casement attic windows (*Plates 92 & 94*) at either gable end of the room are offset from the central position, presumably to accommodate the chimney flues, and there is a blocked brick fireplace built into the W wall (*Plate 92*).

*Plate 92: Internal view ENE of attic/roof space showing blocked fireplace and single light casement window – Building No.1*

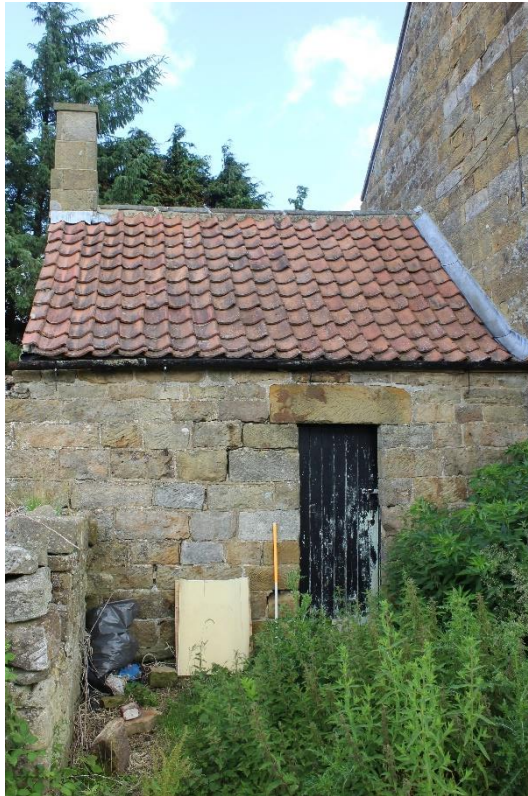
*Plate 95: External view NNW of outhouse of Building No. 1*

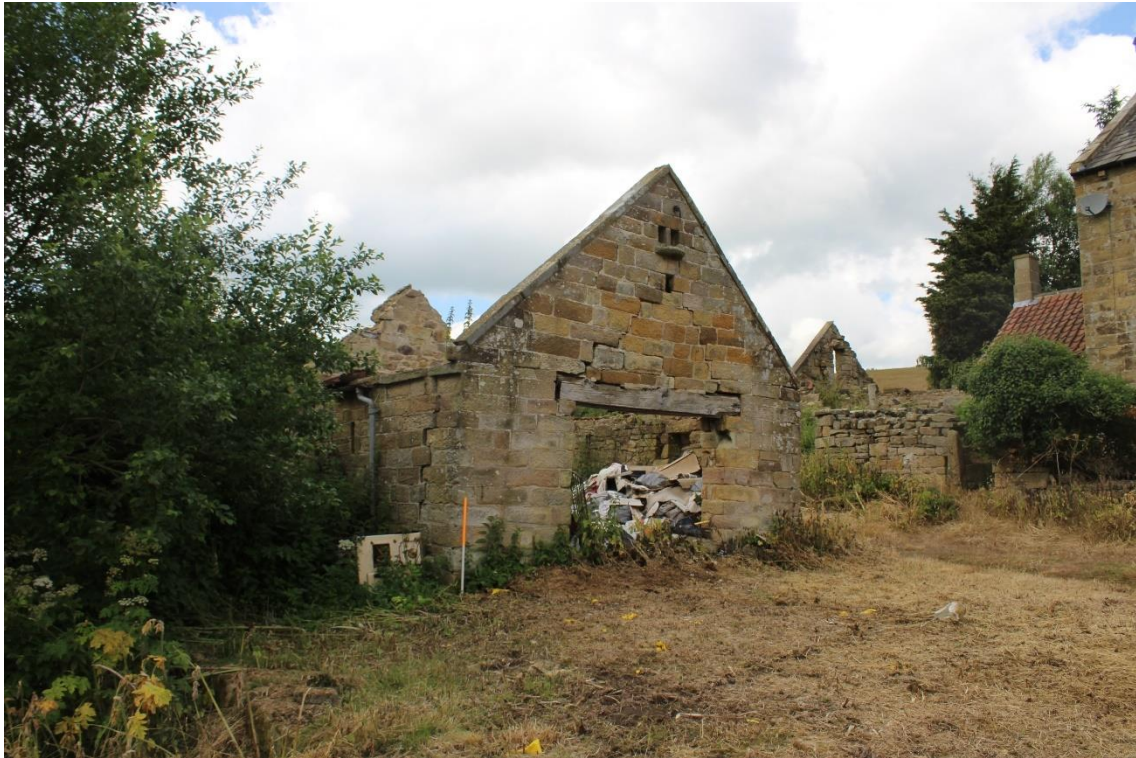
Tree-growth and waste material partially obscured the S elevation (*Plate 97*) but a door and window towards the W end of the structure together with several ventilation holes were visible.

*Plate 97: Exterior view WNW of the S and E elevations of Building No. 2*

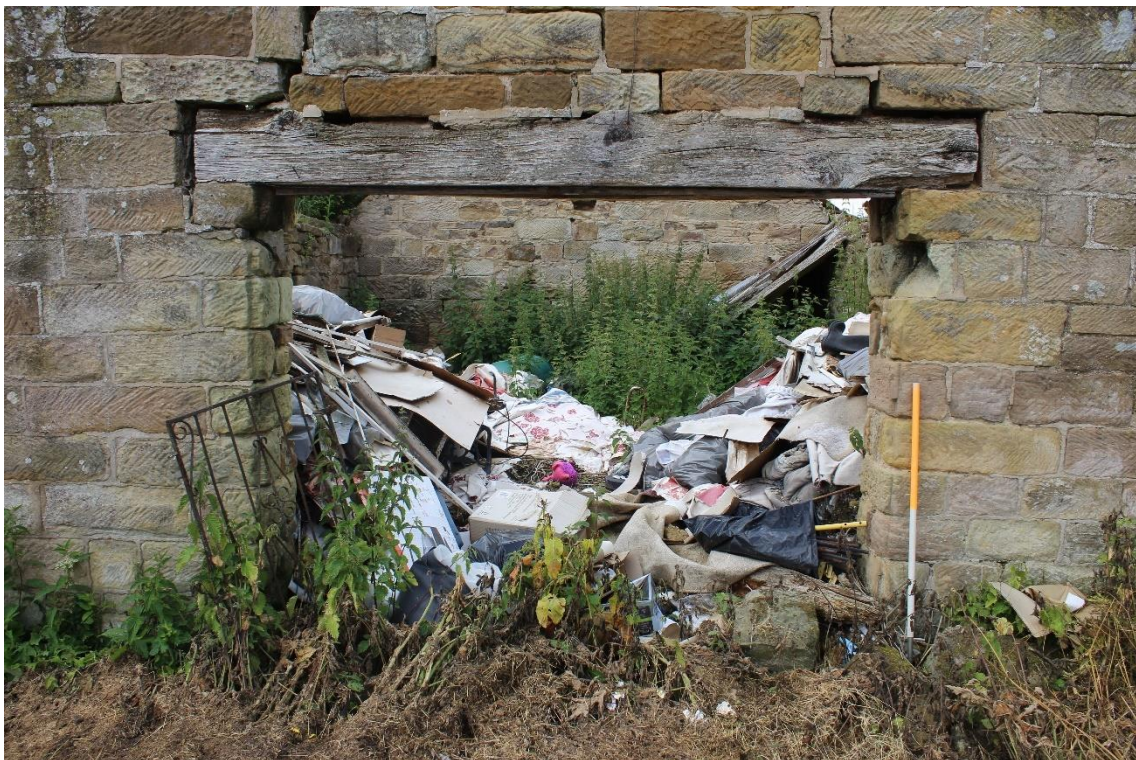
The building's condition raised health and safety concerns and a complete survey of the internal features was not possible. However, the building could clearly be seen to be comprise of two compartments. The ENE compartment is thought likely to be a cart shed, with no identifiable features seen at floor level (*Plate 100*). Views of the internal gable wall show slots for two pairs of purlin timbers (*Plate 101*).

*Plate 100: Exterior close up view E elevations of Building No. 2 and internal area*

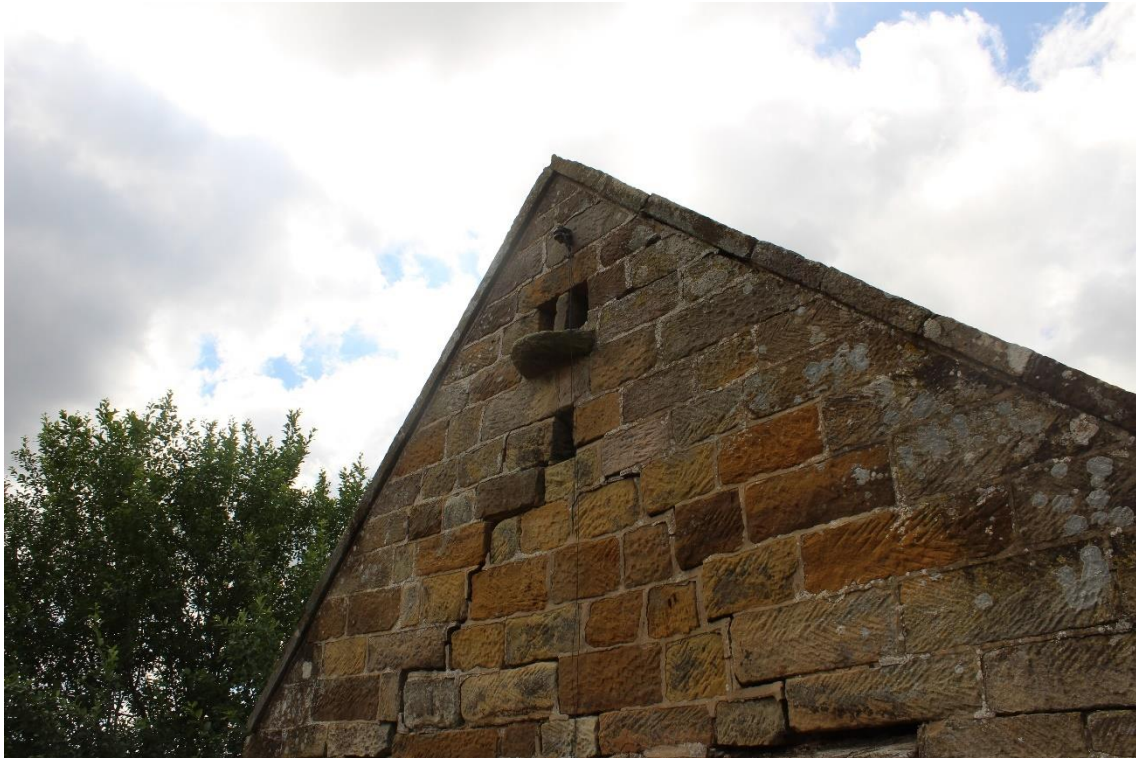
The E-facing gable end had a wide cart entrance with wooden lintel (*Plates 97-101*) and a pair of nesting holes and roosting ledge built into the masonry above the entrance. The N-facing elevation (*Plates 96, 103-105*) is penetrated by several vertical ventilation slits through into the E compartment and three ventilation holes into the W compartment. The W-facing gable end contains an off-centre entranceway with central loading hatchway above (*Plates 105-107*), both of which have surviving iron hinge brackets.

*Plate 101: Exterior close up view showing nesting holes within E elevations of Building No. 2*

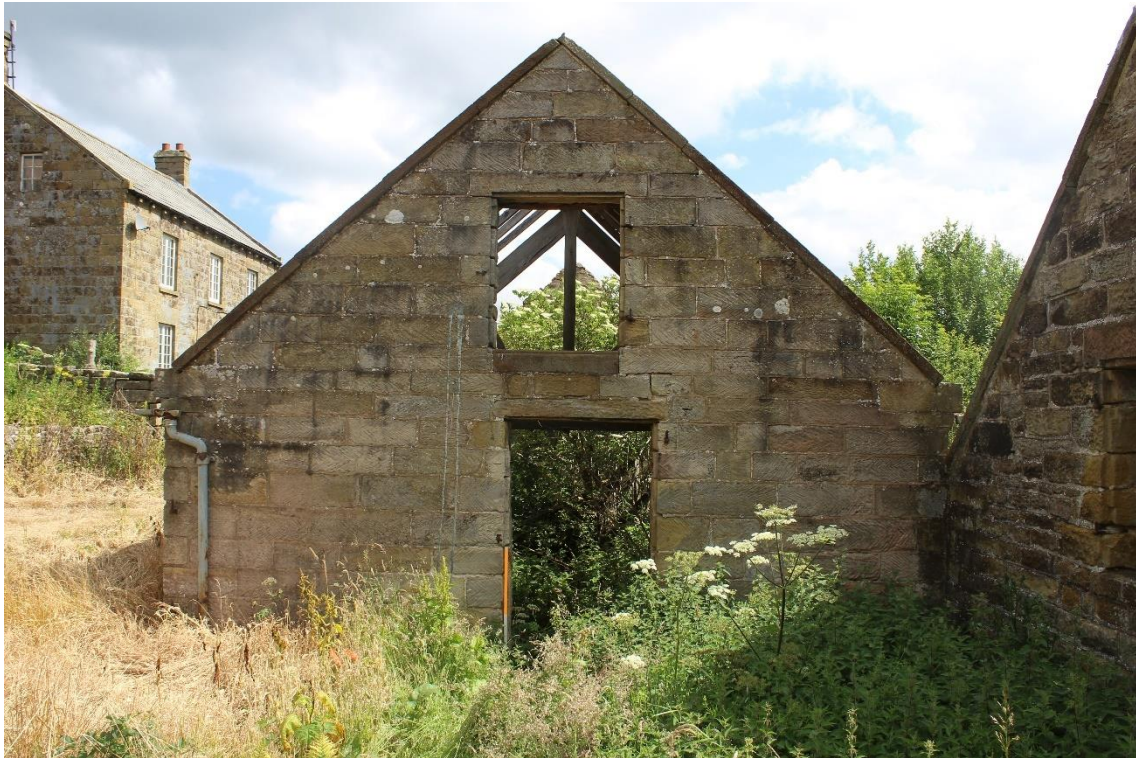
Building No.2 is a single-storey gabled barn of dressed sandstone block construction beneath a partially intact pantile roof, with two separate internal compartments located ENE and WSW and separated by a stone wall (*Figs. 2 & 8*), which probably served as a cart shed and store room, respectively. The barn stands to the SW of the farmhouse and is associated with a second detached barn (Building No.3) to form an L shape in plan (*Plates 106 & 109*). The building is derelict and most of the roof structure has collapsed.

The N-facing gable end of the barn is built into the hillside, causing the exterior roofline to be at ground level (*Plates 106, 109-110*). The wall contains a single window or loading hatch. The W-facing elevation extends along the slope of the hill and has a doorway at its N end opening onto a field beyond the main farmyard (*Plates 110-113*). Iron hinge and latch brackets for a stable door survive within the doorway (*Plate 112*). A tie-pin was noted midway along the wall, with several vents spaced evenly along the roofline. No architectural features of note were observed on the S-facing gable end (*Plates 113-115*). Tree growth and waste obscured part of the E elevation (*Plate 97*) but two stable doors, a window and several vents could be discerned (*Plate 116*).

*Plate 106: Oblique view ESE of Buildings No. 2 & 3*

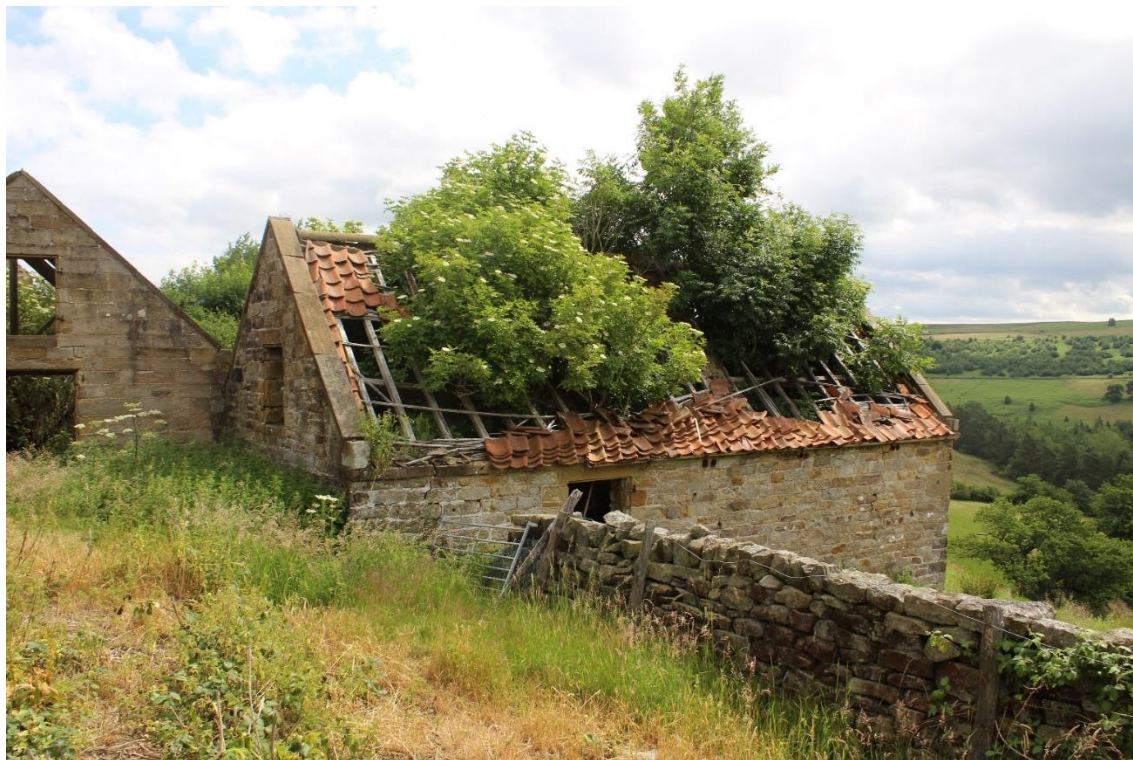
*Plate 109: Oblique view ESE of Buildings No. 2 & 3*

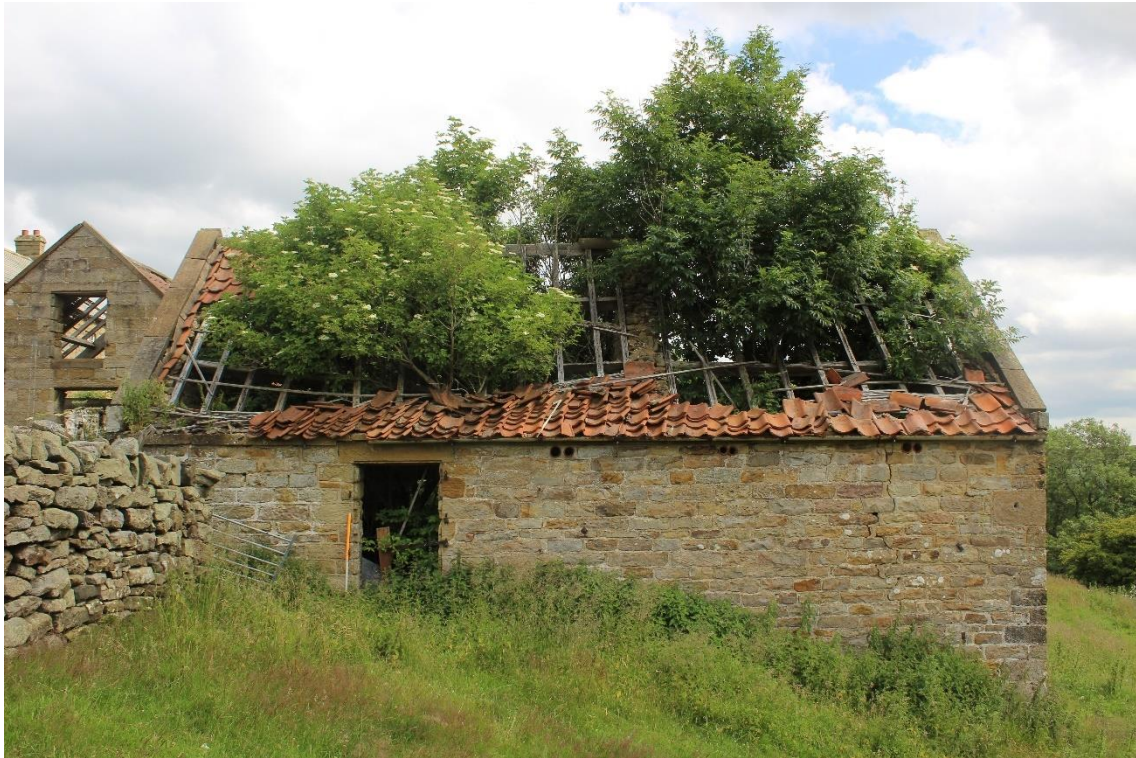
*Plate 110: Oblique view ESE of N and W-facing elevation of Building No.3*

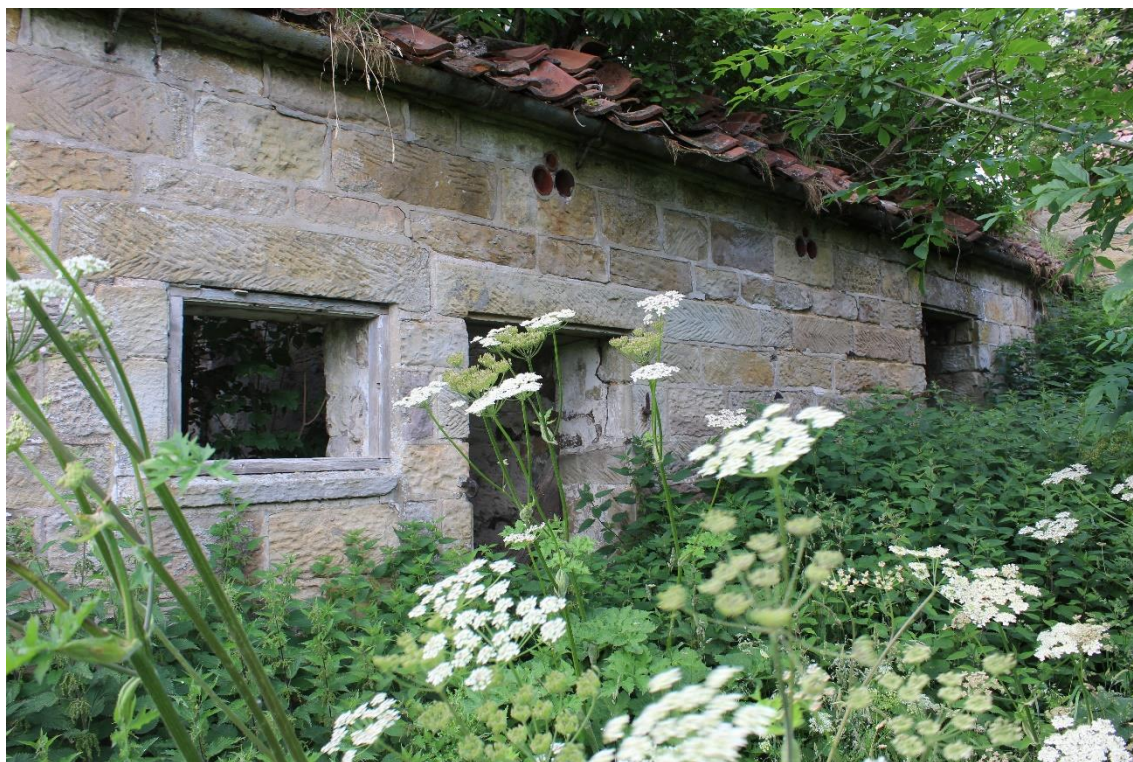
*Plate 115: External view NW of S and E-facing elevations of building No.3*

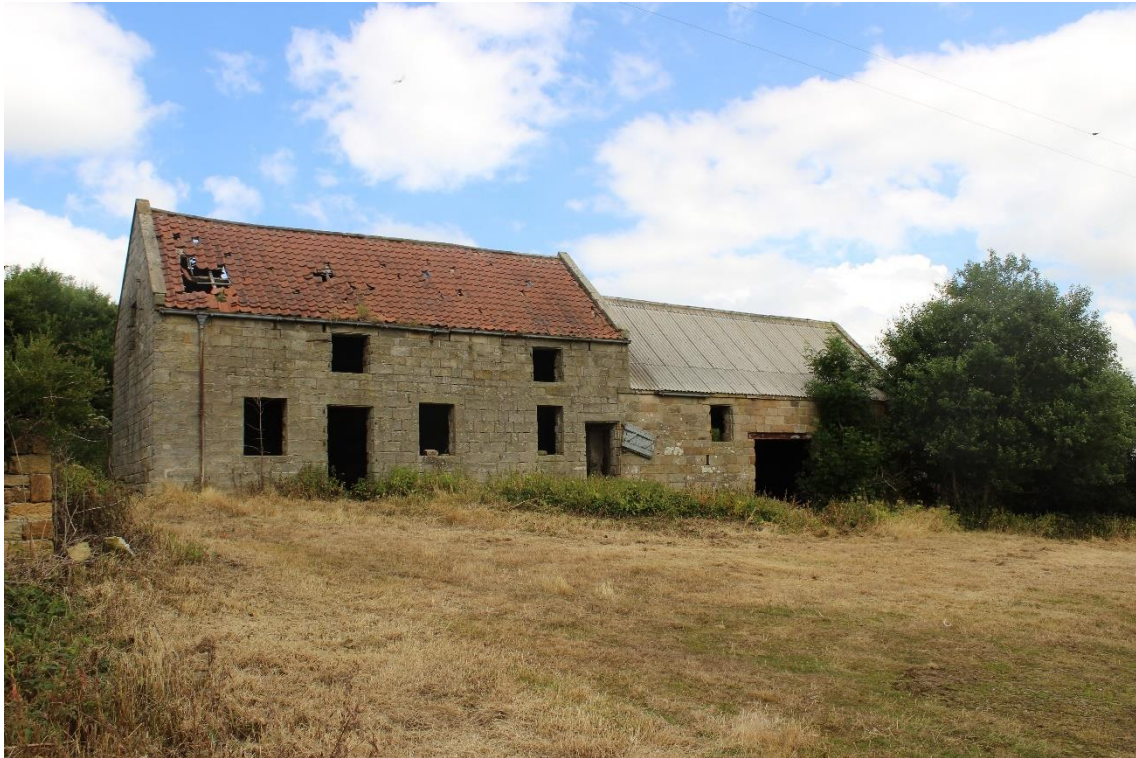
*Plate 116: External oblique view of E-facing elevation of Building No.3*

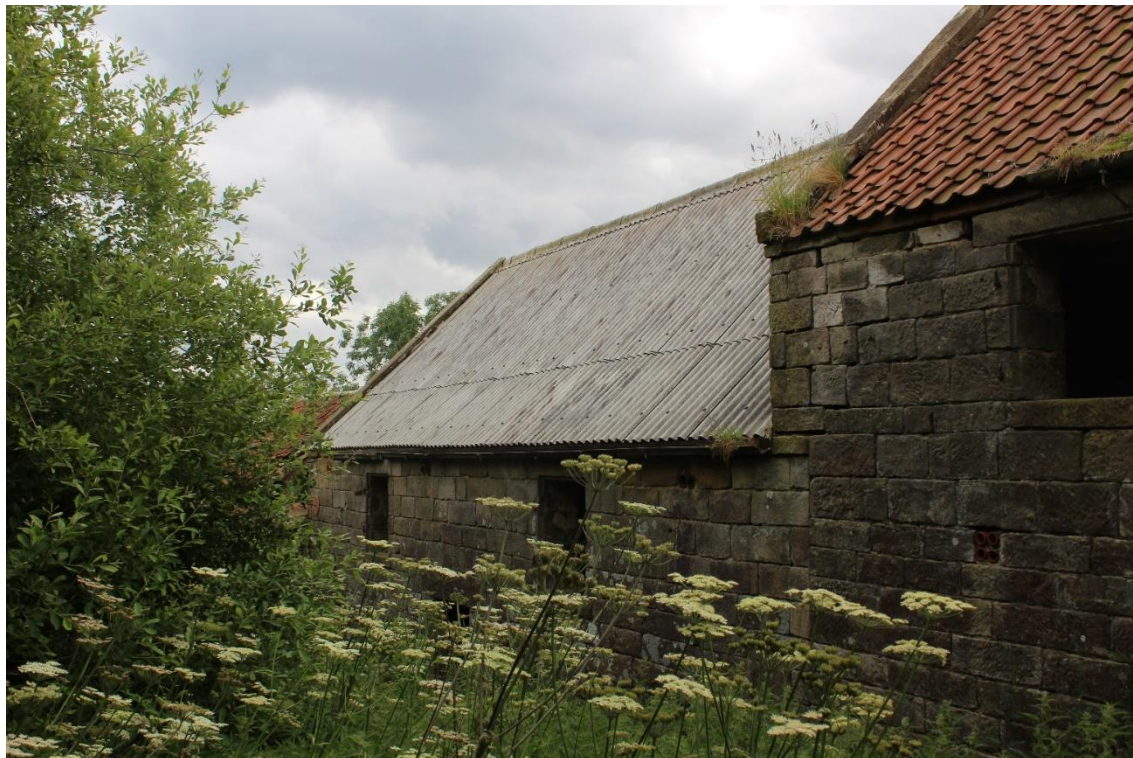
The N-facing elevation (*Plates 124-126*) is similarly staggered over three levels representing the different portions of the barn. The first section has two windows at either end of the roofline with a line of vents beneath (*Plate 124*). The second section (*Plate 125*) has a doorway and wooden lintel with two windows either side of the door at the roofline. A series of ventilation holes were noted beneath the eaves of the roof and a tie pin is located towards the W end of the building section. No features of note were seen within the third section of the building (*Plate 126*). The E elevation was entirely obscured by the tree-line but a widow or loading hatchway could be seen. Earlier aerial photography shows a nesting hole and roosting ledge on the E-facing gable end of the building.

*Plate 124: Oblique external view ESE of N-facing elevation of Building No.4*

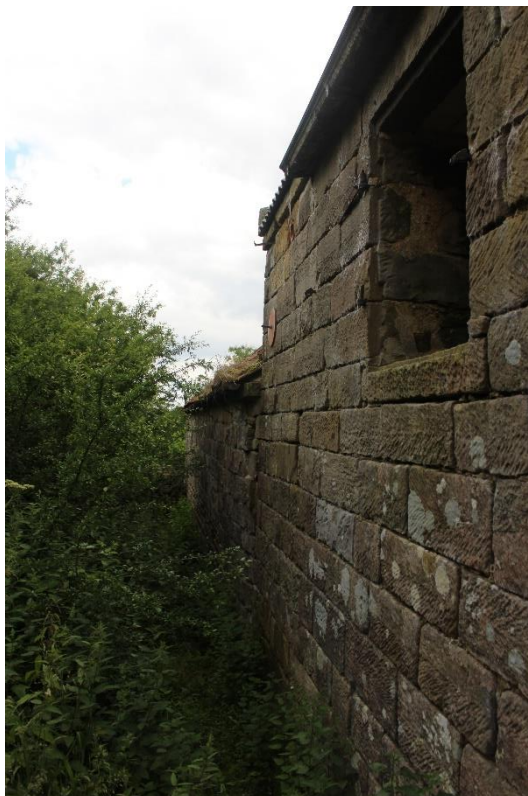
*Plate 125: Oblique external view SSE of N-facing elevation of Building No.4*

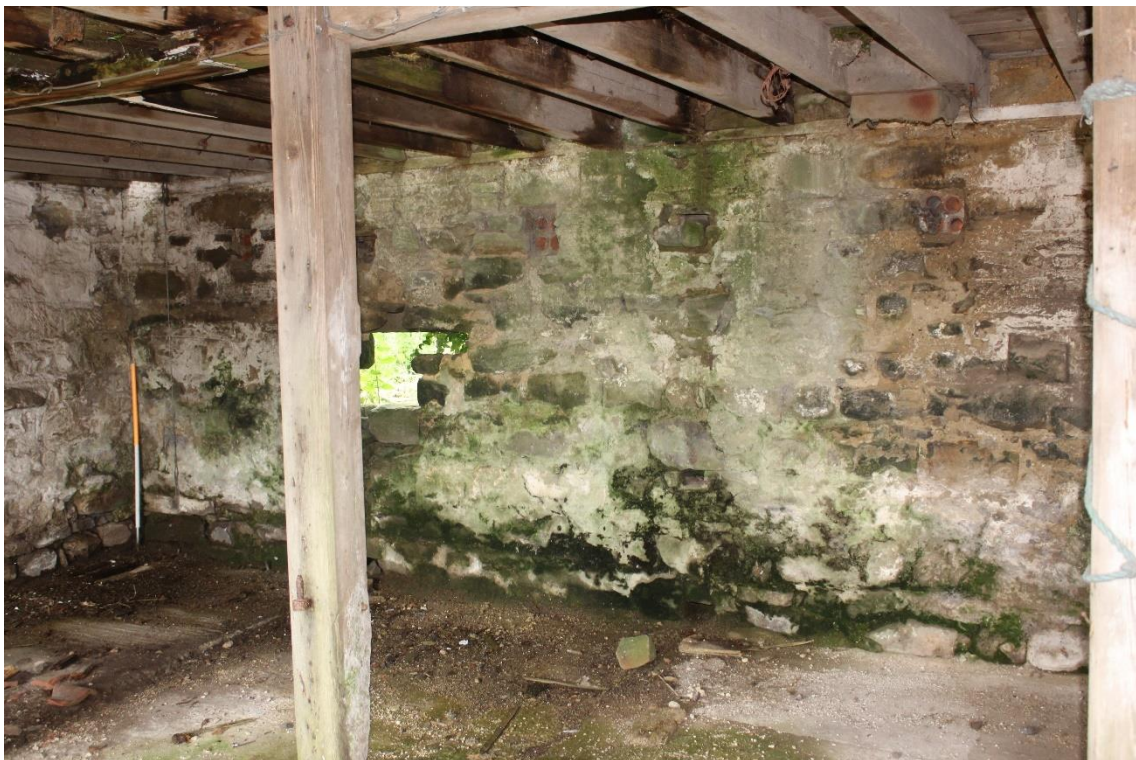
The first compartment opens N (*Plates 127-135*) from the main farmyard and is lit by two windows within the S wall (*Plate 130*). A second door within the SE corner of the room leads into the adjacent compartment (*Plate 127*). It has a concrete floor, whitewashed walls and three timber struts supporting an upper-floor storage area that was inaccessible for health and safety reasons (*Plates 131-132*). The roof structure visible through holes in the ceiling is of a simple king-post truss construction. A hole in the E wall had evidently relatively recently been knocked through into the adjacent compartment (*Plate 134*). Fixtures on the N wall align with the struts, suggesting the room was subdivided to form three bays (*Plate 135*).

*Plate 127: Internal view ESE of the first compartment of Building No.4*

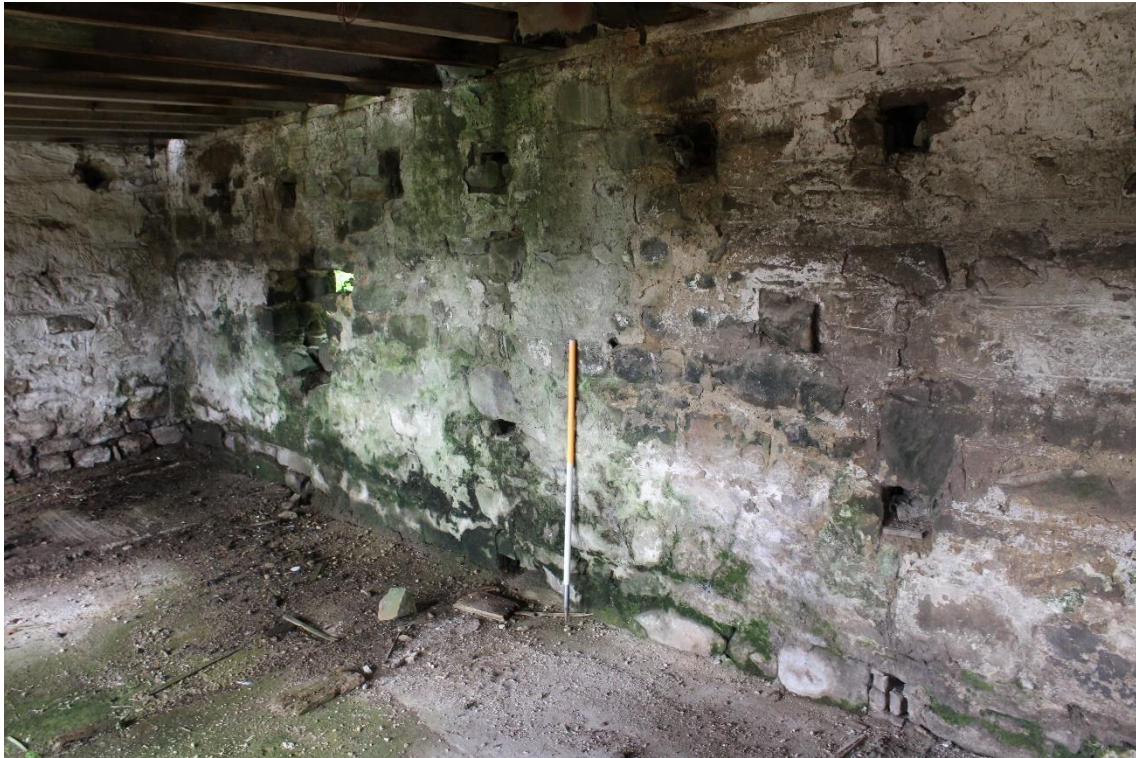
*Plate 135: Internal view NW showing fixtures on the N wall aligned with the struts within the first compartment of Building No.4*

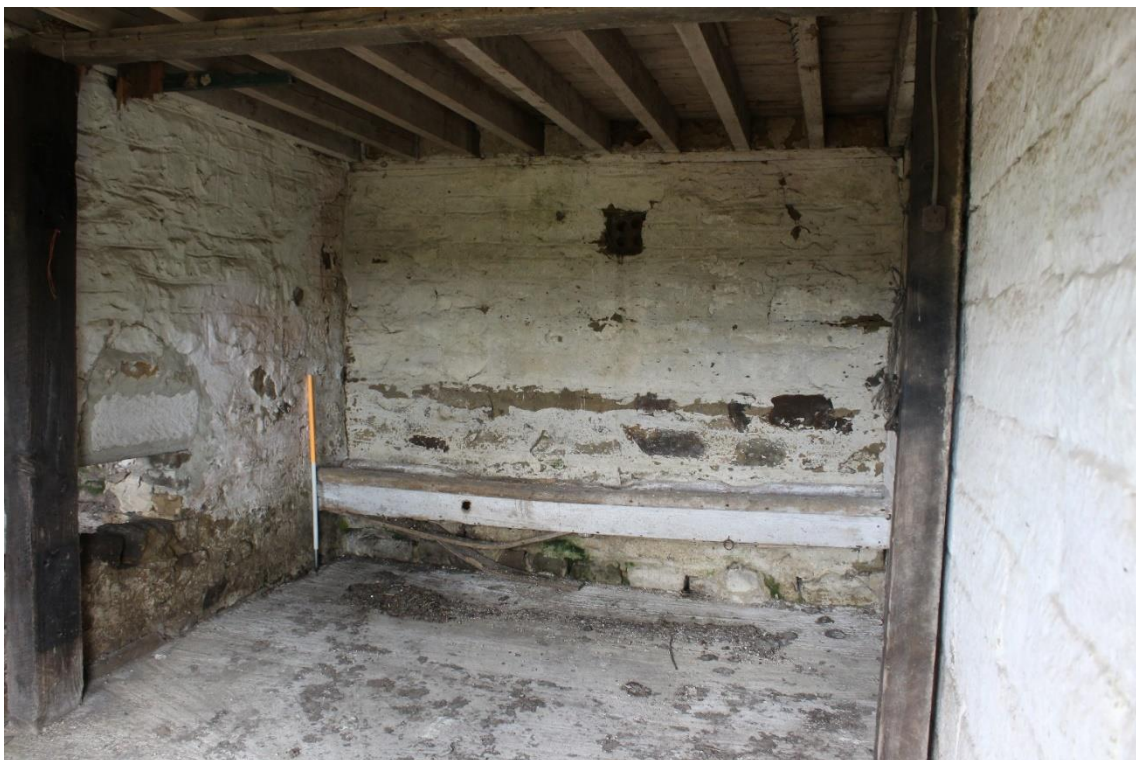
The second compartment (*Plates 136-141*) opens N from the main farmyard and connects with the adjacent compartments by means of doors in the SW and SE corners of the room. A surviving stable door and wooden trough (*Plate 137*) at the rear of the room suggest it was used as a loose box. The room has a concrete floor, whitewashed walls and two timber struts supporting an upper storage area which could not be accessed for health and safety reasons. The room is lit by a window in the S wall (*Plate 139*). An internal window looks into the adjacent compartment to the E (*Plate 140*).

*Plate 136: Internal view NNW of the second compartment of Building No.4*
