**Archaeological Standing Building  
Recording**

**Lodge Hill Farm**

**Whitby, North Yorkshire**

**July 2021**

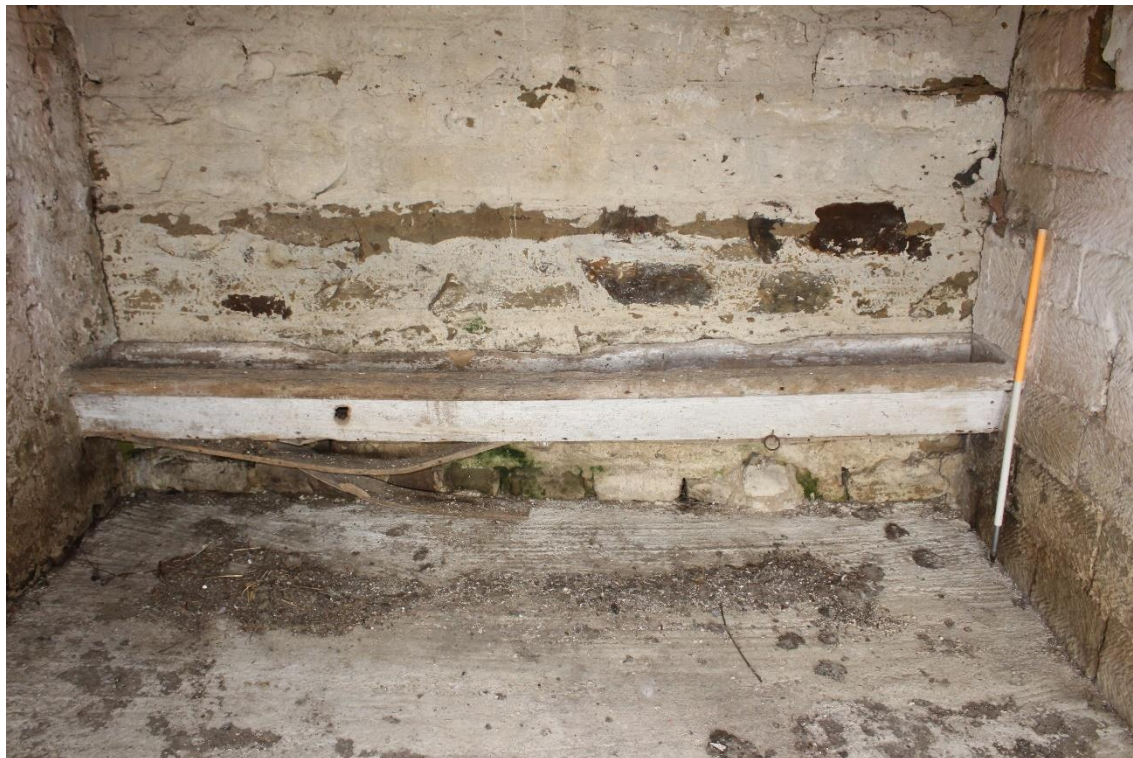
The second compartment (*Plates 136-141*) opens N from the main farmyard and connects with the adjacent compartments by means of doors in the SW and SE corners of the room. A surviving stable door and wooden trough (*Plate 137*) at the rear of the room suggest it was used as a loose box. The room has a concrete floor, whitewashed walls and two timber struts supporting an upper storage area which could not be accessed for health and safety reasons. The room is lit by a window in the S wall (*Plate 139*). An internal window looks into the adjacent compartment to the E (*Plate 140*).

*Plate 137: Internal view N of a wooden trough within the second compartment of Building No.4*

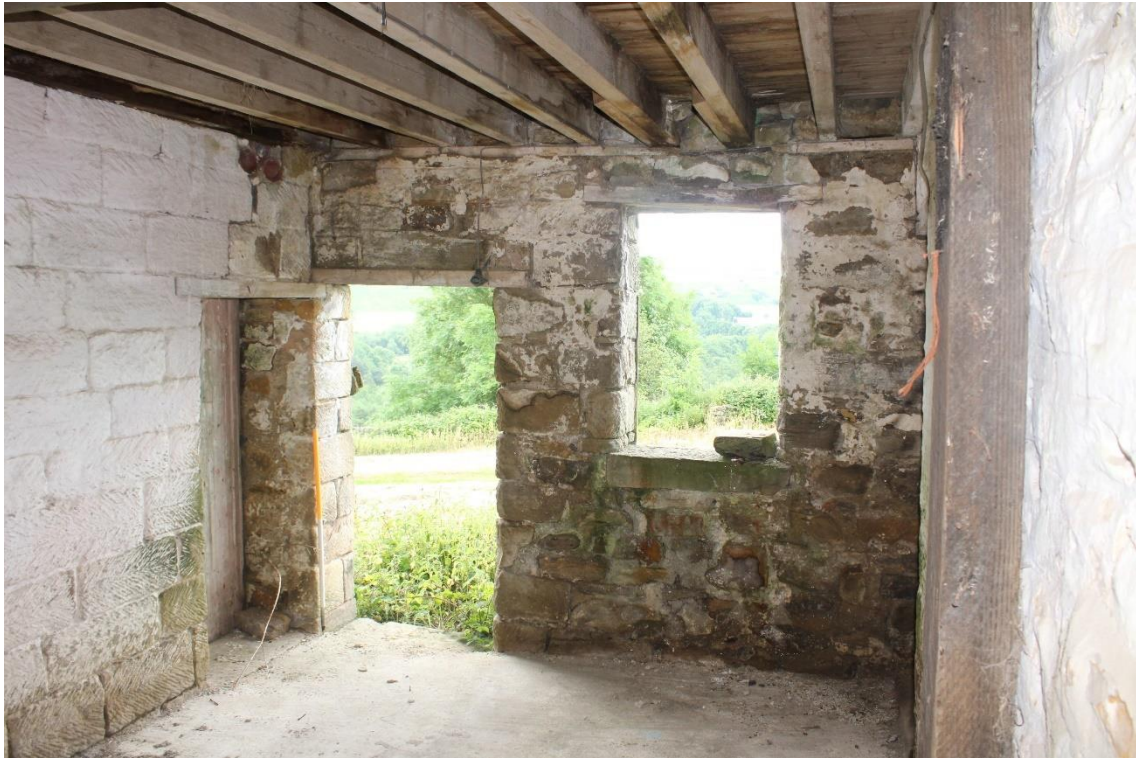
*Plate 139: Internal view S of the second compartment of Building No.4*

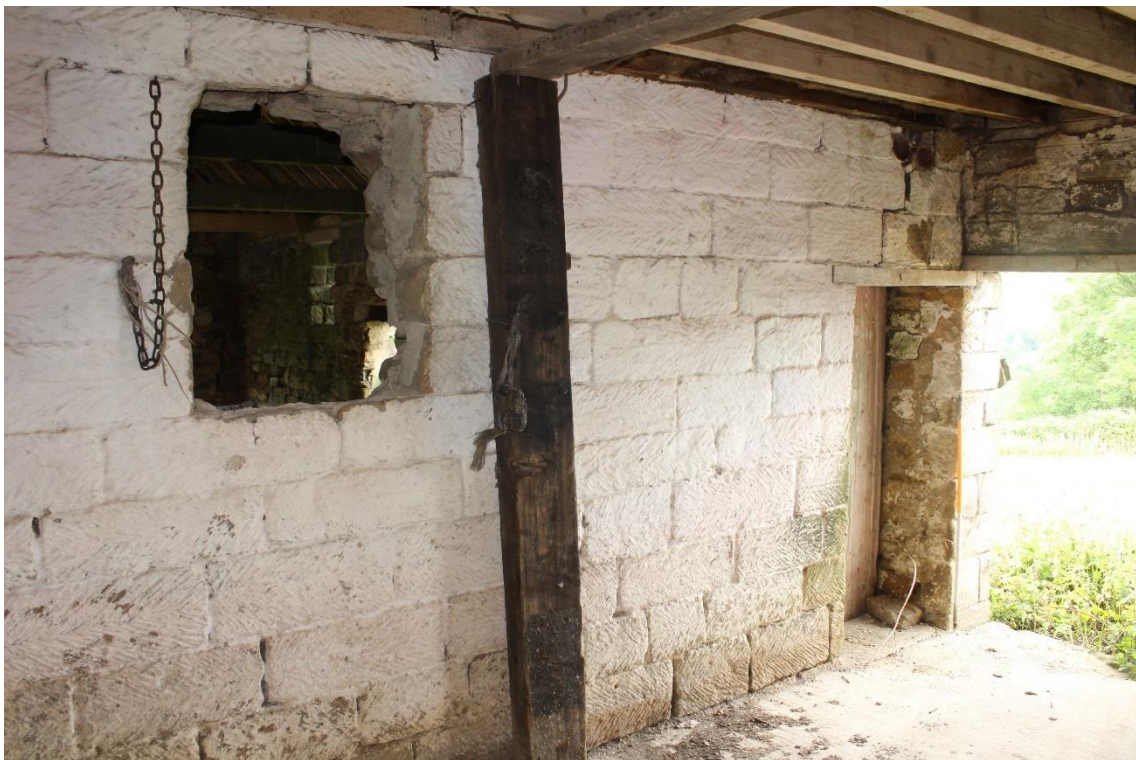
*Plate 140: Internal view SSE of the second compartment of Building No.4*

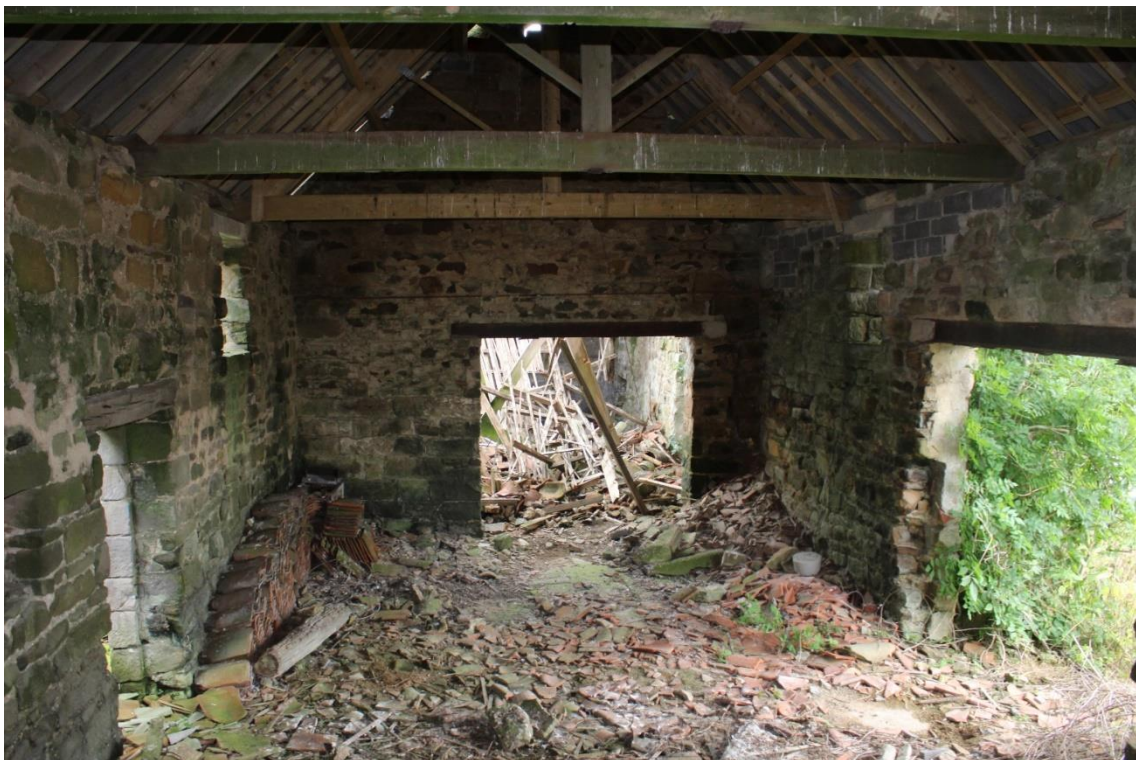
The third compartment (*Plates 142-151*) opens N from the farmyard through a wide cart entrance (*Plate 149*). It is a large open-plan barn with an open roof structure (*Plate 143*). A wide passageway leads into the adjacent E compartment and a short flight of stone steps in the SW corner leads to a door into the compartment to the W (*Plate 148*). A third doorway in the N wall leads to the rear exterior of the barn (*Plate 146*). The room has concrete floors and bare stone walls. The three roof trusses are of a simple king-post construction with angled struts. The room is lit by two pairs of windows in the S and N walls, close to the roofline.

*Plate 142: Internal view E of the third compartment of Building No.4*

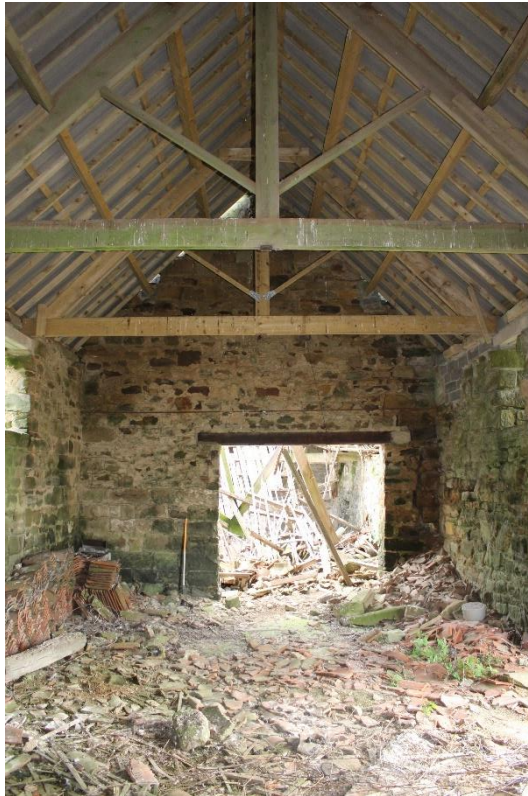
*Plate 143: Internal view E of the third compartment of Building No.4*

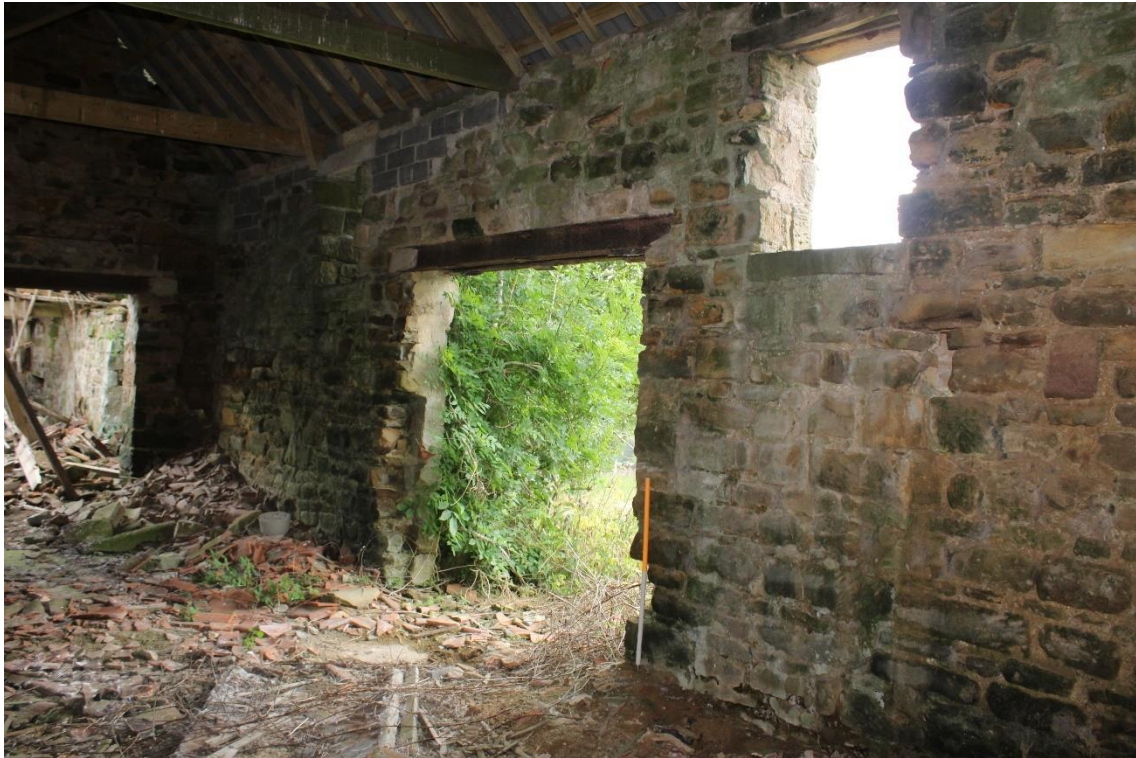
*Plate 149: Internal view SE of the third compartment of Building No.4*

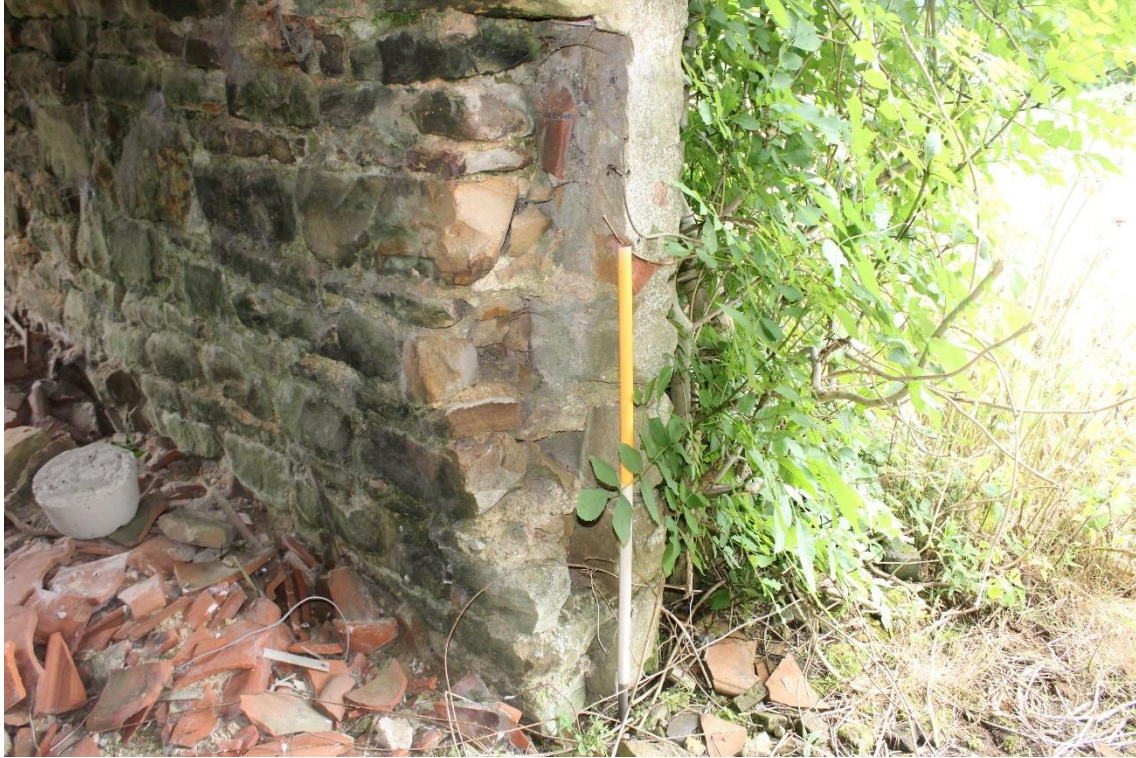
*Plate 151: Internal view SE showing wall construction within the third compartment of Building No.4*
