# Archaeological Observation & Archaeological Building Investigation and Recording

**Phase 3  
New Manufacturing Facility  
Rolls-Royce  
Filton  
Bristol**

**NGR: ST 606 807**

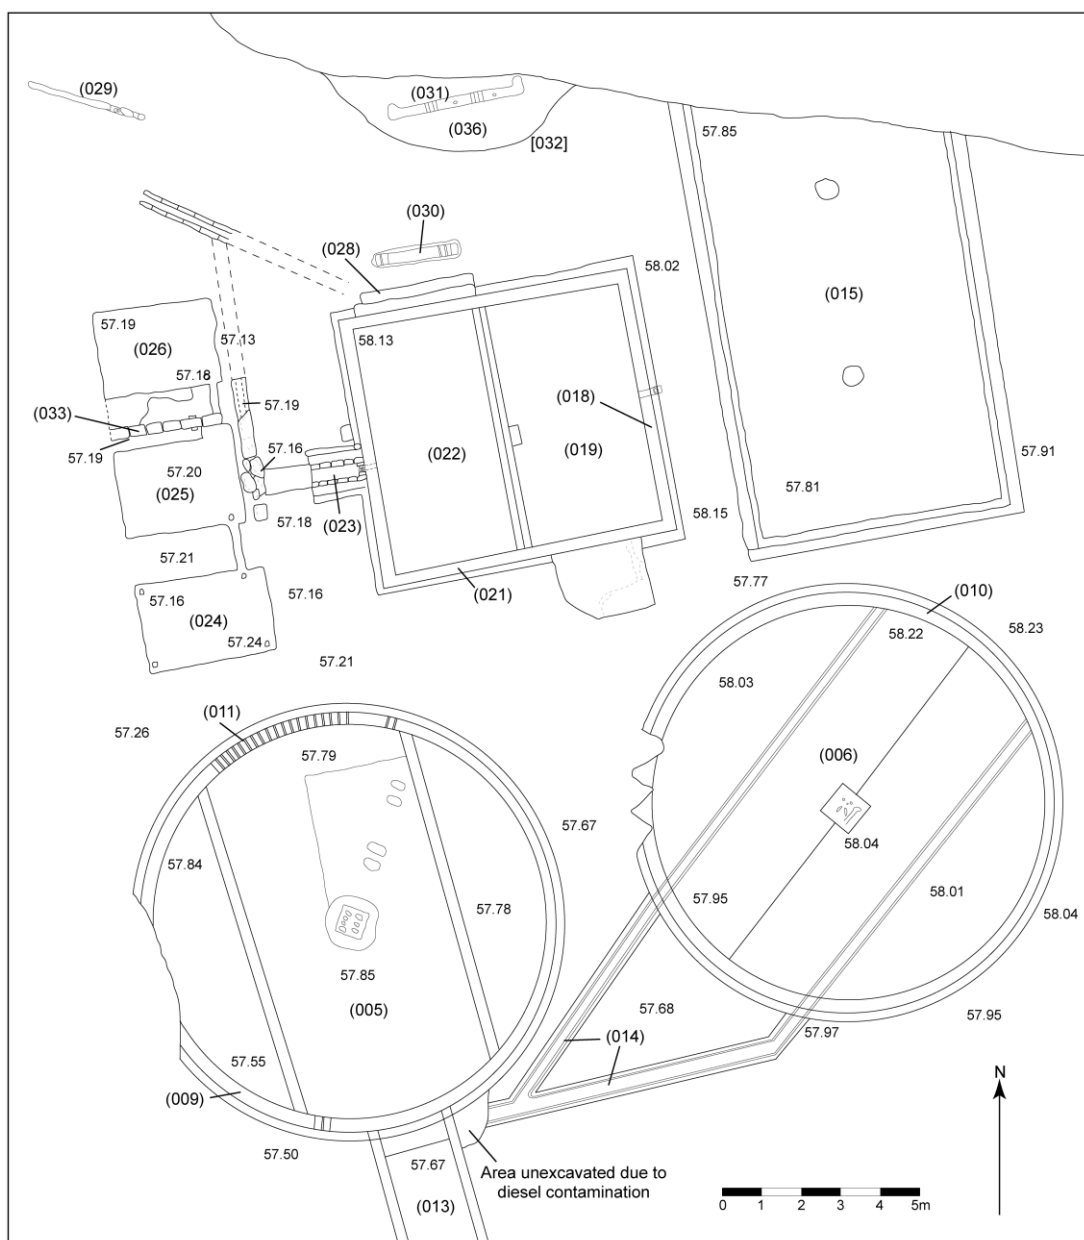
Fig. 3: Plan of sewage filtration plant

Immediately NE of the air-raid shelters were a series of concrete structures apparently relating to sewage treatment (**Figs. 1, 2 & 3**); these appear to have been associated either with the Rolls Royce site or with housing to the N.

The feature consisted of four principal structures, two of which were circular filtration beds with a diameter of 10.9m. These comprised a concrete platform measuring 0.1m (305) / (306) based on reddish-brown gravel (307) / (308), which was approximately 0.15m thick. Slightly stepped in from the edge of each of the concrete platforms was a concrete rim (309) / (310). On the rim of the western filtration bed was a single brick course (311); this feature would evidently have comprised further courses prior to what appears to have been the demolition of this facility.

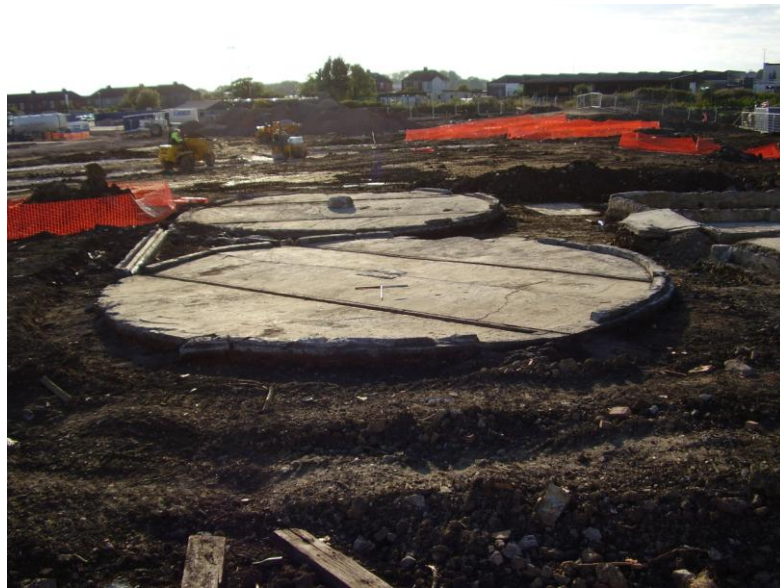
Plate 16: View SW showing filter beds

The concrete platforms themselves were divided into three sections, separated by two concrete drainage channels filled with a compact mixture of ceramic pipe, iron furnace slag and dark grey gritty silt (312). This appeared to be associated with the clinker material that would have filled the filter bed to remove ammonia from the waste. The ceramic pipe seems to have extended along the length of the channels but had probably been damaged during demolition of the facility. In the centre of both concrete platforms was a concrete plinth, which would probably have supported a rotating arm. The concrete platform on the westernmost filtration bed appears to have been 're-surfaced' with an additional 0.1m thick layer of concrete.

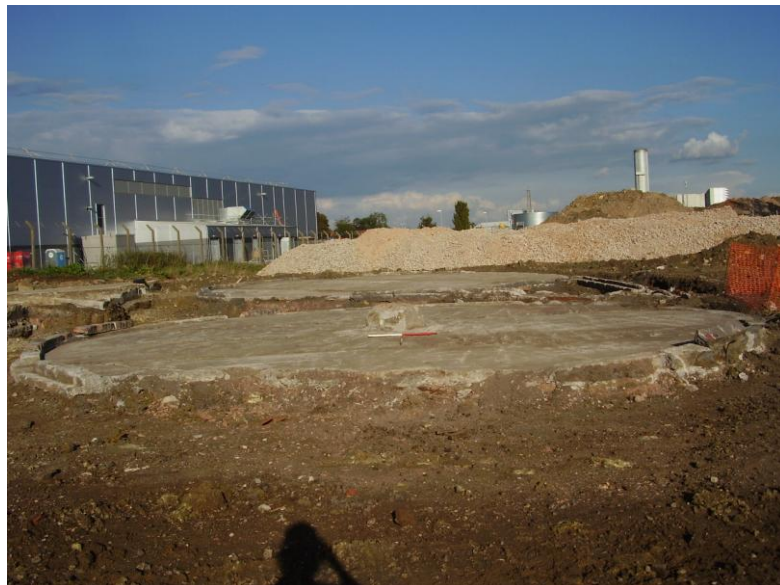
Plate 17: Filter beds, facing NE

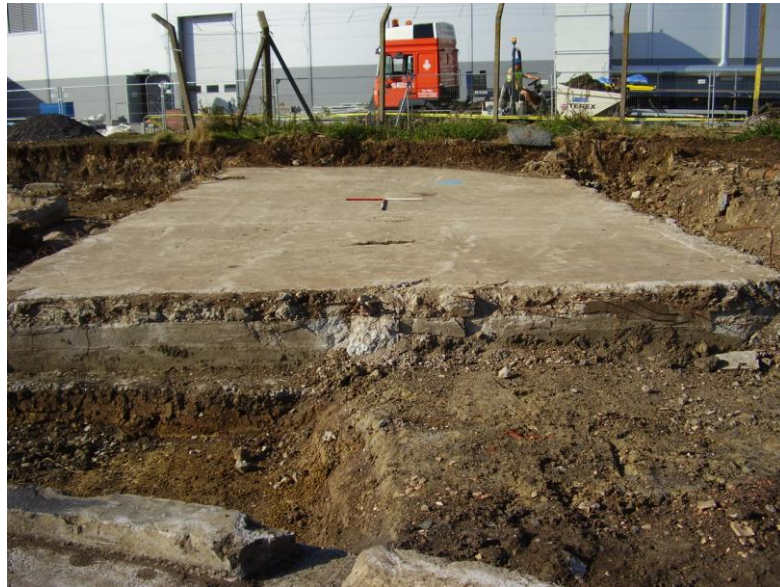
To the N of the filter beds were two concrete structures, which appear to have been liquid holding tanks. The first and largest of these consisted of a large flat concrete platform (315) orientated N–S and measuring 11.7m x 7.2m. The platform sat on a rectangular concrete foundation (316), the centre of which was filled with a pinkish-brown gravel (317). The uppermost concrete layer appears to have had a 0.15m thick steel reinforced concrete wall around the outside edge, which appears to have been demolished.

Plate 20: View NW showing concrete platform / holding tank (315)

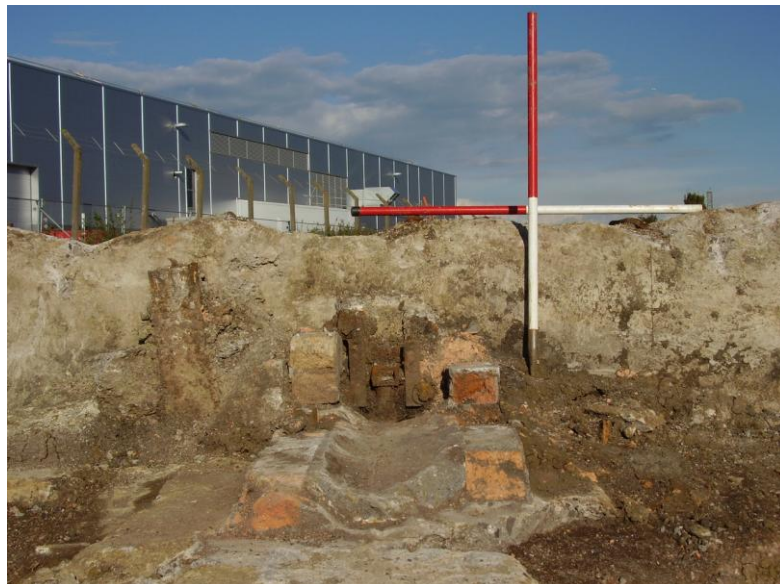
On the western side of this tank was what appeared to have been a sluice, constructed of cast iron girders, which ran into a brick-lined gully (323).

Plate 23: Gully (323), facing NE

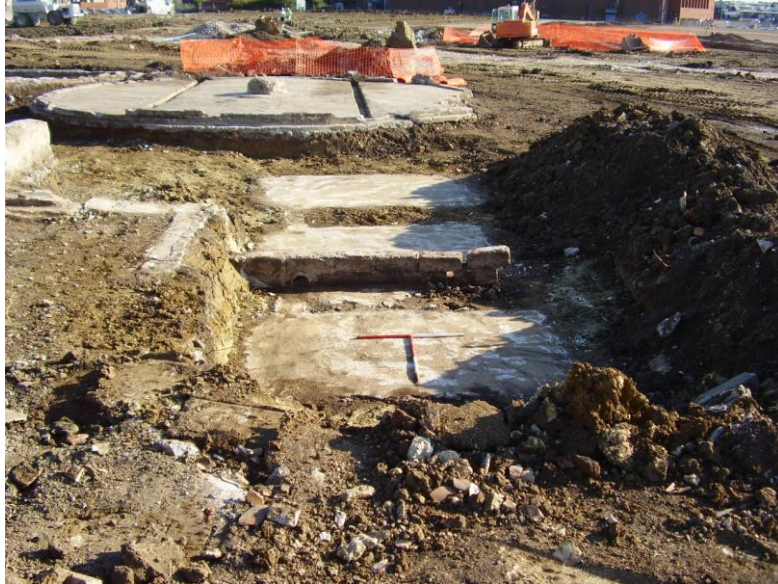
The gully ran to what appeared to be three sunken concrete platforms (324) / (325) and (326), each filled with a 0.4m deep layer of iron furnace slag / clinker (327). A two-course wall of unbonded concrete blocking (333) divided the central and northernmost

platforms. Within the eastern side of the wall was a ceramic tube that appeared to have allowed the flow of liquid between the two platforms. The gully and platforms appeared to relate to an overflow sluice, which would have been released when the holding tanks to the E were full.

Plate 24: View SE showing platforms (324) / (325) & (326)

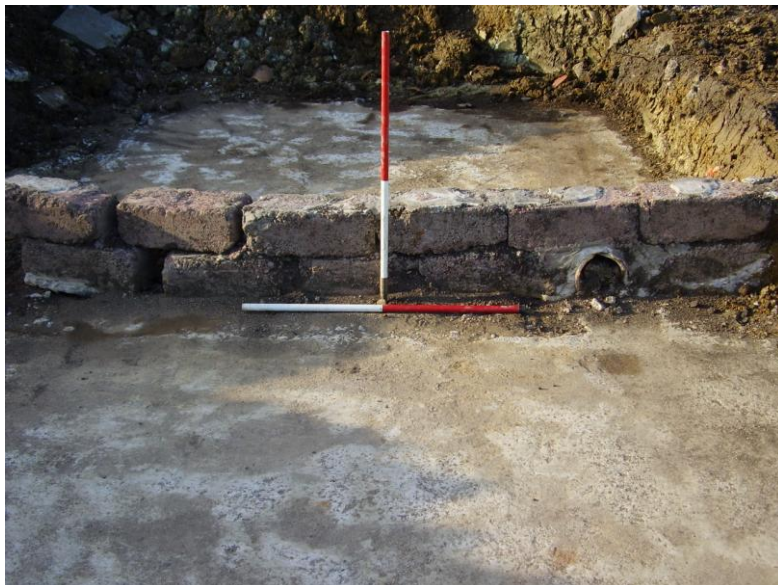
Plate 25: Wall (333), facing N

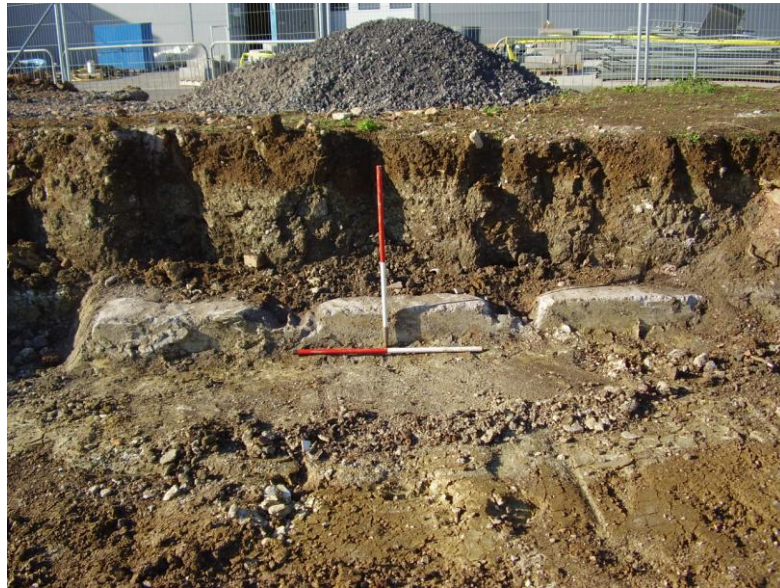
To the N of the platforms was a small section of drainage pipe orientated in a NW-SE (328). To the N of tank (319) was another section of drainage pipe flanked on either side by concrete (329) and a small section of brick wall (330) orientated NW-SE. Immediately to the N of this, and only partially revealed by the excavations, was a small, apparently rectangular concrete foundation with two grooves in the southern side (331). These appear to have held some form of piping. The concrete wall was within a semicircular cut [332] some 5m in length and >3m wide, filled with a creamy / greyish-white firm clay (336) (not excavated).

Plate 26: Concrete foundation (330), facing N

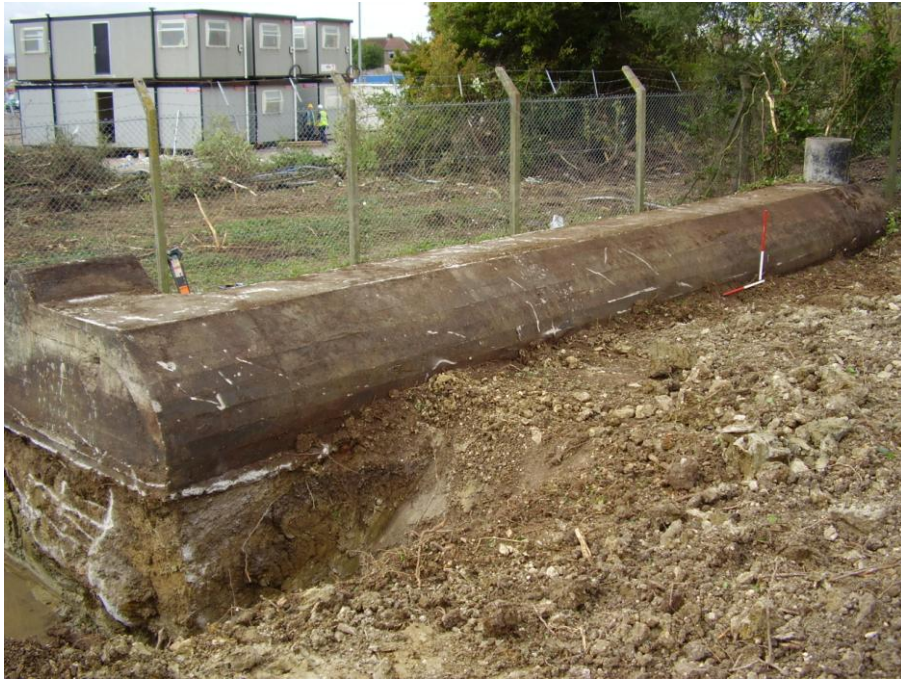
Plate 1: View SW showing external construction of shelter

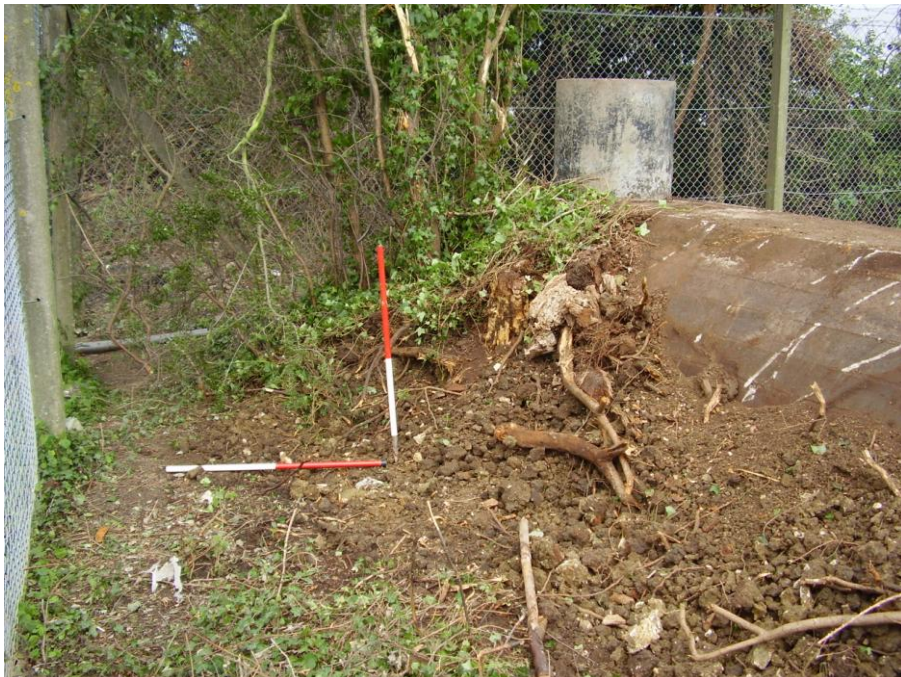
The shelter comprised an L-shaped concrete structure consisting of a main body orientated E-W, with an entrance at the eastern end set at right angles to the entrance opening to the S (**Figs. 1-3, Plate 3**). A circular concrete vent was visible at the western end of the main body (**Figs. 1 & 3, Plate 2**).

Plate 2: View NW showing location of vent

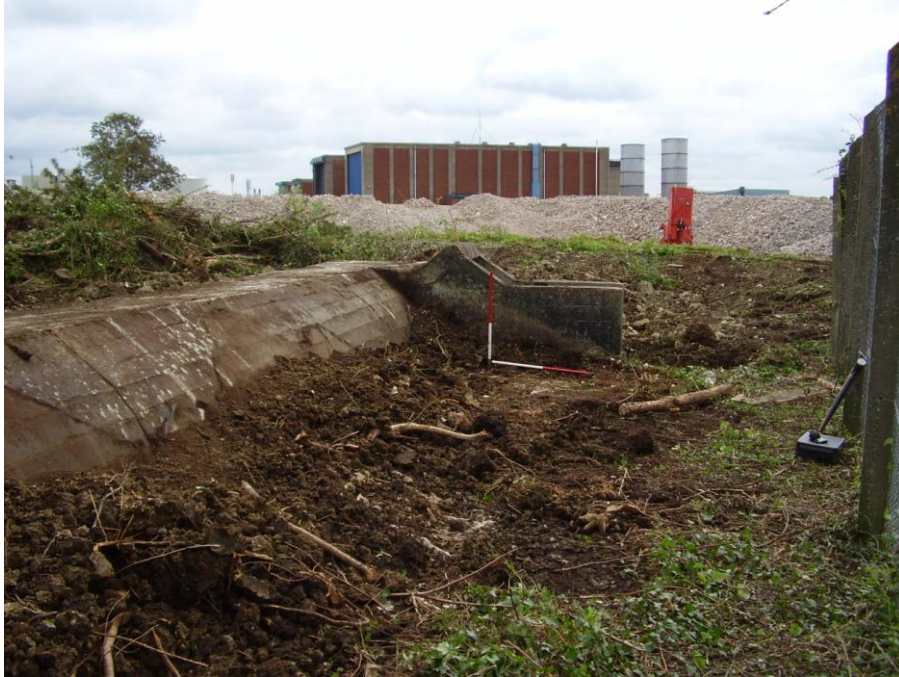
Plate 3: View E showing location of entrance

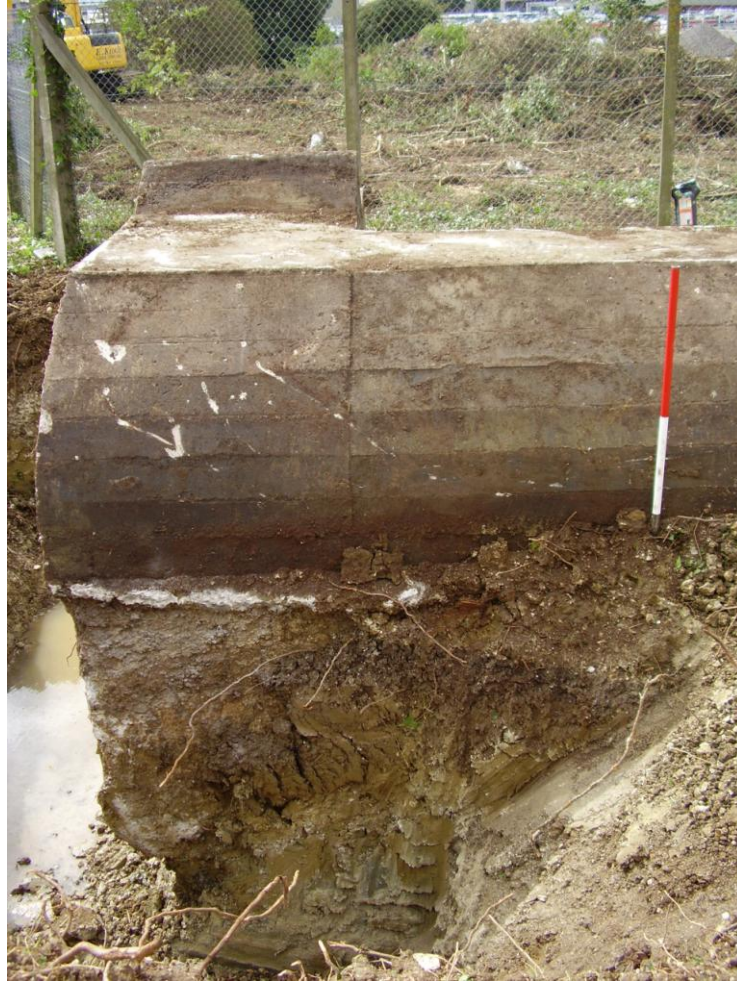
A construction trench appears to have been excavated and filled with concrete to form the lower section of the shelter (approximately 1.4m in height) (**Plate 4**).

Plate 4: View S showing construction

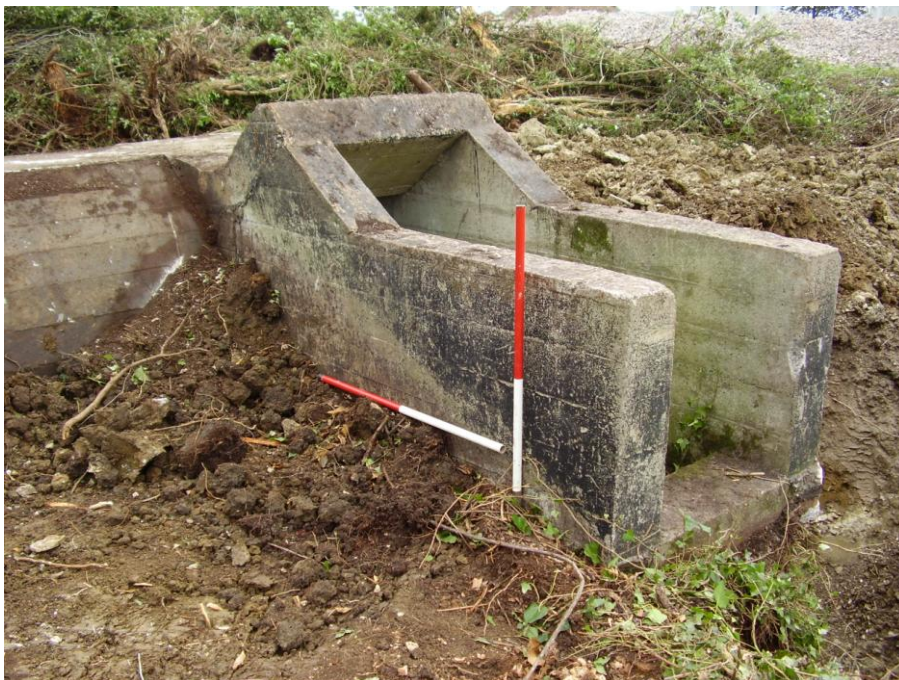
The concrete around the entrance appeared to have been cosmetically treated with a 'stencilling' effect to create the illusion of block construction rather than solid concrete (**Plates 5 & 7**). No other external features of note were observed.

Plate 5: View NE showing entrance construction

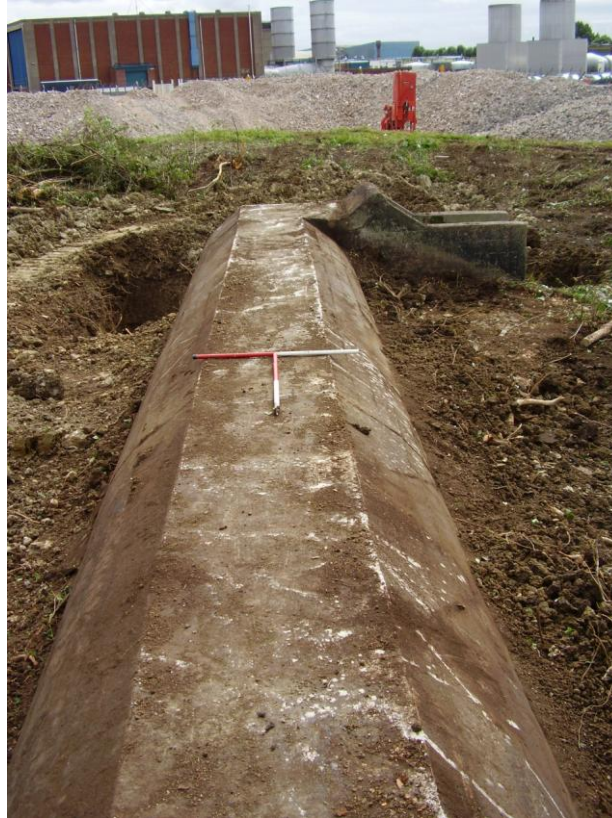
The upper part of the structure (the upper 1m) appeared to have been constructed from pre-cast concrete sections bonded with cement and concrete was also used for the roof construction (**Plate 6**).

Plate 6: View E showing roof construction

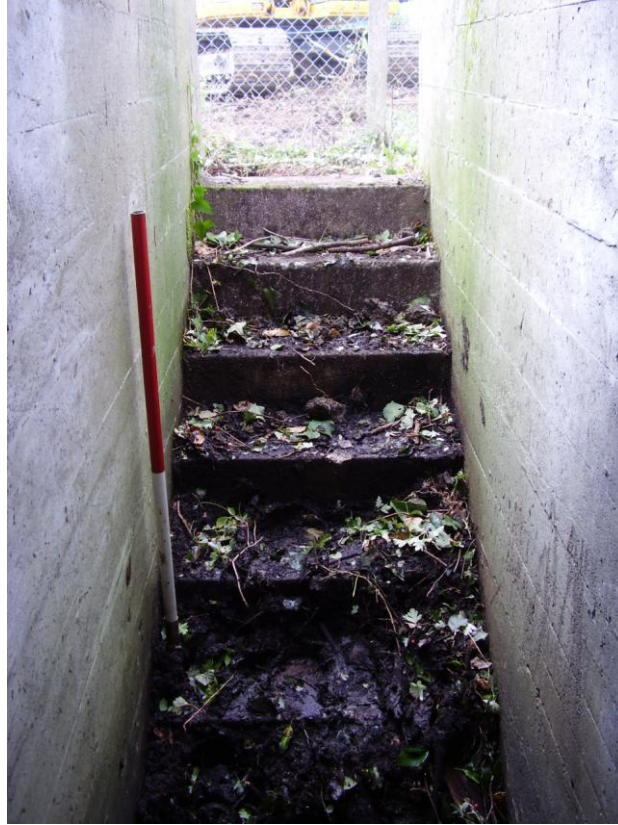
Seven concrete block steps led down from the entrance to the interior of the shelter (**Fig. 1, Plate 8**).

Plate 8: View S showing steps forming part of entrance
