**Archaeological Standing
Building Recording**

Gloucester City Homes

**The Old Coach House (Plot 12)
St James' Close
Quedgeley
Gloucester GL2 4PL**

June 2019

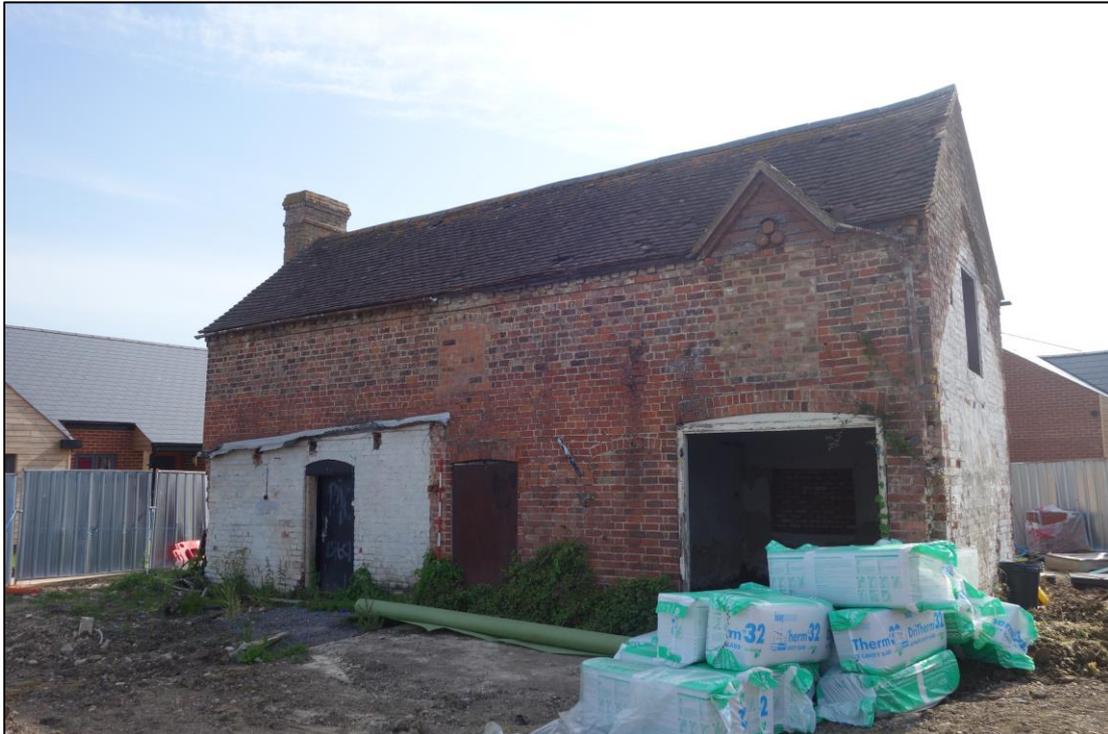
Plate 1: External view looking NE showing principal W-facing elevation of the 'Old Coach House'

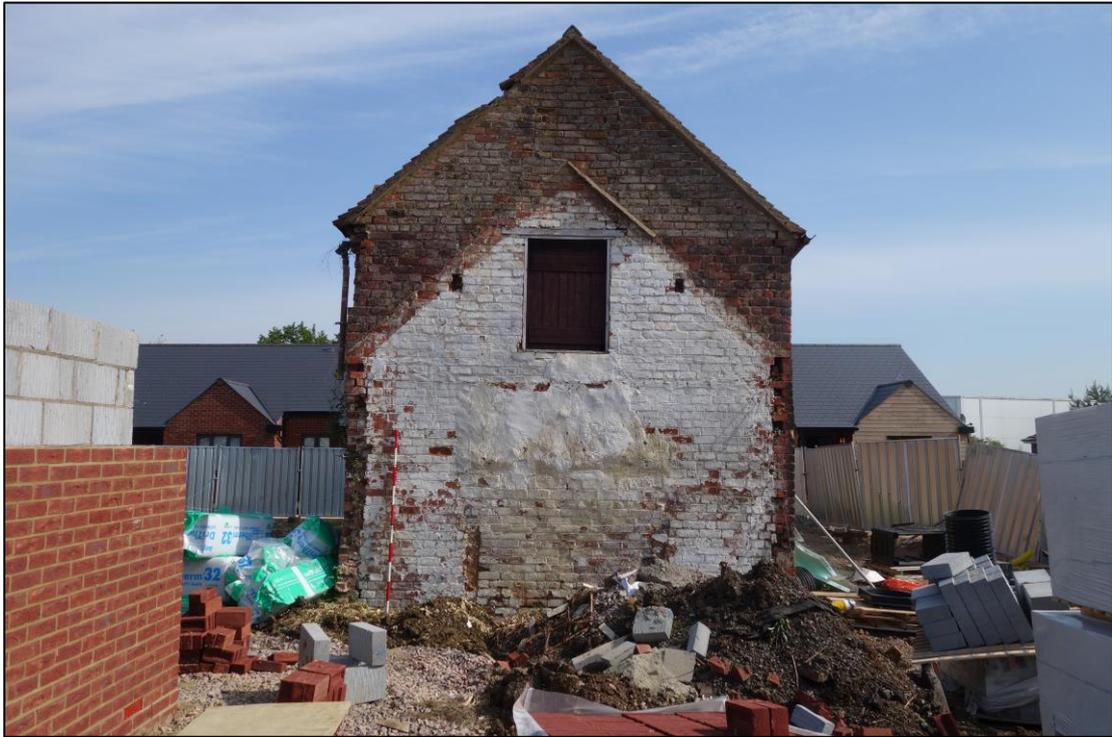
Plate 5: External view looking N showing S-gable elevation of 'Old Coach House'

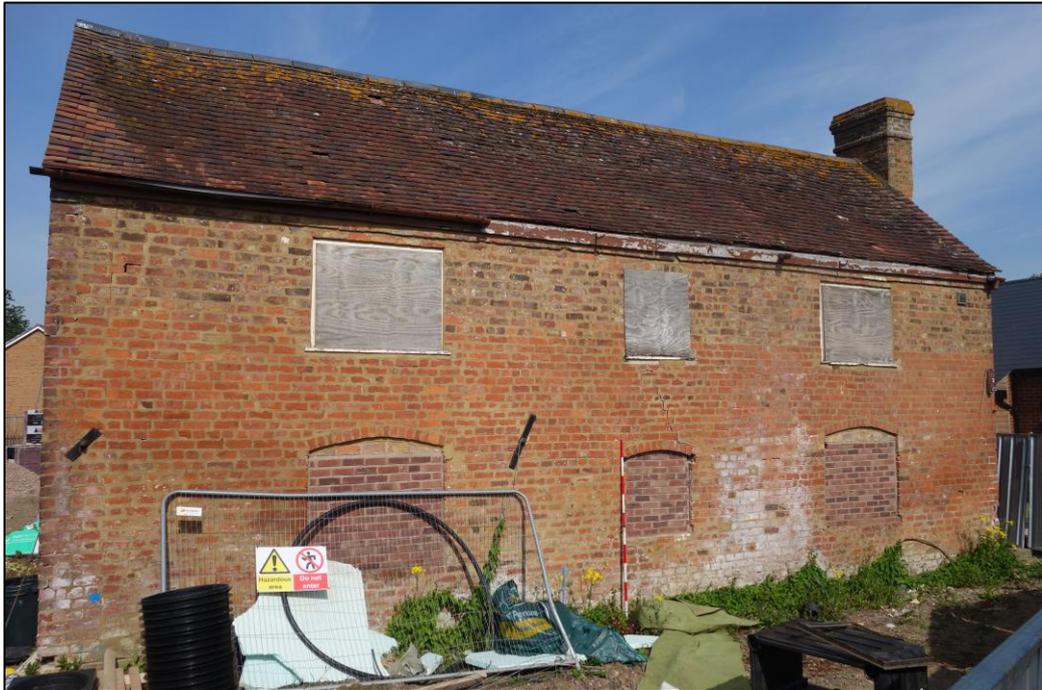
The rear (E-facing) elevation of the Old Coach House has now been cleared of trees and undergrowth, fully exposing the fabric which was largely concealed by trees and undergrowth at the time of the 2015 recording (*Plate 6*). A marked change in brickwork is discernible between the upper and lower storeys, in an identical position to that noted on the W-facing elevation. As in the case of the W-facing elevation, two cast-iron diagonal wall-ties are attached to the masonry of the central and southern bays of the E-facing elevation.

Plate 7: External view looking WNW showing rear (E-facing) elevation of 'Old Coach House'

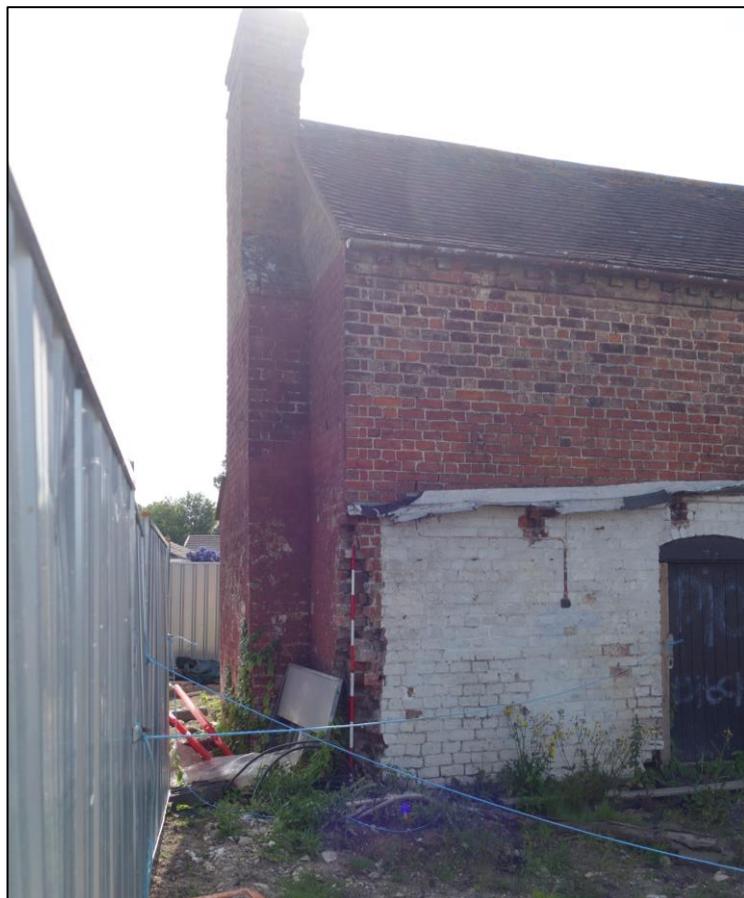
Evidence was noted for a low-pitched roofline extending E-W along the lower stage of the chimneystack and then pitching sharply upwards to the right of the stack. It is likely that the roofline is associated with the lean-to extension attached to the N gable end of the building which was erected in the mid-late 19th century and demolished at some point after the Second World War. Traces of whitewash are visible on the section of wall beneath the roofline, suggesting that this was formerly an interior wall (associated with the lean-to structure). A low, frogged red-brick wall (0.70m high) which formerly extended northwards from the NE corner of the N-gable elevation and appeared to be of modern date, has now been demolished.

Plate 8: External view looking SE showing N-gable elevation of the 'Old Coach House' with chimneystack

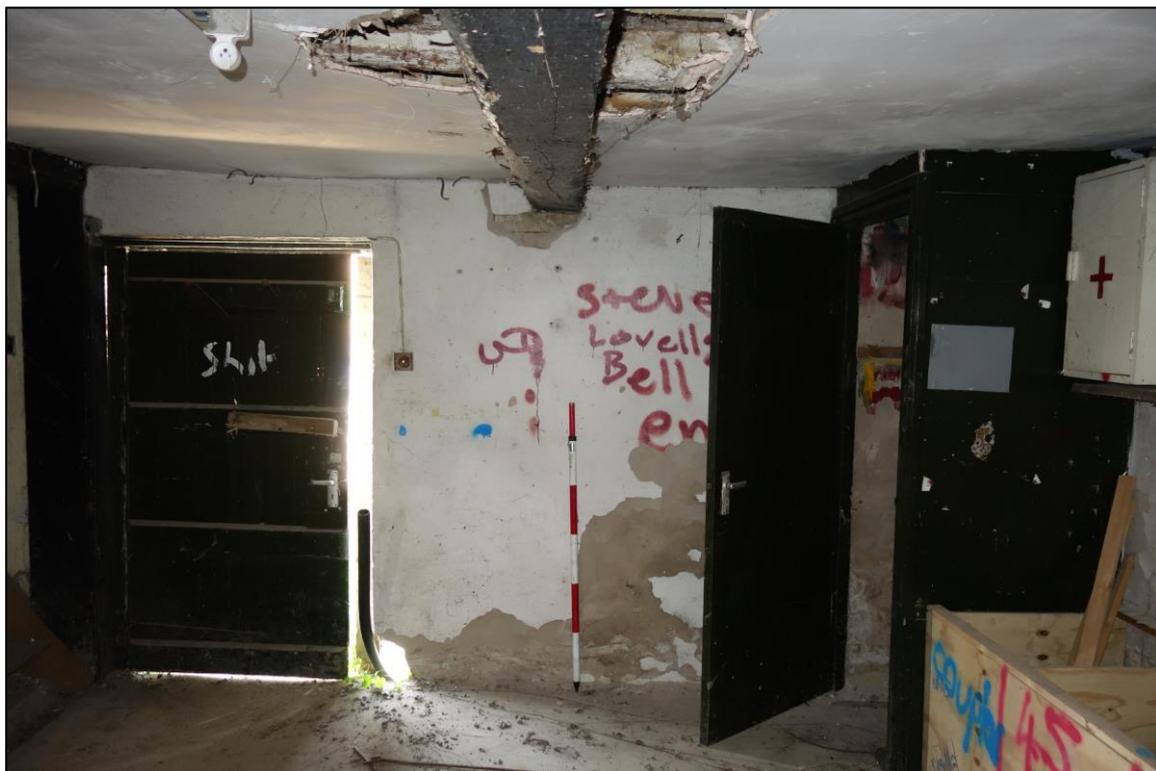
Plate 9: Internal view looking W showing doorway and modern cabinets in W wall of northern compartment at ground level

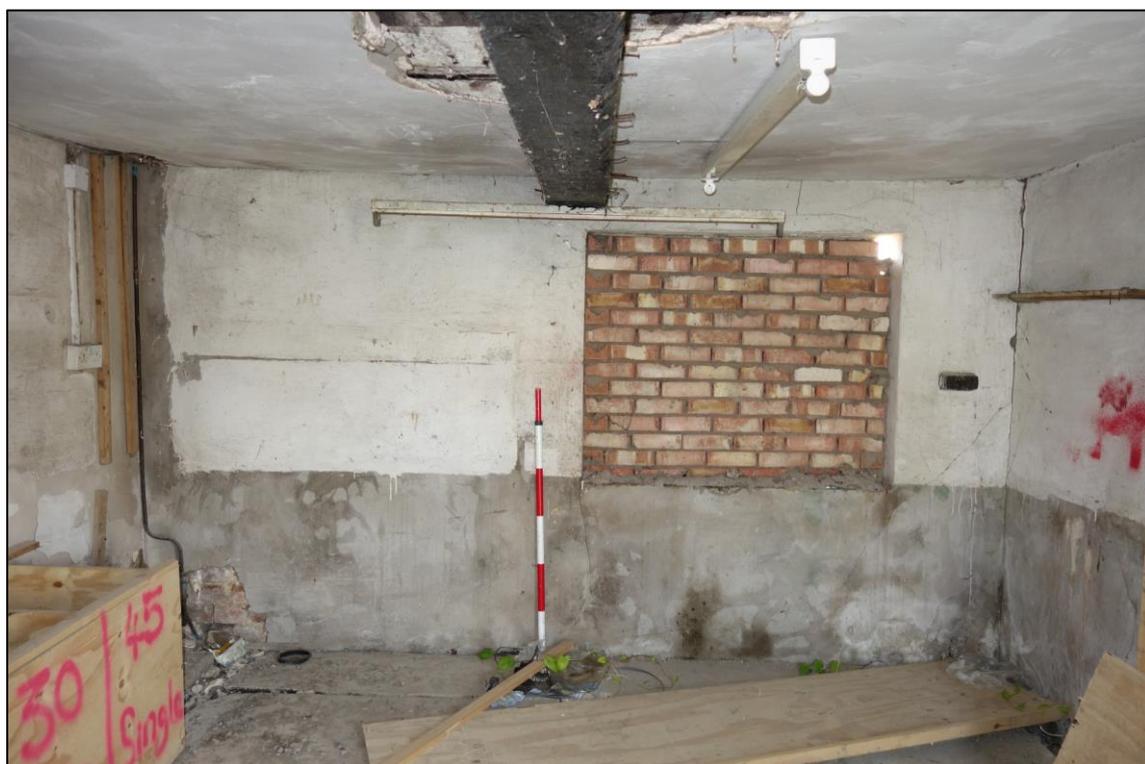
The ground-floor room within the northern bay (which may be identified with the room described as a 'Kitchen, now a Wash House' in the 1889 inspection report) is largely devoid of notable features of interest. A large metal cupboard and a medicine cupboard are located within the NW corner of the room, presumably associated with its use as a clubhouse (*Plate 9*). Evidence for the use of the building in the late 20th century is indicated by the ceiling light fixtures and associated switches and wall plug sockets. A flat-headed doorway with a plain moulded frame in the W wall probably represents a mid-late 19th century addition; there was no internal evidence for the probable doorway associated with the blocked archway that is visible externally. A bricked-up rectangular window opening is visible in the E wall (*Plate 10*).

Plate 10: Internal view looking E showing blocked window in E wall of northern compartment at ground level

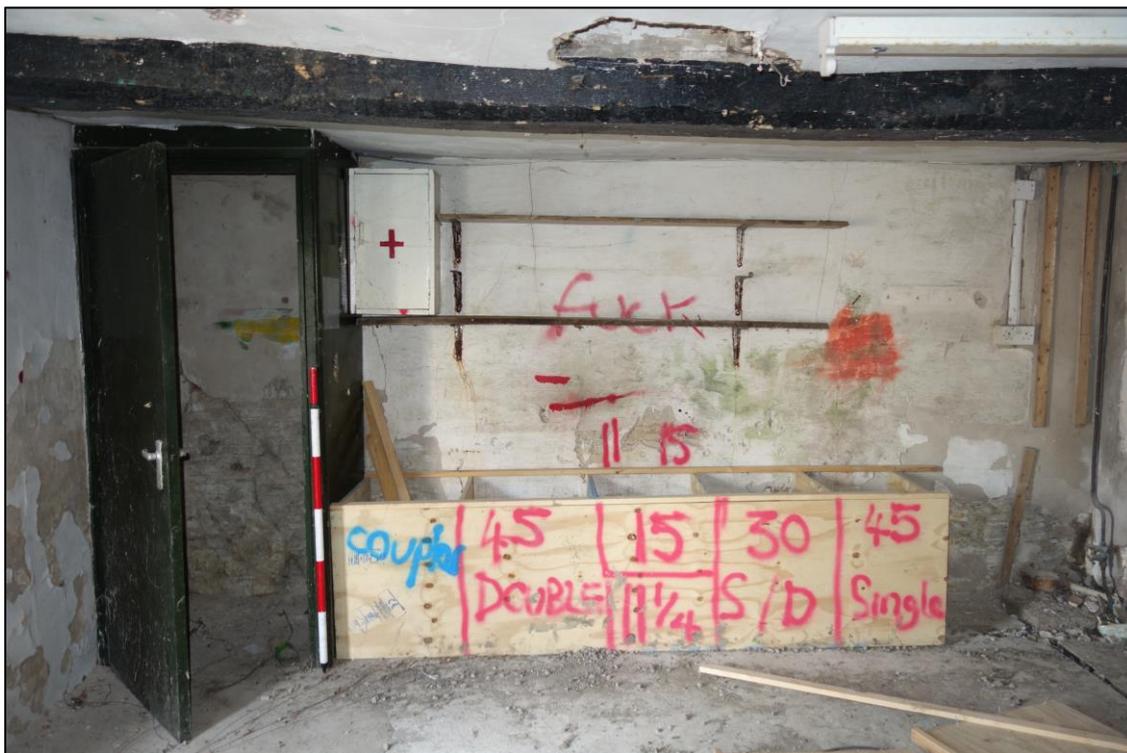
It appears that the fireplace, which must have been located in the N wall of this room (based on the location of the chimneystack), was bricked-up and the wall plastered over; a small hole has been knocked through the lower part of the wall, revealing a void within the wall which is most likely the hearth (*Plate 11*). The ceiling is plastered, although there is an exposed, chamfered beam running E-W across the centre of the room. It is unclear whether this beam represents a former internal sub-division: no evidence for holes or slots for vertical studs or rails was noted, although a large number of nails had been inserted in the thickness of the beam, which was also heavily blackened.

Plate 11: Internal view looking N showing northern compartment at ground floor level with chamfered ceiling beam

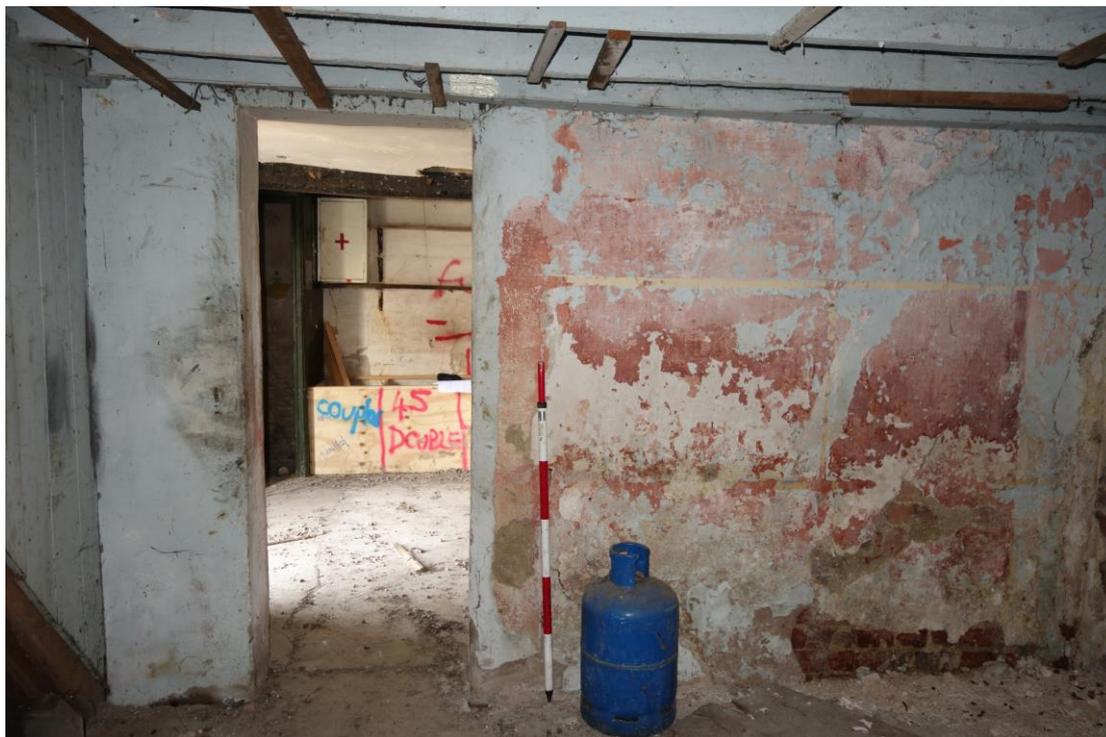
In contrast to the N room, the ceiling joists and rafters in the central compartment are exposed and painted and appear to be of late 19th-century date or later (*Plate 13*). Inserted within the W wall of this compartment is a flat-arched door with a wooden architrave. A steel door has been inserted in place of an earlier plank and batten door which stands next to the doorway. Attached to this earlier door are a number of horseshoes (*Plate 14*).

Plate 13: Internal view looking N showing doorway in N wall of central compartment with whitewashed walls and exposed ceiling joists

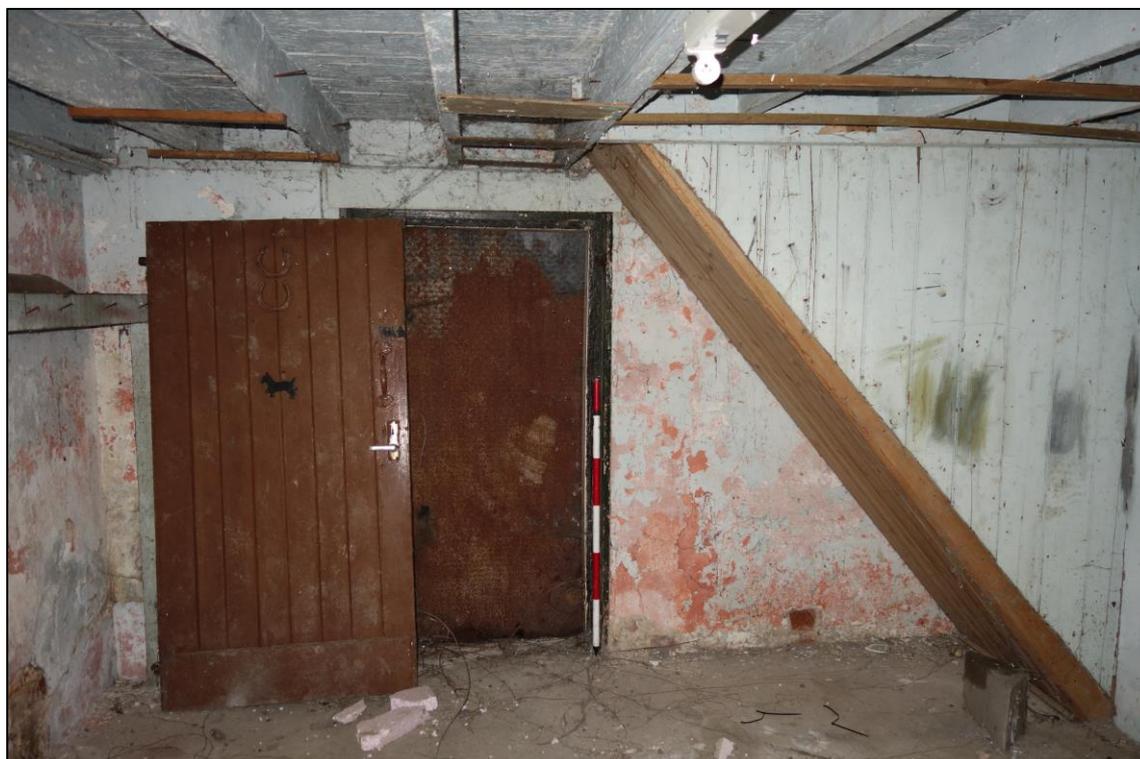
Plate 14: Internal view looking W showing doorway in S wall of central compartment on ground floor, adjacent to which is an earlier plank and batten door with horseshoes attached

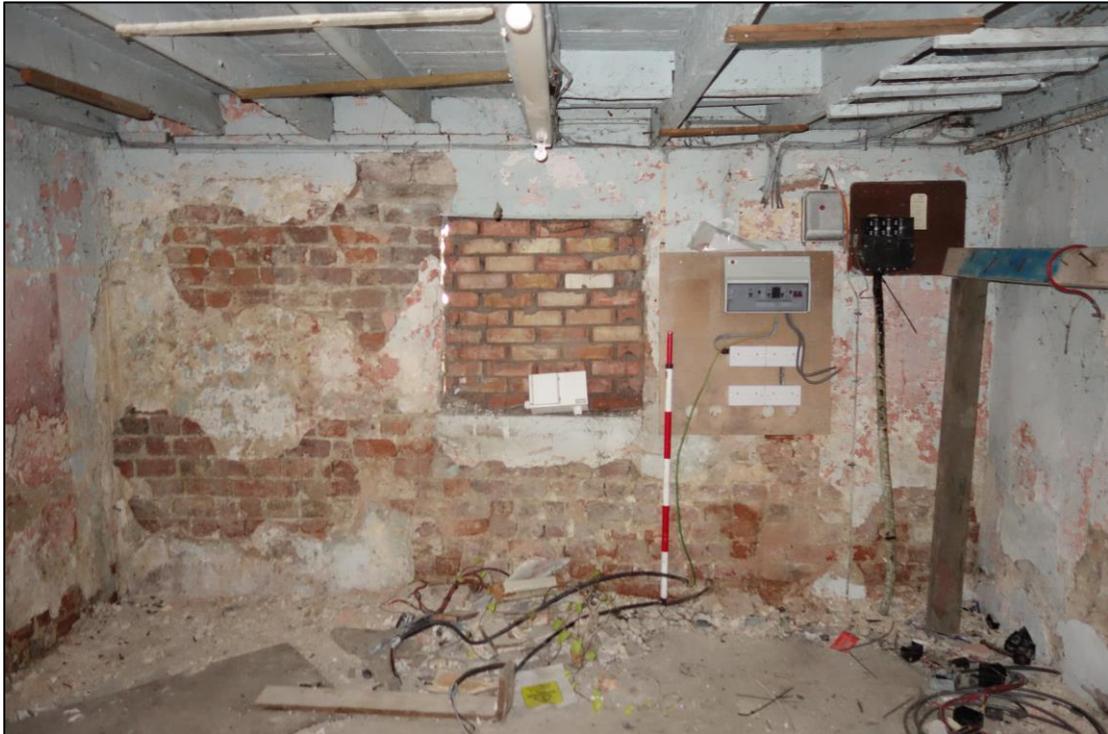
Evidence indicating that this room was also being refurbished for use in the late 20th century is provided by the survival of a modern bar-light fitting attached to the central ceiling joist and a number of light switches and fittings (including a fuse-box) attached to the E wall. A window opening in the E-wall has been bricked-up and the original casement removed (*Plate 15*).

Plate 15: Internal view looking E showing blocked window in E wall of central compartment at ground floor level with exposed, whitewashed ceiling beams and joists

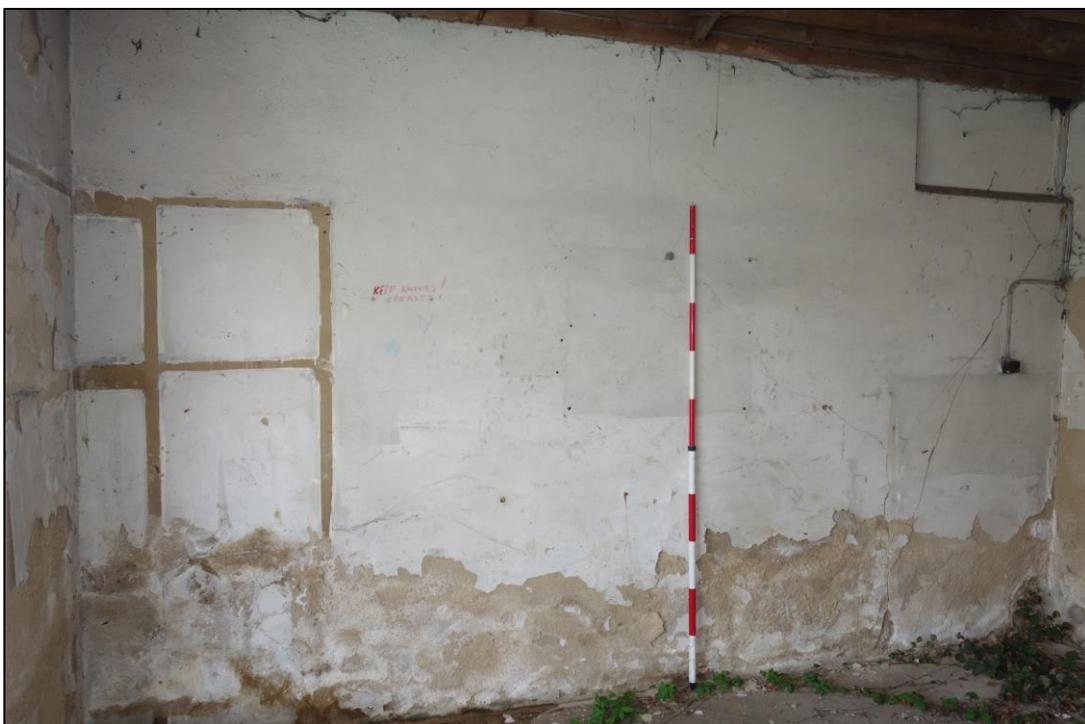
The walls have been coated in thick white plaster (partially denuded in places) and the original floor has been replaced by concrete hardstanding, while the window in the E wall has been bricked up (*Plate 17*). The ceiling appears to have been significantly heightened in the late 20th century (as evidenced by the modern joists and the bar light fitting just beneath the ceiling); however the line of the original ceiling is still discernible, together with the lower part of what appears to be the lower part of the door leading from the first floor landing to the loft above (*Plate 18*).

Plate 18: Internal view looking N showing N wall of southernmost compartment on ground floor showing lower part of blocked doorway to top right of picture

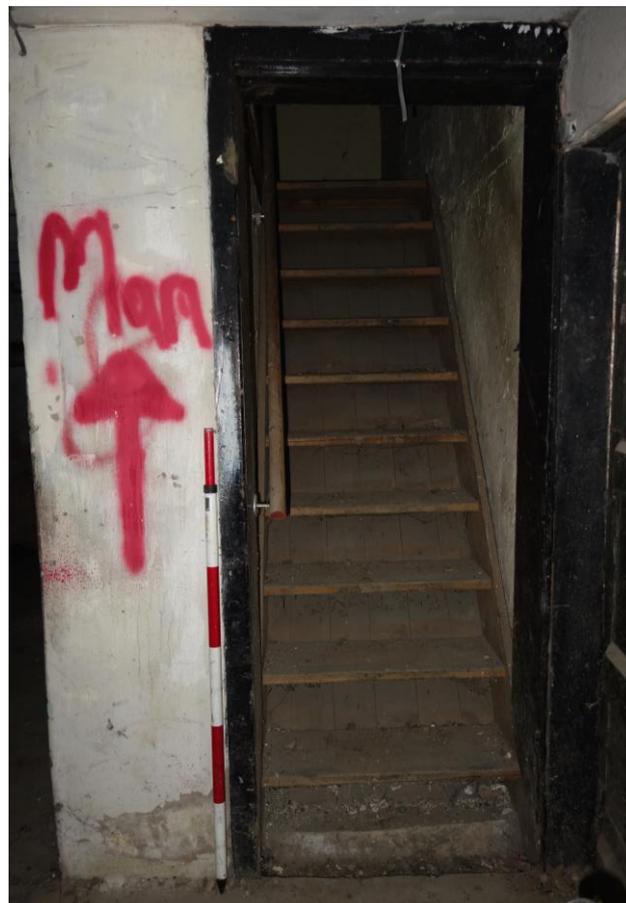
The first floor is accessed from a straight flight of wooden stairs located immediately right of the entrance to the northern compartment (*Plate 20*). The plain moulded door architrave at the foot of the stairs appears to be of mid-19th -century date; however, the existing box staircase and handrail appear to be of later date, probably contemporary with the refurbishment of the building in the mid-late 20th century. Health-and-safety concerns limited recording of the first floor; in specific areas the floorboards were weakened or had been removed entirely, particularly within the northern and southern compartments (the condition of which had deteriorated markedly since the original recording in 2015).

Plate 20: Internal view looking S showing staircase leading to first floor landing

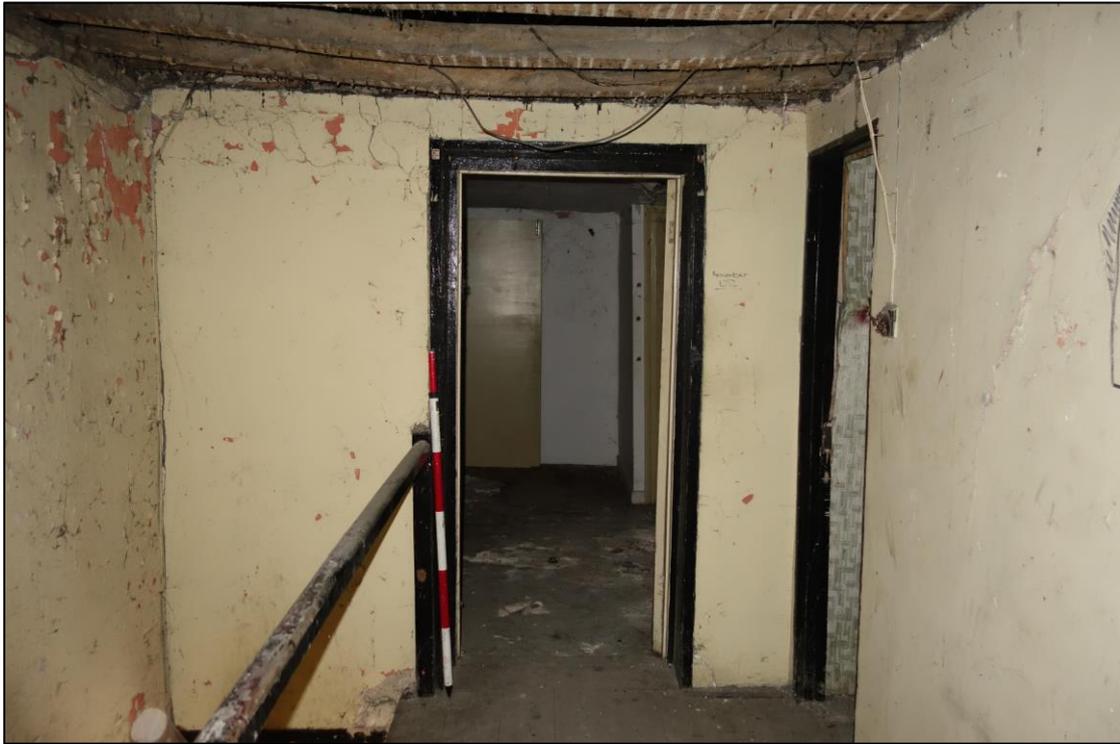
The first-floor landing was originally lit by a window in the W wall, above and to the right of the staircase, which was probably blocked in the mid-late 20th century (*Plate 22*). Two plain moulded doorways lead off to rooms to the N and E of the landing (*Plate 21*): the original doors appear to have been replaced by modern doors (probably installed as part of the mid-late 20th -century refurbishment phase).

Plate 21: Internal view looking N showing rooms to N and E of first floor landing

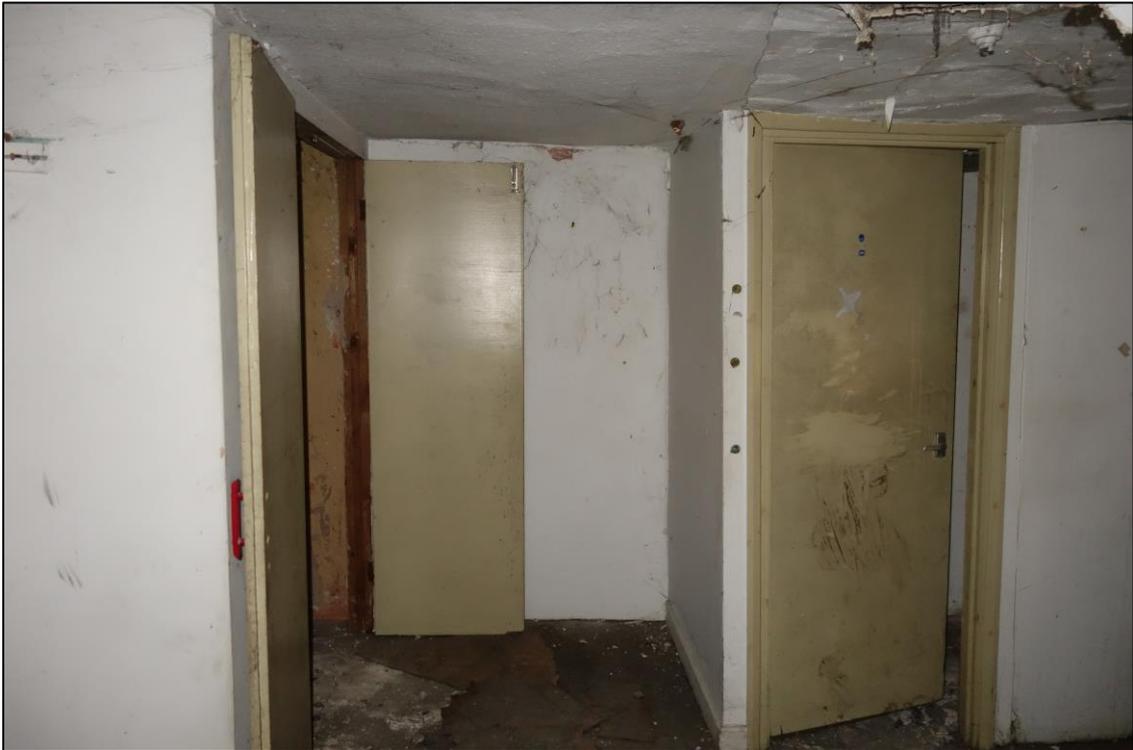
Plate 23: View looking N showing interior of northern compartment on first floor

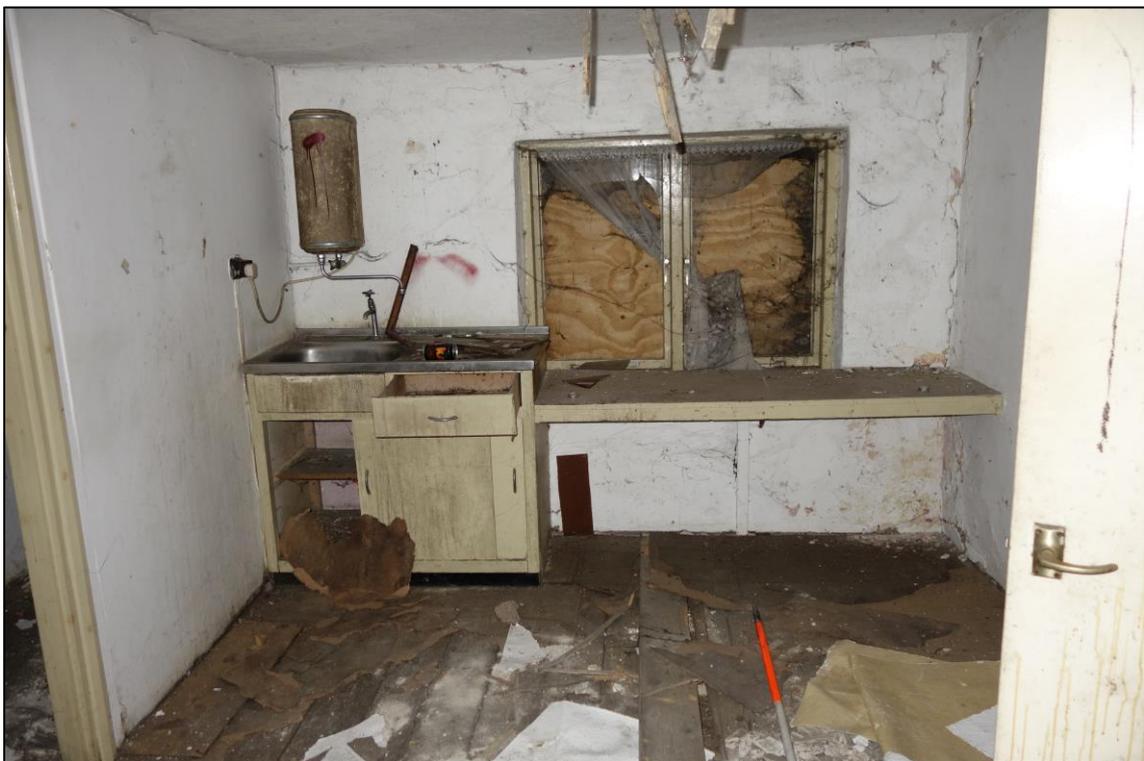
Plate 24: View looking E showing interior of northern compartment on first floor showing modern kitchen fittings and casement window in E wall

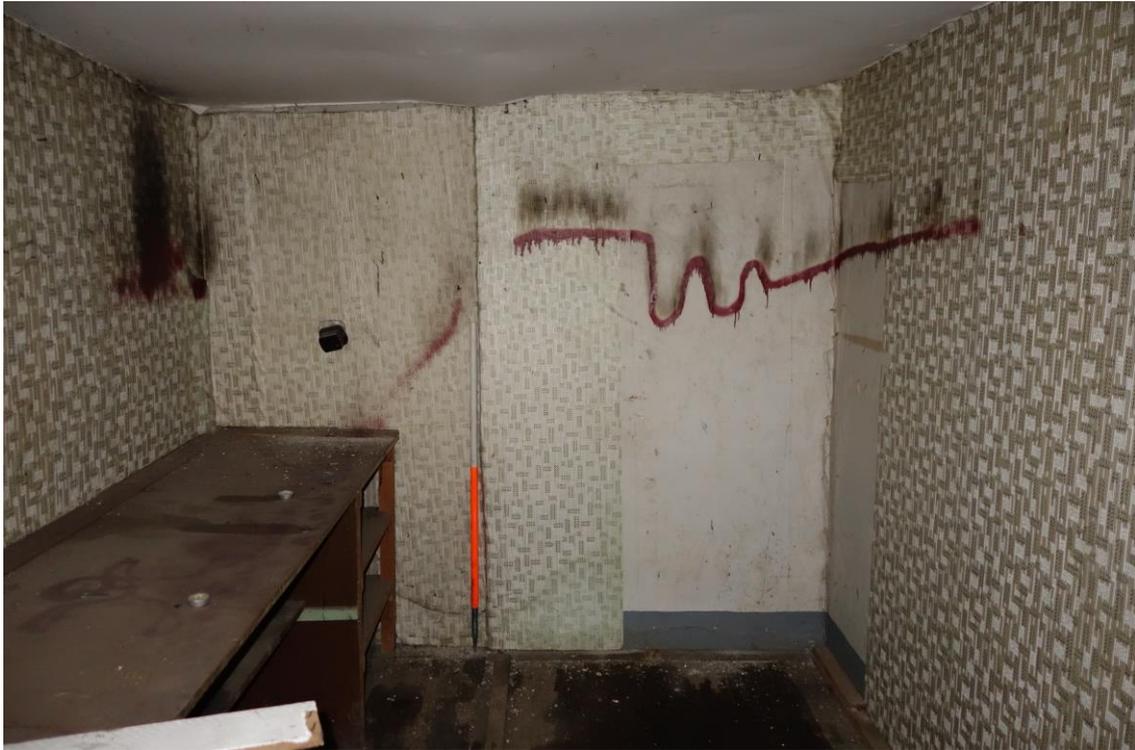
Plate 25: Internal view looking S showing S wall of compartment to E of first floor landing

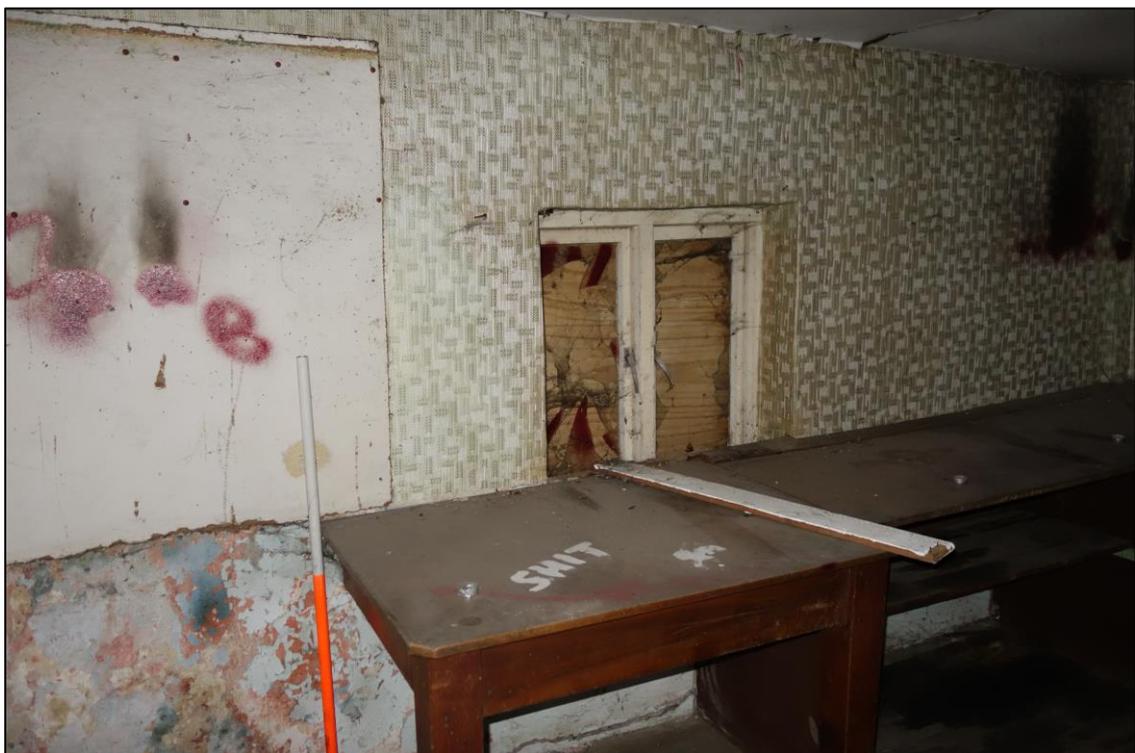
Located immediately E of the first-floor landing is a narrow room extending parallel to the landing: it presumably can be identified with the room over the 'Harness Room' mentioned in the 1889 inspection report. The ceiling is plastered, while the walls are covered in patterned wallpaper of mid-late 20th century date. A cupboard or wardrobe appears to have been situated at the SW corner of the room, indicated by a gap in the wallpaper (*Plate 25*). The window opening in the E wall appears to be an original feature, although the existing two-light casement is clearly of modern date (*Plate 26*).

Plate 26: Internal view looking SE showing casement window in E wall of compartment to E of first floor landing

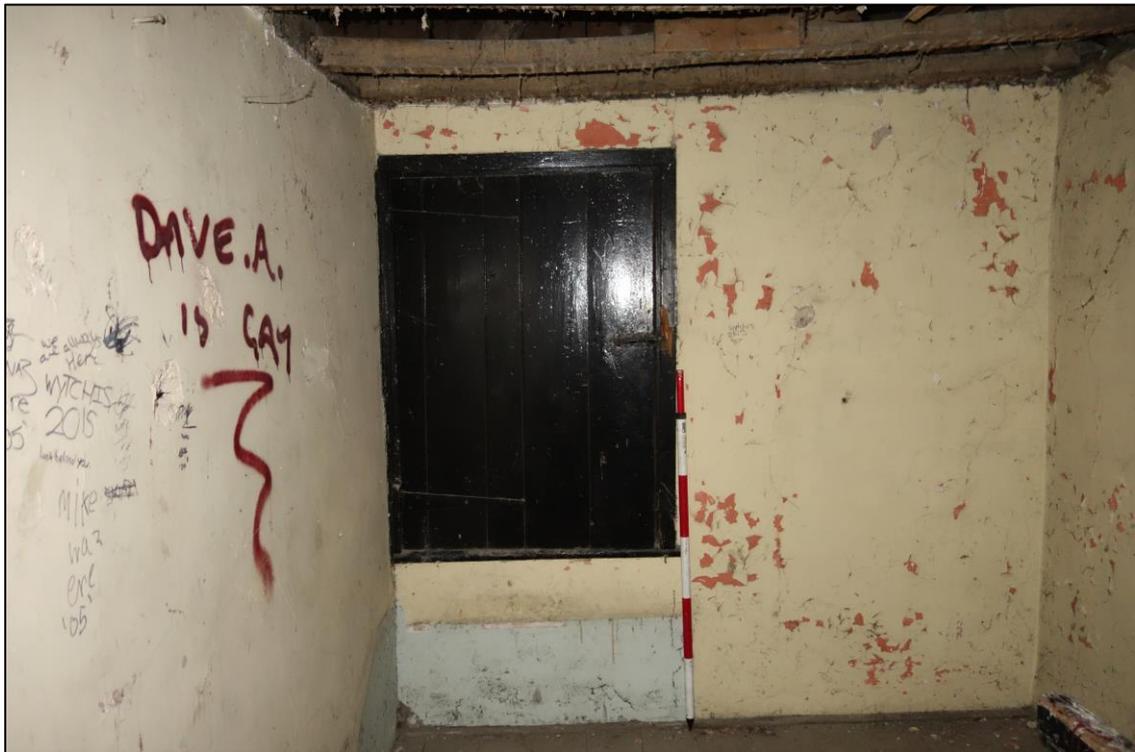
To the S of the landing, a rectangular hatch with plank-and-batten door gives access to a raised loft above the 'Coach House'; the height of the loft floor is approximately 0.50m above the rest of the first floor (*Plate 27*). A flight of wooden steps leading up to the hatch has been removed since 2015. This raising of the floor level appears to have been undertaken as part of the refurbishment of the building in the mid-late 20th century, as evidenced by the ceiling joists visible in the room beneath. The hatch door comprises five planks of unequal width, with cast-iron strap hinges and a sliding door bolt. The form of the hinges is suggestive of a 19th-century date, although it is difficult to be more precise. The sliding bolt attached to the door appears to be later than the hinges; it is possible that it represents a replacement of an earlier latch.

Plate 27: Internal view looking S showing hatch with plank and batten door leading to loft off first floor landing

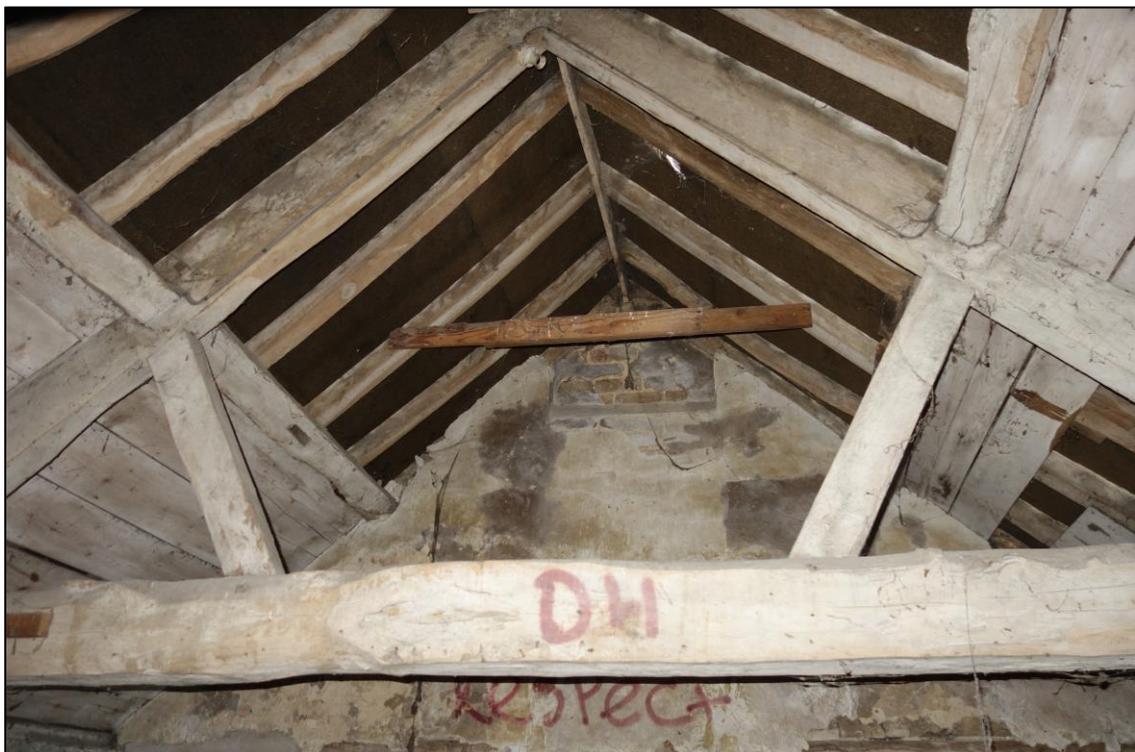
Plate 28: Internal view looking S showing exposed tie beam roof truss in loft compartment with blocked opening in apex of S wall

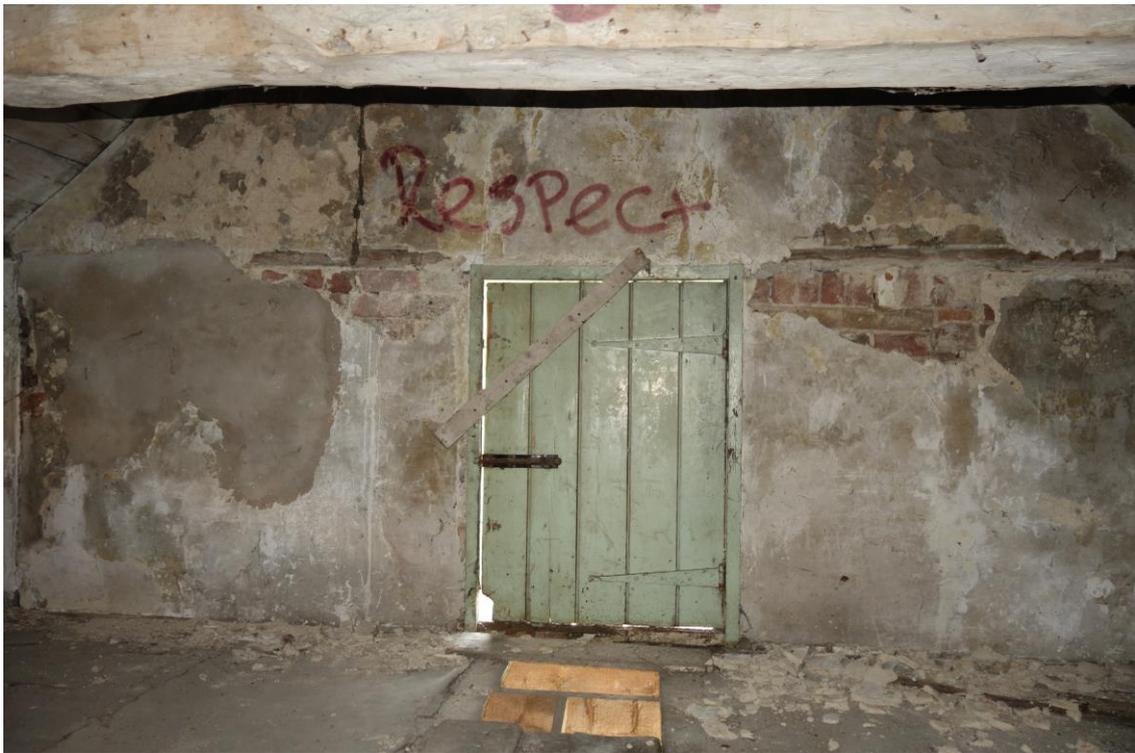
Plate 29: Internal view looking S showing plank and batten door in S wall of loft compartment, formerly leading to stable
