Project No. 1324
July 2005

**New Union Mill, Grosvenor Street West, Birmingham
Historic Building Recording and Fabric Analysis 2005**

New Union Mill, Grosvenor Street West, Birmingham: Archaeological Building Recording and Analysis 2005

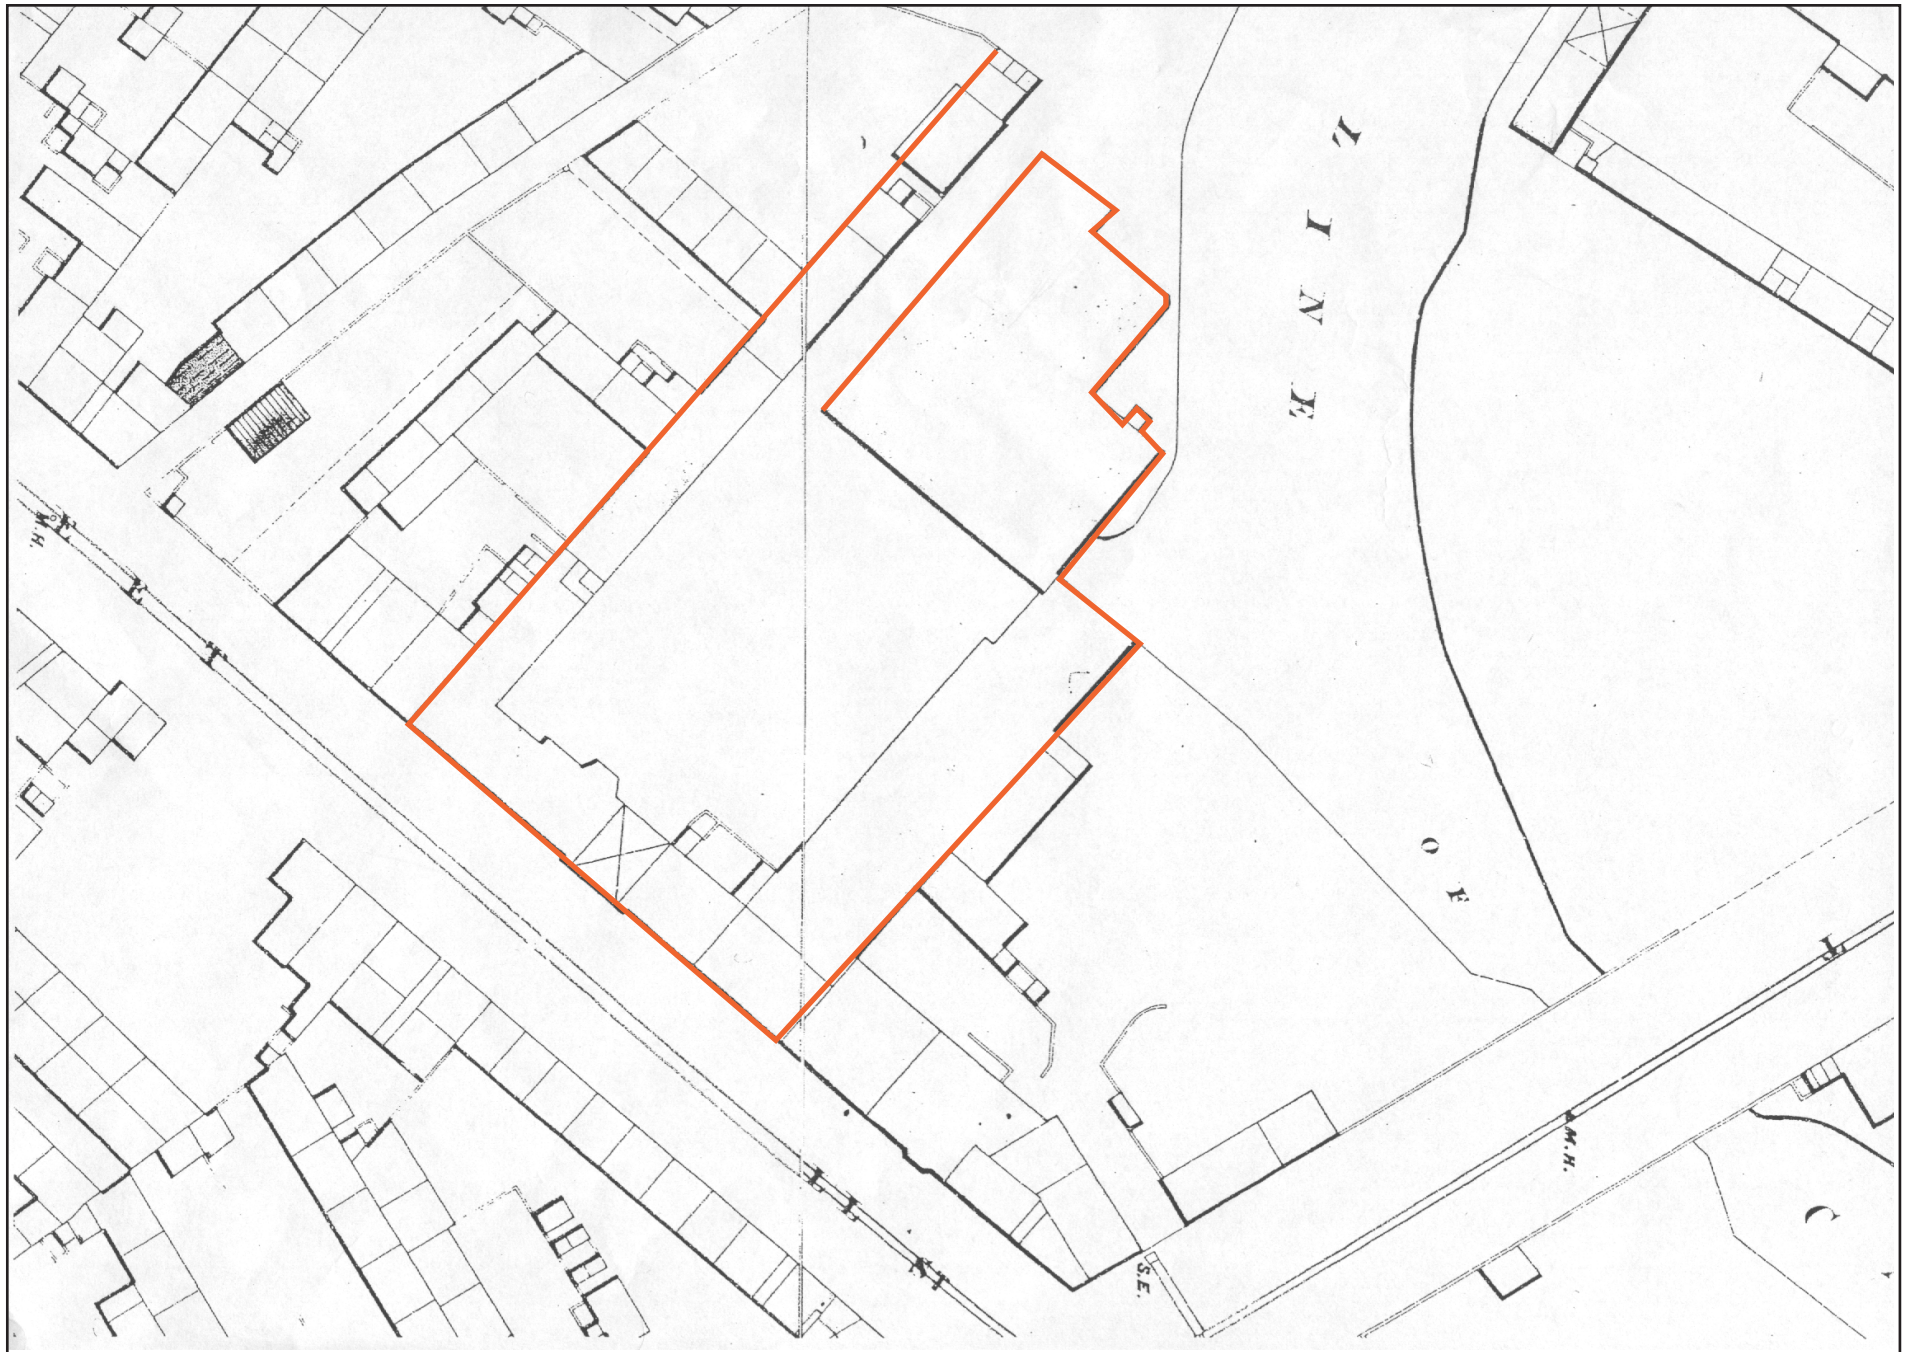
Fig.3

Piggot Smith's Board of Health map of c. 1855 shows the site in more detail (Fig.3). The mill itself lay on the NW side of the courtyard, there was a narrow range on the SW side and a wider range on the NE side. The SE range, which still exists, fronted the street; to the NE of the carriage entrance a small wing or enclosure projected from the NW side.
