1EW03 - Enabling Works Central

Historic Building Recording

Shepherd's Furze Farmhouse,
Steeple Claydon,
Buckinghamshire

Document Number: 1EW03-FUS_COP-EV-REP-CS06_CL09-000014

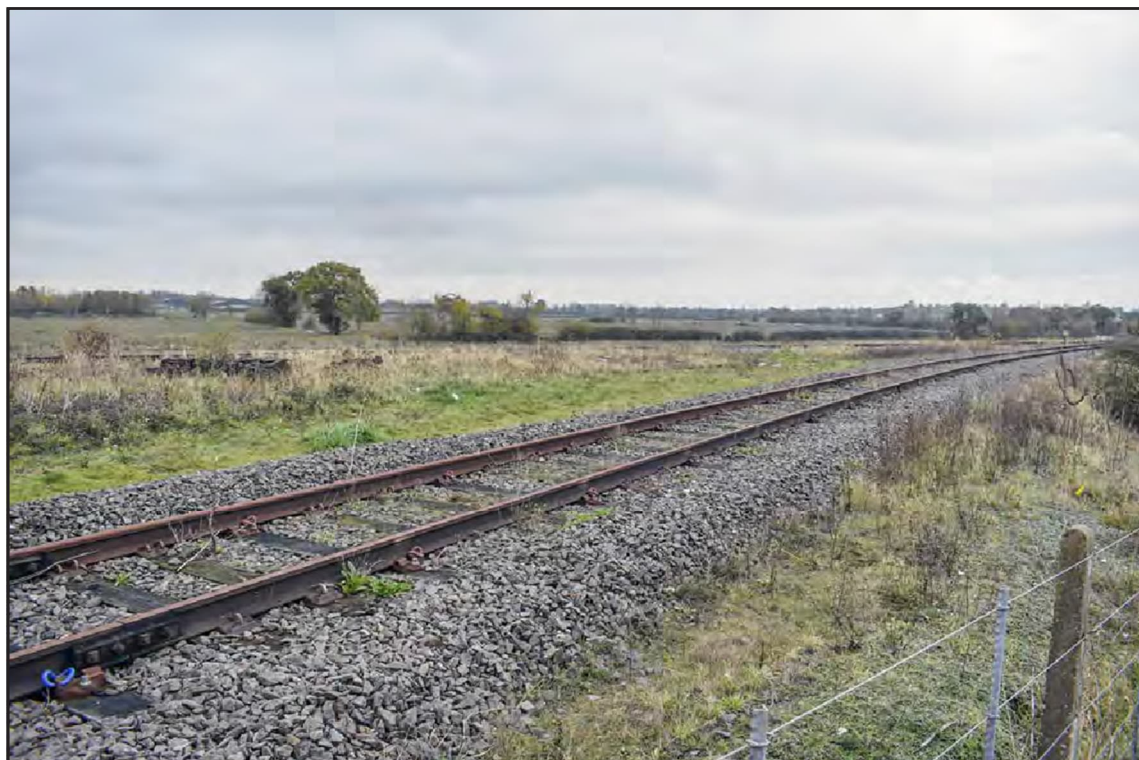
Photo A- 1: The rail loop to the west of the farmstead looking north

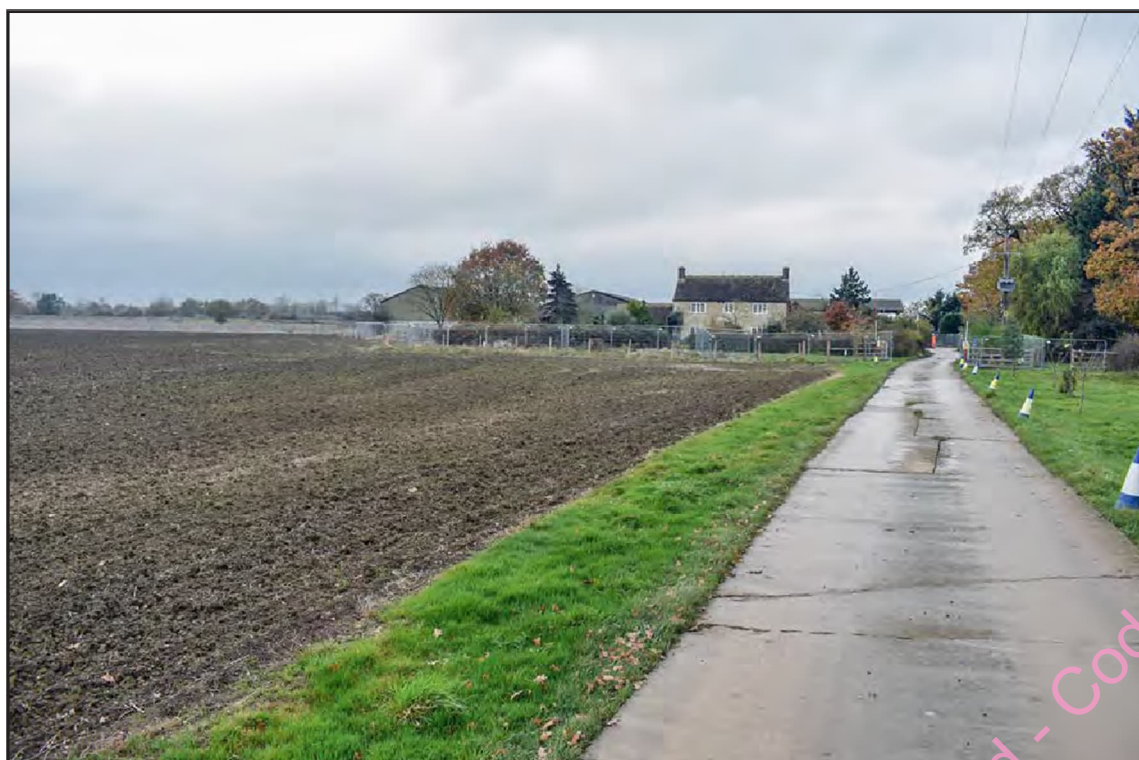
Photo A- 2: West along the approach drive to the farmhouse

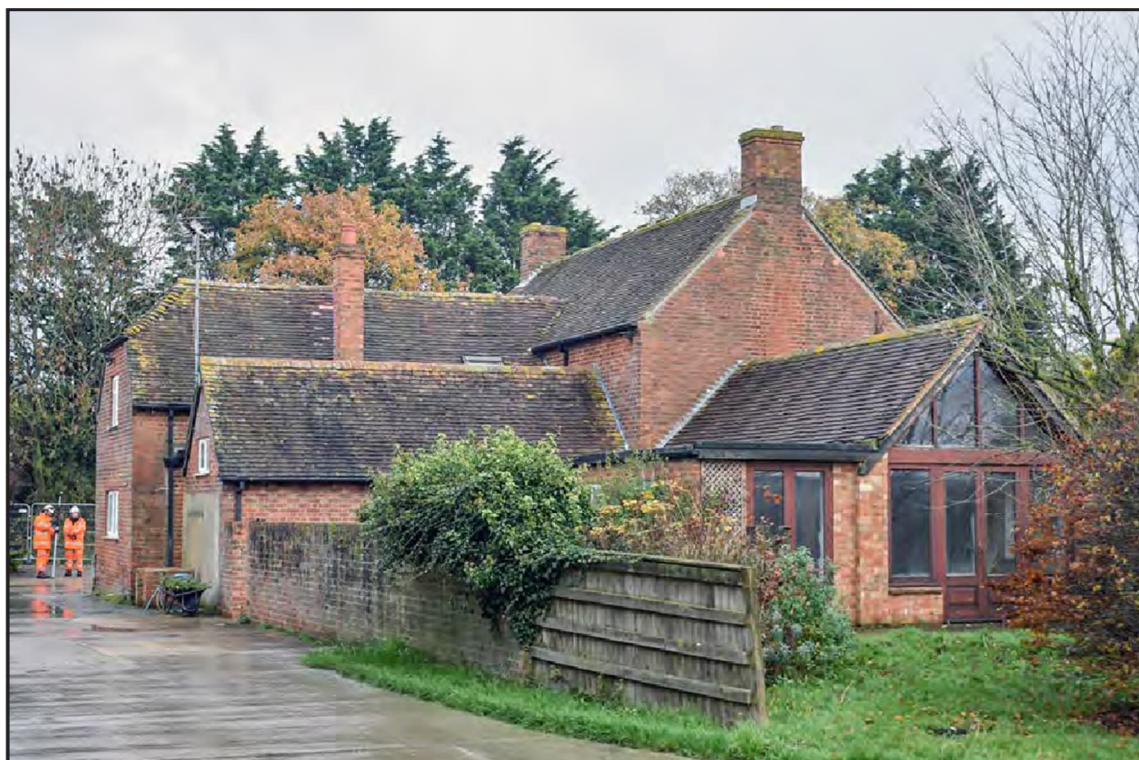
Photo A- 3: Rear aspect of the farmhouse, looking north

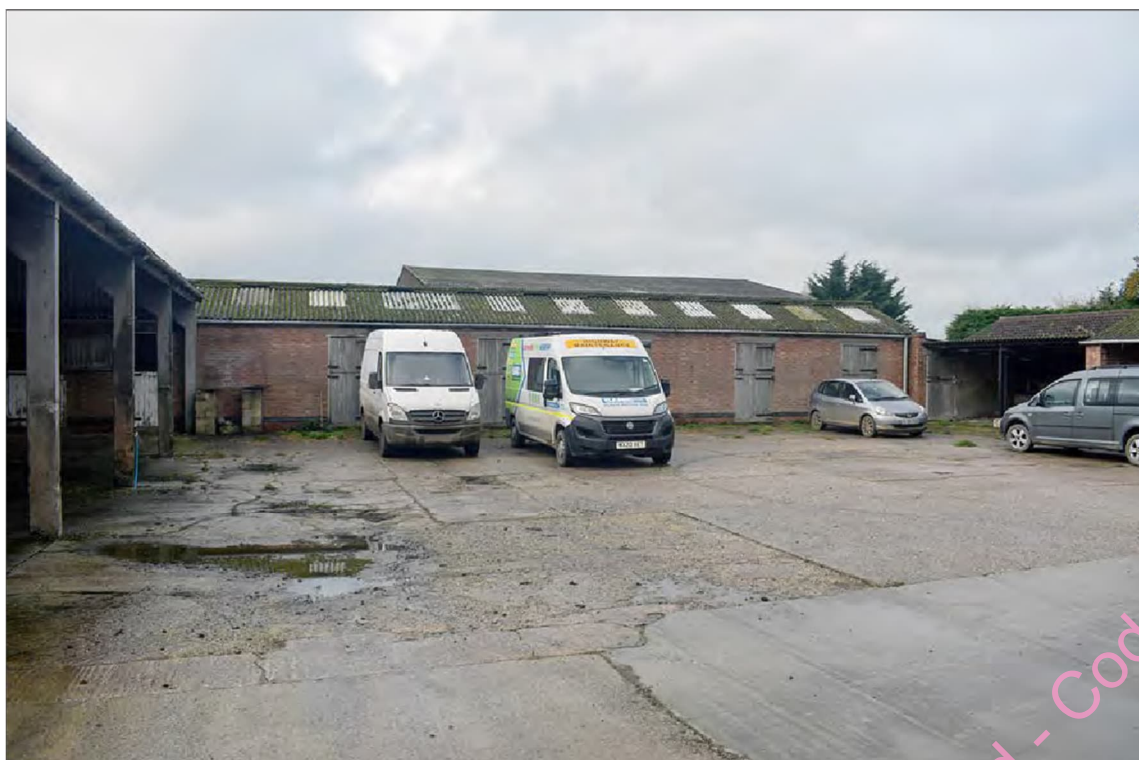
Photo A- 4: Farmyard structures to the rear of the farmhouse looking west

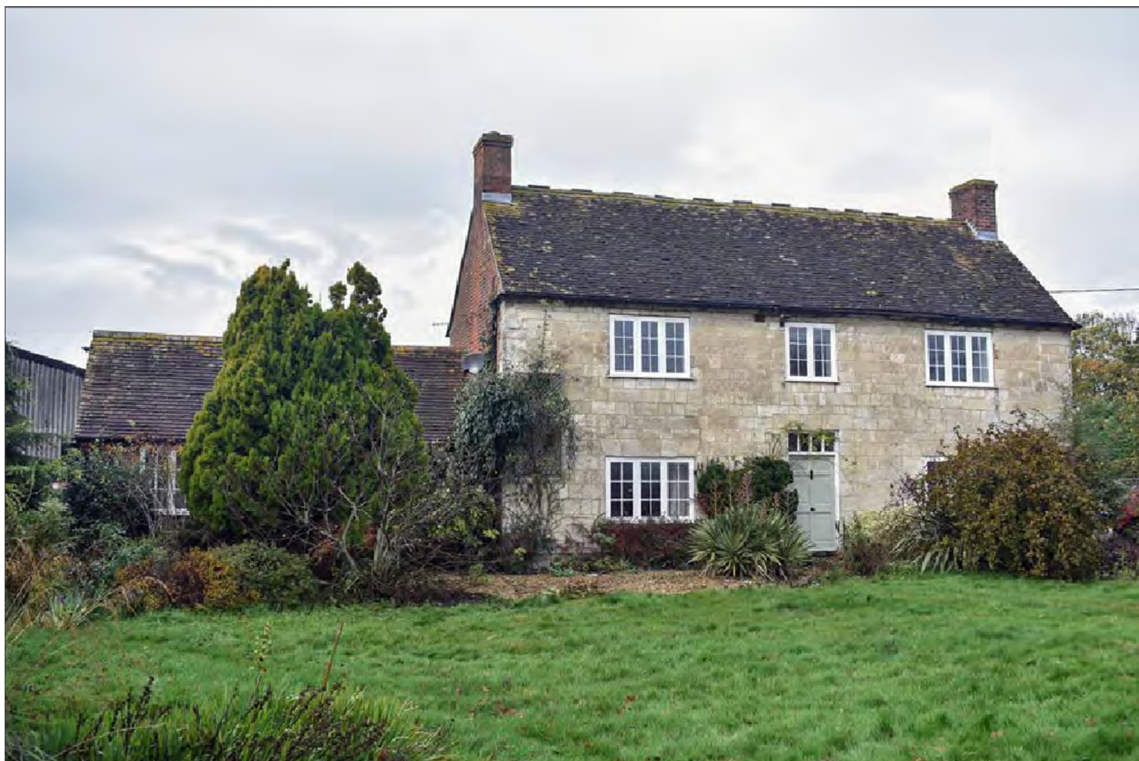
Photo A- 5: The east front elevations of the farmhouse, looking west

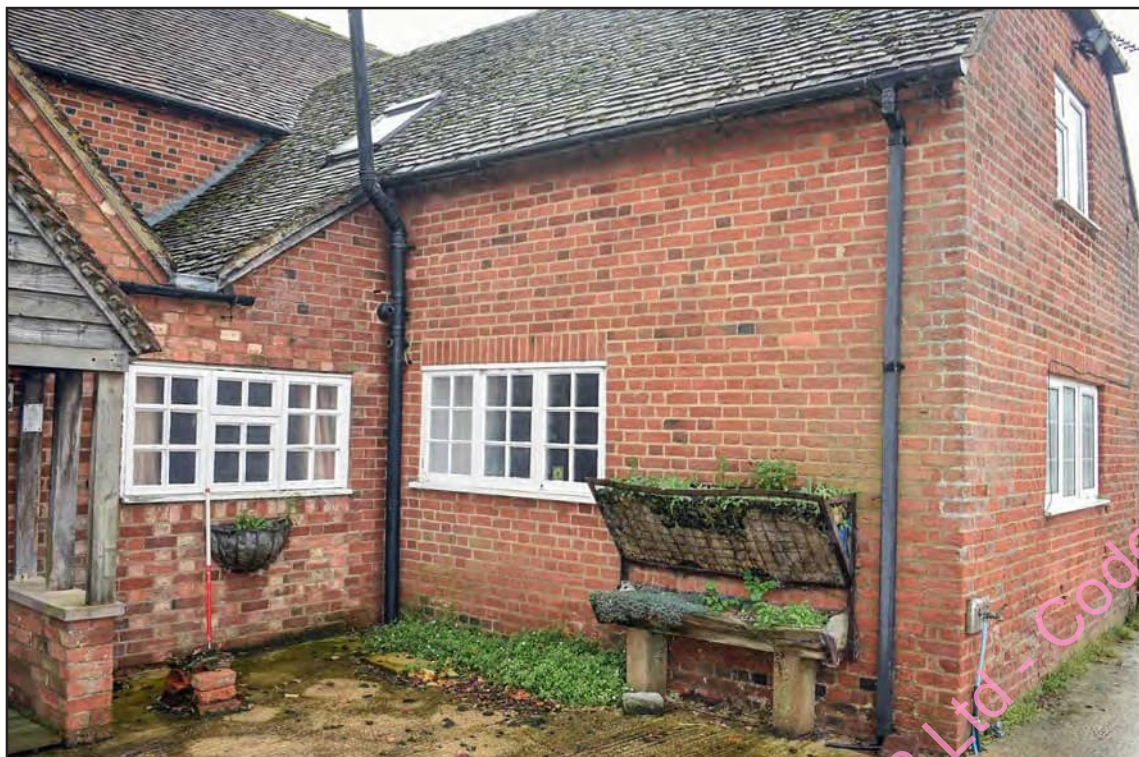
Photo A- 12: The rear extension, north side

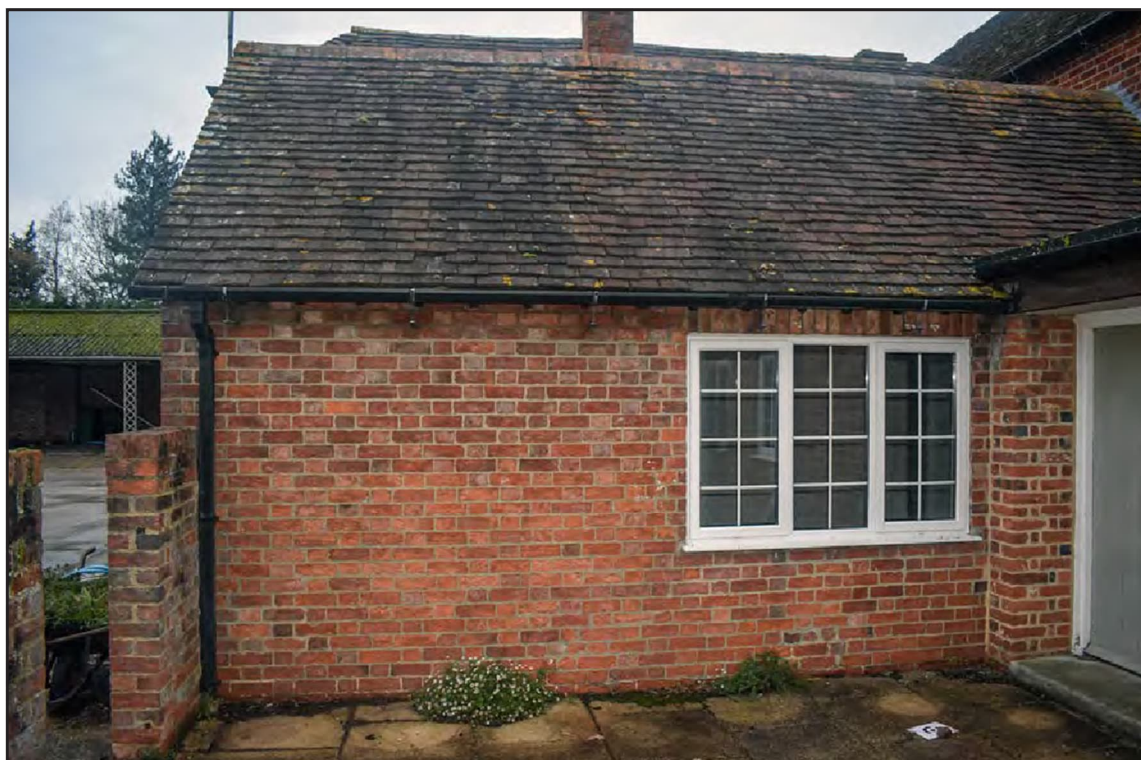
Photo A- 15: The south-west extension south elevation

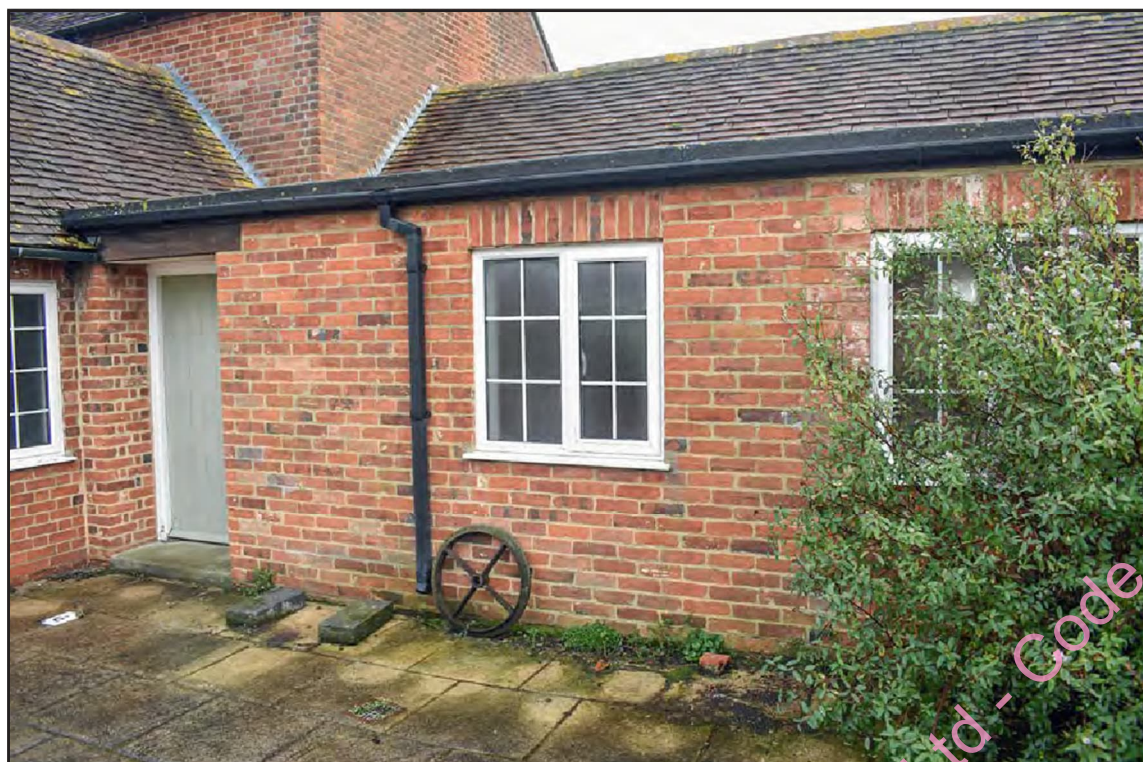
Photo A- 16: The south extension rear section

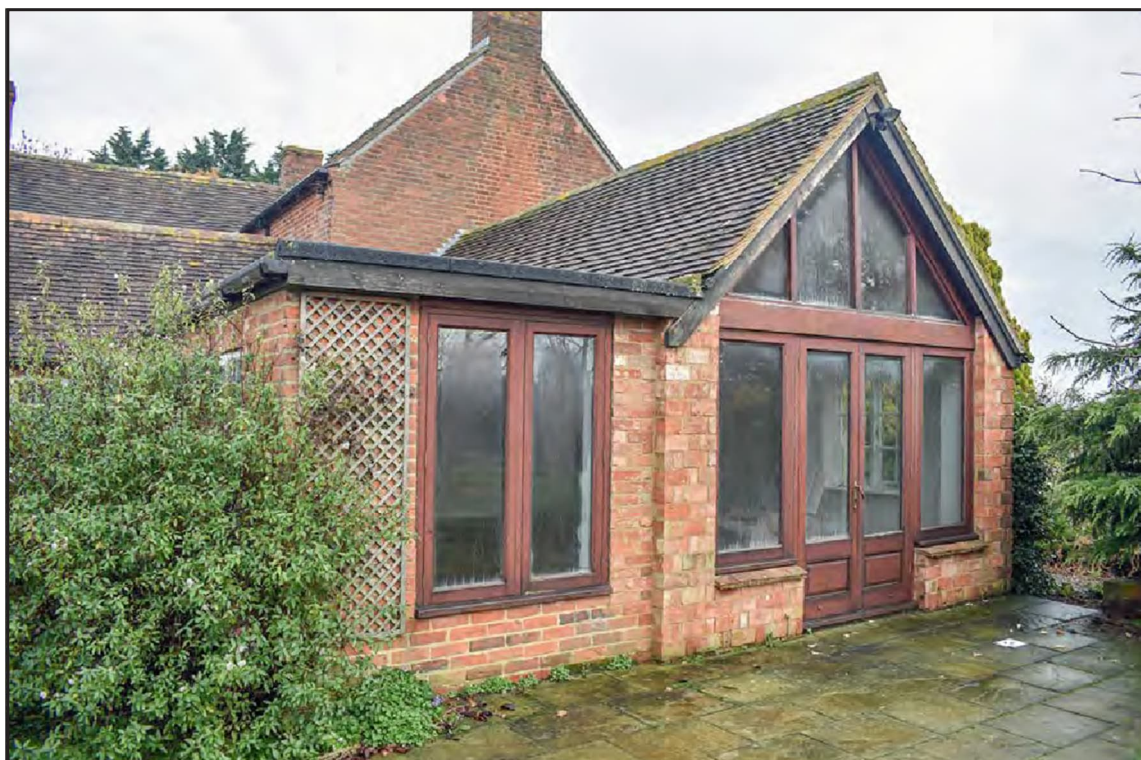
Photo A- 17: The south extension , south elevation

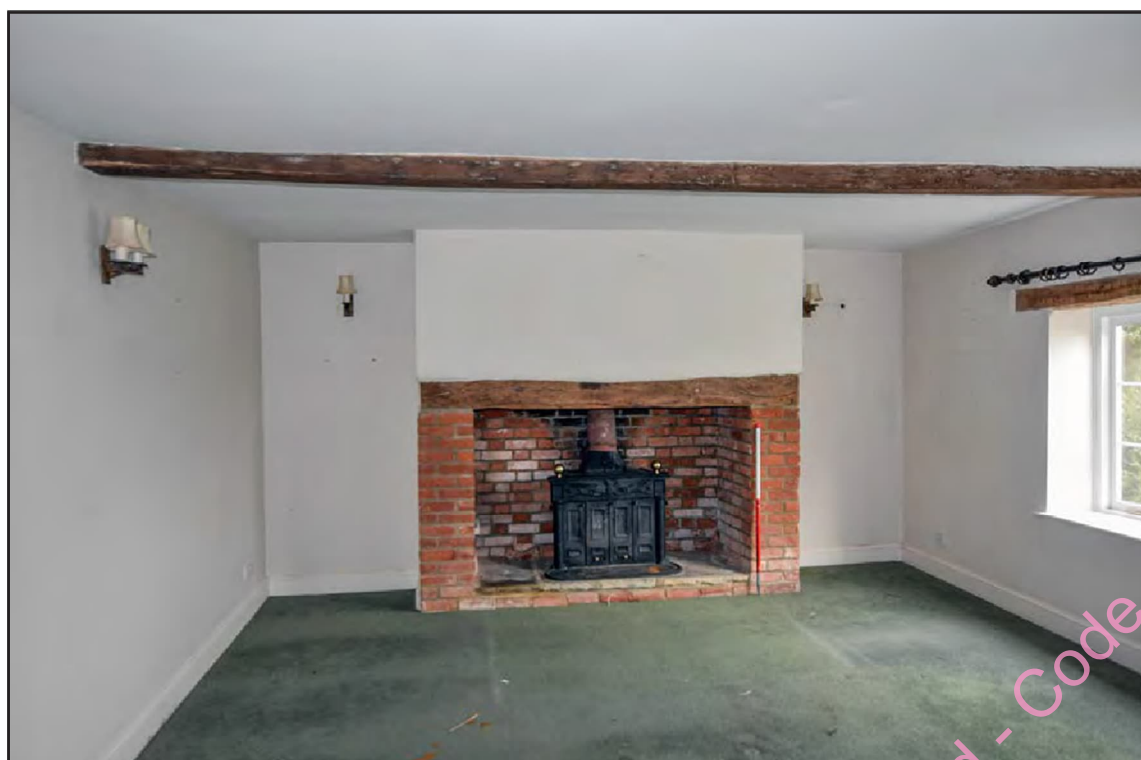
Photo A- 20: Fireplace, north gable G1

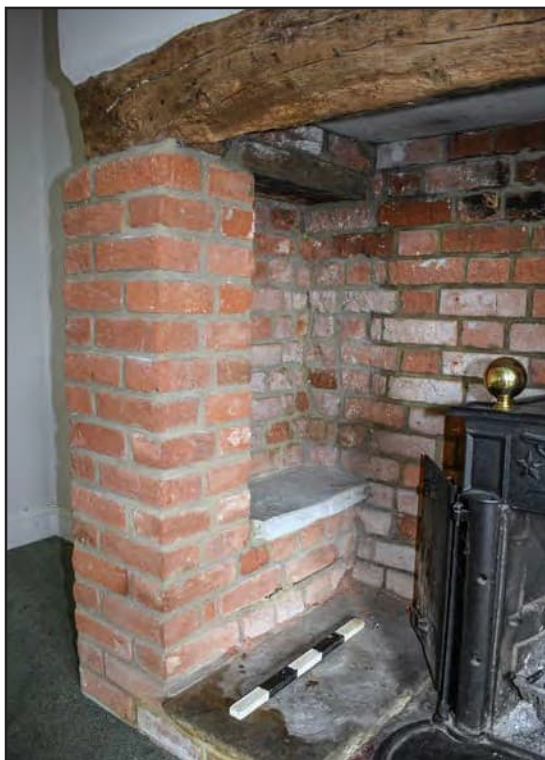
Photo A- 21: The fireplace in G1, detail

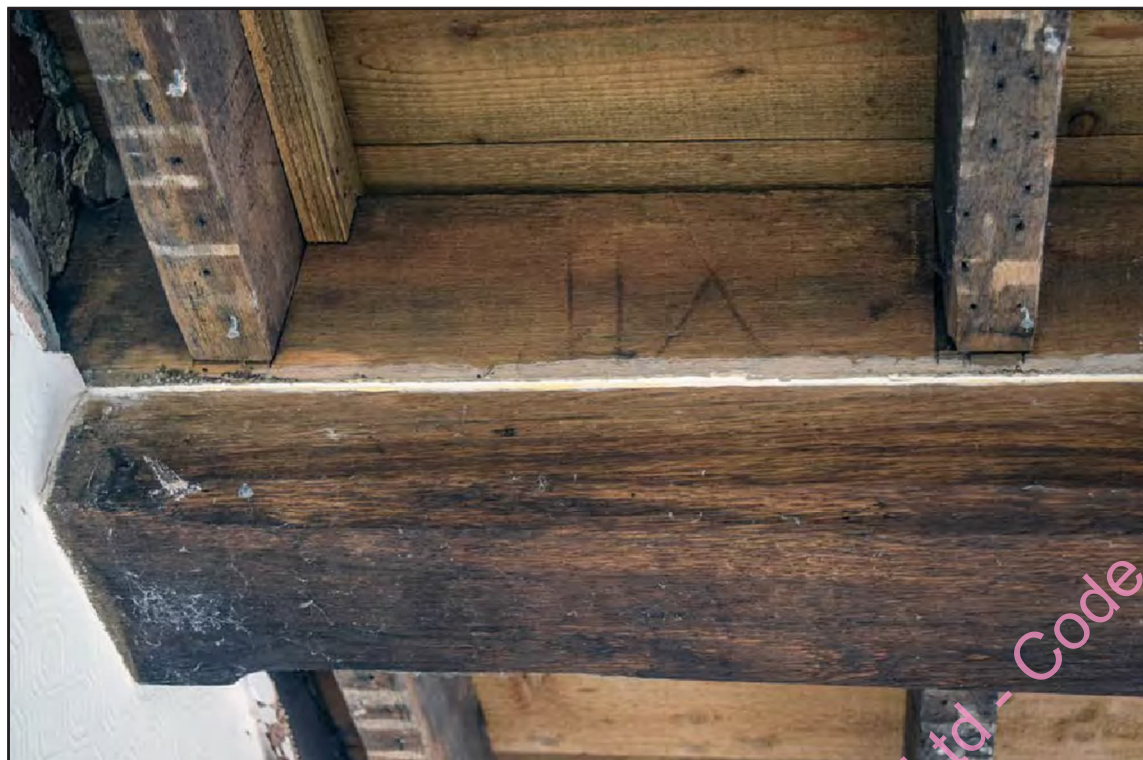
Photo A- 24: Detail of ceiling beam, G2

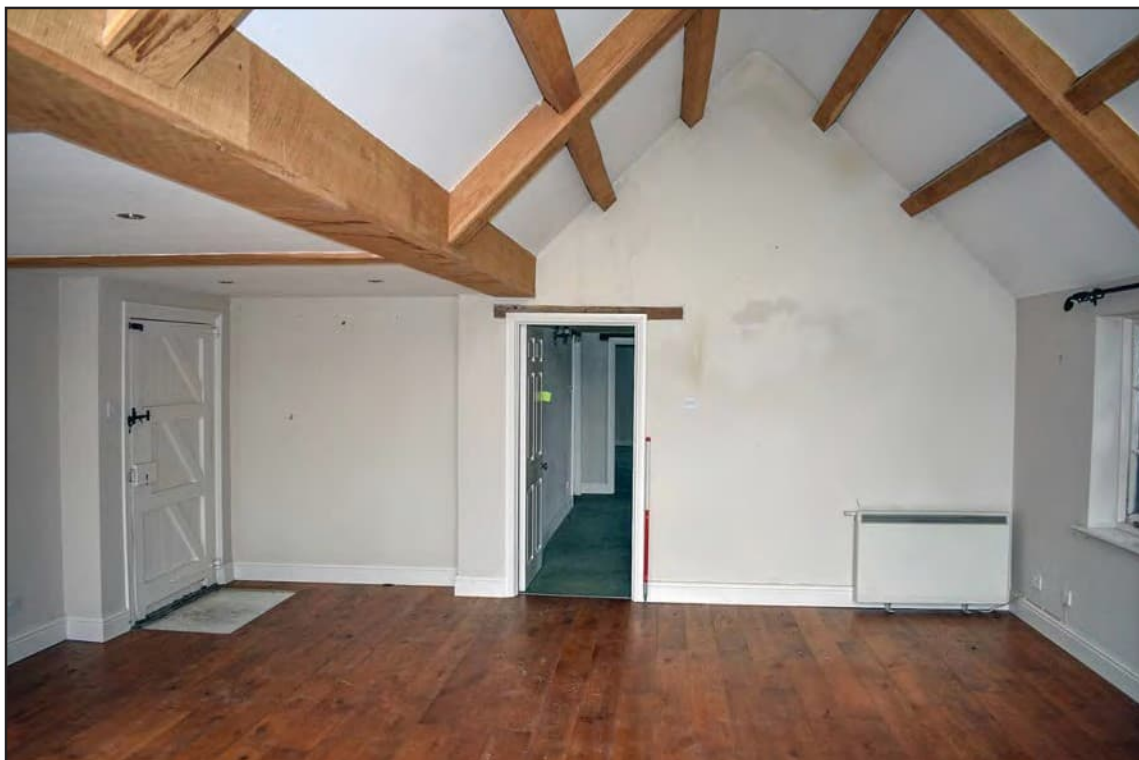
Photo A- 25: Interior south extension G3 looking to G2

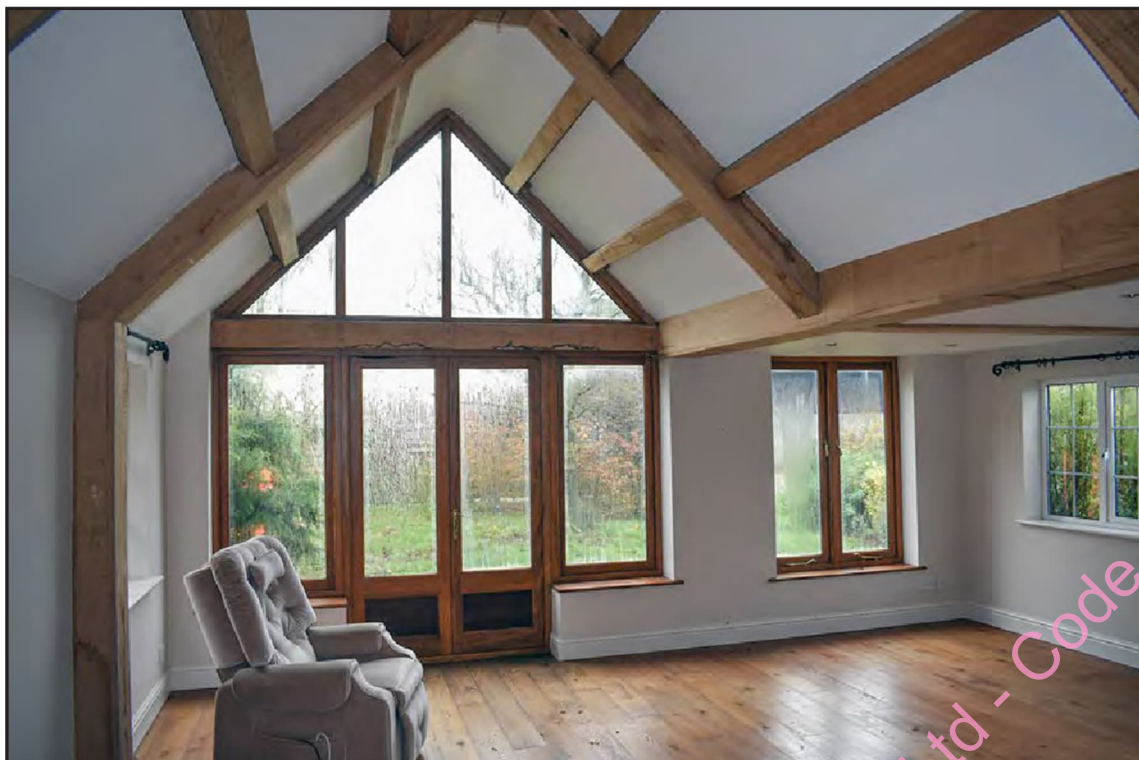
Photo A- 26: South extension G3 looking to south gable

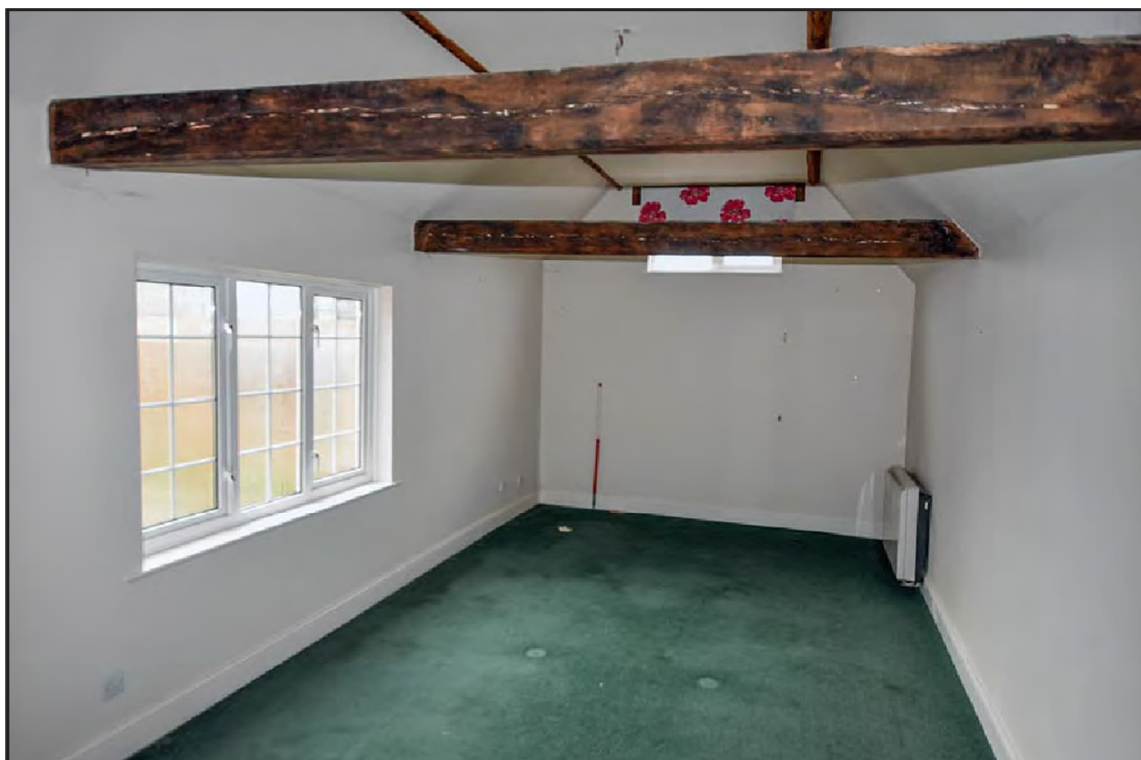
Photo A- 29: Room G4, south west extension looking west

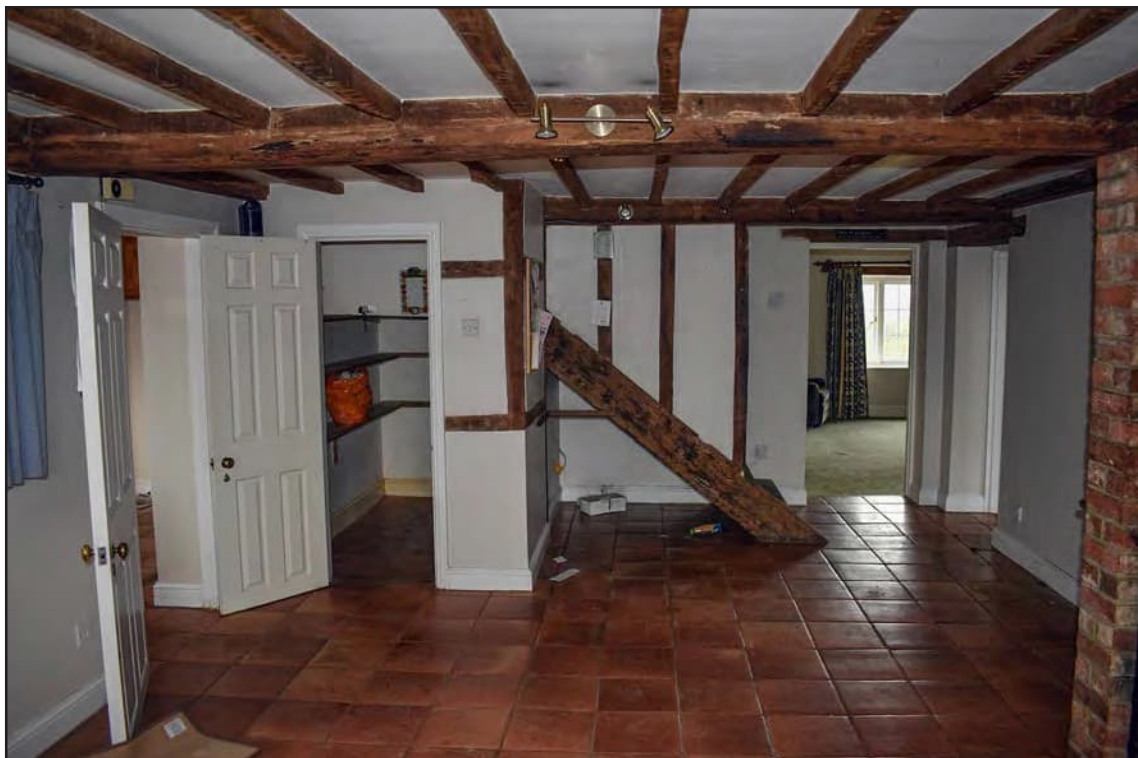
Photo A- 31: Kitchen, G5 in south extension looking to the front

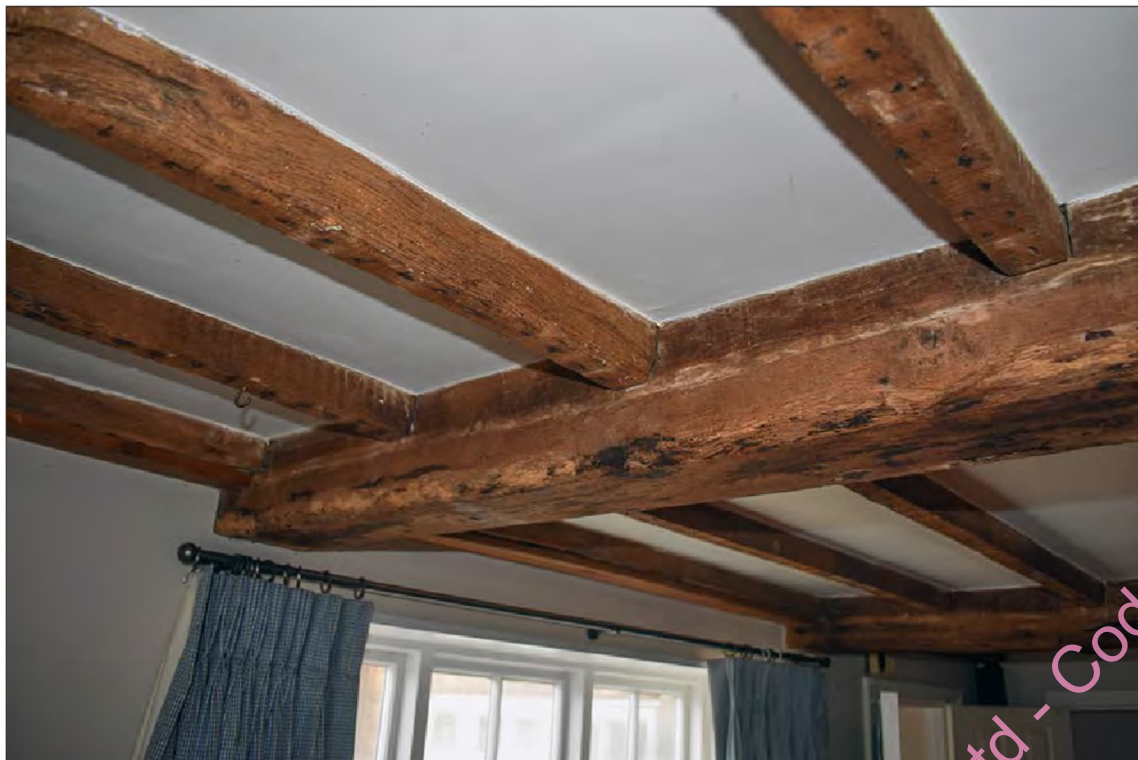
Photo A- 32: Ceiling structure to Kitchen G5 in rear extension

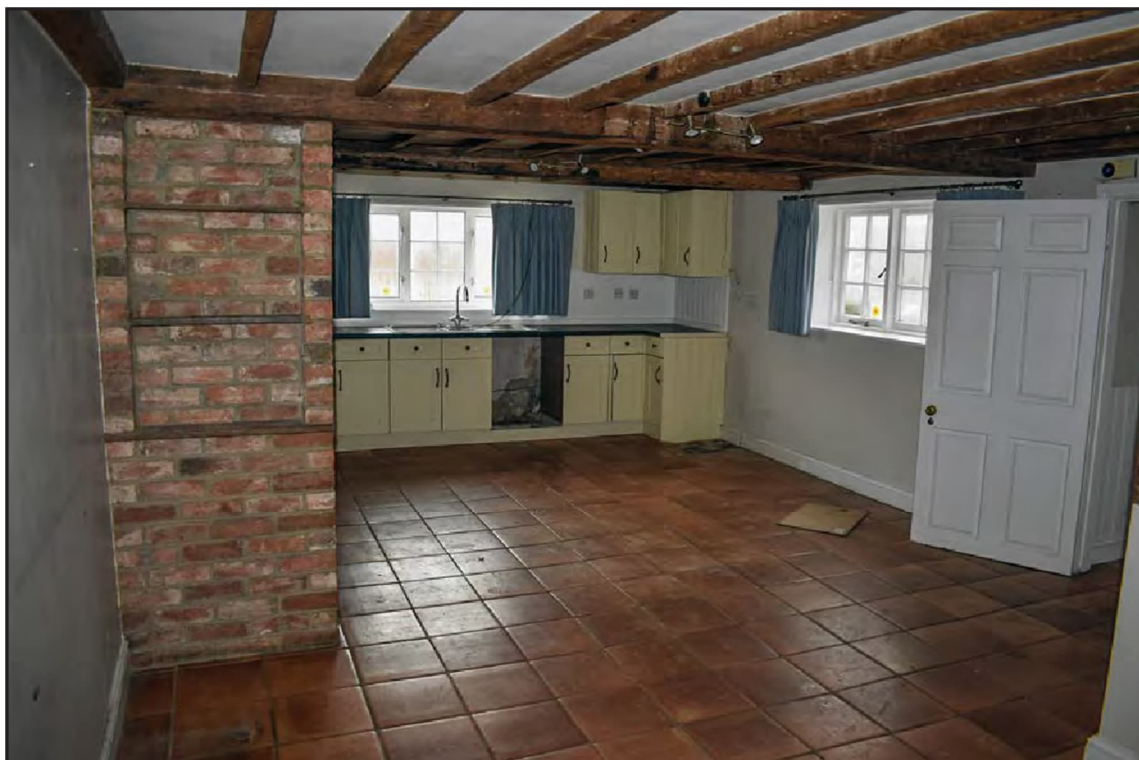
Photo A- 33: Kitchen G5 in rear extension looking to west

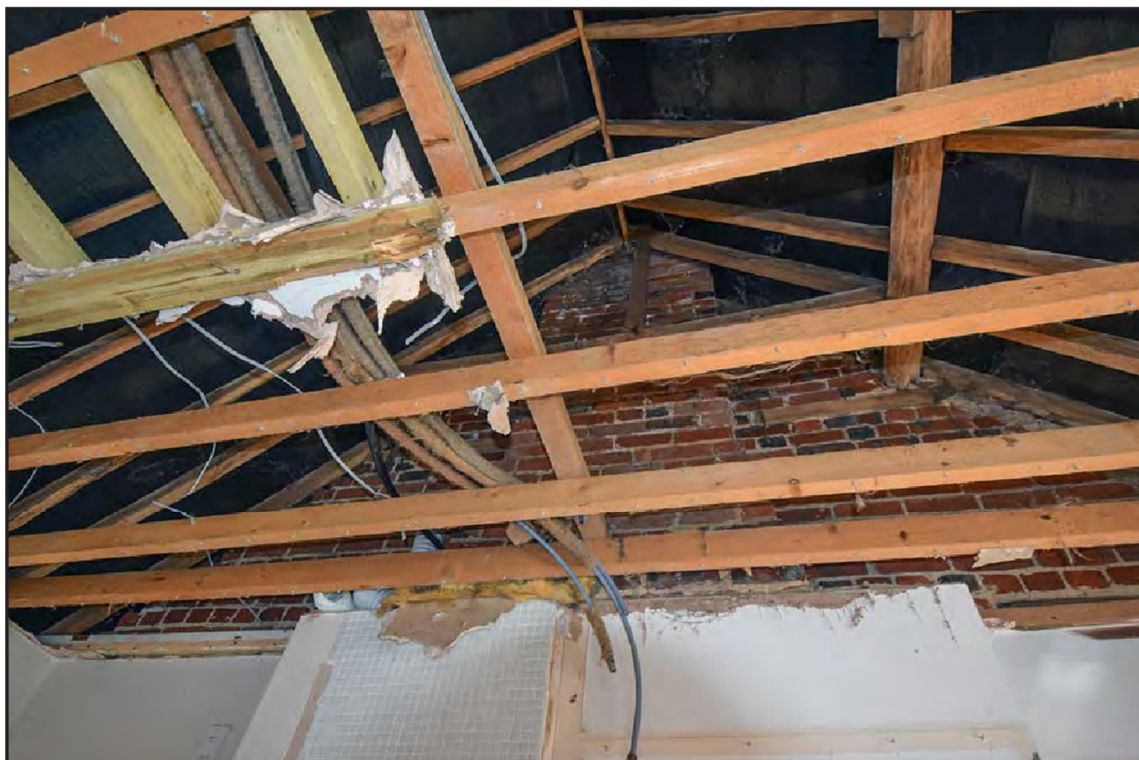
Photo A- 39: Exposed roof structure, bedroom F1

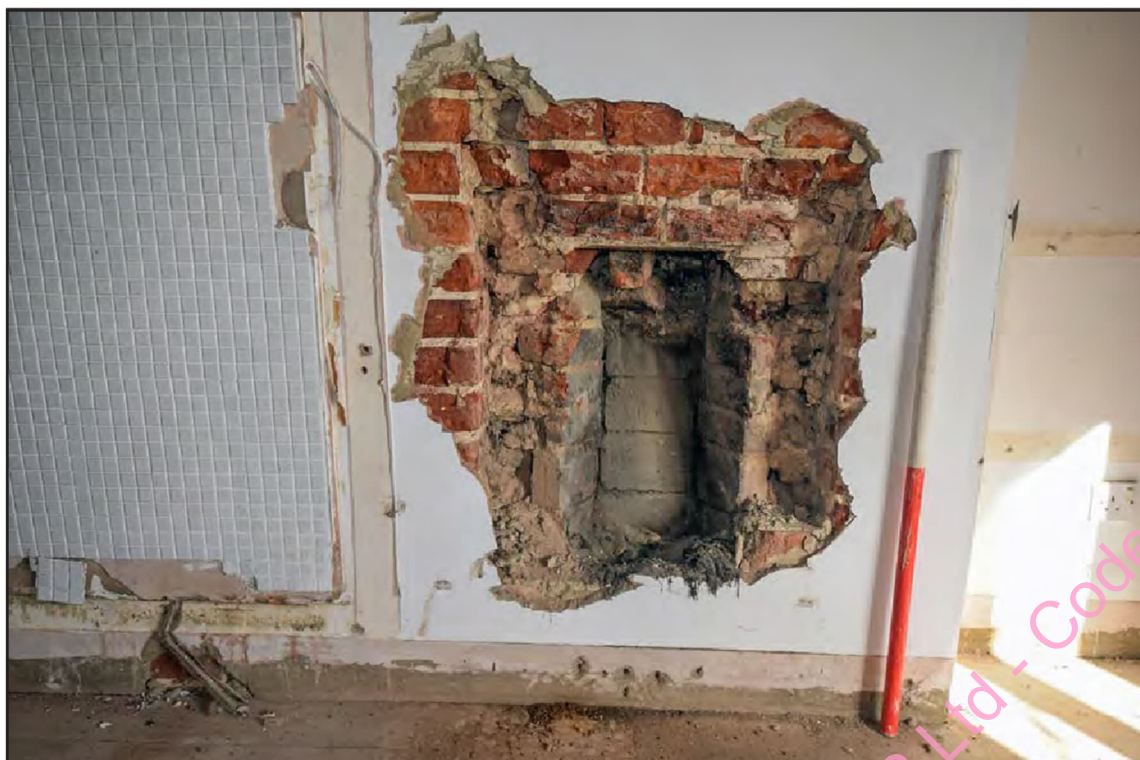
Photo A- 40: Bedroom F1 fireplace

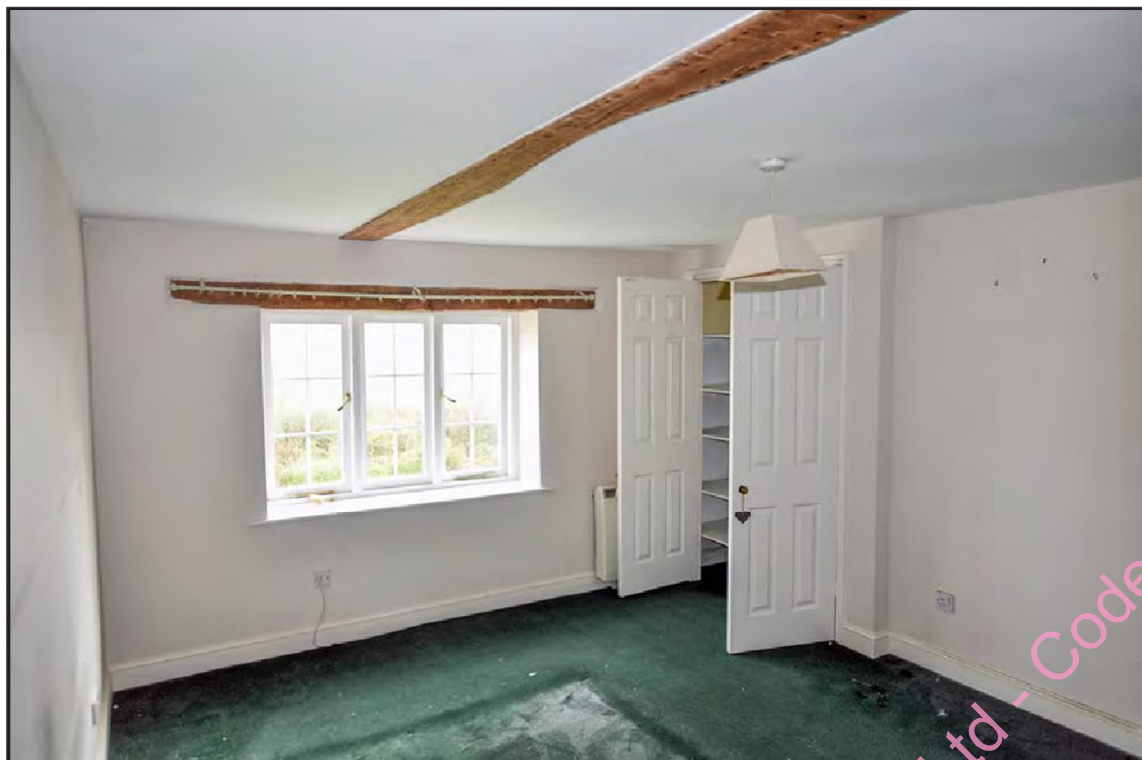
Photo A- 42: Bedroom F3 front elevation

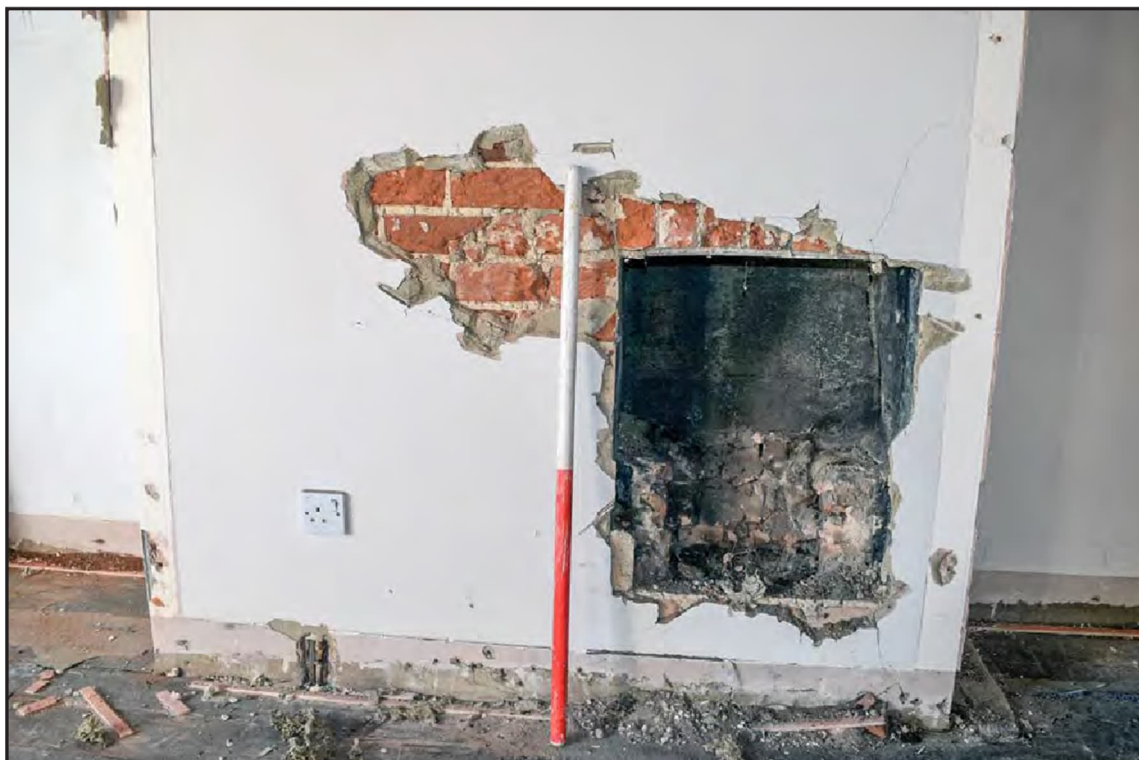
Photo A- 43: Bedroom F3 exposed fireplace in south gable

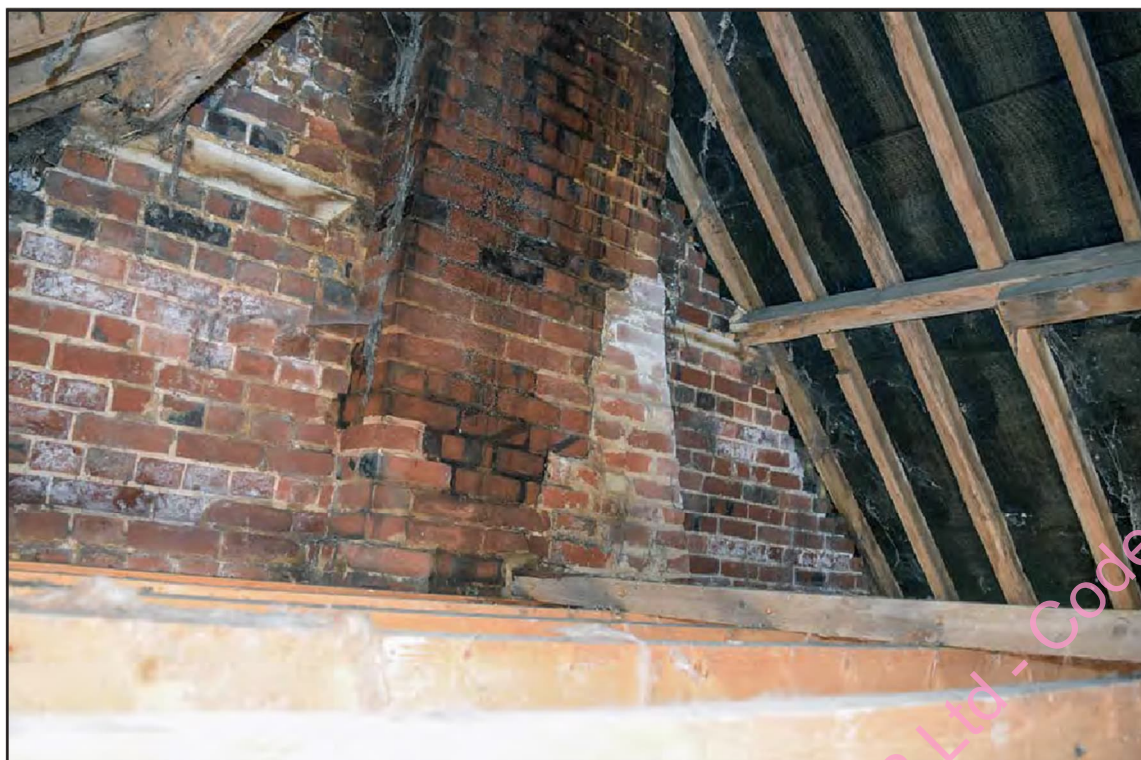
Photo A- 44: Roof structure, south gable

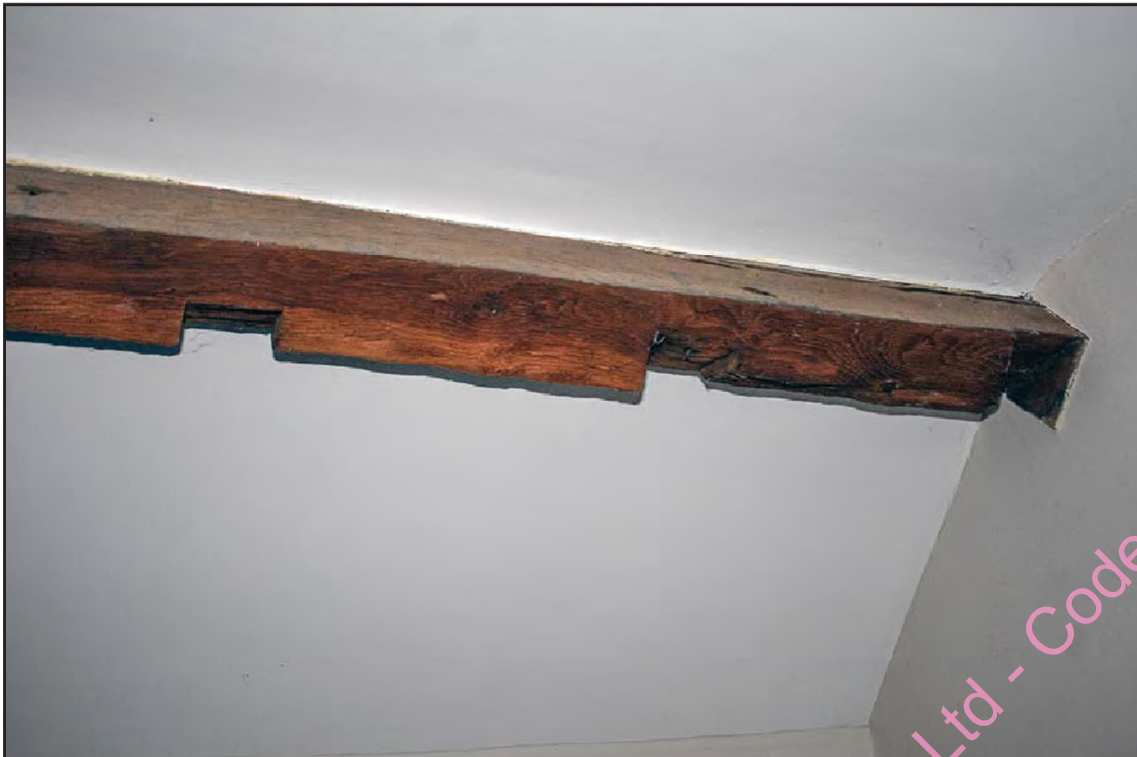
Photo A- 46: Notched purlin, south extension first floor

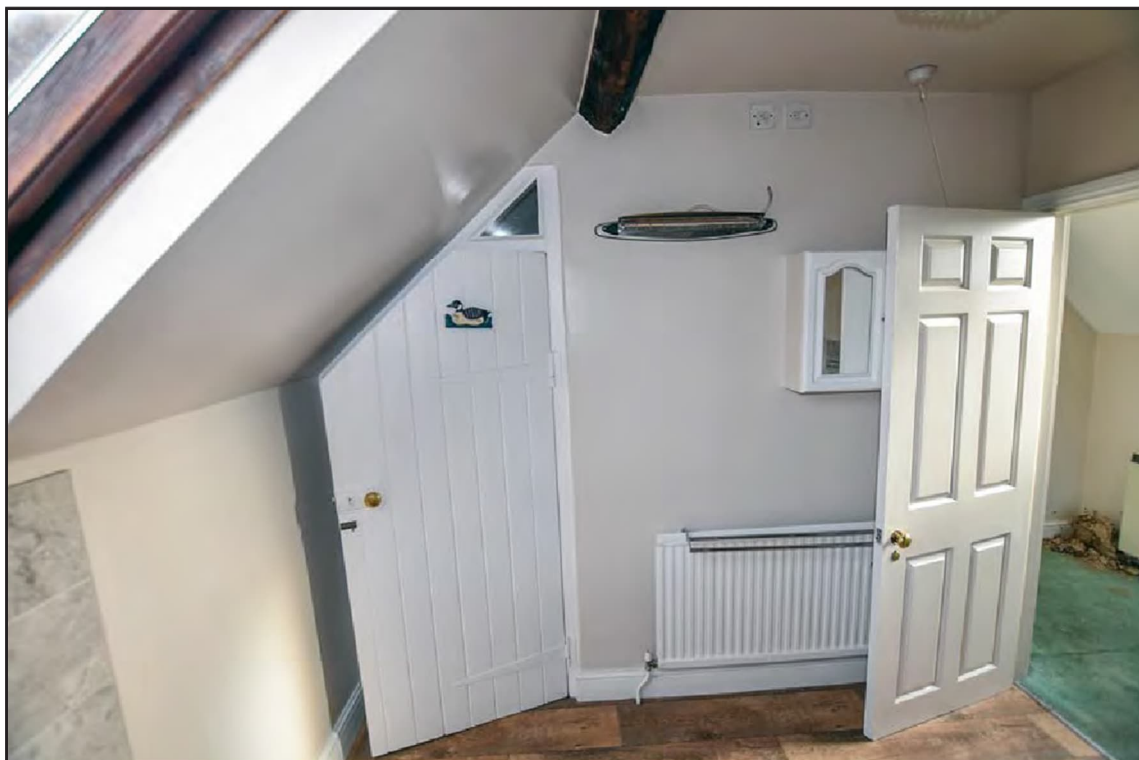
Photo A- 47: Bathroom F5 rear extension showing door to stair

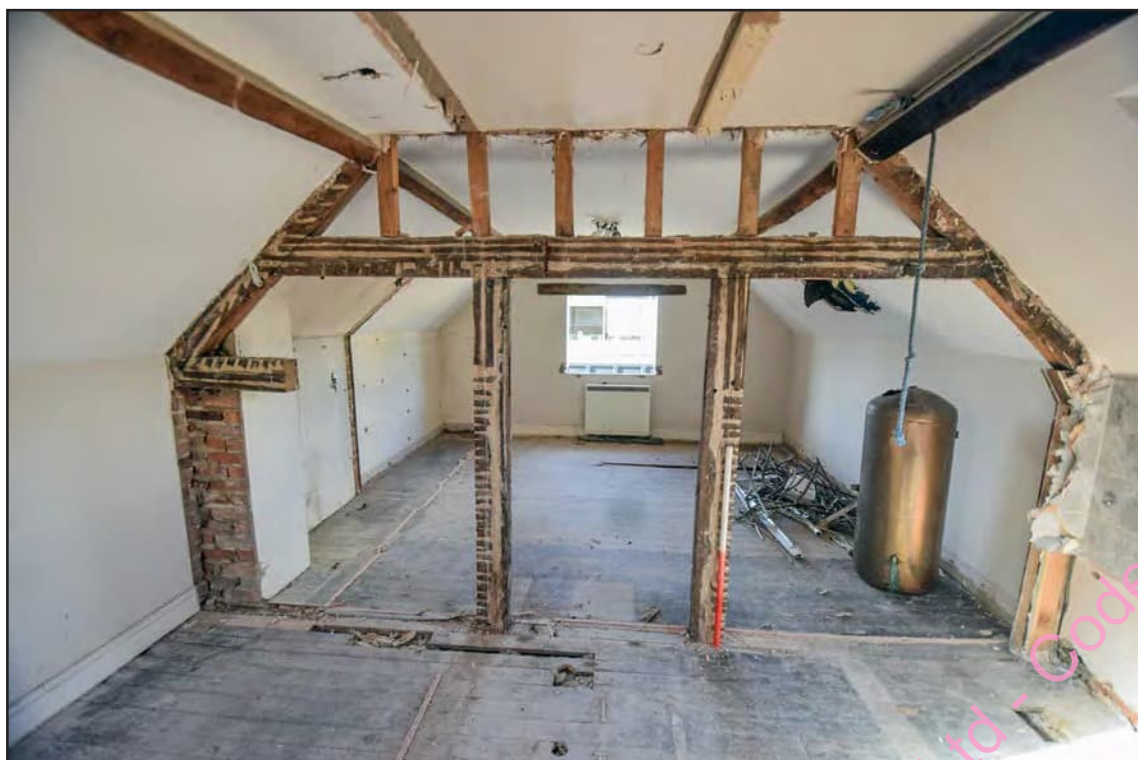
Photo A- 48: Structure dividing wall in rear extension

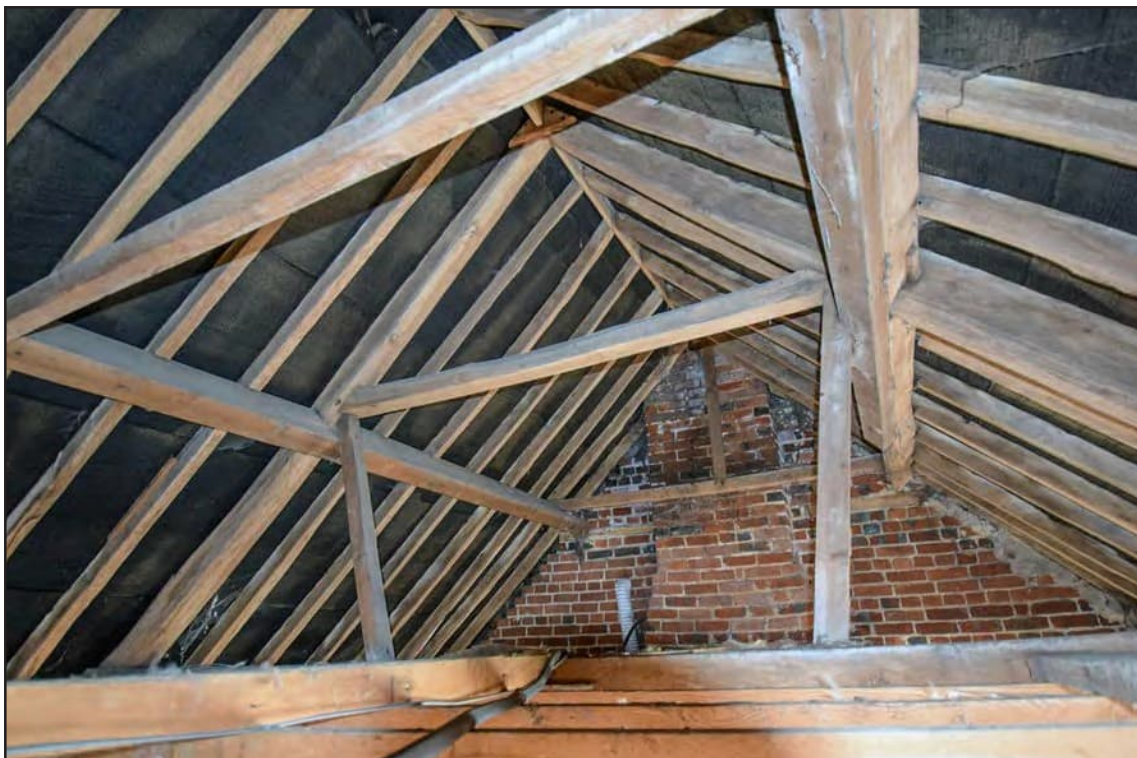
Photo A- 49: The roof structure to the farmhouse, looking north
