1EW03 - Enabling Works Central

Historic Building Recording

Shepherd's Furze Farmhouse,
Steeple Claydon,
Buckinghamshire

Document Number: 1EW03-FUS_COP-EV-REP-CS06_CL09-000014

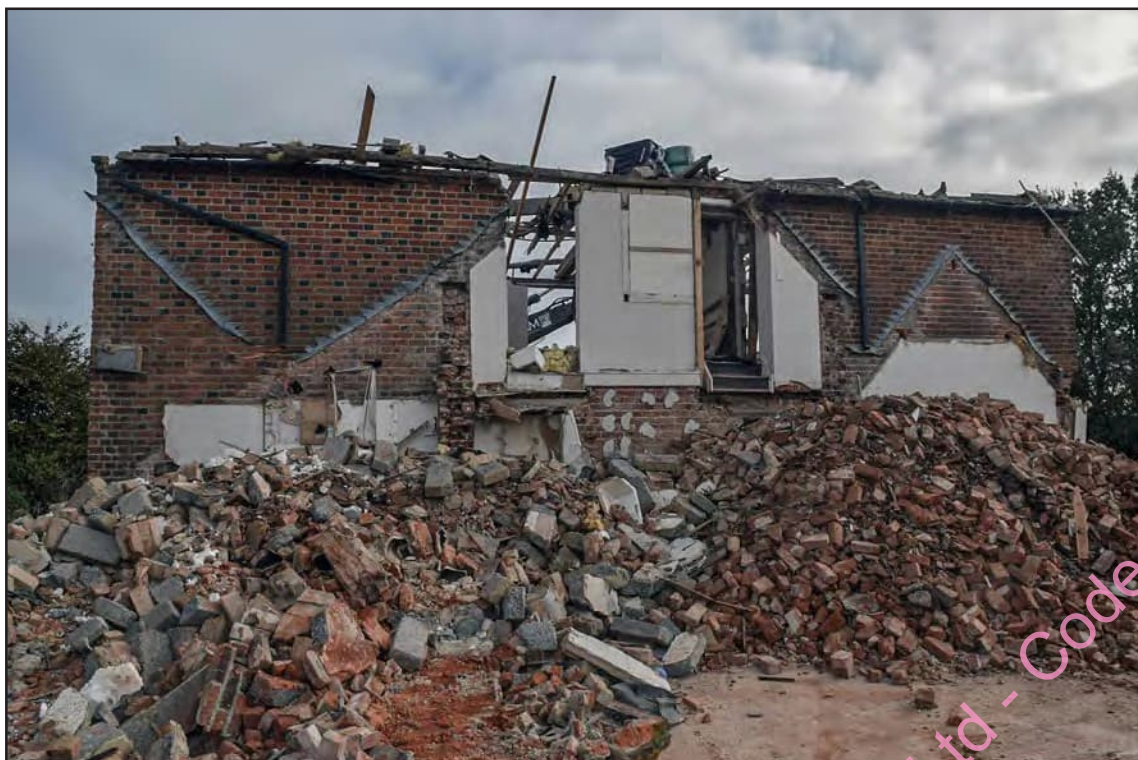
Photo A- 50: Rear, west elevation of farmhouse after removal of rear extensions

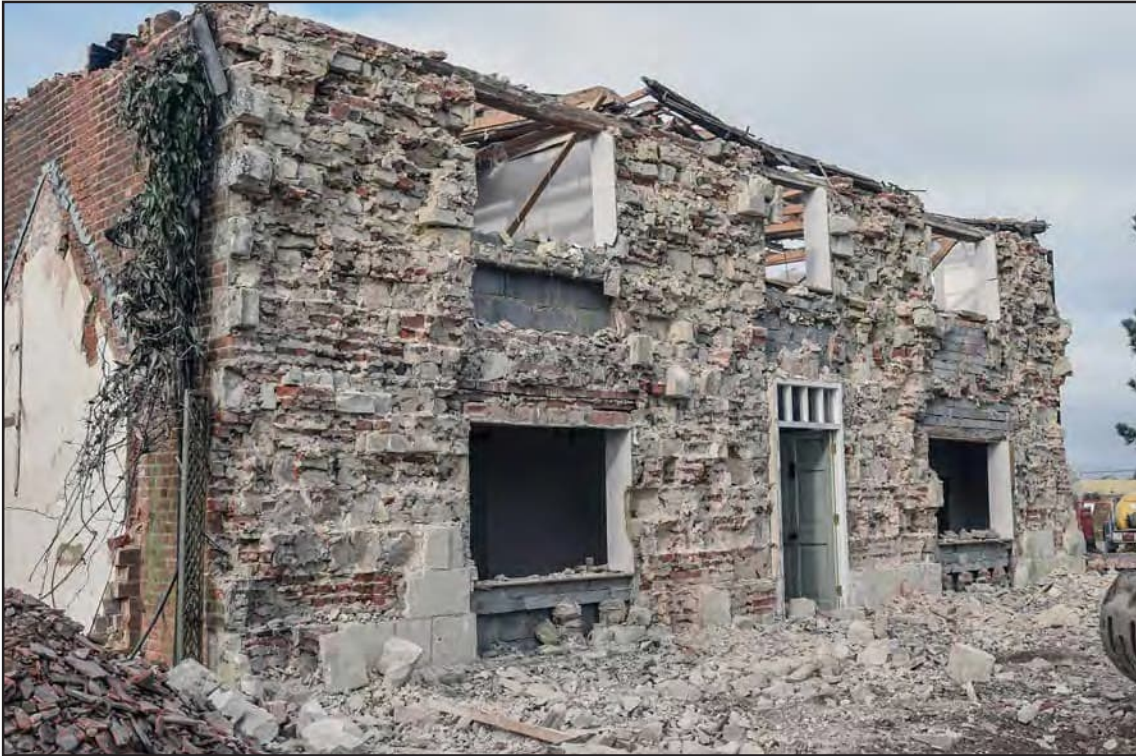
Photo B 1: The east front façade of the farmhouse after the ashlar facing has been stripped away

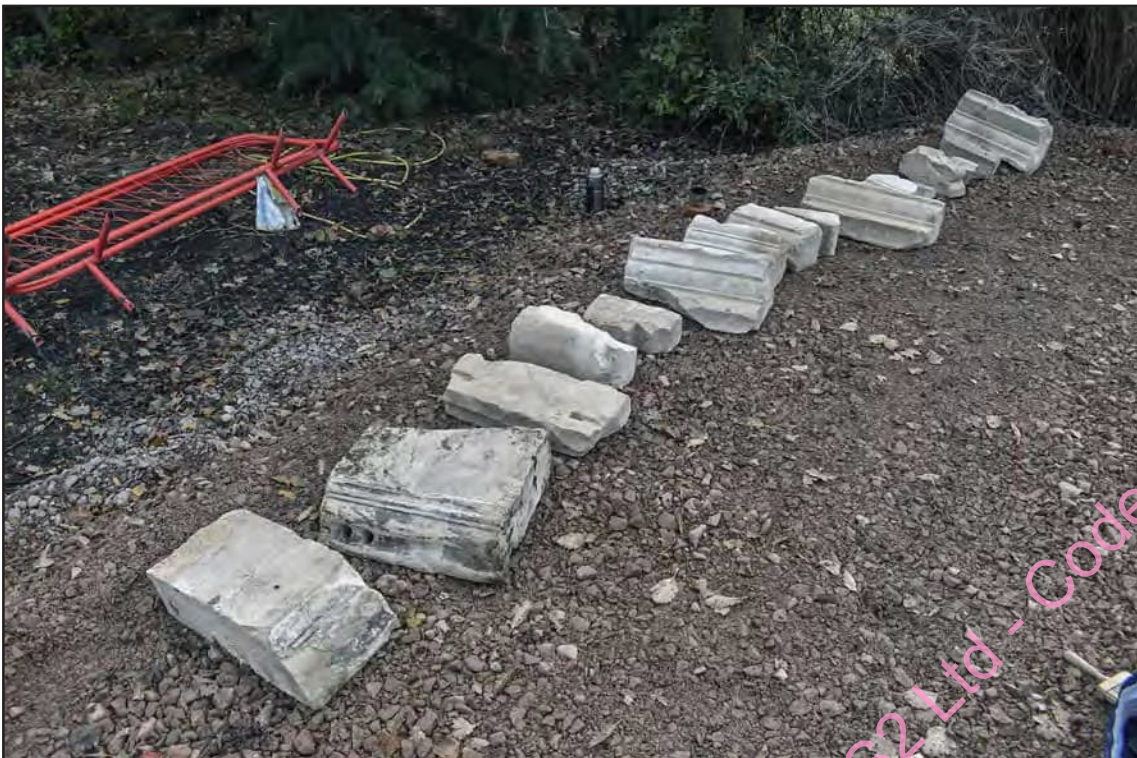
Photo B 2: Some of the masonry that was stripped from the east façade

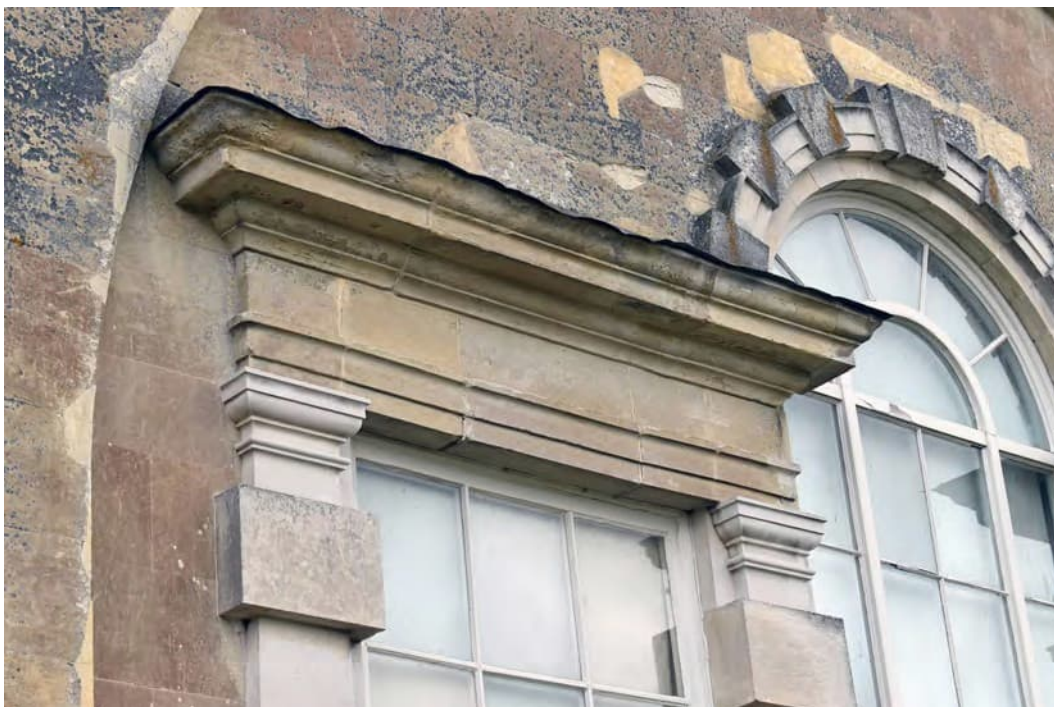
Photo B 19: Detail of the tripartite window in the west front of Claydon House
