WP 029 D – Bucks Head Farm – Enabling Works North Contract Report for Historic Building and Setting Recording

Document Number: 1EW04-LMJ-EV-REP-NS06_NL16-029018

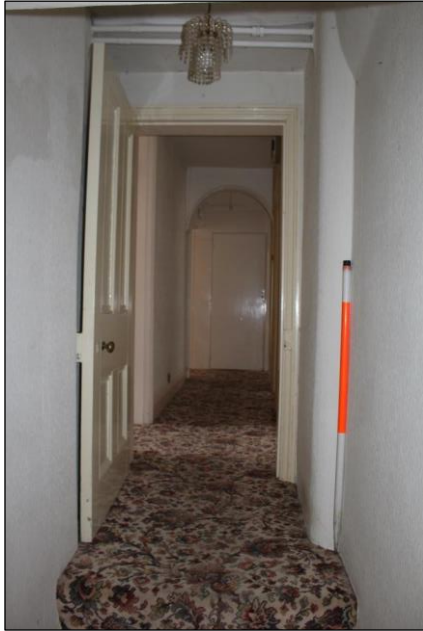
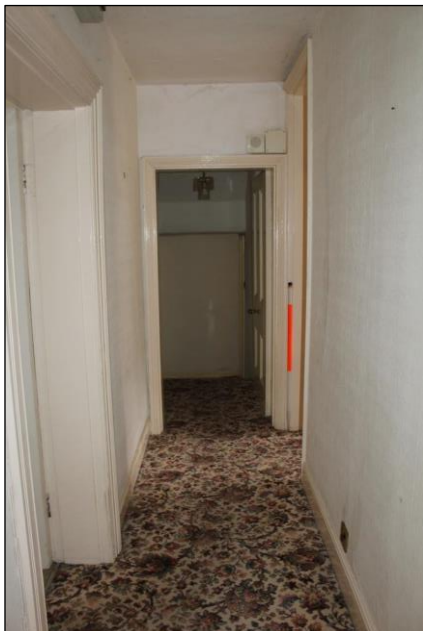
- 5.3.14 The ground floor of the late-19th century eastern range (**Figure 14**) is comprised of two large rooms (Rooms 5 and 6) situated either side of the central hall and stair (Room 4) which runs northwards from the entrance porch of the southern elevation (Room 8) to the northern wall of the eastern range before returning westwards along the north wall to connect the eastern range with the northern projection (Room 7) (**Plates 46 to 48**). The hall passage (Room 4) steps down at its eastern end where it enters the 18th century west range. In this location a small partition has been inserted in the north-east corner of Room 3 (most likely in the late 19th century) to close access between the eastern and western ranges at ground floor level and provide access into the late-19th century rear extension, through an opening inserted into the former northern elevation of the western range (**Plates 46 and 47**).

Plate 46: Overview of Room 4 from the west.

Plate 47: Overview of Room 4 from the east.

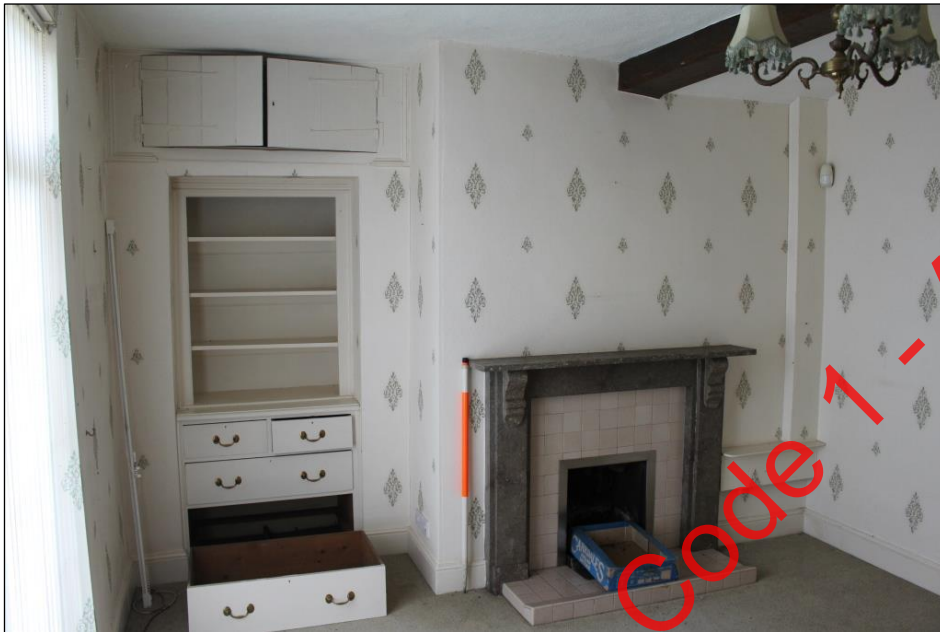
- 5.3.15 Room 5 and Room 6 both comprise regularly shaped rooms and each contains a fireplace (**Plates 49 and 50**) which correspond with the two chimney stacks situated at the eastern and western ends of the late-19th century eastern range. A cross beam runs on an east to west axis across the centre of each room (**Plates 49 to 51**), that within Room 5 has been boxed in.

Plate 49: The western wall of Room 6, Building 1.

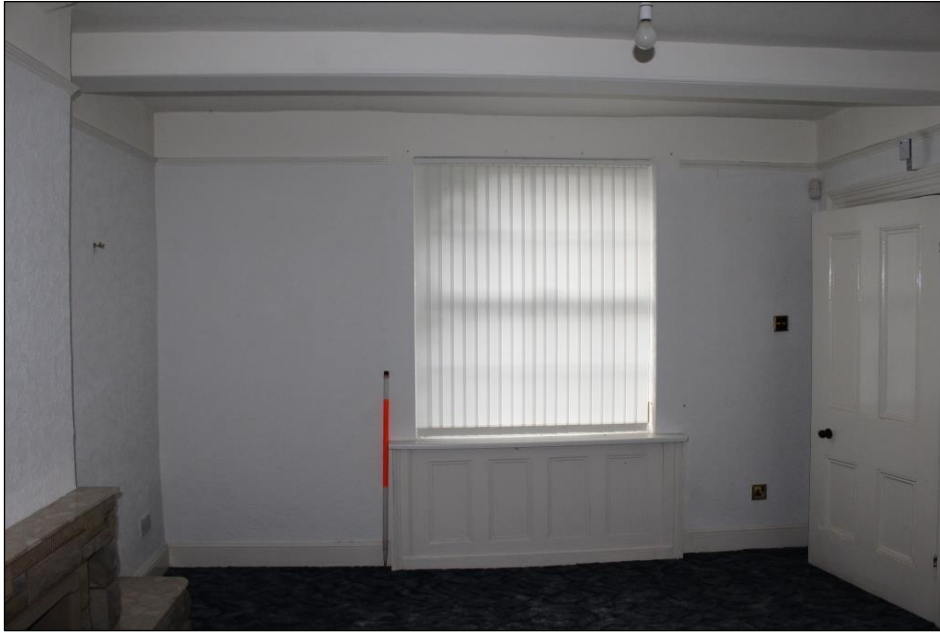
Plate 50: The southern wall of Room 5, Building 1.

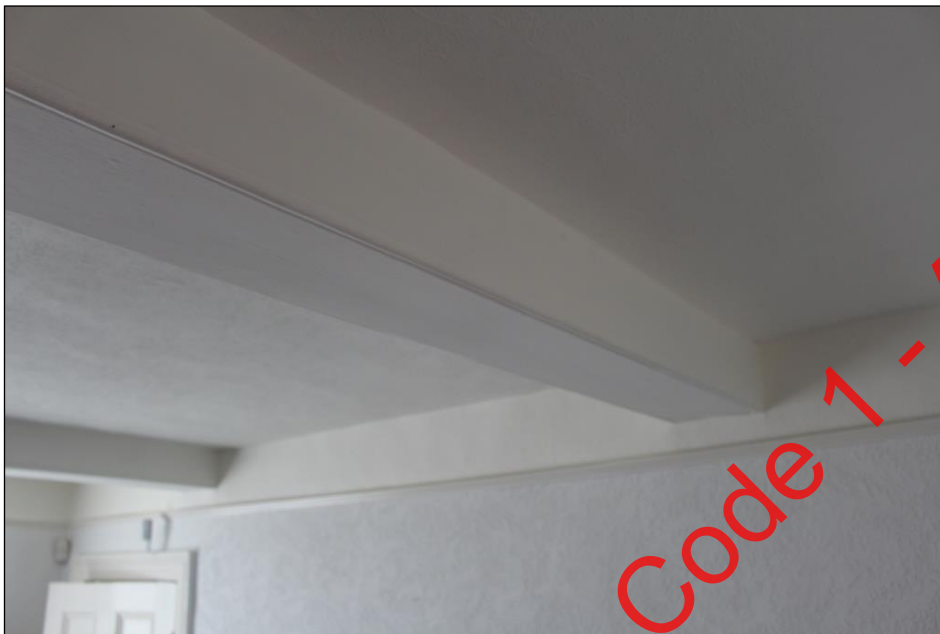
Plate 51: Boxed beams within Room 5, Building 1.

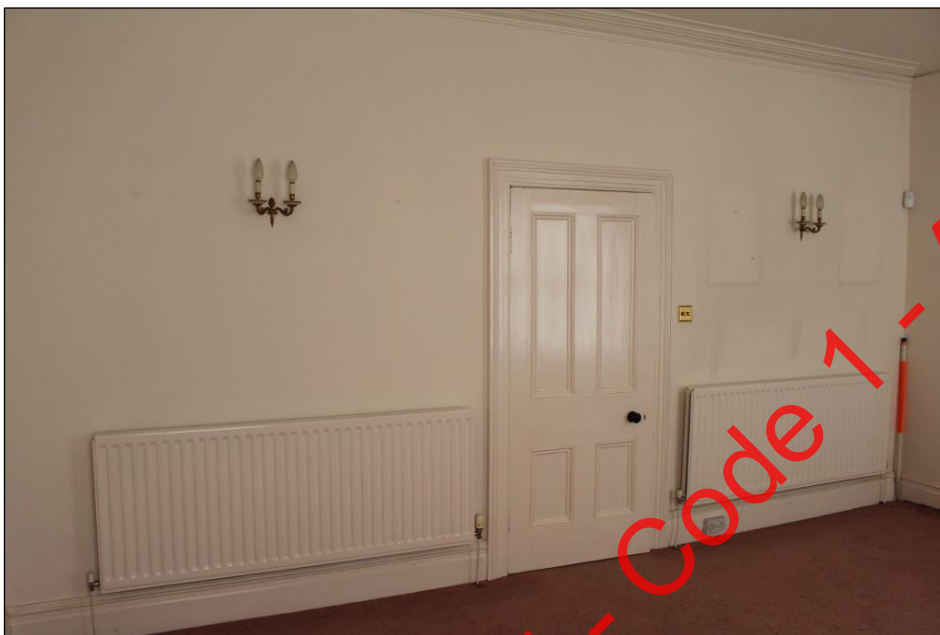
extent of the room is indicative of items being hung to dry as are the series of metal hooks lining the eastern edge of the ceiling. Room 10 (**Plates 53 and 54**) comprises a large open room set to the rear of the eastern range of the farmhouse. The gable ended range in which it is situated contains a chimney stack which forms part of the northern gable (**Plate 34**). A fireplace is set against the northern wall of Room 10, corresponding with the external chimney stack and is of mid-20th century appearance. The presence of the chimney stack and fireplace suggests that this room was constructed to form part of the domestic/residential use of the farmhouse rather than forming part of internal spaces used for utilitarian functions such as a dairy. The extension of the farmhouse in the late-19th and early 20th century with additional domestic space likely reflected the growing wealth of the occupiers and owners of Bucks Head Farm over the course of these periods.

Plate 53: The southern wall of Room 10.

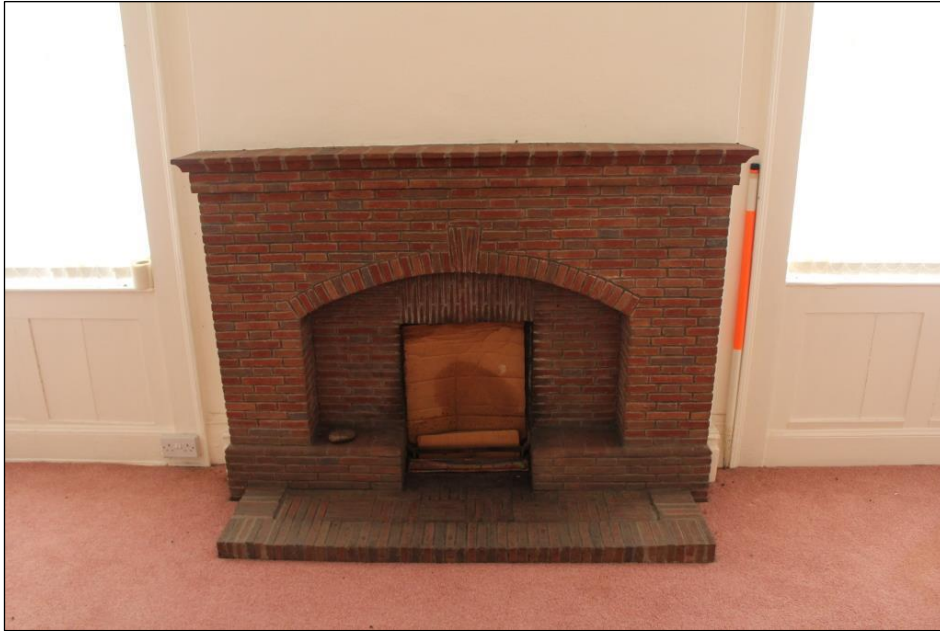
Plate 54: Fireplace set within the northern wall of Room 10, Building 1.

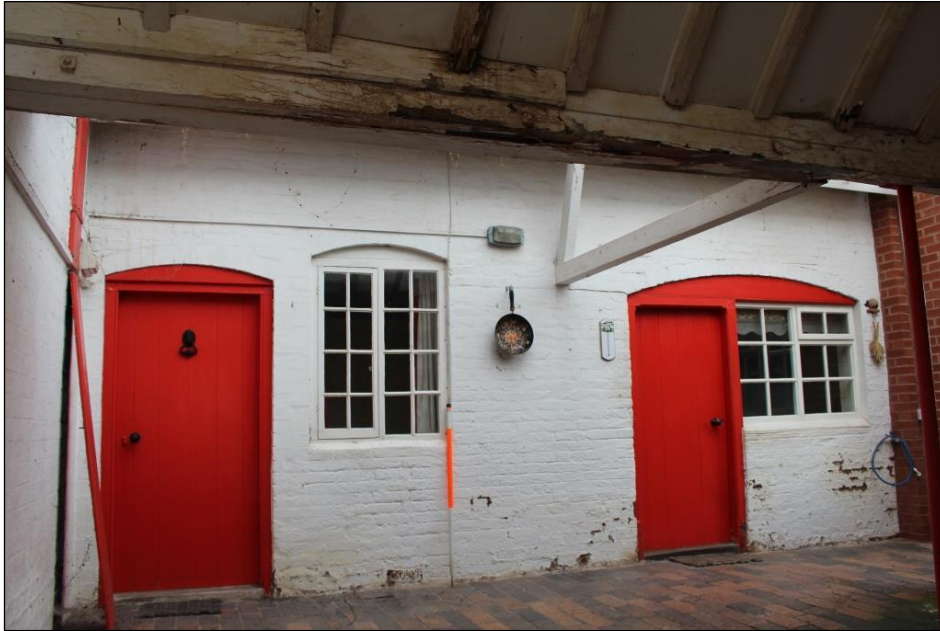
- 5.3.19 The former open yard space between the farmhouse and this detached structure has been covered over with a catslide roof which is supported by a half-timber truss and a beam on steel posts (**Plates 58 to 60**). The south-eastern corner of this structure is set on an angle and contains a door opening into the structure which is set beneath a segmental brick arch (**Plates 60 and 61**). This likely formed the original opening into building when it was a detached structure, prior to the construction of the covered yard in the 20th century. A window and second door opening are situated within the western elevation, and are 20th century insertions (**Plate 39**). The ground floor of the structure is largely open with the exception of a floored storage area within the eastern half of the room which is lit by a 20th-century dormer window inserted within the northern pitch of the roof. In the north-east corner of the room is a WC which has been enclosed by a brick wall and six-light casement window and accessed via a door in its eastern wall (**Plate 62**). To the east of the WC is a narrow brick-built projection containing a fireplace/ hearth situated beneath a segmental brick hearth (**Plates 62 and 63**). The fireplace corresponds with the substantial brick chimney stack (**Plate 39**). The presence of the hearth and chimney stack combined with the former detached position of the building but close to the farmhouse suggests that this building was constructed as a brew house or bake

Plate 58: The northern elevation of the western range of Building 1, viewed from within the covered courtyard.

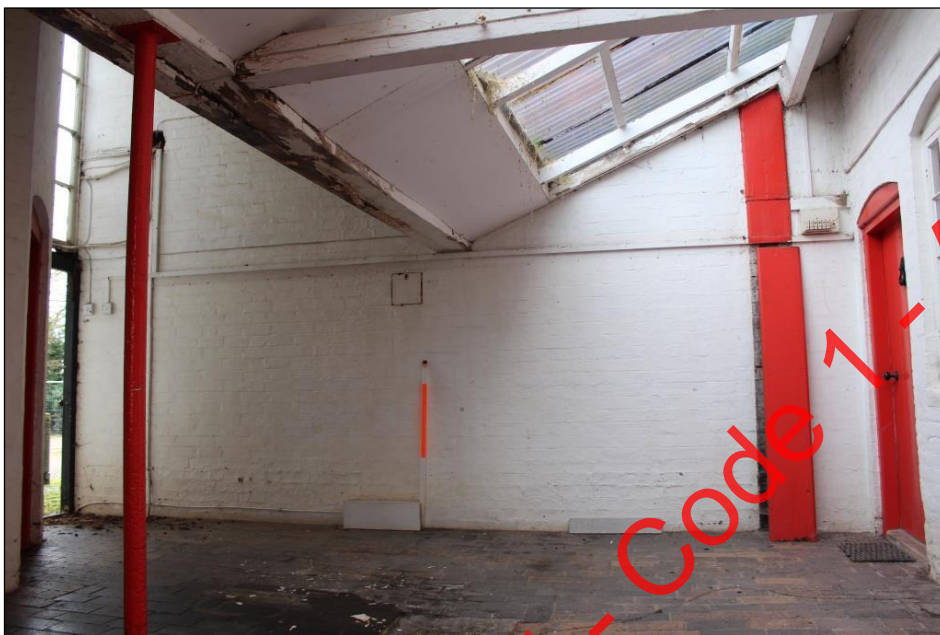
Plate 59: The external, western wall of Room 7, Building 1, viewed from within the covered courtyard.

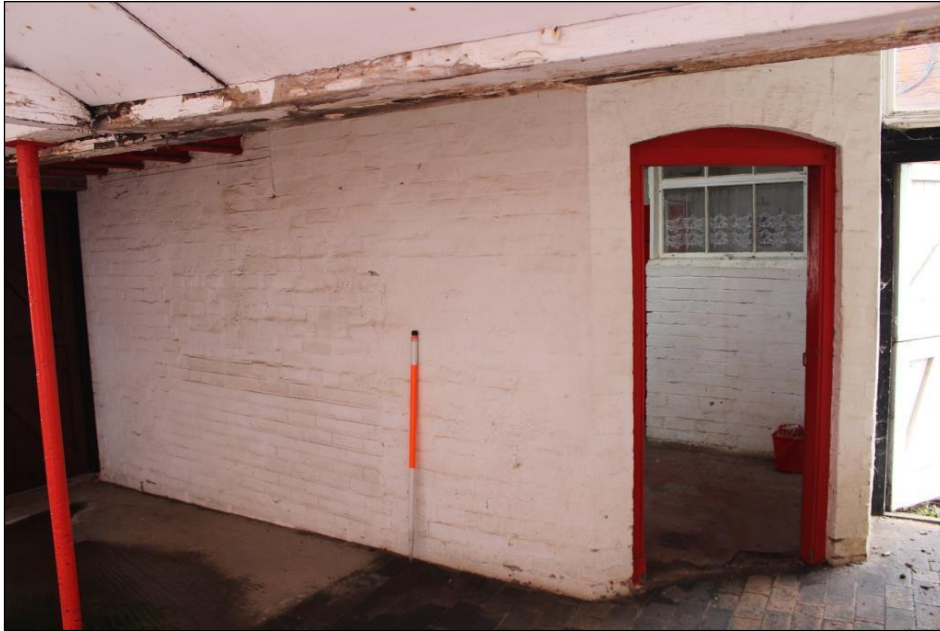
Plate 60: The southern wall of the wash room, Building 1.

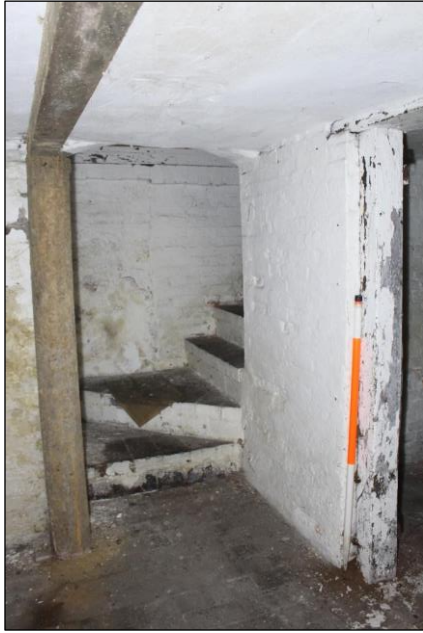
- 5.3.21 The cellar is divided into two spaces (Rooms 16 and 17) with access from the stairwell within the north-western corner of Room 16 (**Plate 64**). A coal chute situated beneath a window is situated within the east wall of Room 16 (**Plate 65**). Room 17 is supported by timber posts and a cross beam (**Plates 67 to 68**) and contains brick-built benches against the northern and eastern walls to enable goods to be stored raised off the ground (**Plates 67 and 68**). A vent feature is present within the south-eastern corner of Room 17 (**Plate 69**) and may have been used as an ash box or simply to provide ventilation for the cellar.

Plate 64: The north-western extent of Room 16, Building 1.

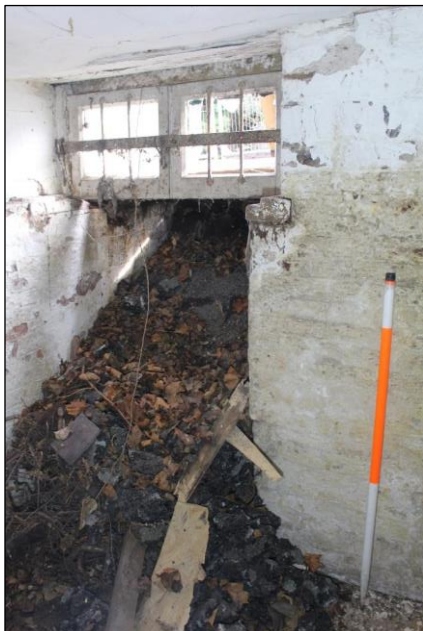
Plate 65: Coal chute and window within the eastern wall of Room 16, Building 1.

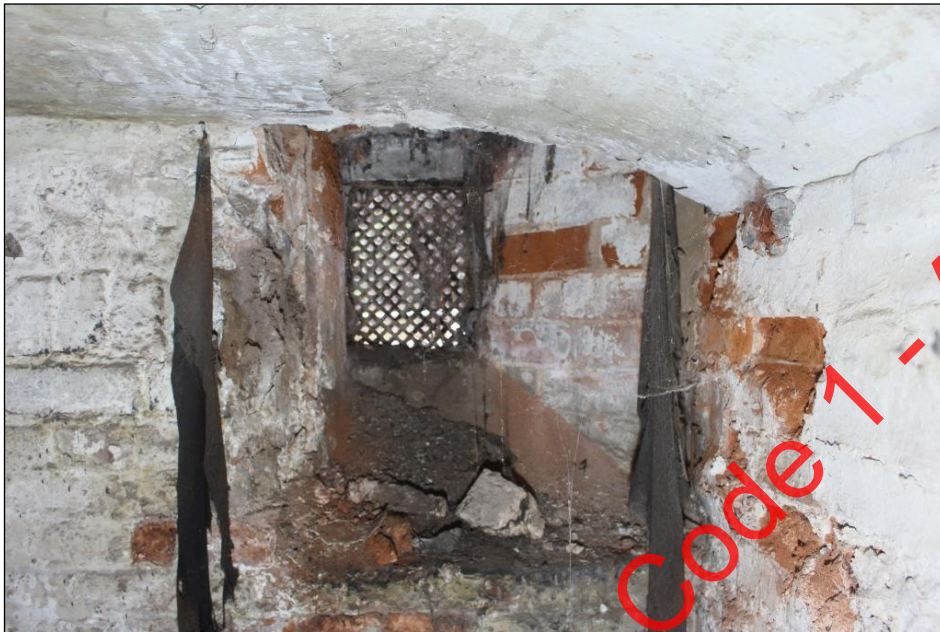
Plate 69: Vent and ash box within the western wall of Room 17, Building 1.

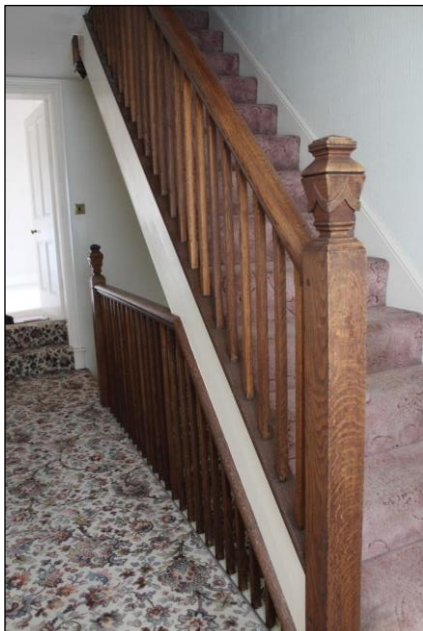
- 5.3.22 The first floor of the eastern range of the farmhouse (**Figure 15**) mirrors the form of the ground floor with two large rooms occupying the southern elevation (Rooms 24 and 25) and set either side of the central landing and stairwell (Room 22, **Plates 77 to 79**). The hallway returns in an easterly direction against the northern wall and provides access into the western range of the farmhouse. A landing (Room 23, **Plate 83**) provides access between Room 22 and the late-19th century northern extension (Room 24, **Plate 84**). The eastern part of the hallway (Room 18) within the western range has a flight of steps up to Room 23 to accommodate the differences in floor level and roof height between the 18th-century range and the late-19th century extension. Room 25 follows the same plan as Room 6 to the ground floor, with a fireplace and inbuilt cupboard against the western wall (**Plate 80**). Room 26 also mirrors the ground floor room with a fireplace set in a central position against the eastern wall (**Plate 81**). Both of the southern principal rooms are lit by a large window within their southern wall, the current windows are modern uPVC replacements. A boxed beam runs in a central position on an east to west axis in Rooms 24 and 25, mirroring the form of the rooms to the ground floor and implying a beam and joist ceiling construction (**Plates 80 and 81**).

Plate 77: Room 22, Building 1, viewed from the south-west.

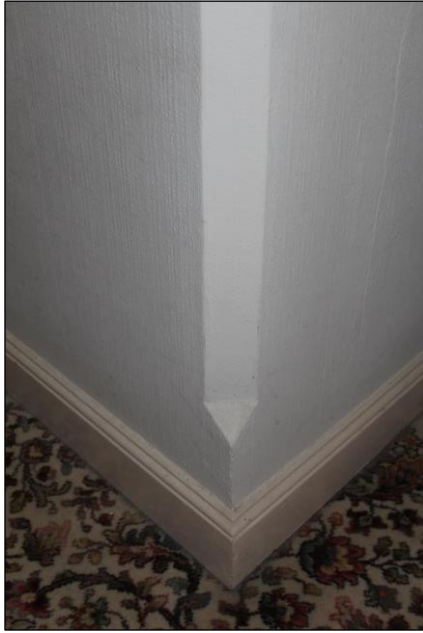
Plate 78: Detail of chamfered corner at the north-western corner of Room 22, Building 1.

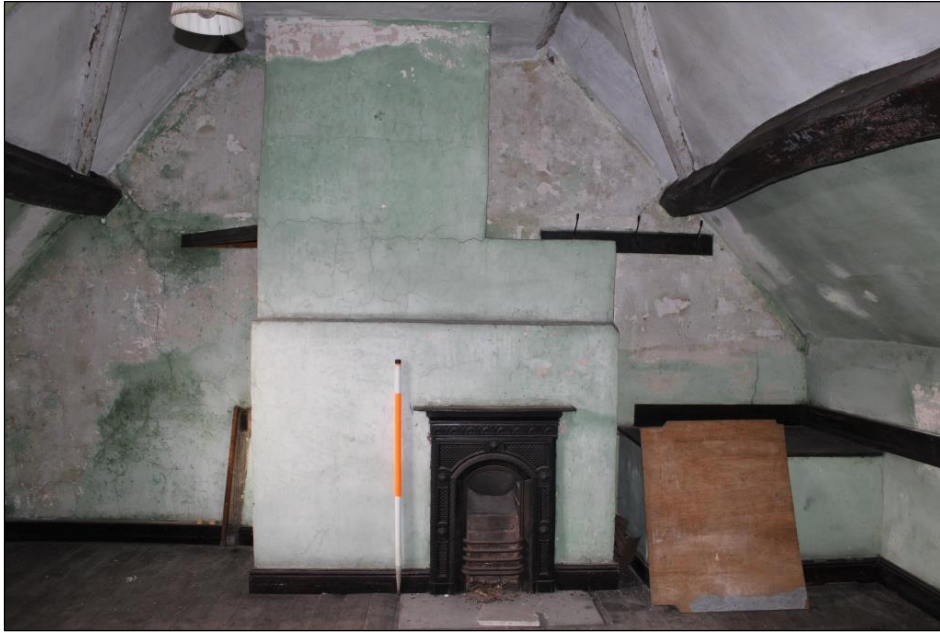
- 5.3.25 The second floor of the eastern range comprises of two principal rooms situated within the roofspace (**Figure 16**, Rooms 34 and 35) which are situated either side of a central landing and stairwell (Room 33, **Plates 93 and 94**). Room 34 comprises a large open room within the roof space and is lit by a dormer window within the southern wall (**Plates 100 and 101**). The roof construction has been enclosed with the insertion of a lath and plaster ceiling (**Plate 102**) with the exception of two black painted purlins running along the northern and southern walls (**Plates 102 and 103**). The purlins are joined by smaller square-section straight braces to an upper purlin, and these would prevent longitudinal movement and support some of the rafters. The beams are not in character with a late-19th-century roof and are either imported or suggest that the structure is older than is otherwise suggested, but this can only be determined by investigation of the floor and roof structure in the building. The southern purlin runs across and in front of the dormer window suggesting that the window is a later insertion rather than forming part of the late-19th century roof construction. The same construction of a lath and plaster ceiling and painted purlins extends within the eastern room (Room 35, **Plates 104 to 107**). Both rooms contain a substantial fireplace to the outer (eastern and western) walls (**Plates 100 and 105**) which contain a decorative iron surround and basket grate of a late-19th century style.

Plate 100: The western wall of Room 34.

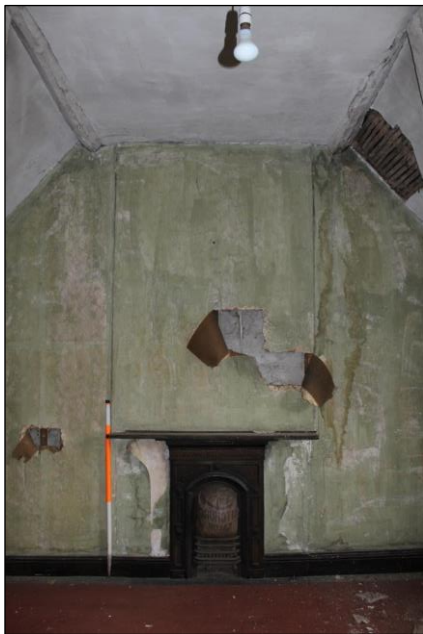
Plate 105: The fireplace within the eastern wall of Room 35, Building 1.

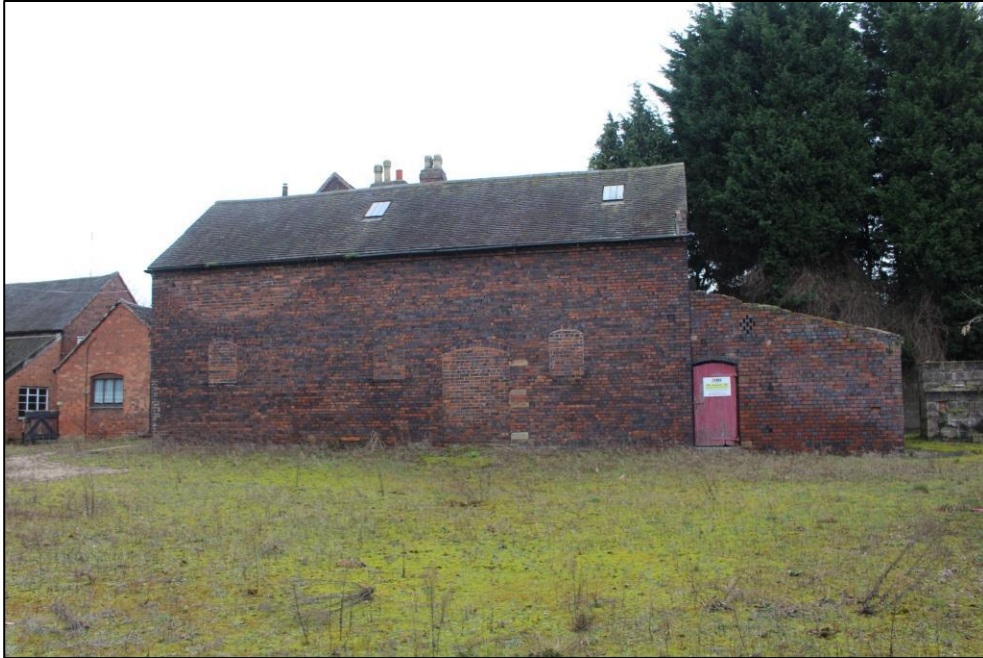
5.4.1 Building 2 comprises a barn and adjoining stables and abuts Building 1 at its north-eastern end (**Figure 14, Plates 108 and 109**). The building is constructed of red and blue bricks, including Staffordshire Blue bricks, laid in English Garden Wall bond. The inclusion of Staffordshire Blue bricks suggest that the building dates from the mid-19th century onwards but possibly represents the re-building of an earlier barn structure attached to the western elevation of the mid to late-18th century farmhouse.

5.4.2 The western elevation of Building 2 (**Figure 17**) fronts into the south-western yard within the farm complex (**Plates 108 and 109**). The western elevation is of red and blue brick construction laid in English Garden Wall bond. A single small window opening situated beneath a segmental brick arch, now blocked, is situated towards the northern end of the western elevation (**Plates 108 and 109**). A door opening situated beneath a segmental brick arch is positioned towards the southern end of the elevation. The door is flanked by two window openings also situated beneath segmental brick arches. All of these openings are now blocked. To the immediate south of the door opening are three stone quoins, the upper two each with a pintel from a former door hinge (**Plates 110 and 111**). The two quoins are situated within close proximity suggesting that they have been re-used in the reconstruction of the brickwork to the immediate south of the door opening. With the exception of the southern edge of the door opening, each of the openings within the western elevation are flanked by brickwork containing queen closers and indicating that they are original openings. The southern end of the western elevation is formed of the western wall of the attached stables and is also of red and blue brick construction in English Garden Wall bond. There is a clear joint between the barn and the stables, suggesting that the stables were constructed as a later addition.

Plate 108: An overview of Building 2 from the west.

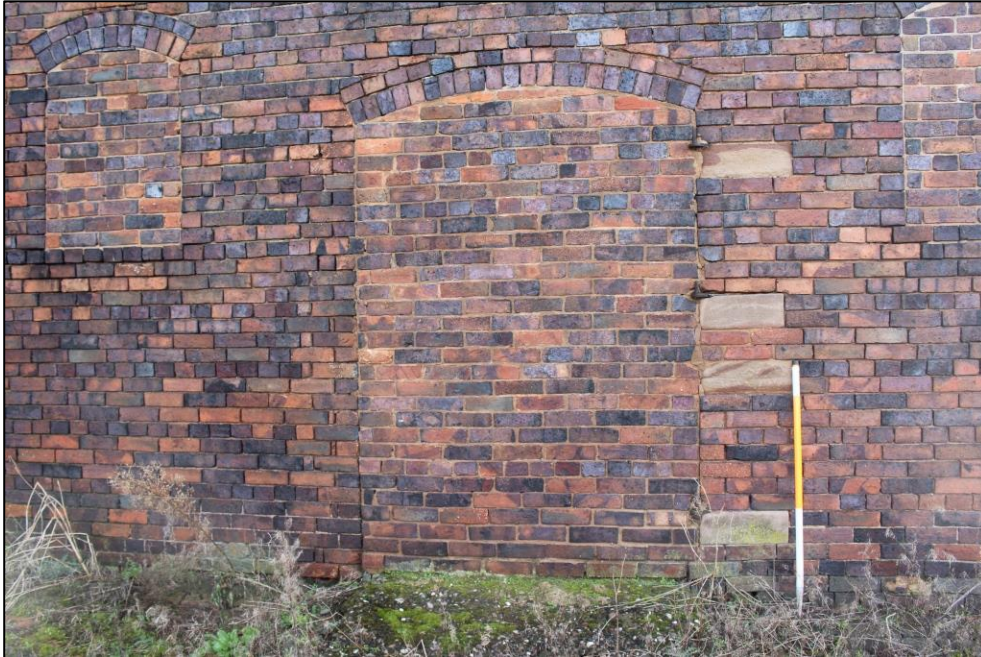
Plate 110: Detail of blocked window and door openings situated beneath segmental brick arches within the western elevation of Building 2.

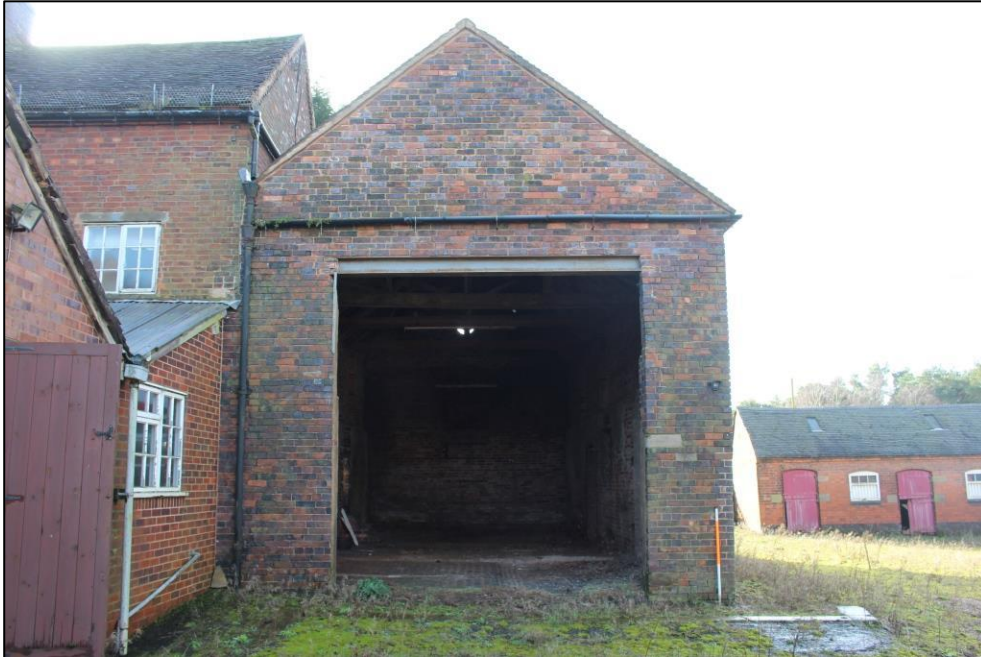
Plate 112: The northern gable of Building 2, viewed from the north.

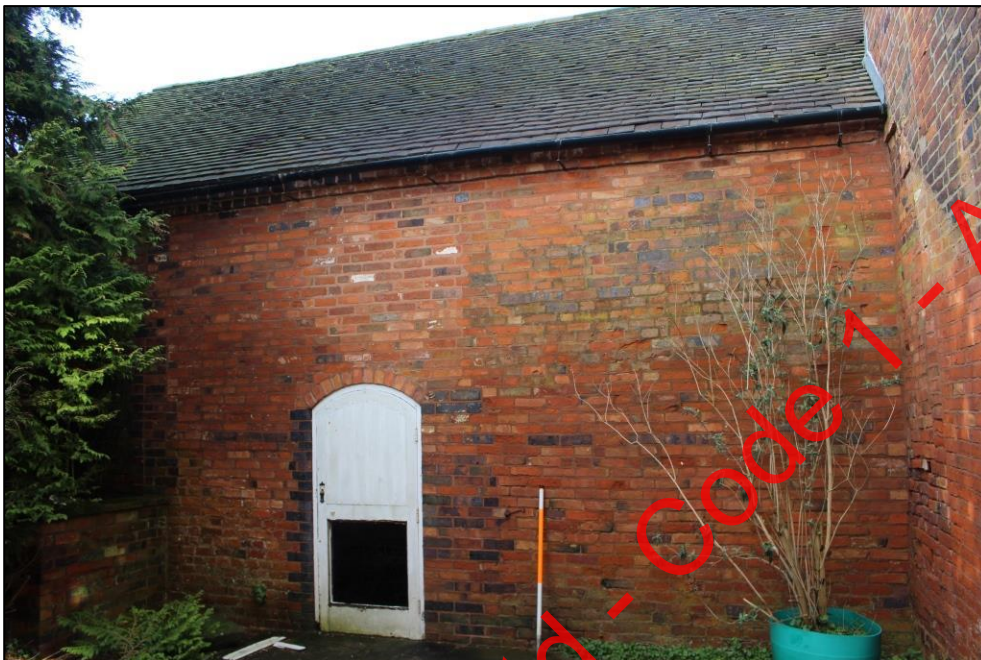
5.4.4 The eastern elevation of Building 2 fronts into the front garden of the farmhouse (**Figures 14 and 17**). The elevation is predominantly of red brick construction with scattered blue brick inclusions and appears to be laid in a variety of bonds (**Plate 113**). There is a single door opening situated in a central position within the elevation which appears as an opposing

Plate 113: The eastern elevation of Building 2.

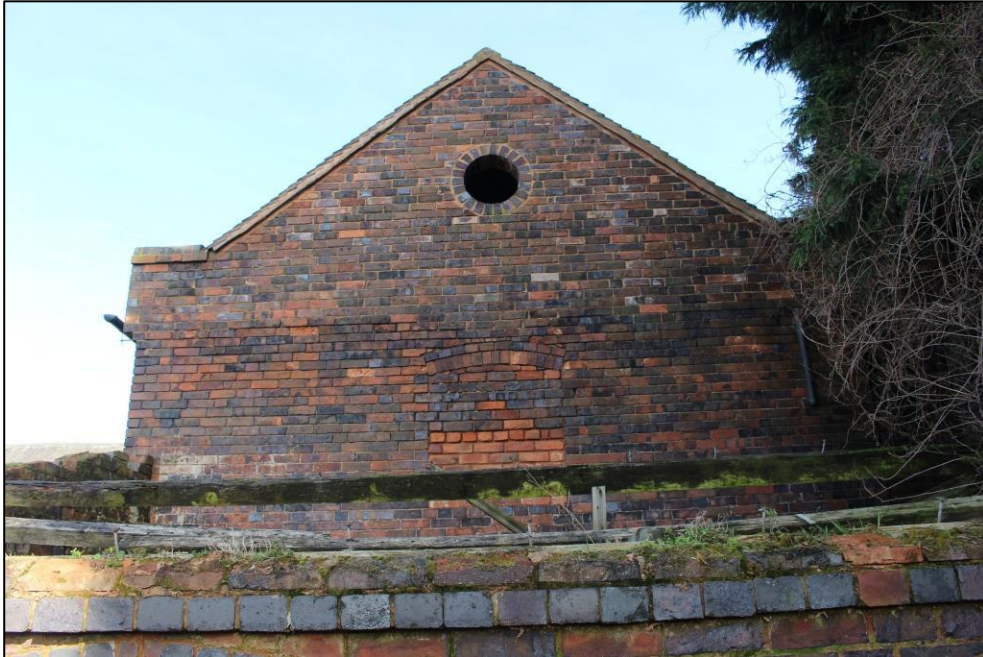
- 5.4.5 The southern elevation of Building 2 (**Figure 17**) comprises the gable end of the barn (**Plate 114**) which is abutted by a single-storey lean to comprising two stables (**Plate 115**). The gable end of the barn is of red and blue brick construction laid in Flemish Garden wall bond. A circular ventilation or owl door is situated towards the apex of the gable and a blocked window or ventilation opening situated beneath a segmental brick arch is visible extending above the roof of the lean-to stable (**Plate 114**). The southern elevation of the two stables each contain a door opening situated beneath a segmental blue brick arch. These doors are flanked on the outer sides of the elevation by a ventilation/window opening also situated beneath a segmental blue brick arch of soldier courses (**Plates 115 and 116**).

Plate 114: The southern gable of Building 2.

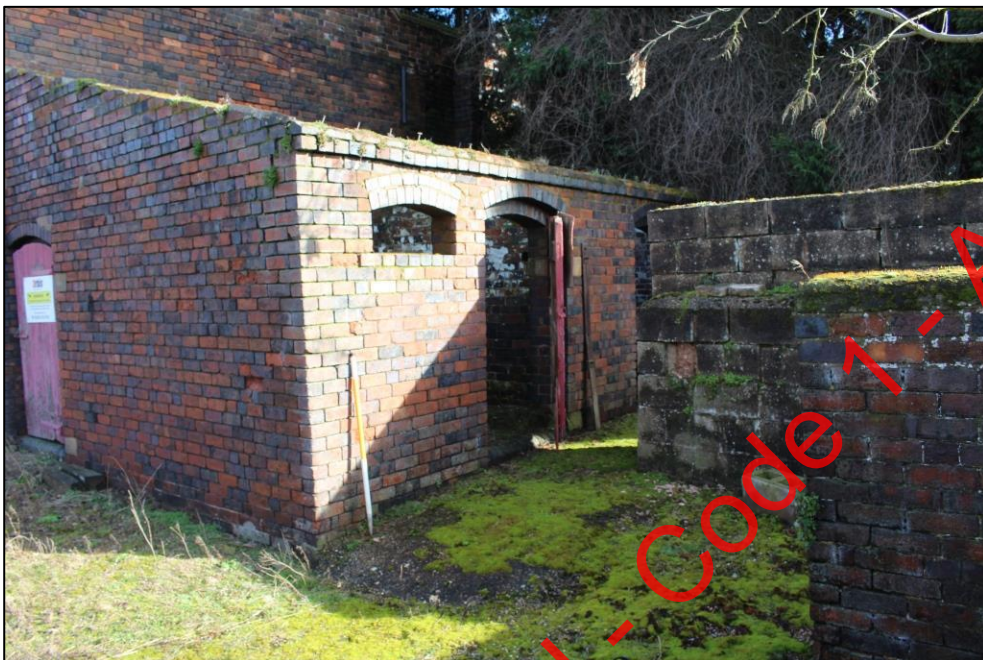
Plate 115: Lean to stables against the southern gable of Building 2, viewed from the south-west.

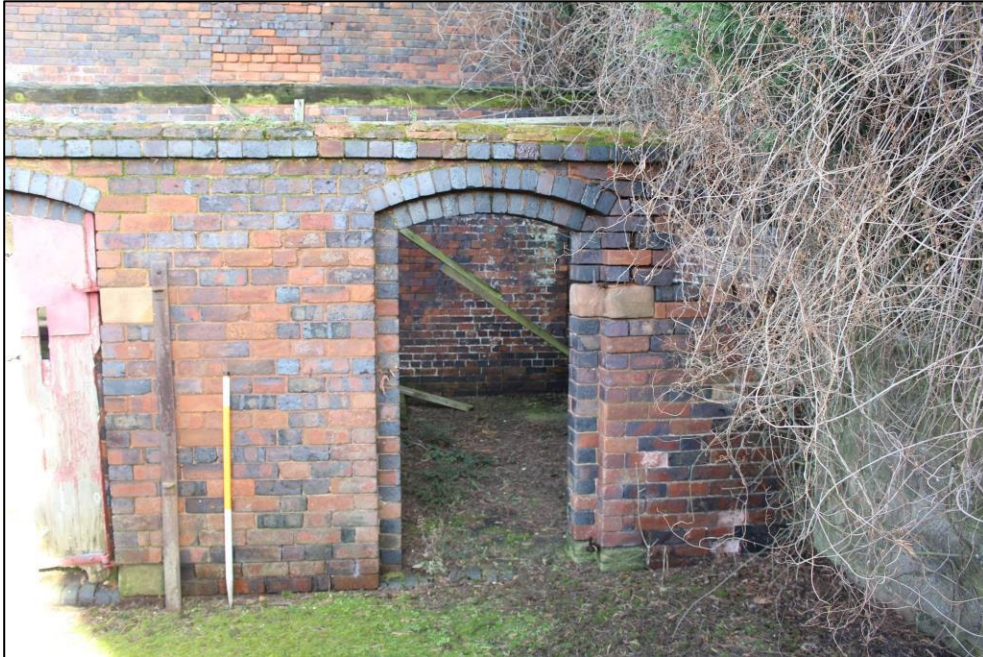
Plate 116: Detail of stable door opening within the southern elevation of the lean-to stable against Building 2.

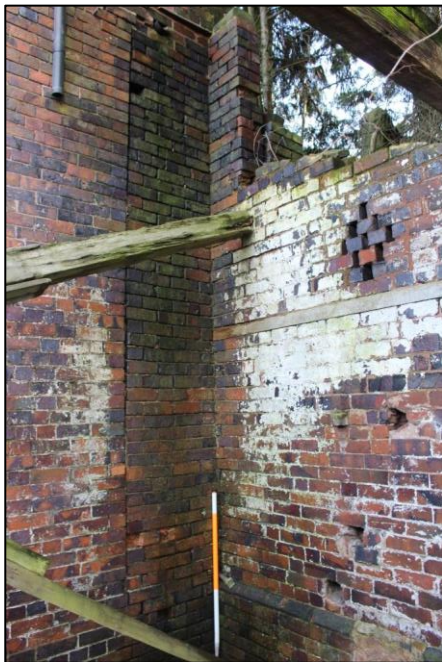
- 5.4.8 There is a clear straight joint in the north-east corner of Room 15 (**Plate 117**) which further indicates that the stables have been constructed at a later date, abutting the southern elevation of the barn. The stylistic similarities between the barn and the stables suggests that they may have been constructed in the late -18th/19th century and not long after the initial construction of the barn, though the extensive use of blue engineering brick may suggest a later date, with such bricks being widely used from the mid-19th century.

Plate 117: The south-eastern corner of the eastern stable (Room 15).

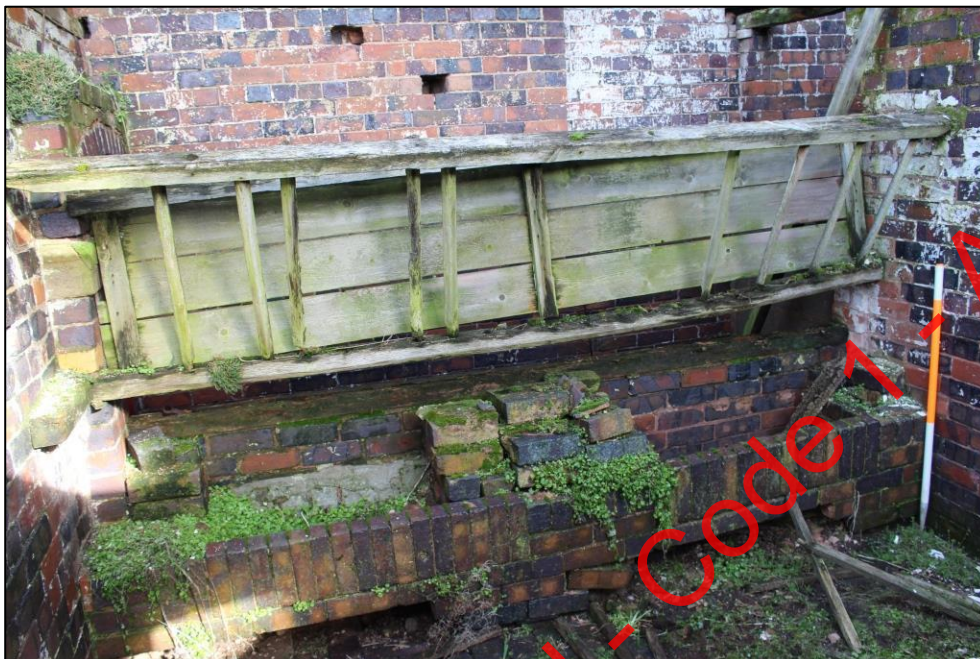
- 5.4.9 The stables are derelict and the roof has collapsed, however a timber hay trough and brick built manger survive within the western stable situated towards the northern end of the stable (**Plate 119**). The door within the western elevation appears to provide access to a service corridor running along the northern side of the stables and from where the manger could be replenished. No fixtures or fittings survive within the eastern stable.

Plate 119: The northern wall of Room 14, Building 2 and the brick and timber built feeding trough.

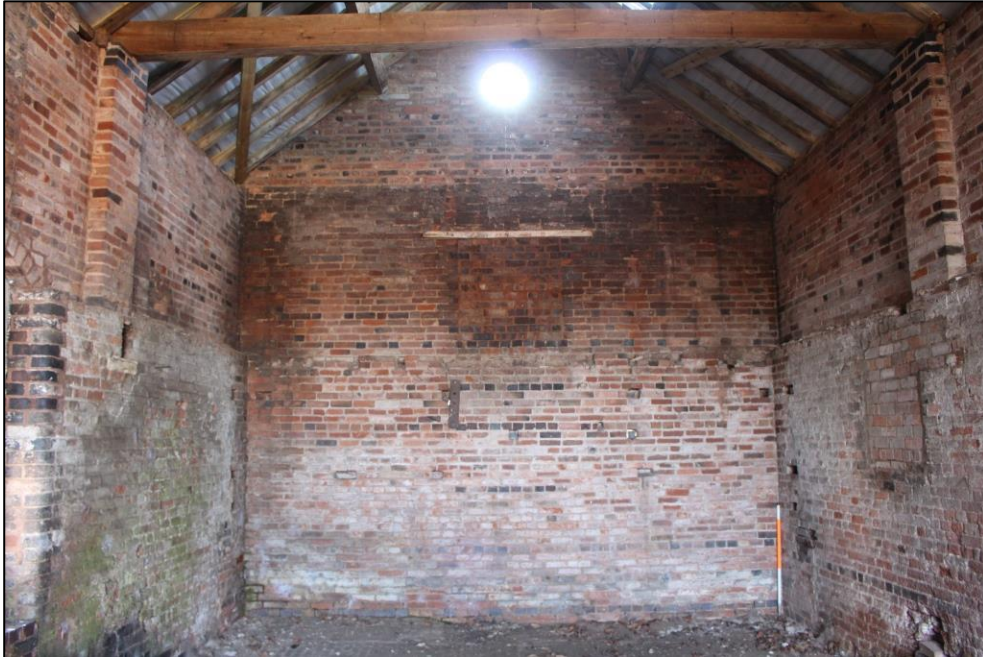
- 5.4.6 The barn consists of a single open space divided into four bays by three trusses supported on brick pilasters added inside the wall that is of reduced width (**Figure 14, Plates 120 to 124**). The northernmost bay is defined by a queen-post truss whilst the southern half of the barn are defined by two braced king-post trusses (**Plate 124**). The rafters are supported by a single purlin and ridge piece, with additional support provided by longitudinal braces. At the southern end of the barn the brick pilasters supporting the trusses only rise from first floor height (**Plates 120 to 122**) possibly suggesting that there was an inserted floor within the barn and also evident by empty mortices for joists within the brickwork of the western wall (**Plate 121**). The presence of full height brick pillars supporting the northernmost truss may indicate that the northern bay was separated from the two-storey southern extent of the barn. The door opening flanked by two window openings which are present within the southern extent of the western wall are indicative of a stable and the proximity of Building 2 to Building 1 (the farmhouse) suggests that it was constructed as a stable and coach house to serve the farmhouse. No stalls survive within the building, but are likely to have been situated within the southern half of the barn with horse tack and possibly a coach or cart housed within the northern half. There was likely a hayloft above the stables within the southern half of the barn which was ventilated by the openings within the southern gable. The building ceased to be used as a stable, with the openings in the western wall being infilled. It is possible that this occurred following the construction of Building 3 and Building 4 as a cart shed and stable during the 19th century.

Plate 120: The interior of Building 2 (Room 13) from the north.

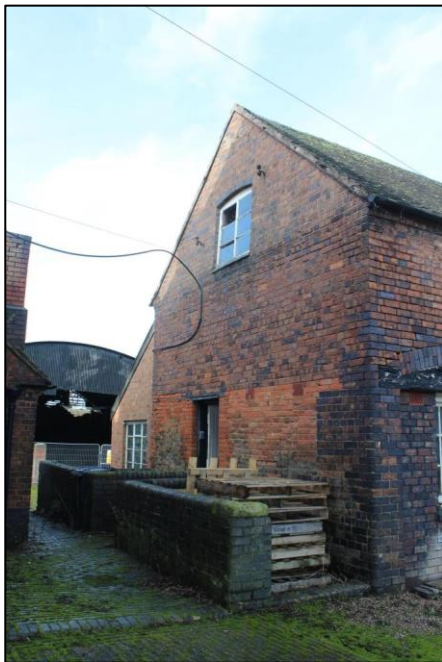
Plate 129: The southern gable of Building 3, viewed from the south-east.

- 5.5.3 The southern elevation of Building 3 has a red-brick gable. The elevation is constructed crudely in a variety of bricks with predominantly red brick to the ground floor and burnt red/blue brick to the first floor (**Plates 129 and 130**). The differences in the brickwork used within this gable suggests that the upper half of the gable has been rebuilt and thus the similarity in the fabric of the upper part of the southern gable with that of the eastern and northern elevations may suggest an earlier structure was rebuilt or repaired. There is a single door opening, situated in an off-centre position to the ground floor. The door opening is flanked to each side by two enclosures bound by low blue brick walls, possibly used for storage (e.g. of stable muck) rather than housing livestock. The door is likely to be a later insertion, following the infill of the arched opening in the eastern elevation in red and blue brick (**Plates 125 and 126**). This infill would have allowed for the conversion of the southernmost bay of Building 3 into a probable dairy. A six-light timber casement window is situated beneath a segmental brick arch to the upper floor.

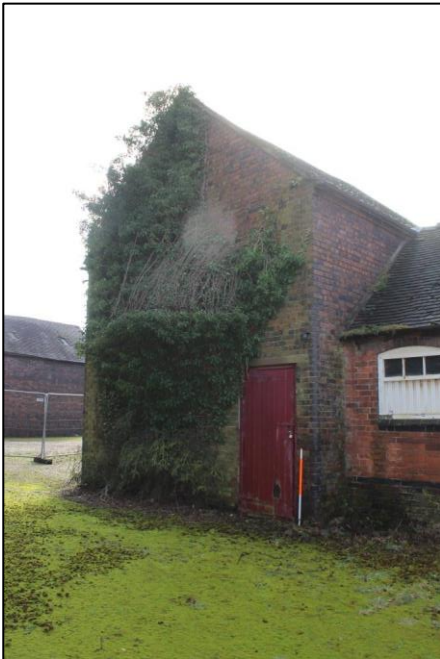
Plate 131: The northern gable of Building 3 and the eastern extent of the northern elevation of Building 4.

- 5.5.4 The northern elevation is partially obscured by vegetation and comprises the northern gable end of burnt red and blue brick, laid in Flemish Garden Wall bond (**Plate 131**). The brickwork at the north-western corner of the elevation has been constructed in bull nose shaped bricks forming a chamfer decoration (**Plate 132**). The vegetation obscures a window opening at first floor level which mirrors the position of a window opening in the southern elevation.

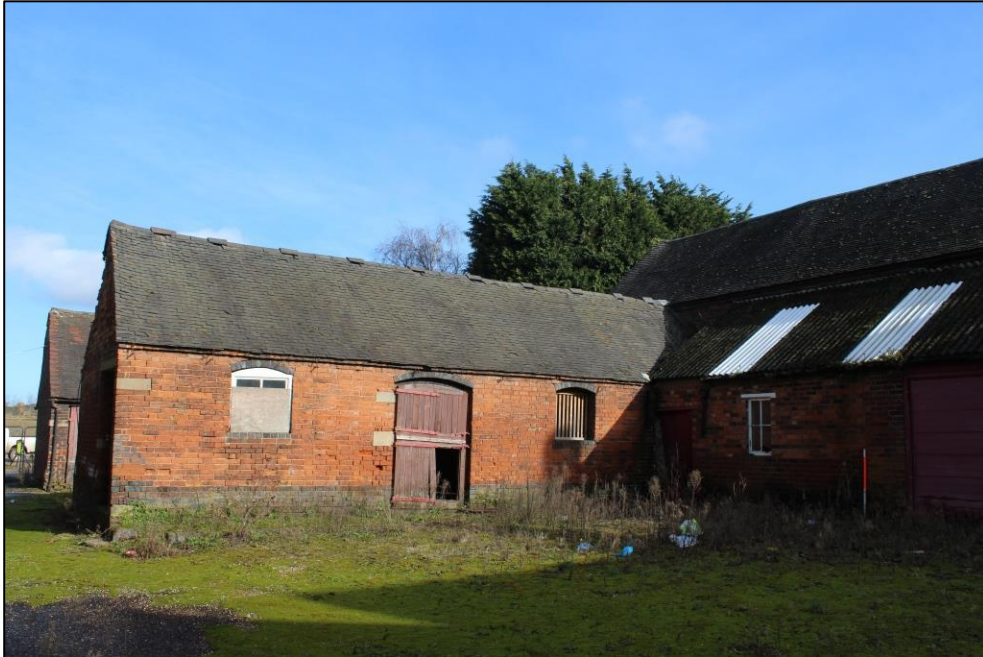
Plate 138: The southern elevation of Building 3 and the western elevation of Building 4, viewed from the south-west.

- 5.5.5 The western elevation of the cart shed has largely been obscured by the construction of a 20th century lean-to (**Plates 138 and 141**). The lean-to is of red and buff brick construction with a corrugated roof. The western elevation contains a timber door situated at its most northern extent, where the structure abuts Building 4 and a four-pane window situated beneath a timber lintel. A wide garage door opening is situated at the southern extent of the western elevation.

- 5.6.2 The southern elevation of the building comprises the principal elevation of the range and is of red brick construction in Flemish Garden Wall bond with a blue-brick plinth (**Plates 138 to 140**). There are three openings within the southern elevation which comprise a central stable door situated beneath a blue brick segmental arch and is flanked to the west and east by

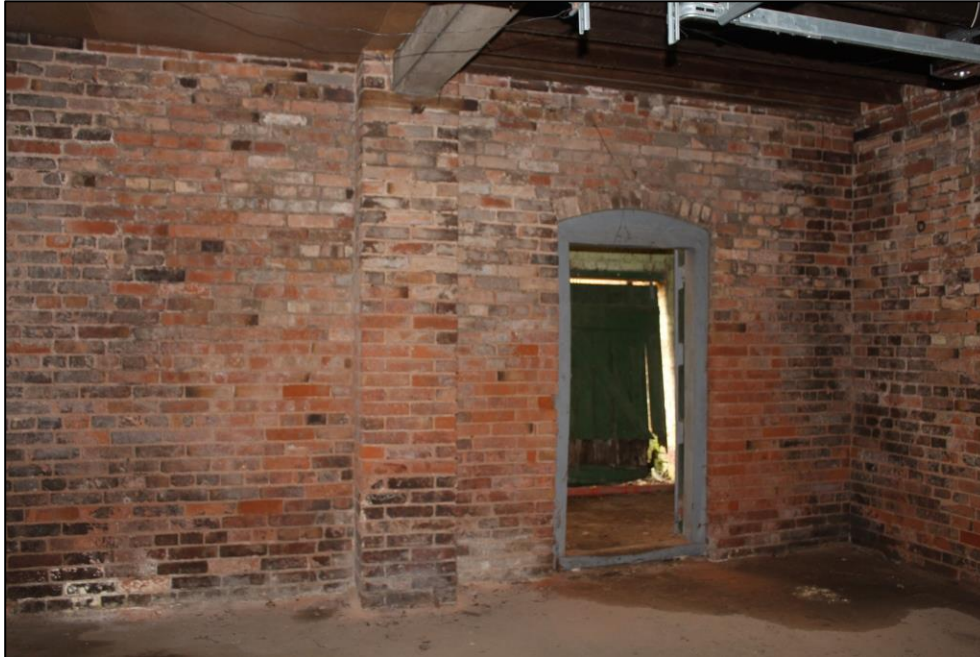
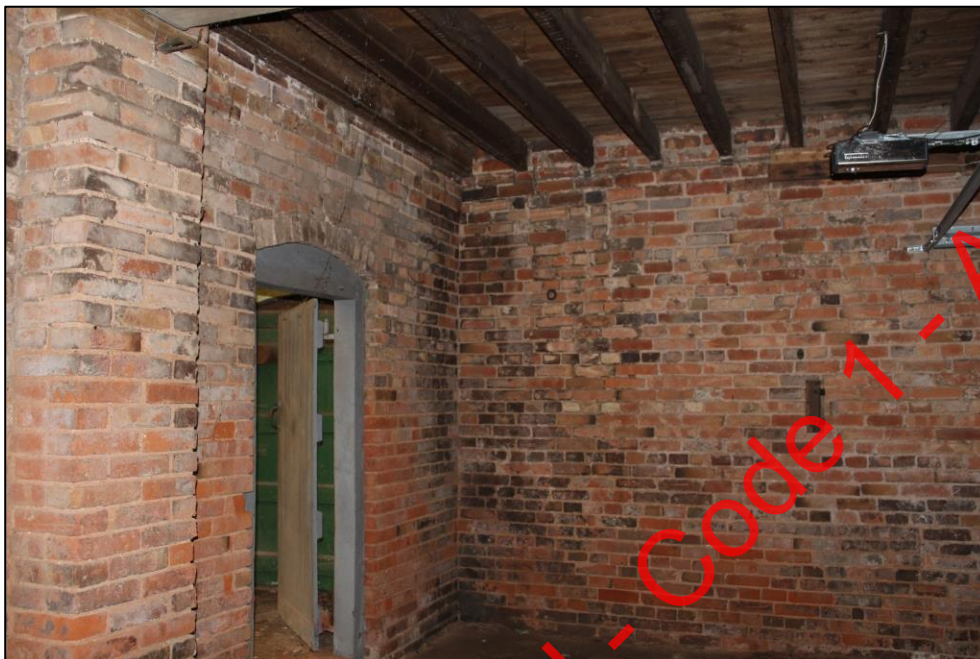
- 5.5.6 The ground floor of Building 3 is divided into five rooms (Rooms 1 to 5, **Figure 18**). The main, central room comprises of a double bay room which corresponds with two of the larger segmental brick arched openings within the eastern elevation (**Plates 142 to 145**). The room has most recently been used as a garage with roller garage doors inserted into the former cart shed openings and the associated mechanisms has been attached to the ceiling (**Plates 144 and 145**). A door, situated beneath a segmental brick arch is situated within the north-west corner of the room (**Plates 142 and 143**). This opening likely formed an external opening from

Plate 142: The western wall of Room 1, Building 3, viewed from the south-east.

Plate 143: The western and northern walls of Room 1, Building 3, viewed from the south-east.

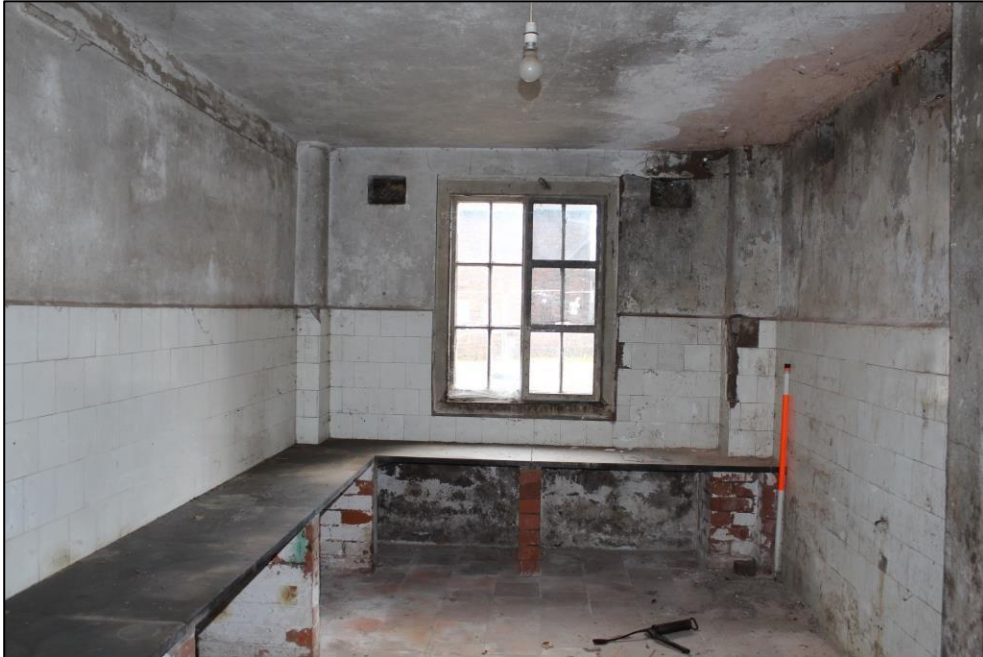
Plate 146: The eastern wall of Room 2, Building 3 from the west.

- 5.5.7 Room 2 occupies the southern extent of the ground floor. The room can only be accessed via the door within the southern elevation and is lit by a single window which has been inserted into the former cart shed opening within the southern wall (**Plate 146**). Along the northern and eastern walls of the room are low brick and slate built benches (**Plate 147**). The presence of these features suggests that the room has recently been used for storage and the proximity of this part of Building 3 to the farmhouse would indicate that the room was used as a dairy and was converted from a former cart shed bay. The partial conversion of the cart shed to a dairy suggests that there was a shift in agricultural practices within the farmstead with a decrease in arable activities and an increase in dairying.
