WP 029 D – Bucks Head Farm – Enabling Works North Contract Report for Historic Building and Setting Recording

Document Number: 1EW04-LMJ-EV-REP-NS06_NL16-029018

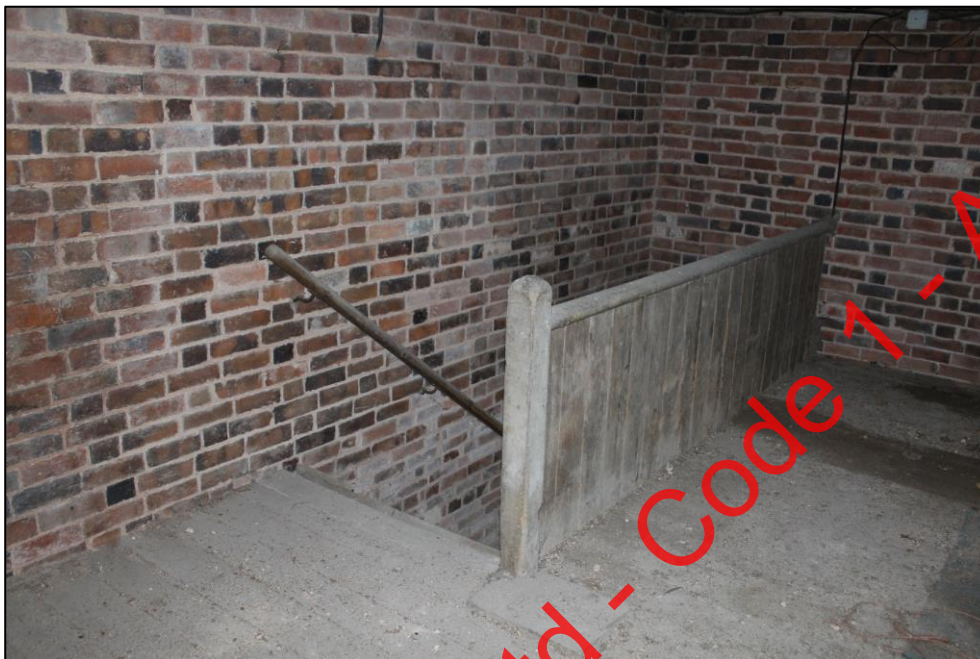
Plate 155: Staircase within the north-western corner of Room 6, Building 3.

- 5.5.9 The first floor of Building 3 is accessed via a door and flight of stairs situated within the north-western corner of the building (**Figure 18, Plate 155**). The first floor is divided into two rooms. The northern room (Room 6) appears to correspond with the two northern bays visible to the ground floor, whilst the southern room (Room 7) appears to correspond with the three bays/ cart shed openings at the southern extent of the ground floor. The two rooms are divided by a brick wall laid in Flemish bond and contains a door opening with steps up into Room 7 (**Plate 156**). Above the timber lintel of the extant door opening is a small segmental brick arch, the

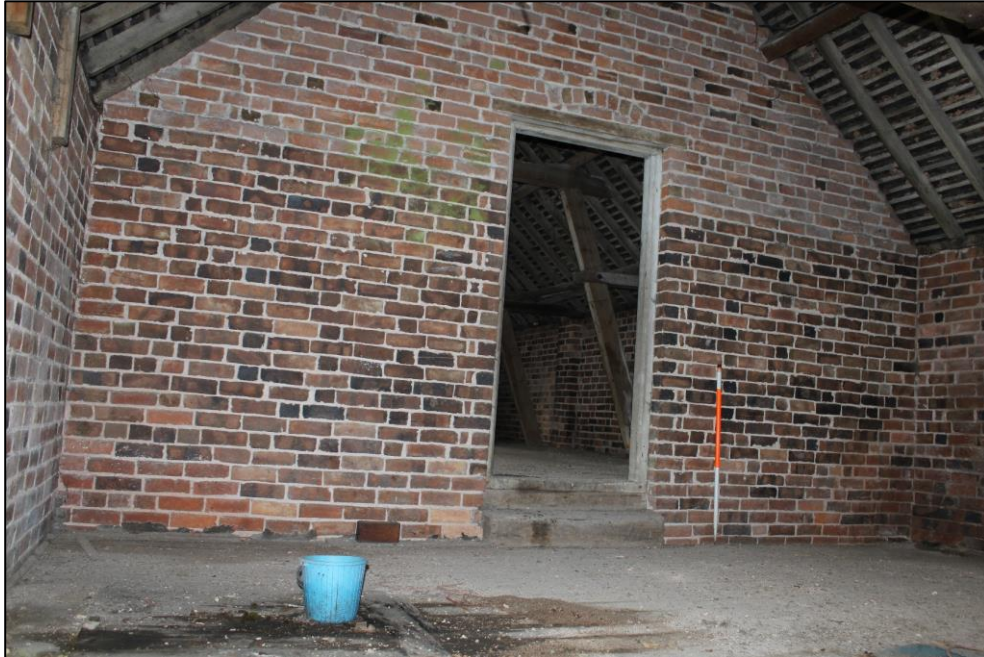
Plate 156: The southern wall of Room 6, Building 3, viewed from the north-east.

size of which may suggest that there was formerly only a window opening and that the northern and southern rooms to the first floor were accessed separately. However, there is no evidence externally of a joint between the two structures and there is no surviving evidence of a second stair within the southern half of the building. Additionally the brick arch above the door opening within Room 7 fits with the size of the door opening, rather than according with a former window opening. A single braced king-bolt truss supports the roof structure within Room 6 (**Plate 157**). The roof structure of Room 7 comprises two angular trusses which are braced and connected to the wall plate, with a truncated tie in two parts is bolted to the rafters and either side of the raking struts that rise to the collar beam (**Plates 159 to 161**). Although an unusual form, perhaps very late 19th or early 20th century, the intention is clear enough to provide an accessible working space for the storage bins against the walls.

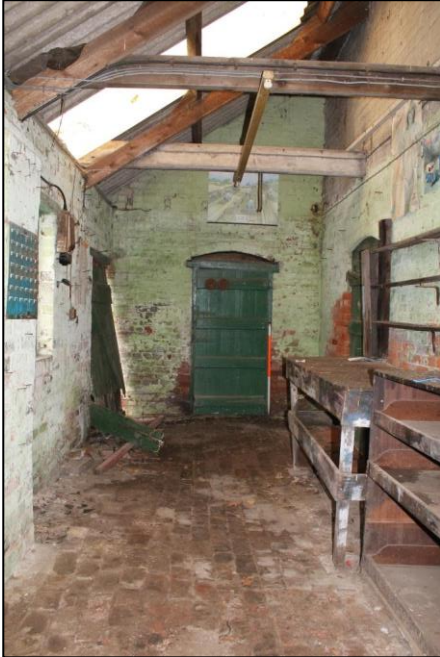
- 5.6.5 Room 10 comprises a 20th-century lean-to constructed against the western elevation of Building 3 and the eastern extent of the southern elevation of Building 4 (**Plates 168 to 170**).

Plate 168: Overview of the northern extent of Room 10, Building 4, viewed from the south.

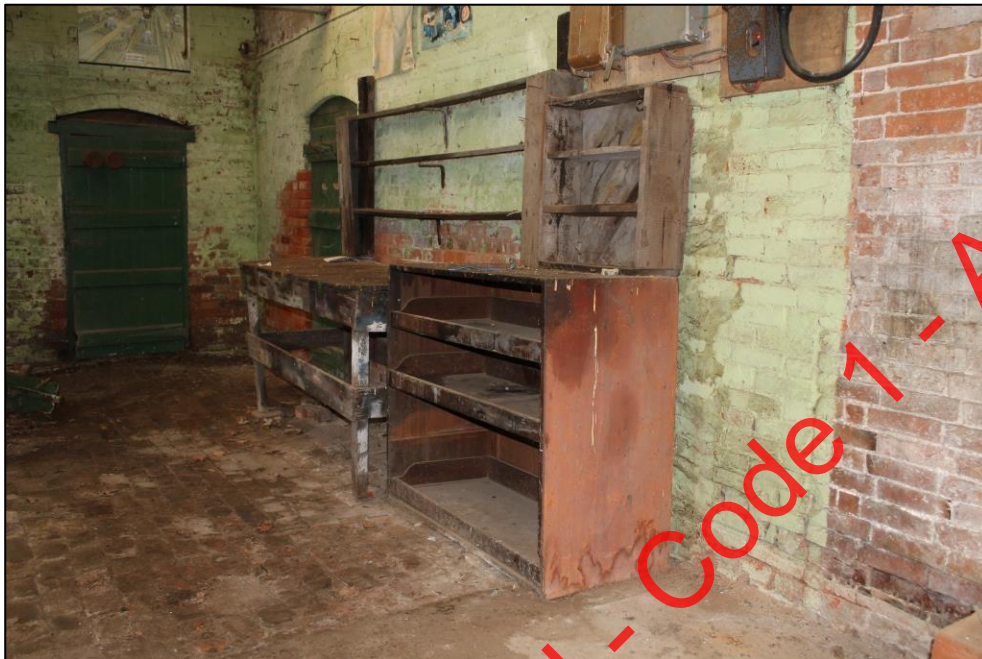
Plate 169: The eastern wall of Room 10, Building 4, viewed from the south-west.

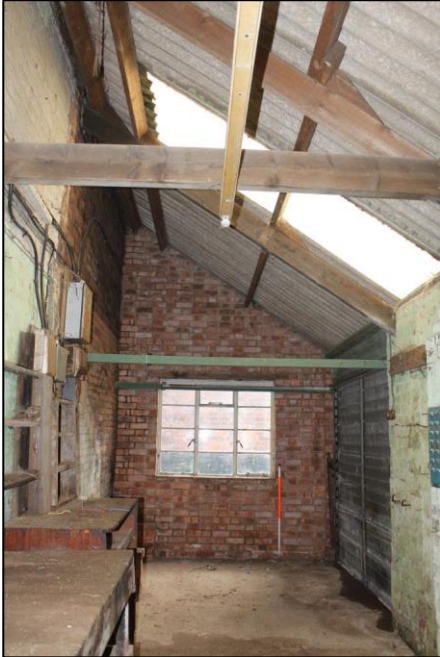
Plate 170: The southern extent of Room 10, Building 4, viewed from the north.

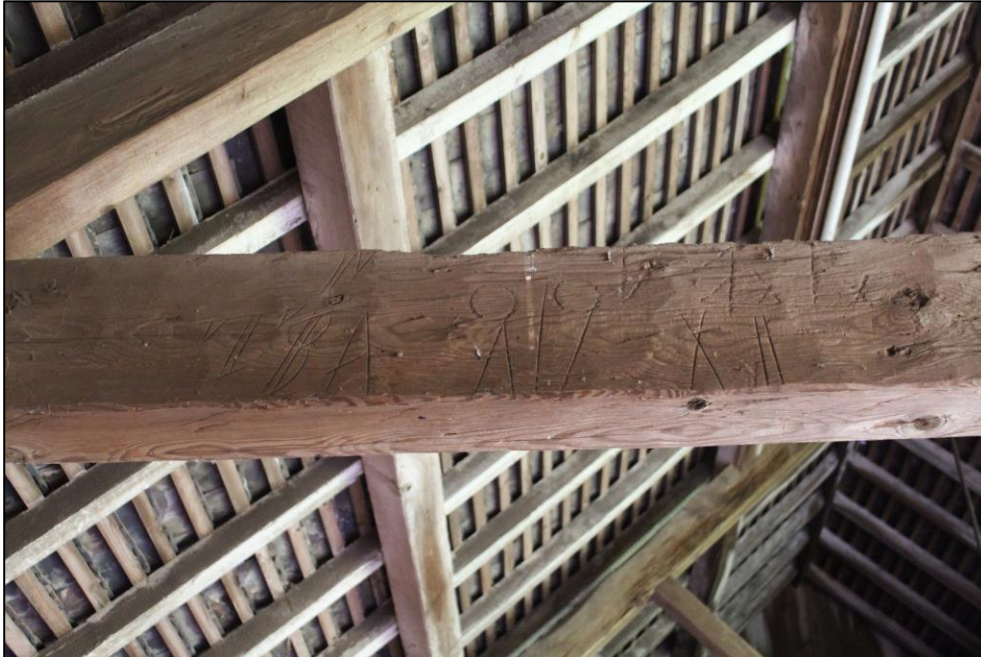
timbers of the 18th and early 19th century.⁵ (**Plates 182 and 183**). The style of these marks, incorporating cross and triangle shapes are suggestive of the Baltic Timber Marks employed by the timber market of Riga, Latvia. The marks also include inscribed lines, typical of the timber market of Memel, Lithuania, however the position of the marks, within the centre of the beam is again more typical of timber from Danzig and Riga where the marks were scribed in the middle of a balk. The presence of these markings would suggest that the tie beams are of an earlier date and have been re-used and incorporated into the construction of this late-19th century building. A door is situated beneath a timber lintel at the northern extent of the brick gable wall between Rooms 3 and 4 (**Plates 180 and 185**). Room 4 forms a separate room at the western extent of Building 5 but appears to have intentional access with the three central bays via a door within the north-eastern corner of the room. The building probably dates from the mid-late 19th century and may have been constructed as an open fronted cart shed or cow house. It is depicted on the 1884 1:2500 OS map as entirely open to the south. The building may have been remodelled in the 20th century with enclosed storage rooms occupying the outer bays and open central bays for the storage of the carts. The 1968 Ordnance Survey map depicts Building 5 with an open fronted central area flanked by two outer rooms.

Plate 182: Detail of Baltic timber marks on the tie beam of the western truss within Room 3, Building 5.

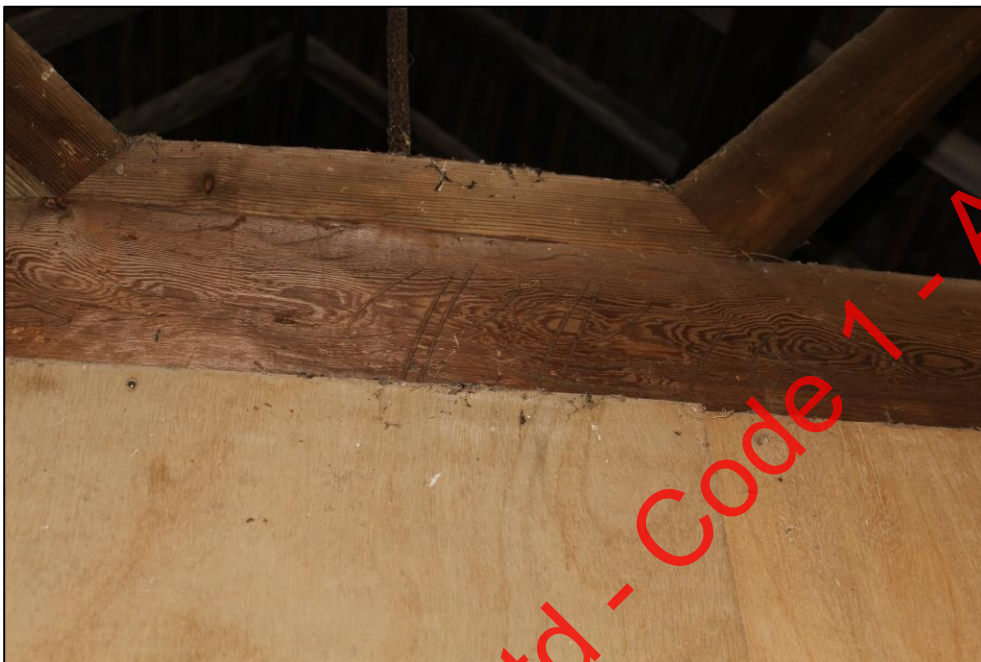
Plate 183: Detail of carvings and Baltic timber marks on the tie beam of the eastern truss between Room 3 and Room 2, Building 5.

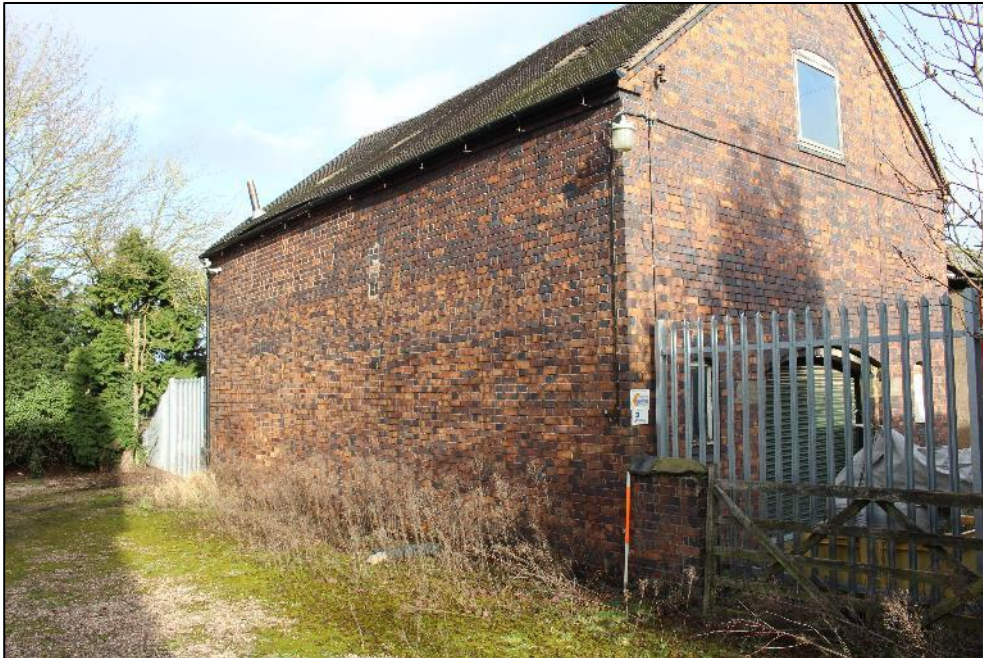
- 5.8.1 To the east, across a farm track and public footpath, is another shed (**Plate 186**) that is somewhat separate from the rest of the farm complex (**Figures 22-24**). The barn first appears on the 1884 OS map in its complete form, meaning it likely dates to the mid-late 19th century. This barn is substantial, and made of a combination of red and blue brick in a Sussex bond. Above this is a large pitched roof, with Staffordshire blue clay tiles, within which three skylights have been inserted, as well as a metal flue. On the eastern side of this building is a slightly lower projecting range, that seems to be contemporary with the original large barn block. This projection has had its eastern elevation opened out, and the building itself has been extended with a breezeblock building covered with corrugated iron. The large openings in the northern and southern elevations of the barn suggest that it was formerly used a space for storage.

Plate 186: View of Building 6.

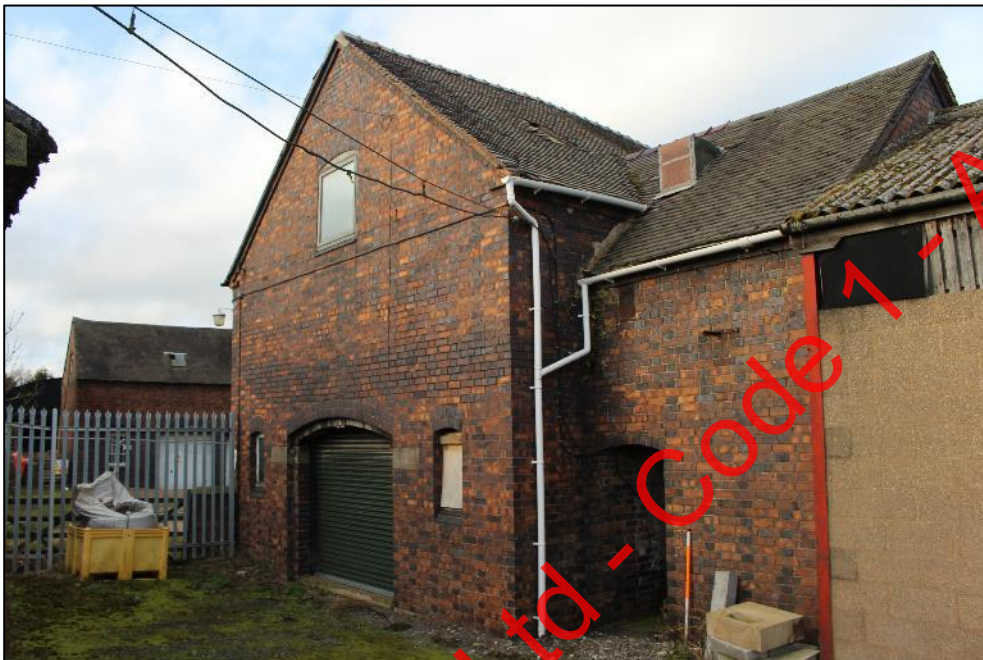
- 5.8.2 The southern elevation of Building 6 (**Plate 187**) contains a large central opening at ground floor level. This is a large doorway covered with a segmented brick arch, with recessed brick jambs. Within these jambs large blocks of sandstone have been inserted to hold pintels, that

Plate 187: The southern elevation of Building 6.

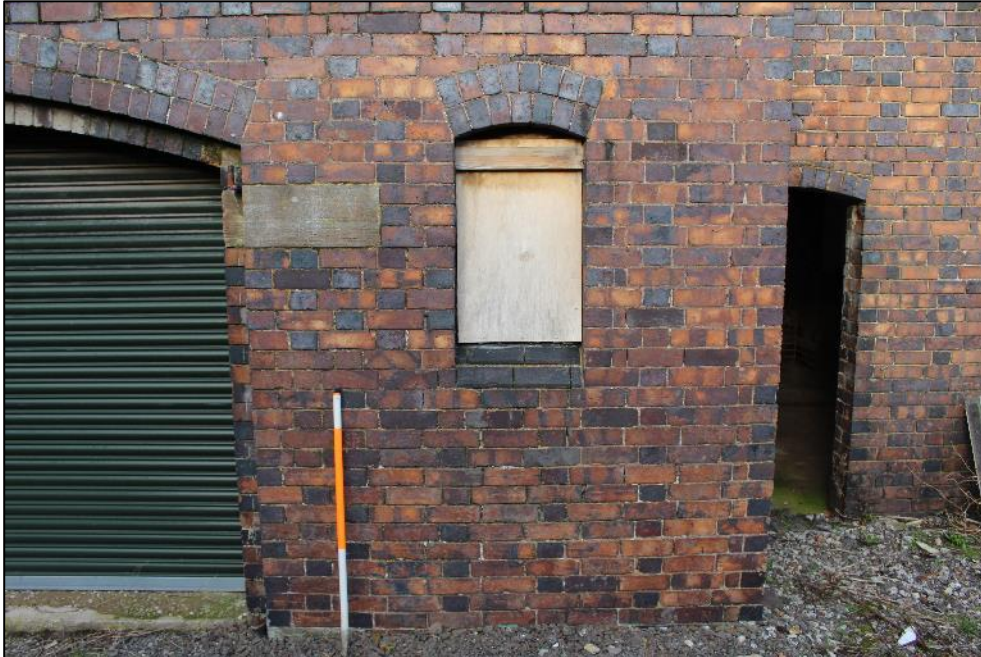
would have carried the weight of former hinged doorways. These have been replaced with a 20th/21st century garage door. Flanking this are two small narrow windows (**Plate 188**), also covered with segmented brick arches, and with chamfered brick sills. In the gable another is a slightly larger square window (**Plate 189**), again covered with a brick arch. A 20th or 21st-century uPVC window has been inserted here, most likely replacing an earlier pitching window. To the east is the north facing elevation of the eastern projection. This contains a doorway with a segmented brick arch.

Plate 188: One of the ground-floor windows on the southern elevation of Building 6.

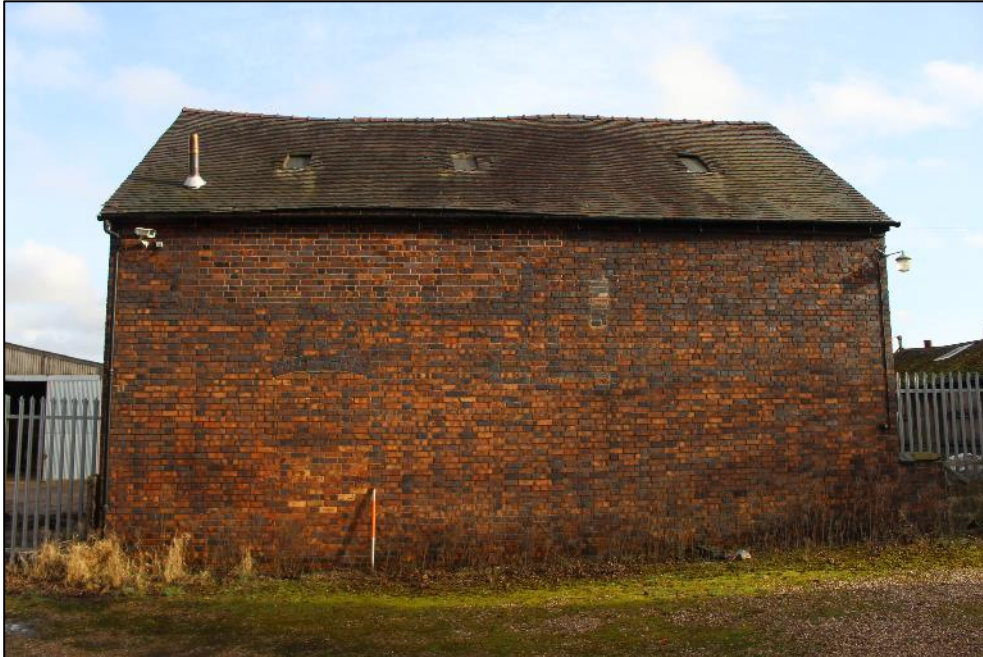
5.8.3 The western elevation (**Plate 190**) is relatively plain. On the southern side of this elevation is a slight projection at ground floor level creating a low boundary wall, to which a gate has been attached. On the northern side of the elevation is what appears to be a former window (**Plate 191**), defined by the extant segmented arch, as well as the clear breaks in brick coursing that define its shape and size. A timber gatepost has been attached to the north western corner of the building.

Plate 190: The western elevation of Building 6.

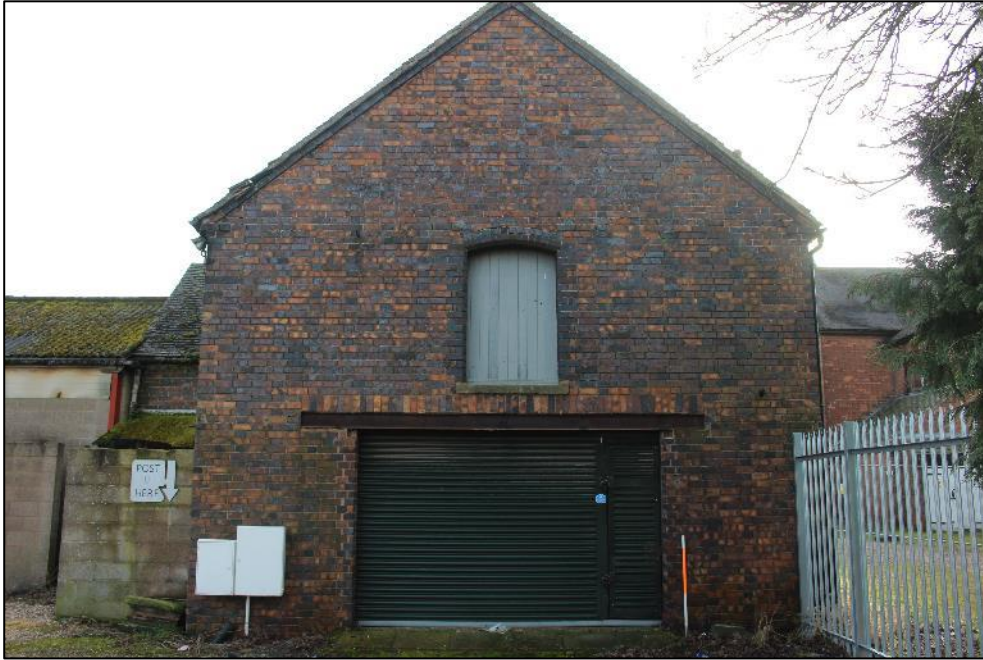
5.8.4 The northern elevation of the building (**Plate 192**) contains another large opening. This is much wider than the one on the southern elevation and does not appear to be original. The breaks in the coursing around the jambs, and the exposed iron lintel suggest this has been inserted at a later date, thus not being contemporary with the rest of the building. Above this is a course of upturned bricks, in a soldier bond. At first floor level is a tall window, similar in style to the rest of the windows in this building. This one, however, has chamfered brick jambs and a sandstone sill.

Plate 192: The northern elevation of Building 6.

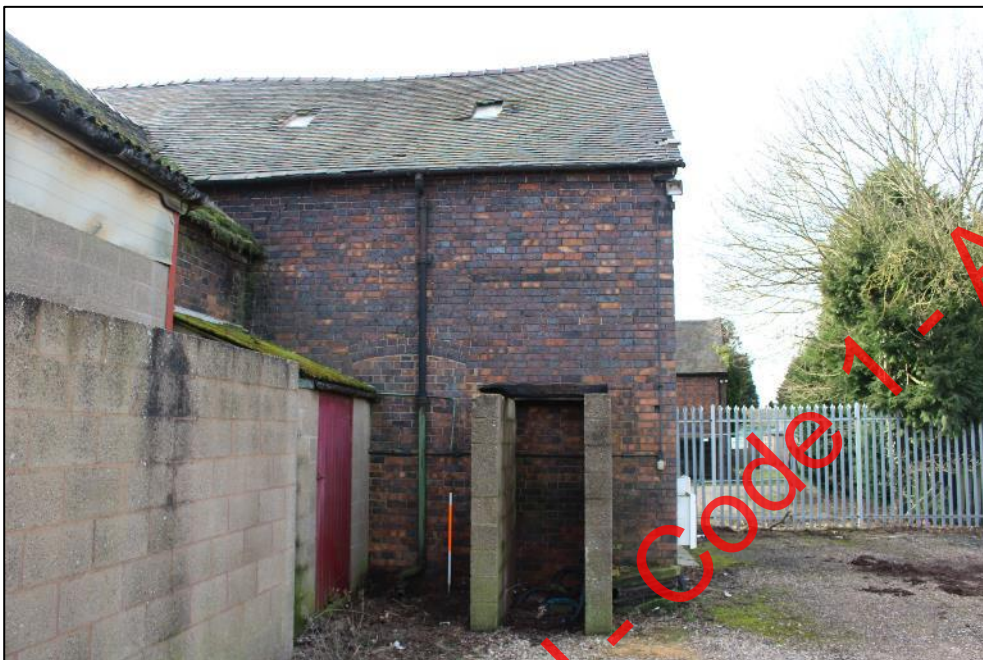
5.8.5 The eastern elevation has largely been obscured by the addition of the breezeblock extension. The northern part of it is still exposed (**Plate 193**), however, and contains another blocked window, opposite the one situated on the western elevation. The rest of the eastern elevation is visible from within the eastern extension (**Plate 194**), however, it is featureless. There are some signs of rebuilding, however, as two courses of brickwork approximately halfway up the wall seem to be somewhat irregular. This may also be the sign of former first floor here.

Plate 193: The northern side of the eastern elevation of Building 6.

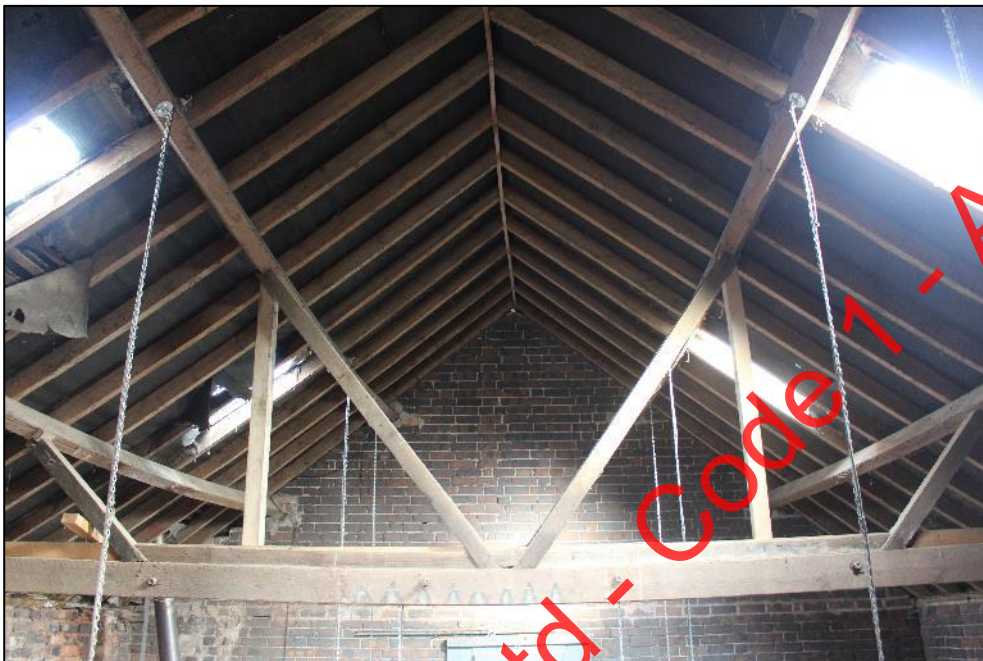
5.8.7 The northern section of the barn is open, with modern suspended lighting hanging from the exposed timber roof (**Plate 195**). There is a single truss in this roof, with lateral braces and posts supporting the purlins. In the northern wall (**Plate 196**) is a blocked feature to the west of the large doorway, that likely relates to a former internal feature. Evidence of a former sandstone sill is visible just above the large doorway (**Plate 197**). In the eastern wall (**Plate**

Plate 195: The roof structure of Building 6.

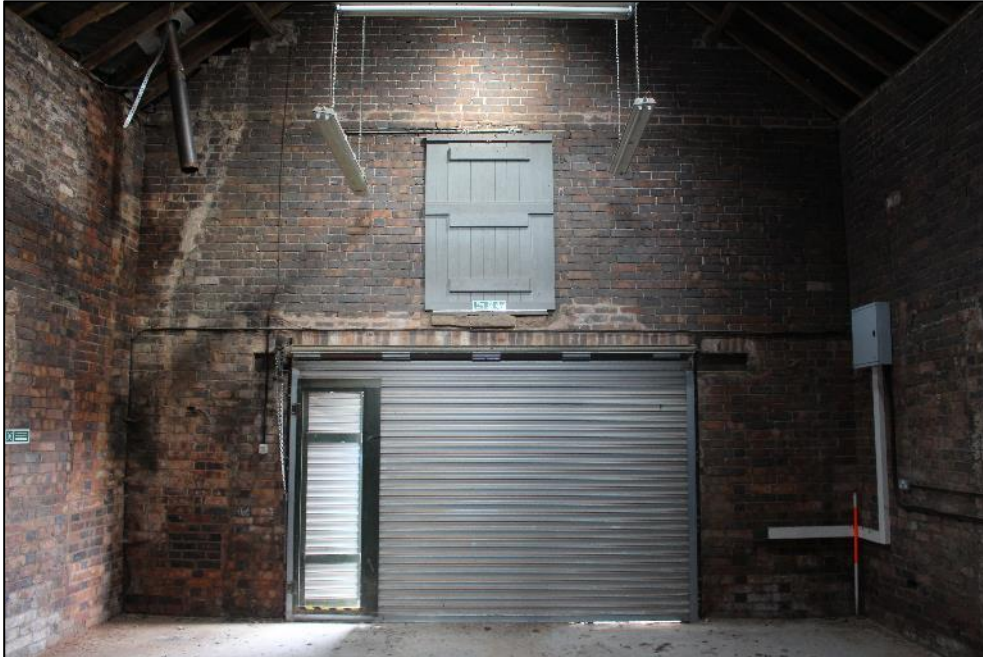
Plate 196: The northern wall in the northern half of Building 6.

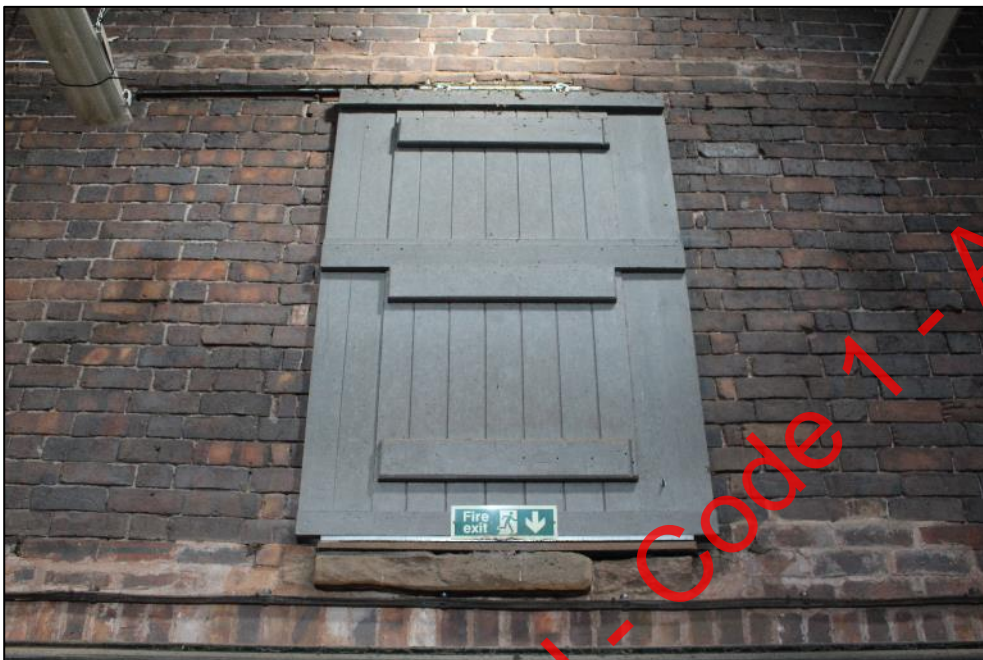
Plate 197: The first-floor window in the northern wall of Building 6.

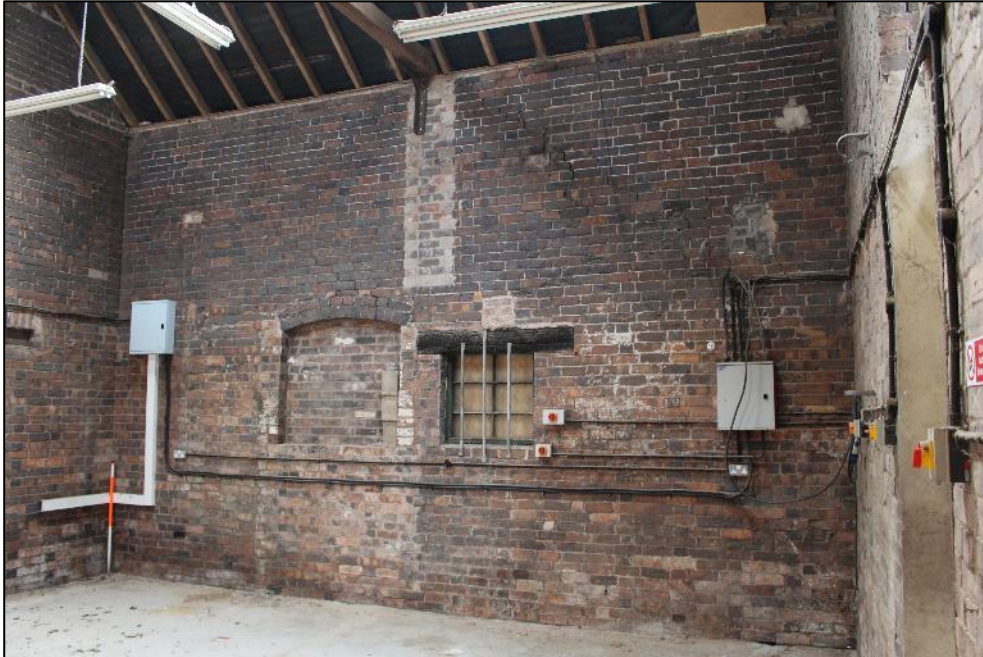
198) are two blocked features. The northern one being the window visible on the external elevation, and the southern being a former window with a timber lintel (**Plate 199**). This window's timber frame remains intact, and is a six-light window. On the southern wall (**Plate 200**) are a series of joist holes in each of the stub walls, from the mezzanine that has been inserted in the southern end of this building. On the western wall (**Plate 201**) are the internal remains of the infilled window, and a long brick corbel above (**Plate 202**) carrying the weight of the roof truss.

Plate 198: The eastern wall in the northern half of Building 6.

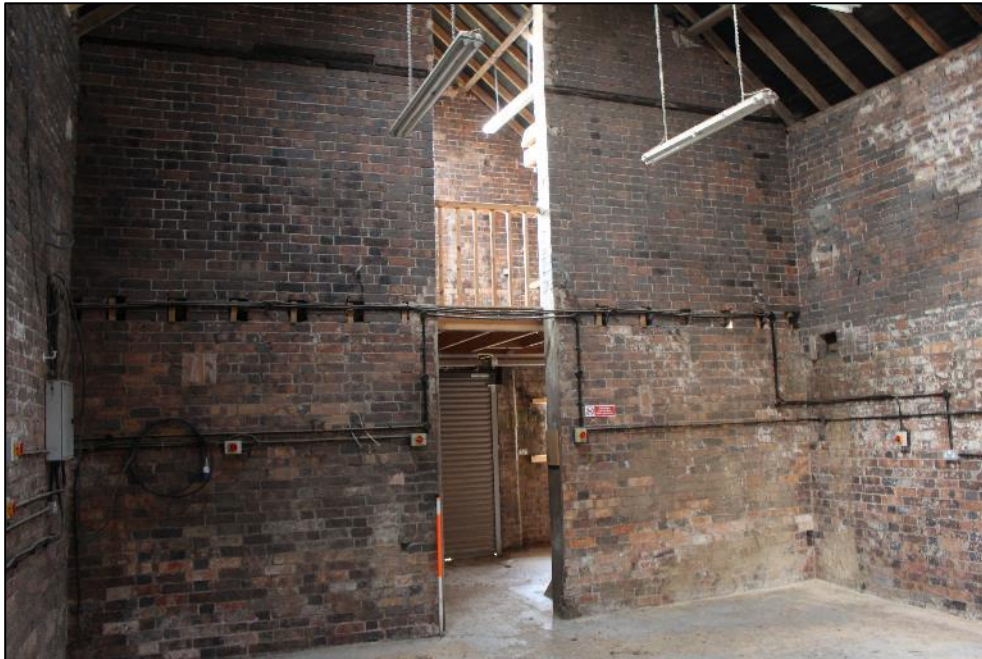
Plate 200: The dividing wall in the centre of Building 6, viewed from the northern half of the building.

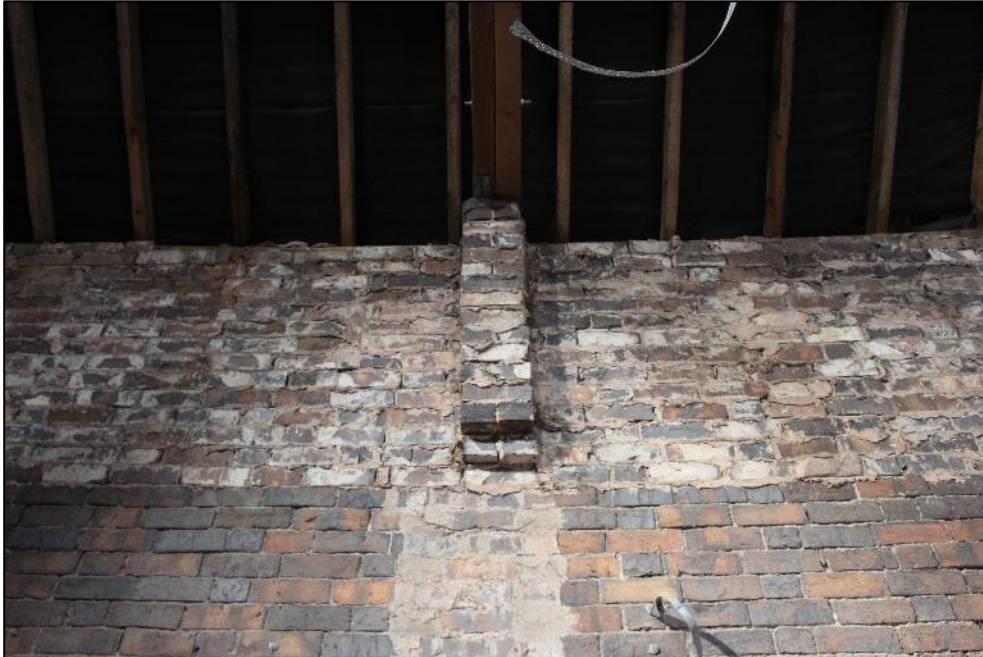
Plate 202: The brick corbel in the western wall of Building 6.

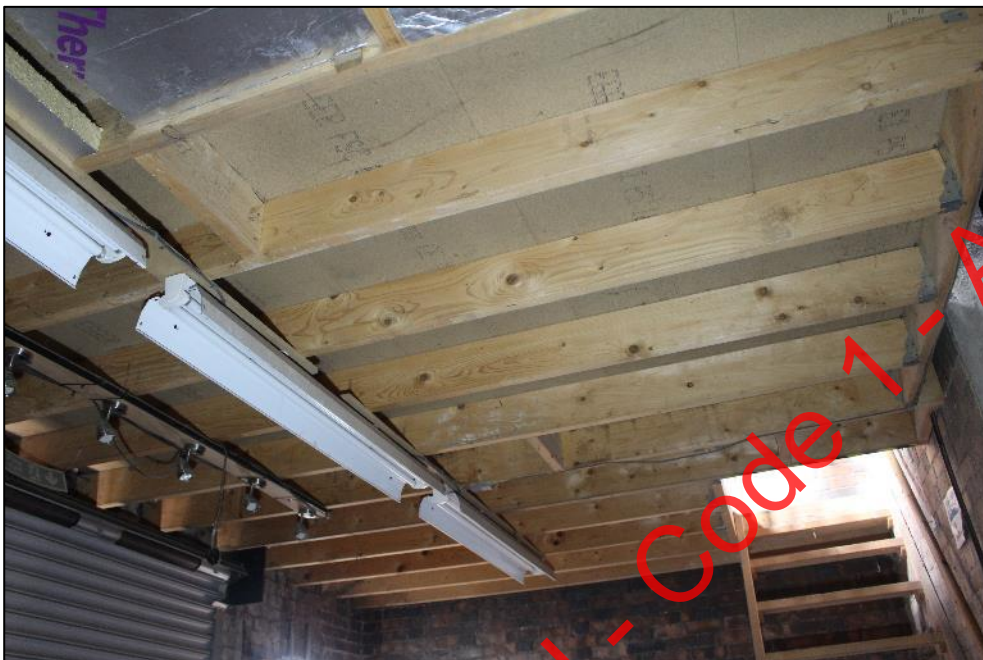
- 5.8.8 The southern section of the barn consists of an empty ground floor level, with no features of note, and an upper mezzanine level. This mezzanine has been constructed with modern timbers (**Plate 203**), most likely dating to the 20th or 21st century, and has a small office built at first floor level, on its eastern side (**Plate 204**).

Plate 203: The floor of the inserted mezzanine in the southern half of Building 6.

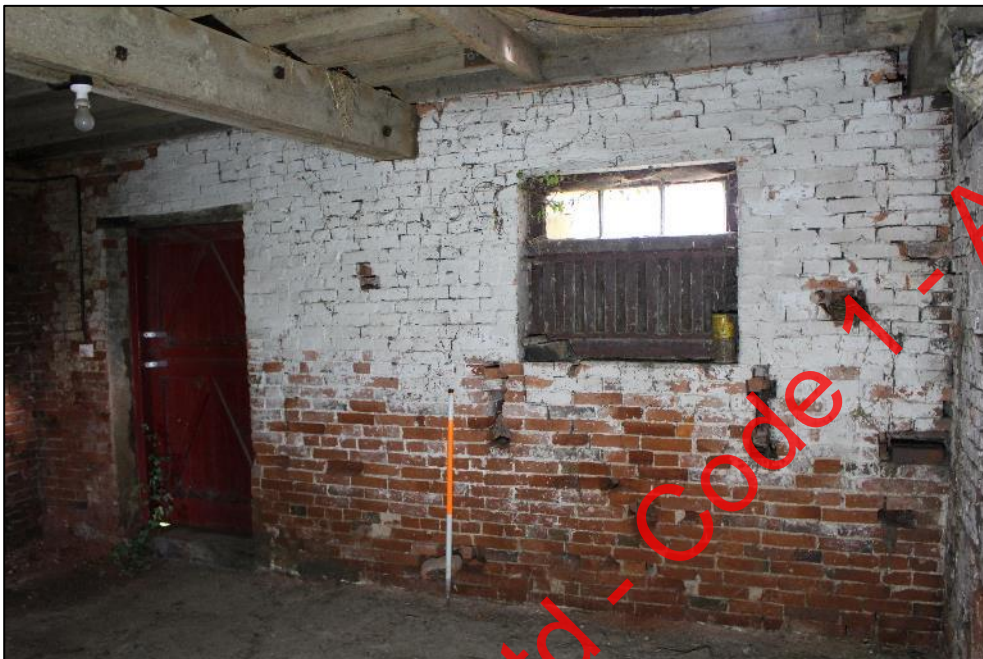
5.9.10 The eastern room contains very few features of note. In the eastern wall (**Plate 219**) it is possible to see, in more detail, the timber louvred window and the details of the timber braced and ledged stable doorway. Two more ventilation slits, much smaller in size to those found on the northern and southern elevations, can be seen below the window. These have been obscured by vegetation externally, and have been infilled with brick. It is possible to see the full extent of the infilled vents in the southern elevation (**Plate 220**) here. Above are the two square vents, with timber framed surrounds and remnants of former sliding shutters (**Plate 223**). In the centre of the elevation is another square feature that has been infilled with brick. This is not visible on the external elevation but may be another former vent. These square features are mirrored on the northern wall (**Plate 222**). The timber floor of the mezzanine above is visible from this space and is supported on three timber joists. In the south eastern corner of the mezzanine a circular hole has been cut (**Plate 224**). This is likely evidence of a former grain hopper, or was simply for the movement of goods between these floors.

Plate 219: The eastern wall in the eastern room of Building 7.

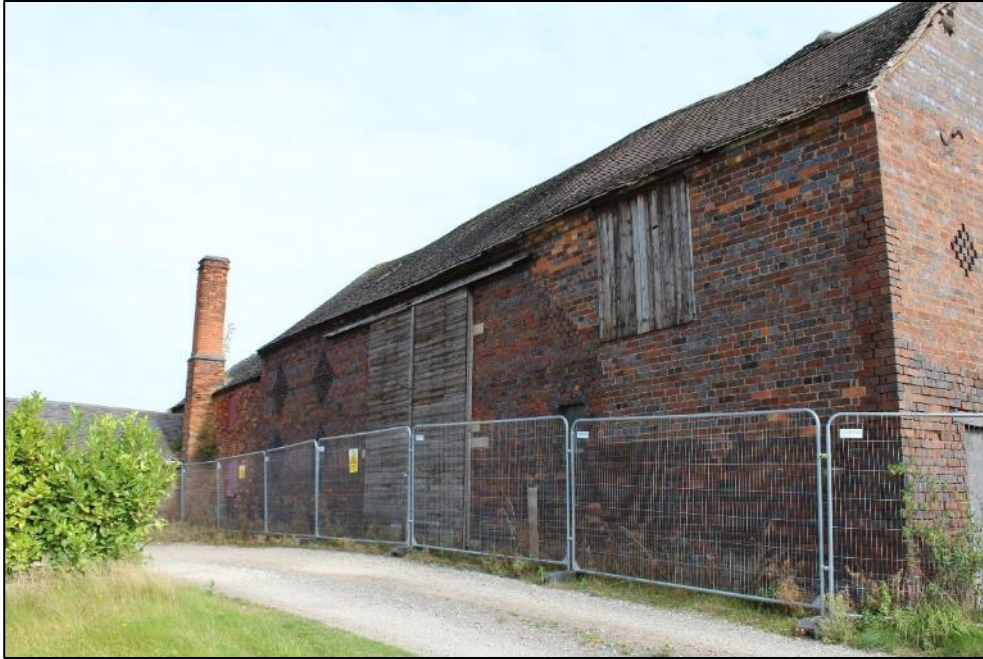
5.9.11 Building 8 (**Figures 25 and 26**) is the large barn occupying the western side of the U-shaped courtyard (**Plate 225**). This building is abutting Buildings 7 and 10, both of which appear to pre-date this barn. Prior to this assessment the roof, and the upper sections of the southern and western walls, had been removed due to their unsafe nature. Some photographs were taken as part of the preliminary works, and are included in the Method Statement (1EW04-LMJ-DJV-EV-MST-NS06_NL16-029004, 2020). This building is of a combination of red and blue brick in an English garden wall bond, and was formerly covered with a pitched roof, with Staffordshire blue clay tiles.

Plate 225: Building 8 prior to its partial demolition. Photograph taken by DJV before partial demolition.

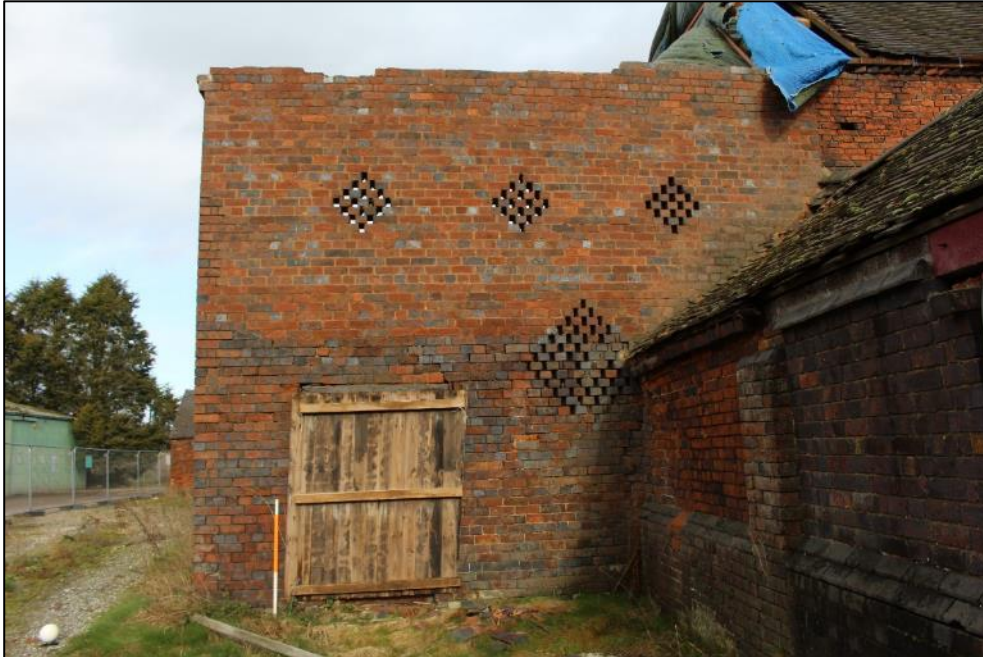
- 5.9.12 The southern elevation of the barn (**Plate 226**) has been partially obscured, on its eastern side, by the later addition of Building 11. At first floor level are three diamond shaped panels of ventilator brickwork (**Plate 227**). Another one is also situated at ground floor level; this is larger and in the centre of the elevation. At first floor level the brickwork has been repointed. On the western side of the elevation is a doorway opening with a timber lintel, that has now been blocked with what appears to be a wooden fence panel.

Plate 226: The southern elevation of Building 8.

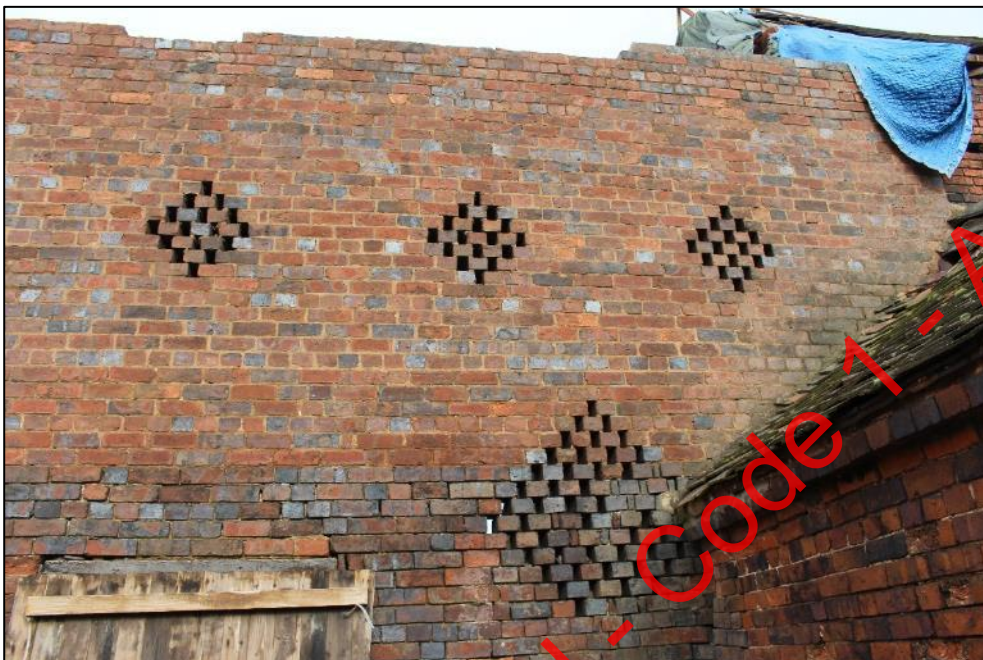
Plate 227: The diamond shaped ventilator brickwork in the southern elevation of Building 8.

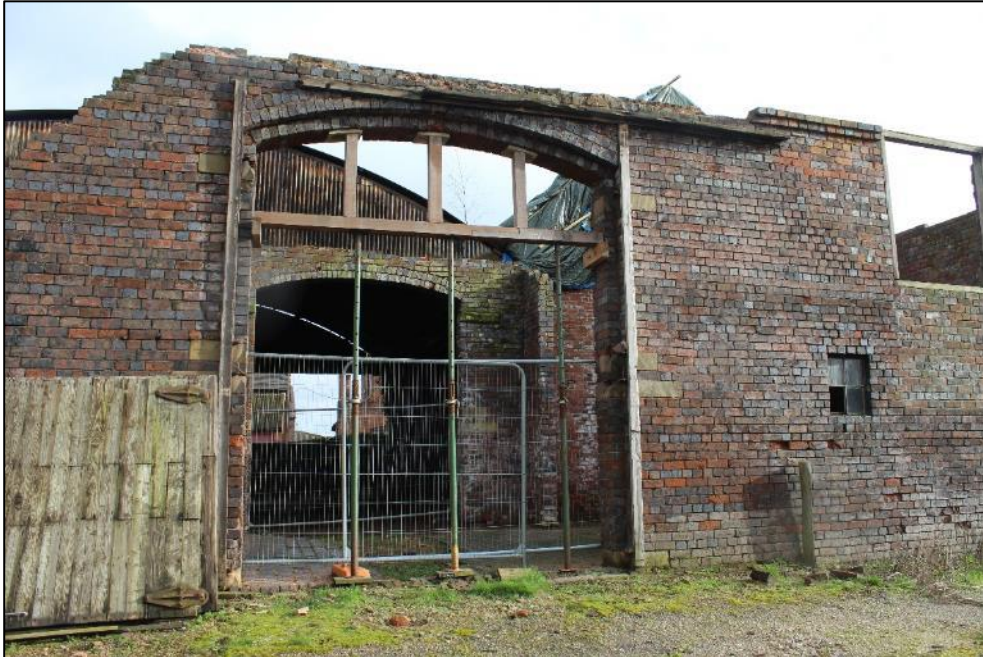
- 5.9.13 The long western elevation of the barn consists of three bays. The elevation is also of a combination of red and blue brick, and is topped with a brick cornice. In the central bay (**Plate 228**) is a large doorway that is covered with a brick segmental arch (**Plate 229**), now supported by modern timbers, likely inserted after the building was partially demolished. Formerly, this doorway was obscured by a sliding timber doorway. In the doorway jambs are three sets of sandstone blocks, where pintels have been set to support a former hinged doorway. Due to the positioning of this door, it is likely that it was formerly used a cart entrance. The southern bay (**Plate 230**) contains a small, four paned, fixed light windows, with timber glazing bars (**Plate 231**). Above this is a large pitching hole, or first floor goods entrance, that is timber framed. The northern bay (**Plate 232**) contains two more diamond shaped panels of ventilator brickwork. To the north of this is a clear building break, dividing this elevation with the western elevation of Building 10.

Plate 228: The western elevation of Building 8.

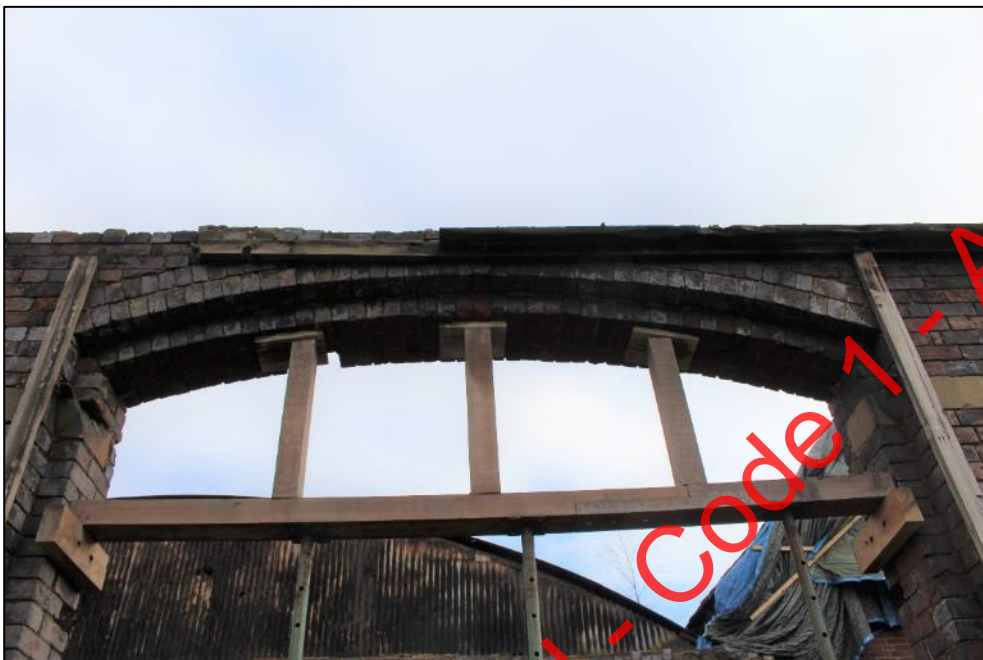
Plate 229: The arch above the central doorway in the western elevation of Building 8.

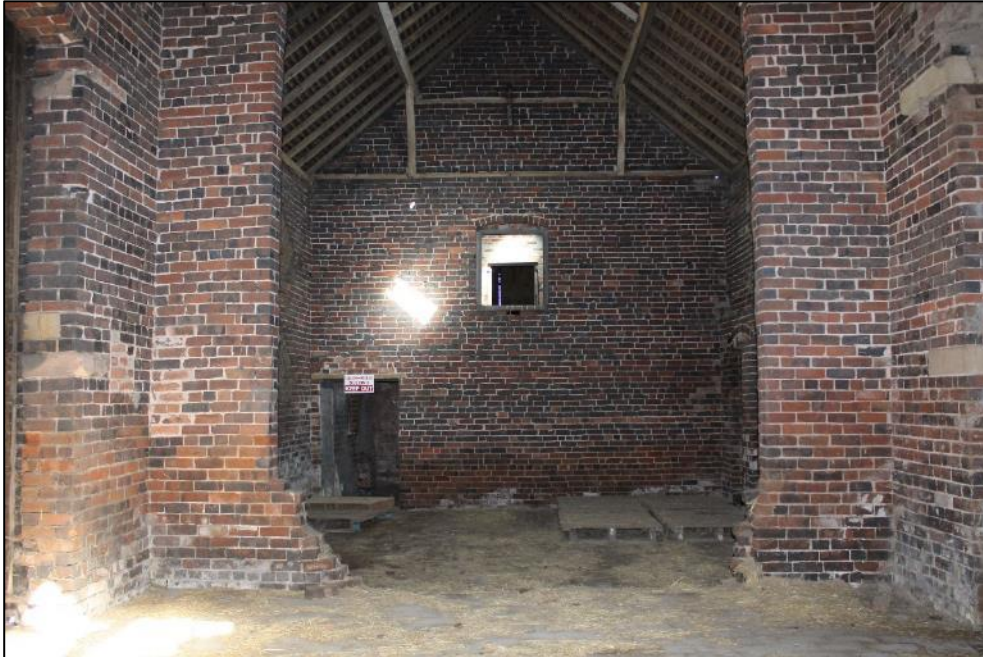
- 5.9.16 Photographs taken prior to the demolition reveal the links this building had with Building 10 to the north (**Plate 236**). The northern wall contained a raised pitching hole, that was timber

Plate 236: The interior of Building 8 prior to demolition, facing north towards Building 10. Photograph taken by DJV.

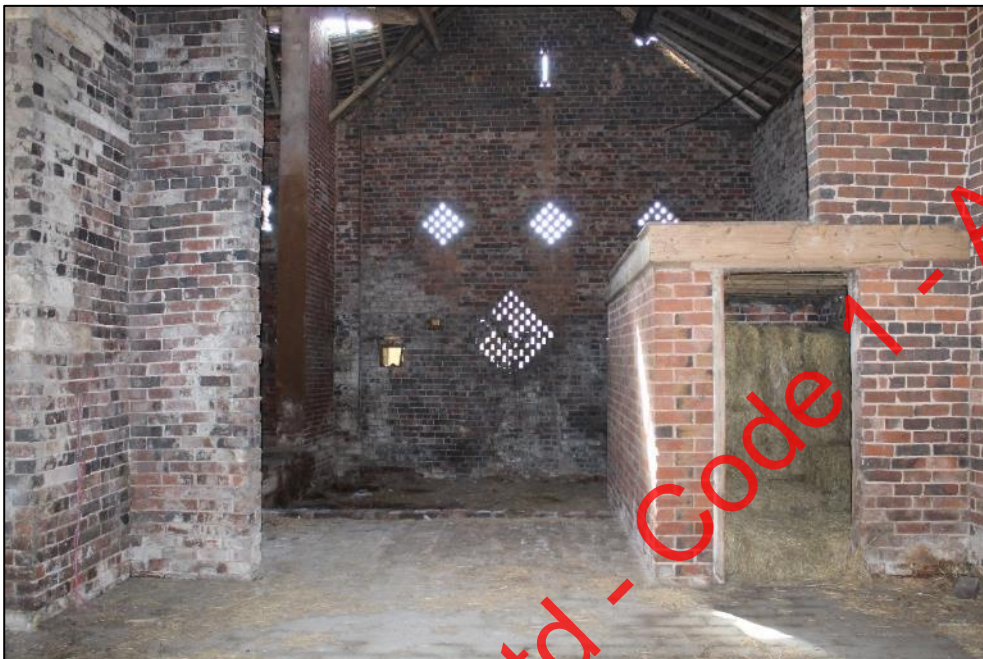
- 5.9.15 The interior of Building 8 (**Plates 236-239**) was deemed unsafe to access at the time of this assessment. Despite this, some observation of the interior was possible from the western gable end of Building 7, that adjoins Building 8 in its south eastern corner. Internally the floor surface is of brick, with two brick stub walls on both the eastern and western walls that define the three bays. Between the central and southern bays is a small brick shed (**Plate 237**), with a timber roof. This was likely incorporated into the building as a storage space. On the southern wall (**Plate 238**) the timber framed doorway is fully visible. This is a wooden plank door and set within a wooden frame. To the east of this is a small alcove. This may have been a former window that has now been blocked by the addition of Building 11.

Plate 237: The interior of Building 8 prior to demolition, facing south. Photograph taken by DJV.

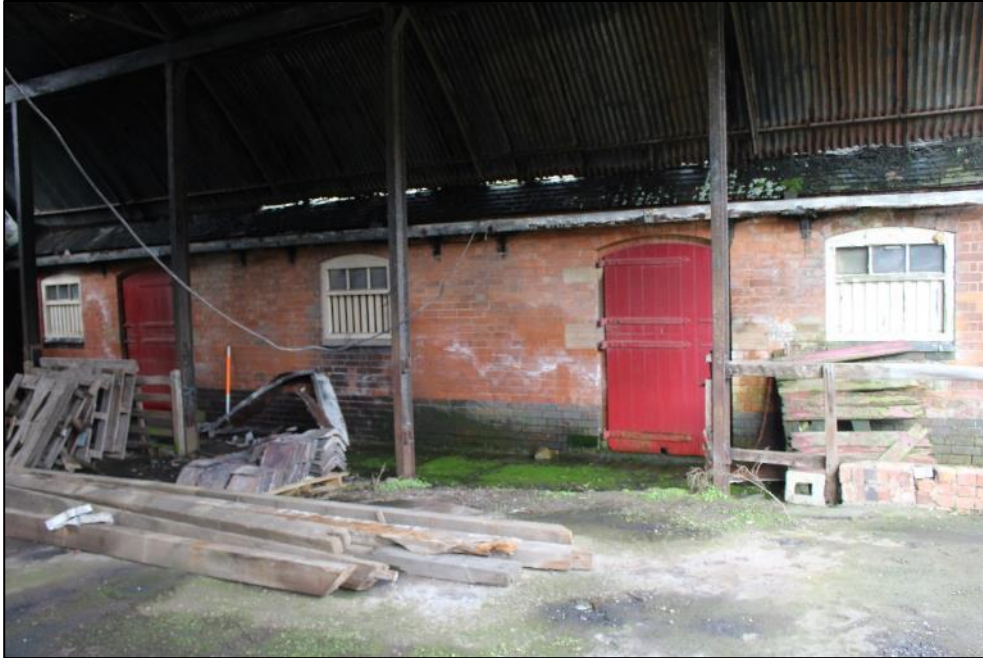
- 5.9.18 The southern elevation of this building (**Plate 240**) is of five bays, and faces into the covered courtyard area. The bays here are defined by alternating windows and stable doorways. There are three windows in total, all of which are timber louvred windows (**Plate 242**) with three light panes above, and chamfered blue brick sills. The doorways (**Plate 241**) are wooden plank construction that are braced and ledged. These hang on large iron strap hinges, with iron pintels and iron latches and fasteners. All of this doorway furniture is attached to sandstone blocks set within the brickwork.

Plate 240: The southern elevation of Building 9.
