WP 029 D – Bucks Head Farm – Enabling Works North Contract Report for Historic Building and Setting Recording

Document Number: 1EW04-LMJ-EV-REP-NS06_NL16-029018

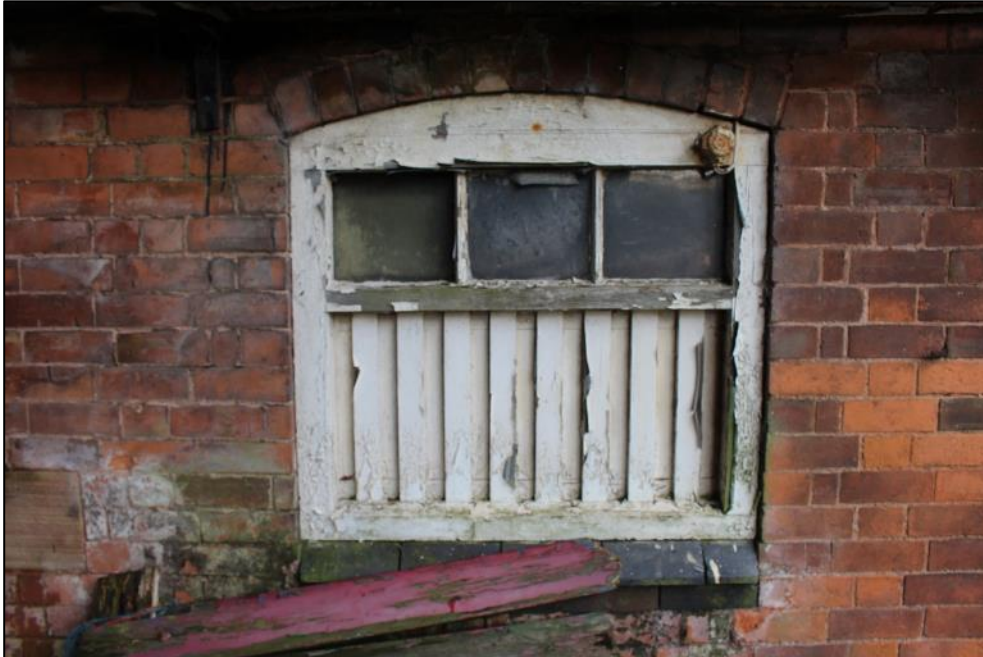
- 5.9.18 The southern elevation of this building (**Plate 240**) is of five bays, and faces into the covered courtyard area. The bays here are defined by alternating windows and stable doorways. There are three windows in total, all of which are timber louvred windows (**Plate 242**) with three light panes above, and chamfered blue brick sills. The doorways (**Plate 241**) are wooden plank construction that are braced and ledged. These hang on large iron strap hinges, with iron pintels and iron latches and fasteners. All of this doorway furniture is attached to sandstone blocks set within the brickwork.

Plate 242: One of the louvred windows in the southern elevation of Building 9.

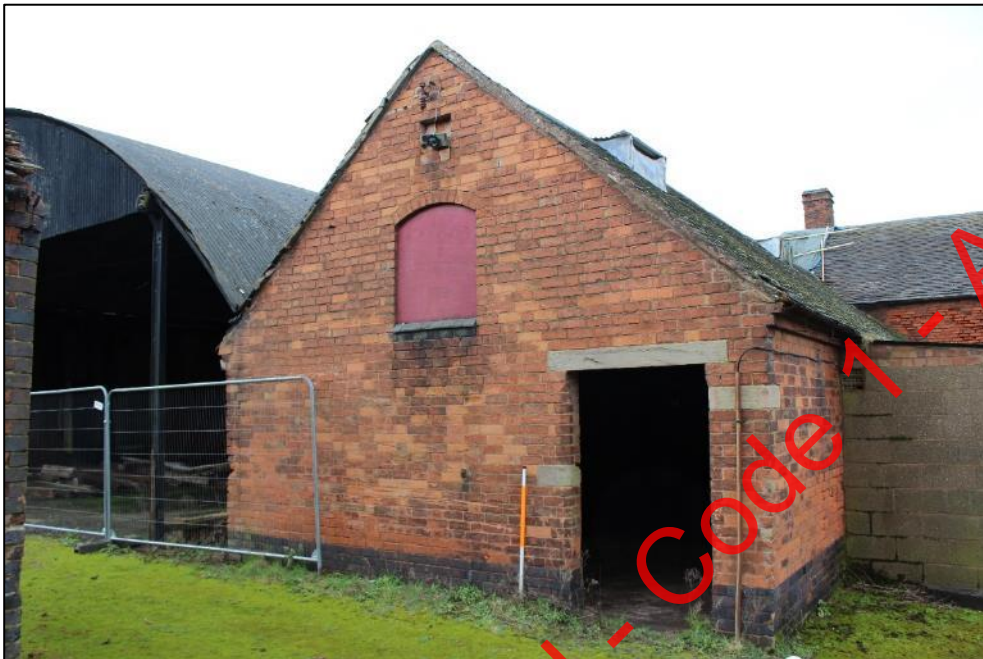
- 5.9.19 The eastern elevation (**Plate 243**) of the building contains a doorway at ground floor level, with a pitching hole above. The doorway has a large sandstone lintel with chamfered brick jambs within which sandstone blocks have been inserted, that likely held former pintels. In the centre of the elevation is the pitching hole (**Plate 244**). This has a segmental brick arch, a chamfered blue brick sill, and has been blocked with a timber panel. Above this, in the apex of the gable, is a recessed feature now obscured by a security camera. This may have been a date stone, as it is similar in size to the date stones found on Buildings 1 and 12.

Plate 243: The eastern gable end of Building 9.

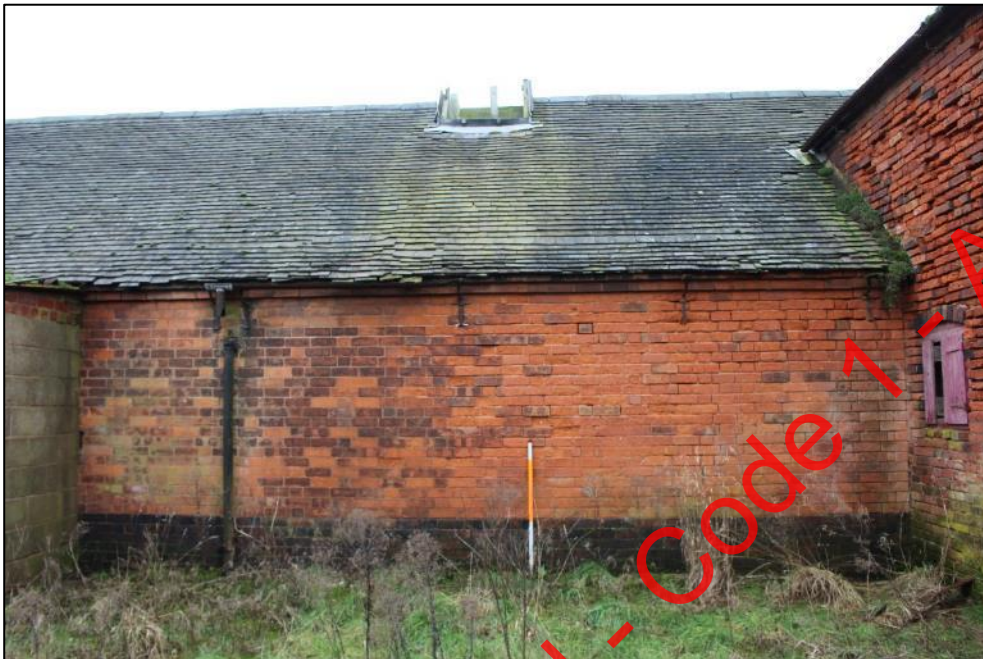
- 5.9.20 The northern elevation (**Plate 245**) of Building 9 is plain. The only notable feature here is the breezeblock extension on the elevations eastern side (**Plate 246**).

Plate 245: The western end of the northern elevation of Building 9.

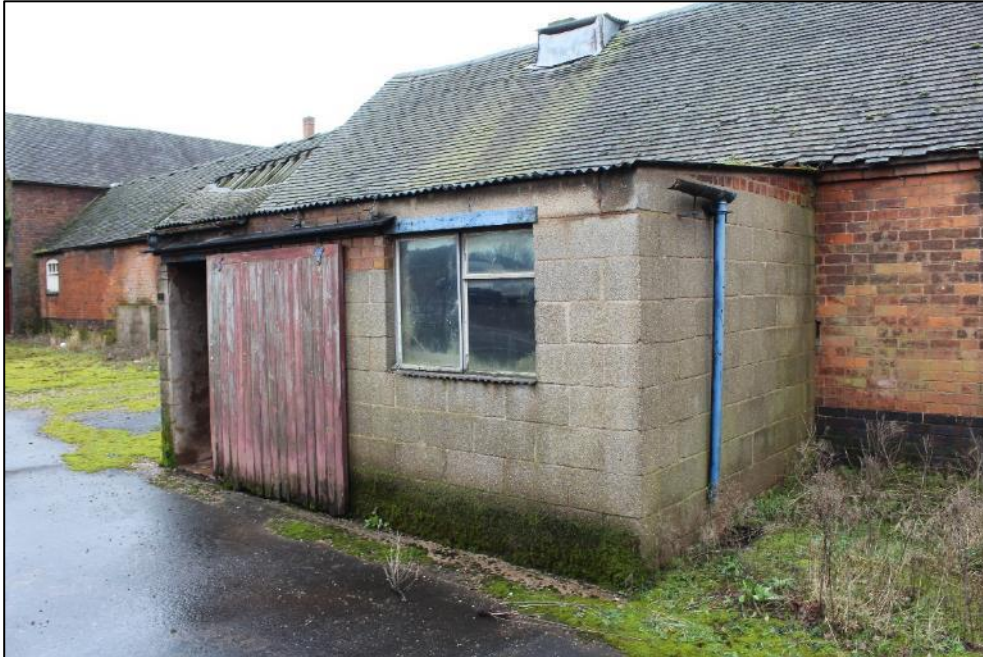
Plate 246: The breezeblock lean-to at the eastern end of the northern elevation of Building 9.

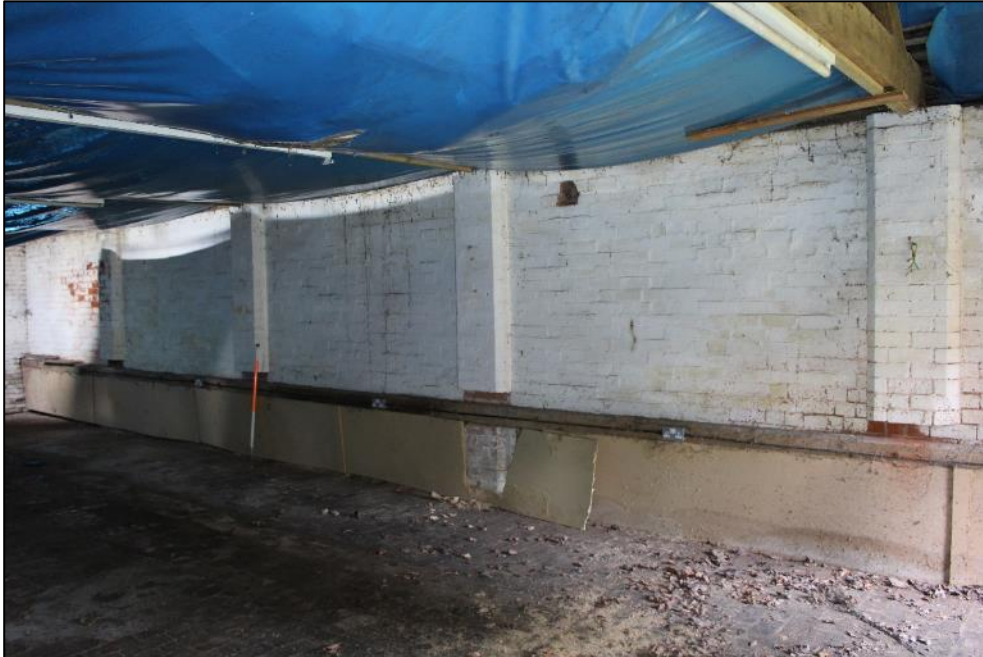
- 5.9.21 The interior of Building 9 (**Plates 247-252**) consists of a single open rectangular room, with whitewashed brick walls and a blue brick floor. Along both the northern (**Plate 248**) and southern (**Plate 251**) walls is a series of internal brick pilaster buttresses. These have been broken on the northern wall by a long strip on timber, that has been boarded below. It is possible that this relates to a former fixture along this wall, such as a feeding trough. The floor

Plate 248: The northern wall in Building 9.

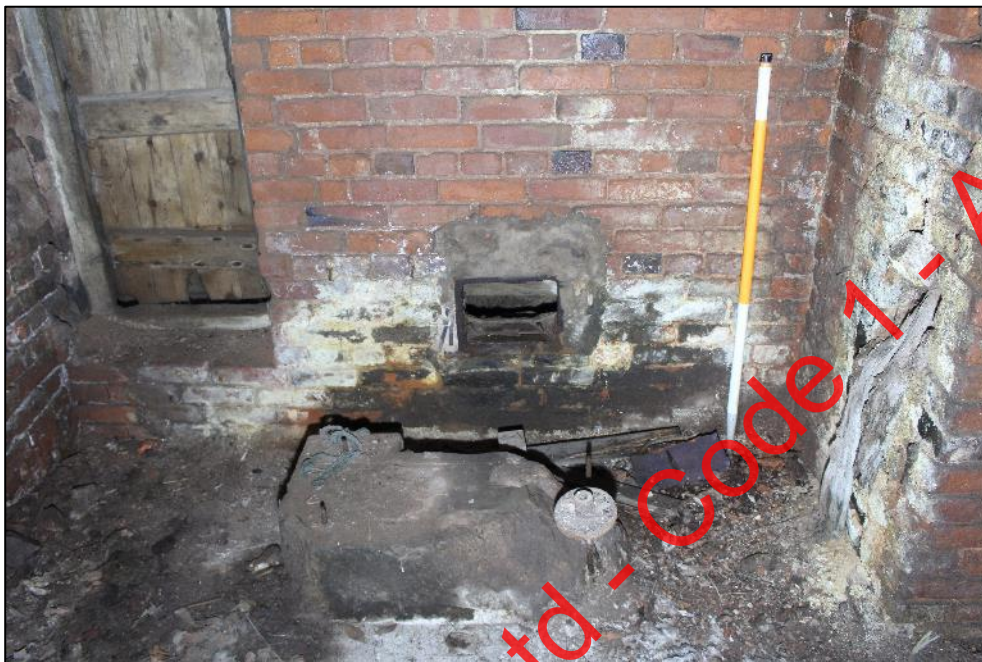
evidenced by clear breaks in the brick coursing around its southern side. Between the door and the furnace to the south is a small square aperture at ground level (**Plate 270**), this is most likely a vent. The brickwork on this western wall shows some other signs of phasing. Below the gable the wall appears to contain an extra skin of brickwork (**Plate 271**), most likely as extra strength to this wall that carries the weight of the chimney. Within this upper gable is the remains of another former aperture that has been infilled (**Plate 271**). This was also probably a vent. The doorway in the western wall of this room has a timber lintel, and an iron pintel on its northern side. The floor surface in this room is of exposed earth.

Plate 270: The low vent in the eastern wall of the eastern room of Building 10a.

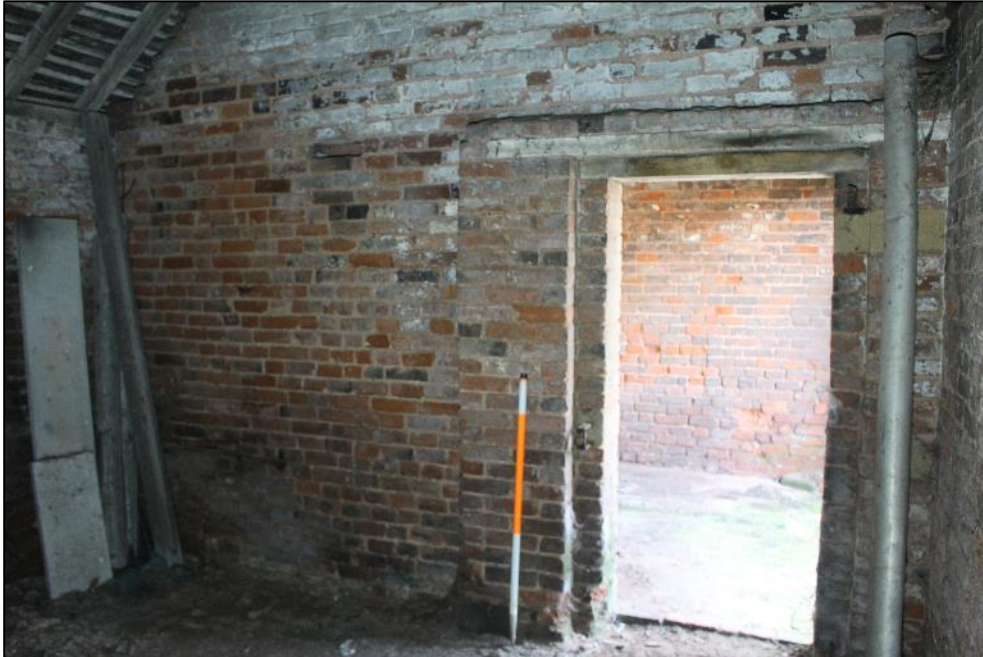
- 5.9.29 The interior of Building 10a has been split into two rooms that are separated by a brick wall, with a doorway opening connecting the two (**Plate 273**). The timber roof structure is exposed here and contain no trusses. Instead, the roof is being supported on the central brick wall.
- 5.9.30 In the eastern room (**Plates 268-273**) is the remains of a large brick furnace (**Plates 268 & 269**), with a fire pit below and covered with a segmental arch opening. This is attached to the south eastern corner of the room, where the external stack is. To the north of this is a narrow doorway (**Plate 268**) that leads up into the barn. This contains a pegged timber frame and a ledged doorway. The doorway seems to be a later addition to this wall of the smithy,

Plate 273: The western wall in the eastern room of Building 10a.

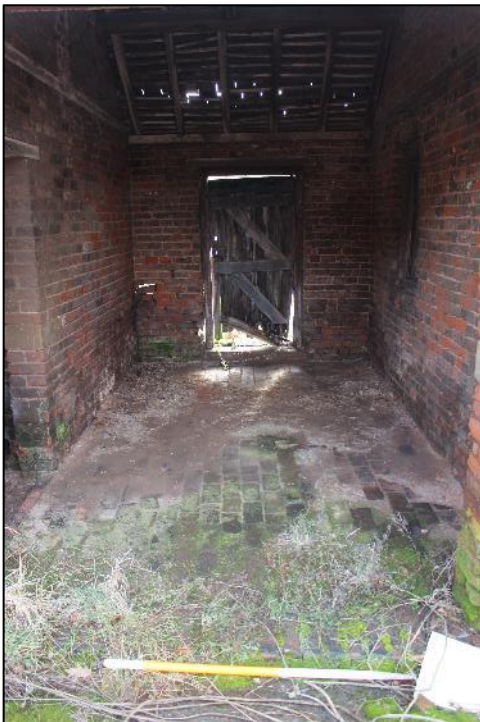
- 5.9.31 The large opening on the northern elevation of Building 10a leads into the western room (**Plate 274**). From within this room the timber doorway and window (**Plate 275**), in the southern and western walls respectively, are visible. The floor surface here has been laid with brick.

Plate 274: View south of the western room of Building 10a.

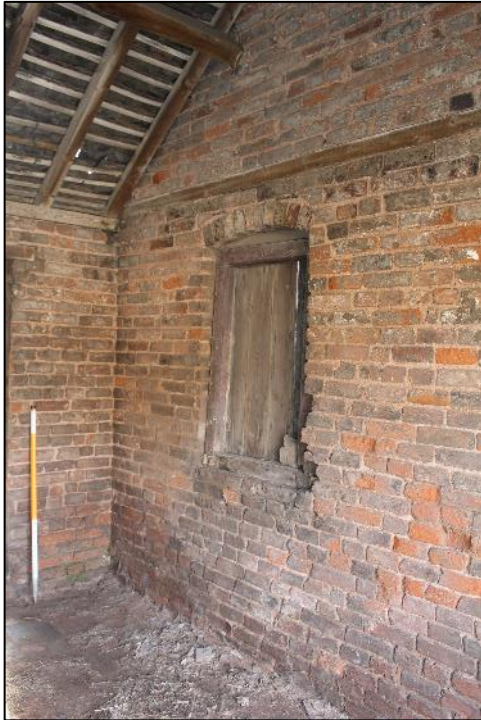
Plate 275: The western wall in the western room of Building 10a.

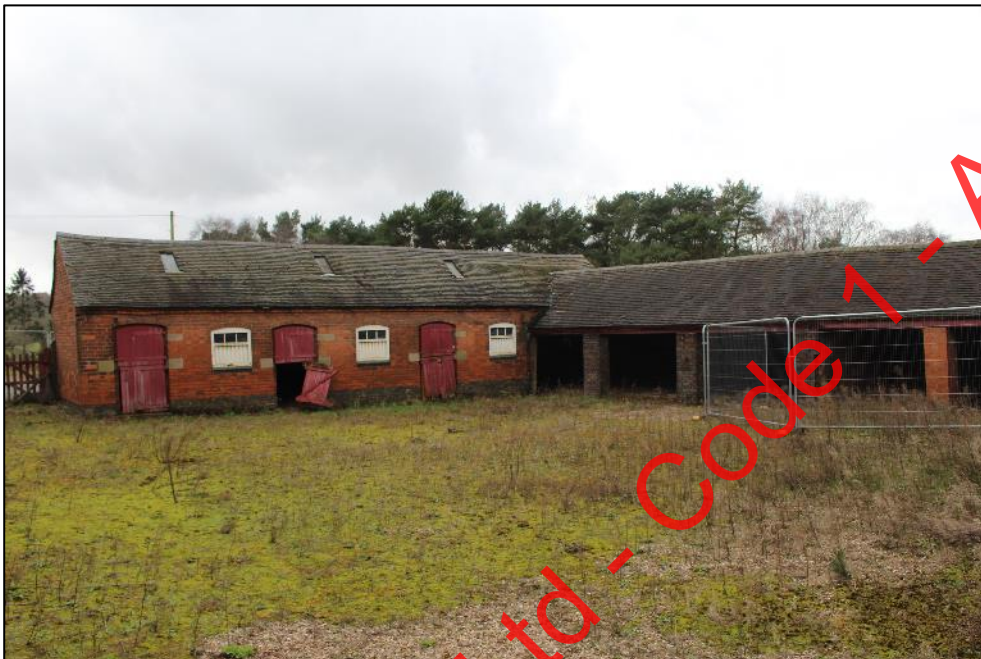
- 5.9.33 Buildings 11 and 12 (**Figures 25** and **26**) are the later additions to the western complex of agricultural buildings (**Plate 278**). Building 11 is abutting Building 7 on its southern side, and was likely originally used as an open cow shed. This building pre-dates Building 12, that becomes visible on historic mapping between 1884 and 1902, corresponding to the date inscribed on the datestone. All of these date to the 19th century. These buildings are L-shaped in form and are constructed of red and blue brick in a Sussex bond, with pitched clay tile roofs and ridge tiles. On the northern side of the roof there have been three skylights inserted. The western range consists of an open fronted cow shed or stable, and the southern range consists of three enclosed stables. On the elevations facing inwards, towards the farmyard, the bottom four or five courses of brick are entirely blue and resemble a plinth. At the top of the elevations, below the eaves, are courses of a protruding brick cornice.

Plate 278: View of Buildings 11 (to the right) and 12 (to the left).

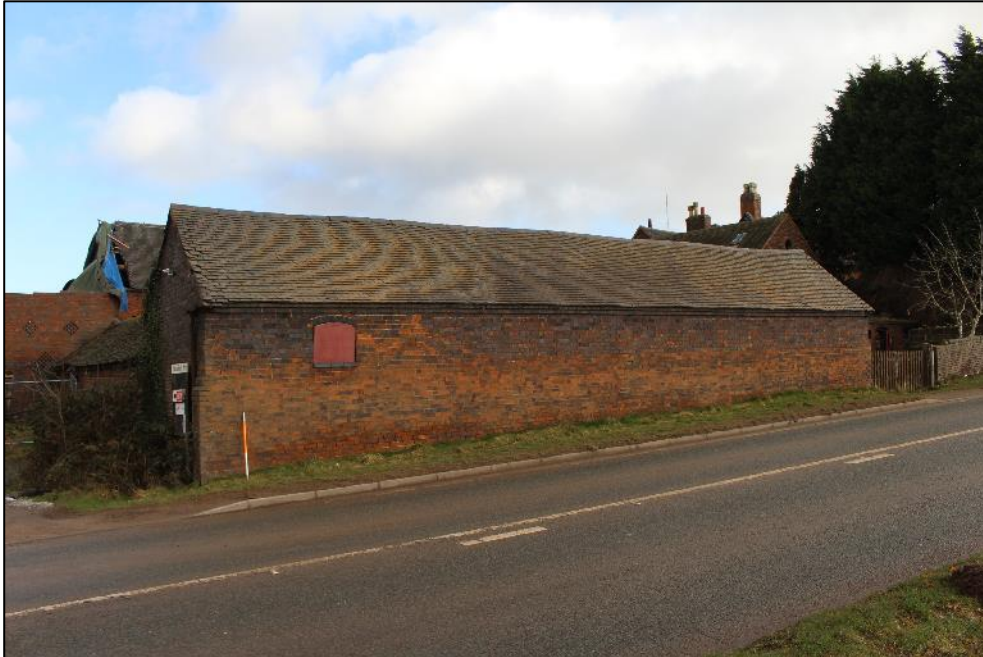
- 5.9.34 The southern elevation (**Plate 279**) of Building 12 faces onto the main road (Watling Street/Rock Hill) and is featureless, apart from a single raised window at the western end. This is a small window (**Plate 280**) that has been boarded, with a segmented brick arch above and a chamfered sill.

Plate 279: The southern elevation of Building 12, facing onto the main road.

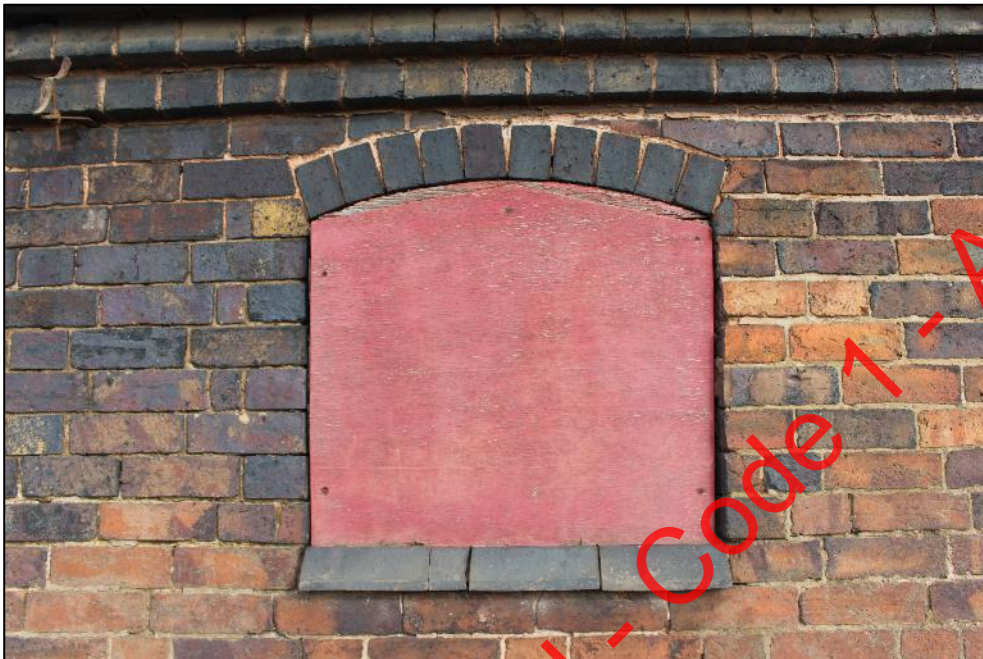
Plate 280: The window in the southern elevation of Building 12.

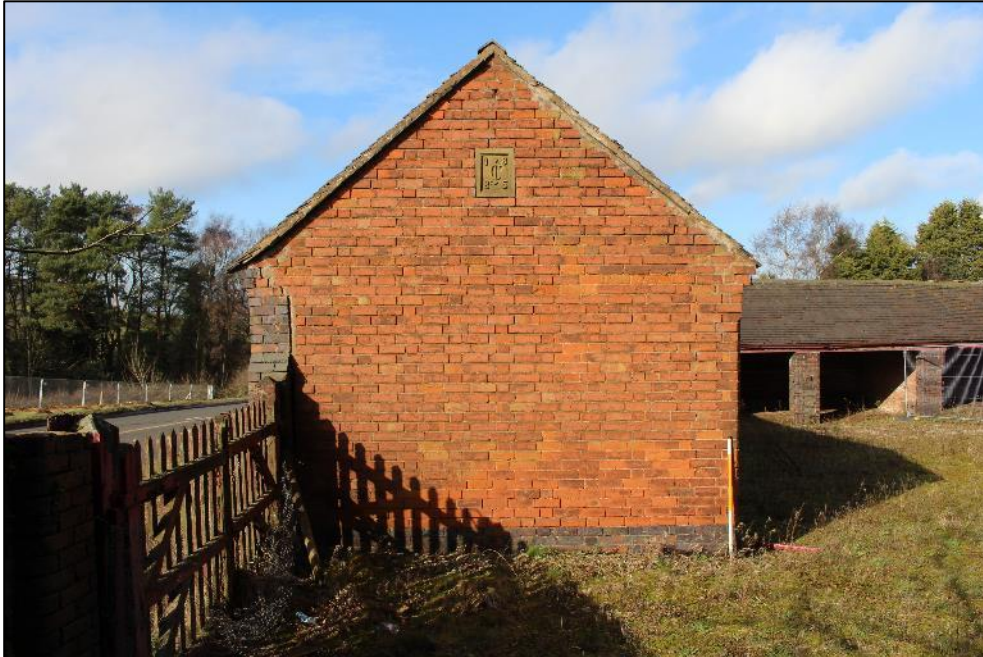
- 5.9.35 The eastern gable end (**Plate 281**) of Building 12 is relatively plain. The only feature of note here is the datestone in the centre of the gable (**Plate 282**). This contains an initial 'JC' (for James Chadwick) and the date '1885'. On the southern end of this elevation is a blue brick buttress, to which a timber gatepost has been affixed (**Plate 283**). The brick on the north eastern corner of the building has been chamfered.

Plate 281: The eastern gable end of Building 12.

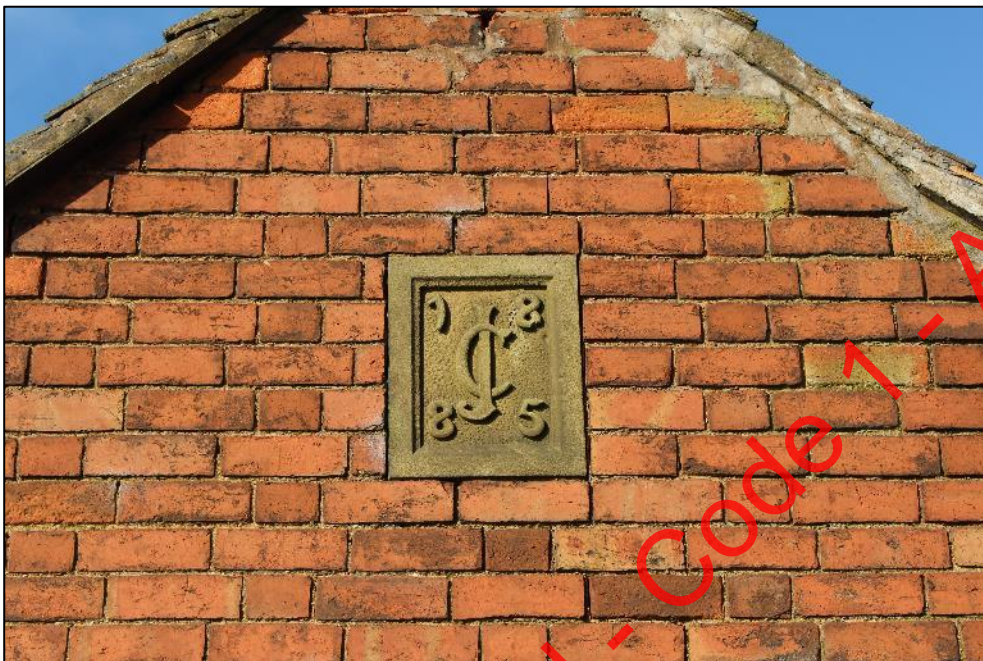
Plate 282: The date stone in the eastern gable end of Building 12.

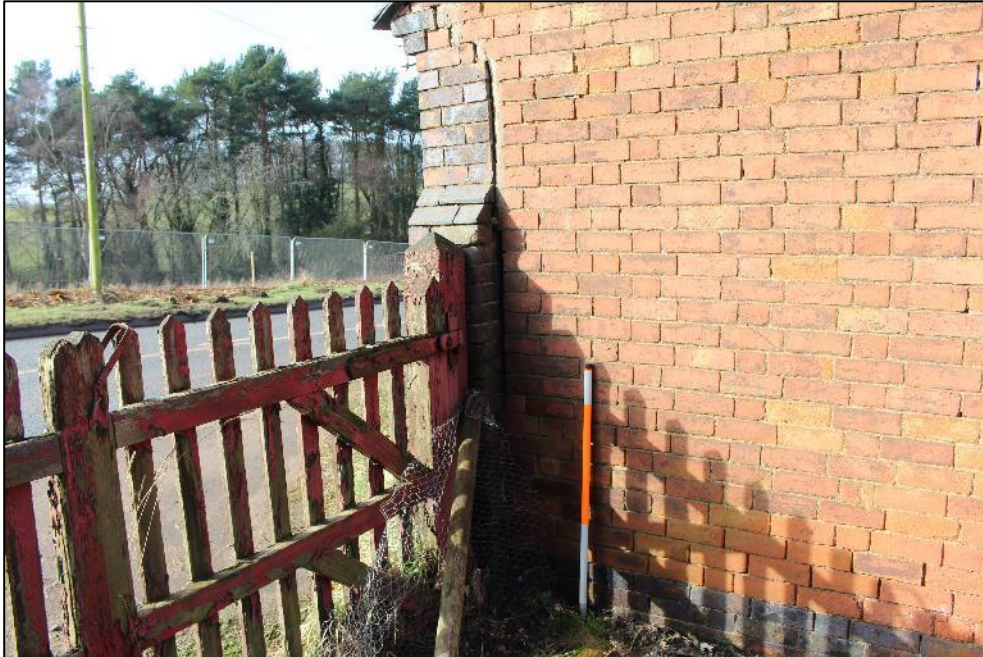
Plate 283: The gatepost attached to the eastern gable end of Building 12.

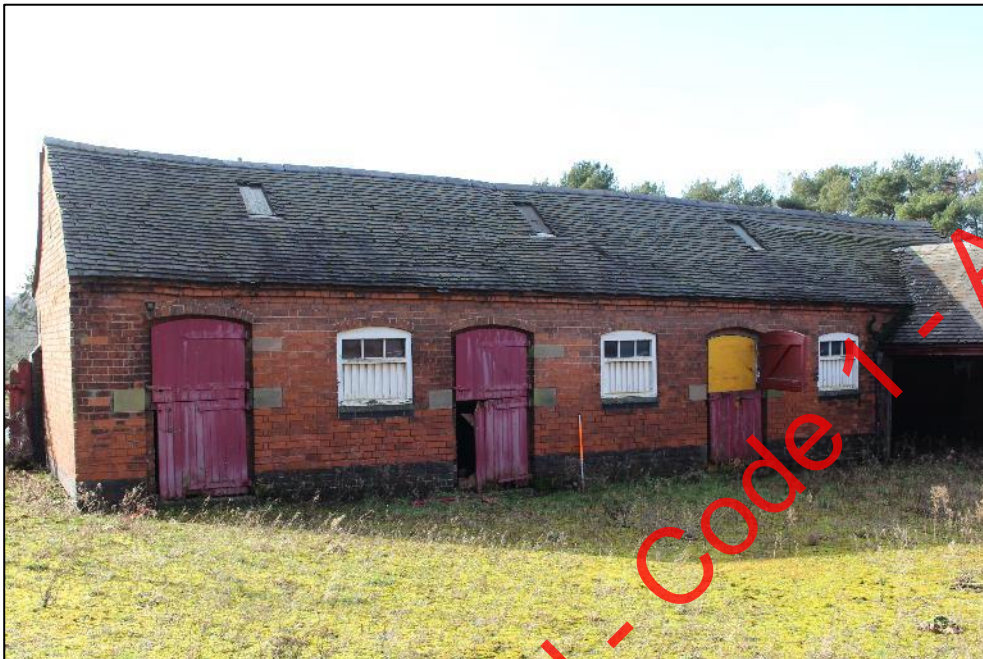
- 5.9.36 The north facing elevation (**Plate 284**) Building 12 is of six bays, defined by alternating doorways and windows. There are three doorways in total. All of these are timber panelled stable doors (**Plate 286**) on iron strap hinges, with iron pintels, latches and fasteners. Like the rest of the doorways in this barn complex, the pintels and latches are set within large blocks of sandstone. Between these doorways are louvred windows (**Plate 285**), with three light panes above, and chamfered sandstone sills. All of the apertures have been covered with segmented arches of brick.

Plate 284: The northern elevation of Building 12.

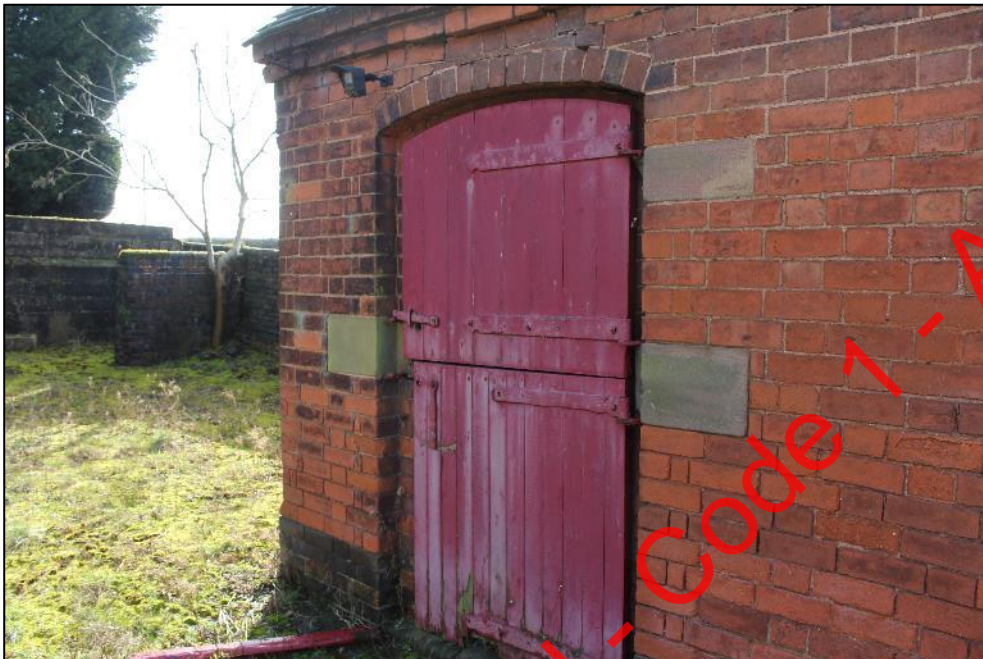
Plate 286: One of the stable doors in the northern elevation of Building 12.

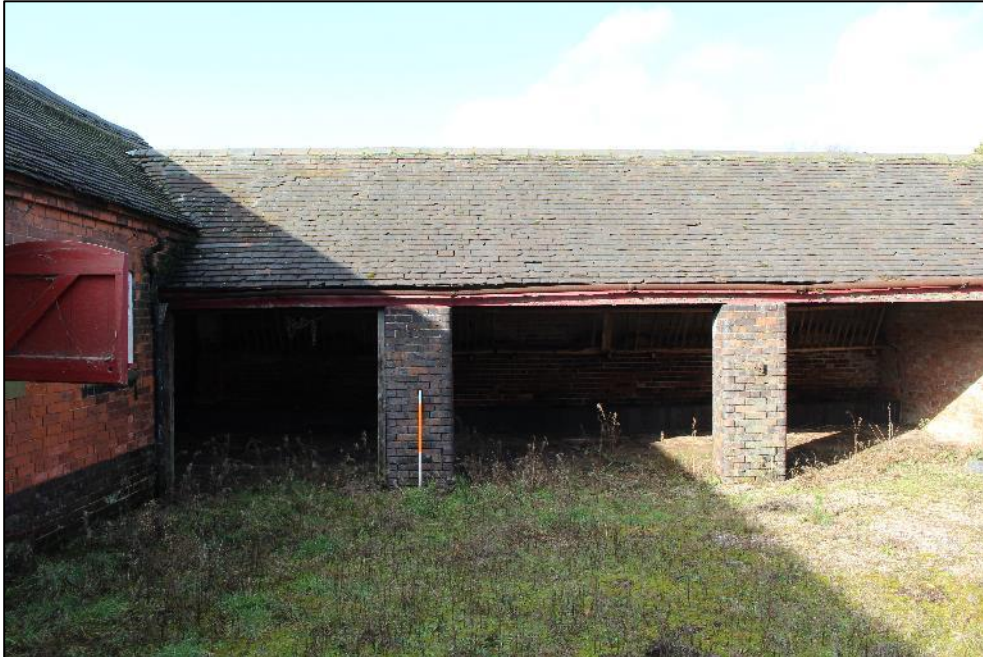
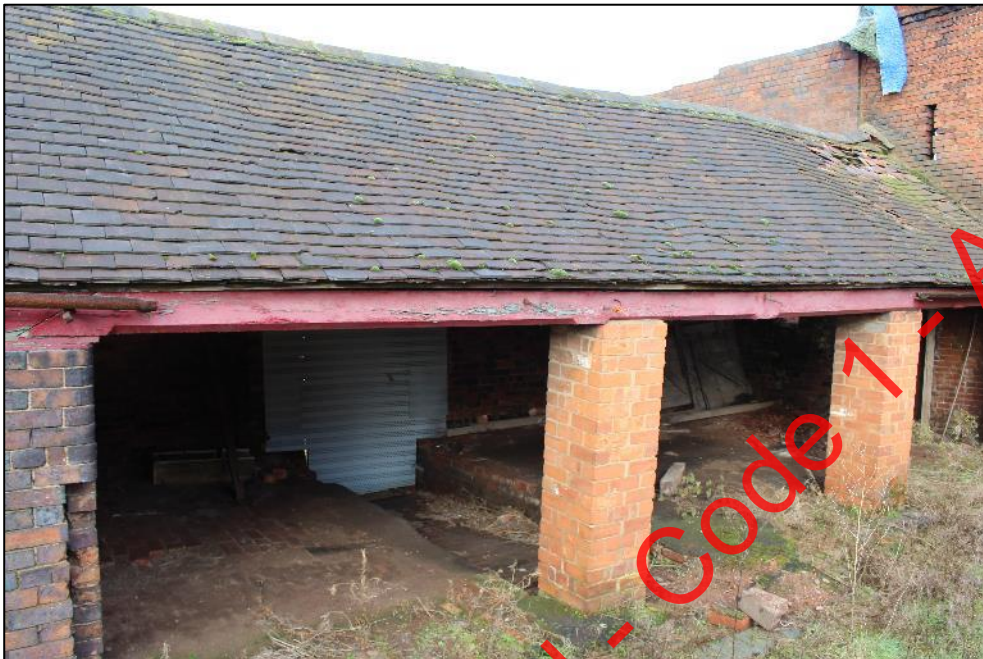
- 5.9.37 The east facing elevation (**Plates 287 & 288**) of Building 11 is of six bays and is open-fronted. This building is slightly smaller in size when compared to Building 12. Each of these six bays are defined by a large opening supported by timber lintels decorated with a simple stop chamfer and separated by brick pillars, with rounded edges. The southern three of these pillars are of blue brick, and the northern two are of red brick. The red brick pillars do not have rounded/chamfered corners and do not align with the position of the openings, marked by the end of the decorative chamfer, and the southernmost red brick pillar cuts the alignment of the path leading to the door in the western elevation. The red brick pillars are therefore most likely later replacements, probably of former iron columns similar to those that have been used to support the open, southern elevation of the late-19th/early-20th century cart shed situated within the south-western extent of the Site (**Plates 313 and 314**).

Plate 287: The southern side of the eastern elevation of Building 11.

Plate 288: The northern side of the eastern elevation of Building 11.

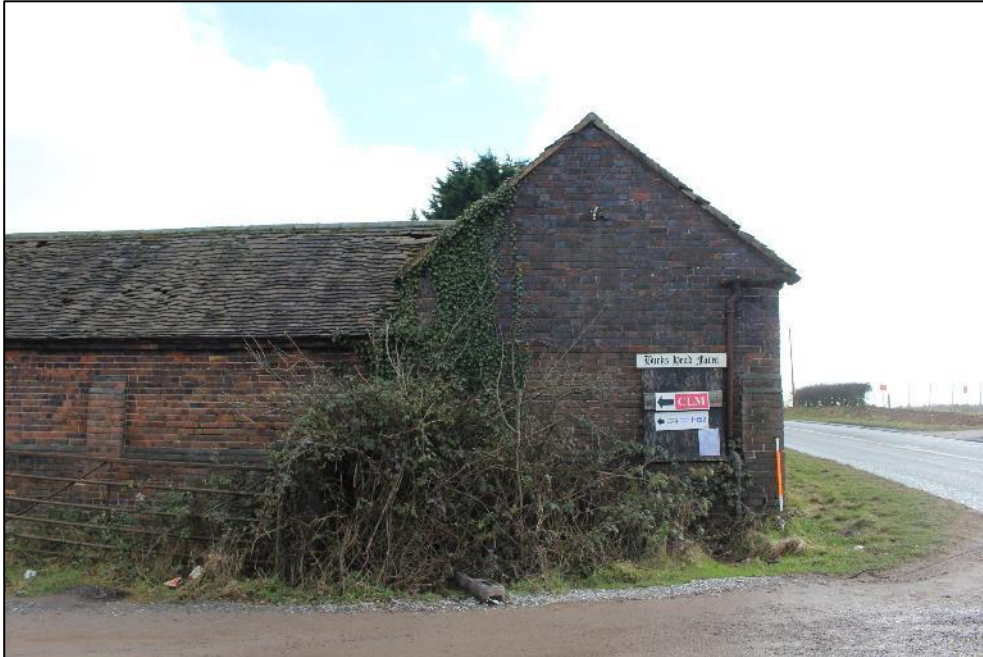
- 5.9.38 The western elevation (**Plates 289-294**) of the buildings consists of the western gable end of Building 12 to the south, and the long western wall of Building 11. These face onto the access road leading into the farmstead. Building 12's gable end (**Plate 289**) does not contain any features of note, apart from a single brick buttress on its southern side. This elevation is made entirely of blue brick. The long elevation on Building 11 contains two buttresses on its southern side (**Plate 290**), with a timber doorway on the north side, flanked by another two buttresses. Along this elevation is a plain plinth of brick (**Plate 291**), laid in an English garden wall bond. Set within this plinth is an infilled drain (**Plate 292**), with a small segmented arch. The doorway here contains a timber braced and ledges door, with a timber lintel. The bay that

Plate 289: The western gable end of Building 12.

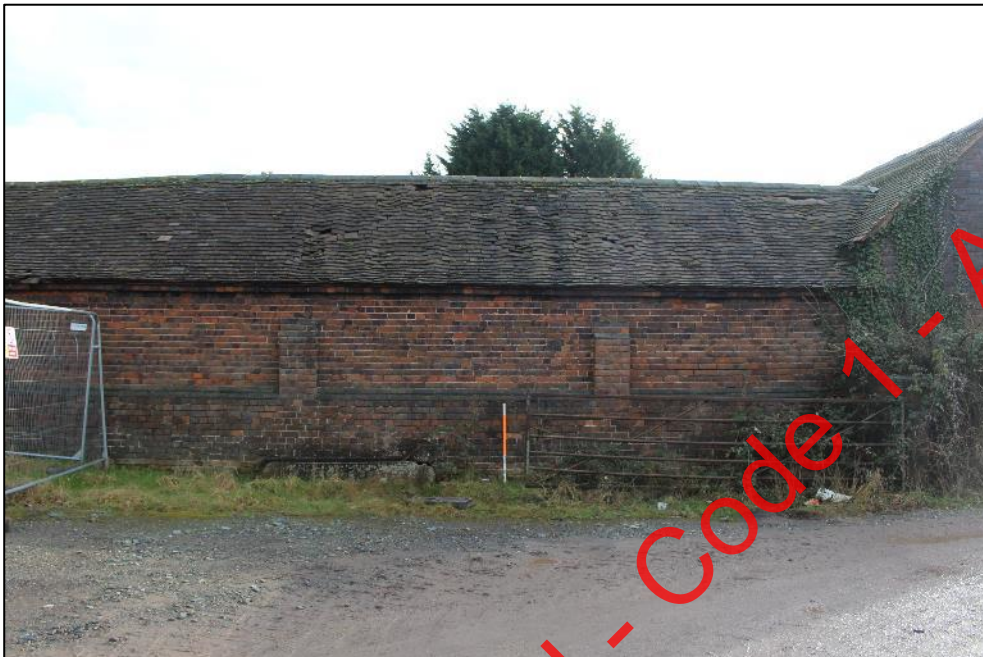
Plate 290: The southern side of the western elevation of Building 11.

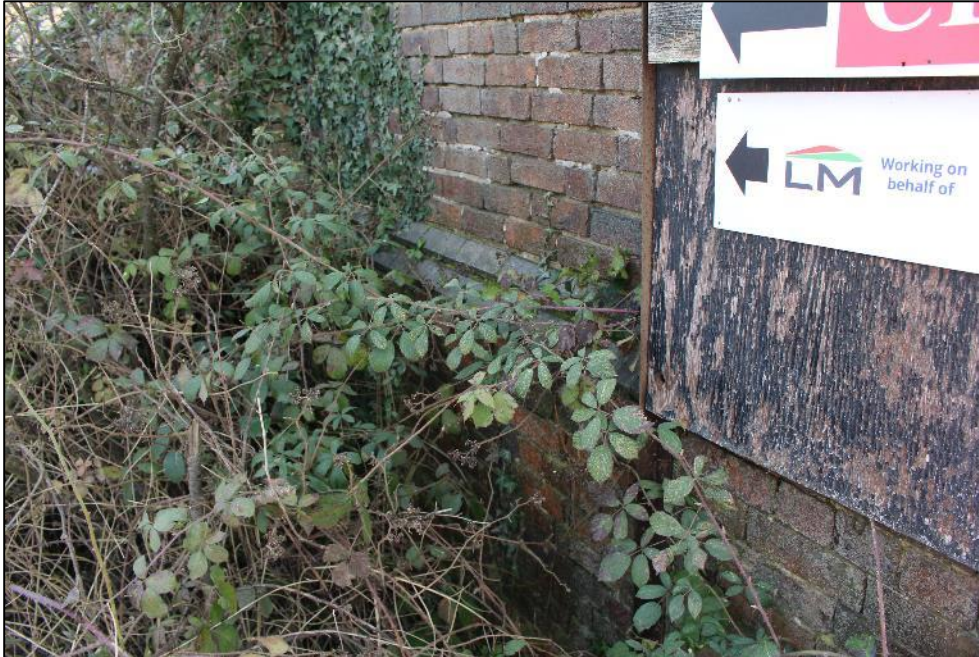
Plate 291: The plinth on the western elevation of Building 11.

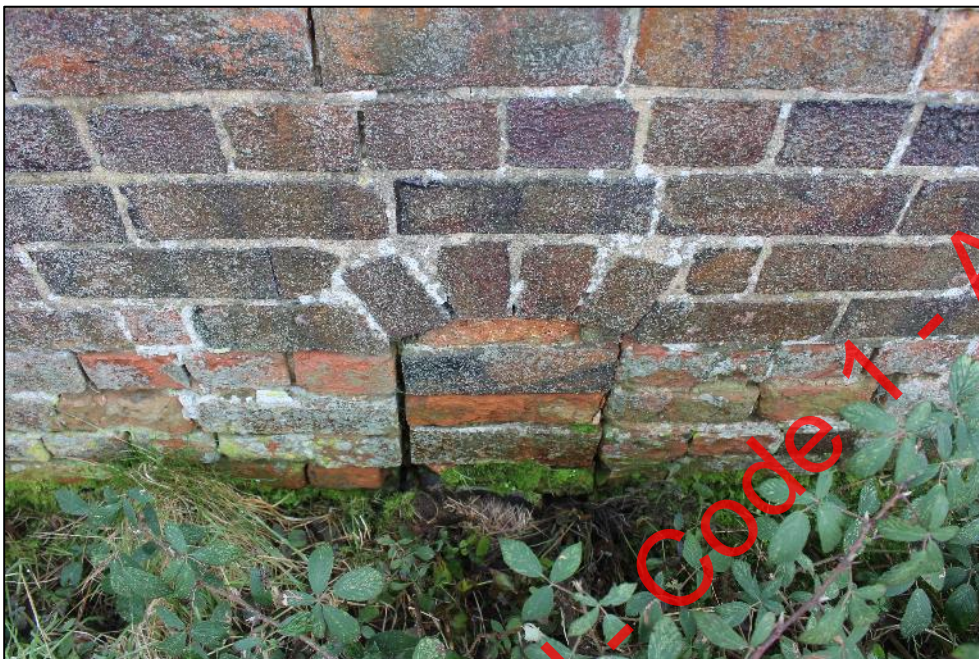
Plate 292: A blocked drainage chute in the western elevation of Building 11.

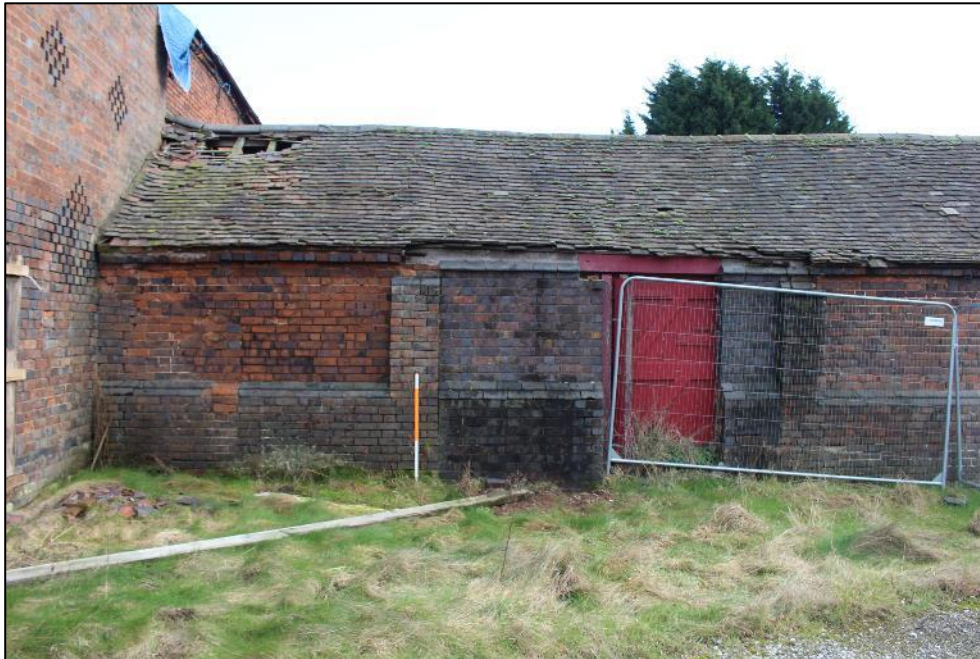
contains the doorway (**Plates 293 & 294**) is made entirely of blue brick, and seems to have been rebuilt.

Plate 293: The northern side of the western elevation of Building 11.

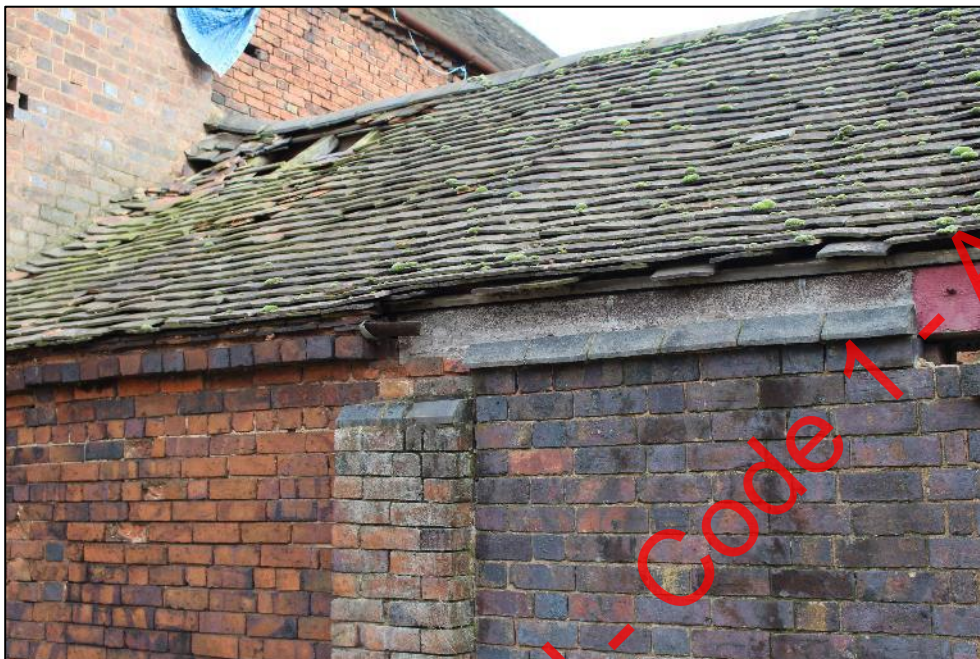
Plate 294: The change at eaves level on the northern side of the western elevation of Building 11, indicative of the blocking of an opening.

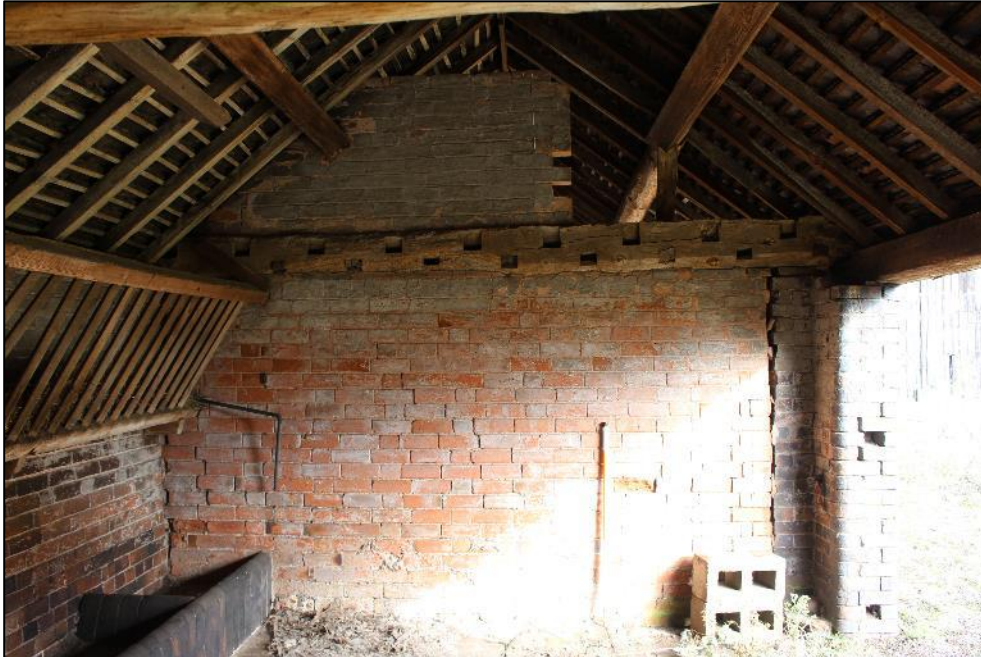
5.9.40 Dividing the northern and southern rooms in Building 11 is a red brick wall (**Plate 301**). This wall has been constructed around the tie beam of the truss (**Plate 302**), with a clear break in coursing between it and the blue brick pillar to the east, suggesting it is a later addition. The northern half of this building was not accessible. However, it was possible to see that the floor surface of this is also of brick, with a brick lined ramp in the centre leading down to the central doorway.

Plate 301: The dividing wall between the northern and southern rooms of Building 11, taken from within the southern room.

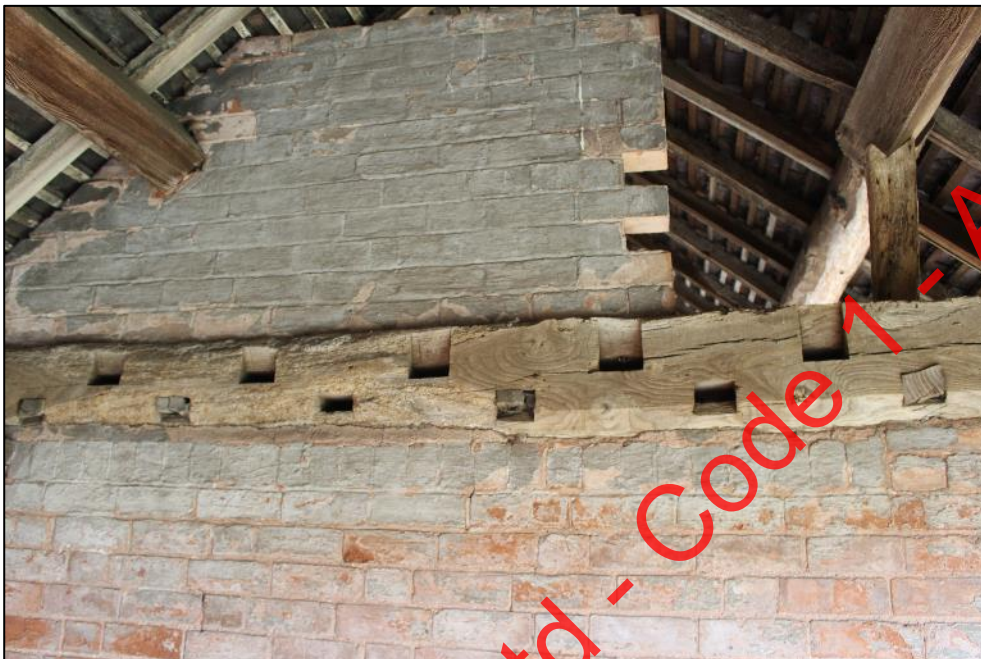
Plate 302: Detail of the truss set within the dividing wall in Building 11.

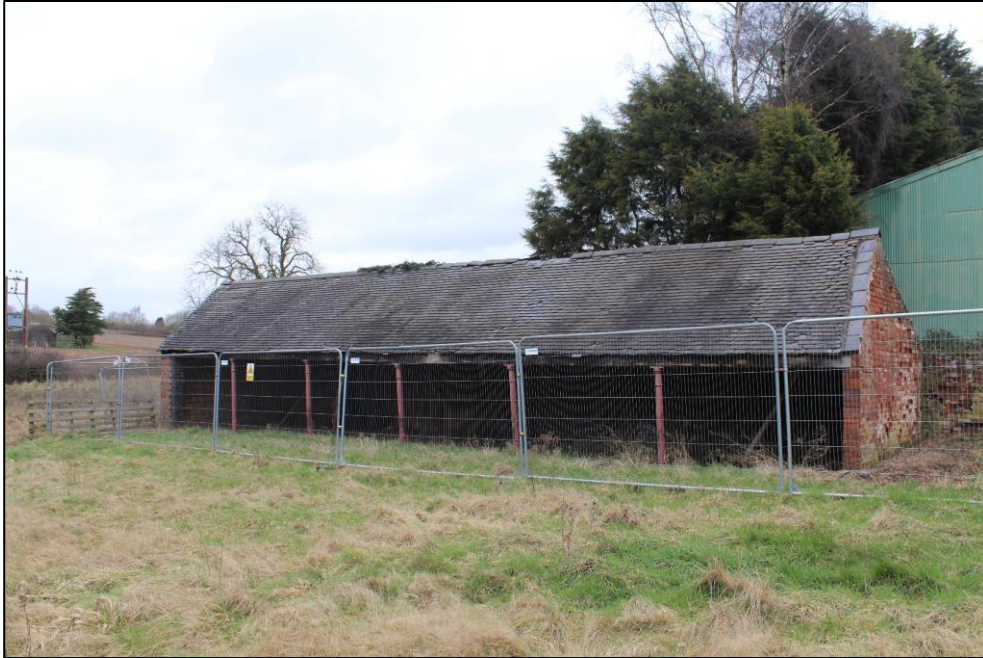
- 5.2.3 An agricultural building is situated against the northern boundary of the field and appears to form the historic and current south-western extent of the farmstead. It is of red brick construction and comprises a single-storey gable ended building (**Plate 313 and 314**). The southern elevation of the building is open and is supported by five cast iron columns which divide the elevation into six bays.⁴ The building is first depicted on maps dating to the early-20th century and appears to have evolved from a smaller, square shaped structure depicted on maps dating to the late-19th century. Subsequent maps show that there was an additional, fully enclosed bay against the eastern gable but this has since been removed.

- 5.2.4 The eastern gable of the building is of redbrick construction and the ridge of the eastern gable is tiled with larger, rectangular slates than the rest of the southern roof slope (**Plates 313 and 314**). A section of red brick wall extends eastwards from the north-eastern corner of this building. Historic maps indicate that in the late-19th century a small square shaped structure occupied the south-western extent of the Site and by the early-20th century this had been extended to the west with the construction of an open fronted building, probably utilised as a cart shed. The extant structure relates to this early-20th century construction and it is thus possible that the eastern gable of the structure, along with the section of red brick wall, relates to the earlier, late-19th century square shaped structure which appears to have been demolished by the late-20th century. This is also confirmed by the construction differences in

Plate 313: The open-fronted cart shed within the south-western extent of the Site, viewed from the south-east.

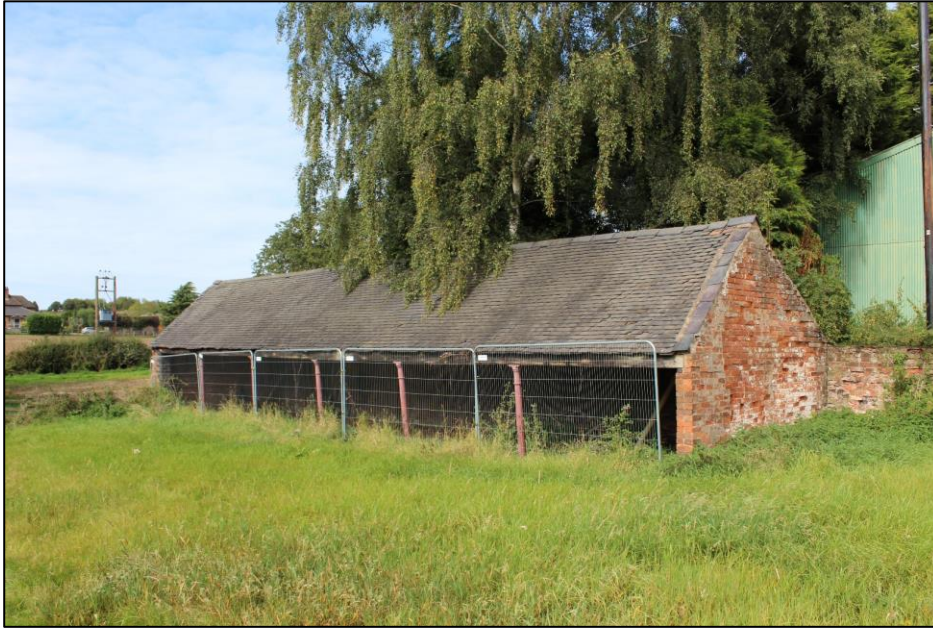
Plate 314: The open-fronted cart shed within the south-western extent of the Site, viewed from the south-east. Photograph taken by DJV.
