**3 Market Place,  
St Columb Major  
Cornwall**

**Historic Building Recording  
and Archaeological Watching  
Brief**

For: **Silverlake Design Ltd**  
On Behalf of: **Mr Giddings**  
ISCA Project: **P02-0013**  
ISCA Report: **R02-0013-2**  
**July 2022**

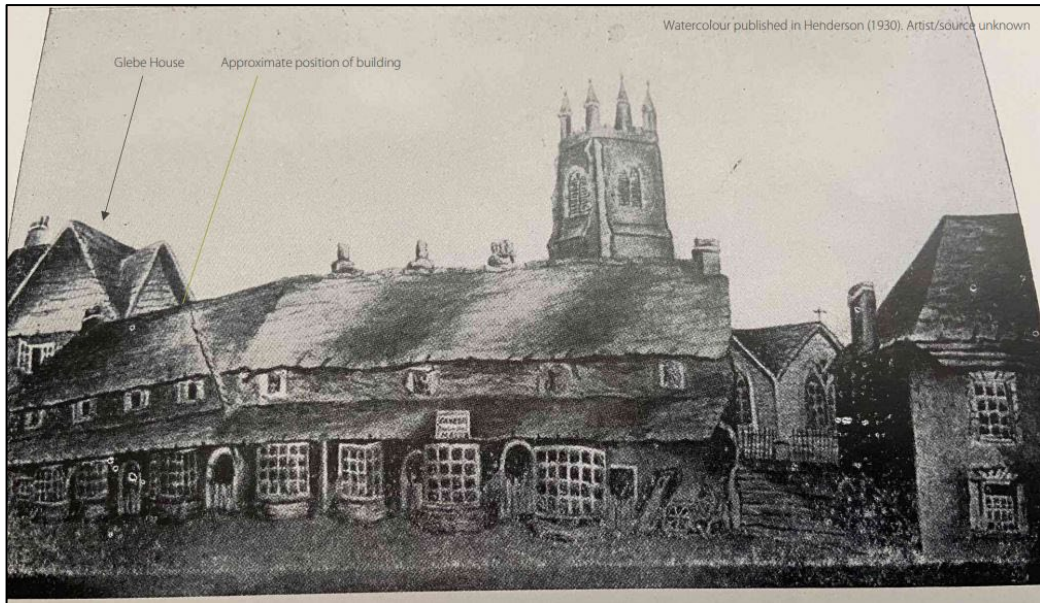
Figure 3: Watercolour published in Henderson (1930) (from Silverlake Design, 2021)

- 4.9. The area of townscape is, to a great extent, faithful to the street plan established during the medieval market town period. Many buildings with facades consistent with the 19th or early 20th centuries may retain fabric associated with earlier phases of development. In respect to the upstanding built form within the Site, a building is present on the 1840 St Columb Tithe Map (Fig. 2) and was identified by a 2021 Heritage Statement (Silverlake Design, 2021). The Heritage Statement identified that the earliest phases of the building likely date to the 16th century, and that these are probably the buildings observed by an undated watercolour reproduced in Henderson (1930) (Fig. 3). This evidence is based on small first floor openings

which could be of a mullion type or finished in a dressed granite characteristic of buildings constructed in the 16th century or before (Silverlake Design, 2021, 14).

- 5.10. A timber shop frontage constructed remains *in situ*. This frontage is visibly different to the frontage demonstrated in Henderson (1930) (Fig. 3) and is likely dated to renovations that occurred in the 1960s, possibly at the same time as the slate cladding was replaced with artificial slate.

- 7.3. The undated watercolour present in Henderson (1930) (Fig. 3) represents the best available evidence for the external form of this earlier “poorhouses/Old Workhouse” phase. A study of this watercolour suggests that the first and second floors, as well as the roof were truncated post-1851 census and pre-1879 1st Edition OS Map.

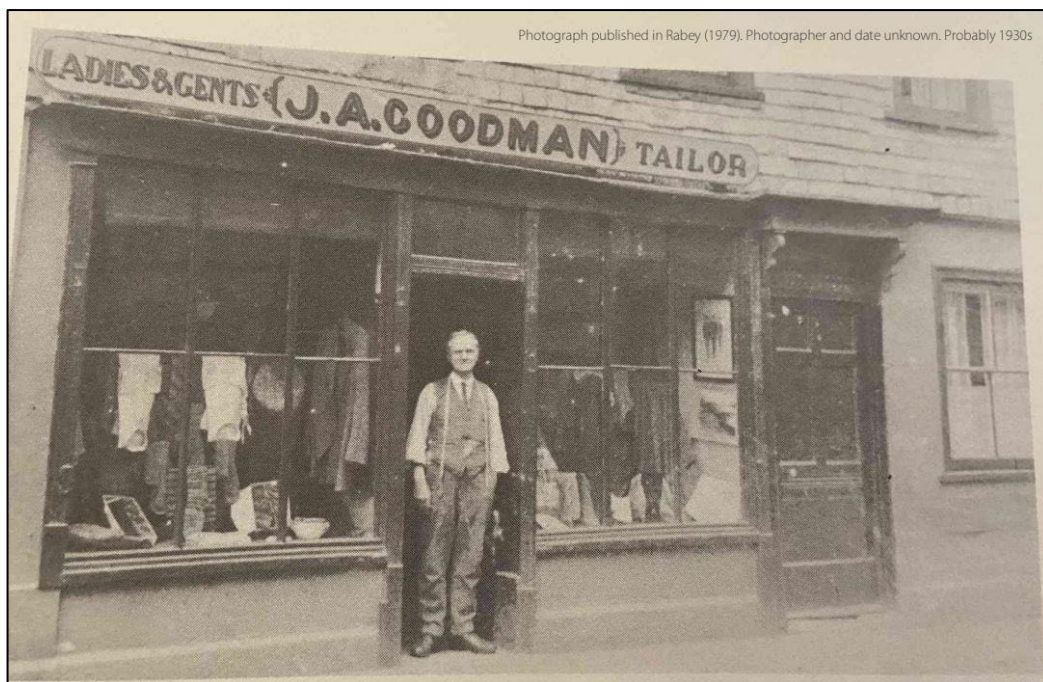
**Figure 9:** Shop front c. 1930s. Taken from Silverlake Design, 2021

- 5.8. Evidence from a photo published in Rabey (1979), which shows the shop frontage in what is presumed to be the 1930s, appear to show rag slate cladding on the southern elevation similar to what is now present in the western and northern elevations. (Fig. 9). It is therefore likely that repair/renovation work was conducted to the western and northern elevations post-1930s, at same time as the slate from the southern elevation was replaced in its entirety. There is also evidence of repair work where slates have been set into mortar.
- 5.9. The roof covering is of double pitch artificial slate hipped to west with red clay ridges/hip. A reduced red brick stack is visible to the party wall to the east. All of the rainwater guttering, and pipes are of modern plastic and not in keeping with the historical features of the building.

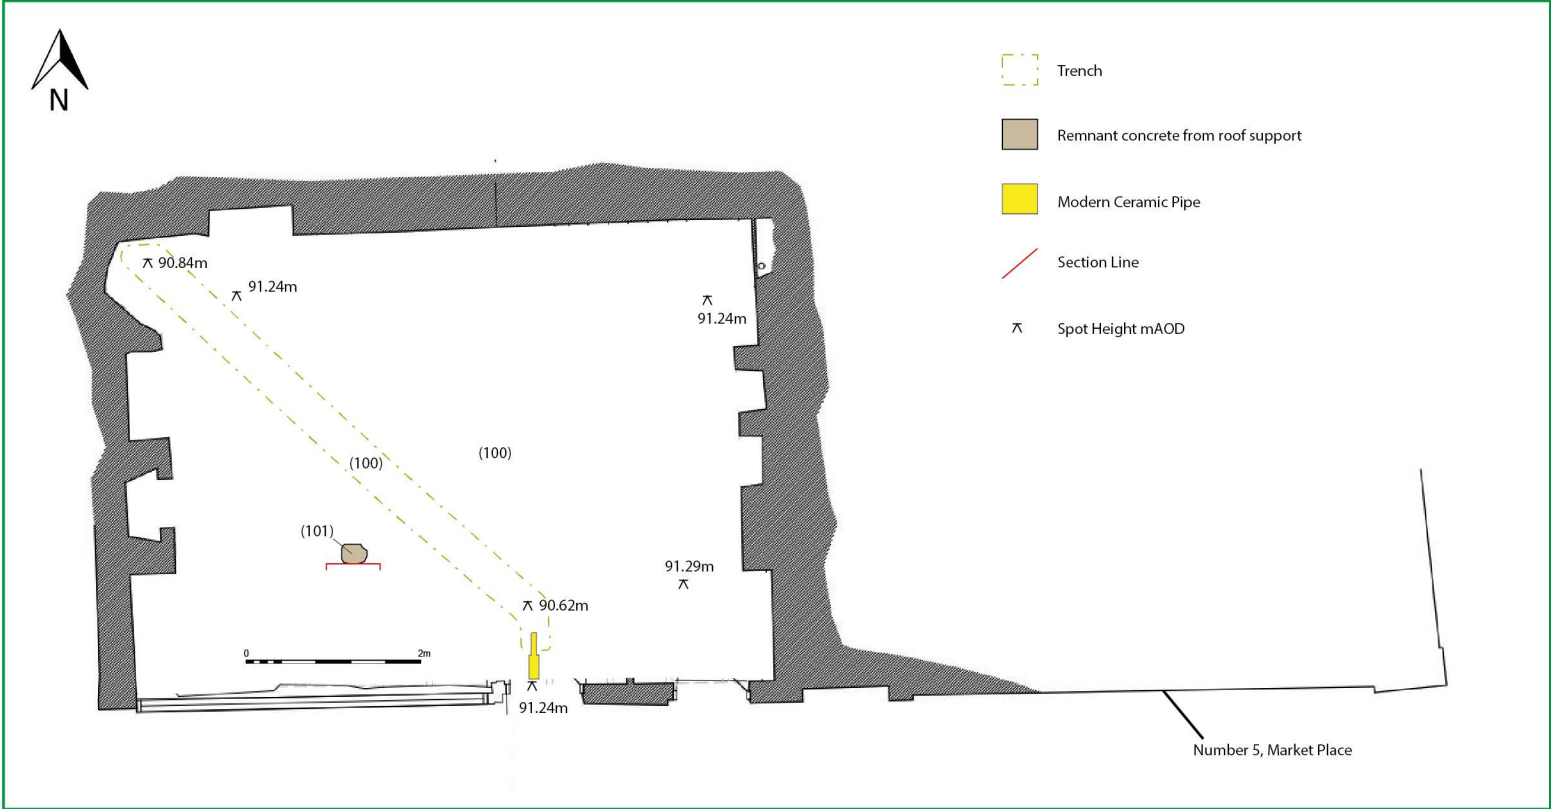
Figure No. 23

3.3. The fieldwork watching brief, which took place on 5th July 2022, followed the methodology laid out within the WSI (ISCA, 2021). An archaeologist was present during all intrusive works, comprising the observation of the removal of made ground in a single service trench in the buildings ground floor (see Fig. 23 for location and extent).

- 6.2. This section provides an overview of the watching brief results. The results of the watching brief are illustrated in Figs. 23 and 24. Detailed summaries of the recorded contexts can be found in Appendix 1. No artefactual materials were recovered.

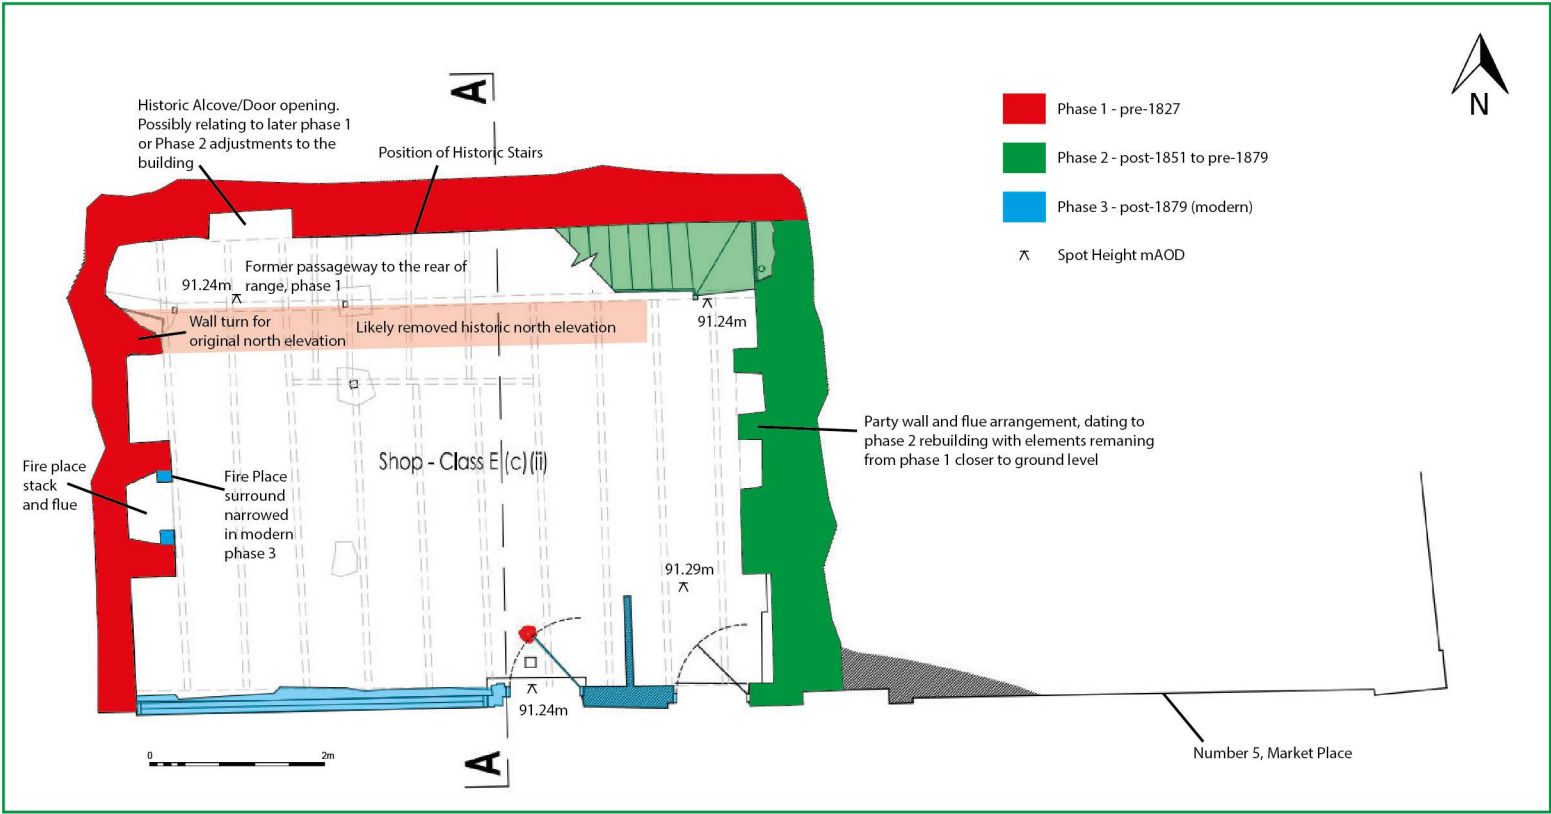
Figure No. 25

- 7.6. Built form within the Site have therefore been placed into three broad periods. These phases have been illustrated in annotated plans and elevations in Figs. 25 to 28. These phases consist of:
