## BUILDING SURVEY REPORT

# The ruins of the church of St Andrew Walberswick WLB 112

St Andrew's Church, Walberswick, Suffolk

Suffolk HER site code	<b>WLB 112</b>	OASIS Ref:	<b>davidgil1-265676</b>
Suffolk HER event no	<b>ESF24809</b>	Listed Building no	<b>285568</b>

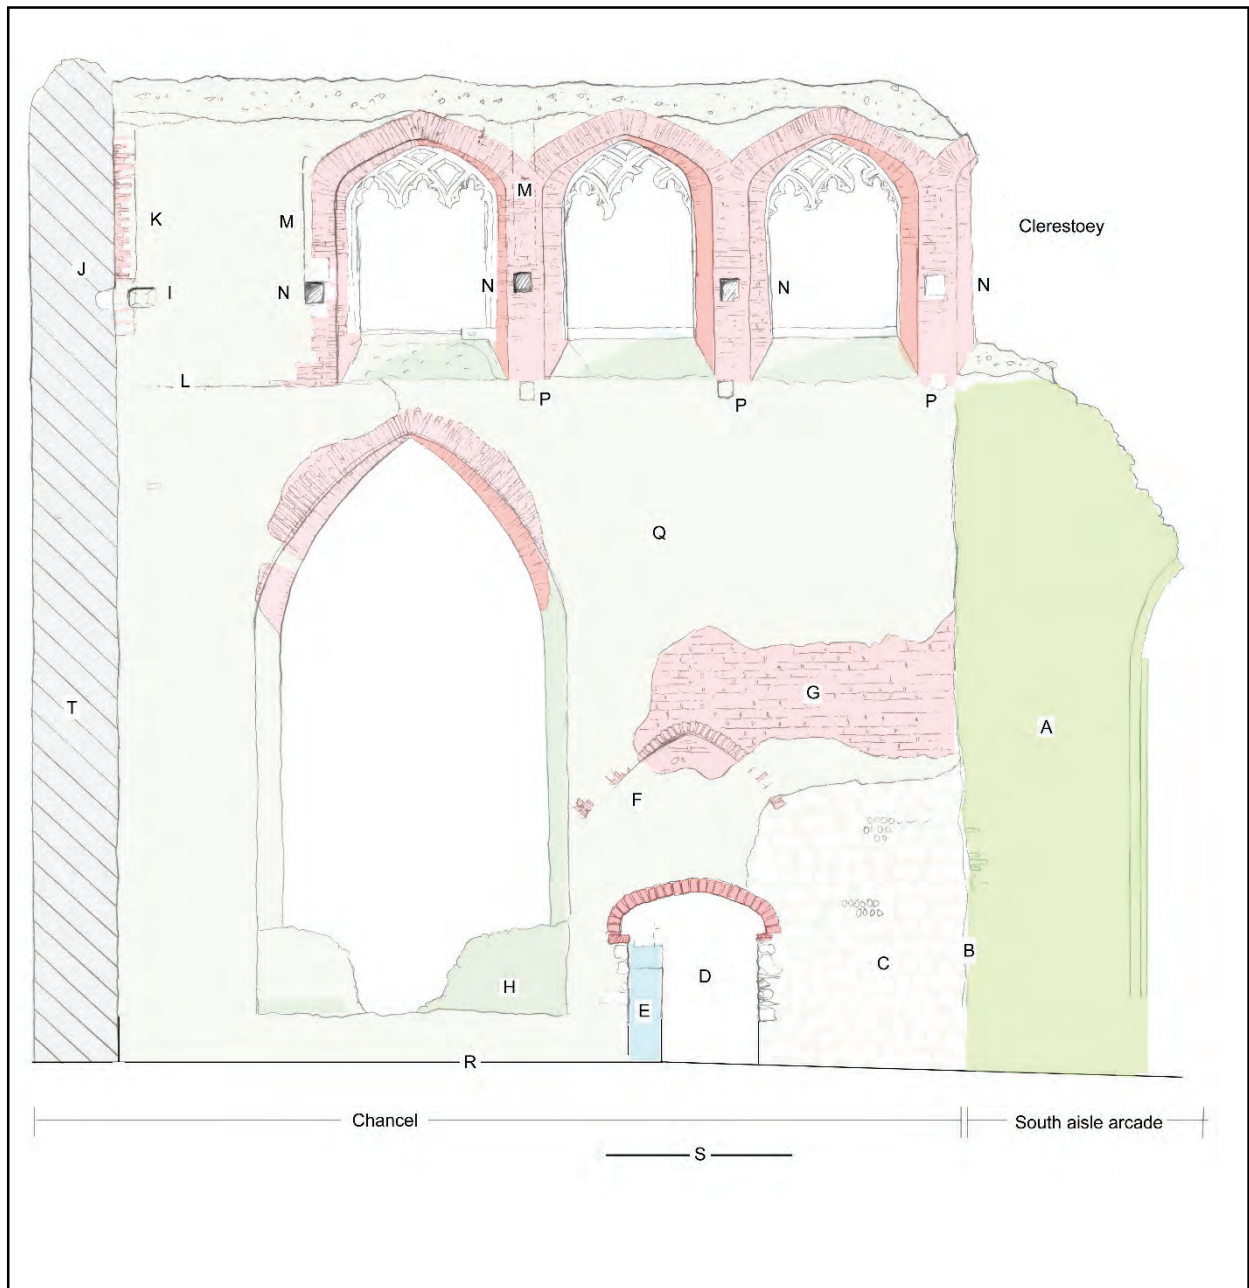
Figure 3. Internal (north) face of the Chancel south wall

The south side of the chancel (see Fig. 3) includes a short length of the south arcade **(A)** and the respond for the first of the arches. The arcade wall is made up of rolled beach pebbles, laid in horizontal courses with single rows of brick stretchers dividing the pebble-built sections into bands; the brick rows are irregular and not always complete. Thin purple bricks, similar to those used at the base of the north aisle wall and fragments of dressed stone, including window tracery in a soft clunch, are interspersed throughout the build. The fabric of the chancel wall begins at the joint **(B)**; the construction of the chancel south wall is unusual in that a majority of the wall (the complete central portion) is faced with brick and this is the only wall in the (15th century) church where this mass-use of brick occurs. The lower part of the wall **(C)** conforms with the construction of much of the rest of the church in its use of rounded pebbles as the principal material and this building method extends to the east wall to a height that includes the dropped-sill that is built into the base of the large window; the high altar piscina, however is set within brickwork. Much of the wall is masked by plaster but the brickwork is best seen in an exposed patch **(G)** over the priest door. The brickwork extends to the height of the clerestory window sill where flints seem to have become available again and the change is delineated by a small lip **(L)**. Where exterior face has fallen away the core is visible and shows that the south wall is made up with a high proportion of broken orange bricks, these are inserted at a miscellany of angles, rather than flat, a phenomenon which was not seen elsewhere in core fabric. There is a priest's door **(D)** with shallow Tudor-style arch and above it

a strainer or relieving arch (**F**) has been built into the brickwork (Pl.8); the door is similar to the opposing blocked door to the Sacristy; the door heads on both are quite clumsily built but this would

have been concealed by plaster. On the outside of the church there is a rebate surrounding the priest's door from which the dressed stone surround has been removed and the opening has been compromised by a buttress. Inside the door width has been reduced from 1.10m to 0.85m, by building up the east jamb (**E**), to match the rear of the buttress but the original can still be seen in a quoin of large flints. Despite partially overlapping, both the exterior buttress and the priest door appear to be 15th century features but the buttress must have been a slightly later modification perhaps in response to the increased height of the chancel when the clerestory was added. Most of the buttress has been heavily restored but a small area of unadulterated fabric remains at the base (Pl.8). The present ground level (**R**) on the south side of the chancel has built up over time reducing

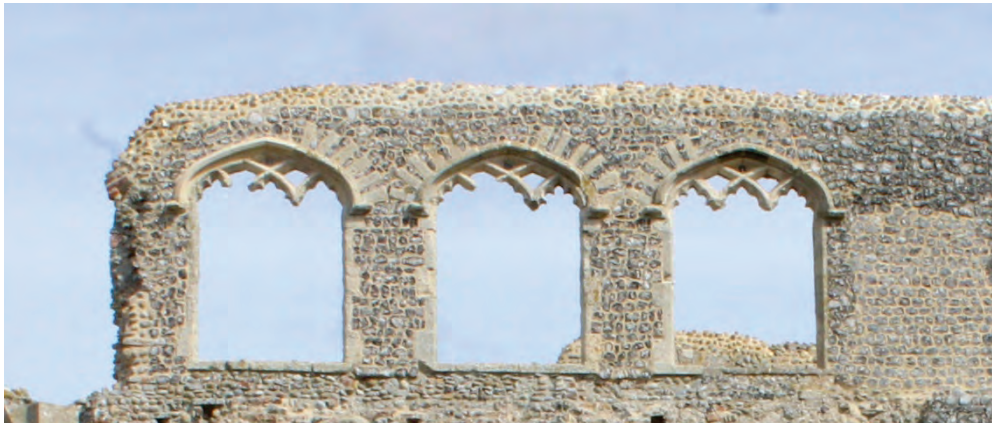
Three clerestory windows survive on the south side of the chancel and one on the north. The openings are topped with four-centre arches and the remaining tracery indicates they were three light windows. The tracery pattern resembles (but is not the same as) the two-light window on the first floor of the Sacristy but it is not one repeated elsewhere in the church.

Plate 9. Clerestory windows on the south side of the chancel

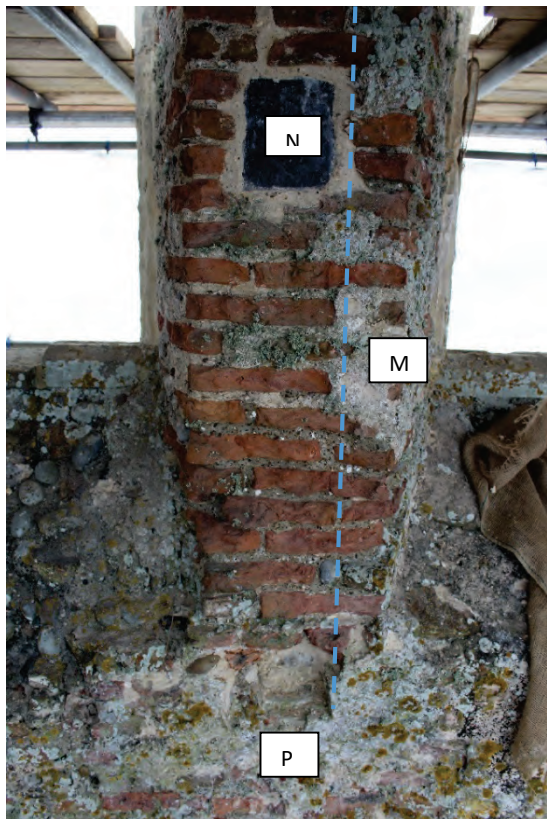
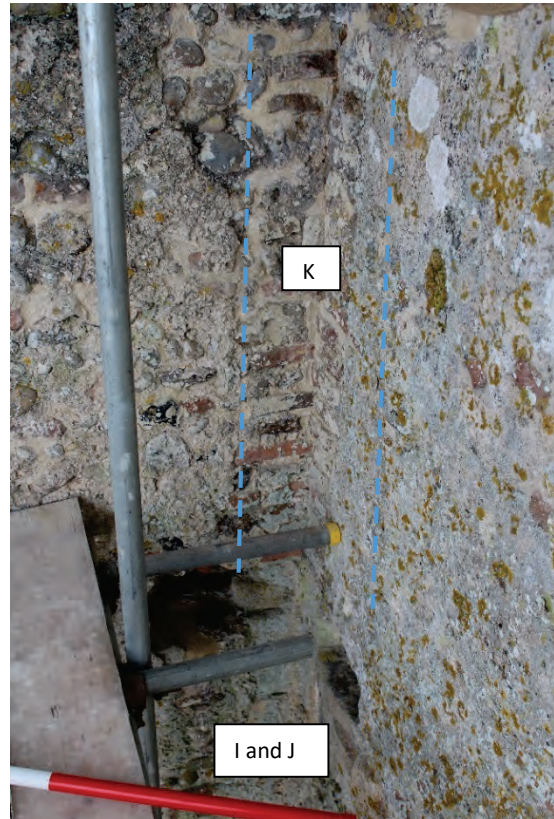
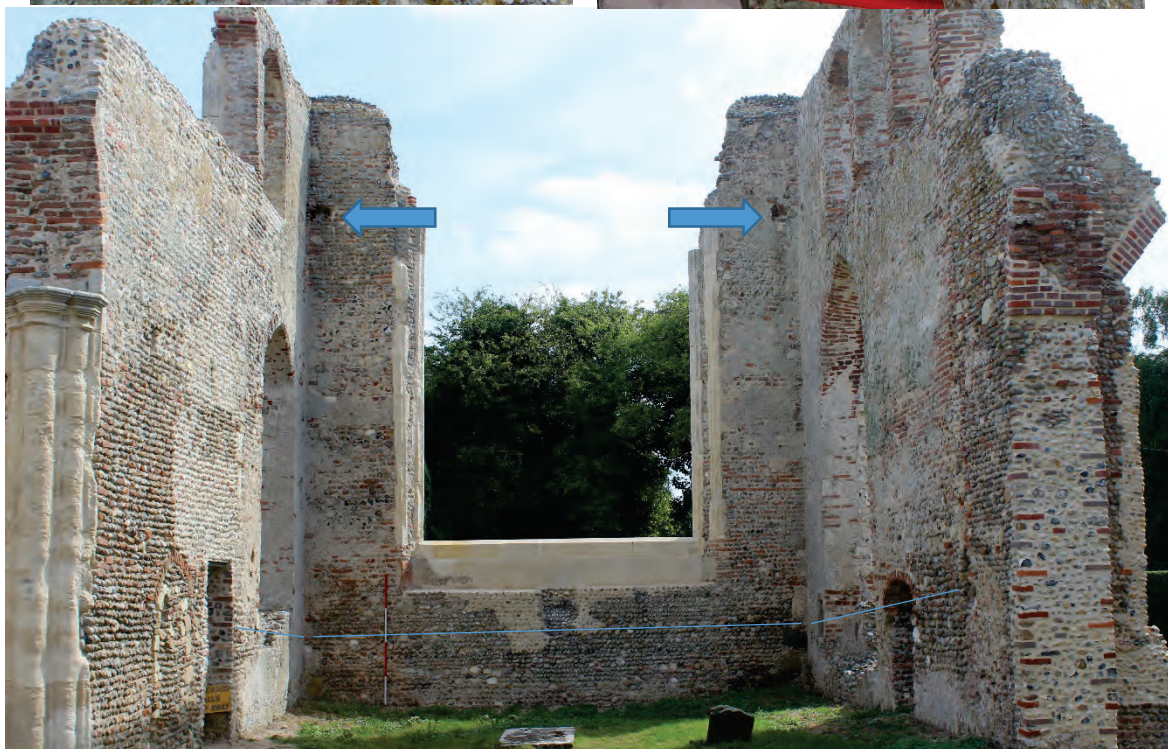
The positions of wall-posts, vertical timbers attached to the face of the wall to support the roof - trusses (Pl.11), could be seen in outline as gaps in the plaster. The marks of posts (**K**) were recorded in each of the chancel corners and extending down between the southern clerestory windows(**M**); the corner posts had a rectangular profile 180mm x 200mm whilst the wall posts were 200mm wide. Sockets for corbels (**I and J**) existed at the bottom of the corner post but were positioned either side of the post, as if bridging the corner, rather than directly under them. The holes were roughly cut, as opposed to being built into the wall, and could be the result of extraction. There were further sockets (**N**), at the same level, below the wall posts and set in the jambs between each of the clearstory windows; these occurred only on the south side and there were no opposing ones on the north.

Plate 10. The Chancel looking east (bottom). The picture top left shows the line of the wall post, evidenced by the limit of the plaster (M). The sockets, which were at the mid-point (N) and base of the post (P), are for an attachment point and corbel respectively. The picture top right shows the line of the corner post (K) as a break in the plaster, large ragged holes at the base of the corner posts are probably for corbels (I and J). The letters used to annotate the photographs correspond with those used on the drawing in figure 3. The corbels at the base of corner post are highlighted in the lower picture and a change in a phase of built marked with a blue line.

At the base of the windows' sloping reveals, were small, shallow pockets (**P**) that had been built into the wall to hold narrow timber corbels; the sides were formed from bricks on edge and at their base was woodgrain in the mortar. The pockets were 130 x130mm and 75mm deep, their tops coincided with the bottom edge of the reveal and a shallow lip (**L**) marked a change of build east of the clerestory windows. The internal pockets were at the same horizontal level as a row of putlog holes on the exterior wall face but did not align with them vertically. These details were only seen on the south side and were not matched with equivalent holes on the north wall.

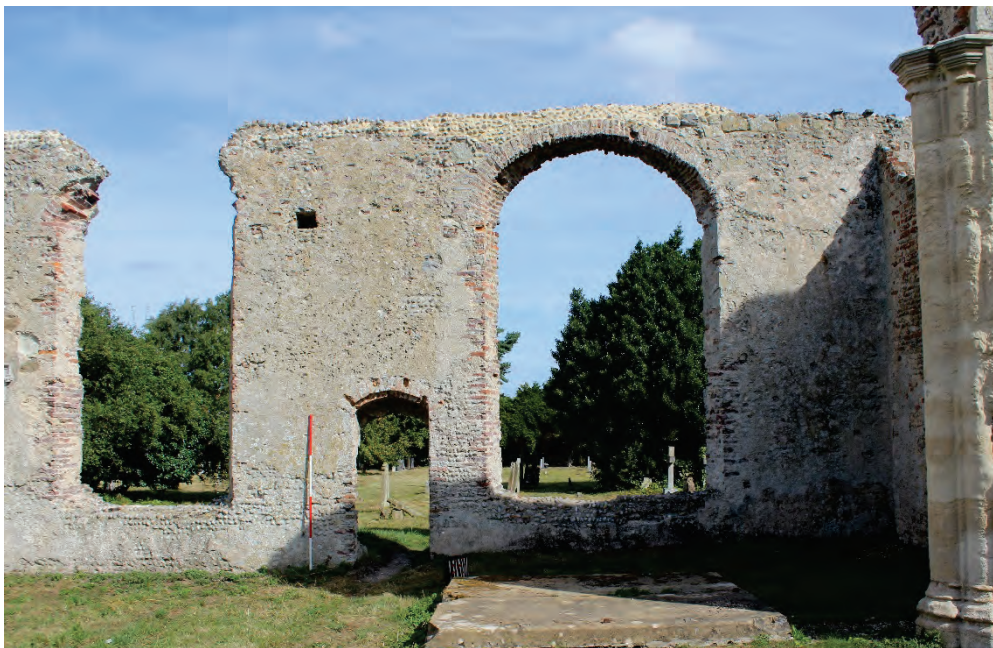
**Bricks:** The edge of the window reveals are built in brick and the construction of the north wall is characterised by use of overfired purple bricks. The bricks measure 8 $\frac{3}{8}$ "-9 $\frac{3}{8}$ " x 4" x 1 $\frac{1}{2}$ "-1 $\frac{3}{4}$ " and are overfired so as to be distorted and brittle – with some bordering on the unusable. The over-fired bricks appear with such frequency that it is likely that they are from a single batch (the churchwarden's accounts record single purchases of 3400 bricks) and their use defines phases of build. The extensive use of burnt bricks occurs twice, separated by a period when 'unburnt' bricks were available, and the distribution of the brick types divides the wall horizontally into three bands (Pl.13). These extend across the entire length of the north aisle exterior wall and defines the vertical progress of the wall builders. The burnt bricks occur with most frequency in the bottom half and

Plate 12. Area of the chapel at the north aisle, showing the large window and priest door. The socket, the possible location of a screen, can be seen near the top of the wall (above the scale).

could be seen forming the north priest door, the bottom half of the windows and the lower part of the east stair turret. The burnt bricks extend higher up the wall in the corners suggesting that the wall ends were raised in advance of the centre, as one would in building a brick wall.

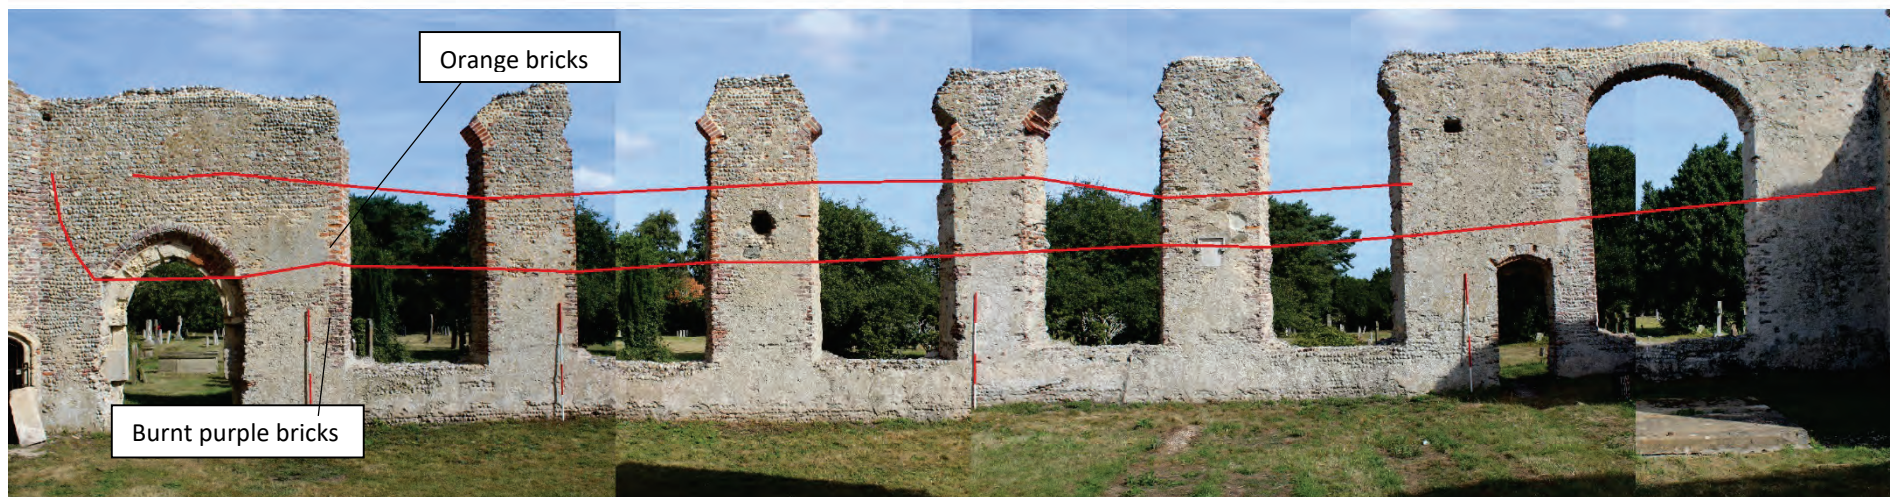
Plate 13. The internal face of the north aisle north wall showing the changes in build identified in the change of bricks

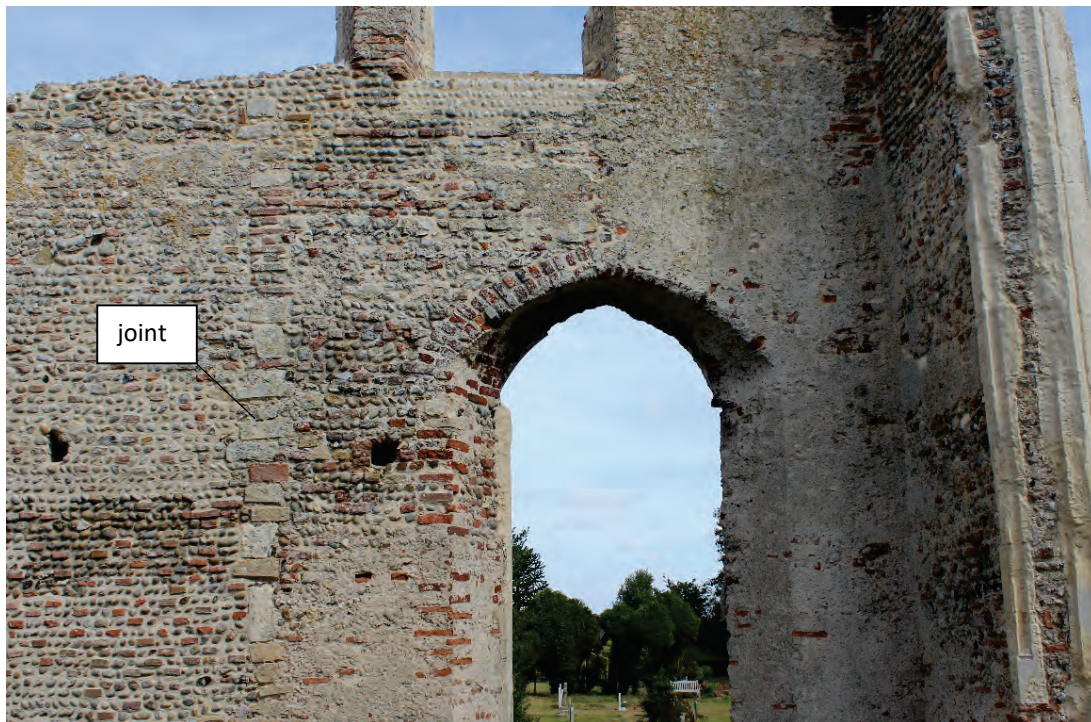
A sacristy or vestry with a room above was created when the east end of the north aisle was partitioned off. The internal walls of the Sacristy, which are coloured green on the phase plan (Fig 2) were later insertions that were jointed into the inside of the north aisle exterior wall with block-stitching. The two inserted walls were built simultaneously and at their junction in the SW corner of the Sacristy the two walls were woven together during construction; the phase included the short projecting wall which forms the eastern respond at the start of north aisle arcade. Where the Sacristy south wall butted against the later chancel the two were stitched together using a combination of long limestone blocks and long (240mm) bricks in a vertical join.

Plate 17. Joint between the chancel (right) and Sacristy walls stitched together with limestone blocks

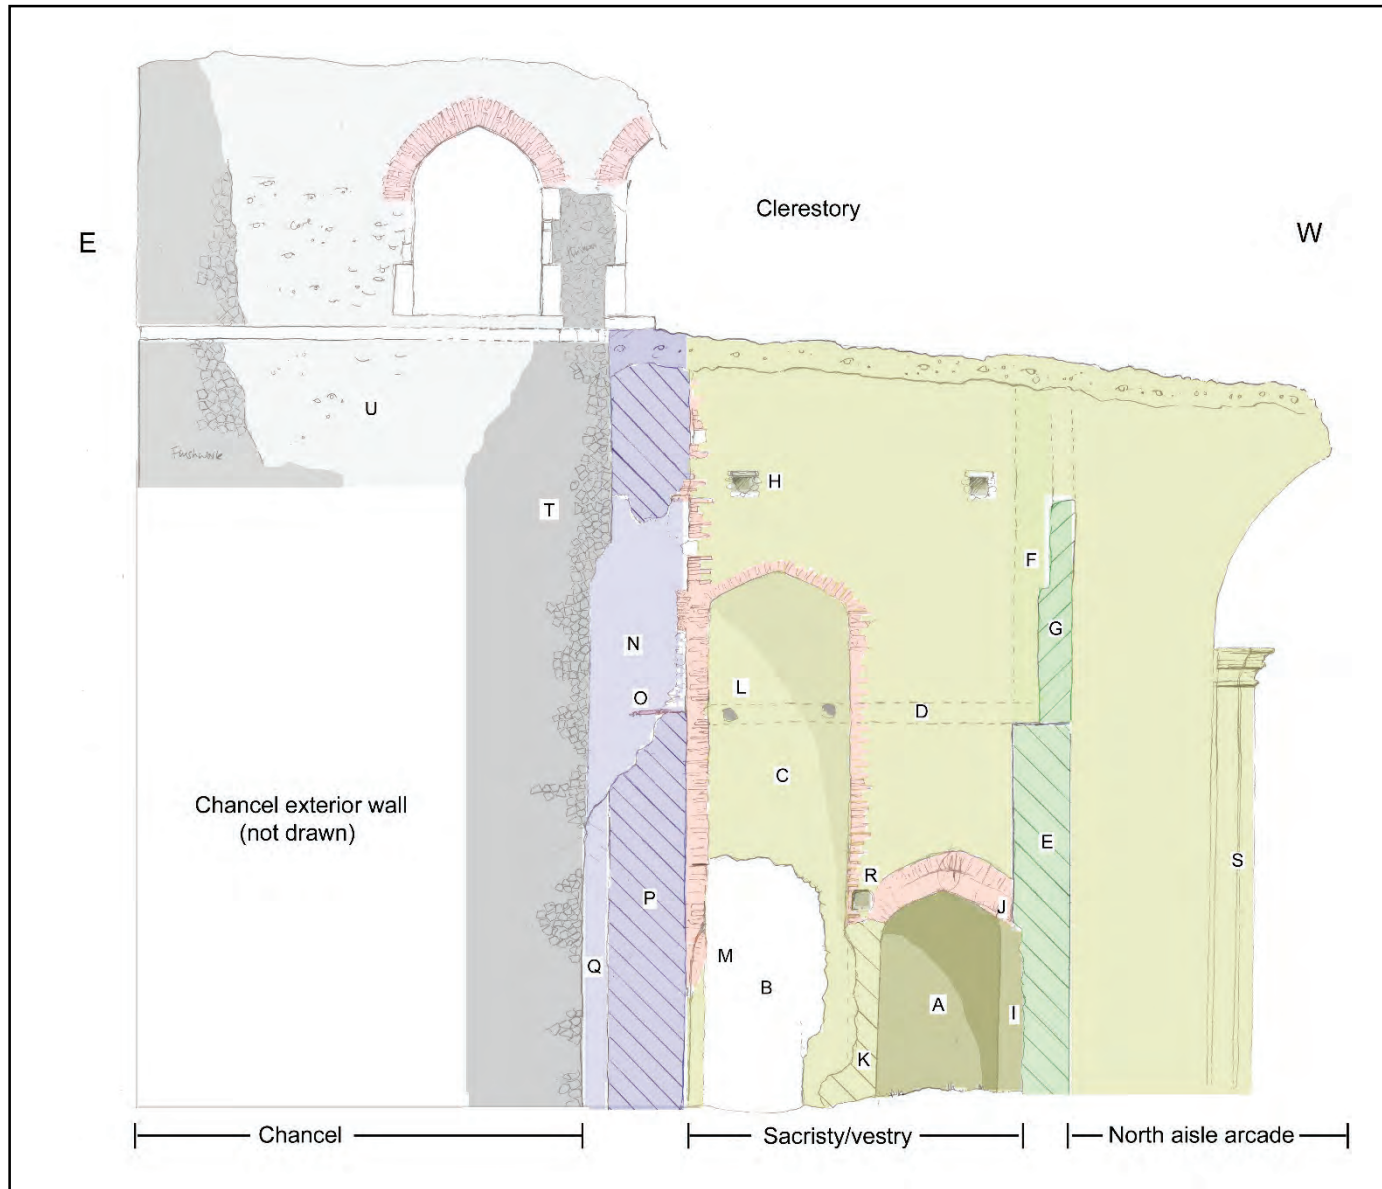
Figure 4. Elevation showing exterior of the north wall of the Chancel, south wall of the Sacristy and respond for the north arcade viewed from the north.

A tall recessed alcove with an arched top (looking like a blind window) ran full height of the Sacristy (Fig.4 (C)). It was 300mm deep (c. 30% of the wall thickness) and built in the south wall at the east corner. The east jamb of the recess did not extend from the floor but sprung from an arched corbel

(M) at about head-height. The reason for the alcove is uncertain but it passed uninterrupted through the level of the first floor (D) and connected the ground and first floor rooms; it is possible that marginal increase in space afforded by the alcove was to accommodate a wooden, dog-legged stair. A socket for a 5"x6" timber (Fig.4 (R)) was set into the brick pier that formed the south edge of the recess and pockets for timber joist trimmers (Fig.4 (L)) were hacked into the back of the recess at first floor level. In clearing away the ground floor, a large stone pierced centrally with a circular hole (Pl.8) was discovered set in the ground, this was interpreted as a possible anchor point for a stair newel or centre post. The suggested stair recess was located alongside the lost stone stair turret suggesting a certain continuity of layout.

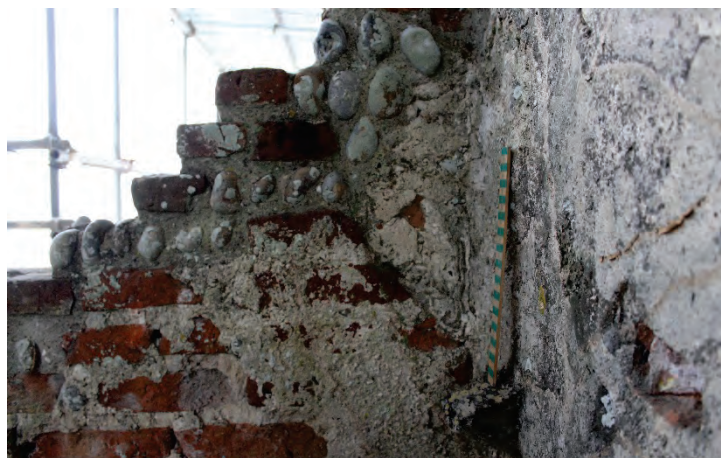
In the NW corner of the Sacristy upper room there is a small fragment of a stone (?) corbel projecting from the north wall and alongside it on the west wall a curving shape is outlined in brick (Pl.20). The shape described by the bricks is basin-like with an external radius of 20cms and 20cms deep, it is located 60-70cms above the floor. Is this a corbel for a wall post or the setting for an oil lamp??

Plate 20. The scale rests on a fragment of projecting limestone stone whilst a curving shape can be seen in the outline of the brickwork of the wall behind

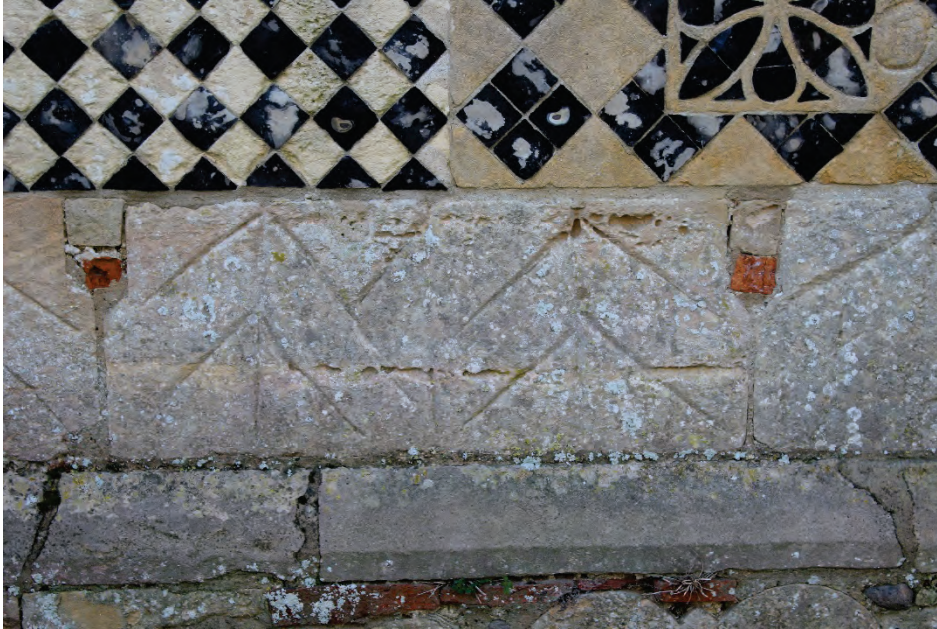
Plate 23 (?) Superstitious marks scratched on the stones below the east window of the 17th church

There are a series of etched marks on a row of stones below the east window of the 17th century church, they occur only in this one place, they run in a horizontal row and have the appearance of a runic script. It was suggested by the mason working on the repairs that the marks were joggles (a scoring on the mating surface of stones) for keying the mortar, but they occur nowhere else even though the bedding faces of hundreds of re-used stones are visible. The arrangement of the marks would suggest that they were carved once the stones were *in-situ*, and therefore post 1696, it is possible that they are superstitious marks protecting the building from witchcraft and V W and M type markings are used commonly found in domestic buildings of the period (C16-18th). The ones at Walberswick church however do not conform with previously seen marks- or with known merchant marks - and so remain a mystery.
