WAGON REPAIR SHED, CHADDESSEN SIDINGS FIREPLACE WORKSHOP, WYVERN WAY, DERBY HISTORIC BUILDING REPORT

Document Title	Historic Building Report
Prepared for	Montagu Evans
Prepared by	TEP - Market Harborough
Document Ref	8712.01

Job Number:	8712
Project Name:	Wagon Repair Shed, Chaddesden Sidings, Wyvern Way, Derby
OASIS Number:	theenvir1-420821

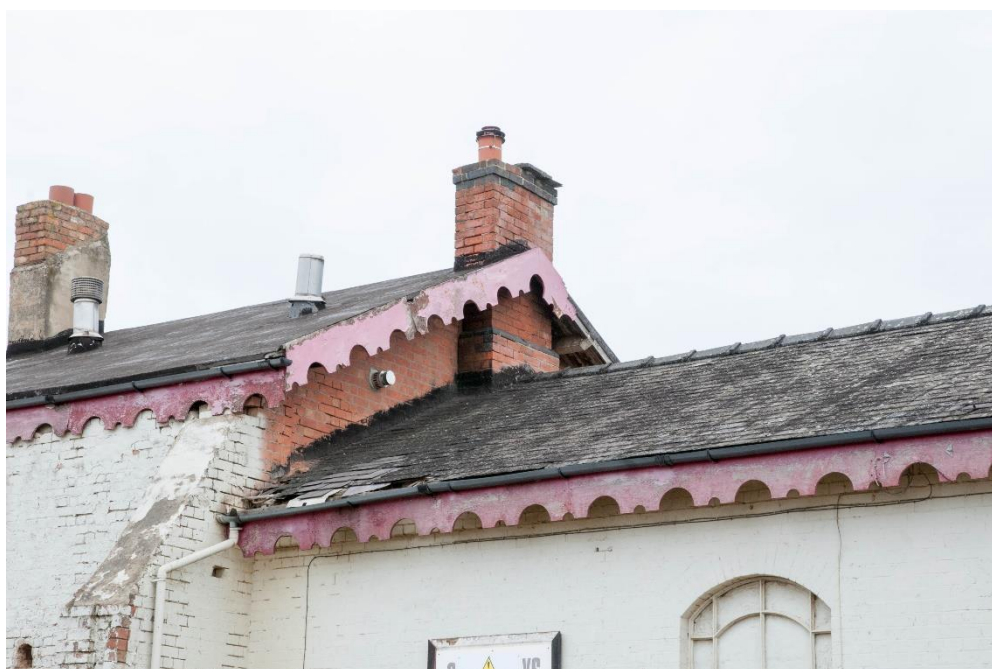
- 5.20 The eaves had simple red-painted wooden fascia boards with circular cut-outs but lacked the decorative embellishment present on the north elevation (Fig 5).

Figure 5 The east gable of the main building; note the remains of a former wall return

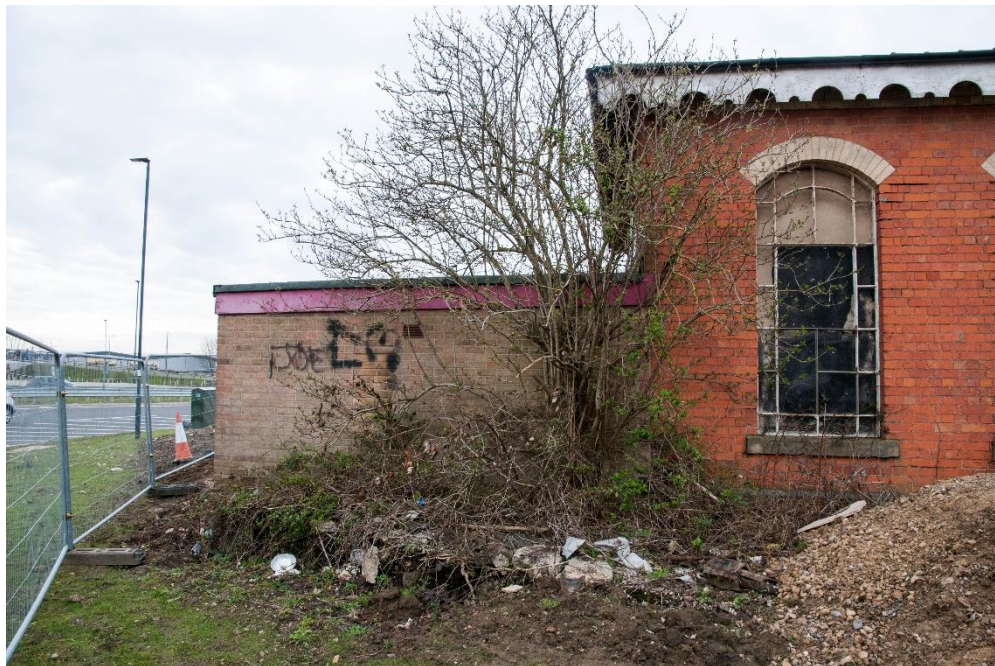
- 5.15 The eastern extension, Building 3, was likely added in the 1970s-1980s when the building was taken over by the Derby Fireplace Company. It was a simple single-storey structure of modern brick in stretcher bond (Fig 10). The north wall was flush with the elevation of Building 2 and the brickwork had been keyed into the earlier fabric of the adjacent structure. A single window, blocked in brick, was visible. The flat roof was surfaced with roof sheets.

Figure 10 The modern extension, looking south

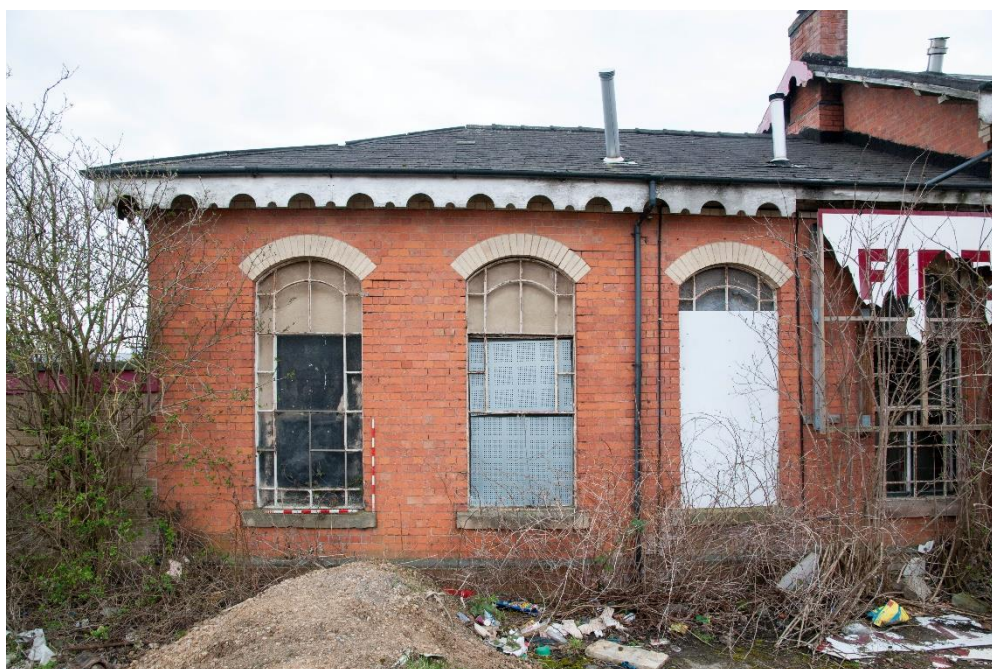
- 5.14 The north elevation of Building 2 was of a matching though simpler design to Building 1, comprising red brick walls in English bond and with four windows each with segmental heads of gault brick (Fig 11). These windows were set flush with the wall and were not set within recessed panels. The metal frames of the windows were of the same form as on Building 1 and each window had a simple stone sill. At the base of the wall was a simply brick plinth with black chamfered coping and the cornice was comprised of gault brick with individual roll-moulded bricks serving as dentils.

Figure 11 South elevation of the single-storey block

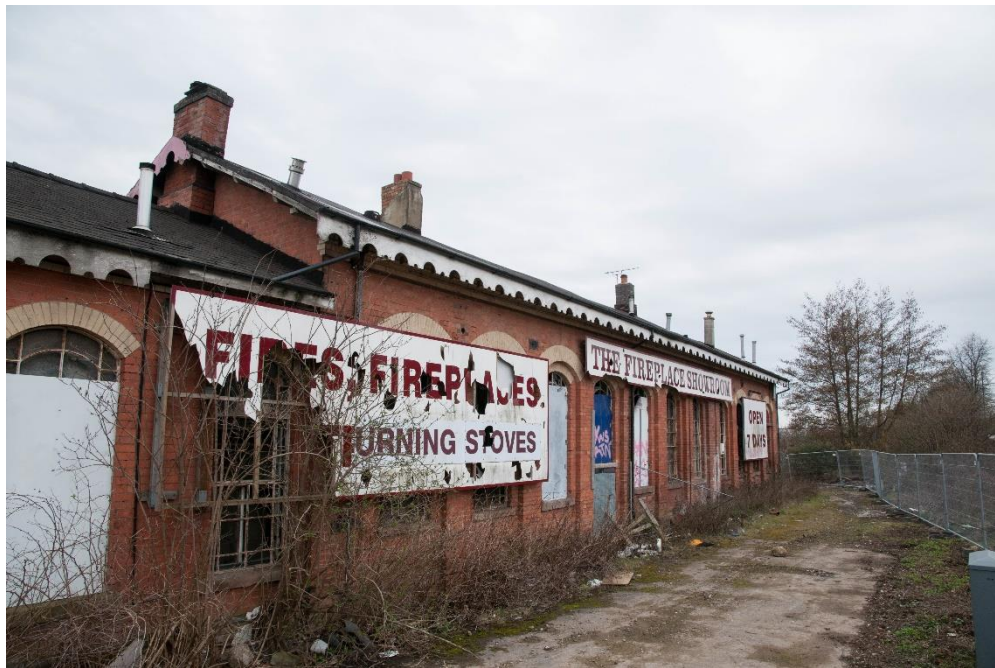
- 5.5 The north elevation now comprises the principal public view of the building and was historically aligned towards the former Derby Canal (now replaced by the A52 which passes immediately in front of the building) (Fig 13).
- 5.6 Comparison of the present building with historic maps and photographs reveals that a significant portion of the building, comprising c8 bays of windows or approximately 18m of the building, has been lost from its western end.
- 5.7 The building is principally brick-built of red brick in English bond (alternating header and stretcher courses) and the bricks were of standard dimensions, c230mm x 110mm x c70mm with five courses measuring c370mm. The use of English bond was typical for the construction of industrial buildings in the 19th century and was considered to be the strongest of the bond types.

Figure 13 View of the north elevation, looking west

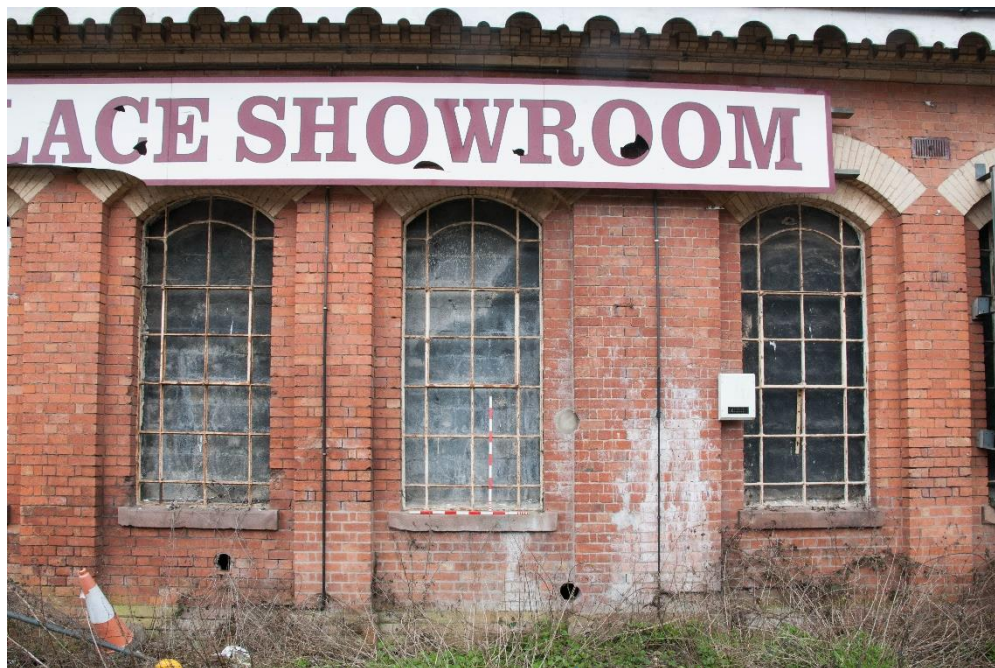
- 5.8 The north wall of Building 1 was dominated by repeating closely-set segmental-headed windows, a common feature of railway and industrial buildings of the late 19th century, allowing maximum light into the building (Fig 14, Drawing 5). The window openings were c1.1m in width and c2.75m in height and each window was set within a recessed panel also with a segmental head. At the base of the wall was a chamfered plinth course which was continued into the window recesses which reached the ground. The bricks forming the segmental heads of the windows and their recesses were in gault-type bricks which created a decorative contrast to the brickwork of the wall. The short columns of brick left between the window recesses served as springers for the arched heads.

Figure 14 View of the windows

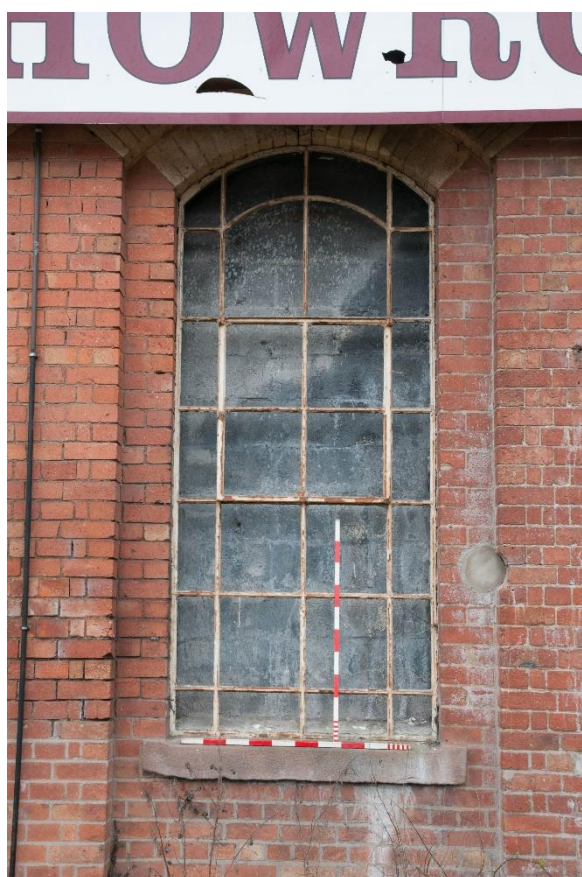
- 5.9 The windows were metal framed and divided into regular grids of squares and rectangles with a Diocletian style design to match the curved head (Fig 15). The central panel of each window appears to have been top-hung for ventilation but otherwise the windows were fixed. Each window had a simple stone sill. No glass remained in the windows and many were boarded internally for security.

Figure 15 Detail of the windows

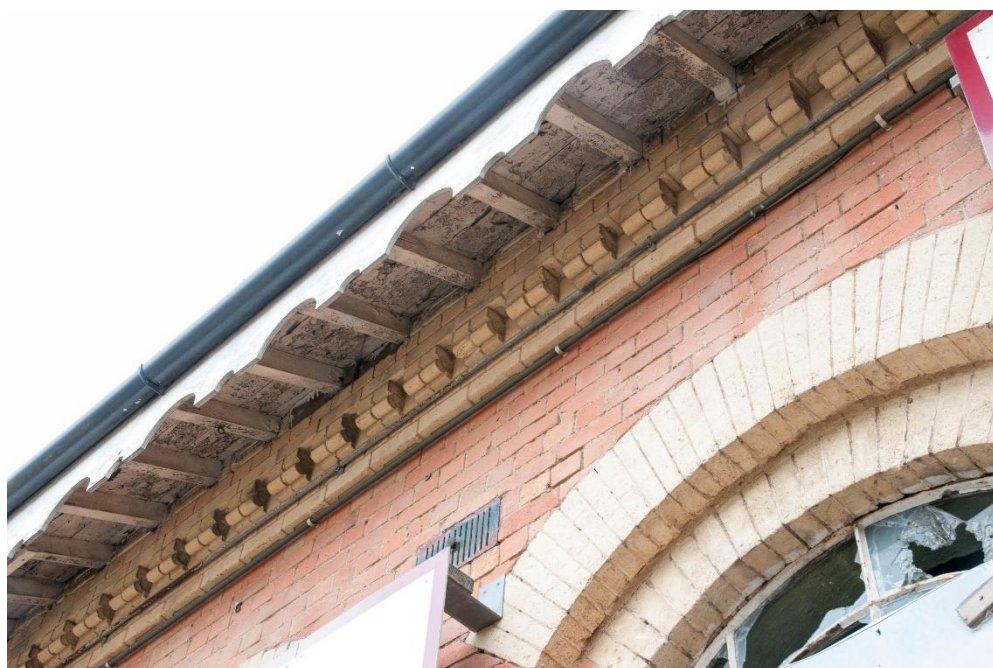
- 5.11 The eaves were overhung with the ends rafters projecting out from the wall face. The ends of the rafters were protected with wooden fascia boards with rounded cut-outs and white painted planks were placed over the rafter ends to hide the roof covering. Photographs of the c1980s do now show these fascia boards which are therefore fairly recent. The cornice, comprising six courses of brickwork, was formed of gault-type brick and projected out from the main wall face. The cornice included projecting dentils, each dentil comprising two bricks with decorative rolls on the outer edge (Fig 16).

Figure 16 Detail of the cornice, dentils and projecting rafter ends

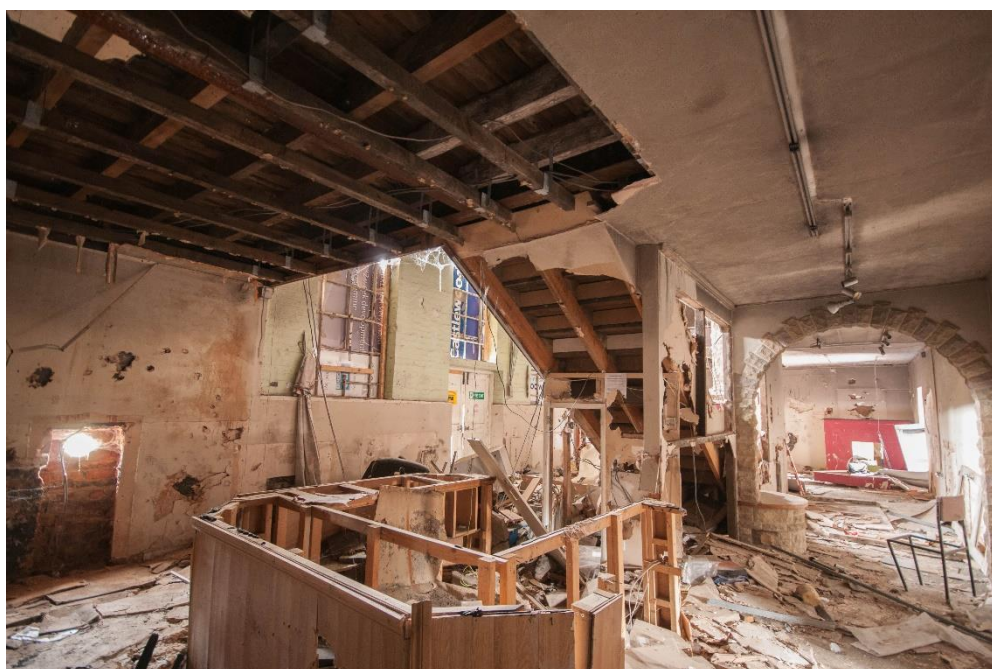
Figure 23 Room 1, looking east, showing exposed floor and stair

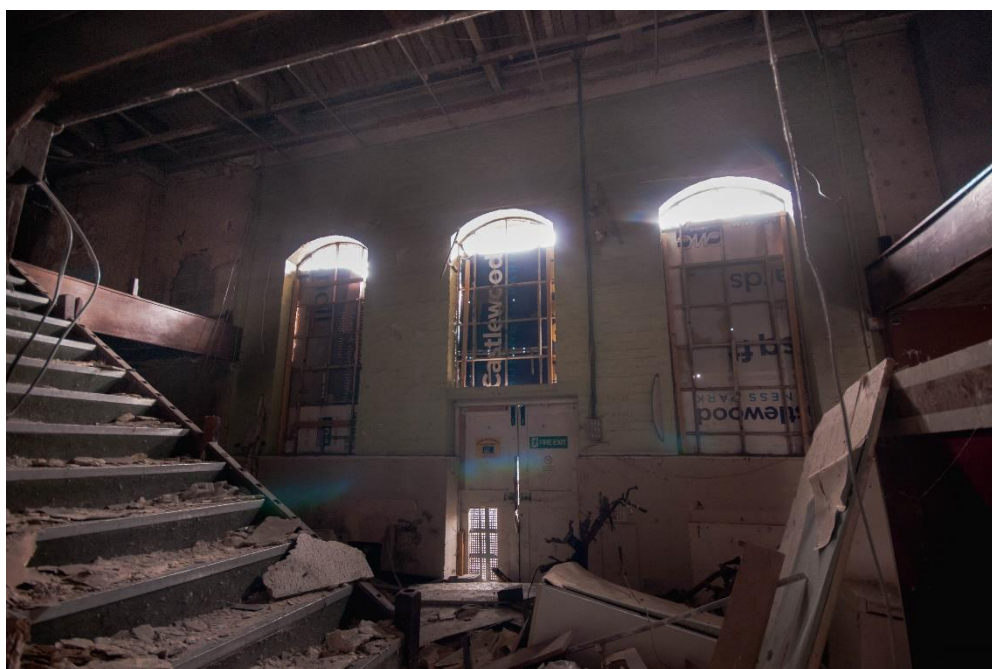
Figure 24 View of the north-facing windows; note door inserted below central window

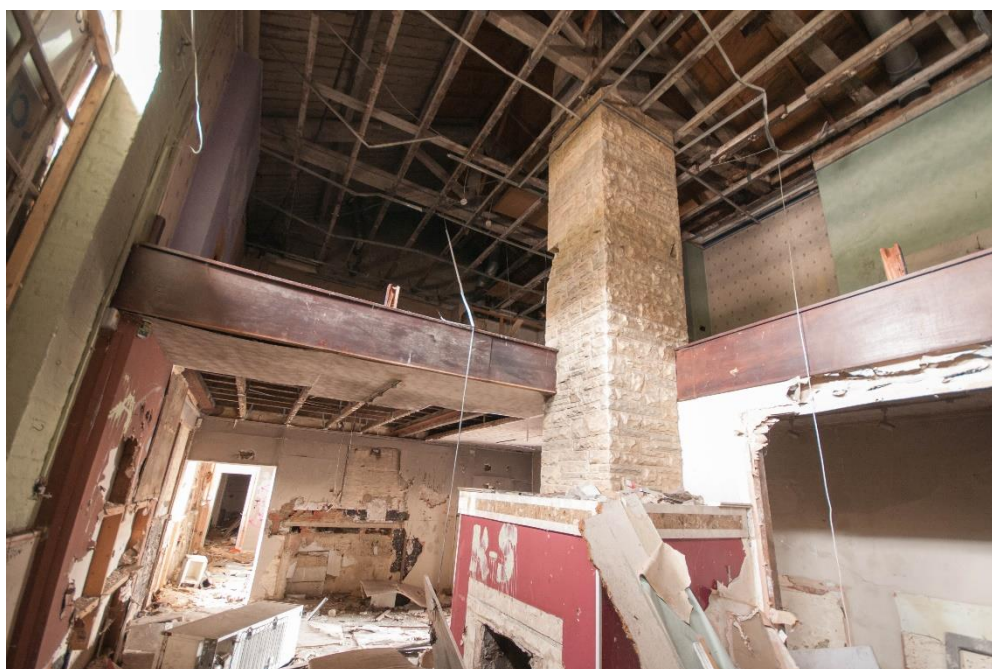
Figure 25 Room 1, looking east, showing inserted chimney and first floor platform

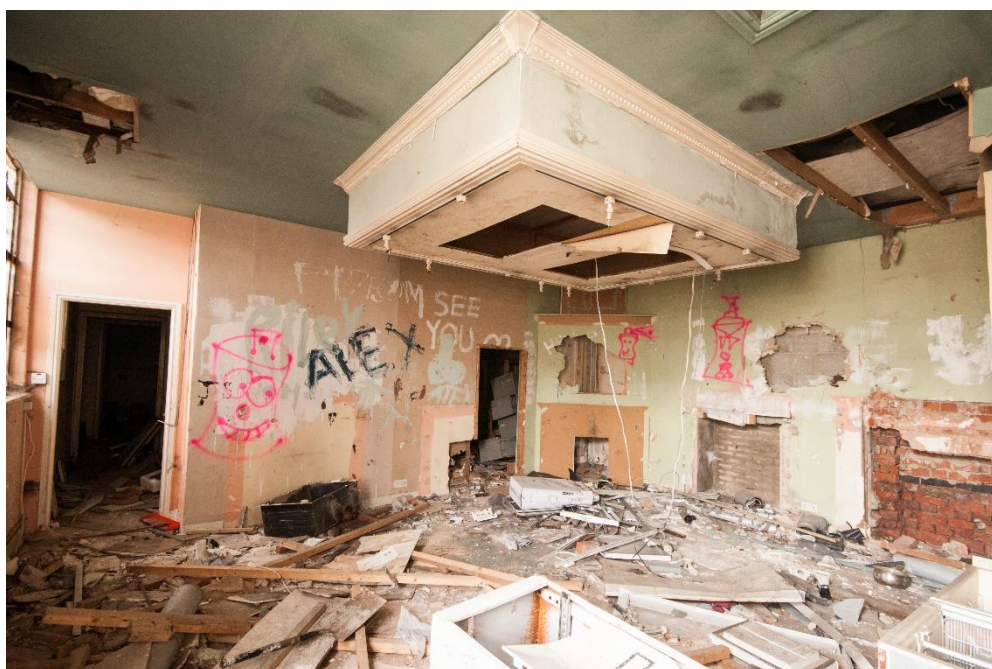
Figure 29 Room 3, looking east; showing lowered ceiling and modern alterations

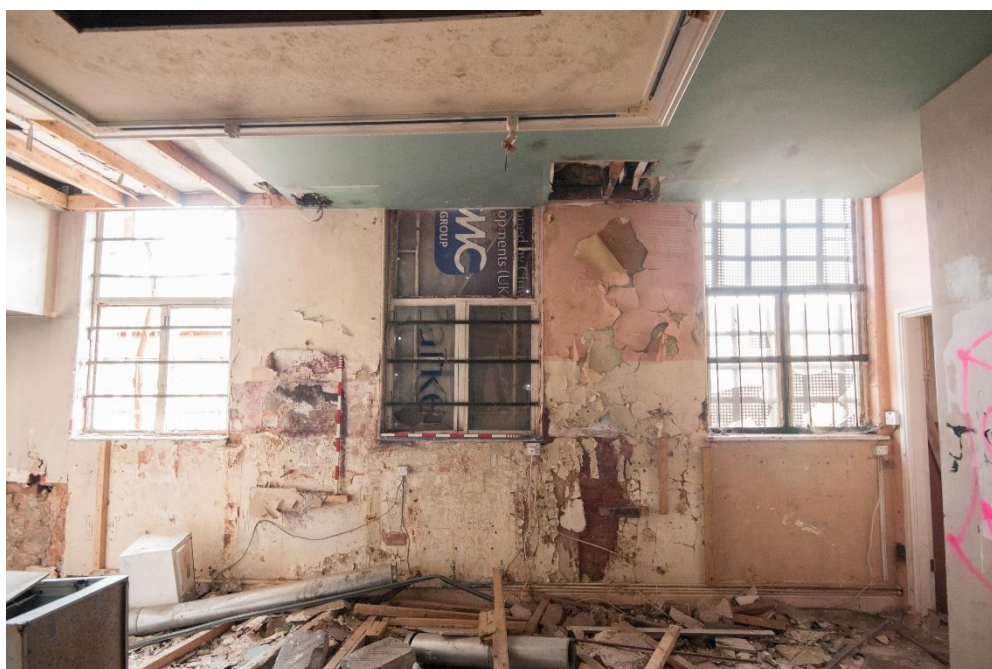
Figure 30 Room 3, looking north, showing the modern ceiling over the windows

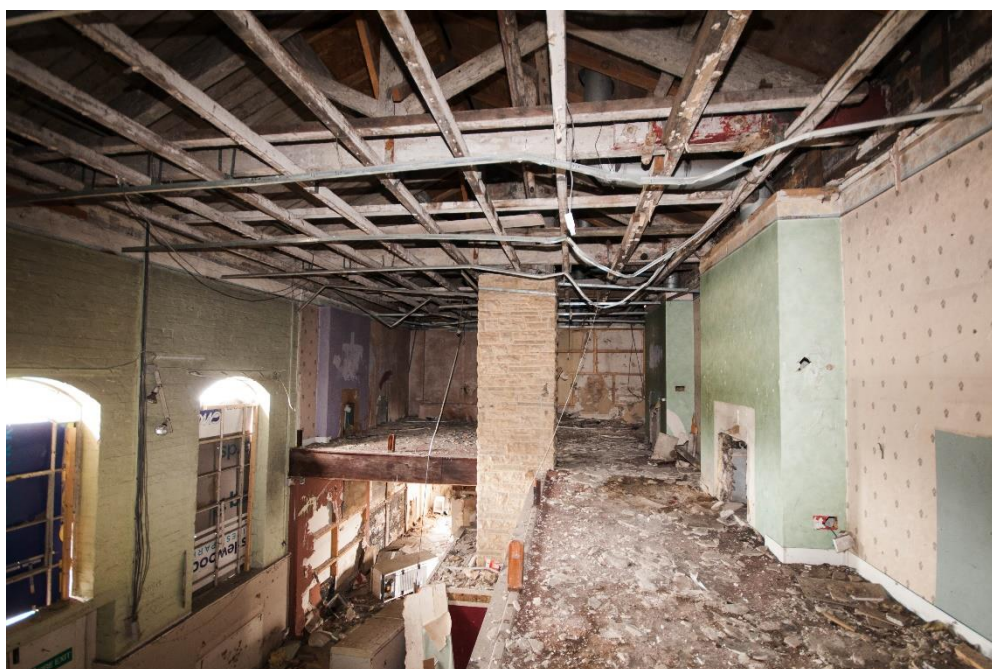
Figure 34 The first floor, looking east, showing modern fake chimneys
