**PIRTON GRANGE GATEHOUSE  
PIRTON  
HERTFORDSHIRE**

**HISTORIC BUILDING RECORDING,  
DOCUMENTARY RESEARCH AND  
ARCHAEOLOGICAL MONITORING**

Document: 2012/95  
Version: 1.0

30th August 2012

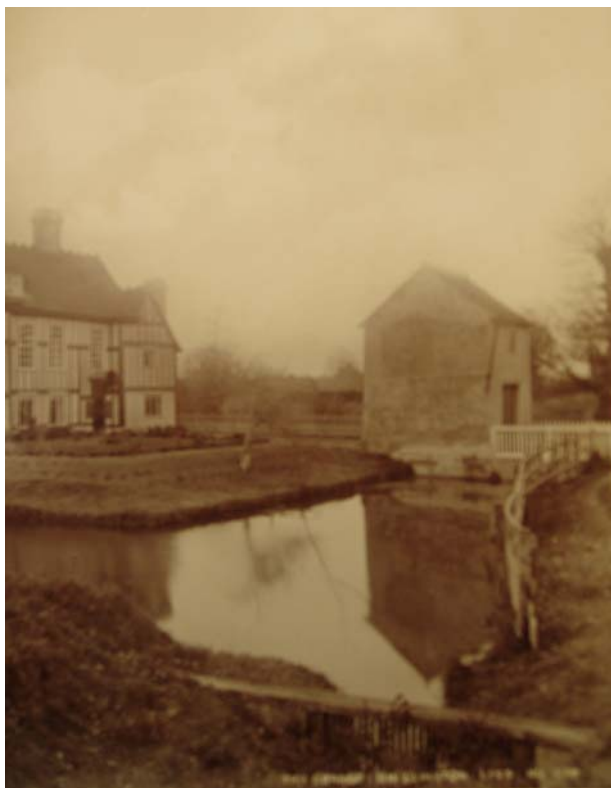
The Grange 1895: the garden walls have gone and the sides of the moat have been cleared of vegetation. The photograph shows repairs to the render on the south wall of the gatehouse. It has a tiled roof with decorative ridge tiles and there are wooden doors at its entrance in the east elevation, above which is a small window at first floor level.

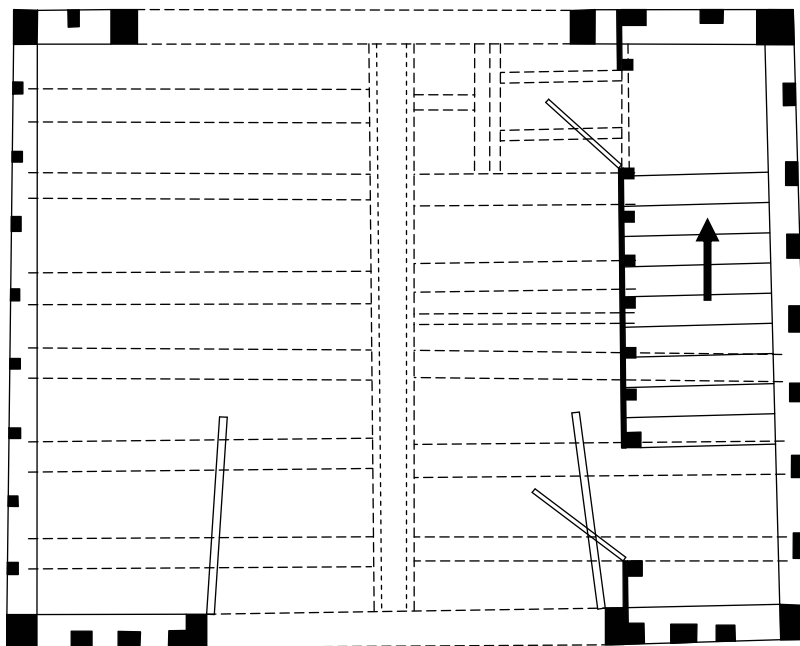
**Figure 2: Ground floor plan** (scale 1:50)

The floor is supported by an east-west aligned principle joist and a series of north-south aligned common joists whose outer ends rest on top of the end girts (Figure 2). The common joists were laid flat and have average dimensions of 200mm by 150mm. The pattern of joists is interrupted in the north-east corner of the floor where a trimmer joist suggests the presence of an earlier stair opening which has been filled. An area of narrow floor boards on the north side of the room was probably a later replacement, possibly associated with the alterations to the stair opening. The existing stair in the north end of the building emerges in the north-west corner of the room with the opening guarded on two sides by a roughly constructed wooden rail.

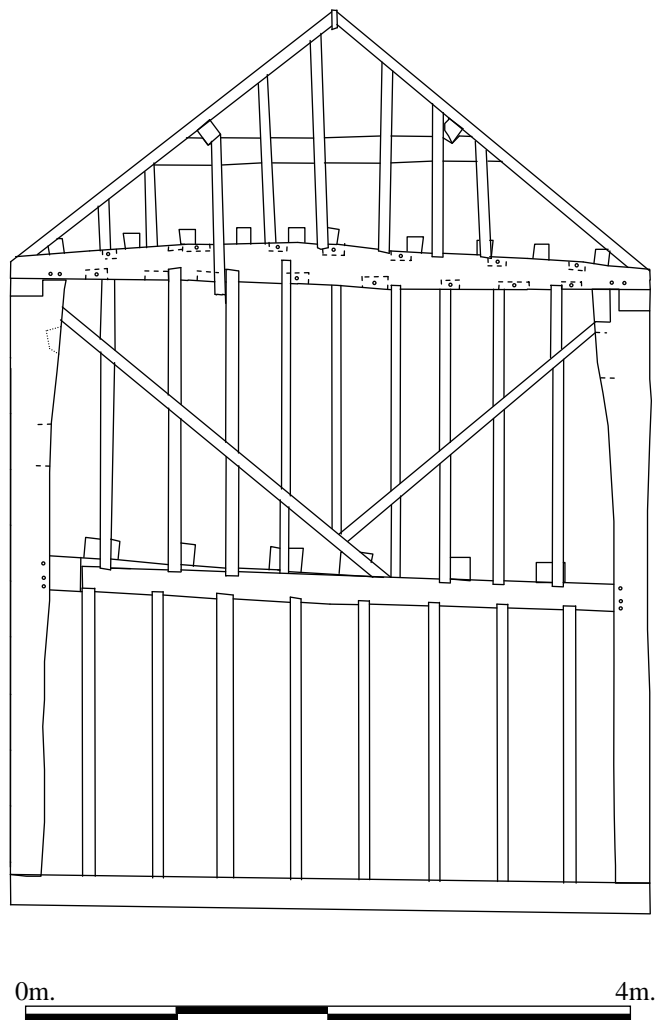
**Figure 6: South elevation (scale 1:50)**

The frame at the south end has been largely rebuilt in the modern period. The original elements comprise the tie beam, corner posts, side girt and sill beam (Figure 6, Plate 15).

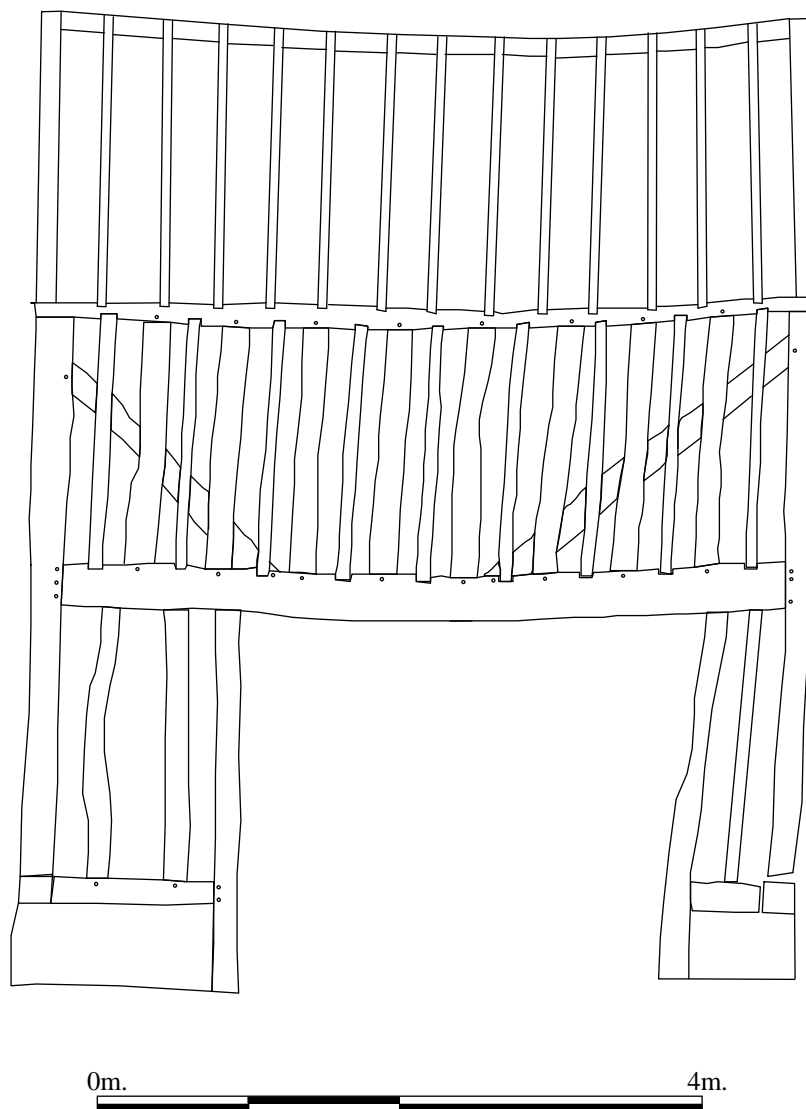
**Figure 7: West elevation** (scale 1:50)

The frame on the west/rear side of the gatehouse survives intact with minor later additions (Figure 7, Plates 4 and 16). It has a wide opening at ground level and a continuous wall at first floor level with no evidence for any openings. The frame has closely set studs, pegged at top and bottom. The studs at first floor level have assembly marks on their lower ends. Roman numerals cut with a chisel from I to VIII start at the south end of the wall. The wall is braced by two diagonal down braces of relatively thin section which are let into recesses in the studs. Stave holes and groves indicate former wattle and daub infill with three vertical staves and one mid height horizontal stave to each panel.

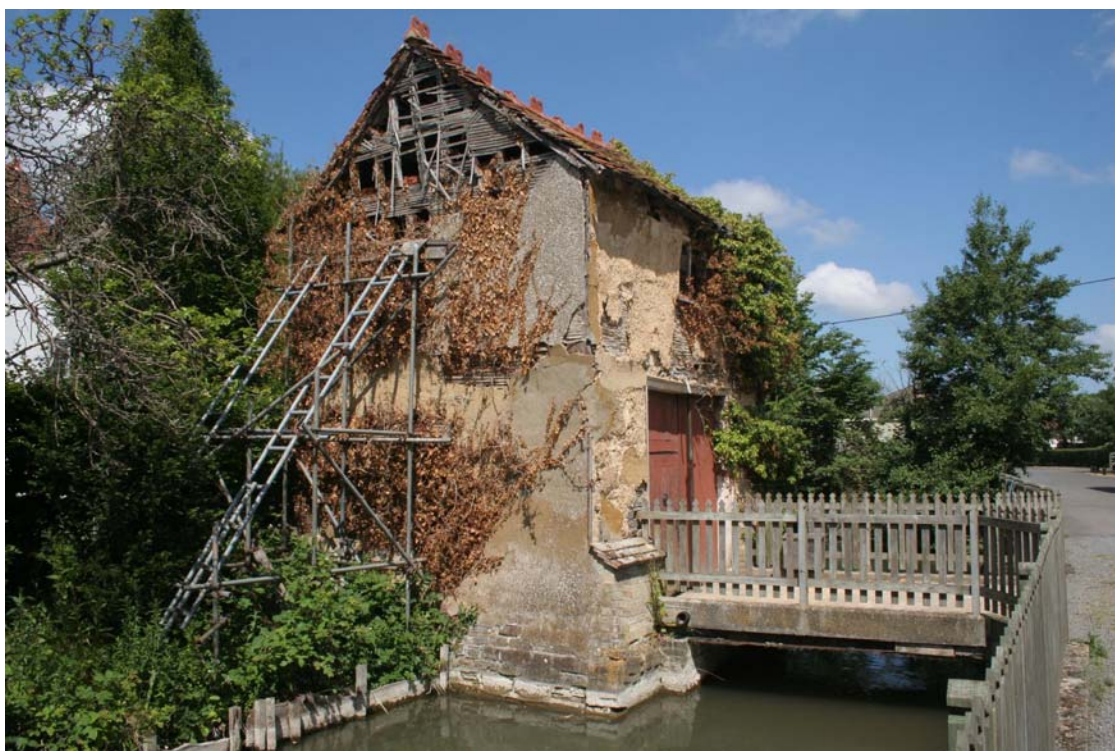
**Plate 6: South elevation**

The end walls (north and south) consist of plain gables with a roughcast finish on riven laths (Plates 6 and 7).

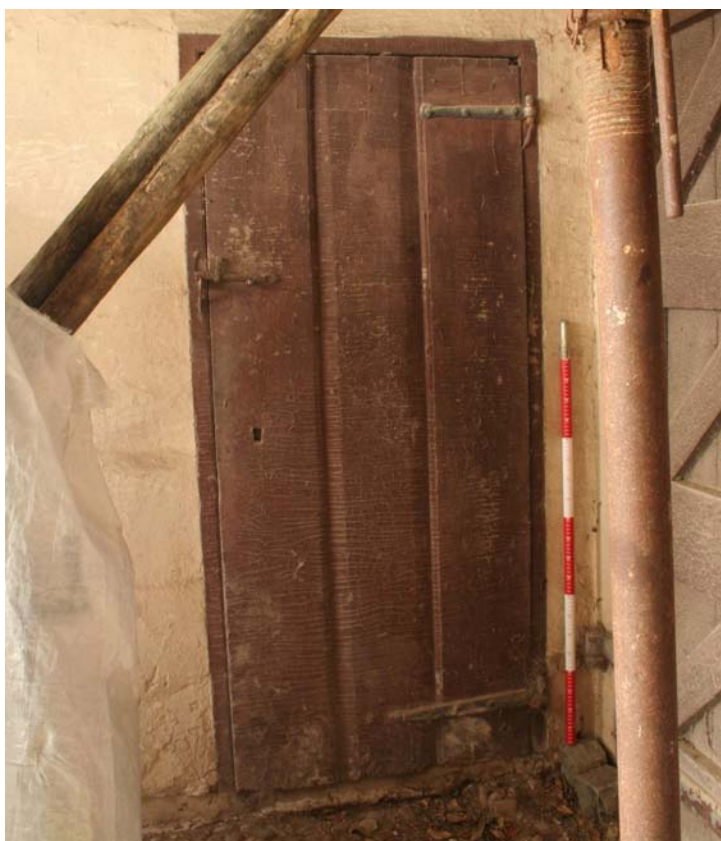
**Plate 9: Ground floor interior, detail**  
(Door to stairs)

The stair door is a plank and batten door made up of three planks with four battens on the rear side (see drawing below and Plate 9). The outer planks have simple moulded rebates where they meet the central plank which has chamfered edges. A similar treatment appears on a door from Suffolk dated to 1614 (Hall 2005, p37, fig 2.44); however in that case the door is made up of multiple, narrow planks. In this case the appearance is similar to a type of three plank door referred to as a creased door, in which the central plank is given prominence (Brown 1986, 130 and Heritage Directory 2010). Creased doors date from the later sixteenth and seventeenth centuries.

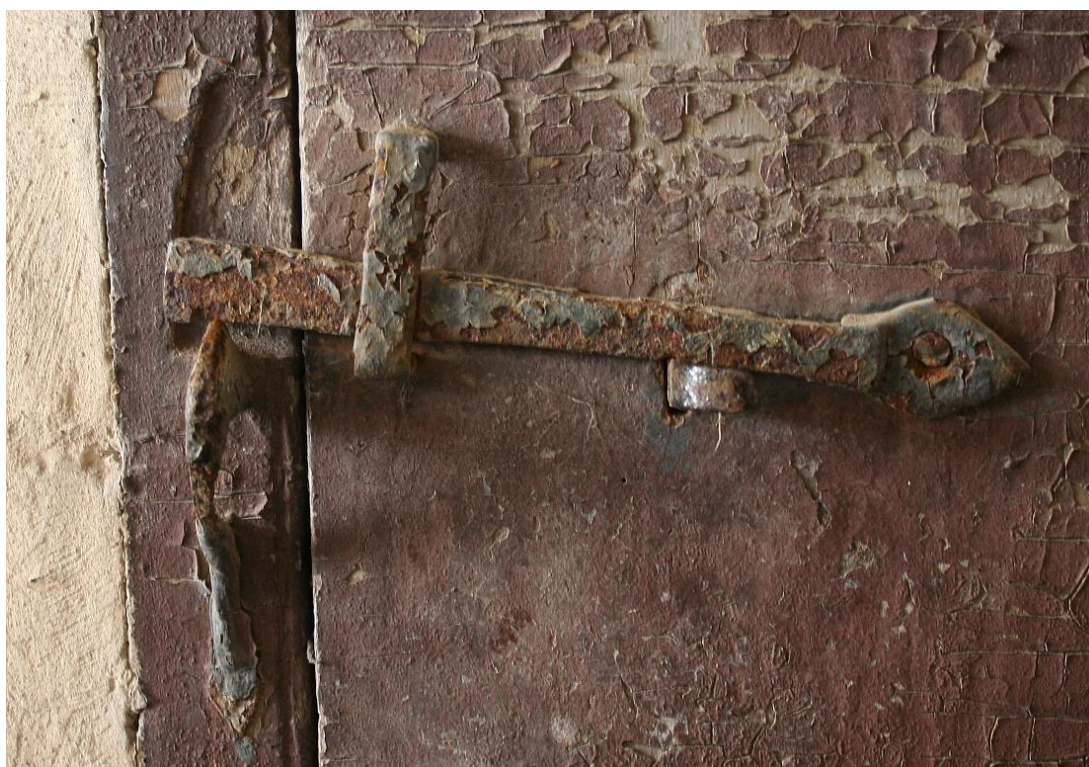
**Plate 10: Ground floor interior, detail**  
(Latch on door to stairs)

The cupboard door is also plank and batten, with bead mouldings along the rebate on the inner and outer faces of the door (Plate 11). Both this door and the stair door have iron latches and latch fasteners of a type in use during the 17th and 18th centuries (Plates 10 and 12). The latch on the cupboard door is decorated with a saltire cross between vertical lines, a form of decoration which went out of use during the 18th century (Hall 2005, p58-60).

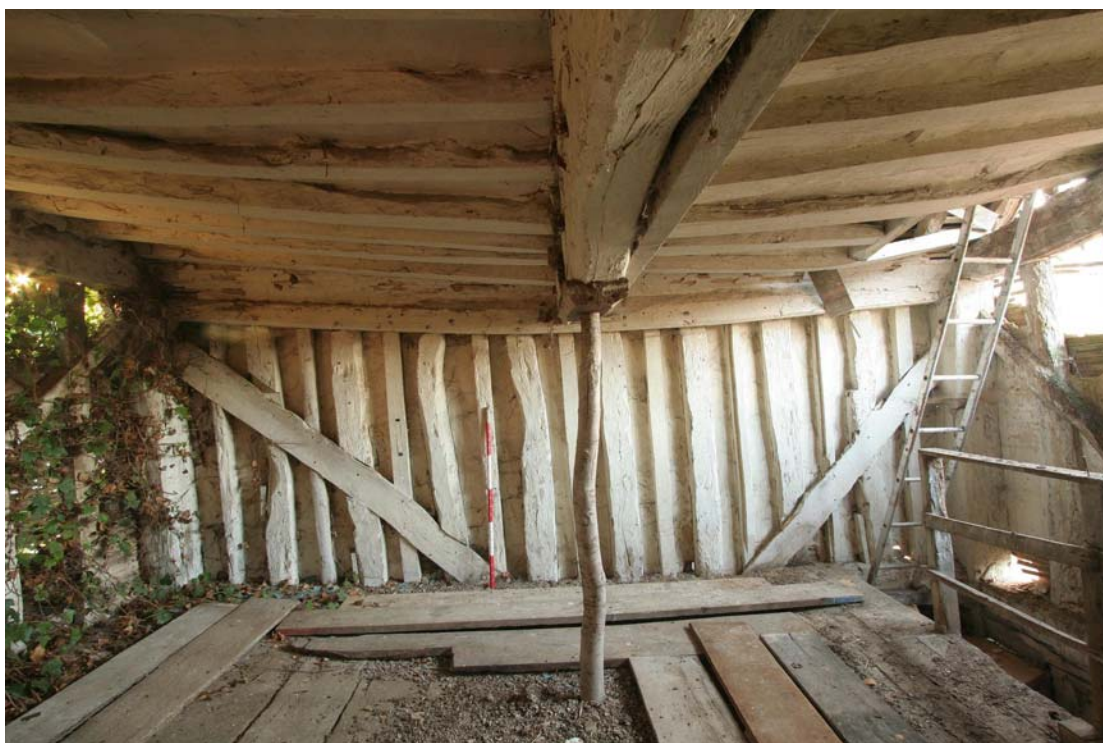
**Plate 16: First floor interior, west wall**

The ceiling of the first floor room was supported by a central, cambered tie beam aligned east to west (Plates 14, 16 and 19). A series of at least six peg holes situated close to the upper edge of the beam suggest that it once supported studs. The underside of the beam contained two long mortises with double peg holes. These were situated close to the ends of the beam and probably held the upper end of arch braces. The walls beneath either end of the beam showed no corresponding mortises for braces, possibly suggesting that the tie beam had been reused in this position.
