**HARRINGWORTH MANOR COTTAGES
HARRINGWORTH, NORTHANTS**

ARCHAEOLOGICAL BUILDING RECORDING

Document: 2014/8
Version: 1.0
January 2014

Albion Archaeology Project Code: HMC2319

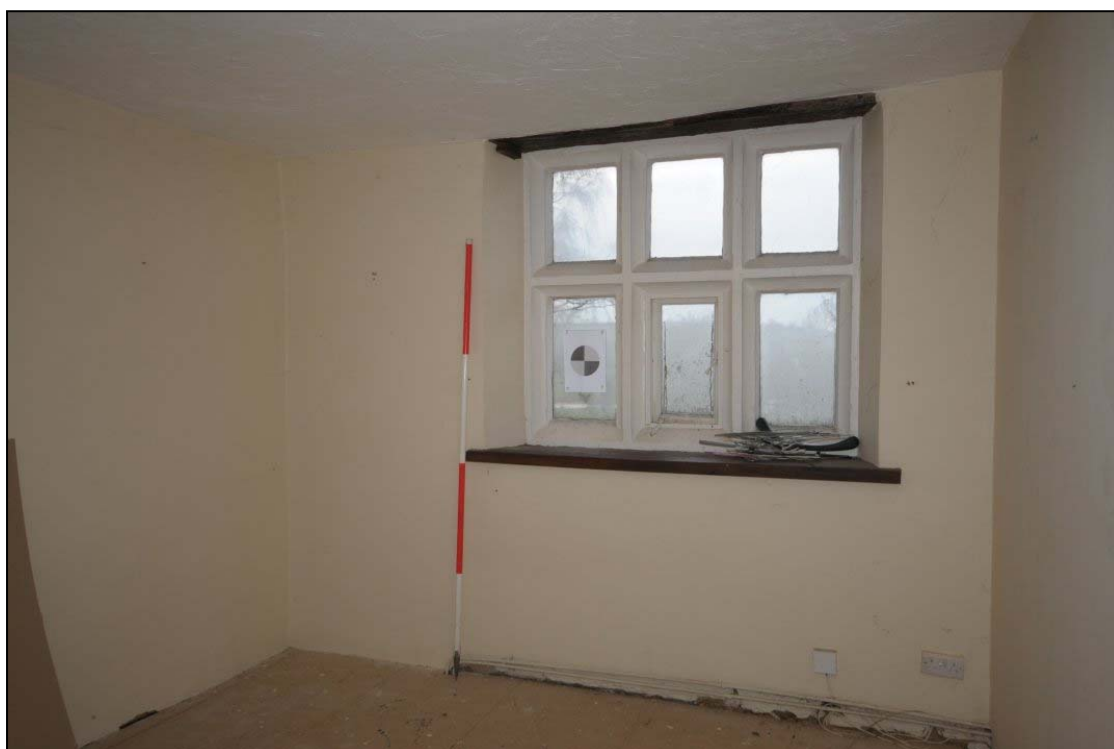
Figure 48: Room F5, facing north-west

A limestone three light window with a transom in the north wall is located slightly left of centre in the west wall (Fig. 48). The mullions and underside of the transom have hollow chamfers. The lower section of the central light contains a modern wood casement.

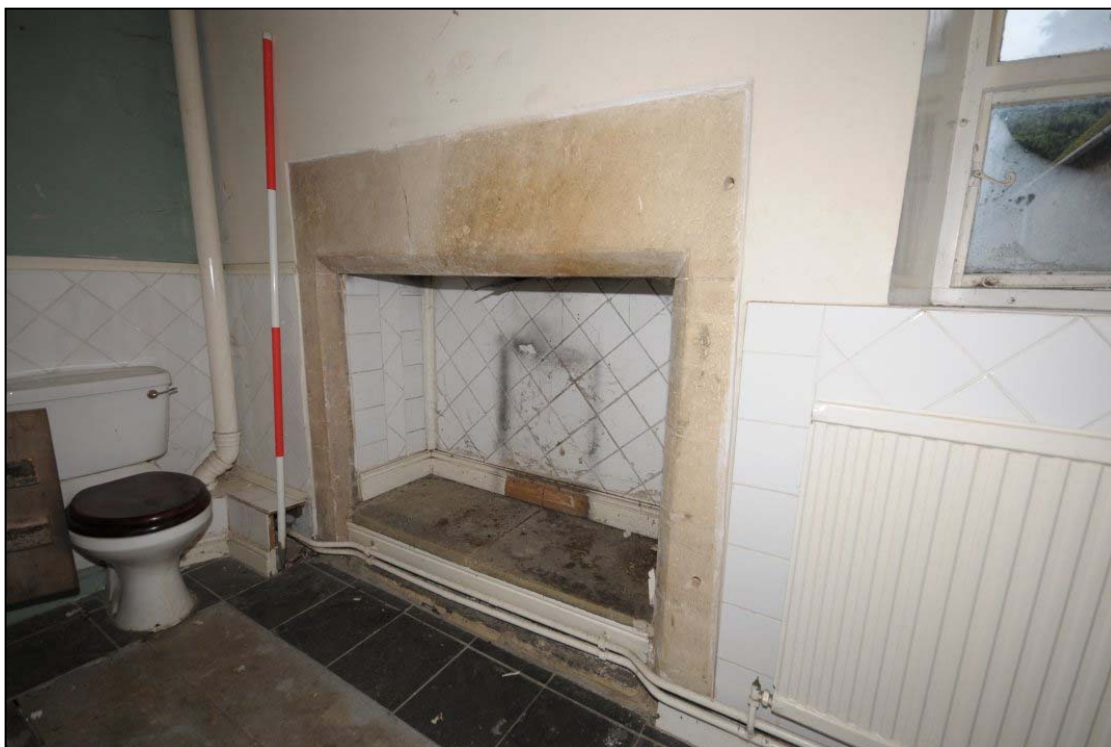
Figure 51: Room F5, facing north-east

The east wall of the bathroom contains a finely dressed limestone fireplace with square-headed opening with a plain chamfer (Fig. 51).

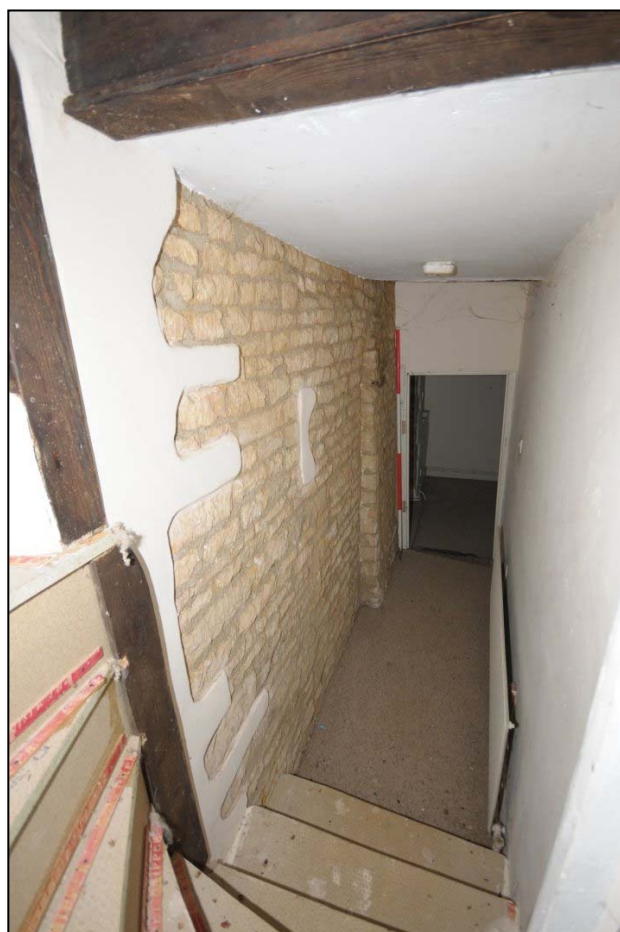
**Figure 52: First floor corridor,
facing east**

A change in thickness in the exposed limestone walling forming the north side of the room indicates a break in the masonry (Fig. 56) which can also be seen at first floor level (Fig. 52).

Shows corridor between stairs to
S3/S4 and the western first floor
landing

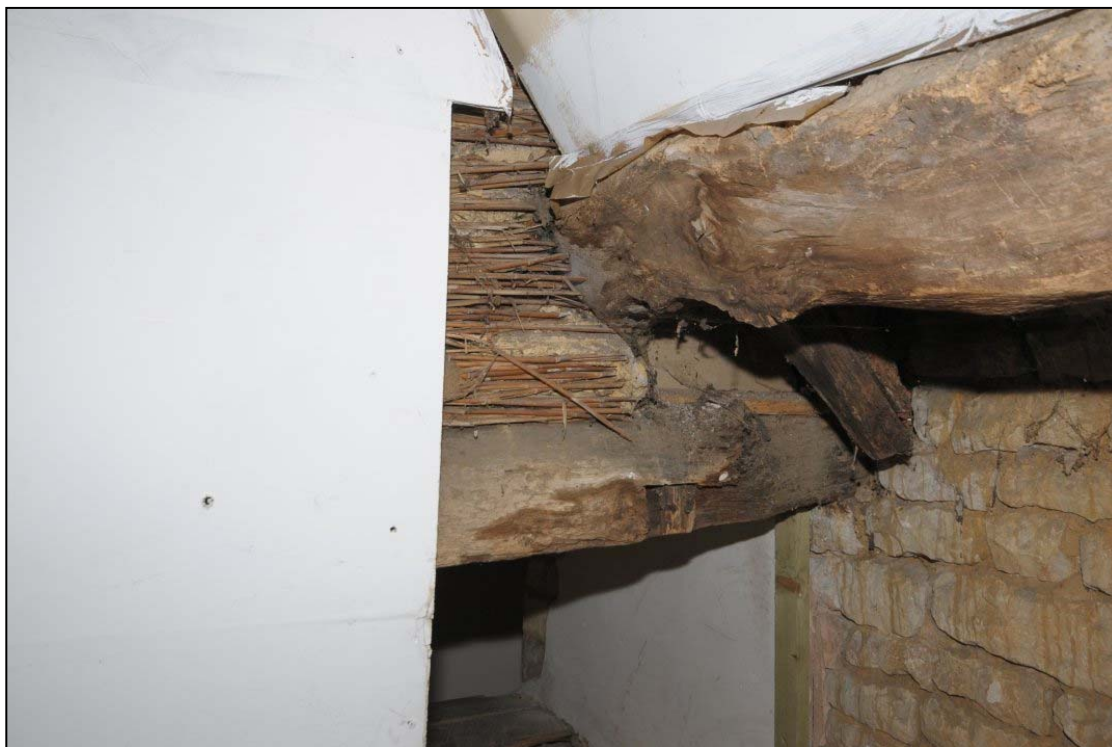
Figure 57: Attic S2, detail of reed and daub/plaster infill

This is a narrow attic space located towards the west end of the south range, and located between two roof trusses. Its walls and ceiling are lined with plasterboard or fibre board partitions and the floor is carpeted. A small section of reed and plaster lining is visible above the current small access at the north end of the west wall (Fig. 57). Few details of the roof structure are visible in this compartment, but a cut-off stub of an earlier purlin is visible below the current purlin in the southern side of the roof.

Looking north-west, above access hatch into compartment
