**FALCON COTTAGE
VILLAGE ROAD
DENHAM
BUCKINGHAMSHIRE**

**HISTORIC BUILDING RECORDING
AND
ARCHAEOLOGICAL OBSERVATION,
INVESTIGATION, RECORDING, ANALYSIS AND
PUBLICATION**

Project: FCD2732
Museum accession no: AYBCM 2015.164
OASIS ref.: albionar1-233910

Document: 2016/88
Version: 1.0

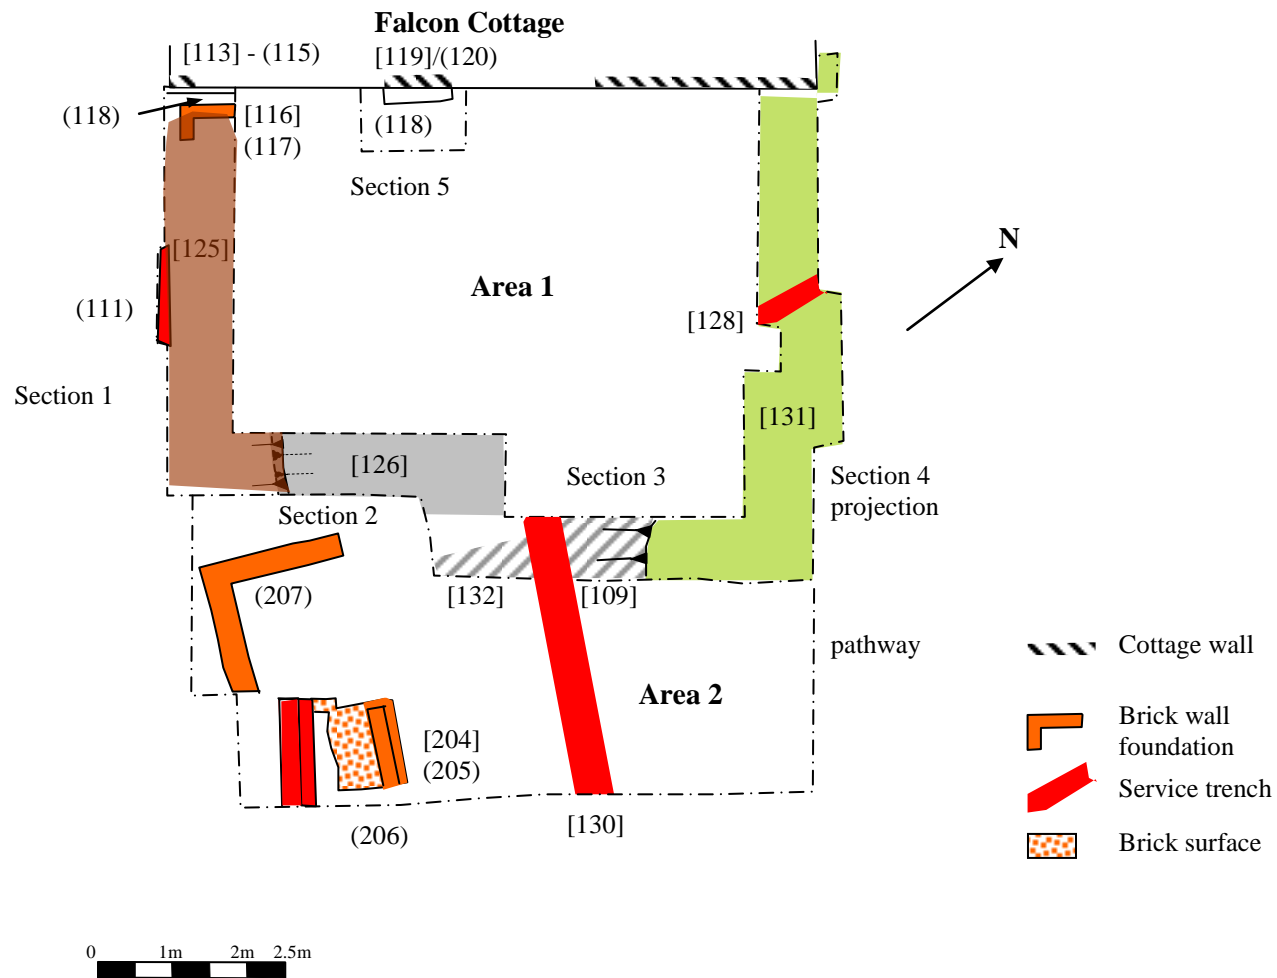
Figure 9: Plan of features revealed during the observation works

In the southern part of the site an extensive NW-SE aligned feature was traced for 4.9m (light brown feature on Figure 9); it appeared to stop at the eastern limit of footing trench. The pit was at least 1.7m wide and up to 0.82m deep, with a steep northern edge and roughly flat base (Figure 10: sections 1 and 2; Figure 13: image 32). The upper deposit (101) was mid brown-grey sandy gravel up to 0.6m thick, which faded out to the west. This deposit contained fragments of brick and tile. Below this was a more extensive mid grey-brown, loose, gravelly sand deposit (102), which was up to 0.54m thick in the west.

Extensive deposits were revealed in the northern part of the site, extending at least 6.5m by 2.5m — the full length of the northern footing trench (Figure 9). The upper deposit (107) comprised up to 0.5m of loose, dark brown to black, gravelly clay. This sealed a mid brown-grey sandy gravel (108) that was up to 0.3m thick (Figure 10: sections 3 and 4). Three abraded and undiagnostic animal limb bone fragments (60g) were collected from (107) and (108). The latter also contained a sherd of 17th- to early 18th-century iron-glazed earthenware (48g).

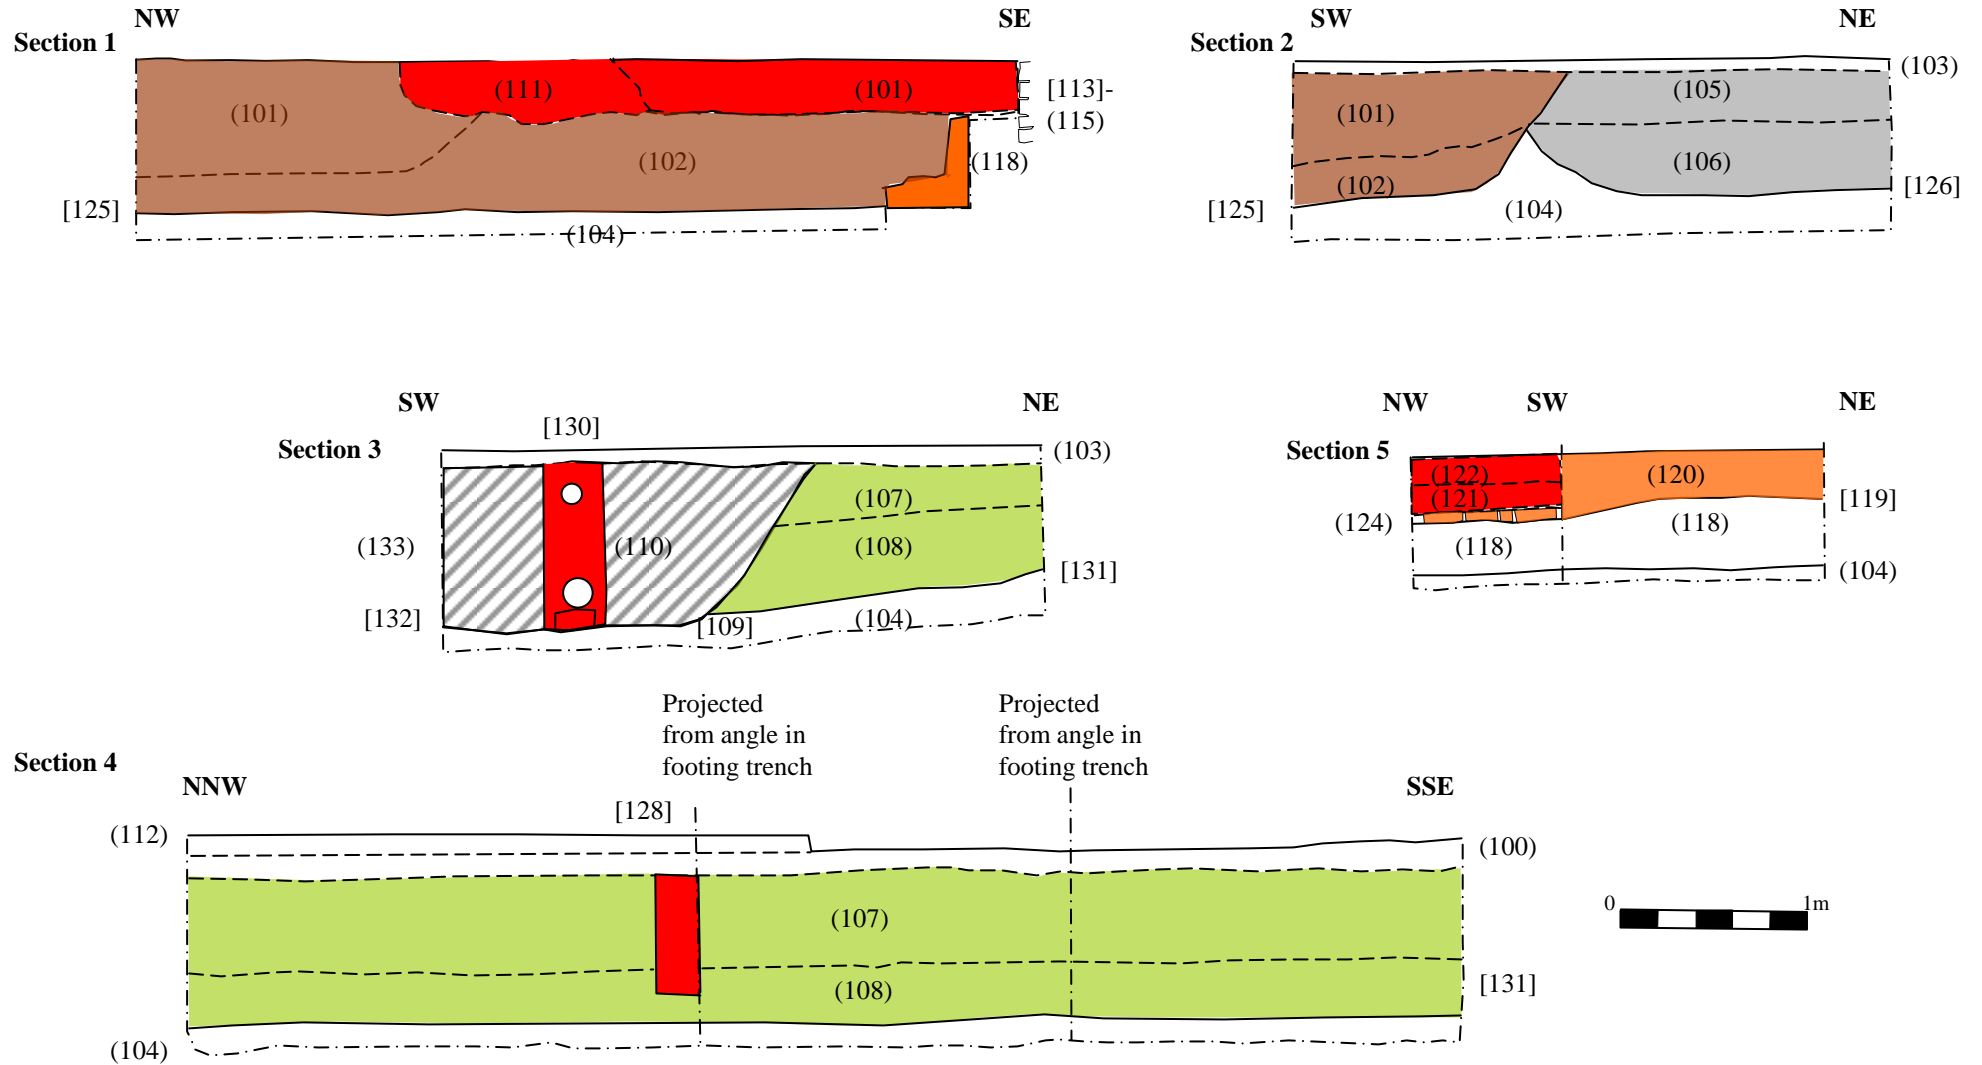
Figure 10: Selected sections 1 to 5

Located at the eastern margin of the extension footprint, this pit was bisected by a modern service trench. It was at least 2.9m north-south and 0.88m deep with a well-defined, steep northern edge and flat base (Figure 10: Section 3). The mid to dark orange-brown sandy gravel fill (110) / (133) contained an abraded piece of post-medieval (or later) sand-tempered flat roof tile (79g). To the south the continuation of this feature [132] was identified in a step in the eastern wall footing for the new extension (Figure 13: image 33). The pit truncated deposit (107) to the north.

Revealed in a narrow band adjacent to, and apparently extending beneath, the cottage wall footing was a black-brown sandy gravel layer (118). It was up to 0.4m thick (Figure 10: sections 1 and 5; Figure 11: images 28 and 29). Again, this may be a former cultivation soil, although less substantial than layer (107) to the east.

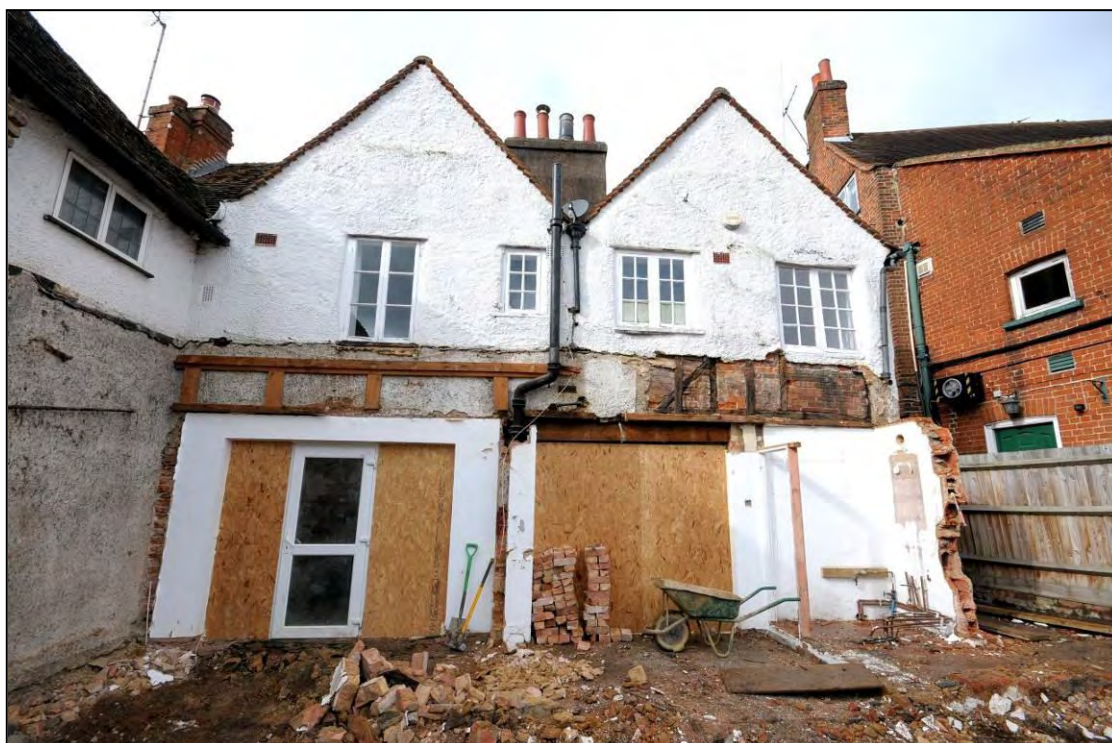
Image 4: Rear (east) elevation

Showing building after demolition of modern extension.

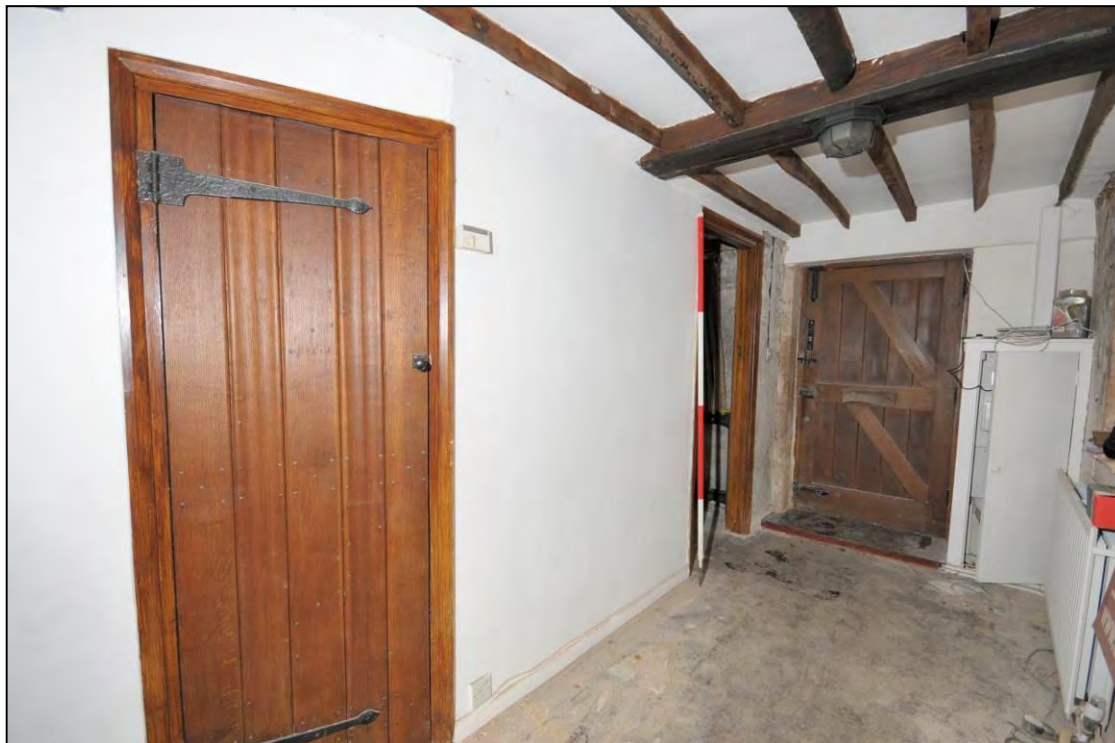
Image 6: Entrance hall

Shows ceiling beams continuing from adjacent living area and modern doors (Scale 2m).

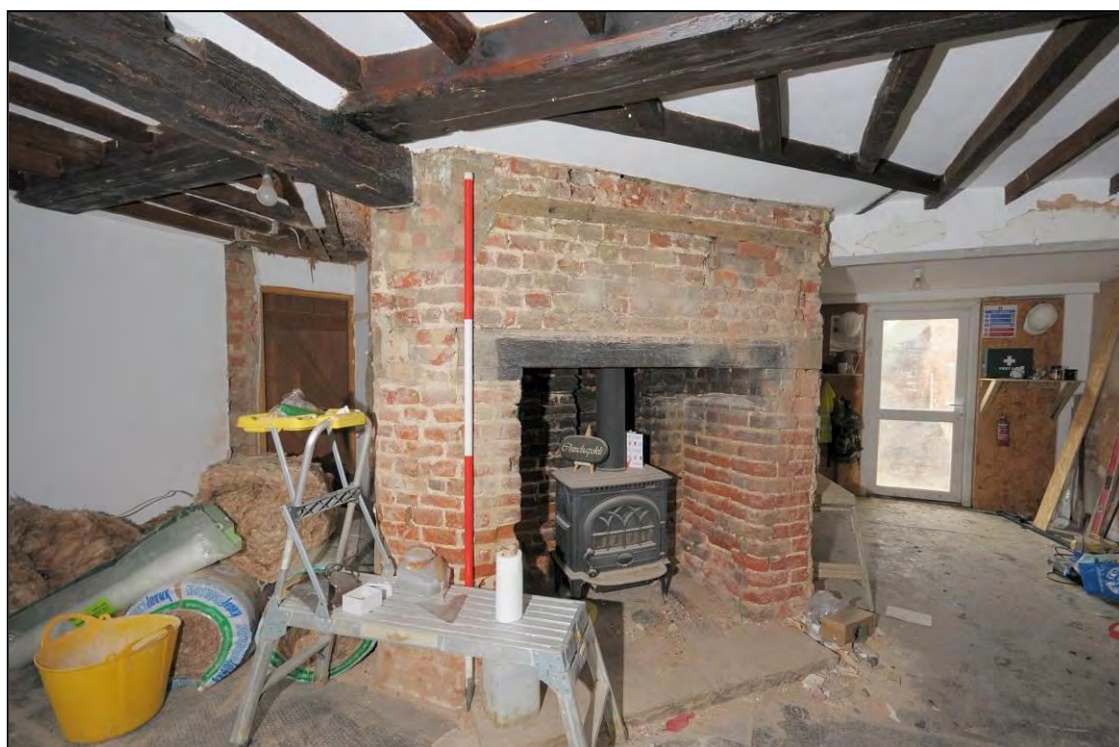
Image 8: Living area, general view looking east

Shows room opened up during modern alterations with right-hand side opened to the rear of the building (Scale 2m).

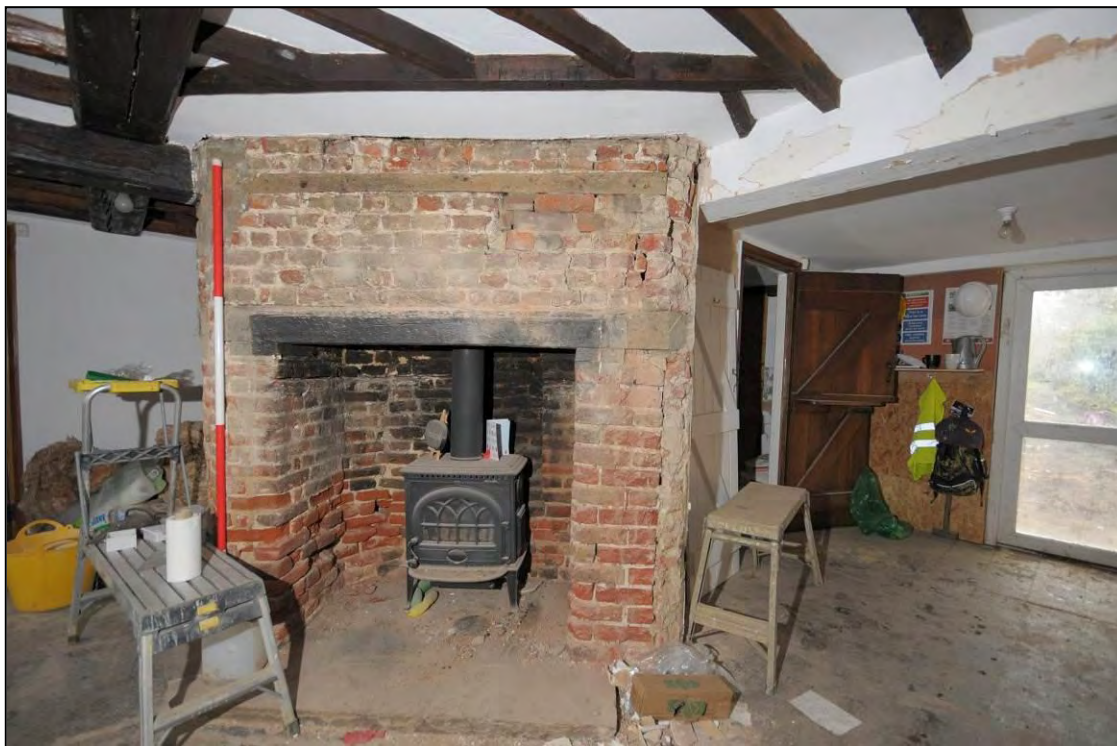
Image 9: Living area, southern fireplace

Looking north-east with boxed beam above opening to rear range at right
(Scale 2m).

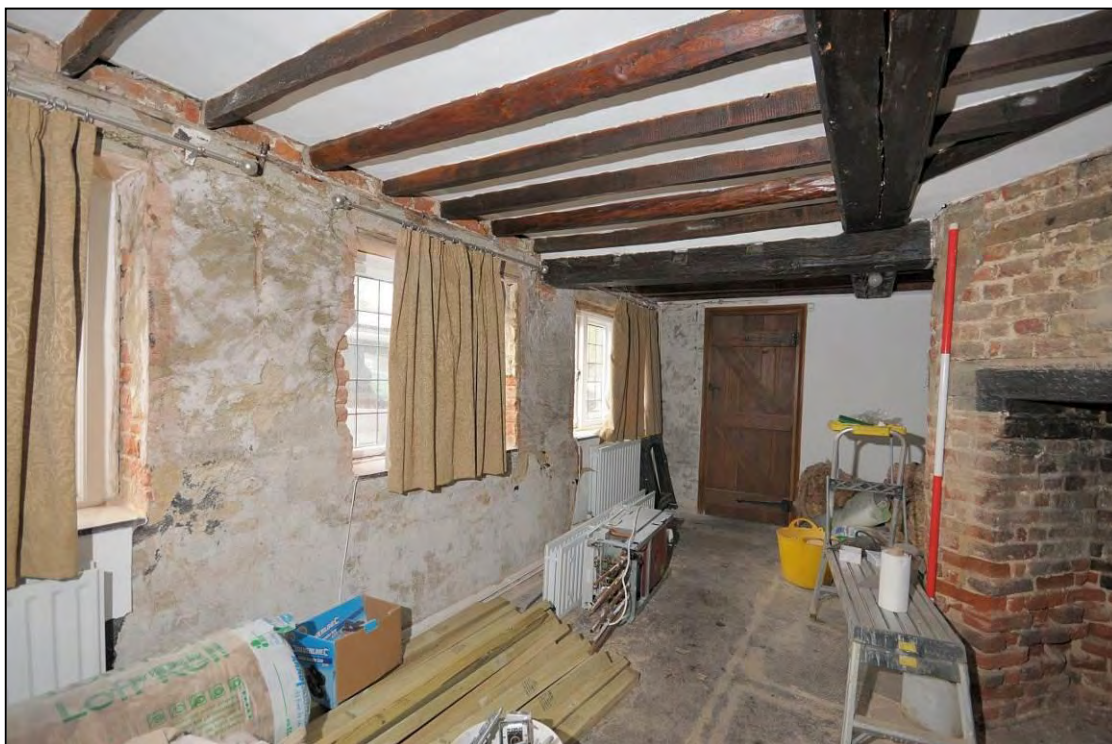
Image 10: Living area, general view looking north

Shows front range, looking north towards door to entrance hall (Scale 2m).

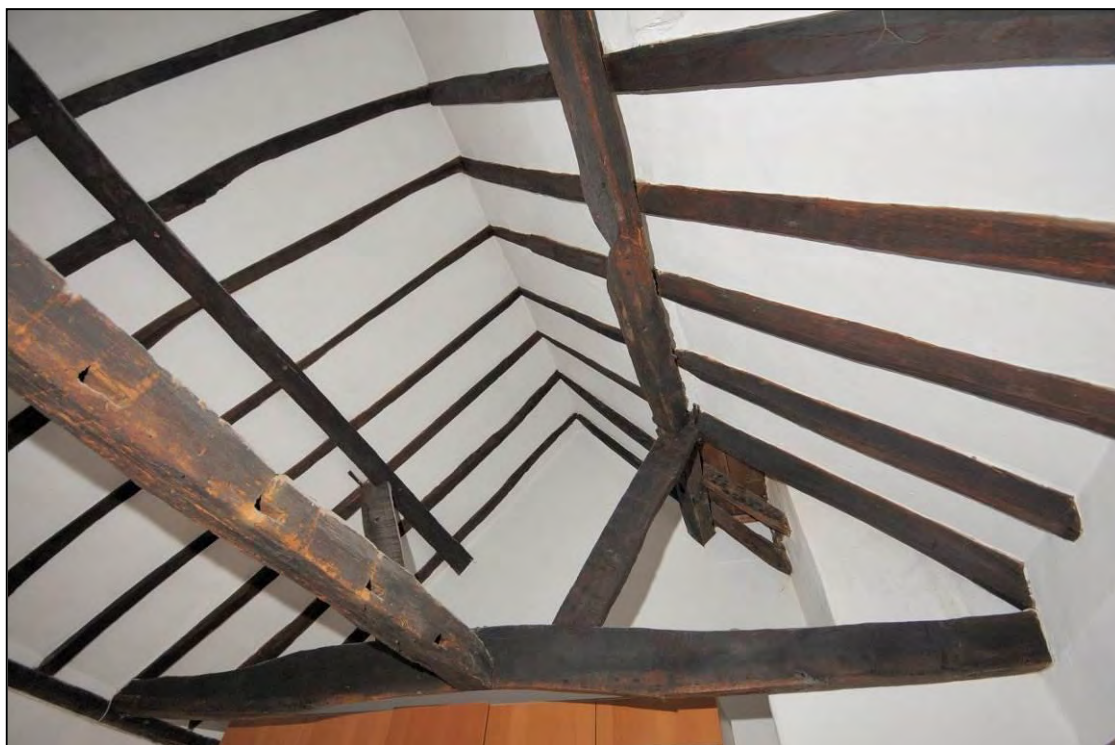
Image 15: Bedroom 1, roof

Looking north, showing roof axial beam (left) and tie beam with raking purlin struts and side purlins.

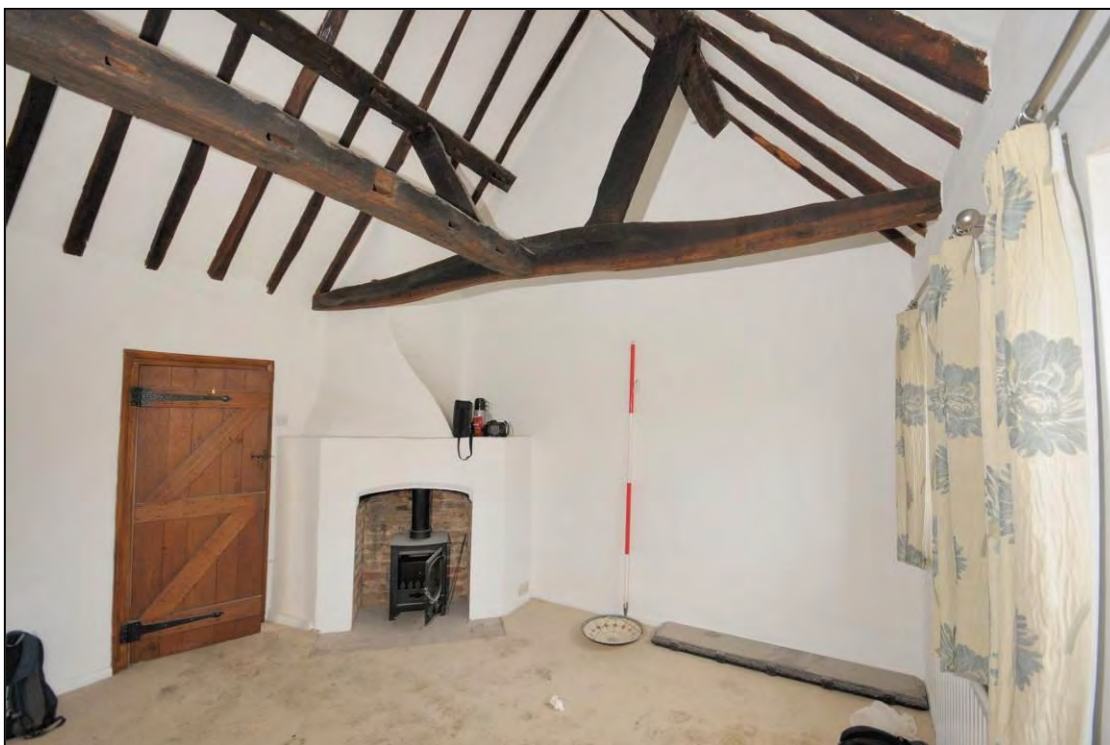
Image 17: Bedroom 2, looking south-east
Showing corner fireplace and roof truss (Scale 2m).

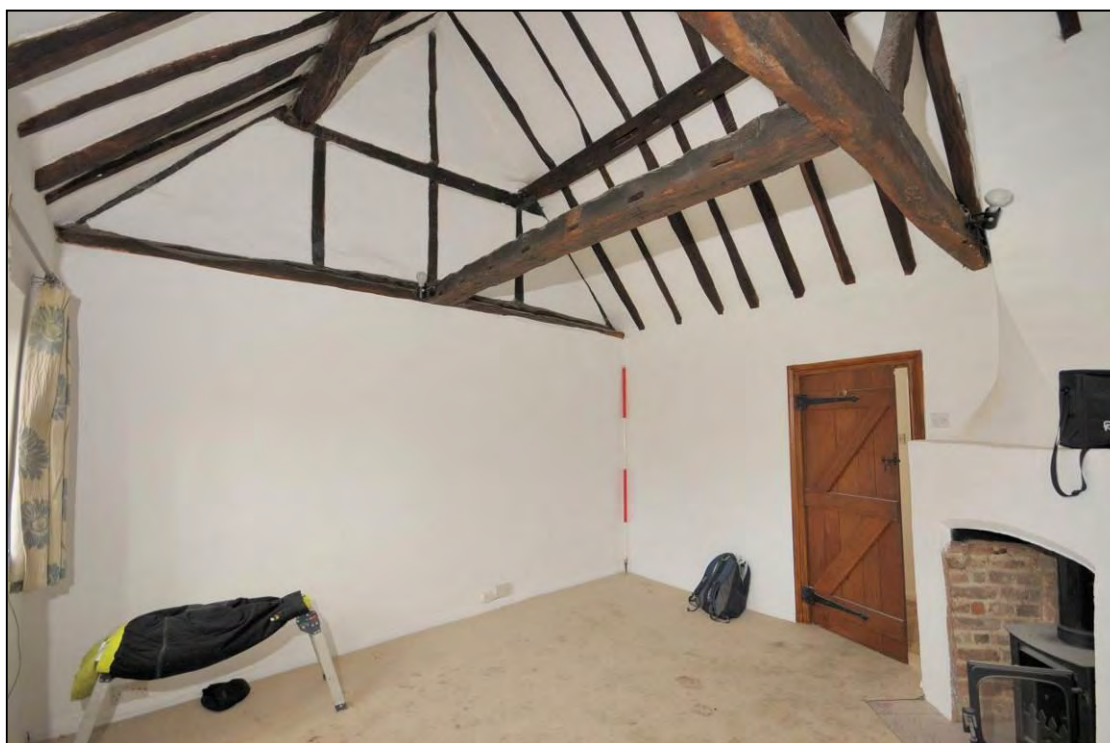
Image 18: Bedroom 2, looking north-east
Showing timber frame in end wall and axial beam with empty mortise holes for ceiling/attic floor (Scale 2m).

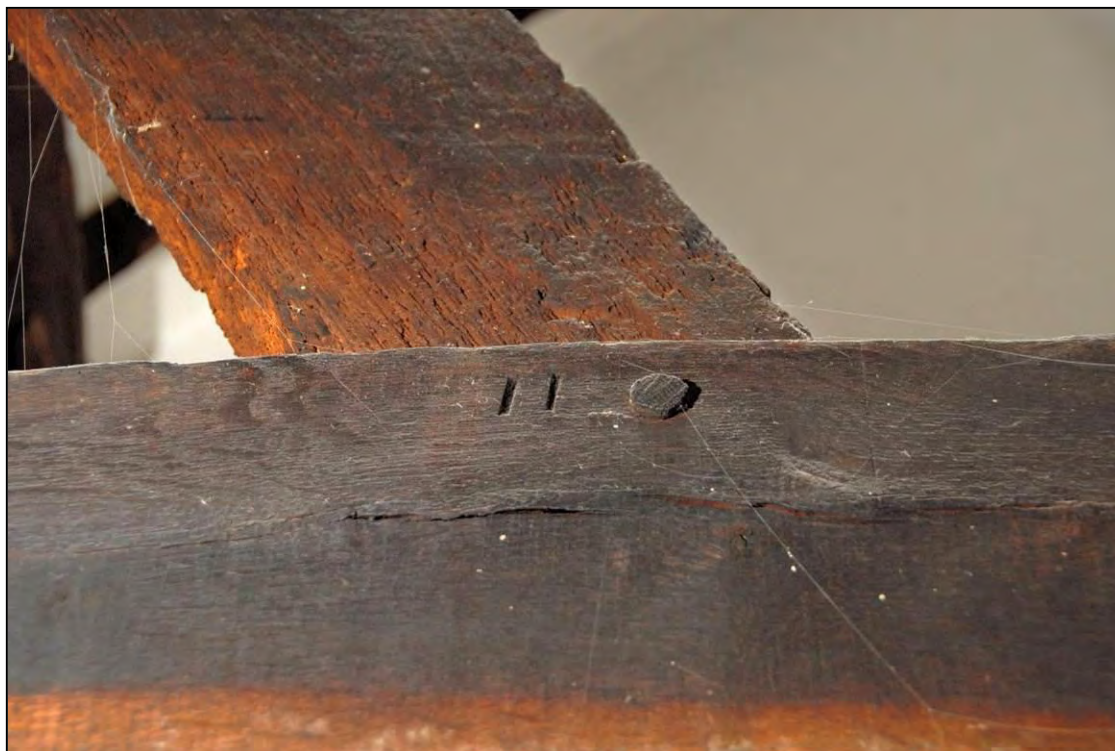
Image 20: Bedroom 2, detail of assembly mark

Assembly mark cut into north face of tie beam at base of left-hand raking purlin strut.

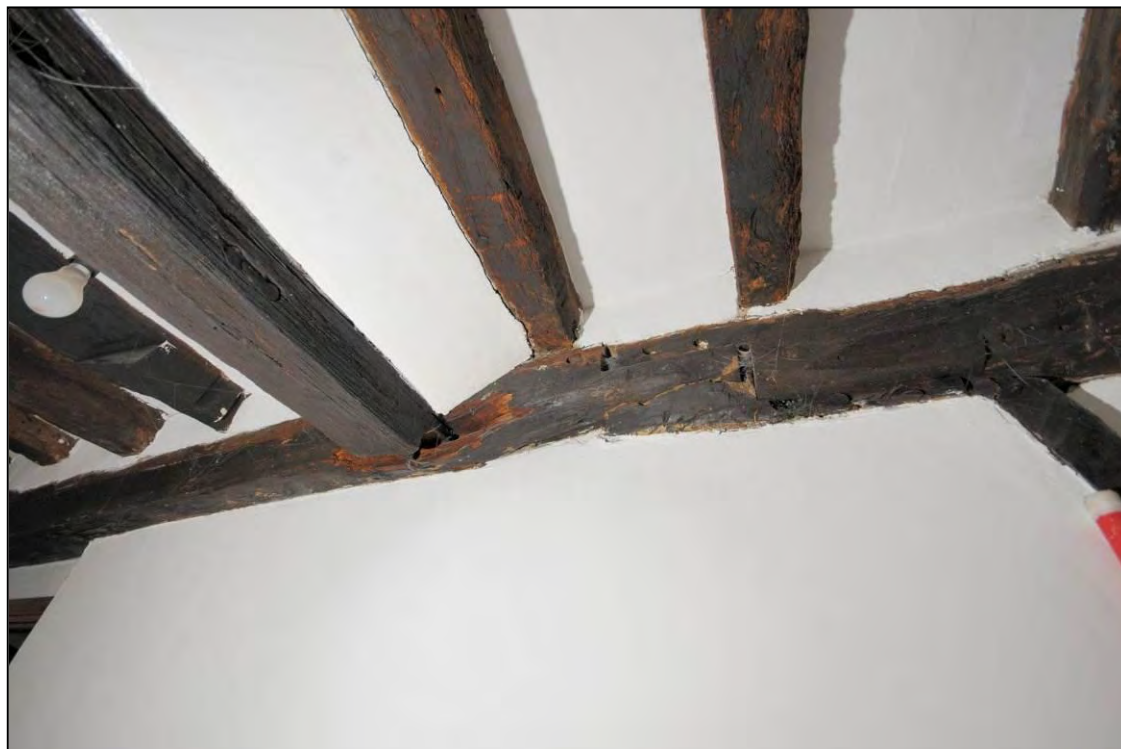
Image 21: Rear range, corridor

Looking west, showing beam supporting valley between gables (at left) and face-halved scarf joint in wall plate in rear wall of front range (centre/right).

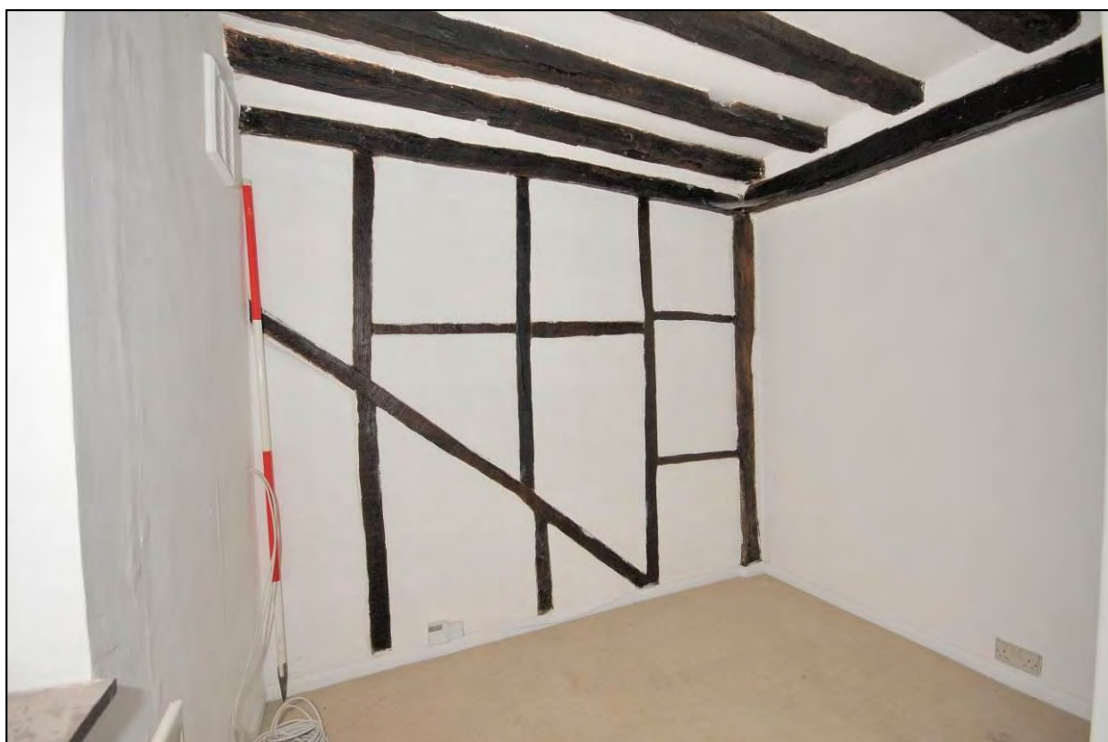
Image 22: Rear range, study

Looking south-west, showing primary bracing in southern wall (Scale 2m).
