**CHURCH OF ST PETER
ARLESEY
BEDFORDSHIRE**

ARCHAEOLOGICAL WATCHING BRIEF

Project: SPA3412
OASIS ref.: albionar1-348426
Museum accession no.: BEDFM 2019.43

Document: 2019/46
Version 1.0

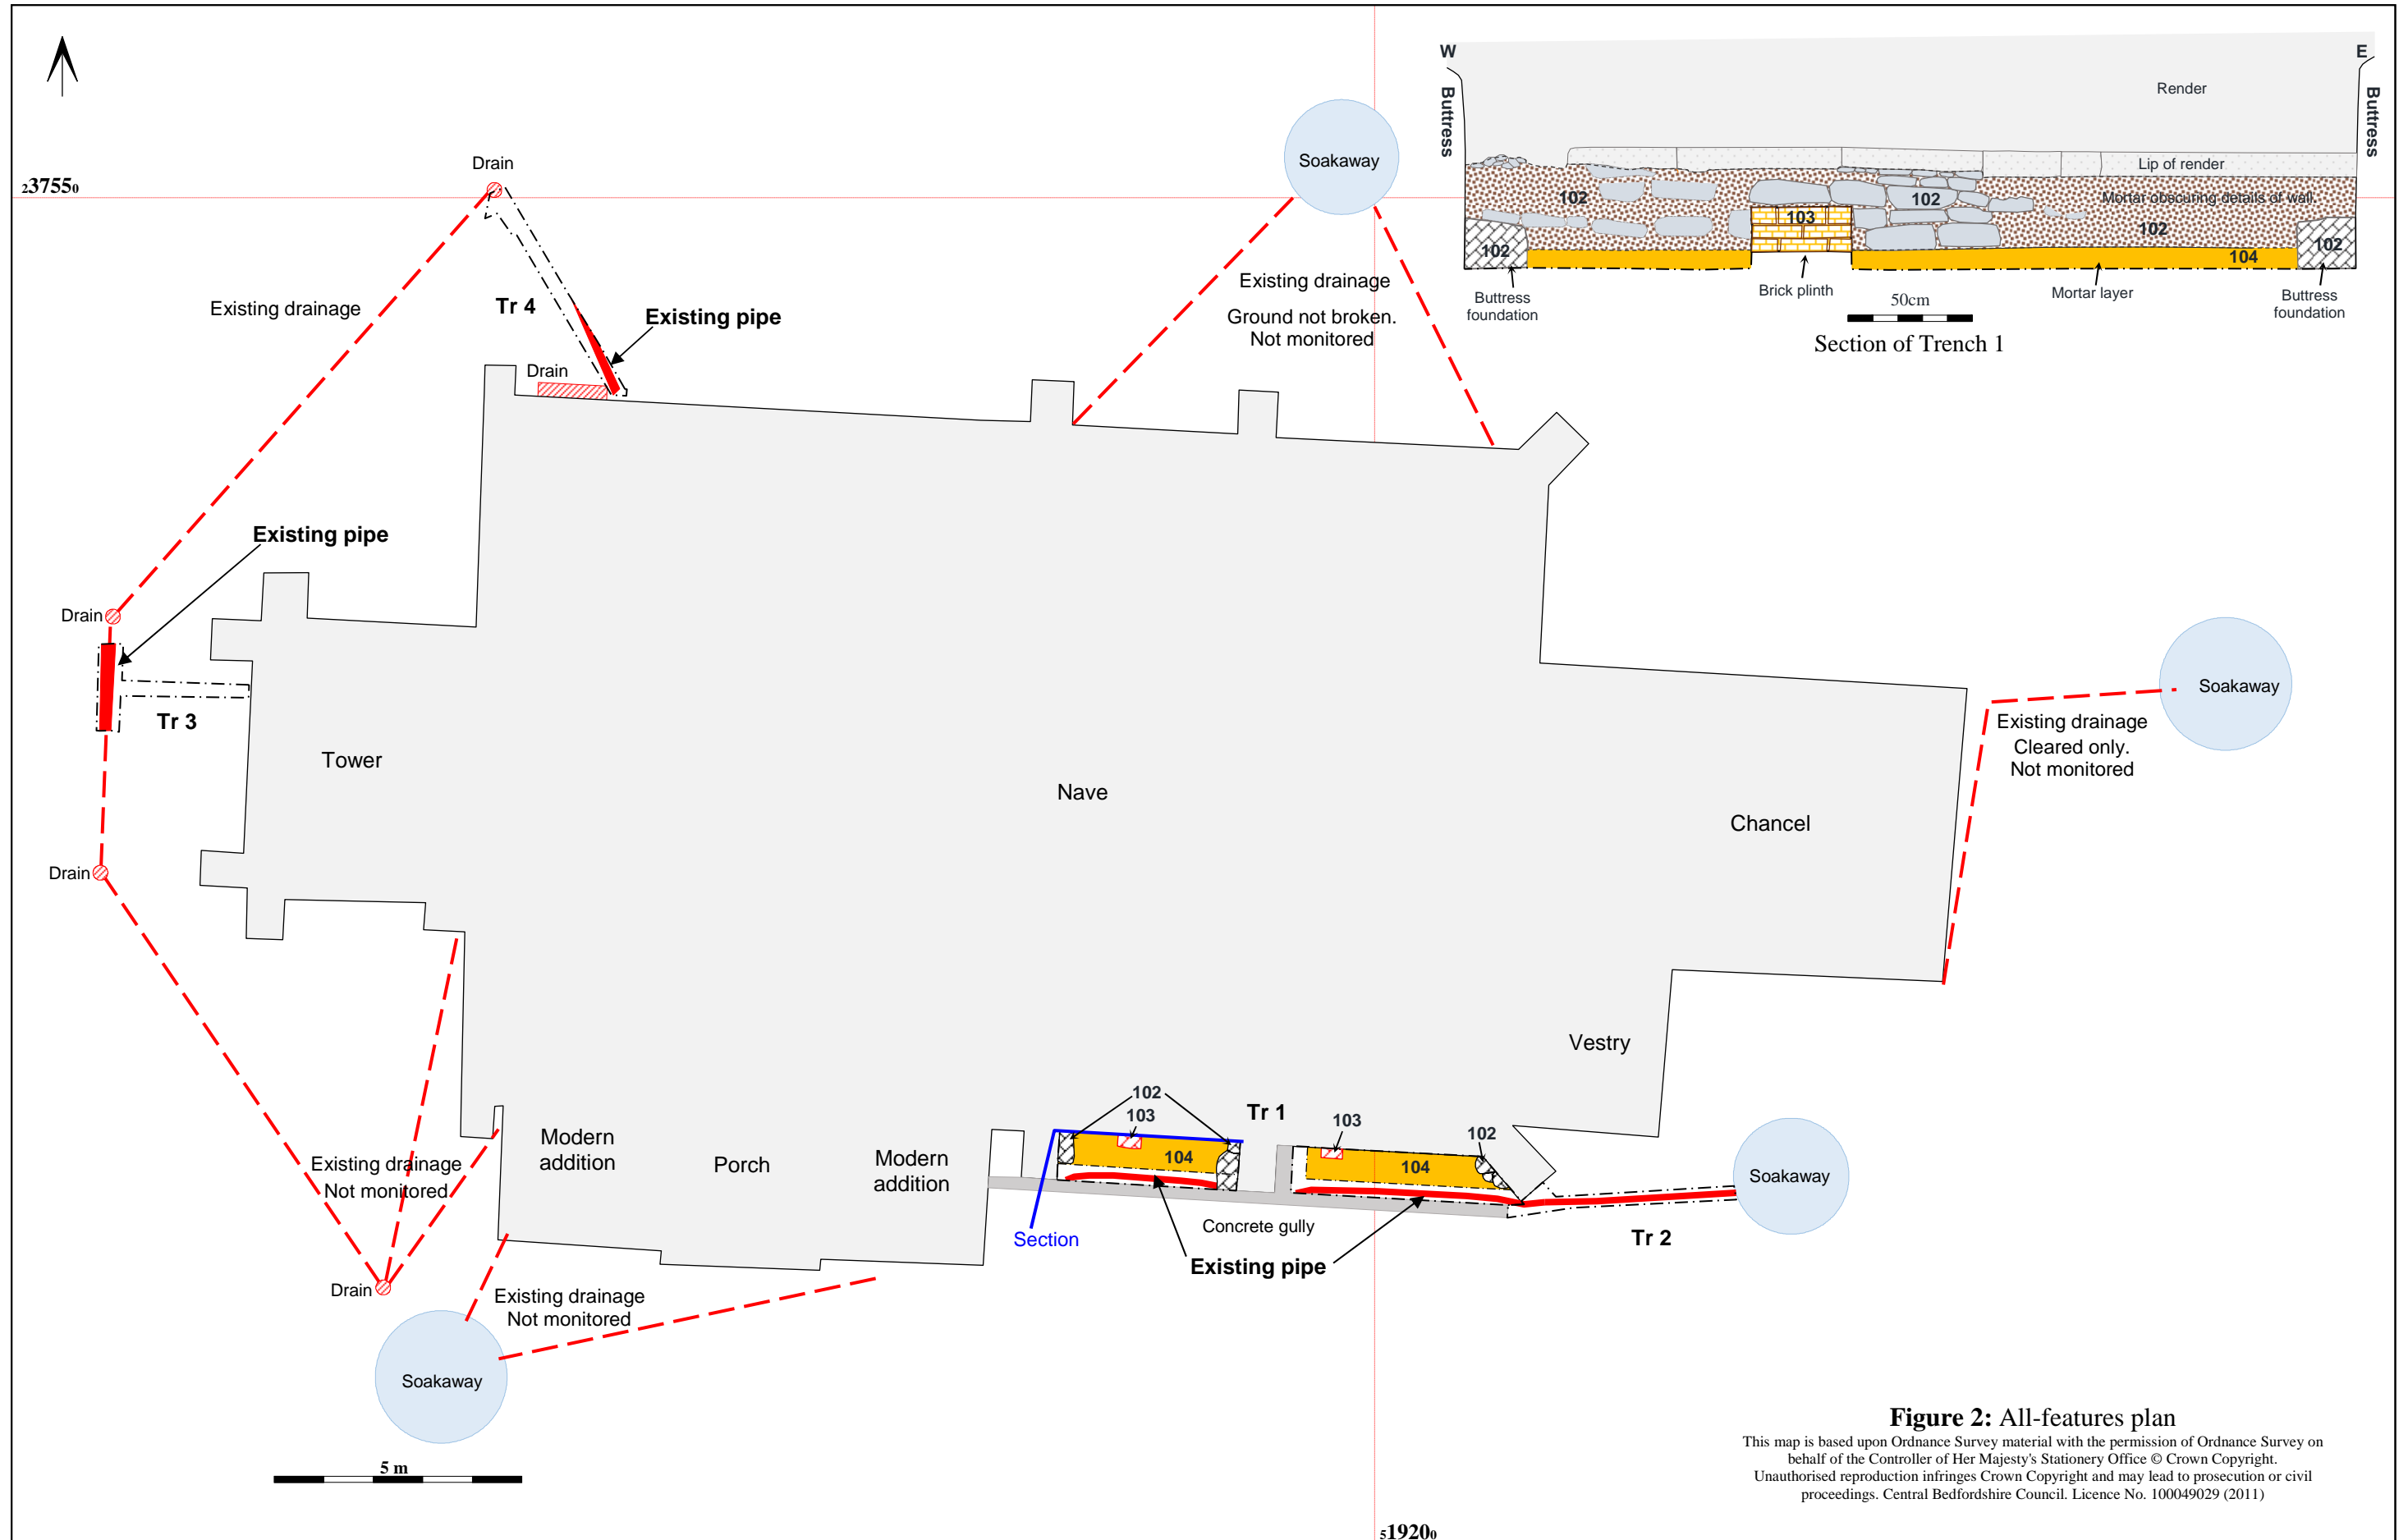
Figure 2: All-features plan

The French drain trench was 1m wide and c.0.85m deep (Figures 2 and 3). All other new drains measured 0.3m wide and 0.7m maximum depth. Several existing drains were cleaned only and hence not monitored.

A drain was excavated 1.5m south of the vestry, connecting the east end of Trench 1 with an existing soakaway 3m south of the chancel (Figure 2.). The trench was 5m long x 0.3m wide x 0.6m deep.

Trench 3 was excavated east-west, perpendicular to the 19th-century tower. It was 2.6m long x 0.3m wide x 0.45m deep and ran from the tower wall through the tarmac path to form a T-shaped, 1.4m-long north-south end. This end of the trench cut through the edge of the graveyard to connect with an existing drain (Plate 4; Figure 2). None of the tower foundations were exposed and no human remains were disturbed.

Trench 4 was aligned NW-SE and was excavated from an existing drain close to the north-west corner of the nave. It extended for 5m to meet an existing manhole (Plate 5; Figure 2). The first 2.6m of this trench, from the manhole, broke new ground but thereafter followed an existing pipe trench to the north-east corner of the nave (Plate 5).
