**157 BEDFORD ROAD
WOOTTON
BEDFORDSHIRE**

**ARCHAEOLOGICAL OBSERVATION
INVESTIGATION AND RECORDING**

Project: BRW1728
Document: 2012/184
Version: 1.0
OASIS: albionar1-100638

25th October 2013

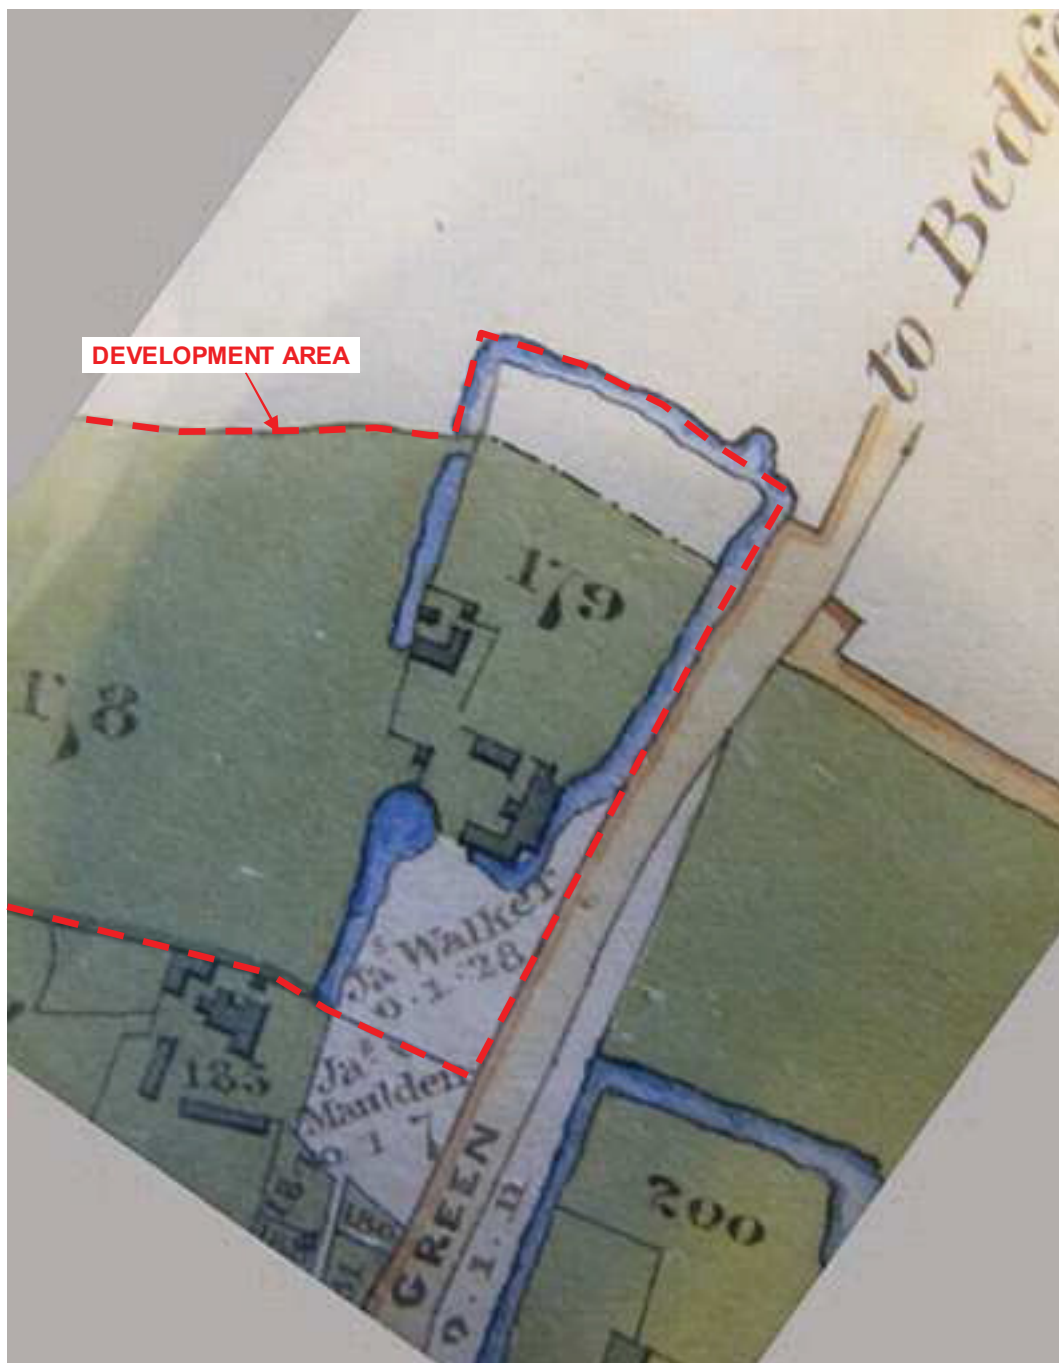
Figure 4: Detail from the Wootton Enclosure map (1838)

The parish map of 1838 (Figure 4) illustrates a small building located close to the north-east end of the end-stack dwelling and the boundaries of a small enclosure around the property that were probably defined by ditches. The ditch [703] may be associated with the small structure or the boundary ditches. The parish map also illustrates the presence of the end-stack dwelling but does not clearly illustrate the first build pantry. However, this is probably simply a drawing omission as the pantry is likely to be contemporary with the addition of the fireplace for the reasons discussed in section 3.4.4.

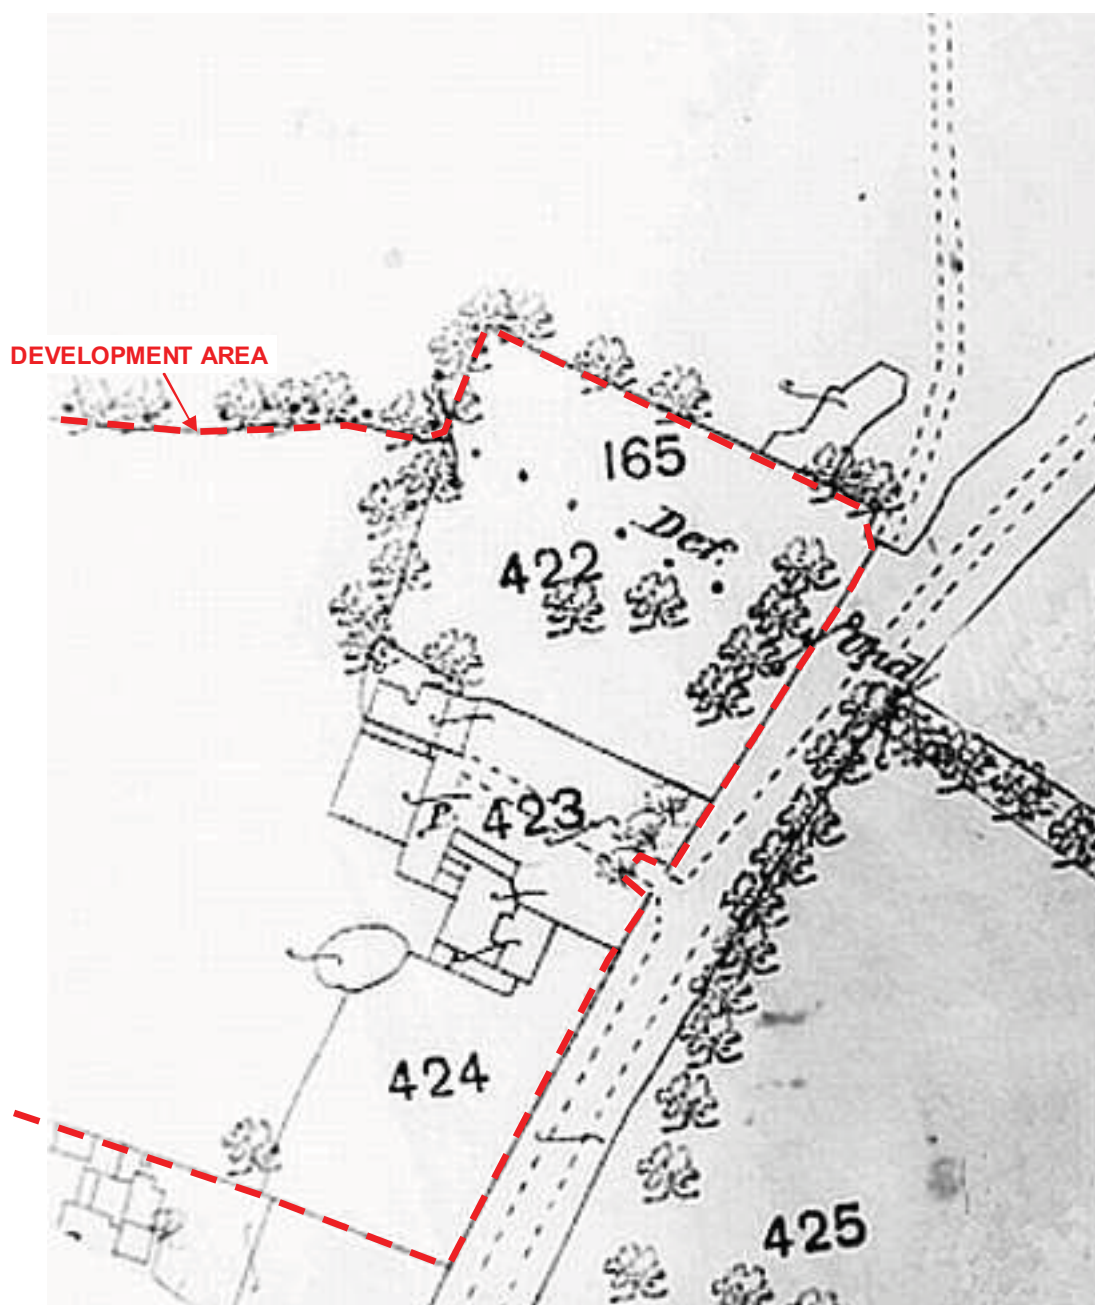
Figure 5: Detail from the Ordnance Survey First Edition (1883)

The later OS 1st edition map of 1883 (Figure 5) does illustrate the pantry but the separate building close to the north-east end of the end-stack dwelling is missing. Slight differences in the boundaries close to the property are also indicated. The OS 2nd edition map of 1901 is essentially the same as the 1883 map.

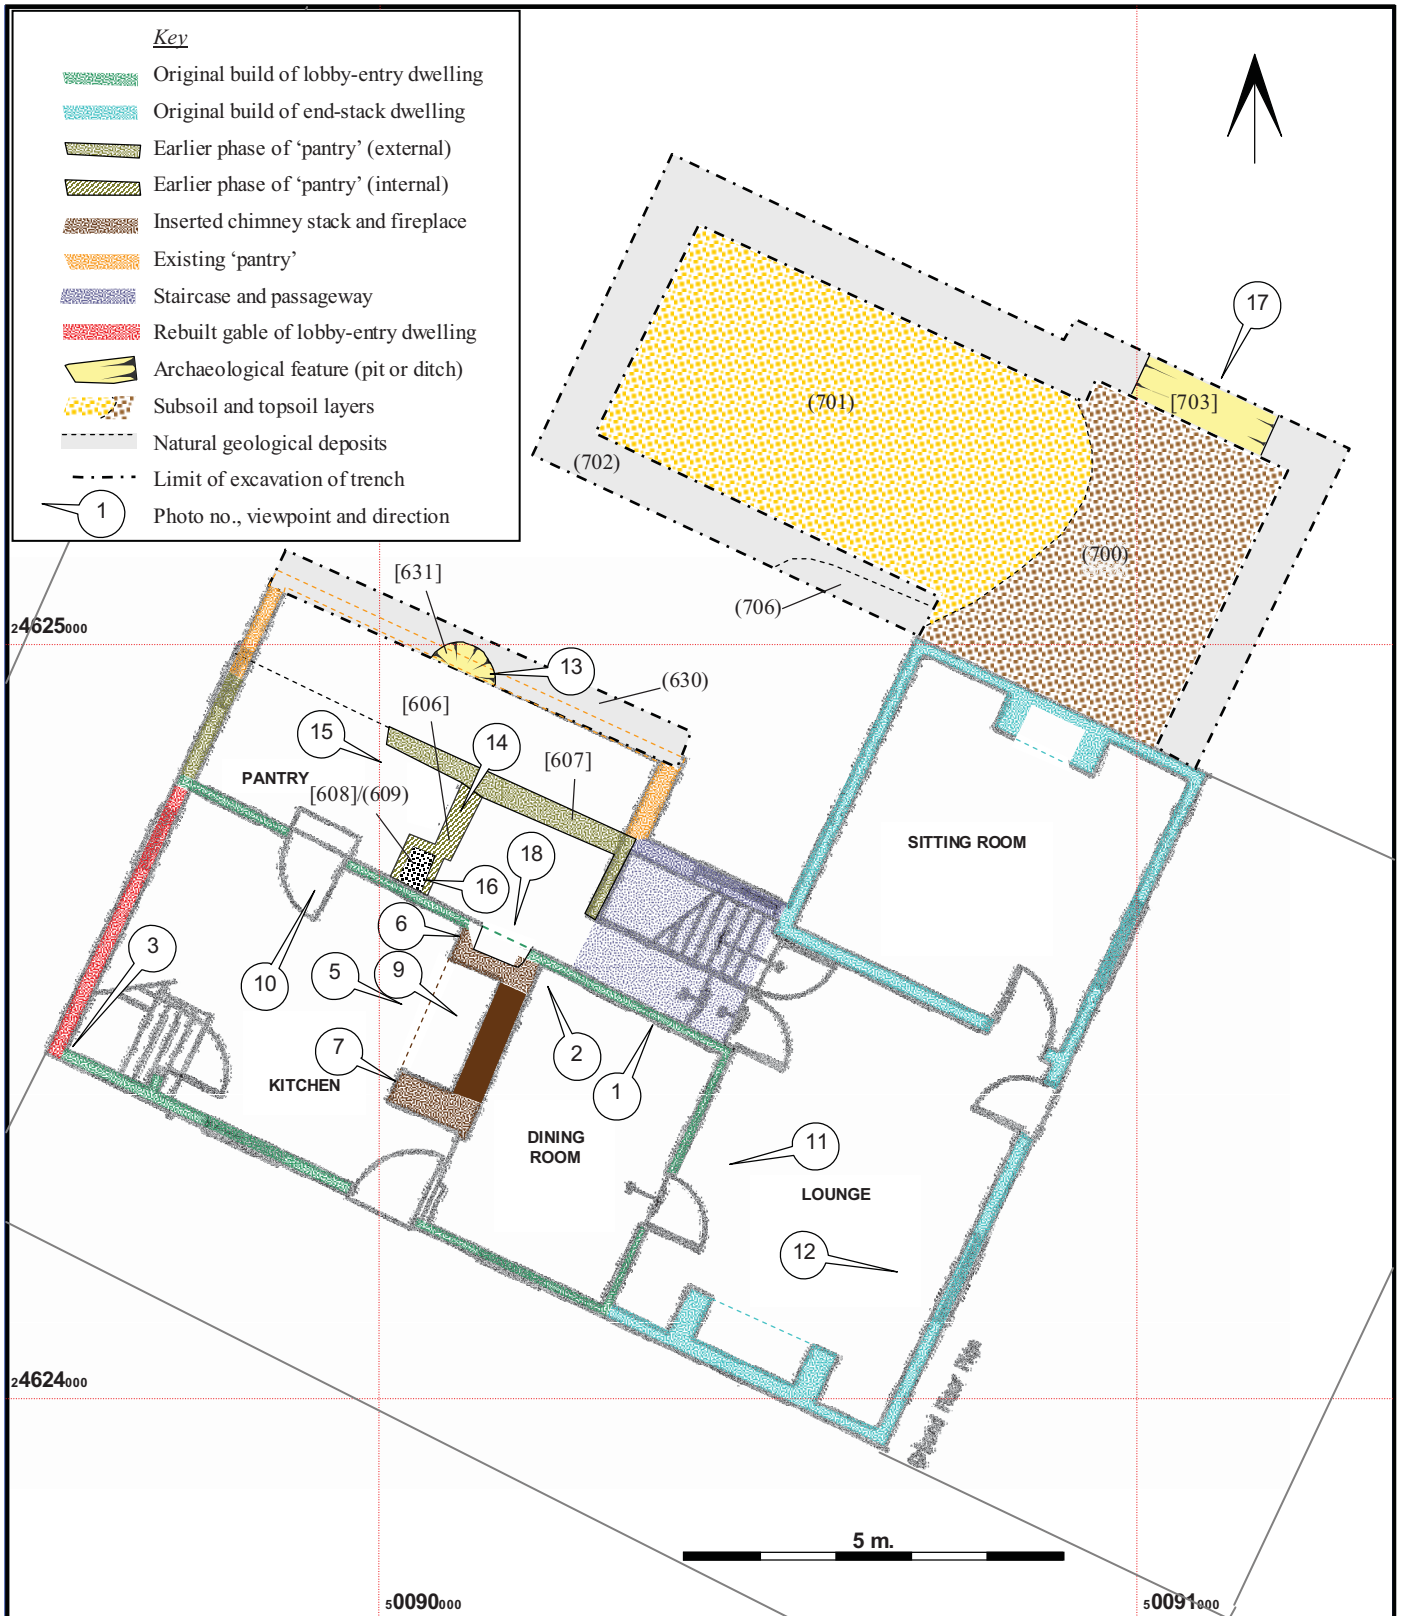
Figure 8: Location of works to the farmhouse and archaeological observations

An attempt by the conservation builders to underpin the pantry wall was unsuccessful, so the wall had to be demolished and rebuilt. The foundation trench for the new wall was excavated under archaeological supervision (Figure 8).

A concave-sided feature [631] that was sealed by layer (633) was identified in the north-east facing section of the new foundation trench (Figures 8 and 14). It was 0.90m wide and 0.28m deep and contained a deposit of light orange-brown clay silt with occasional charcoal flecks and medium stones (632). It did not contain any artefacts.

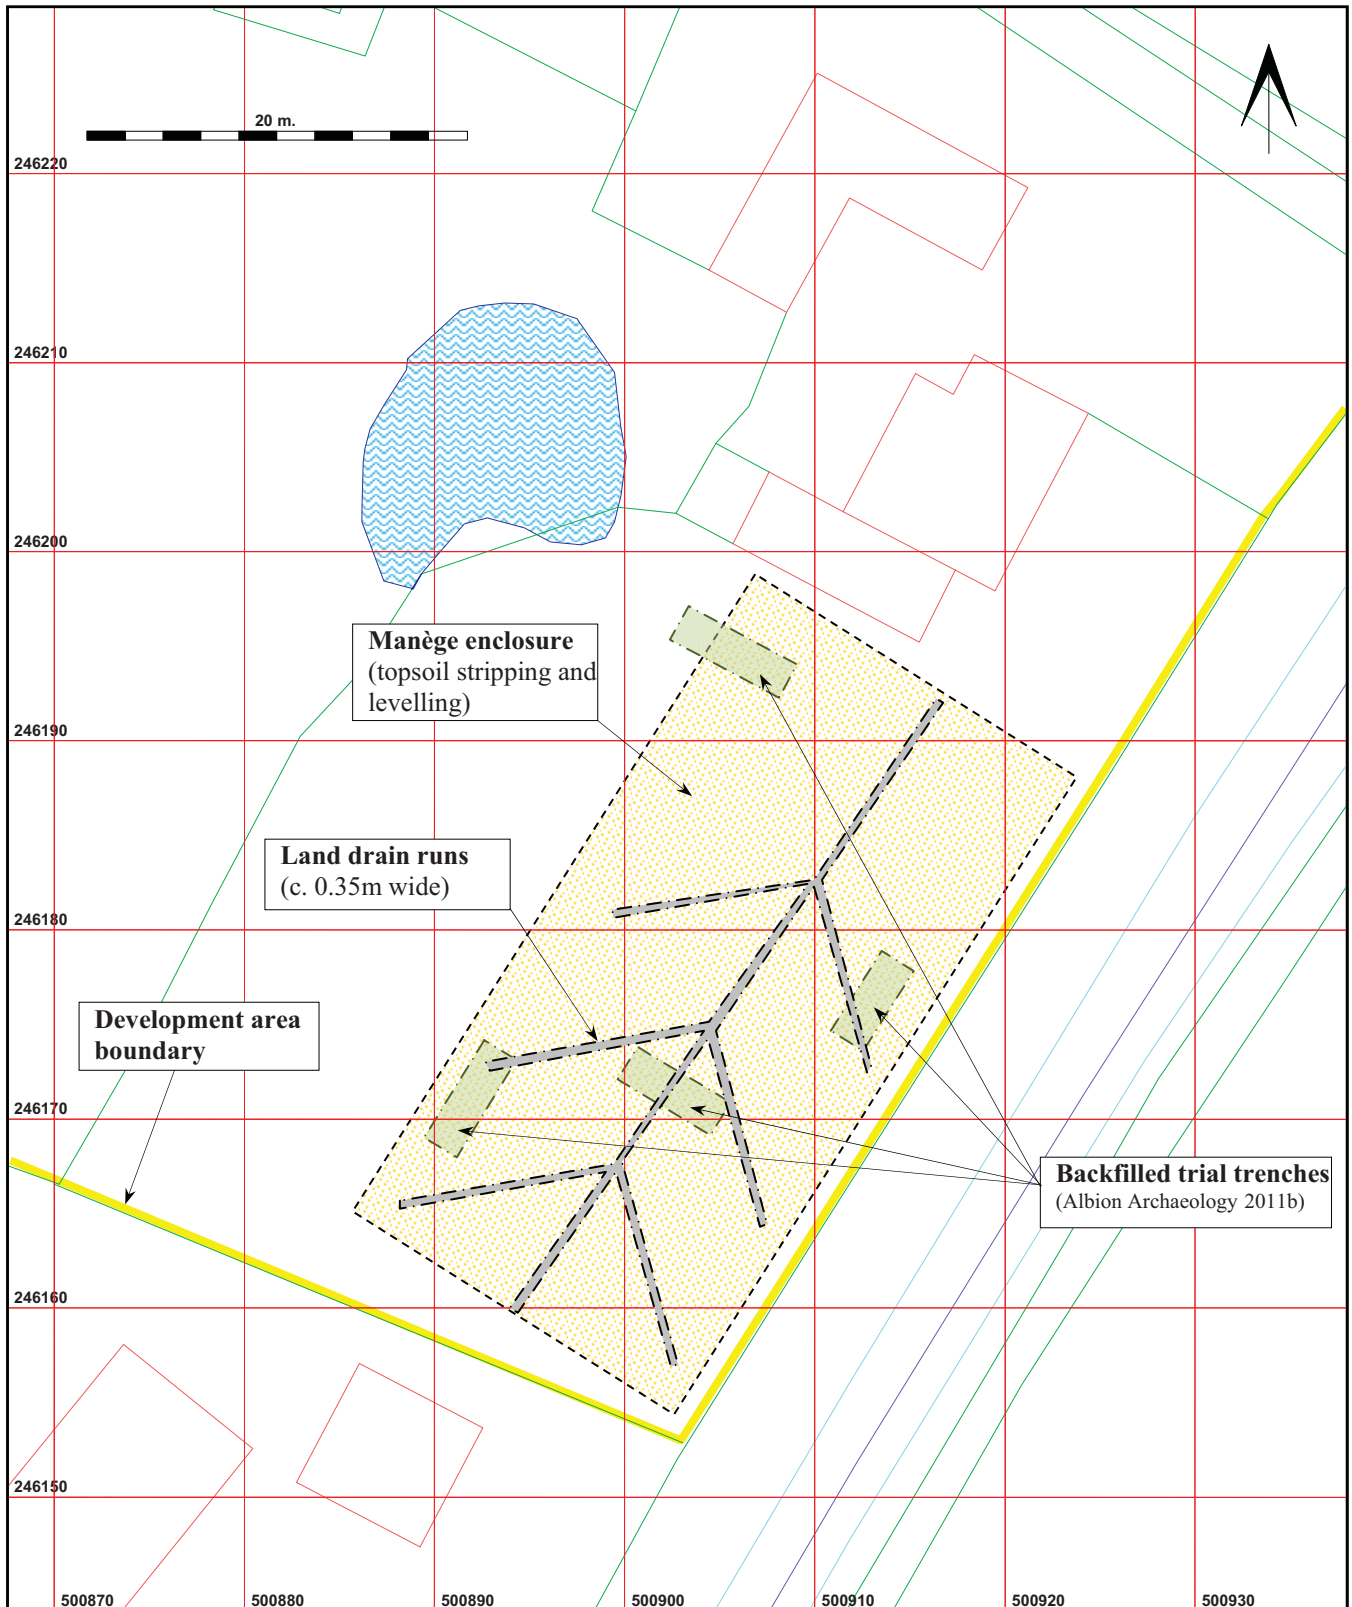
Figure 9: Location of works to the manège

Prior to laying the manège surface, the ground was levelled up to *c.* 41.2m OD. Below this formation level, drainage runs in a herringbone configuration (Figure 9) were machine excavated to a depth of between 0.2m (to the south-west) and 0.5m (to the north-east). The top of archaeological deposits identified by trenching lay between 40.9m OD and 40.8m OD, so some disturbance of archaeological deposits was possible. However, no archaeological features were observed, which demonstrates that the integrity of the underlying remains has not been compromised.

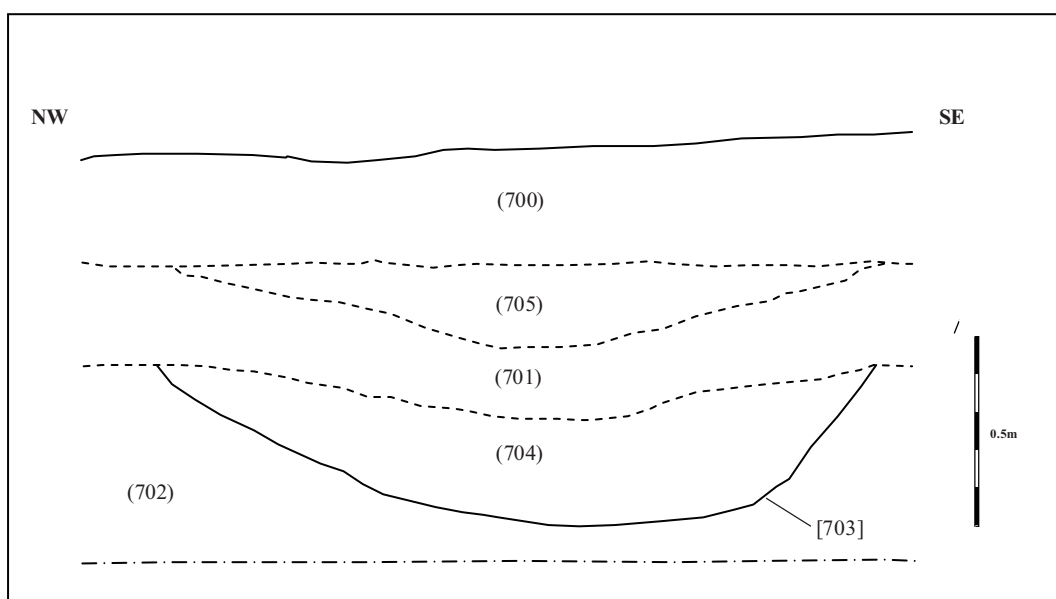
Figure 13: Section (foundation trench for new extension)

- 0.35m thick upper topsoil layer of dark grey-brown sandy silt (700) with occasional modern (post-1750) brick and roof tile fragments (Figures 8 and 13). Its thickness suggests it was cultivated soil, which in turn suggests some form of horticulture within the moat;
- 0.27m thick buried former topsoil layer of mid-brown-grey clay silt (701) with occasional modern (post-1750) brick and roof tile fragments (Figures 8 and 13). Again, this thick soil is likely to have derived from cultivation;
- > 0.50m thick geological layer of mid-grey-yellow clay sand (702) (Figures 8 and 13);
- > 0.50m thick geological layer of mid-yellow-grey clay (706) (Figure 8).

A single feature [703] was identified in the north-east foundation trench for the new build lounge (Figures 8 and 13; Photo 17). It was 1.90m wide and 0.32m deep, with a concave-sided, flat-based profile. It contained mid-brownish-grey clay silt (704), which produced no artefacts. The feature was sealed by the buried former topsoil layer (701). A depression in layer (701) that followed the profile of the ditch had been levelled with a mid-brownish-grey sandy silt deposit (705); it contained post-medieval brick and roof tile fragments. Above this was the topsoil layer (700).

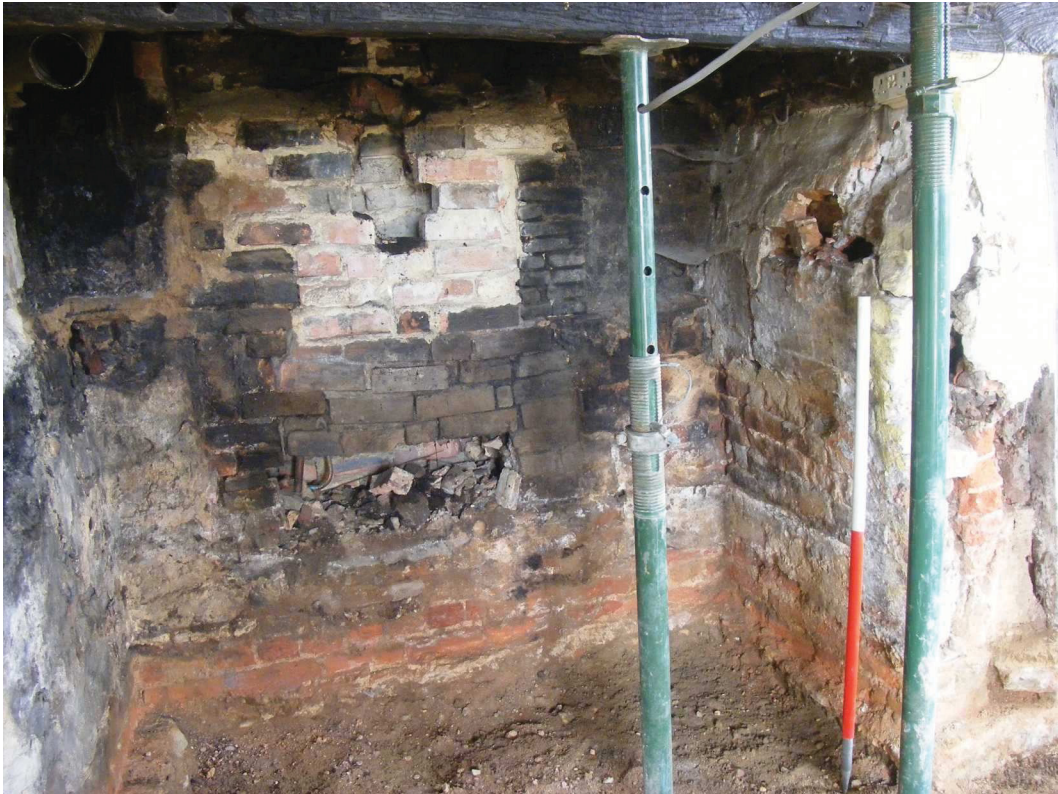
Photo 9: Brickwork at the back of the 'kitchen' fireplace

The back of the fireplace had undergone several phases of rebuilding in brick (Photo 9) and it was clear that there was once an opening into the chimney from the dining room side.
