**DODFORD MANOR FARM  
DODFORD  
NORTHAMPTONSHIRE**

**HISTORIC BUILDING RECORDING**

Document: 2011/82  
Project: DM1782

July 2011

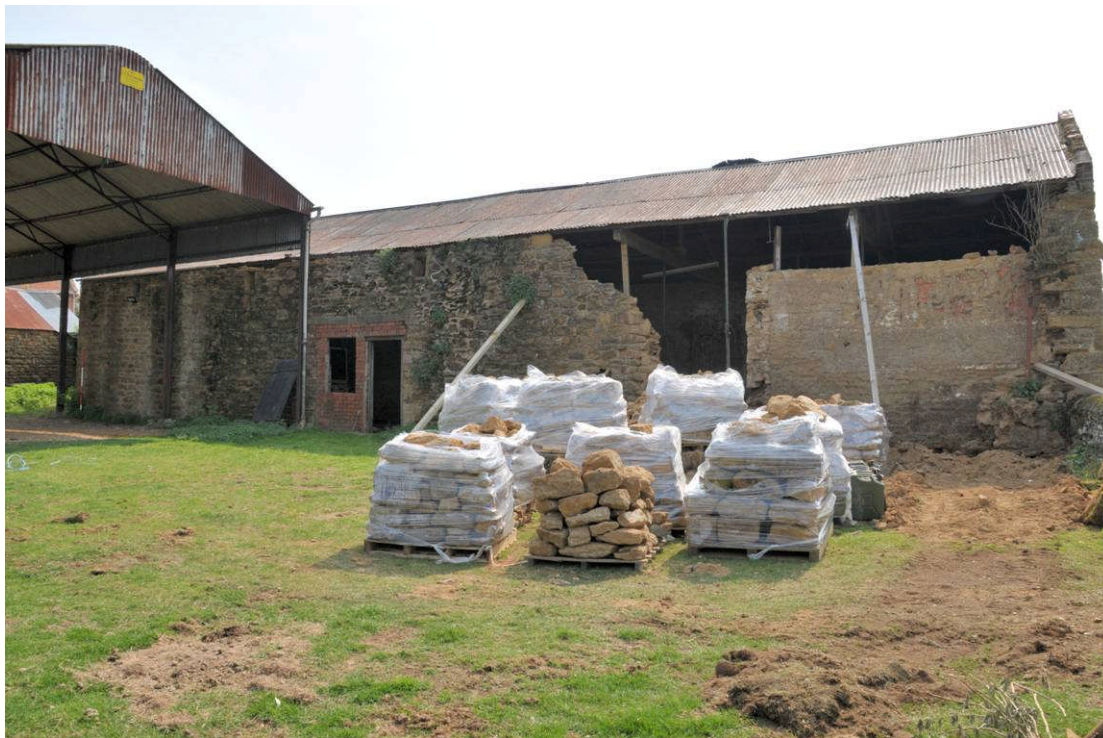
Plate 13: Barn (Building C), northern elevation

The full-height opening in the southern elevation has remained largely unaltered as is evidenced by the rough block quoining forming the door jamb, although brick insertions have been made by way of repair and infilling of holes (Plate 18). The opposing opening in the northern elevation (Plate 13) has however been altered over time. Initially to half-height as evidenced by the insertion of a stone lintel and infill above and then by the insertion of brick to form a standard door and adjacent window opening. Brick infill has replaced the stone quoining on the eastern side of the door, although the stonework remains intact on the western side. The construction of the adjacent Dutch barn against the door opening was probably the catalyst for decreasing the size of the opening still further. Although there appears to be evidence of infilling above the inserted stone lintel at half-height level (Plate 18), there are no quoin stones to indicate a former full height door. These higher quality stones may have been removed for use elsewhere prior to the blocking.

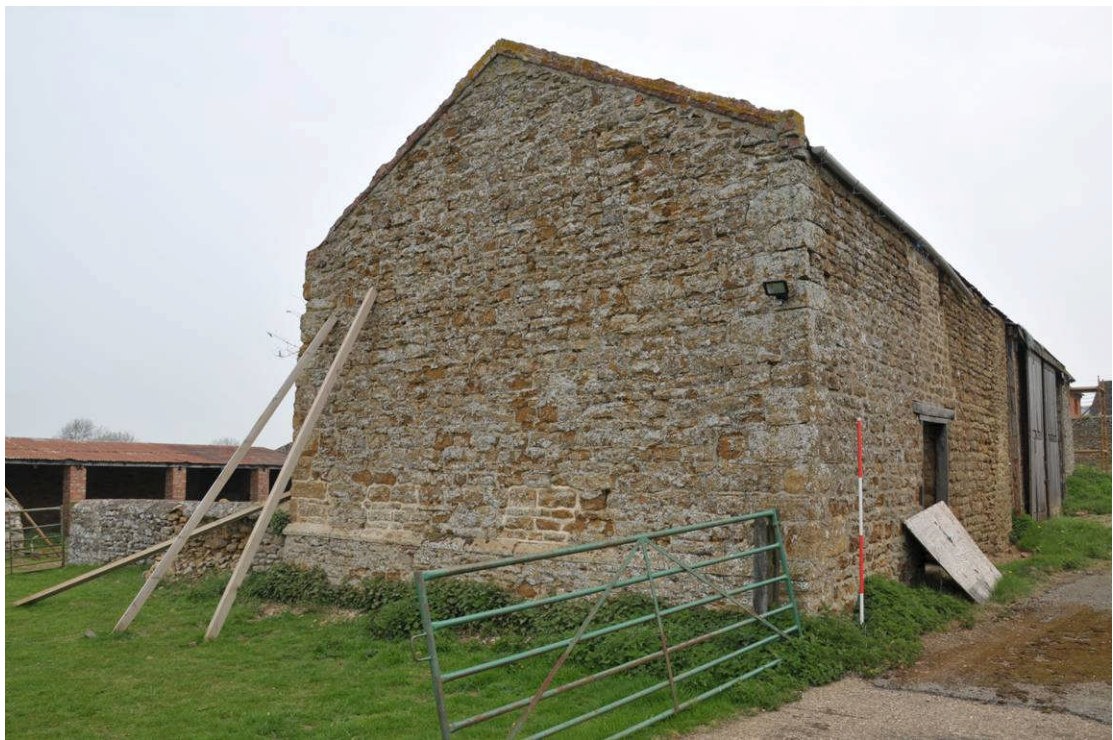
Plate 15: Barn (Building C), western elevation

The western gable end, with its brick-faced parapet (Plate 15), is very different to the eastern gable end suggesting that it may have been re-built either as a result of disrepair, or in order to present a better image on its more public-facing side adjacent to the trackway leading directly from the post road.

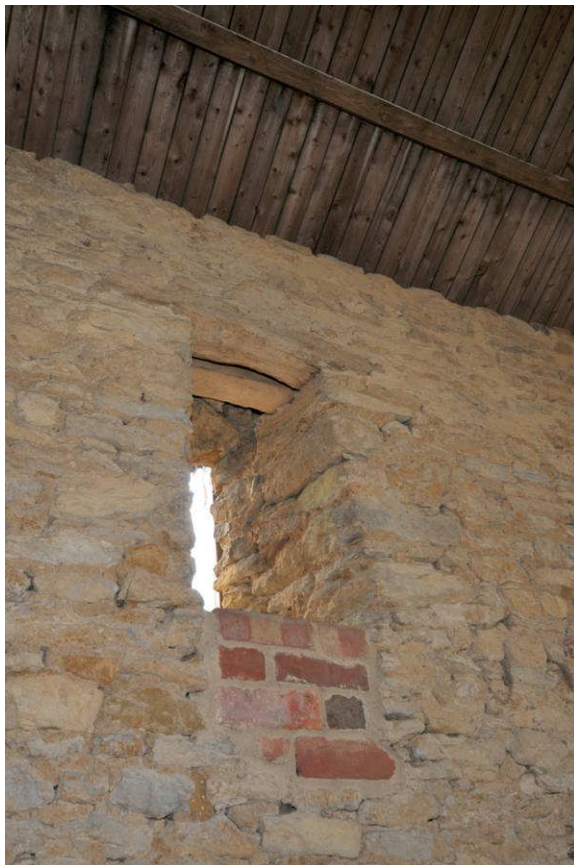
Plate 17: Barn (Building C),  
detail of slotted vent

The four slotted vent openings on the north elevation have stone surrounds (Plate 17), although the three to the south elevation do not. The long slot nature of these vents is typical of 16th century barn design. This adds weight to the argument that the barn may have been constructed as early as the 16th century.

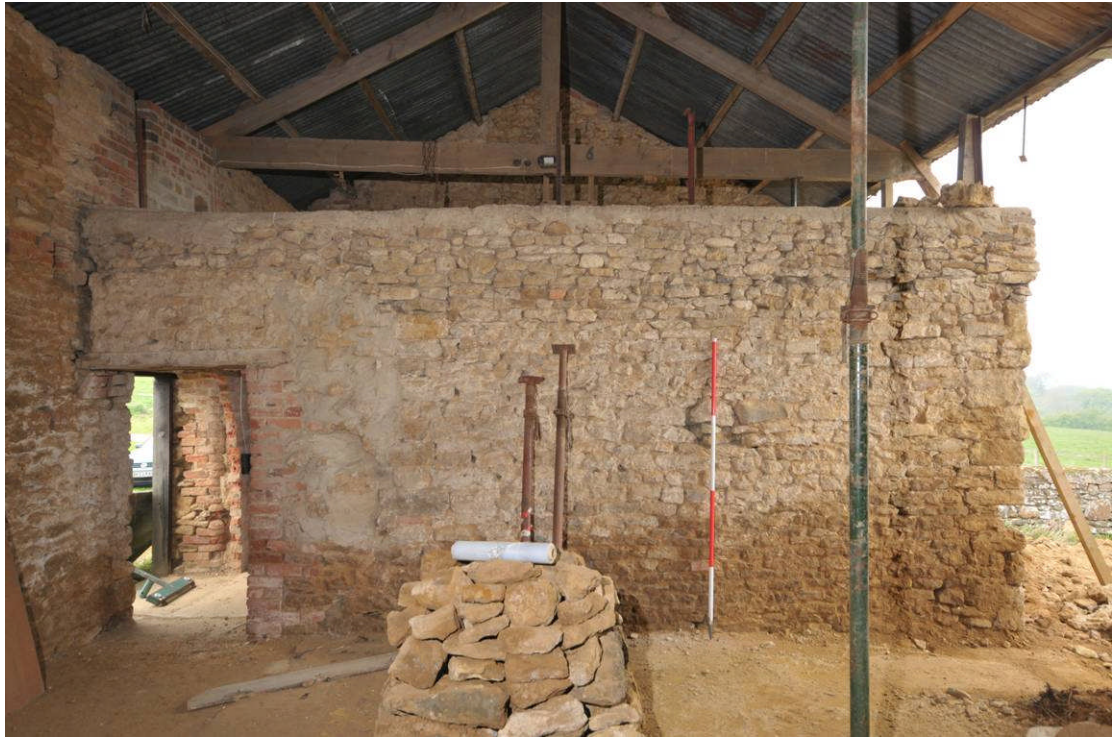
Plate 20: Barn (Building C), interior, partition wall

Internally the building is subdivided by a three-quarter-height stone partition wall at its western end (Plate 20). The partition wall has a door opening with wooden lintel at its southern end. The partition wall itself is

not tied into the side walls of the building, although the wooden door lintel is. The northern end of the partition wall and part of the external northern wall at this point have fallen into disrepair and only partially survive. One side of the door opening through the partition wall comprises the southern external wall of the barn, the other is finished in brick. The partitioned area has been lined with a single skin of brick with the cavity between that and the outer stone wall filled with concrete (Plate 21).

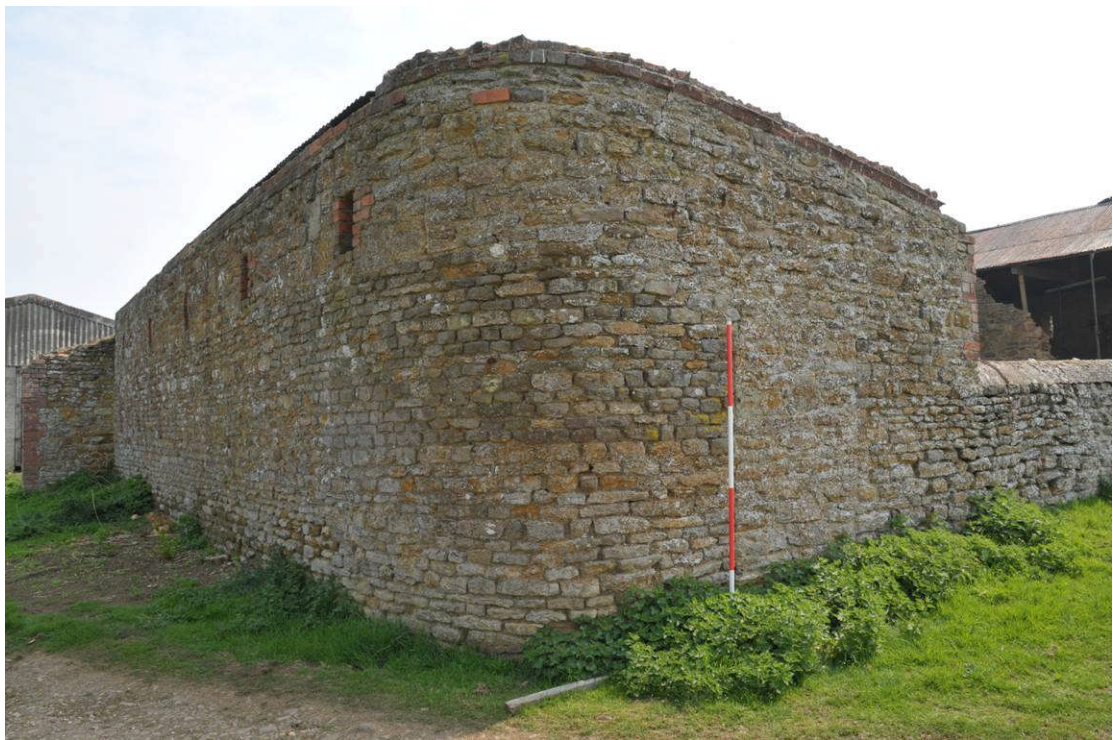
Plate 23: Open-fronted shed (Building D), western and northern elevations

The building comprises 4 bays and measures approximately 13.7m x 4.6m. The external wall is curved on its western corner following the line of the track (Plate 23). There are now blocked openings in the western (Plate 25), eastern and northern walls (Plates 24, 26) of the shed and within the northern wall five brick-lined vents similar to those present in the northern elevation of the main barn. The building has a mono pitch roof constructed from machine sawn timbers and clad with corrugated metal sheeting.

The rear and western walls appear to have been raised by approximately eight courses at the same time as the openings in these walls were blocked (Plate 23). The door opening in the eastern wall has also been blocked with stone (Plate 26) although it is not possible to tell whether this blocking was contemporary with the blockings in the northern and western walls. Alcock (in ctd 2010) suggests that the raising of the walls could represent the change from a pitched to a mono pitch roof. It is likely that

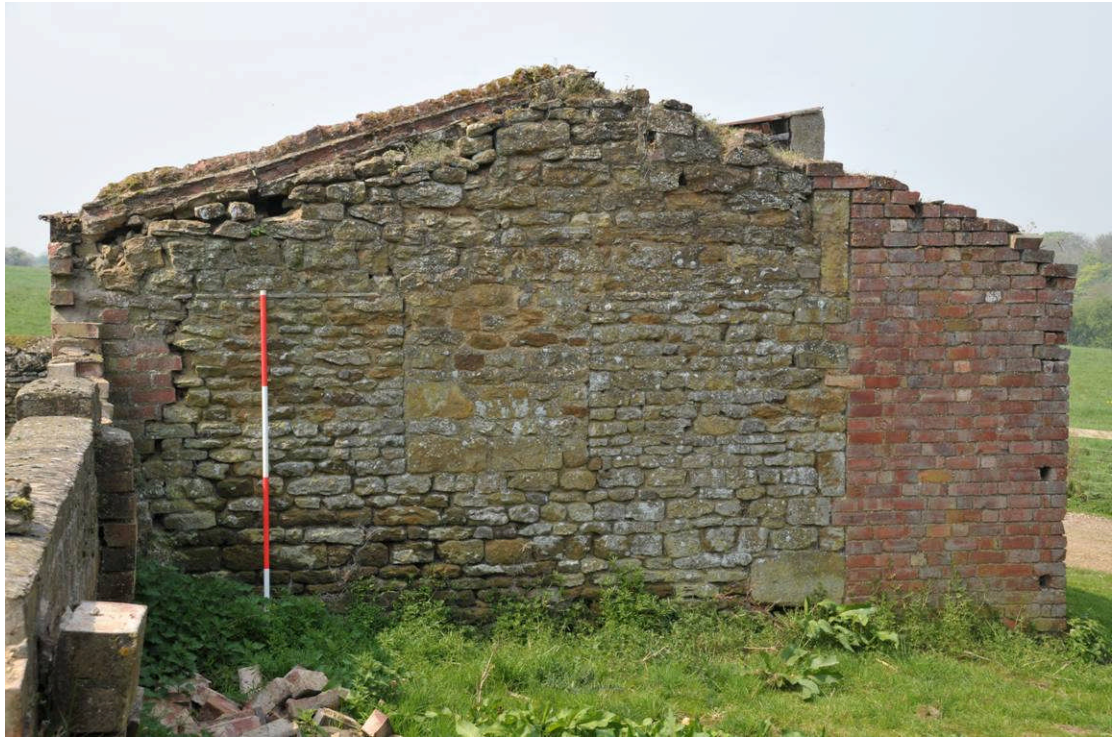
Plate 24: Open-fronted shed (Building D), eastern elevation

Stonework clad with modern brickwork extends from the north-east corner of the building, this once formed the gable end of an adjoining pitched-roof building that infilled the gap between Building D and the modern concrete barn, Building A (Plate 24). A building in the same position can be seen on the 1968-1980 OS map and clearly shown on historical aerial photographs.
