**THE OLD BAPTIST CHAPEL SCHOOL ROOM
LITTLE STAUGHTON
BEDFORDSHIRE**

**ARCHAEOLOGICAL BUILDING RECORDING AND
INVESTIGATION**

Project: LS1945

Document: 2012/100 v.1.1

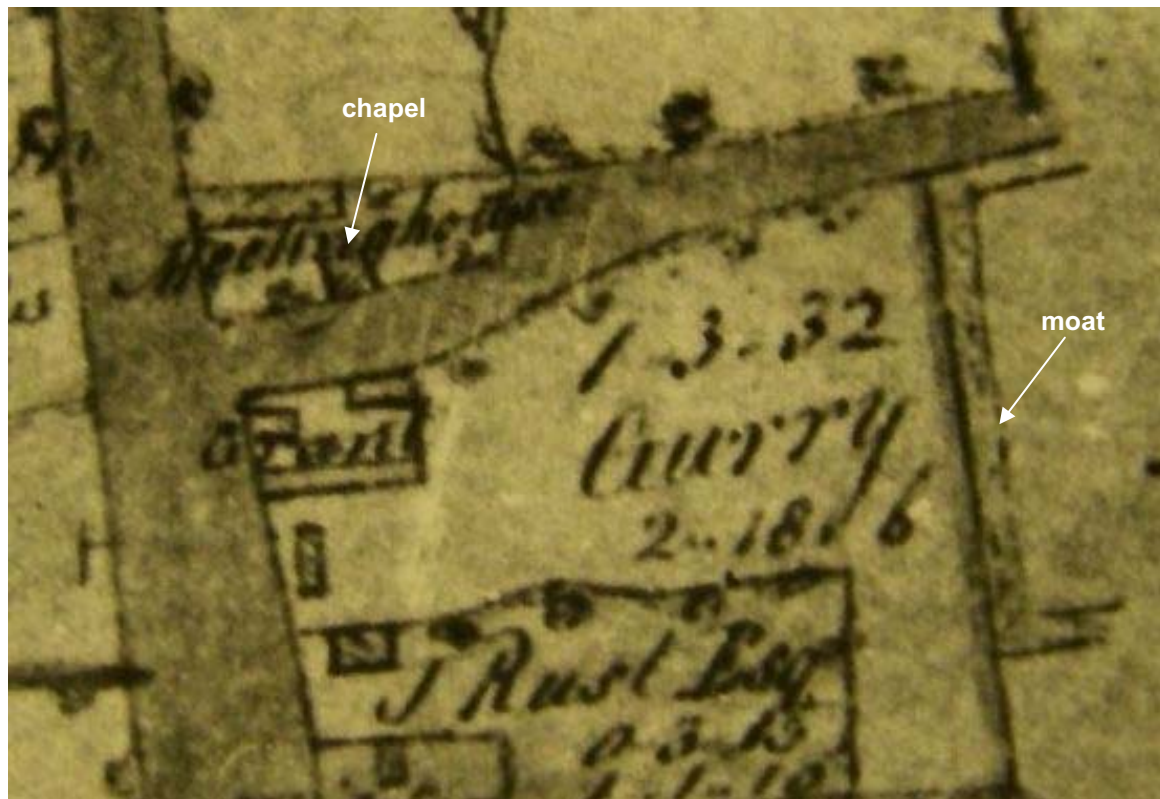
Figure 2: Enclosure map 1803

Evidence of earlier utilisation of the site was also identified. The nature and date of the roughly N-S aligned ditch [7] is unclear. As the Colmworth Road (High Street) was significantly wider in the 18th/19th century than it is today (compare the 1803 and 1884 maps Figures 2 and 3), it is possible that it may represent an early roadside flanking ditch.

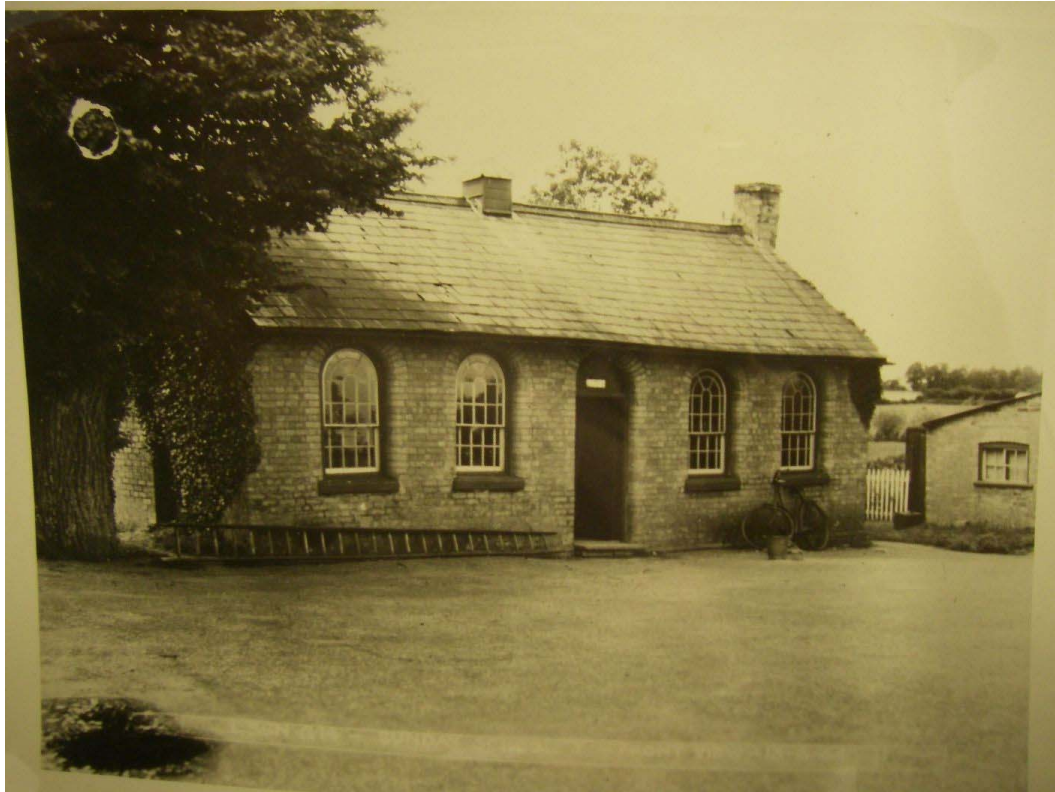
Figure 6: School room, east-facing side 1944

The school room had a low pitched, open roof, which was slate-covered and had thin, internal, metal braces and cross struts (Figure 15). A small ventilation tower in the centre of the roof visible in the 1944 photographs (Figures 6 and 7) was subsequently removed.

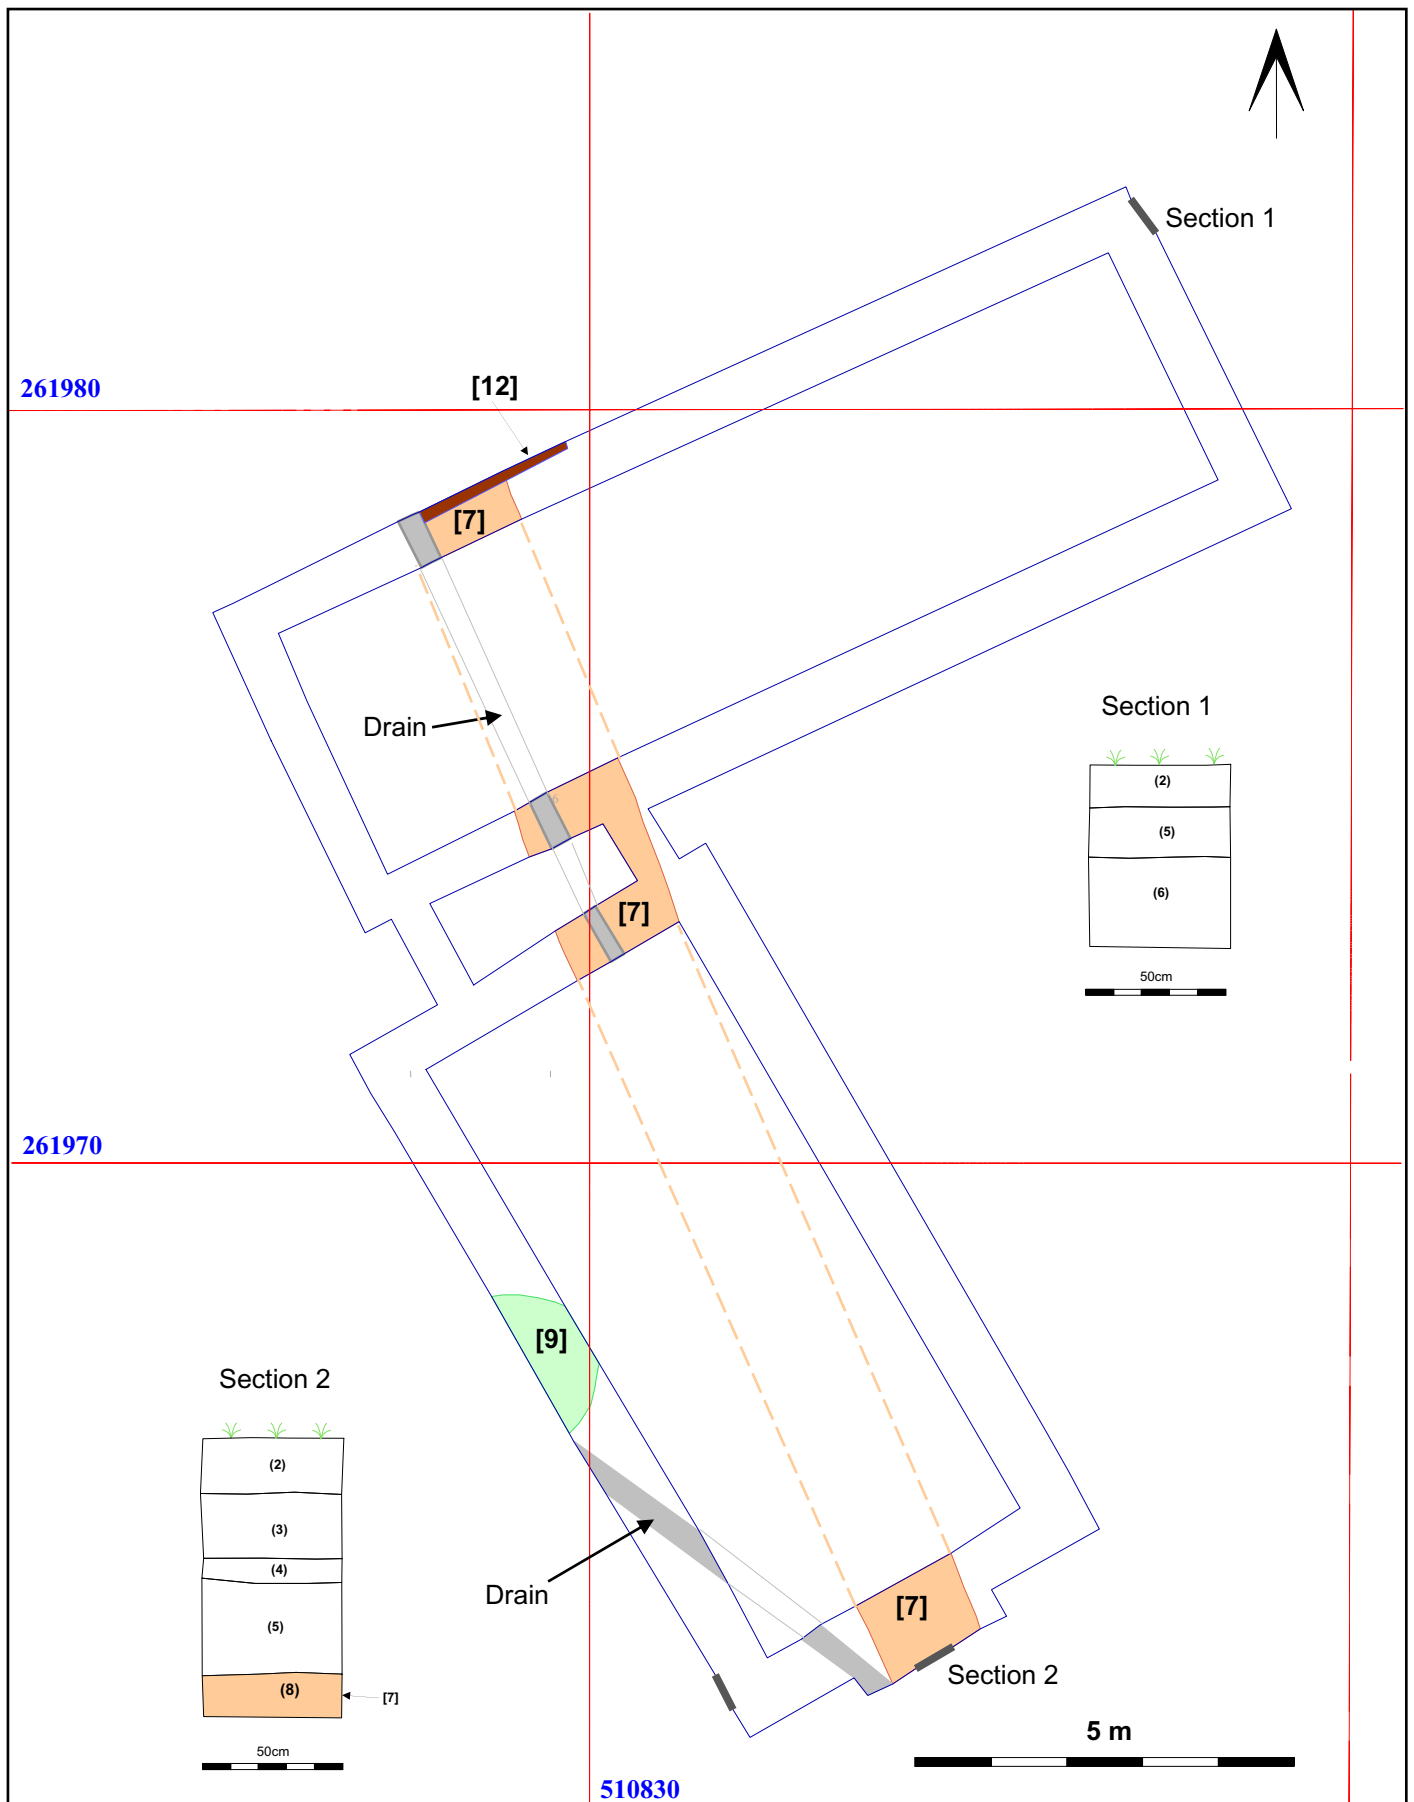
Figure 20: All features plan

The excavation for the footings of the reconstructed school room and its NE extension were observed. An all features plan is shown in Figure 20.

Topsoil (2) comprised a dark brown grey clay silt 0.15–0.40m thick, which would suggest an old cultivation soil. In the central and eastern side of the DA this deposit overlay a 0.20–0.38m thick subsoil (5), comprising mid grey brown clay silt. Undisturbed glacially derived light blue-grey chalky clay (6) was reached throughout the footings trench at a depth of 0.32–0.70m below ground level (Figure 20: section 1).

A NNW-SSE aligned ditch [7], *c.* 1.5m wide, was found within the footings for both the SW and northern parts of the building (Figure 20). This was located at 0.85m below ground level (Figure 20: section 2). Only the top 0.15m of the upper fill (8) of the ditch was excavated, therefore the full depth and shape of the ditch could not be ascertained.

A segment of a probably circular pit [9] of uncertain function was identified towards the SW limit of the footing trenches (Figure 20). It was at least 2.1m long, by 0.75m wide and at least 0.75m deep with concave sides and base.

Two make-up layers (3) and (4) were recorded in the southern corner of the DA (Figure 20: section 2). They consisted of mid grey and grey brown silty clay and were 0.23m and 0.08m thick respectively. It is likely that these layers are associated with the construction of the school room.

Two brick drains were also identified within the footings trenches (Figure 20). One was in the southern corner of the DA, in the same general area as make-up layers (3) and (4). It was aligned NW-SE and was mainly constructed of brick, although there were also some badly damaged ceramic drain sections adjacent to the brick. The bricks used for it were the same as those used for the building of the school room.

A linear band of bonded bricks (12) was exposed below the garden soil (1) at the northern limit of the DA (Figures 20 and 22). The two courses of NE-SW aligned red bricks were traced for *c.* 2m. The nature of this structure is unclear. It may define the footing of an earlier building, possibly associated with the caretaker's cottage or its predecessor.
