LUTON - DUNSTABLE BUSWAY BEDFORDSHIRE

STRUCTURAL RECORDING

Document: 2010/71

23 September 2010

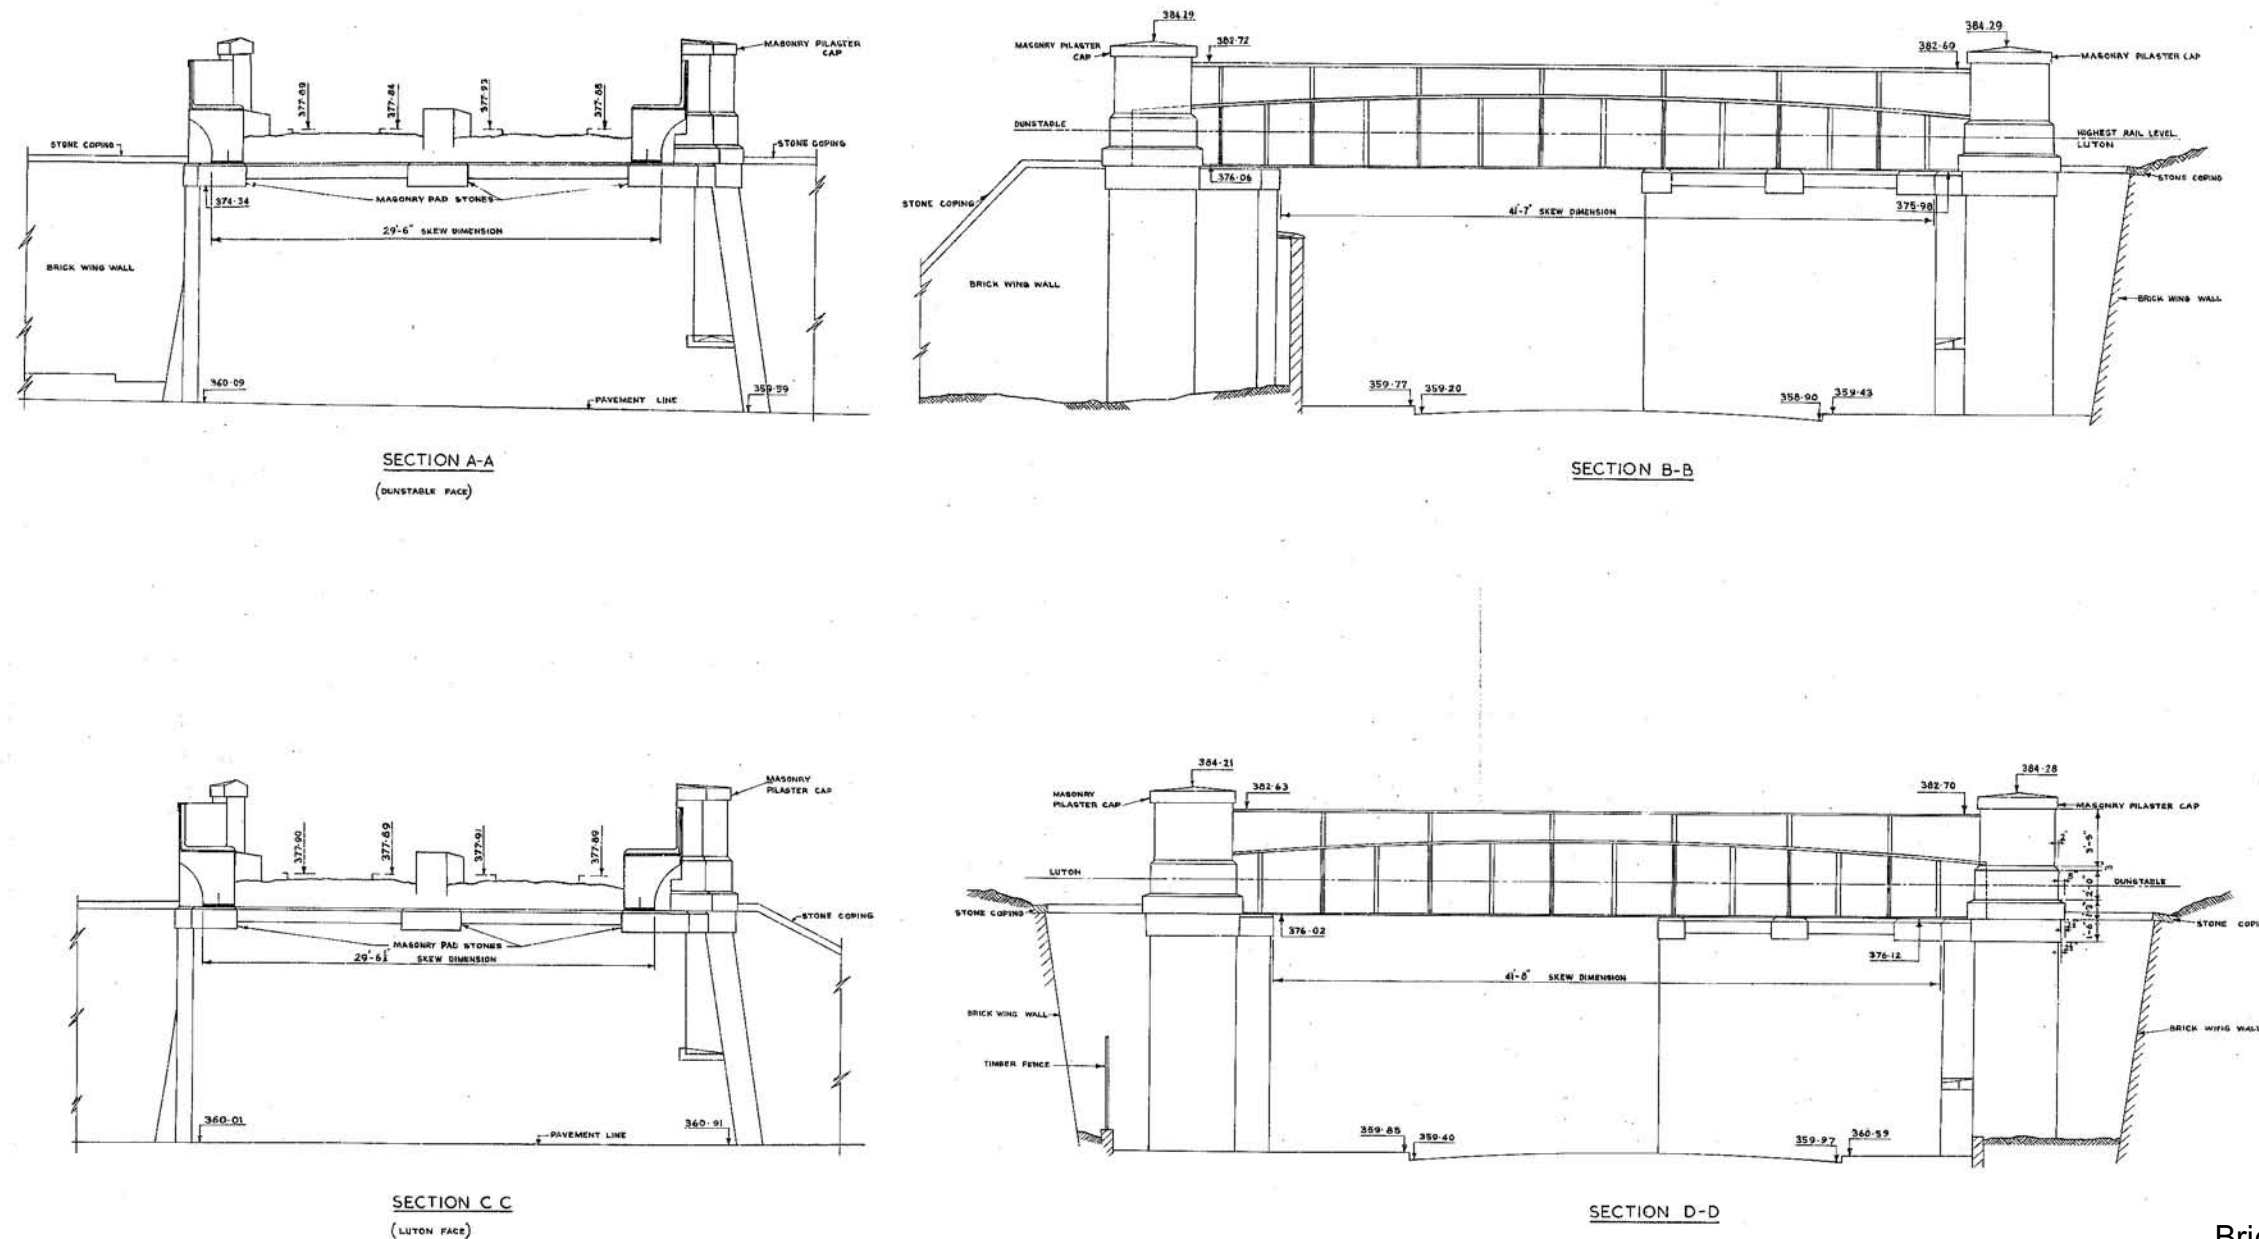
Figure 9:
Bridge 31 - Dunstable Road, Luton.
(Not to scale)

Surveyed before alterations added in
1960s.

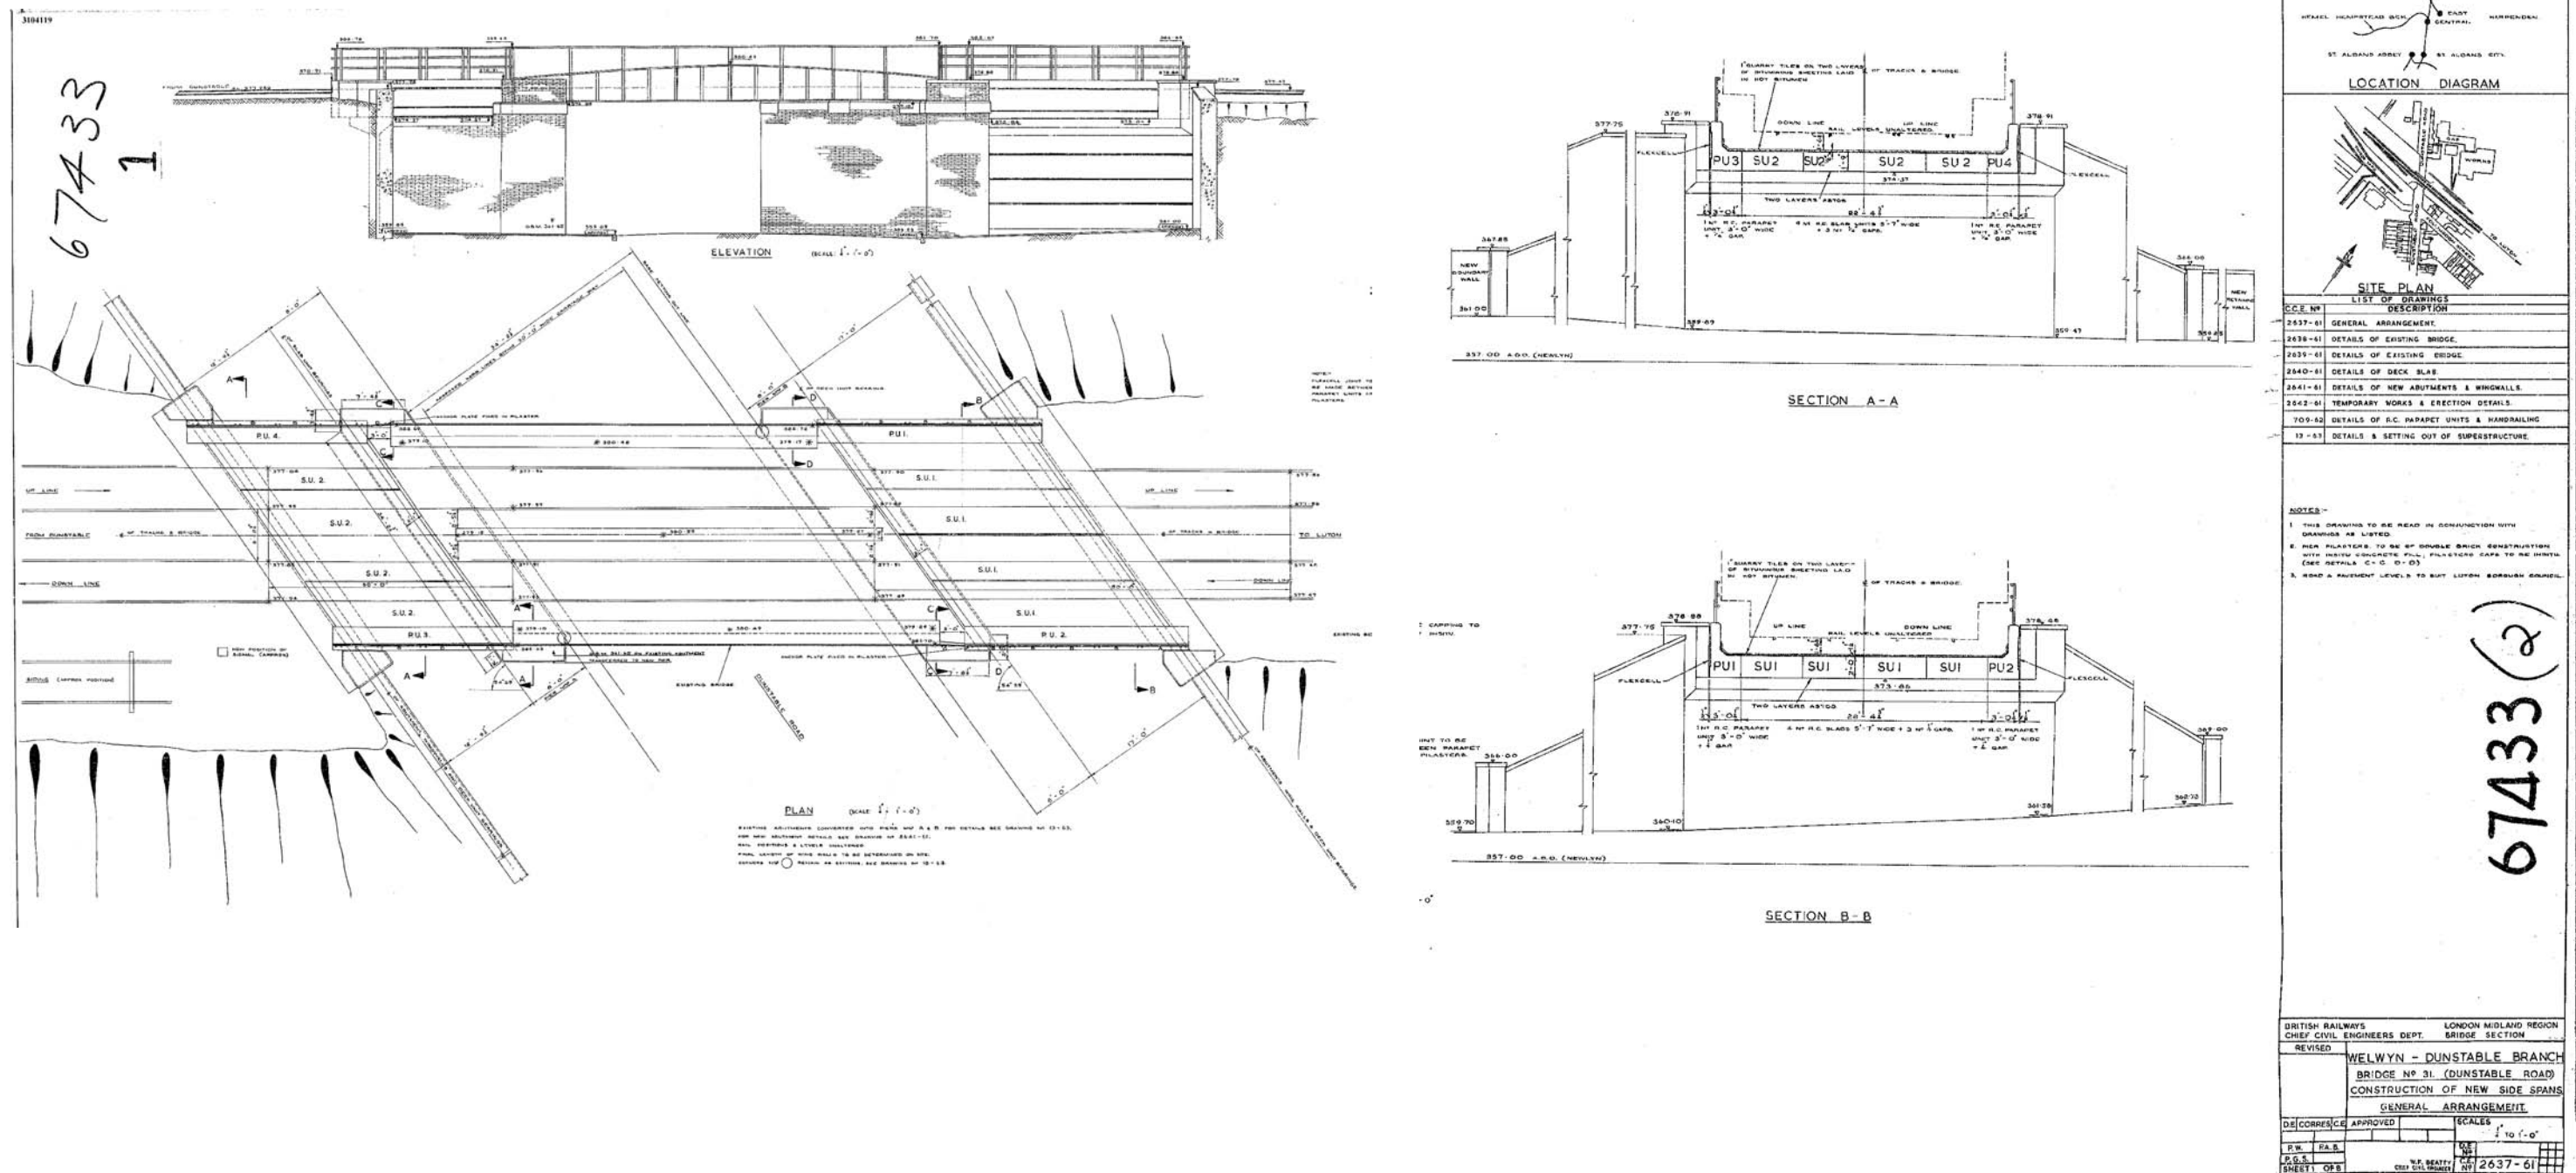
Figure 10:
Bridge 31 - Dunstable Road, Luton.
(Not to scale)

After alterations in 1960s.

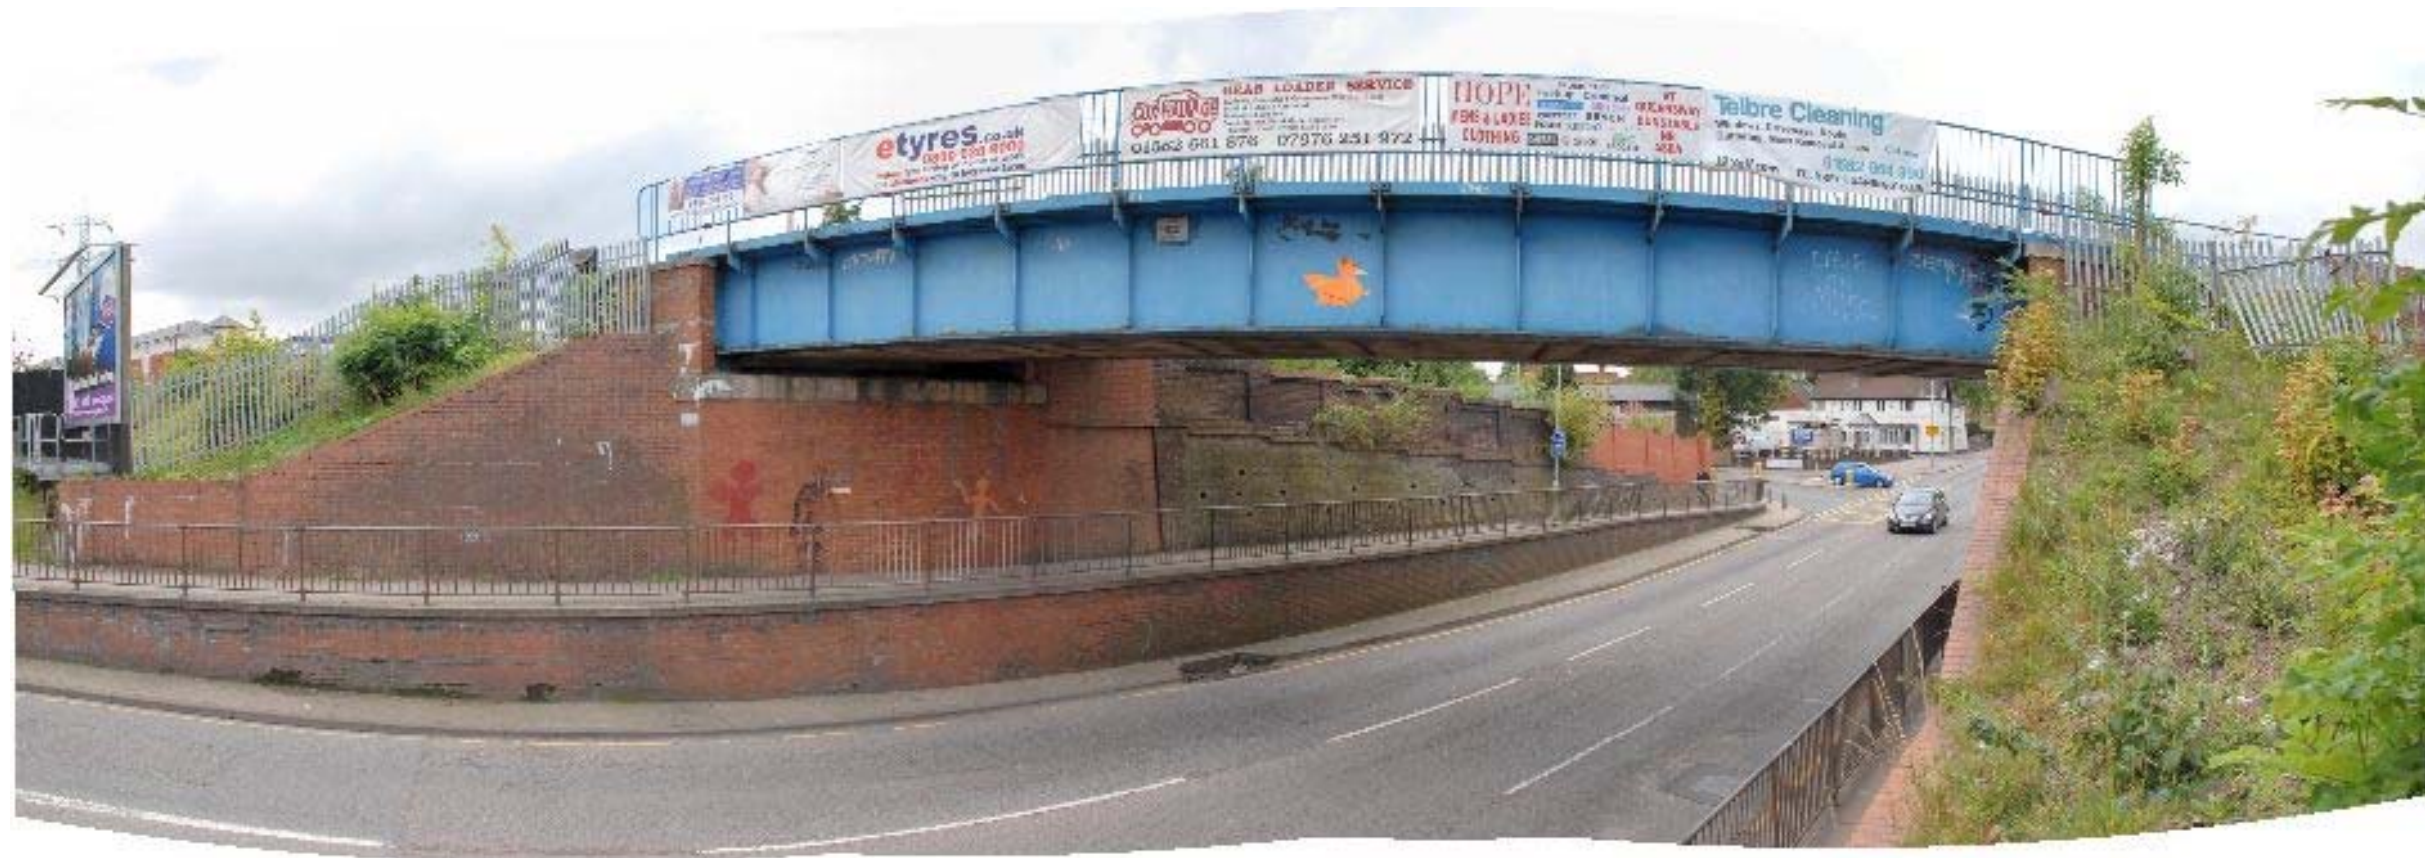
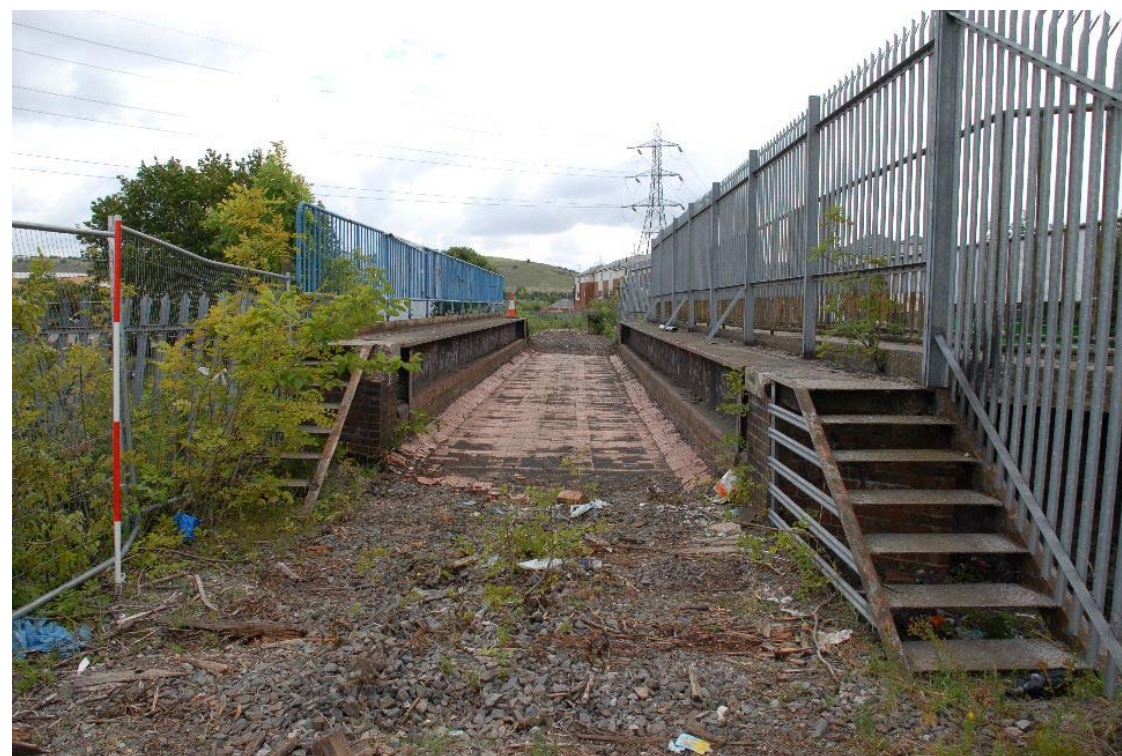
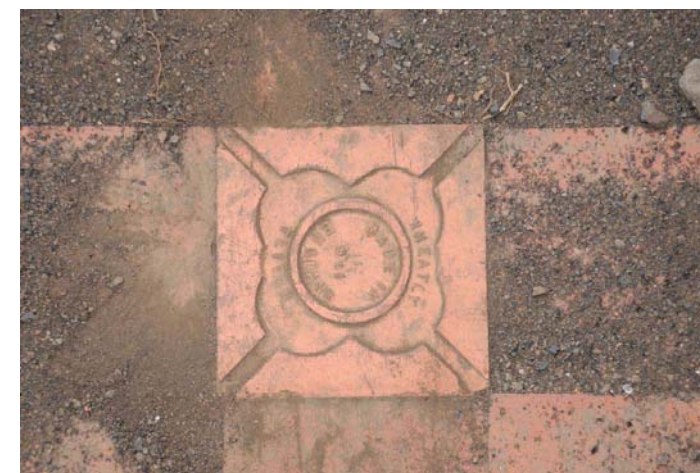
Plate 1 (a, b, c):
Bridge 35 – Church Street, Dunstable

Plate 1a: Bridge 35, west-facing

Plate 1b: Bridge 35, looking south-east towards Blow's Downs

Plate 1c: Detail of floor tiles

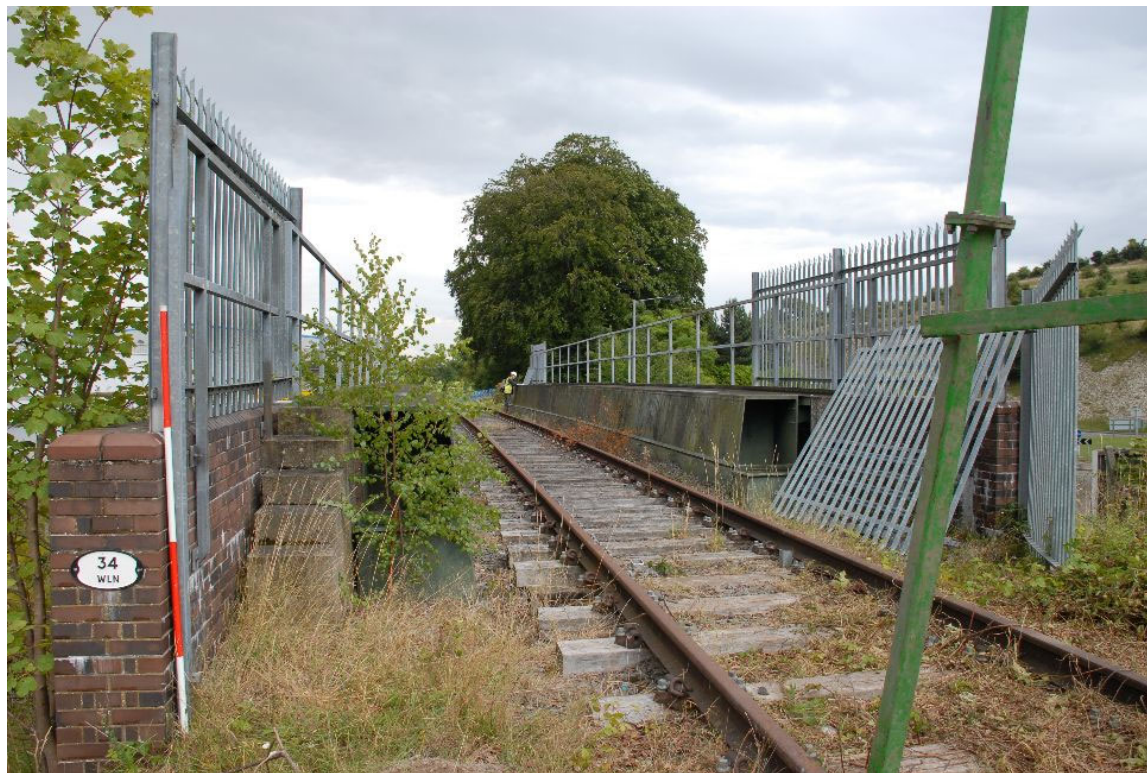
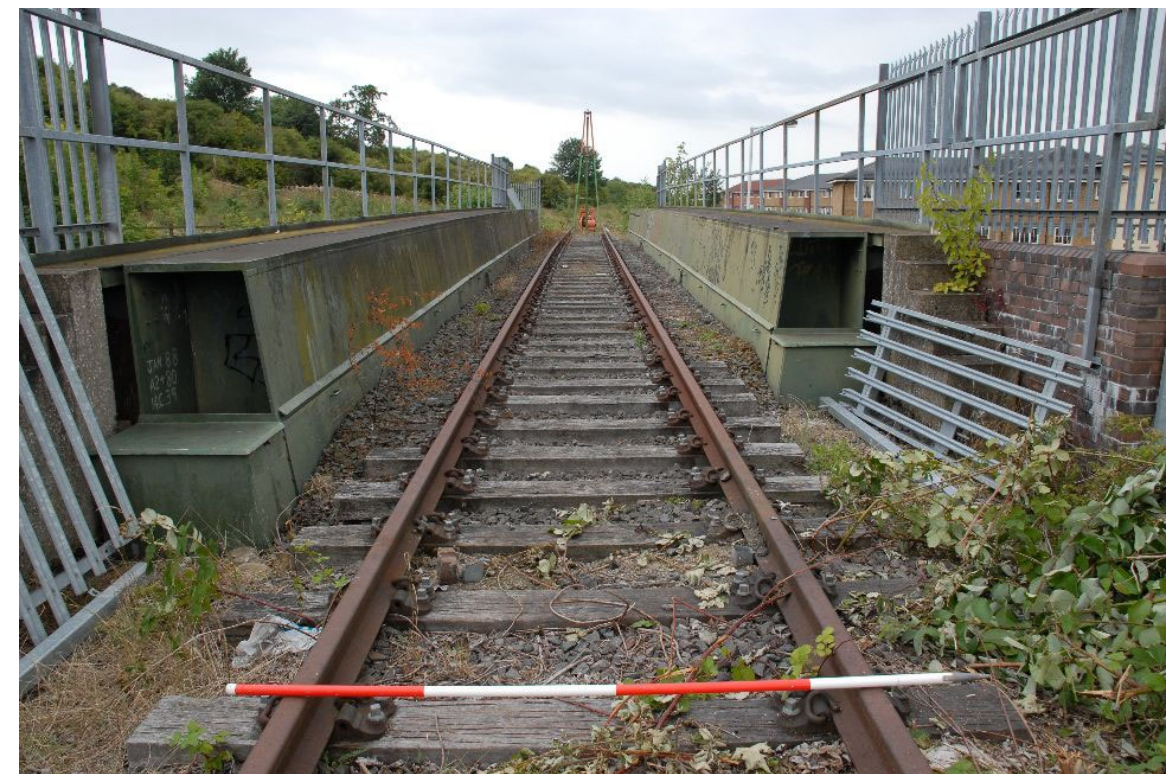
Plate 2 (a, b, c, d):
Bridge 34 – Skimpot road.

Plate 2a: Bridge 34 looking east towards Luton

Plate 2b: Bridge 34 looking west towards Dunstable

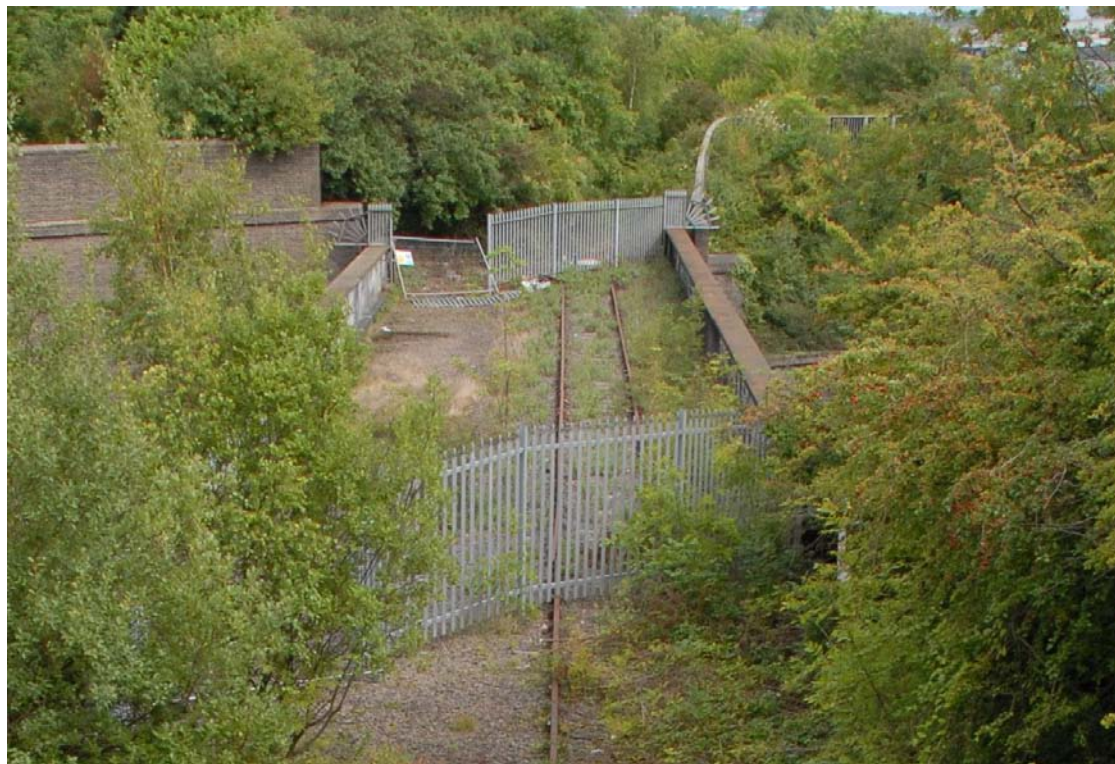
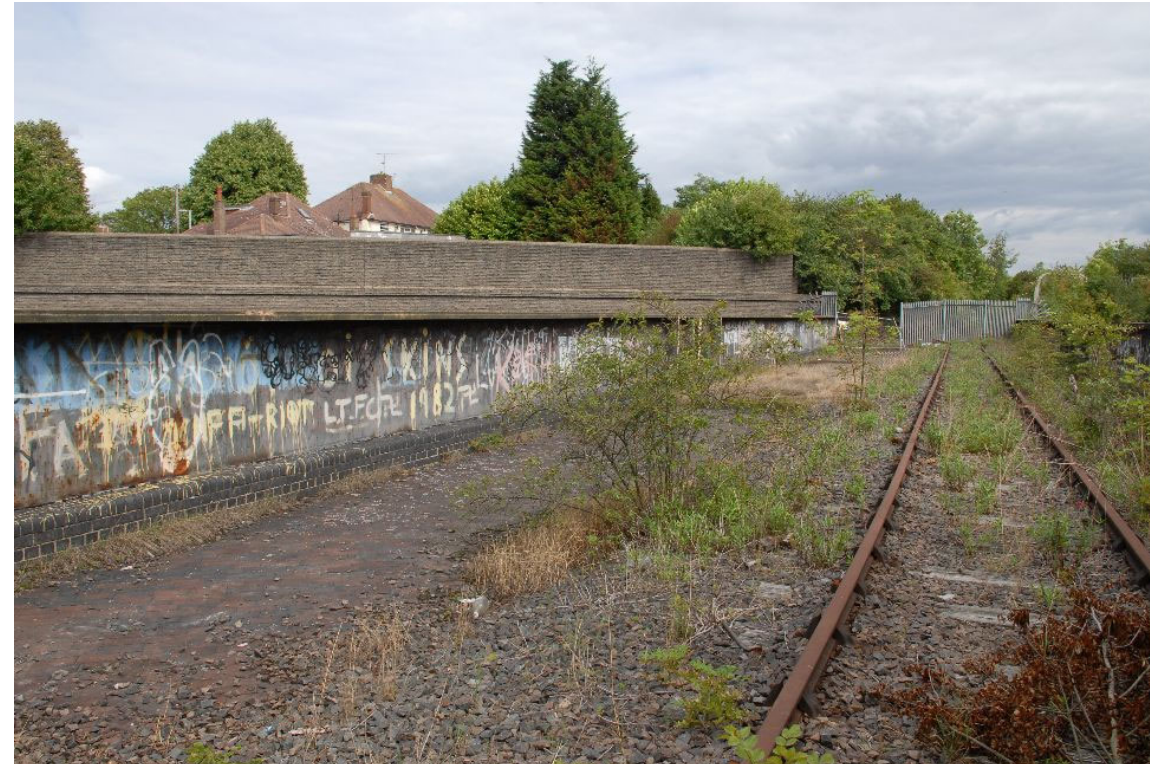
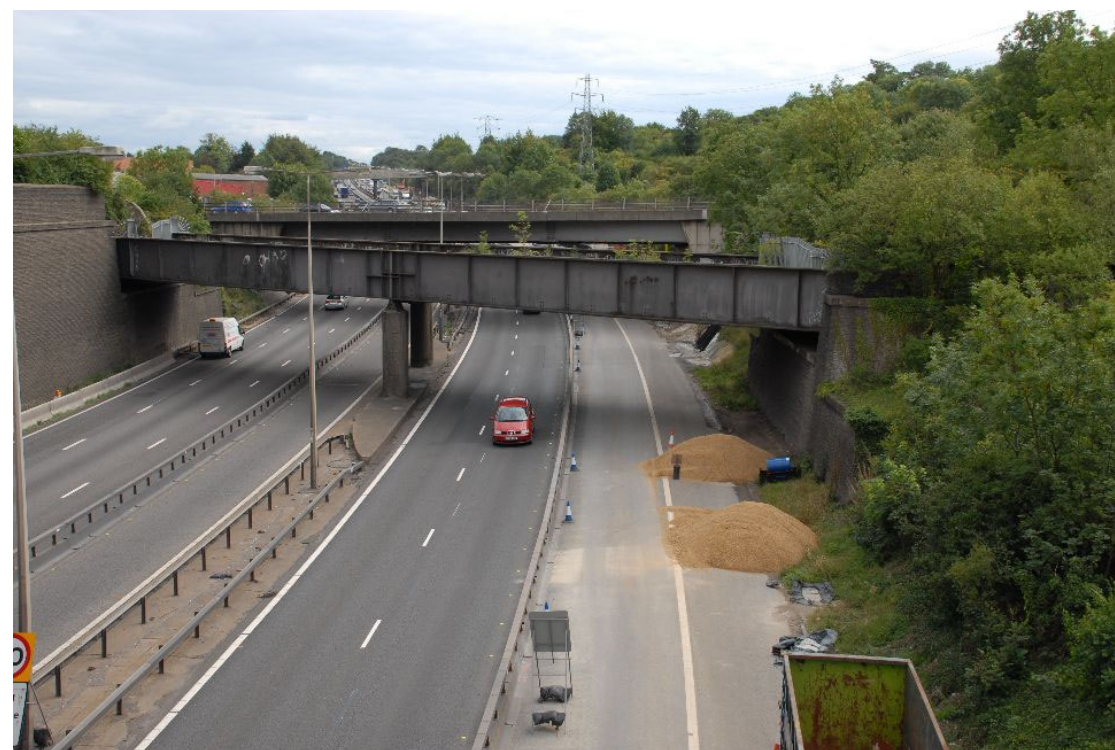
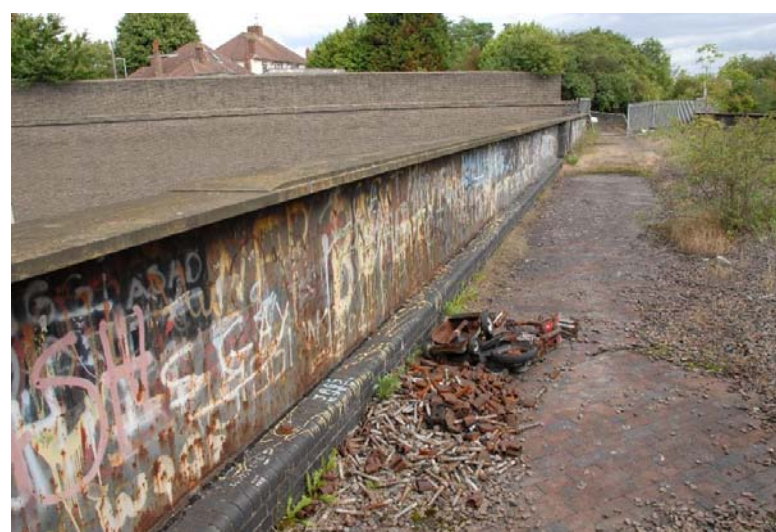
Plate 4 (a, b, c, d):
Bridge over M1.

Plate 4a: Bridge over M1, looking east towards Luton from Bradley Road footbridge.

Plate 4b: Bridge over M1, northern steel parapet and one remaining track.

Plate 4a: Bridge over M1, north-facing elevation

Plate 4b: Bridge over M1, northern steel parapet detail.

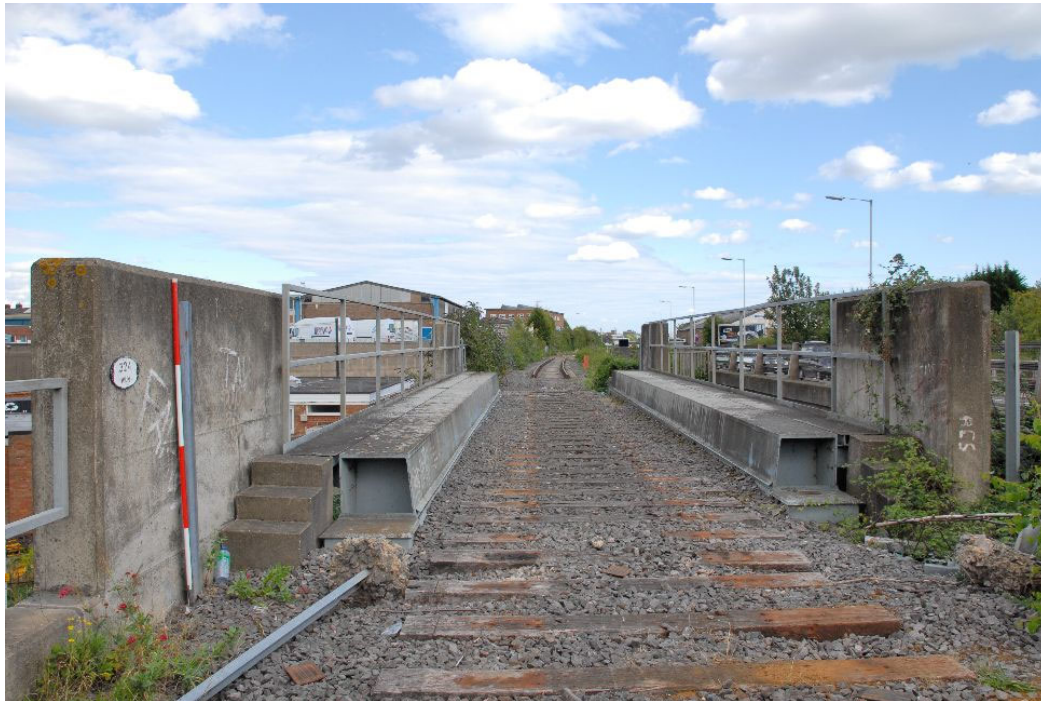
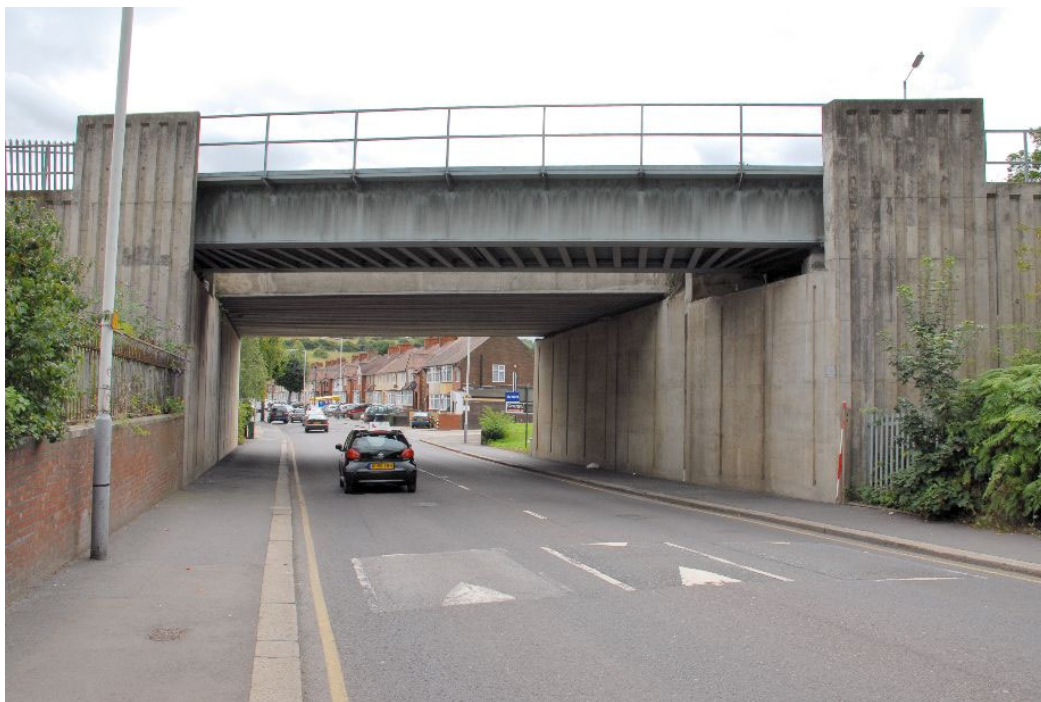
Bridge number		32a
Location		Kingsway
Date		1986
Plans	Current	3074883.tif, 3219042 .tif, 3219043.tif
	Original	n/a
Photo refs		6041-6048, 6215-6225
Figure refs in this report		Figure 8, Plate 5
Construction		Concrete abutments, steel superstructure
Conditions		Clear and accessible. Good repair.

Plate 5: Bridge 32a – Kingsway.
Railway bed looking east towards Luton (top); north-facing elevation
(bottom).
Cross ref with Figure 8.

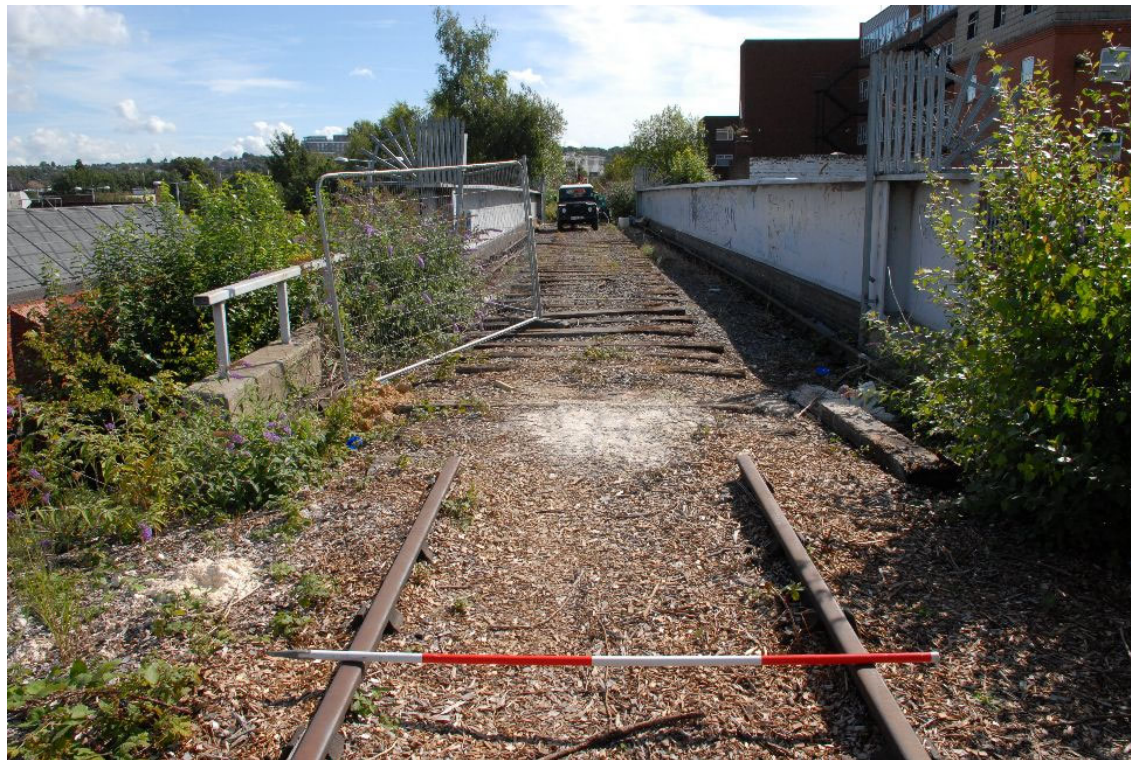
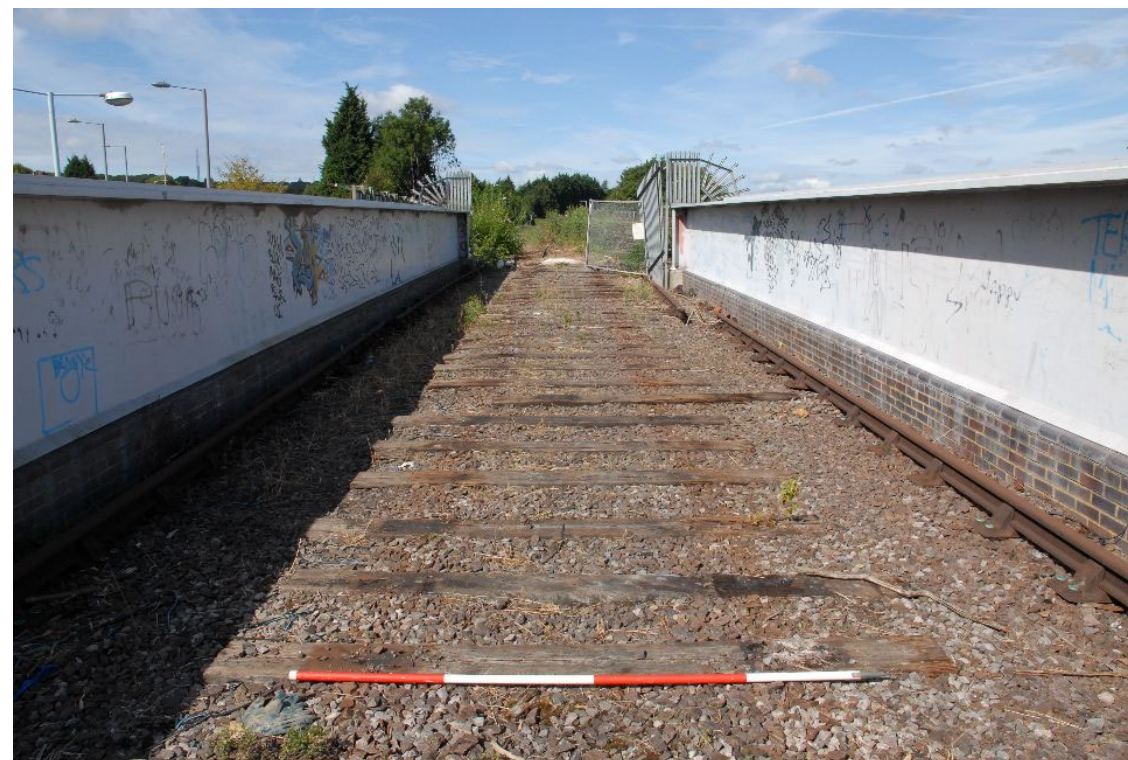
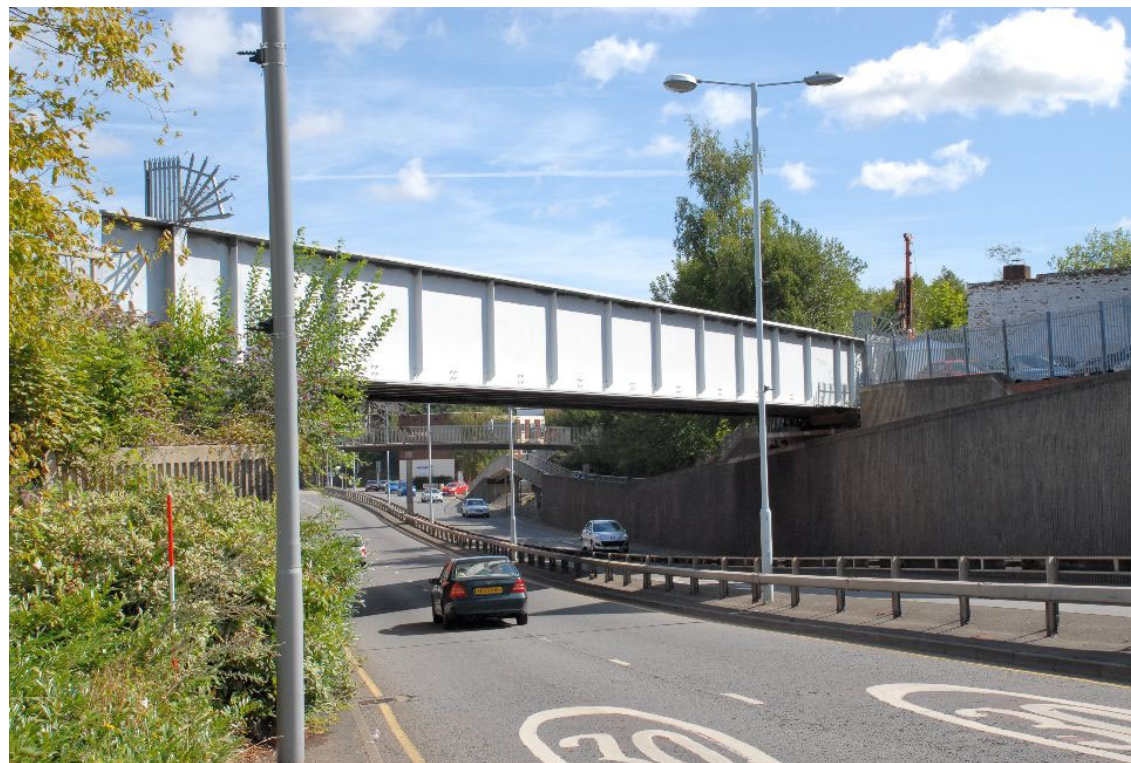
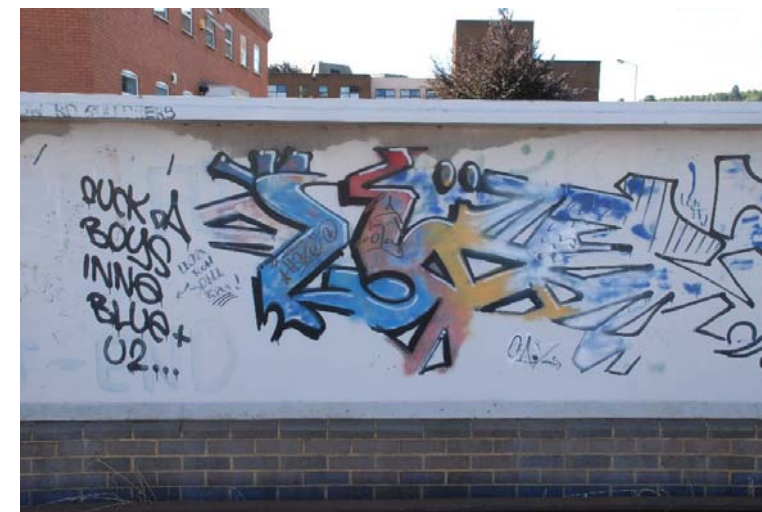
Plate 7 (a, b, c, d):
Bridge 30a, Telford Way, Luton.

Bridge number		30a
Location		Telford Way, Luton
Date		1978
Plans	Current	3046157.tif
	Original	n/a
Photo refs		6140-6149.tif
Figure refs in this report		Figure 11, Plate 7
Construction		Concrete and steel
Conditions		Clear and accessible. Track removed.

Plate 7a: Bridge 30a, looking east towards Luton Station

Plate 7b: Bridge 30a, looking west towards Dunstable

Plate 7a: Bridge 30a, north-facing elevation

Plate 7d: Bridge 30a, steel girder graffiti

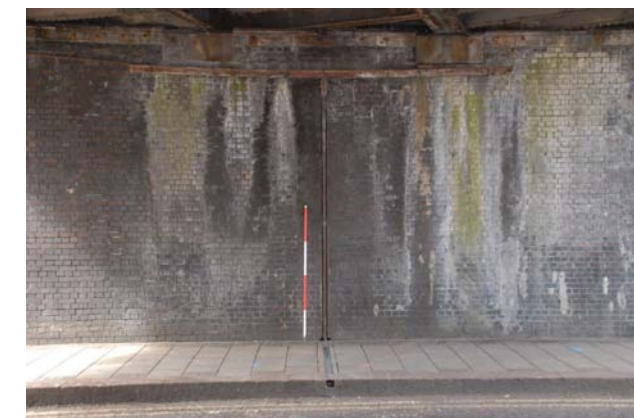
Bridge number		30
Location		New Bedford Road, Luton
Date		1898
Plans	Current	3092811.tif
	Original	n/a
Photo refs		6158-6181.tif
Figure refs in this report		Figure 12, Plate 8
Construction		Brick substructure, steel superstructure
Conditions		Overgrown but accessible.

Plate 8a: Bridge 30a, gutter and drainage pipe underneath bridge

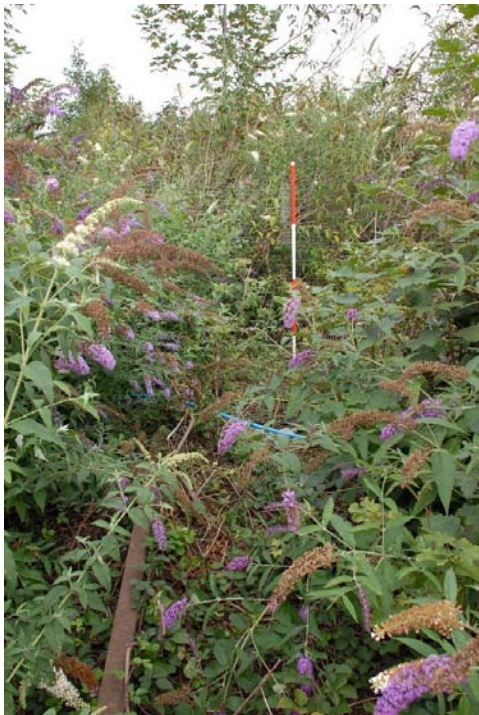
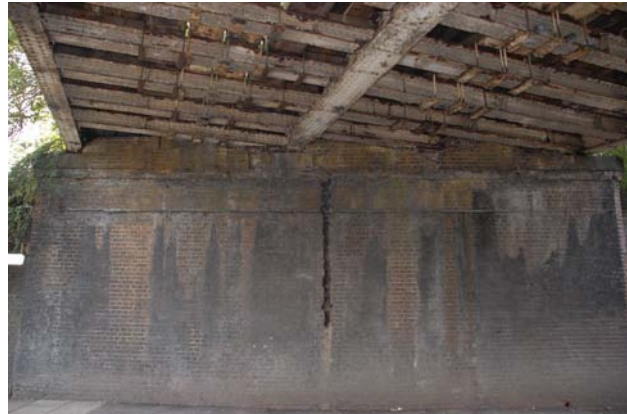
Bridge number		none given
Location		Church Street, Luton
Date		1898?
Plans	Current	No plans available
	Original	n/a
Photo refs		5972-5989
Figure refs in this report		Plate 10
Construction		Brick substructure, steel superstructure.
Conditions		Severely overgrown and inaccessible.

Plate 10: Bridge at Church Street, Luton.
North-facing elevation (top); bridge railway bed (bottom left), underside
of bridge with drain pipe removed (bottom right).

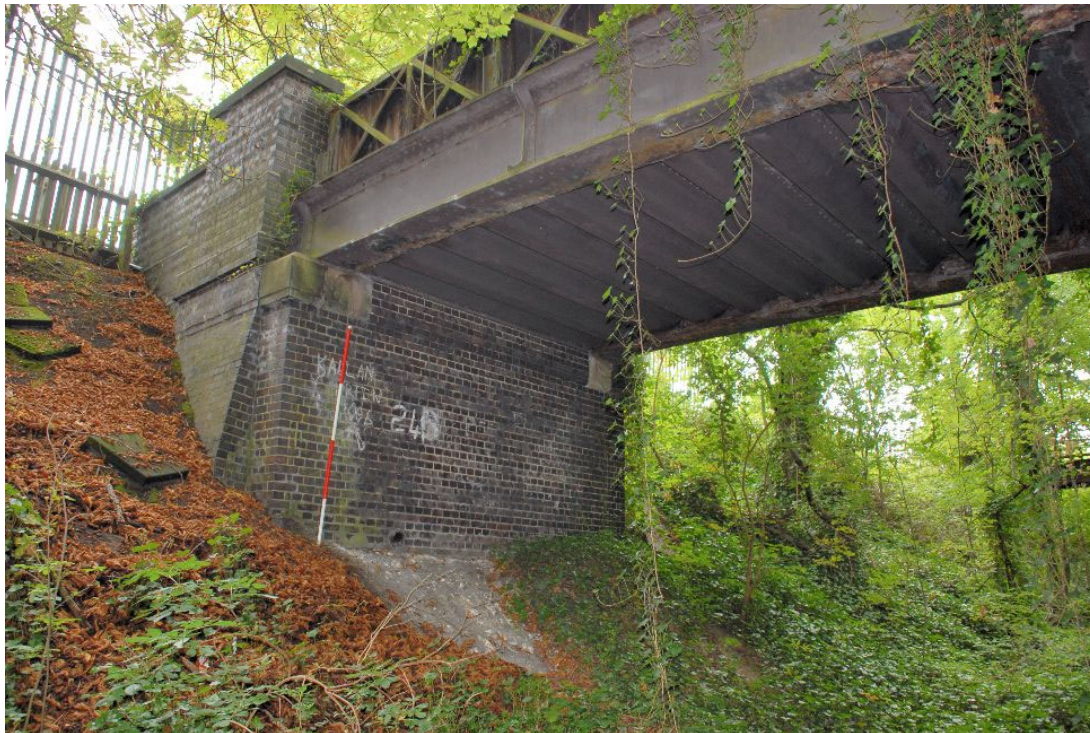
Bridge number		none given
Location		To the south of Crawley Green Road, Luton
Date		19th century ?
Plans	Current	none
	Original	none
Photo refs		5946-5951
Figure refs in this report		Plates 11 and 12
Construction		Brick abutments, steel and timber superstructure
Conditions		Overgrown and inaccessible

Plate 11: First footbridge to the east of Crawley Green Bridge. West-facing elevation and underside

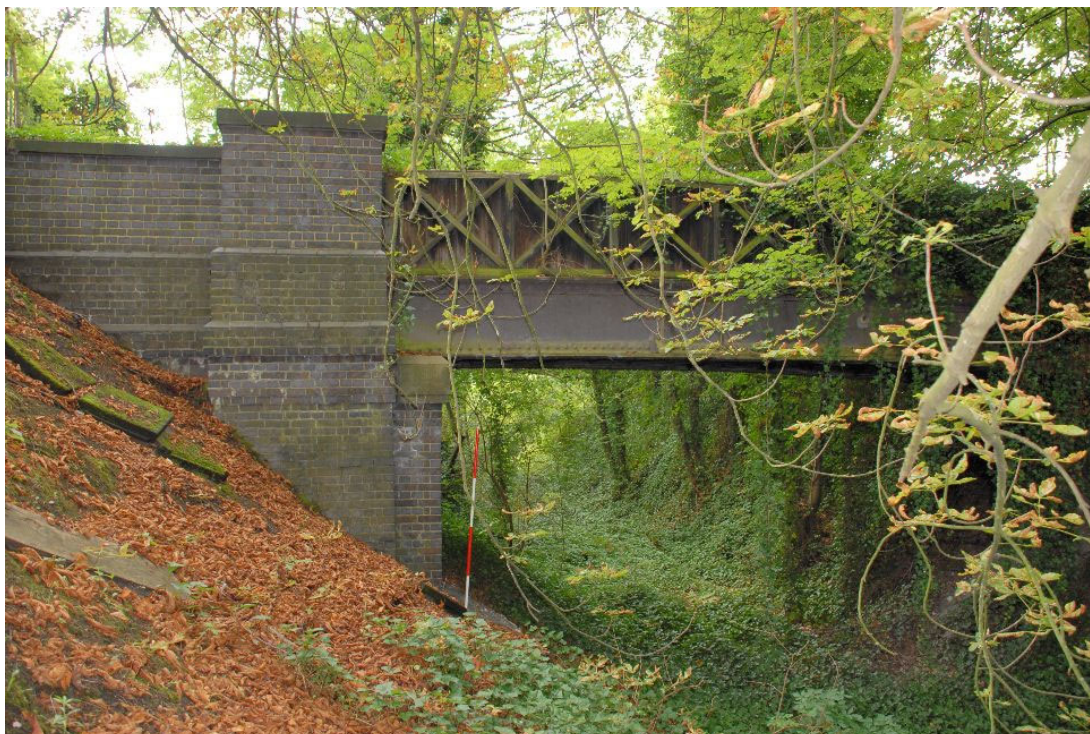
Plate 12: First footbridge to the east of Crawley Green Bridge. West-facing elevation

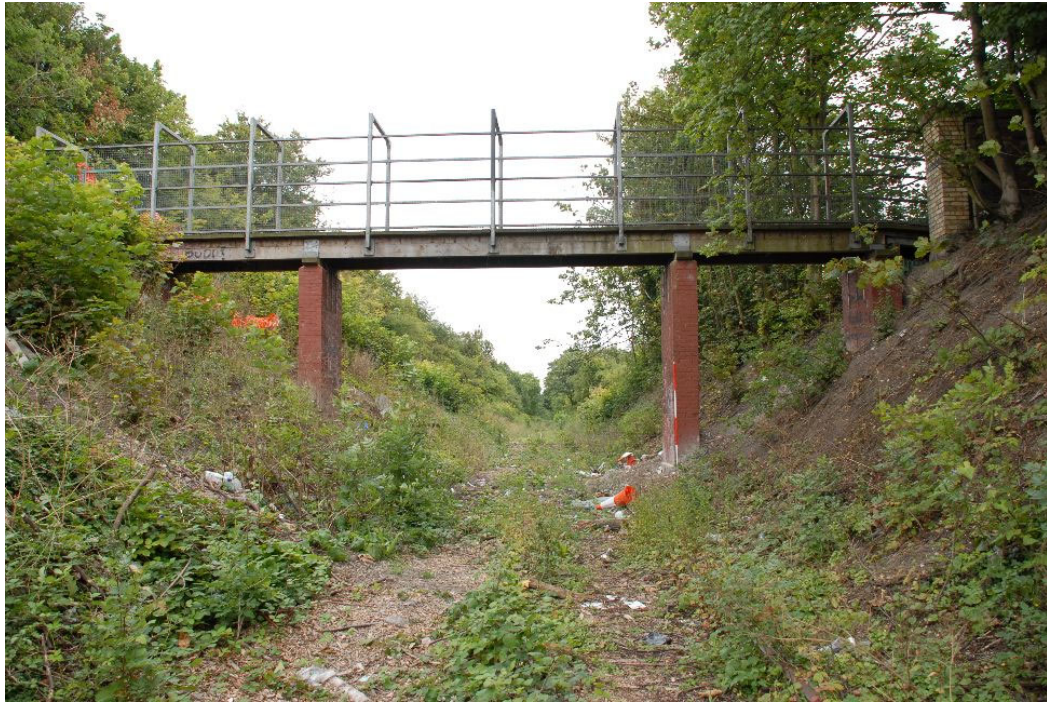
Bridge number		none given
Location		Dog Kennel Path, Dunstable
Date		??
Plans	Current	No plans available
	Original	n/a
Photo refs		5594-5609
Figure refs in this report		Plates 16 and 17
Construction		Concrete and steel
Conditions		In public use.

Plate 17: Dog Kennel Down path footbridge western elevation

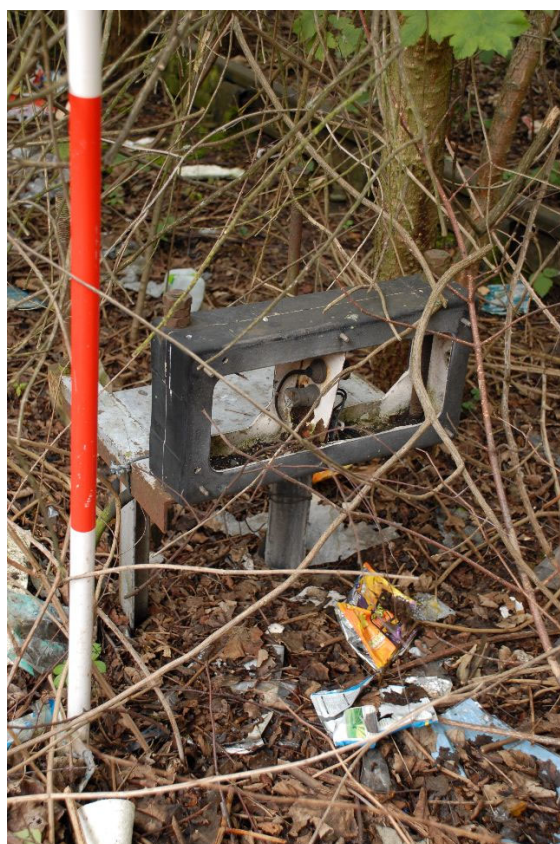
Plate 23: Ground signal (new) west of Crawley Green Bridge
