LUTON - DUNSTABLE BUSWAY BEDFORDSHIRE

STRUCTURAL RECORDING

Document: 2010/71

23 September 2010

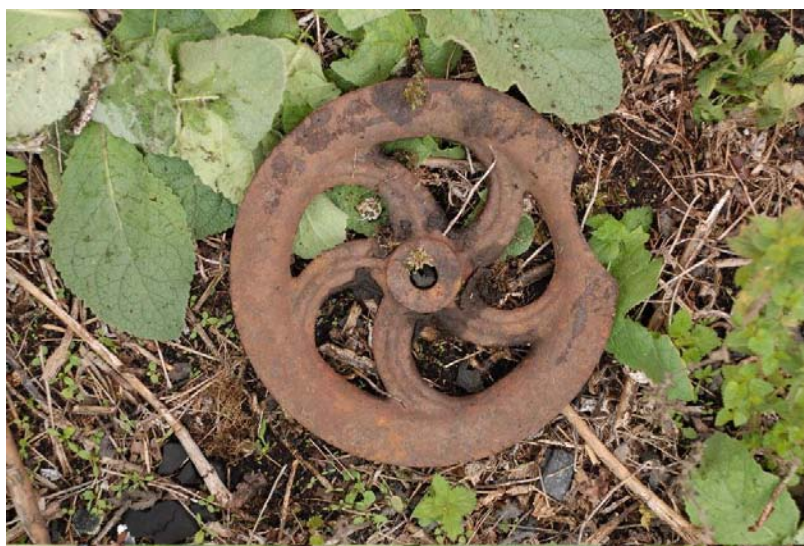
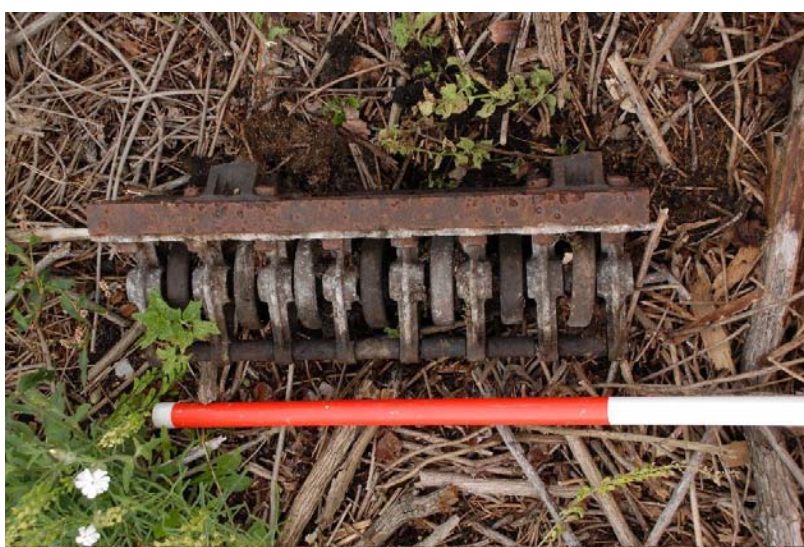
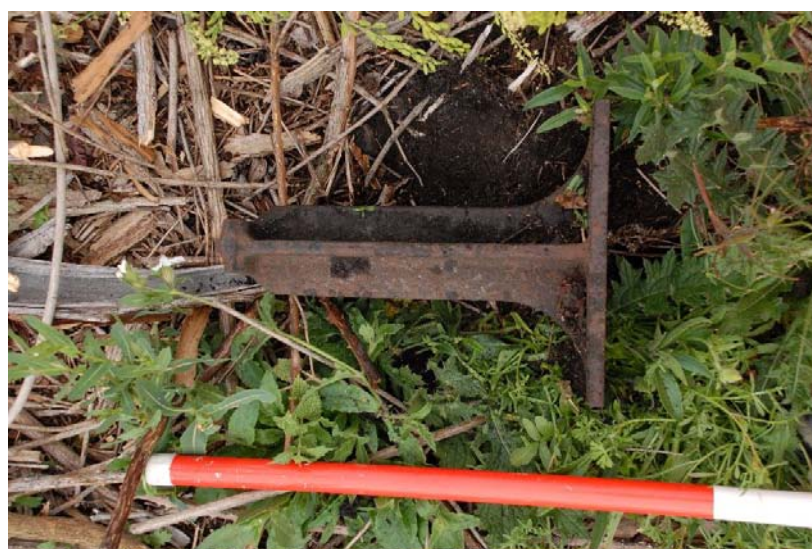
Plate 24: Discarded signalling equipment on Network Rail land east of Luton Station

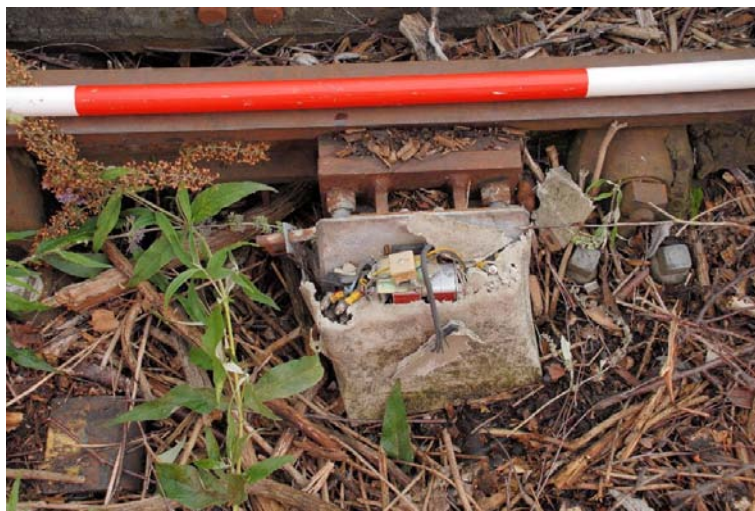
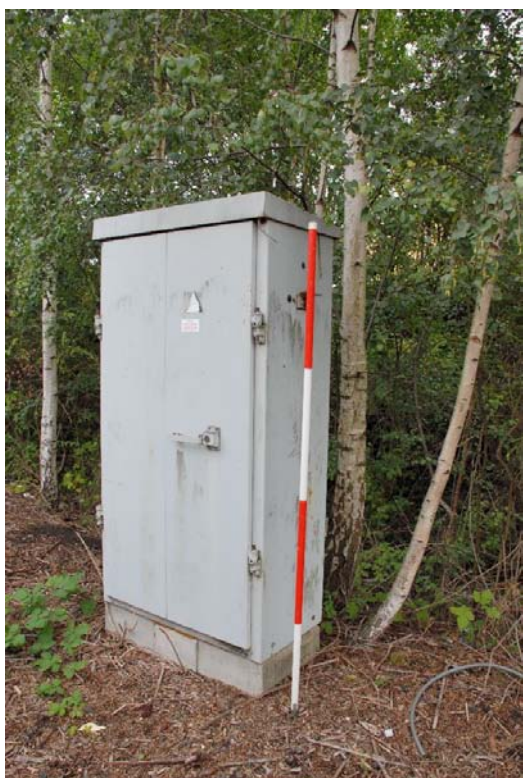
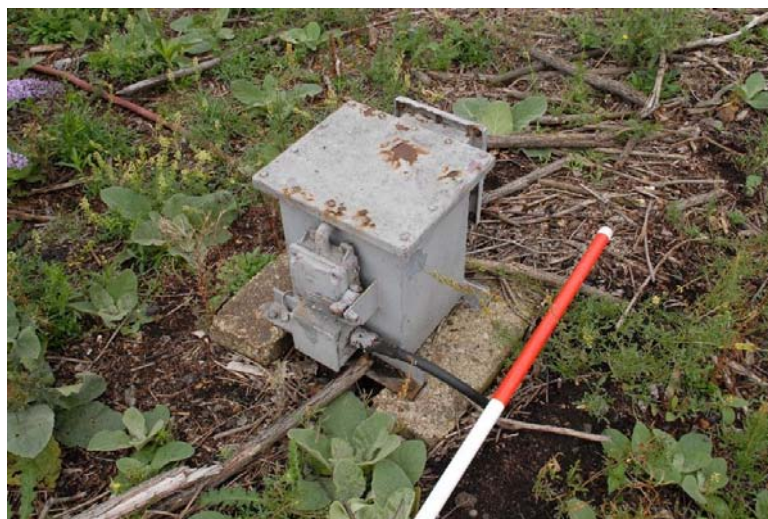
Plate 25: Disconnected electricity infrastructure for signals and points

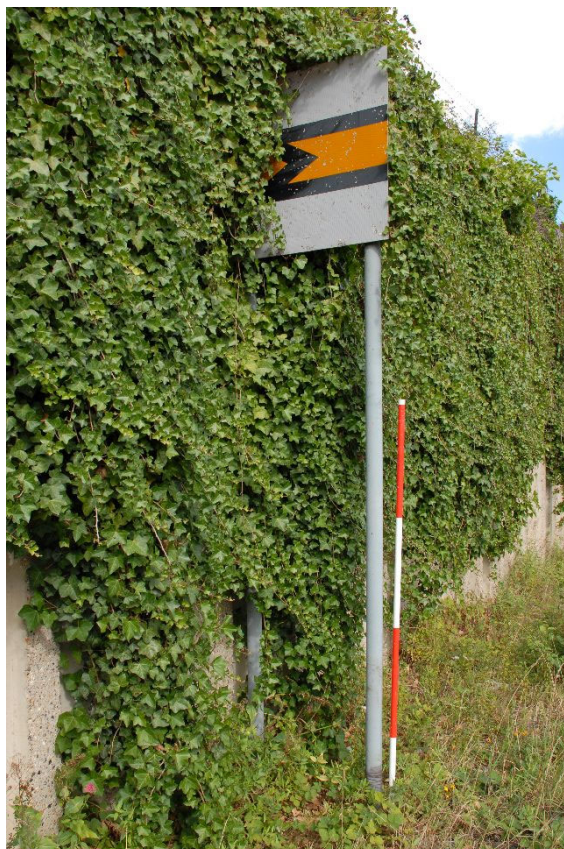
ID	Type	Description	Date	Plate
F3	Ground signal 2	Signal facing east standing to the south of the track circa 10m north of Ground Signal 1. Electrified ground signal, consisting of a rectangular, horizontal, black metal housing reaching to around knee-height. Considerably vandalised. Probably a replacement for Ground Signal 1.	Late 20th century	Plate 23
F4	Discarded signalling equipment	Located in area of track between live Midland Mainline and surviving single Luton – Dunstable track. Remains of old manual signalling equipment.	Early 20th century	Plate 24
F5	Electricity boxes and supply	Several electricity points and switch boxes survive on Network Rail land. Some are still <i>in situ</i> while others have been uprooted and lie next to the track.	Late 20th century	Plate 25
F6	Fixed trackside signal	Reflectorised distant board, facing west, near Luton Town Football Club. It consists of a horizontal orange bar with black borders and a single black arrow against a white background. These signs were developed in the 1980s as part of establishing a cheaper means of signalling lightly-used lines. It was a reflectorised notice board style equivalent of the fixed distant signal (SDL 2005-2010).	Late 20th century (1980s)	Plate 26

Plate 26: Reflectorised distance signal near Luton Town football club

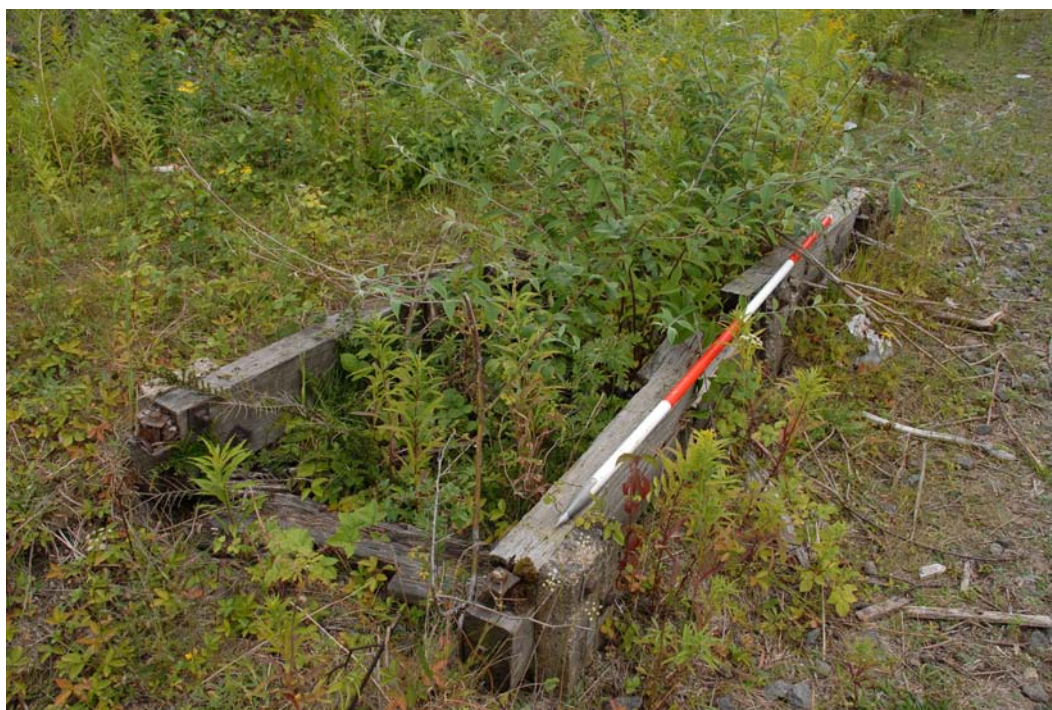
F7	Uncertain structure	Rectangular structure, measuring 1.5 m x 0.9 m in the area of former sidings to the works along Boscombe Road, Dunstable. In the form of a box lined with wooden planks. Function unclear. Very overgrown.	Early 20th century	Plate 27
F8	Points infrastructure	Very overgrown and only partially visible possible remains of manual points operating system next to sidings to the south-west of Dunstable Church Street Station.	Early 20th century	Plate 28
F9	Telegraph poles	The remains of a large number of telegraph poles still survive beside the track. None of the poles are upstanding. In some cases only a wooden stump survives, in others the complete pole lies beside the track. In most cases the wood is considerably decayed.	various	Plate 29
F10	Steam plate	A metal steam plate was fixed to the east-facing elevation of Crawley Green Road bridge. This would have prevented the steam from the locomotives passing directly up the face of the bridge.	Early 20th century	Plate 30

Plate 27: Rectangular structure

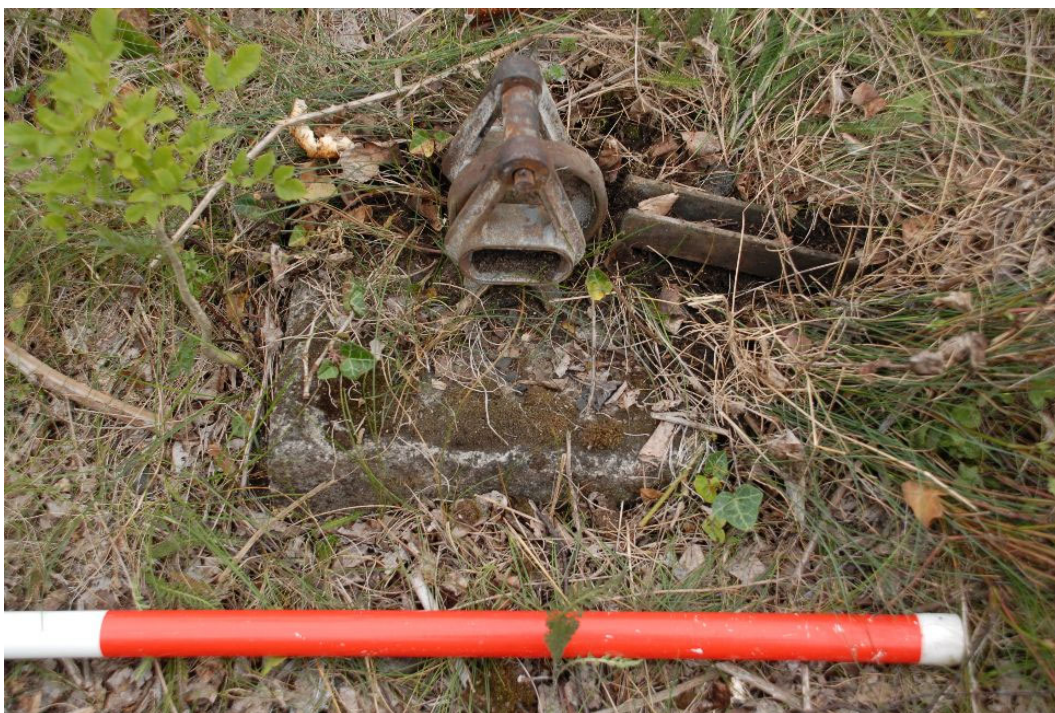
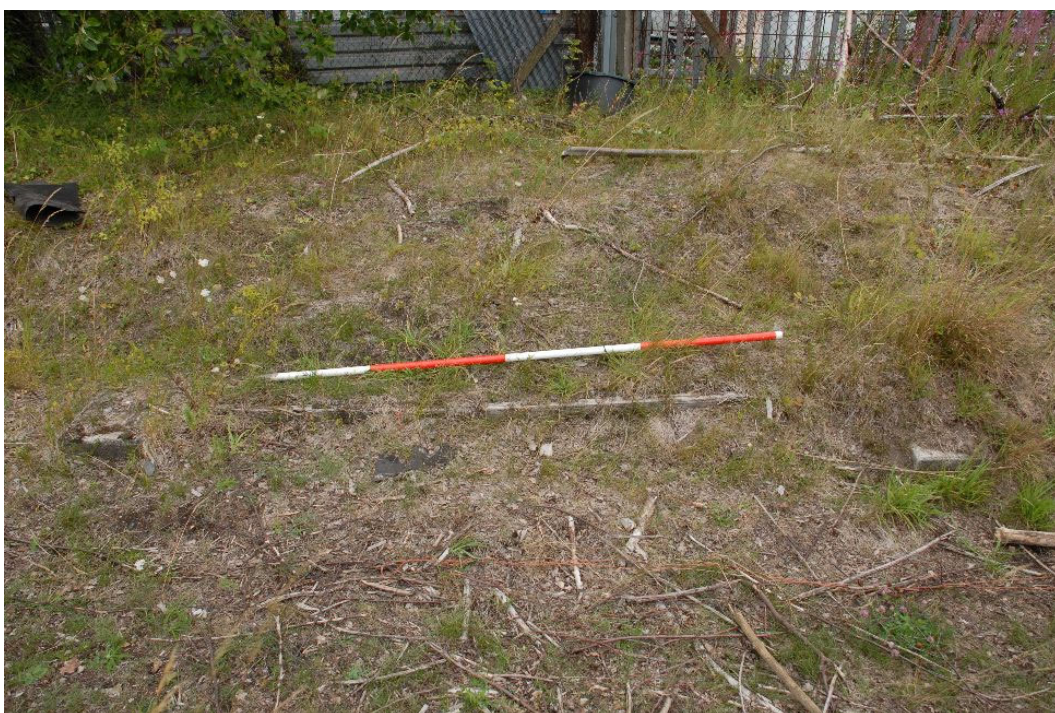
The most interesting *in situ* remains are the remainders of the signalling or points changing ground frame equipment at the junction to the Dunstable Town Station at the foot of the Blow's Downs (Plate 28), and the small ground signal F2 (Plate 22), north of Crawley Green Road bridge, and the steam plate F10, fastened to the eastern elevation of Crawley Green Road bridge itself.

Plate 28: Signalling equipment near Dunstable Church Street station

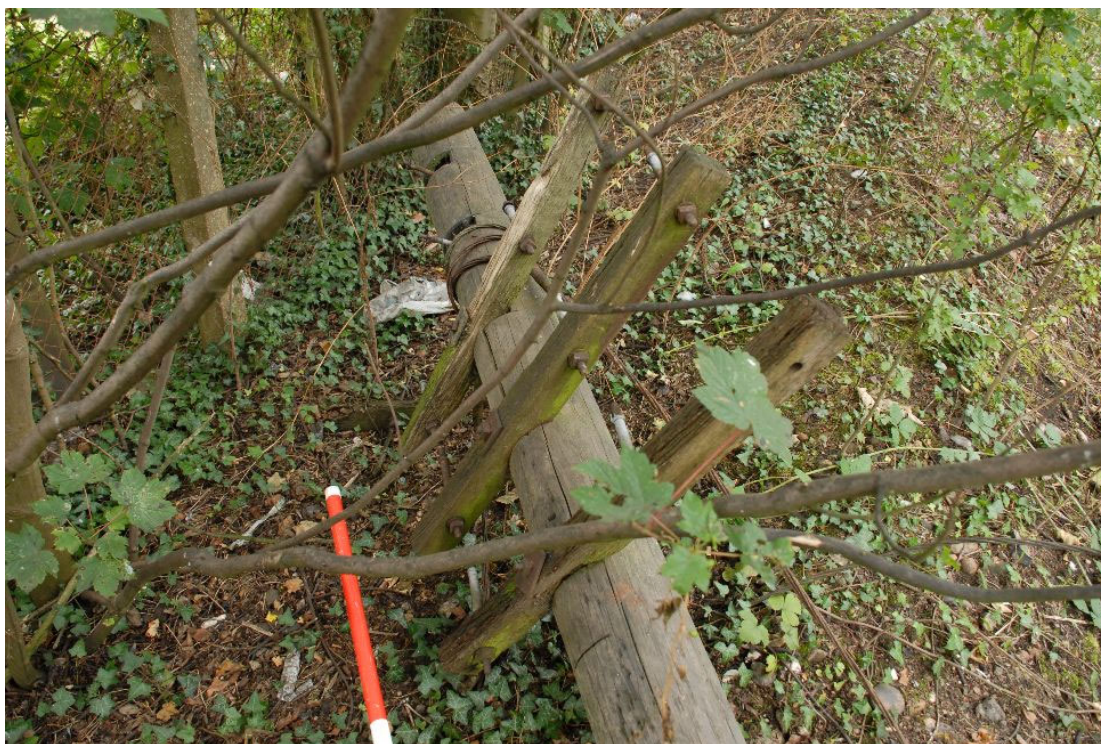
Plate 29: Felled telegraph pole

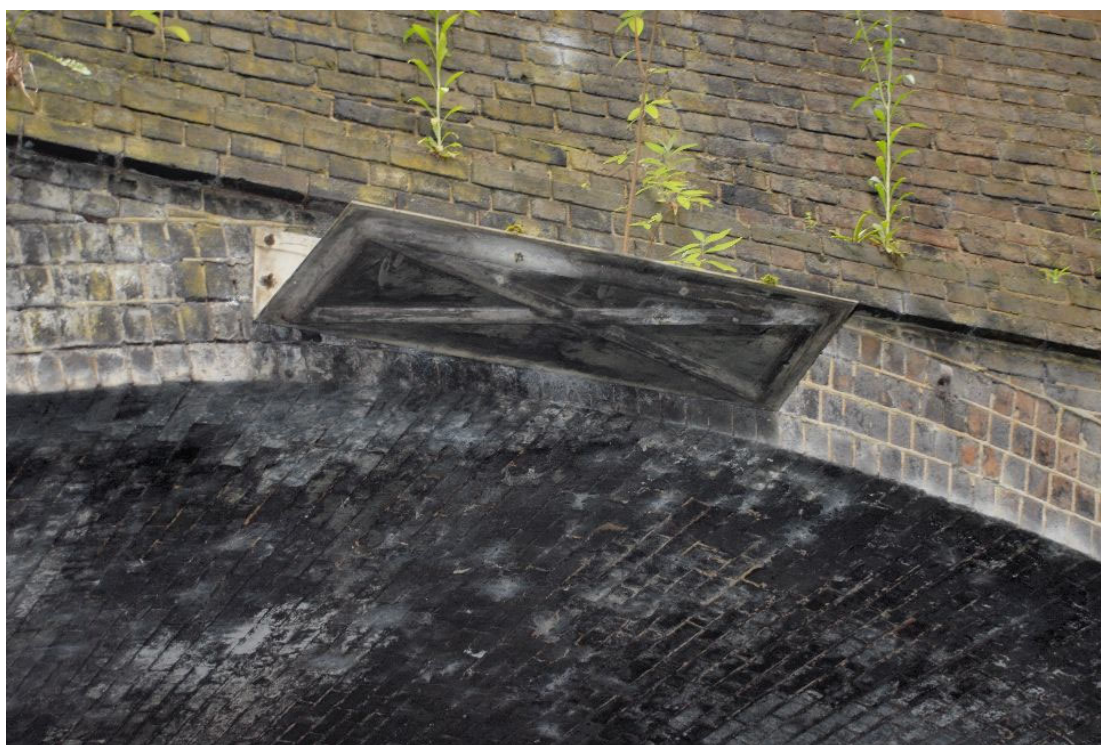
Plate 30: Steam plate on eastern side of Crawley Green Bridge, Luton
