**WOOD BURCOTE MANOR FARM
PLOTS 3 & 4
WOODBURCOTE
NORTHAMPTONSHIRE
HISTORIC BUILDING RECORDING**

Document: 2015/51
Version: 1.0
April 2015

Albion Archaeology Project Code: WB2558
Northamptonshire Archaeological Resource Centre entry number: ENN107938
Oasis reference: albionar1-210391

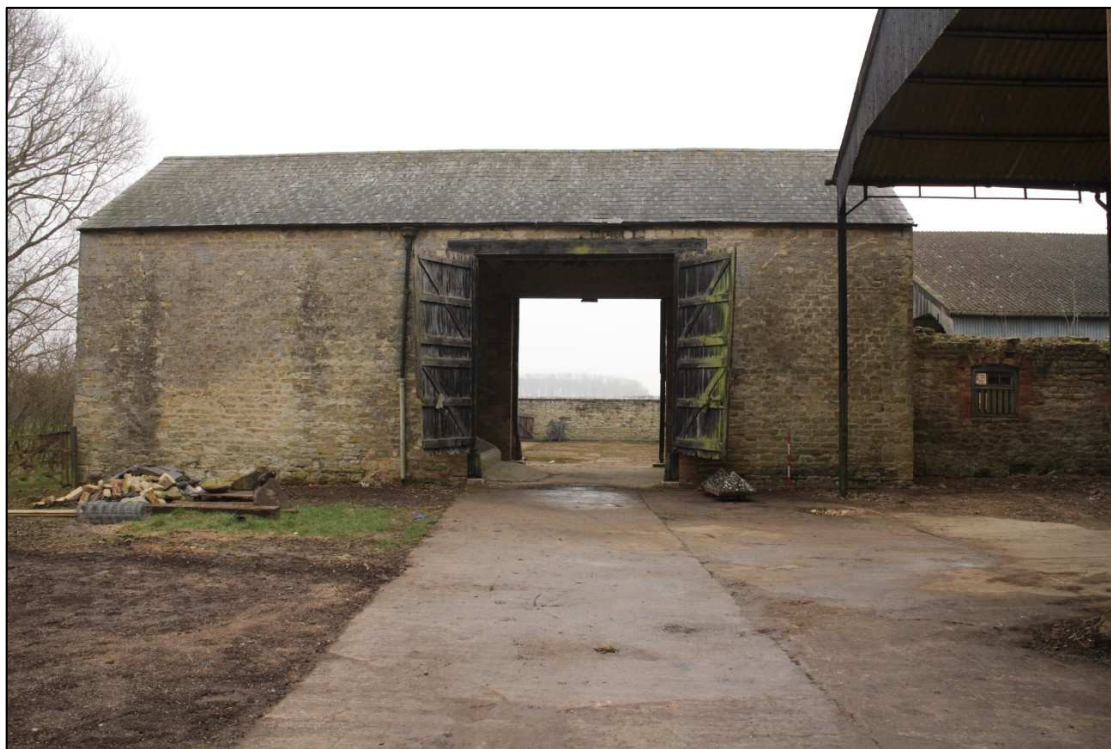
Image 17: North range: C7 Barn: Exterior view of north elevation
Shows proportions of barn with longer section to east of doors

Opposing, near full-height double doors are positioned off-centre to the west (Images 17 & 18). The openings have paired timber lintels with plain a chamfer on the face of the external beam. Surviving doors in the north door opening are ledged and braced with locking and hanging stiles. They are hung with strap hinges with 'holly-leaved' terminals.

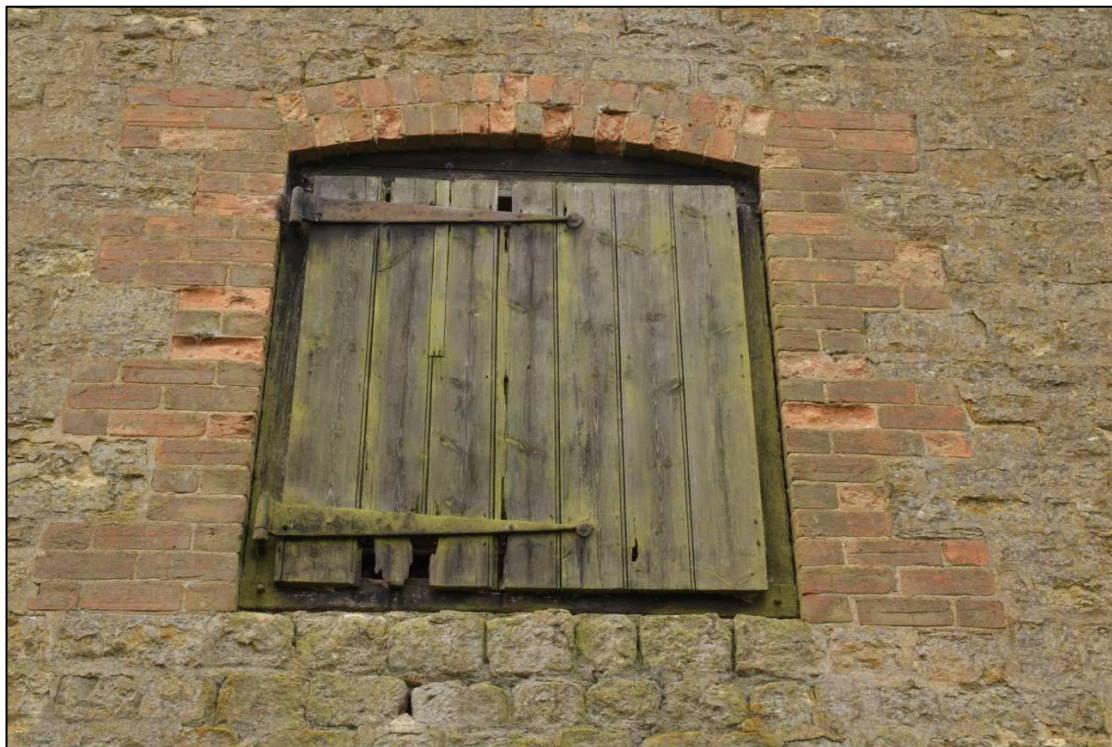
Image 19: North range: C7 Barn: Interior looking west

Shows high level opening in west east end wall of barn

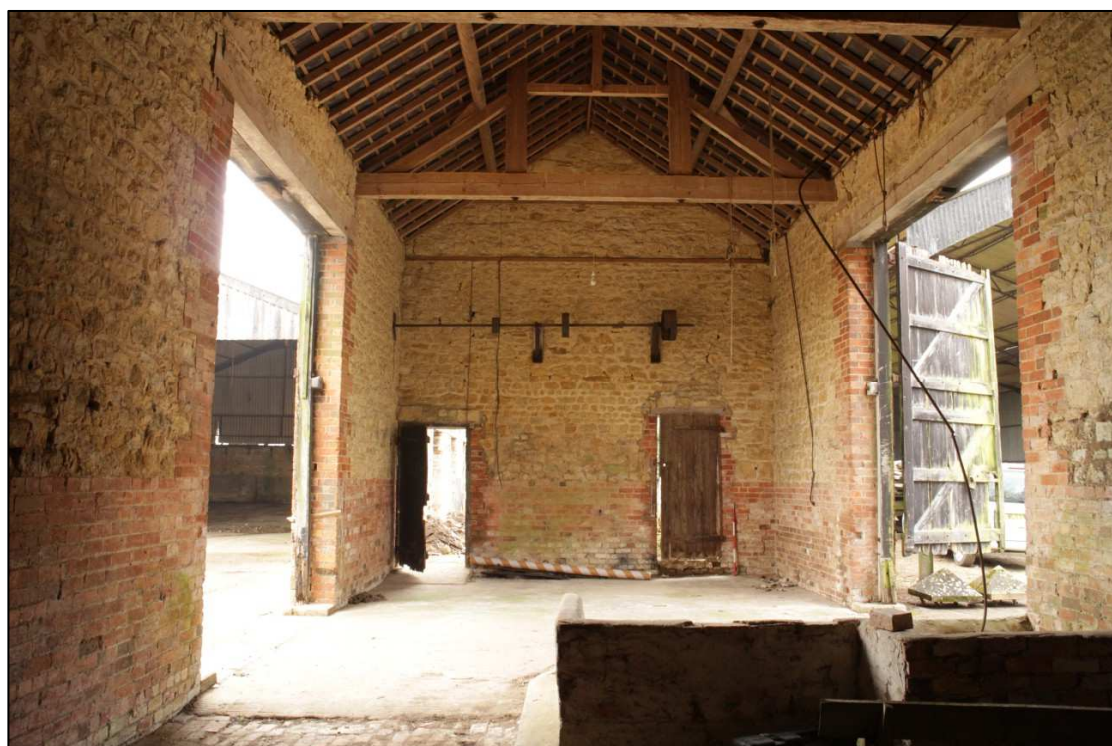
Image 20: North range: C7 Barn: Interior looking west

There are two doors in the west wall, the northern one gives access to the feeding passage that runs through C5 and C6 (Image 20). Both have ledged and braced doors; the south one with strongly tapered hinges with round terminals whilst those on the north door are parallel sided with spear shaped ends.

Shows double doors through to C6 with line shafting mounted on wall above

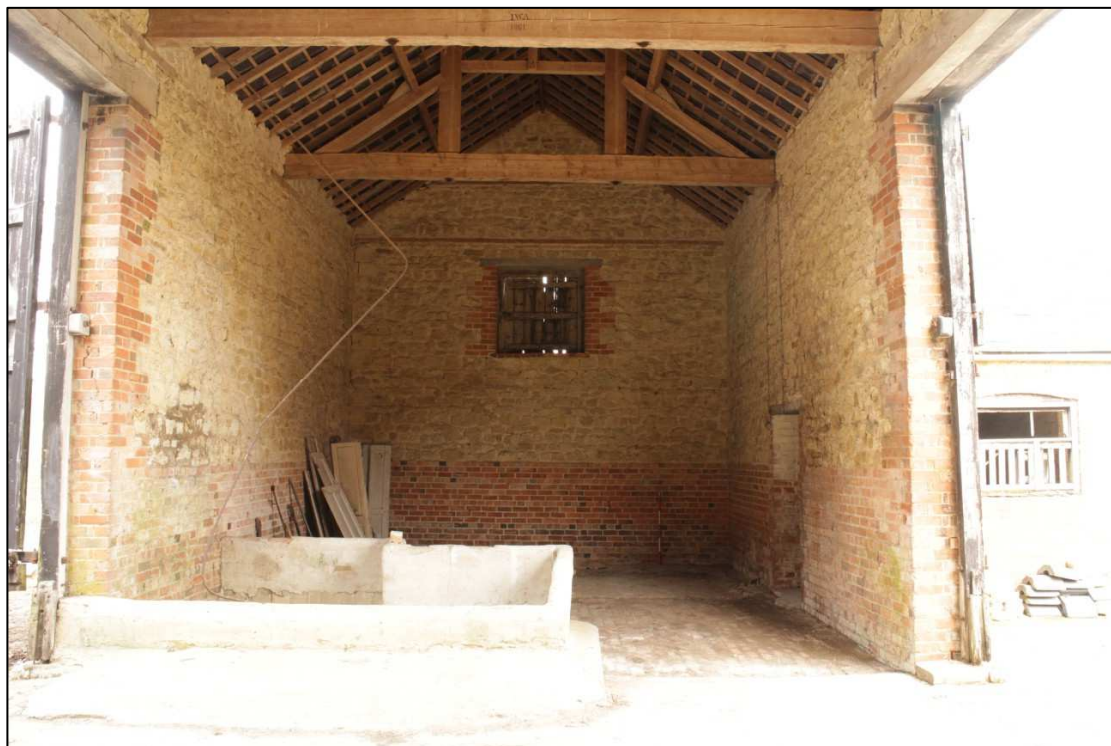
Image 21: North range: C7 Barn: Interior looking east

Shows high level opening in east wall

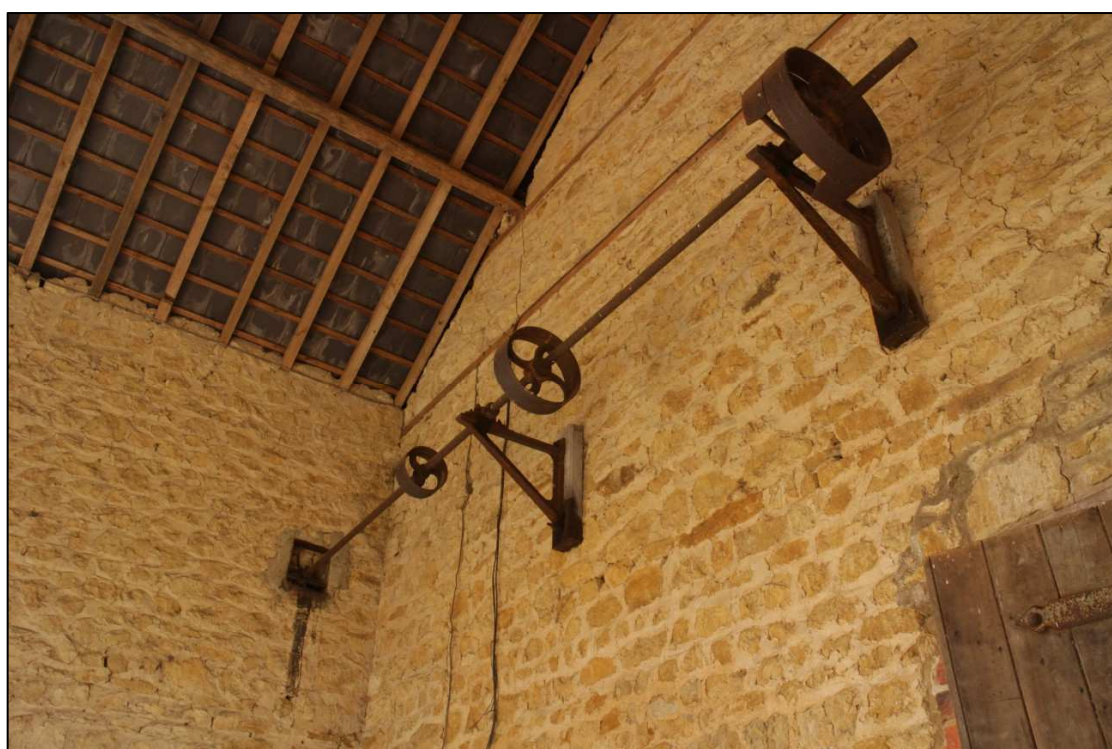
Image 24: North range: C7 Barn: Interior detail showing line shafting

Line shafting is fitted to the upper part of the west wall (Image 24). The shaft is supported by two cast-iron brackets and extends from a box in the south wall. It has three pulleys which diminish in diameter from north to south. No evidence of the shaft can be seen on the exterior but it may originally have passed through the box in the south wall to be powered by a portable engine in the yard.

Shows shaft mounted on brackets on west wall with end in south wall

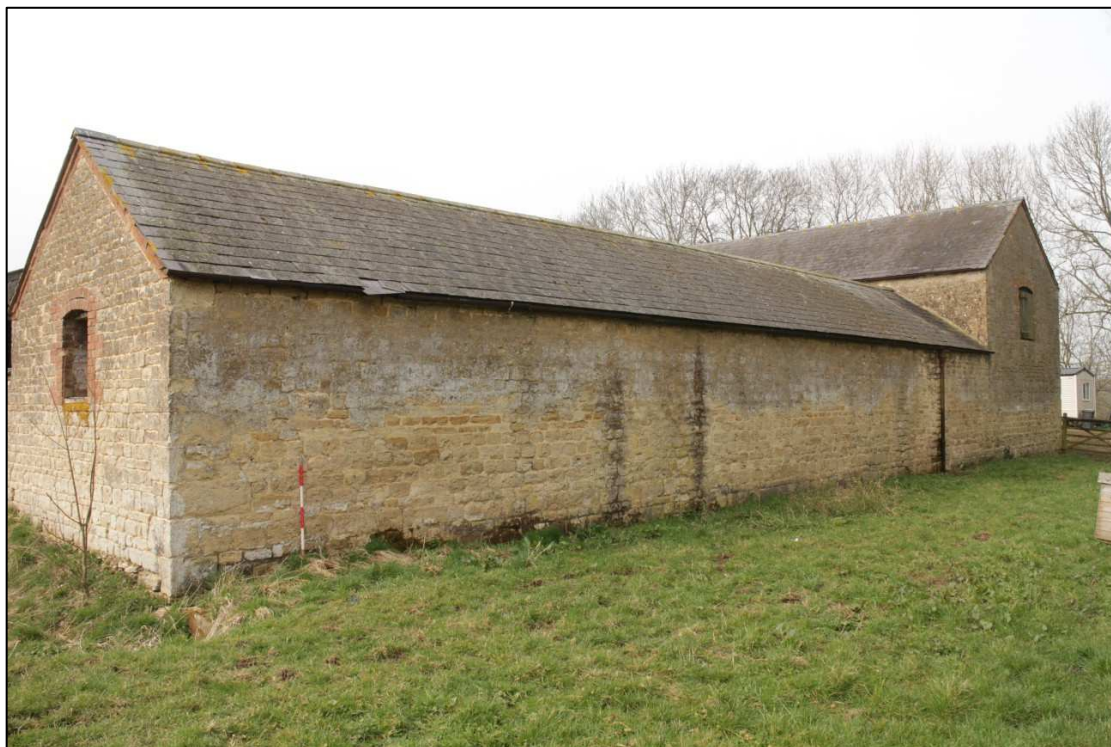
Image 25: East range: Exterior view of east side

The east range is a single storey range that ends in a gable end at the south and abuts the side of barn C7 at the north (Images 25 & 26). Brick partitions form short compartments at the north and south with a larger open-fronted section between (Image 27). The partitions are in English garden wall bond with three courses of stretchers to each header course. The upper sections of the cross-walls have single thickness panels with gaps left between the bricks for ventilation.

Shows gable end and rear wall of the east range and the east end of barn in the north range

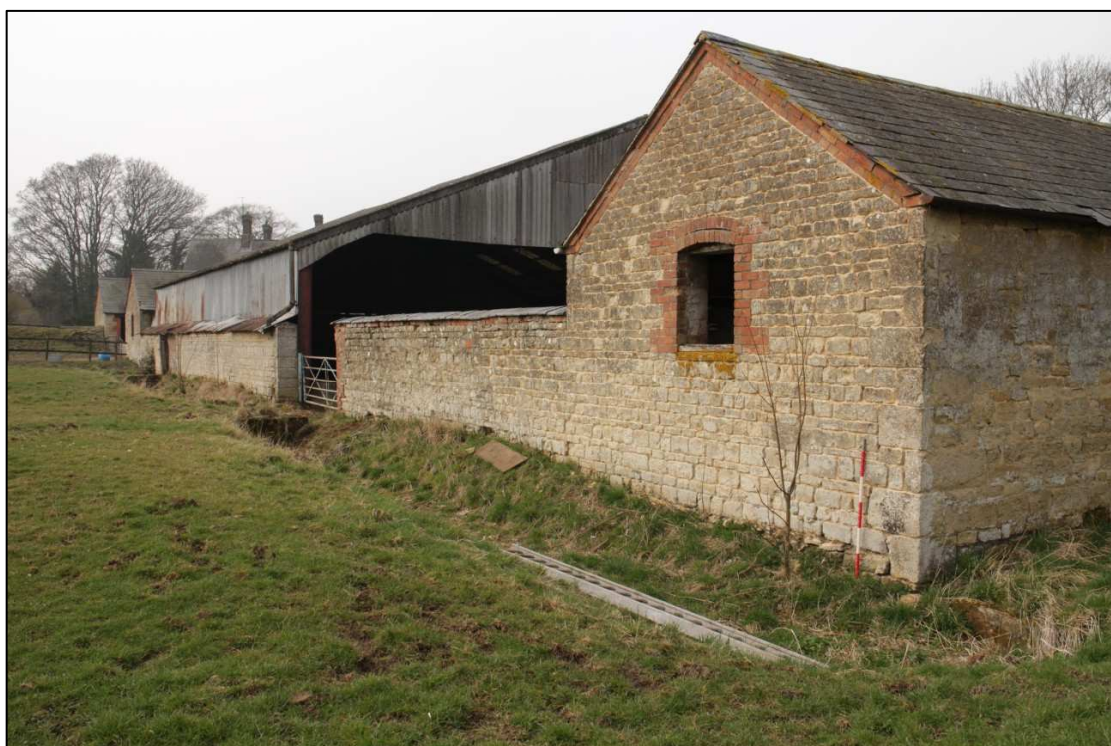
Image 26: East range: Exterior view of south gable end

Shows gable end of east range and yard wall

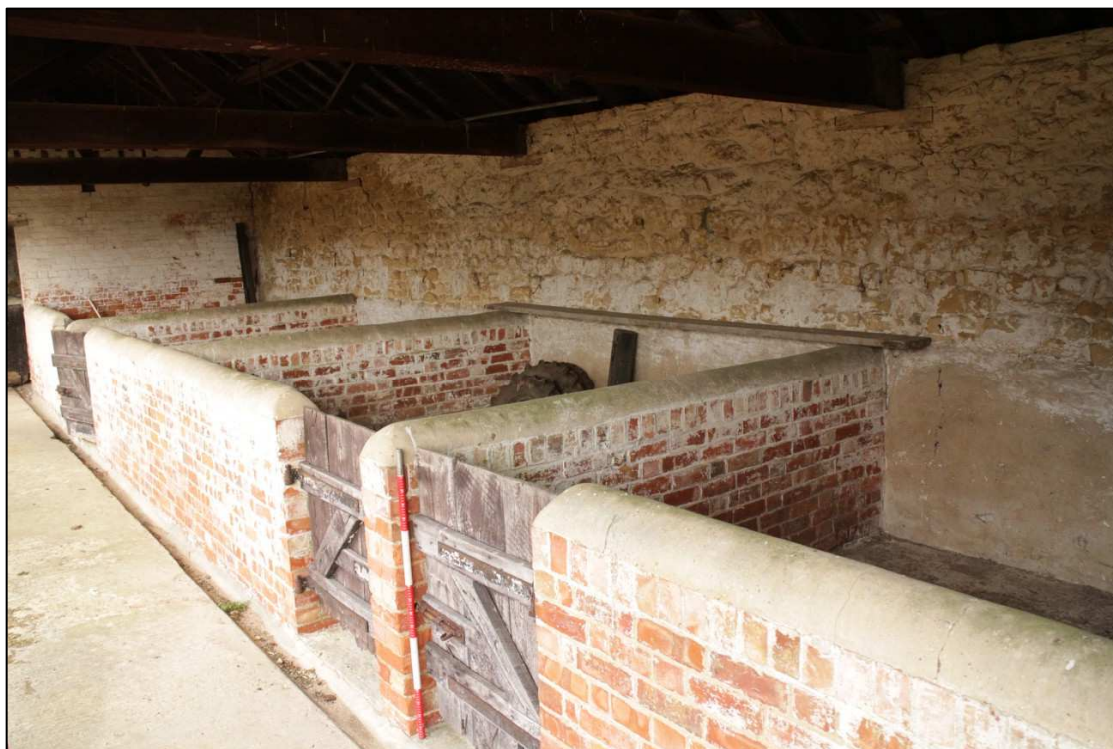
Image 29: East range: C9: Detail of pigsties

A series of four pens along the eastern side of the space are formed by 1m high brick walls (Image 29). These are in red brick laid in Flemish garden wall bond. Cement has been used to form a rounded coping along the tops of the walls. Gates on the pens are ledged and braced and hung from plain strap hinges with square ends.

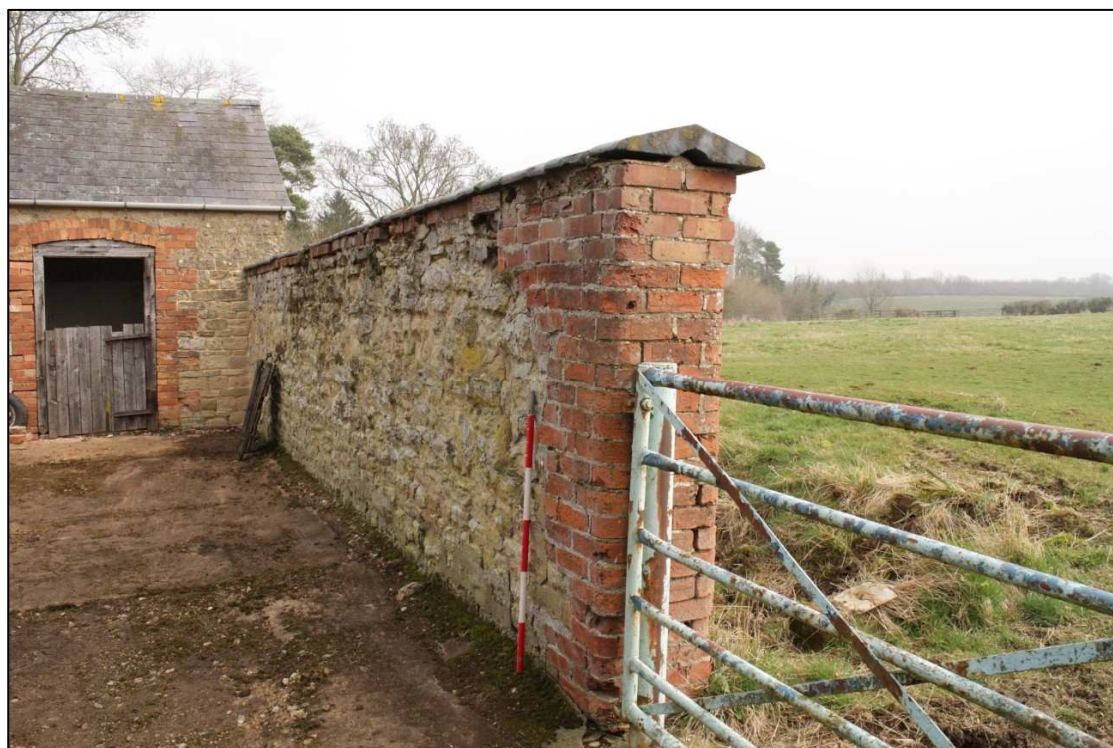
Image 30: Yard wall: east end

The yard is enclosed on three sides by the ranges of buildings. It measures 38.4m east-west by 19.6m north-south. It is enclosed on its south side by a 2m high limestone wall (Images 30 & 31). The wall is in coursed, squared limestone capped with a single course of red brick below grey saddleback coping bricks.

Looking east from inside yard, shows brick dressing to opening and tile copings

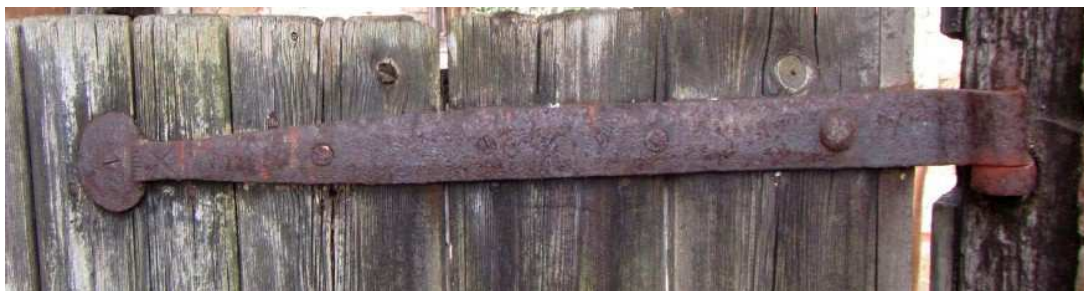
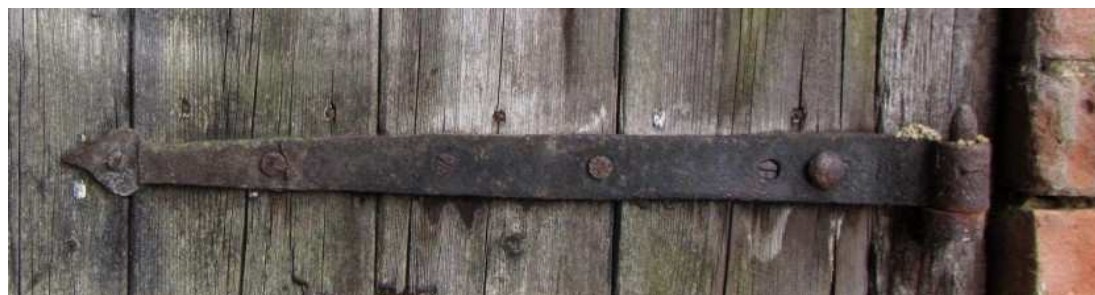
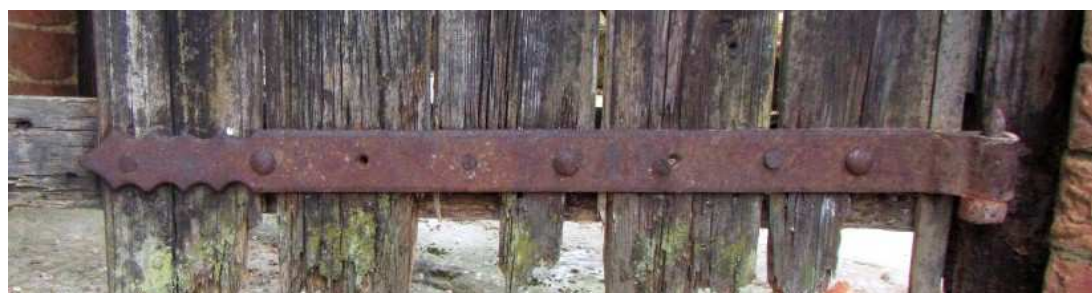
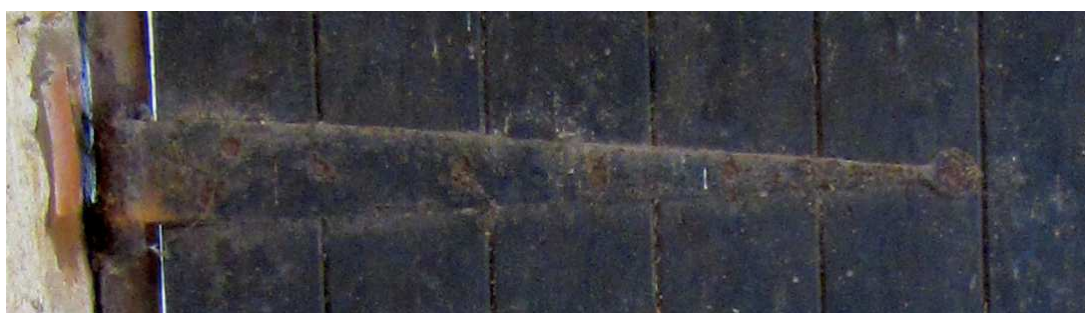
Image 33: Various strap hinges

The ironwork includes items consistent with a late 19th century date. These consist of parallel-sided strap hinges with square ends or decorative terminals in the form of either spear-shaped or a serrated 'holly-leaf' shape (Image 33c). However, a large proportion of the hinges appear to be earlier fittings that have been re-used. These are hand-forged, tapered hinges with spear-shaped (Image 33b) or rounded terminals (Image 33a & d). These two types continued to be produced into the mid 18th and early 19th century respectively (Hall 2005, 48-52).
