**BASSMEAD MANOR  
STAPLOE  
BEDFORDSHIRE**

**HISTORIC BUILDING RECORDING**

Document: 2013/73  
Version: 1.0

Issue date: 29th May 2015

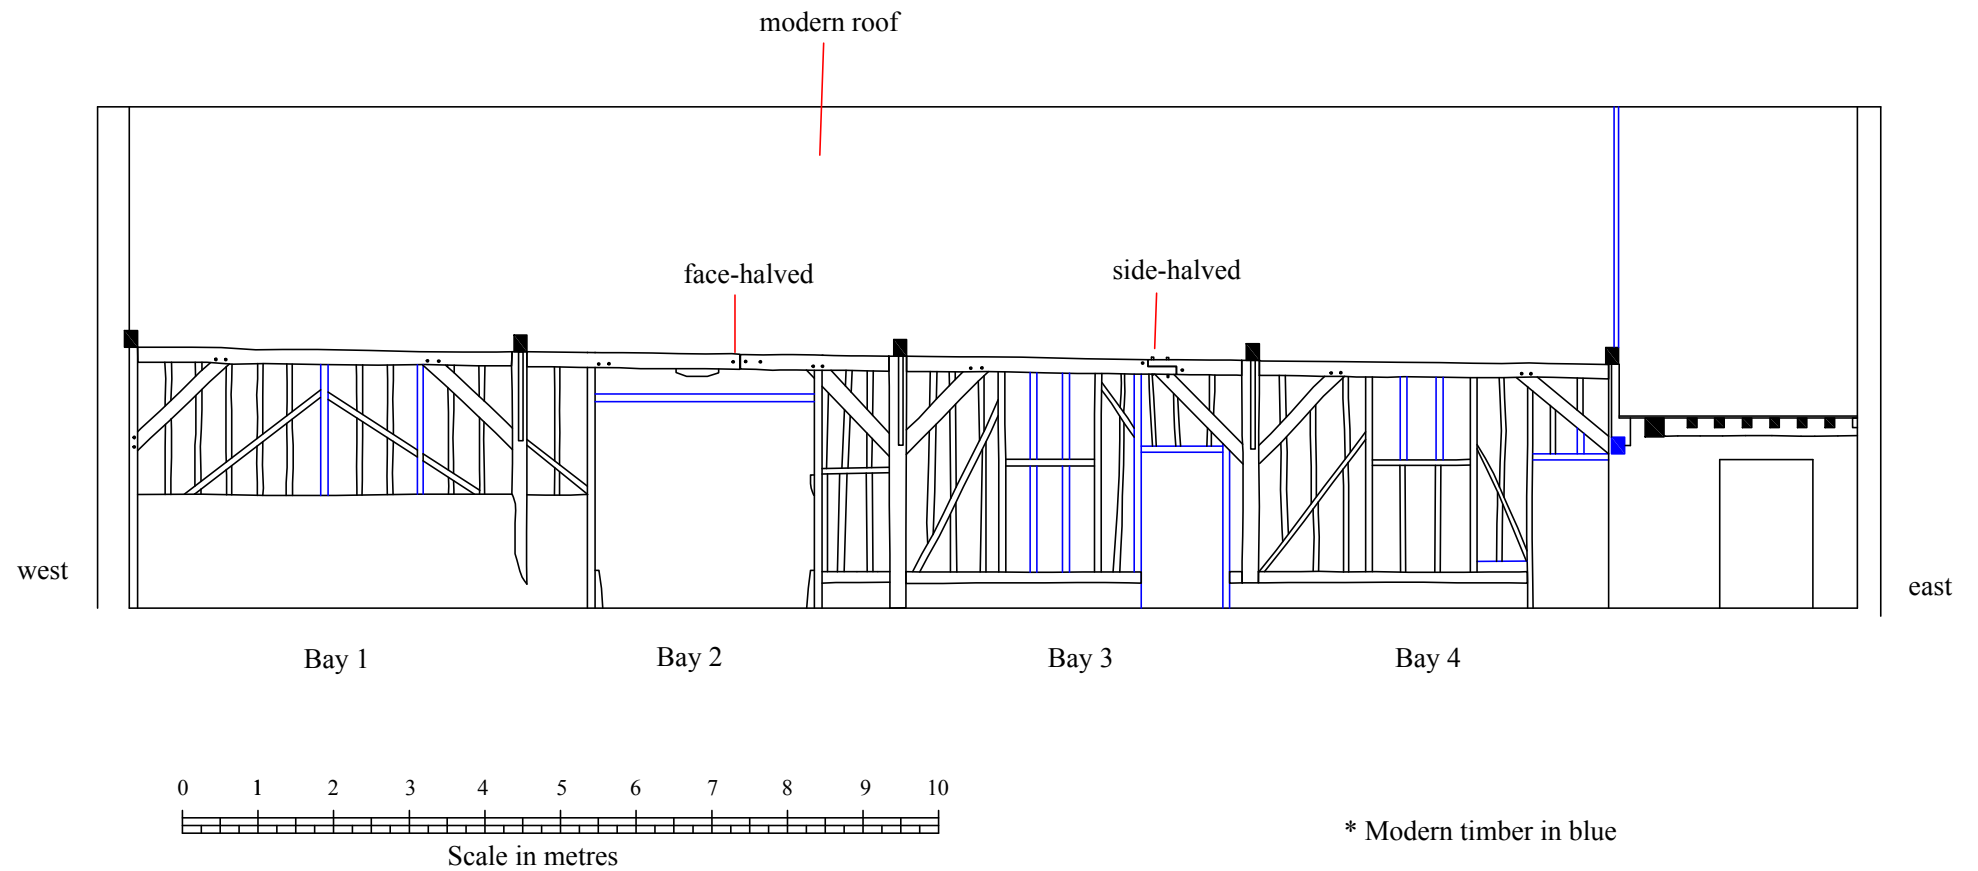
Figure 5: Bean Barn: internal north elevation

The aisle plate is made up of at least three parts with two visible scarf joins. In bay 3 it is edge-halved with bridled abutments with two additional pegs inserted vertically through the central part of the scarf (Image 7). In bay two the scarf join is face halved with bladed abutments (Image 8).

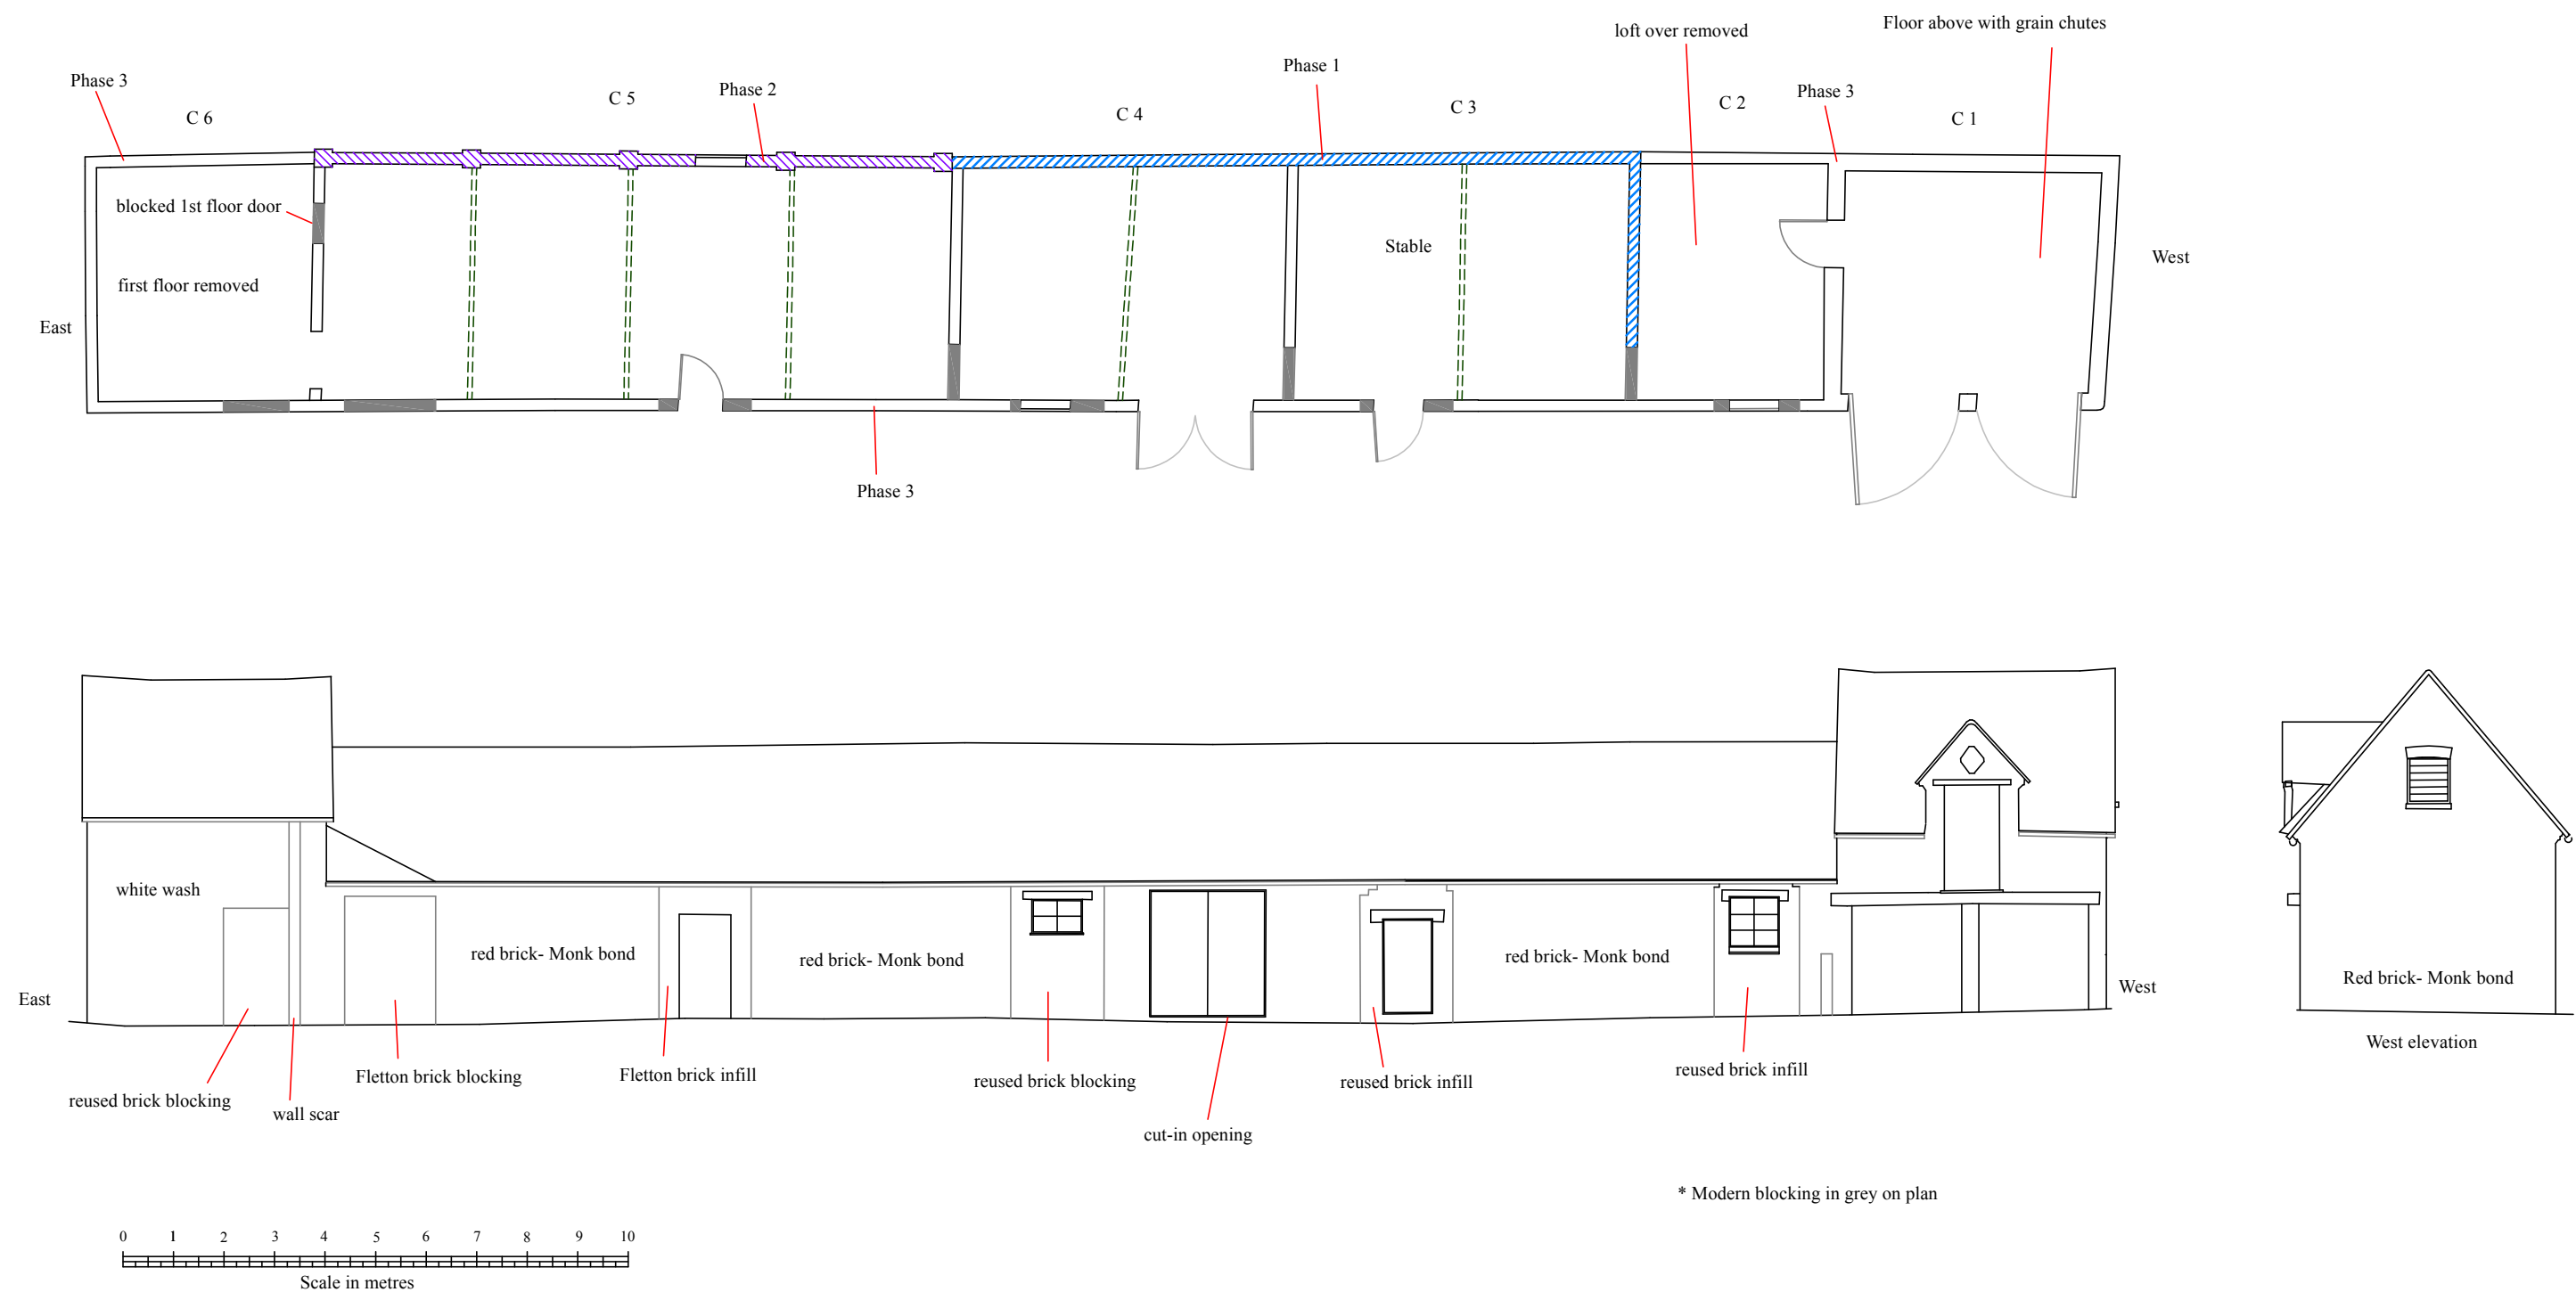
Figure 7: Long Barn: plan and north elevation

Whitewash on the two-storied section at the east end of the range (C6) (Figure 7; Image 15) indicates that this was formerly an internal wall. It would have formed the south end of a demolished range extending along the east arm of the moat. Evidence for the demolished range includes a vertical wall scar consisting of cement-filled holes where bricks have been removed and a short return and valley gutter in the roof over C5.

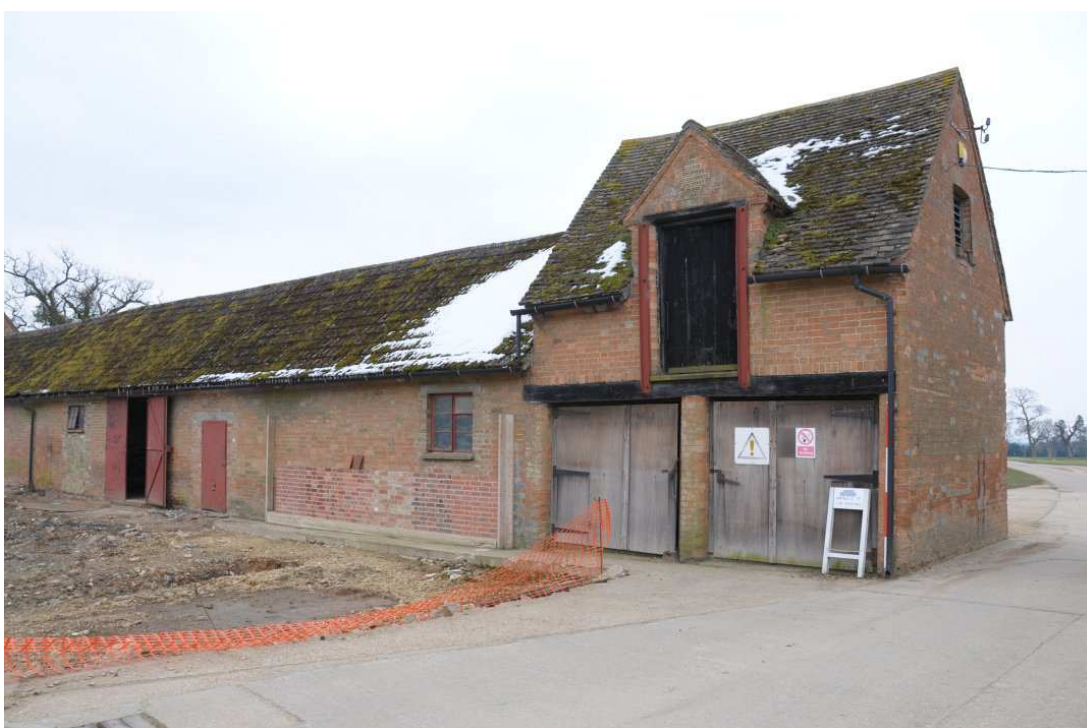
**Image 16:** Long Barn, west end  
Looking south-east (scale 2m)

Apart from later modifications the north elevation is in red brick laid in Monk bond. The two-storey section at the west end (C1) retains its original openings with two wide doors separated by a brick pier on the ground floor and a high-level door on the first floor in a gabled dormer (Image 16). All of the other openings in the north elevation are either modern or have been blocked or modified in the 20th century.

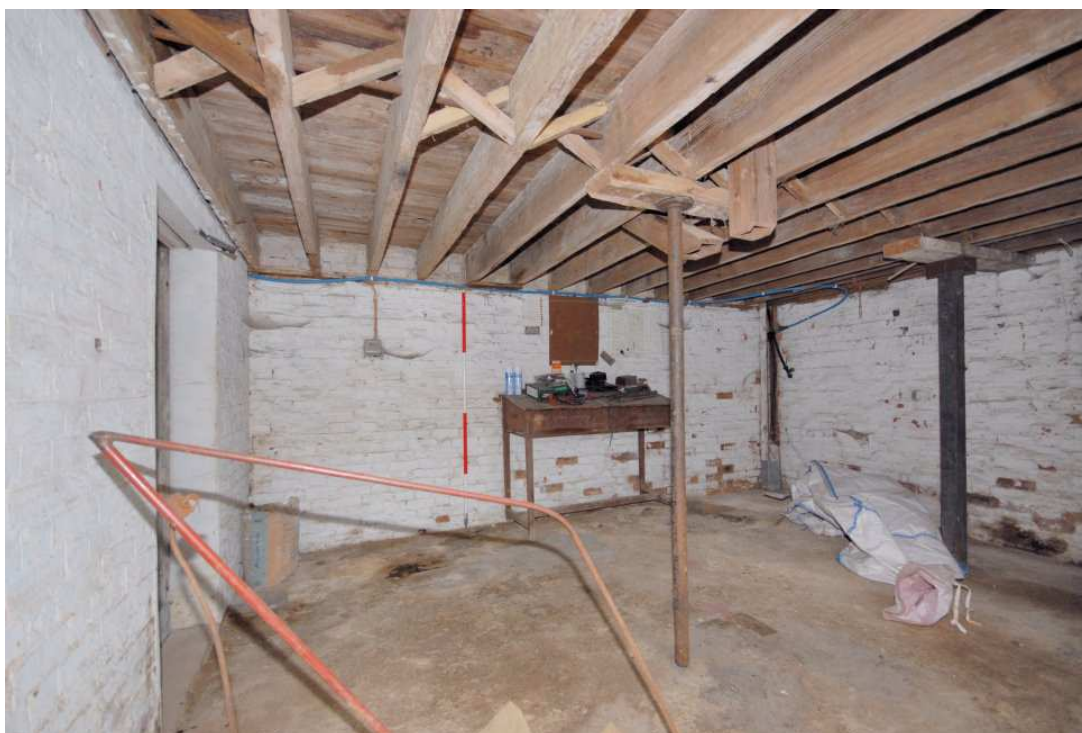
**Image 19:** Long Barn C1, looking south-west

It is approximately square in plan, 5m N-S and 4.3m E-W. The room is open on the north side with a central pier of moulded brick between a pair of large wooden doors (Image 20). The first floor is supported by N-S aligned joists with a single row of herringbone strutting and a metal tie-bar (Image 19). Two wooden chutes down from the first-floor level emerge in the centre of the ceiling (Image 21).

Showing floor joists with herringbone strutting and metal tie-bar (scale 2m)

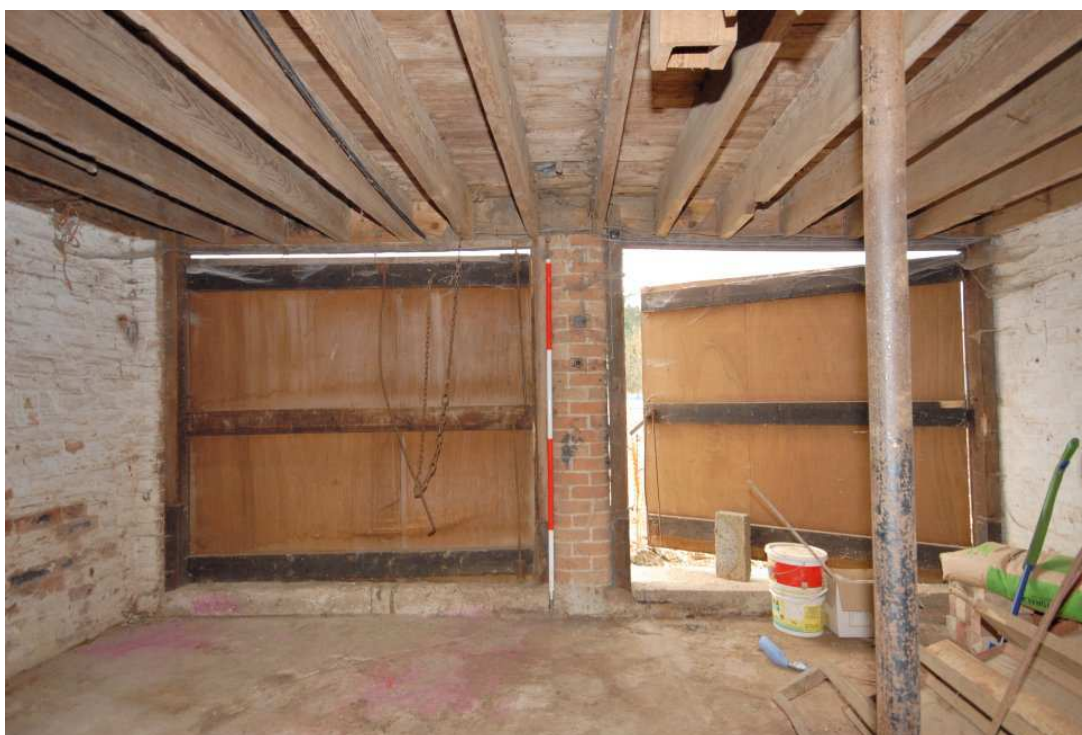
**Image 20:** Long Barn C1, north wall

View looking north showing doors and central brick pier (scale 2m)

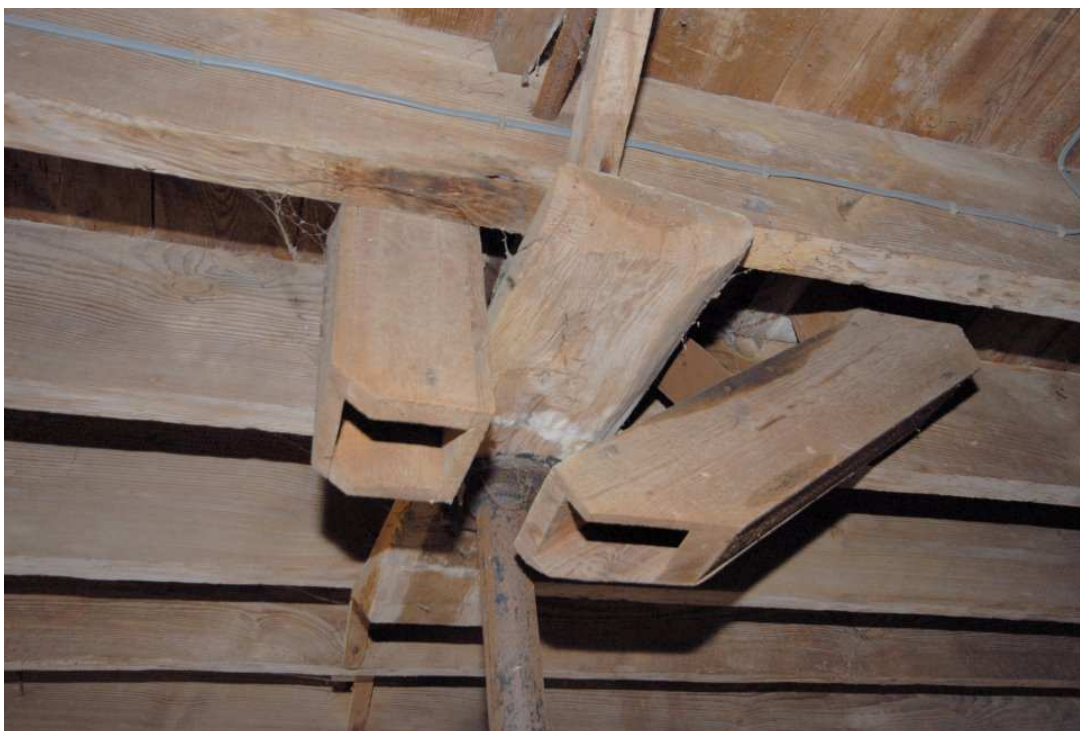
**Image 21:** Long Barn C1, detail  
Wooden chutes in centre of ceiling

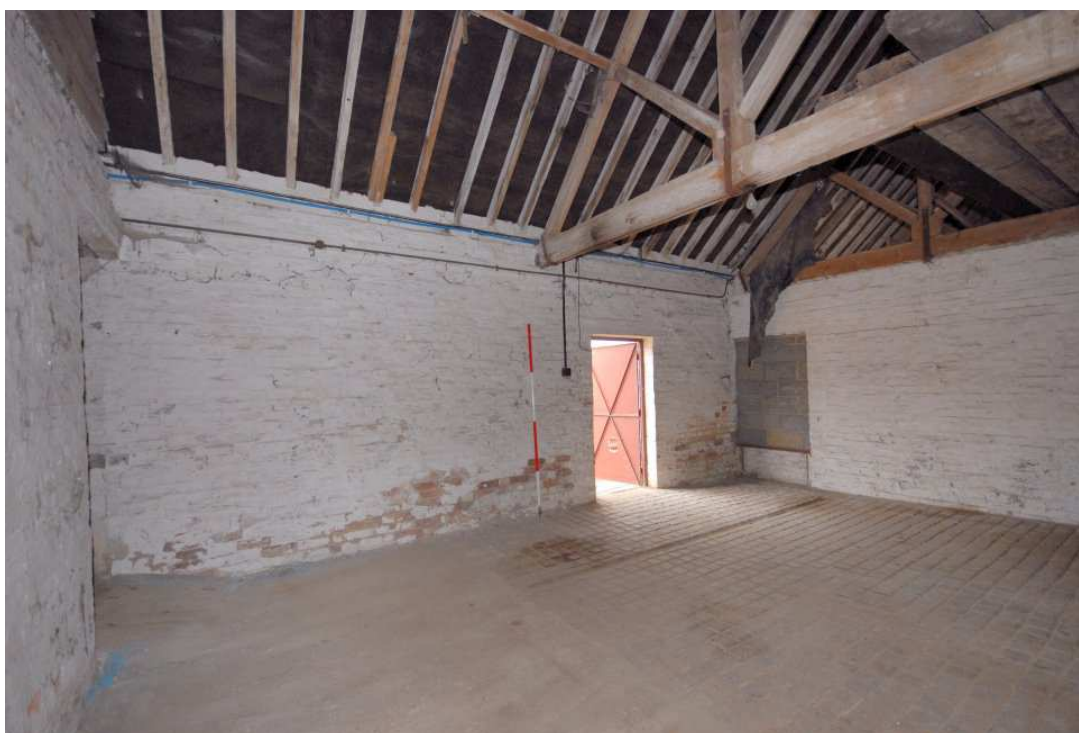
**Image 26:** Long Barn C3, looking north-east

Showing paved floor with drain (scale 2m)

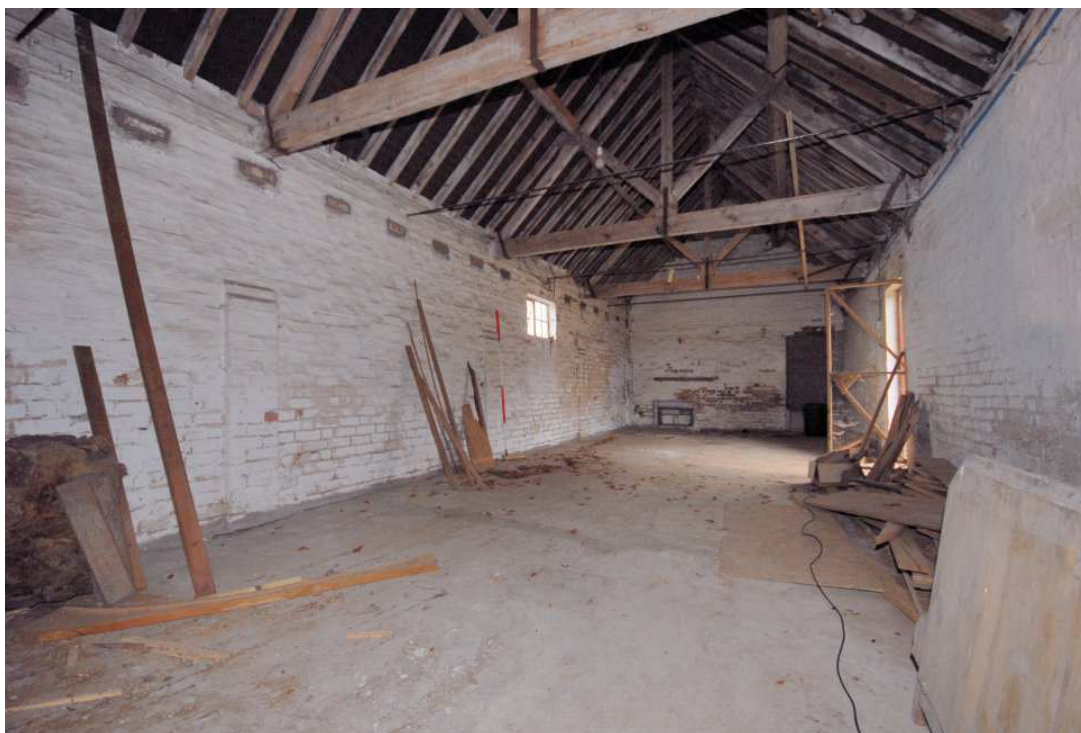
**Image 29:** Long Barn C5, looking south-west

General view showing pilaster strips and high-level vents in south wall  
(scale 2m)
