**BARNS OFF EDENS LANE
CARLTON
BEDFORDSHIRE**

HISTORIC BUILDING RECORDING

Document: 2015/114
Version: 1.0
11th September 2015

Project: EL2692
Bedford Museum Accession Number: BEDFM 2015.52
Oasis reference: albionar1-215336

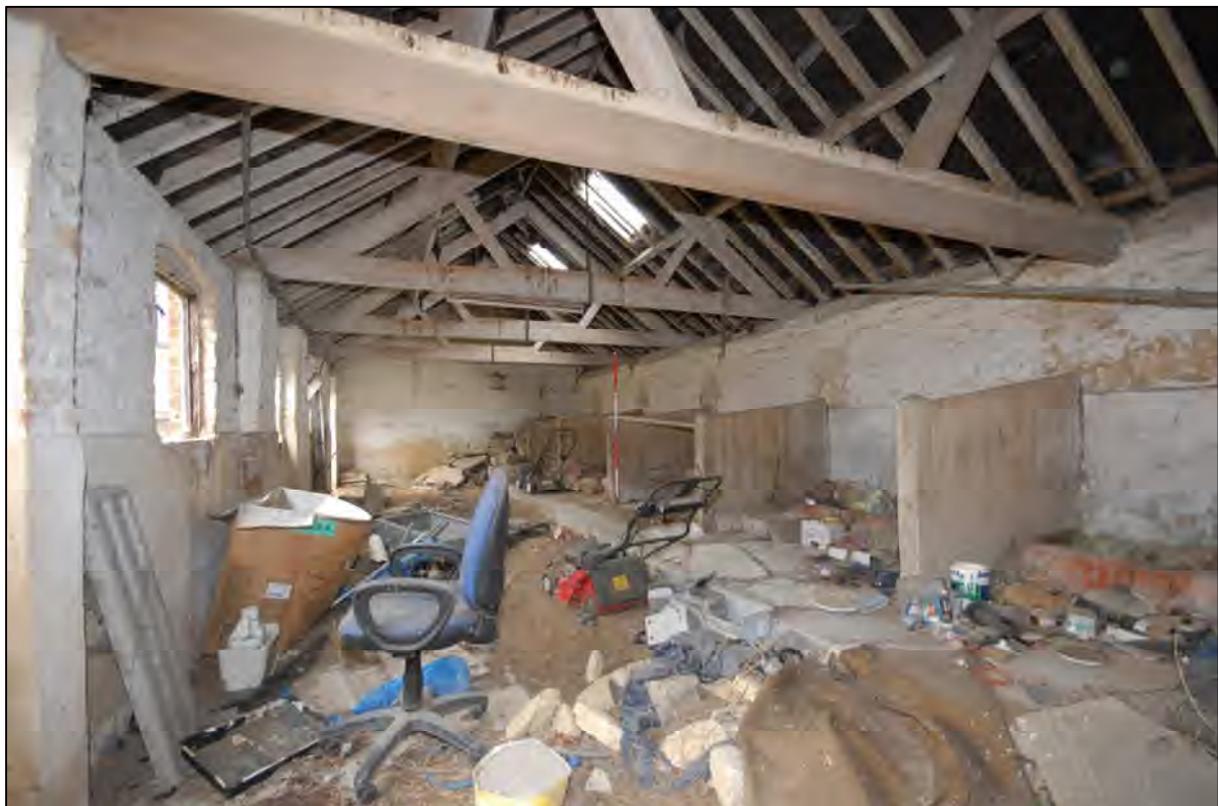
Image 32: Compartment C10, view looking north

C10 is the southernmost compartment of the east range that falls within the survey area (Images 31 and 32). It is 12.5m long north-south and 5.1m wide.
