34 BEDFORD ROAD
WILSTEAD
BEDFORDSHIRE

HISTORIC BUILDING RECORDING

Document: 2016/38
Version: 1.0
2016

Project: BR2723
Bedford Museum Accession Number: BEDFM 2015.71
Oasis reference: albionar1-224764

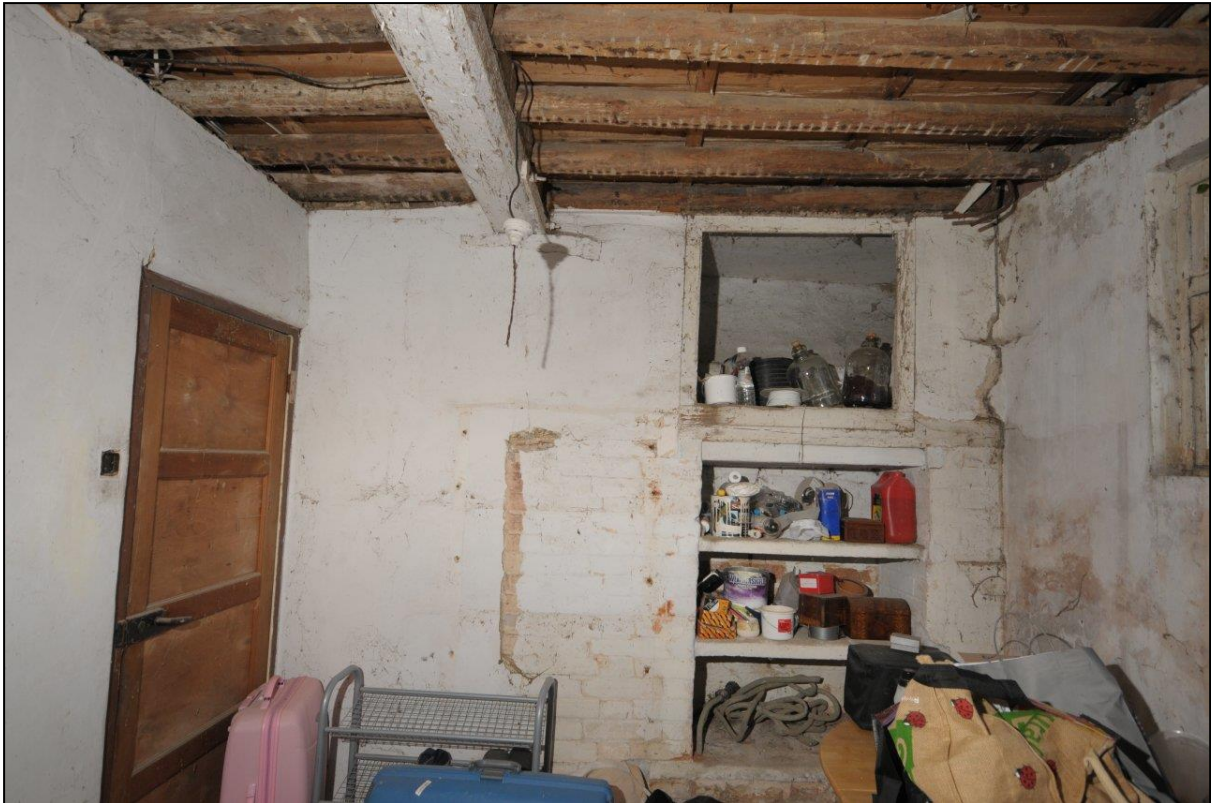
Image 37: Room F3, looking north-west

Shows axial beam in ceiling and shelves formed in recess in side of main stack

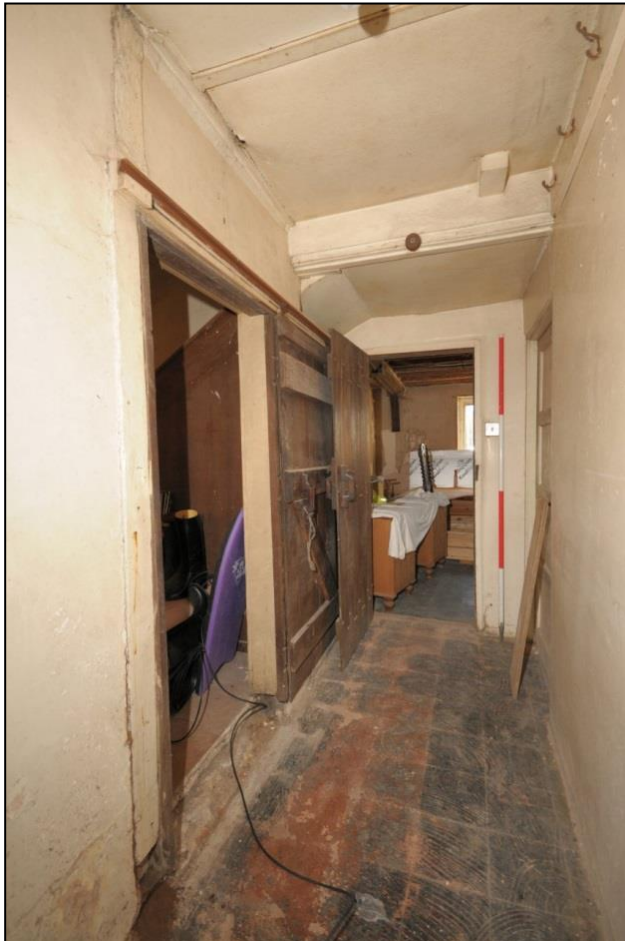
Image 38: Ground floor corridor

Looking north-west showing sliding door to outshot on left (G4) and door to G1 at far end (Scale 2m)

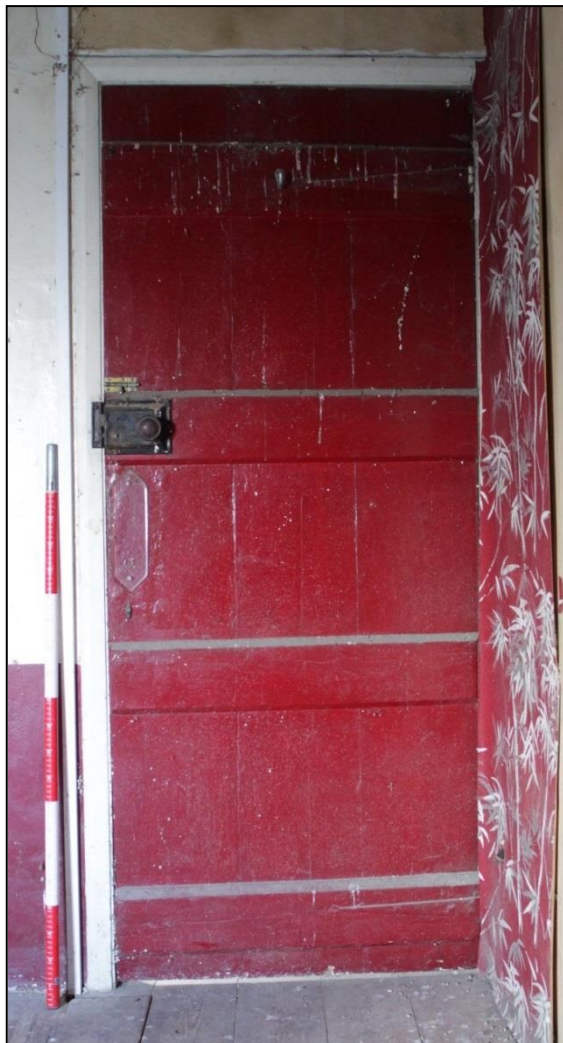
Image 40: Room F3, detail of door

Shows plank and batten door with T-shaped hinges with rounded terminals (Scale 1m)

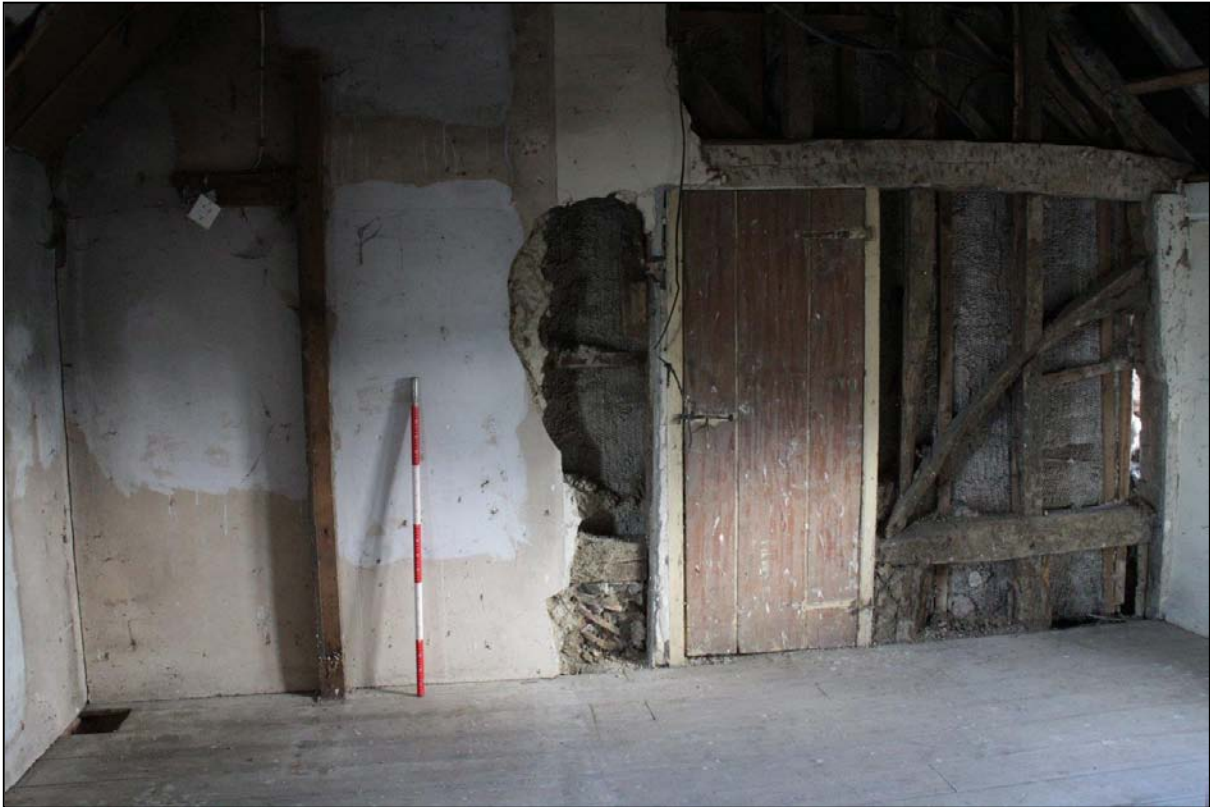
Image 41: Room F3, showing south-east wall (Scale 1m)

The timber frame visible in the south-east wall is the remains of the gable end of the rear wing (Images 41 to 43). At the right hand side of the wall is a corner post with a gunstock type jowl. At the base of the wall are two substantial studs which are pegged into a large horizontal timber at their upper ends. This horizontal timber is situated c400mm above the floor. Above this timber there is some primary bracing made from irregular, waney edged timber with nailed fixings. The character of this part of the framing suggests that was probably a later addition. No peg holes or empty mortise holes were visible to indicate earlier timbers in this location. Between the tie beam and the collar are five or possibly six studs with pegged fixings. Staves are nailed to the sides of these studs for wattle and daub infill which had been removed. The wall above the collar retained wattle and daub infill.

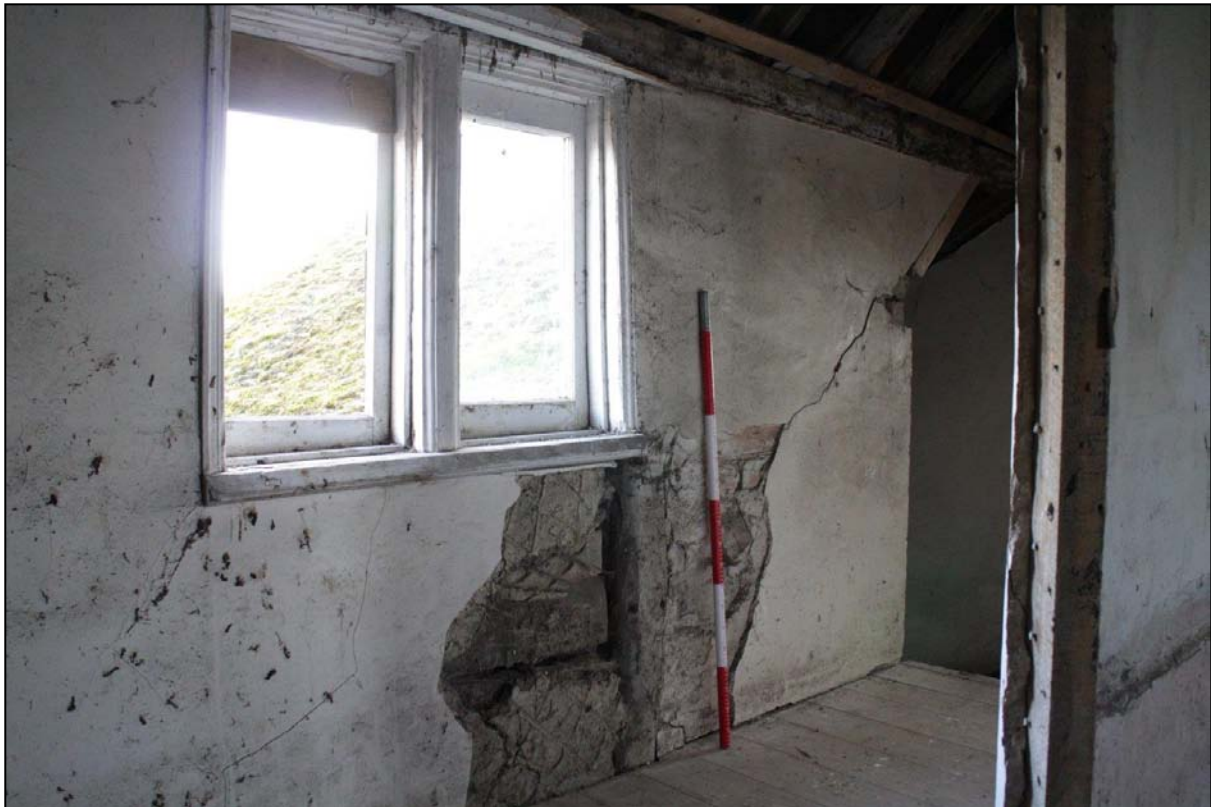
Image 44: Room F, looking west

A small section of frame below the window in the south-east wall consisted of a post located at the right hand side of the window and a horizontal timber which was pegged into the side of the post c.300mm above the floor (Image 44).

Wall contains stud to the right of the window with a rails on either side of the stud c.300mm above floor level (Scale 1m)

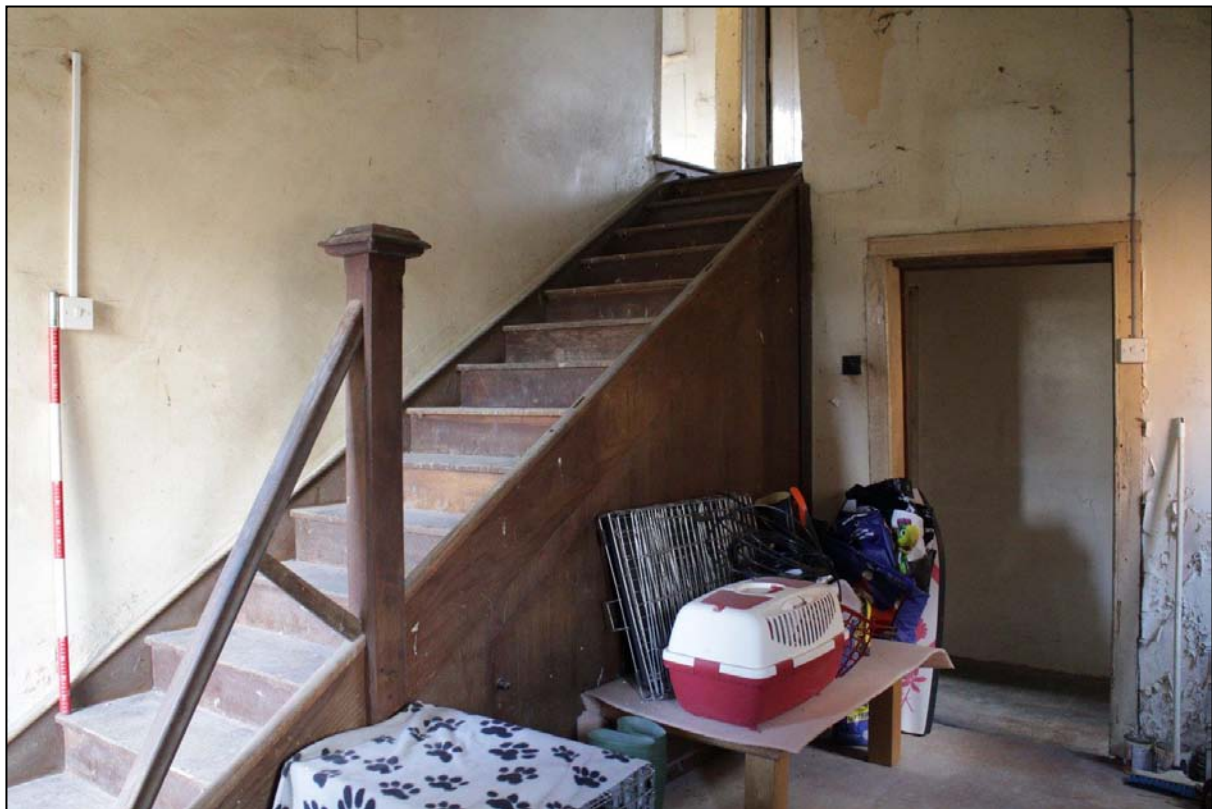
Image 45: Room G4, looking north

Shows modern stair to first floor (Scale 1m)
