**RUTTERS FARM  
OLD MILTON ROAD  
THURLEIGH  
BEDFORDSHIRE**

**ARCHAEOLOGICAL MONITORING  
AND  
HISTORIC BUILDING RECORDING**

Document: 2015/14  
Version: 1.1

Issue date: 24th March 2015

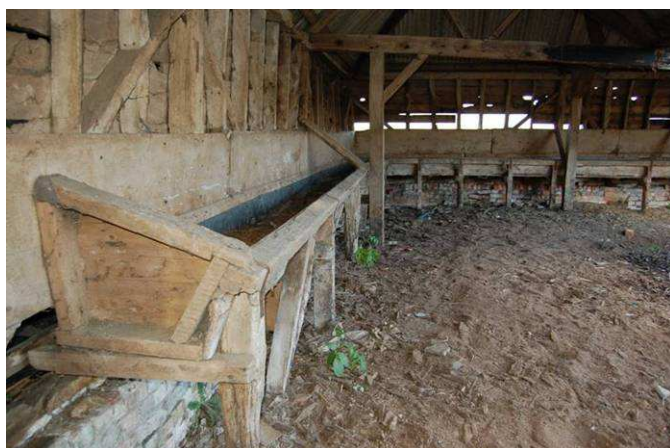
**Figure 9:** Barn 5: open-fronted shed

The wall farming comprises original pit-sawn oak studs, plates and primary bracing, largely nailed. The manger is likely contemporary with the original structure as is the partitioning within the building.

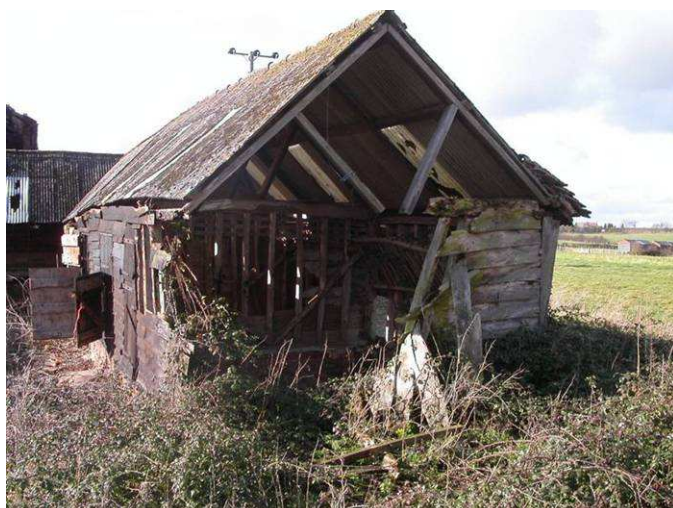
**Figure 10:** Barn 5: stock sheds/stables at eastern end

Barn 5 is an 'L'-shaped livestock building (Figs 8–10). The eastern end of the eastern arm of the range comprises three enclosed individual animal sheds; otherwise the building is open-fronted with mangers running along the back walls. The frame is in oak and much of the original oak cladding remains. The

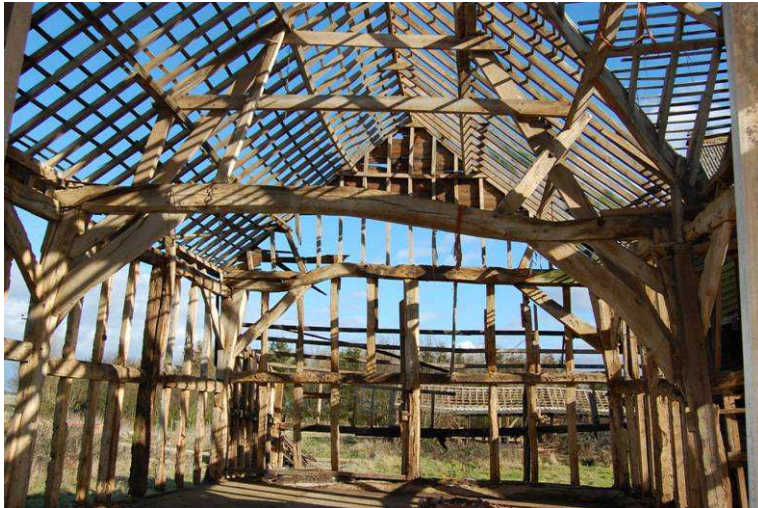
**Figure 13:** Barn 6: internal view towards eastern gable

The oak timbers are relatively substantial and each bay contains a full-height mid post and a mid rail runs around the building. The principal posts have swept jowls. The posts, including those in the porch have straight braces morticed to the underside of the wall plates; those forming the mid stray each have double braces. As Rogers notes the pegs here are larger than normal (>35mm in diameter). There is a single ogee brace in the north-west corner of the barn, similar to those seen in Barn 9 (see below).

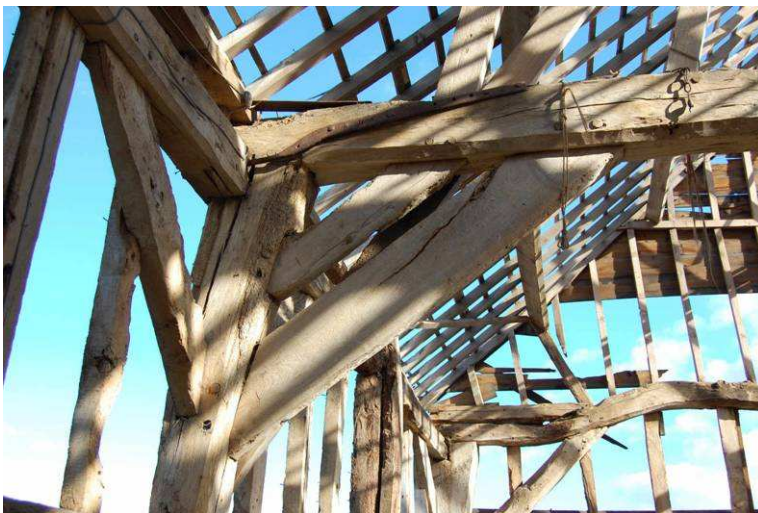
**Figure 14:** Barn 6: double bracing

There are carpenters' marks on the opposing faces of the cross frames at the midstray. The joints of the four braces to the tie beam on the western and eastern frame of the midstray are similarly numbered I and II and III and IIII.

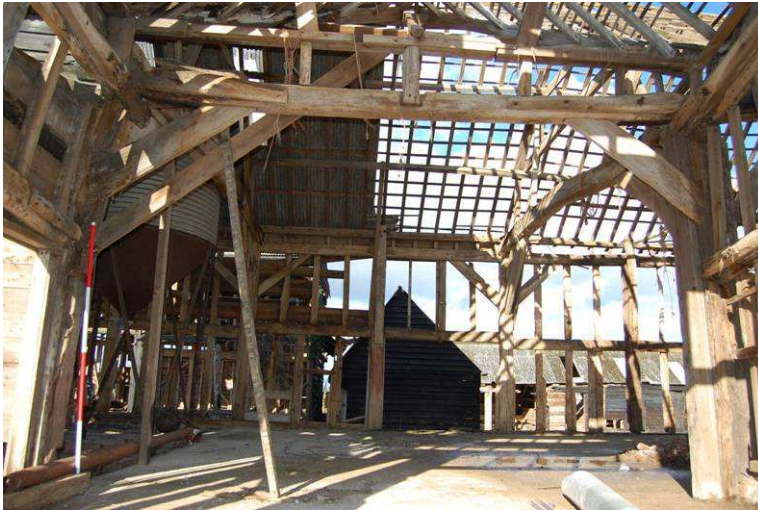
**Figure 15:** Barn 6: View from porch towards northern wall

Although a number of posts in the wall opposite the porch are missing, the alignment of the original posts indicates that the door opening in this side was always small and the barn did not therefore have a similar sized opening opposite the porch as was often the case. The use of a smaller draught door may be partly explained by the drop down to the external ground level against this wall necessitating a flight of steps, now patched and rendered in concrete.

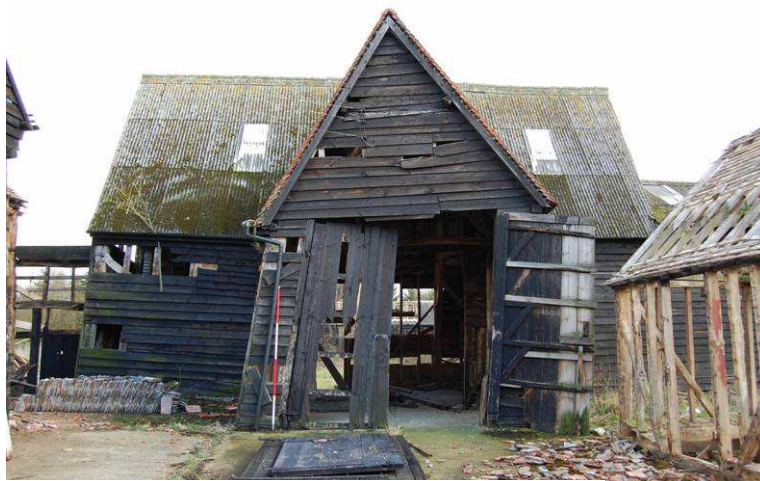
**Figure 18:** Barn 9: view towards east

Barn 9 is a small, three-bay barn with weatherboard cladding. It sits on a plinth mostly constructed of stone but with some brick patching. The roof pitch is very steep. The western porch is not integral to the barn indicating that it is either a replacement or later addition. A first floor storage area with grain bins has been added to the northern bay in recent times. The fourth and fifth bays of the list description form a separate two-bay space to the south of the threshing barn. This has a replacement roof with a ridge height set much lower than the adjacent barn.

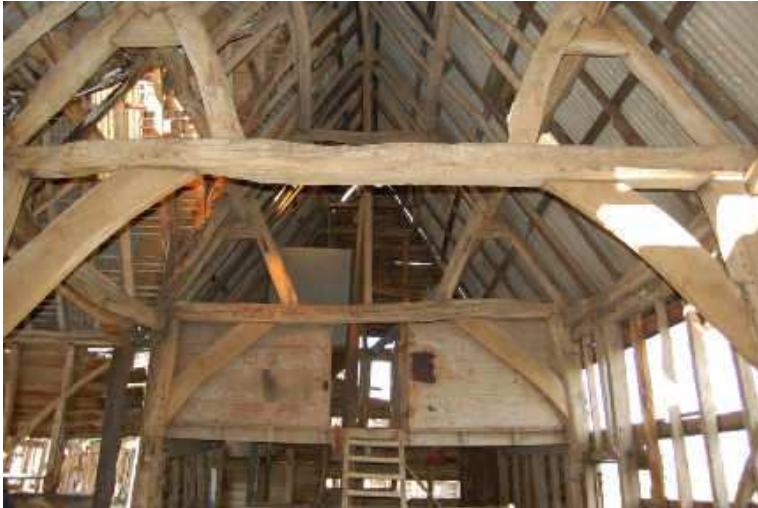
**Figure 20:** Barn 9: roof structure, view to north

More of the original roof structure exists than in Barn 6, with the replacement roof supported on blocks above the earlier frame. The roof has double purlins, the upper being clasped by the collar and principal rafter. The lower purlin is clasped by the principal rafter but, unusually, there is a yoke below the strut on each of the tie beams.

There are wide braces under the tie beams and downward, ogee braces above the mid rail.

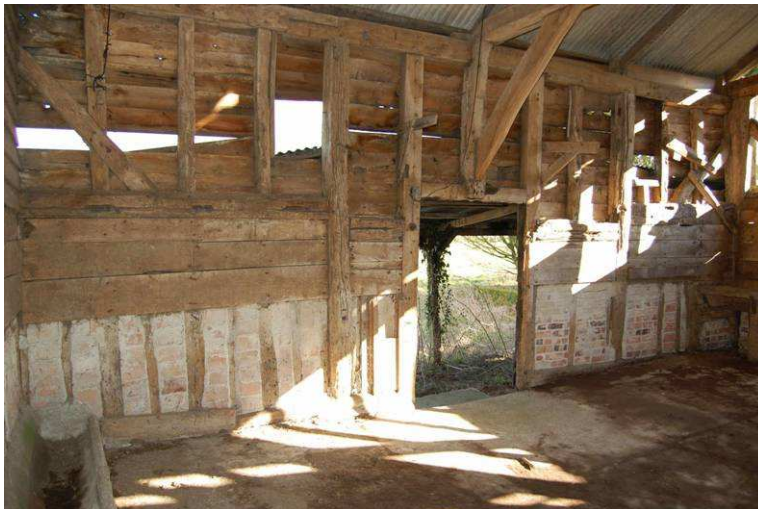
**Figure 23:** Barn 10: internal view of eastern wall

Barn 10 is built in a similar style to Barn 9 with evidence of the re-use of domestic timbers, full height mid posts, a mid rail and ogee bracing. The mid post within the eastern wall of the northernmost bay is not central, possibly placed to support the scarf joint above. Wooden troughs against the north and south end walls indicate the building's former use as a stock shed. Most of the studs below the mid rail have been infilled with brick, no doubt to protect the structure from damage by the cattle that would have been housed in this building.

The barn has a window in the western wall and an inserted door in the eastern wall. In order to allow room for tying stock on either side, the door was inserted centrally, by cutting the centre post and dropping the mid rail within each of the adjacent studs. The window in the western wall probably represents the position of a door which was subsequently blocked by the insertion of a stud and brick infill. This re-alignment probably took place when buildings to the east of the main complex came into use.

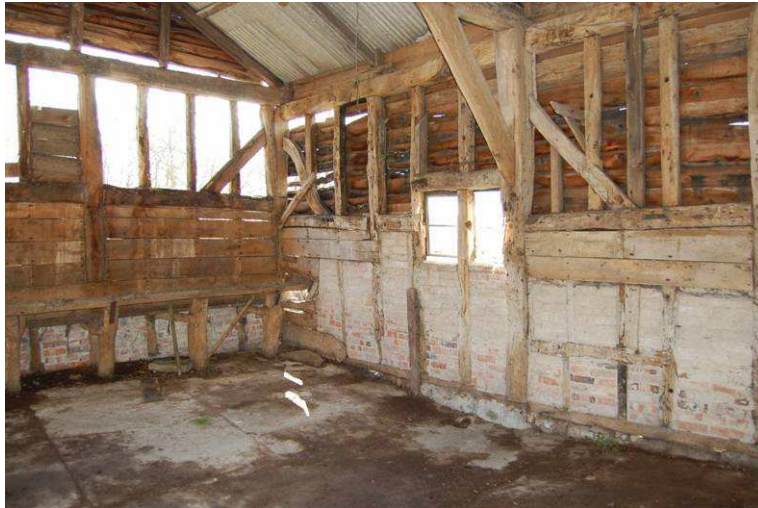
**Figure 24:** Barn 10:  
internal view of western  
wall

Rogers (2004) suggests that Barn 10 was an early extension to Barn 9; however at the time of this survey it was noted that the wall plate along the eastern wall of

Barn 9 continues through into Barn 10 where it is joined to the next length of wall plate just beyond the dividing wall. This indicates that the barns were contemporary, possibly more likely built south to north.

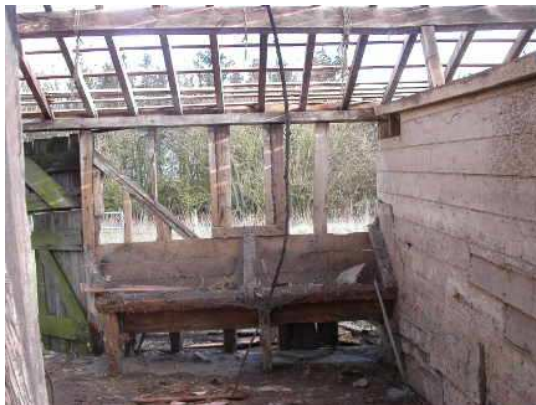
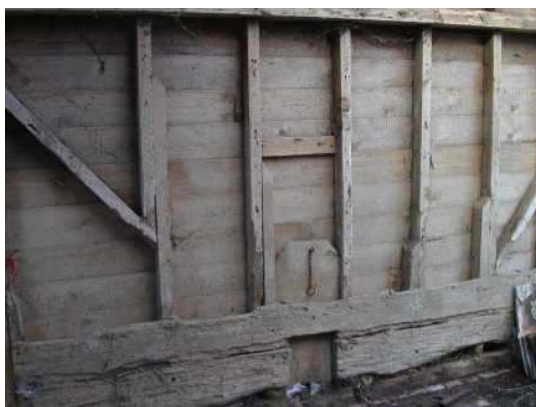
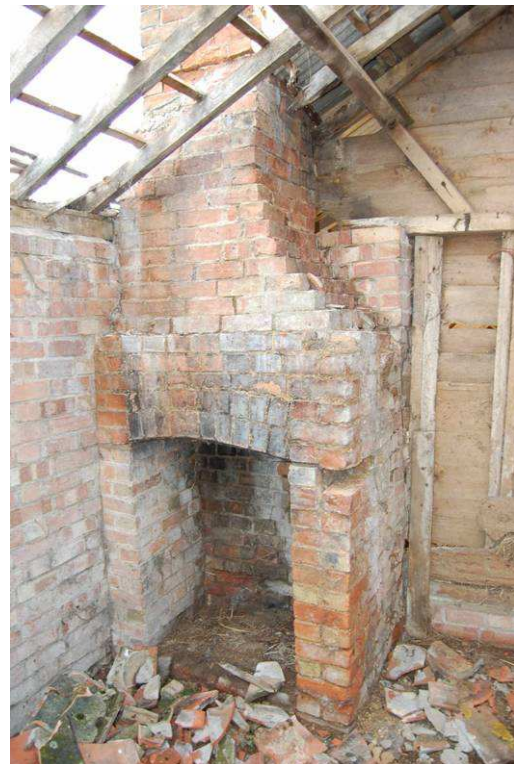
**Figure 30:** Barn 14: internal views of  
sheds at southern end

The third and southernmost bay was boarded on each side to full height and contained a chimney and hearth in its north-west corner. This is suggestive of a nursery unit with fireplace for overnight use by the stockman. At one stage this compartment had functioned as a chicken coop as the boarding between it and the compartment to the north contained a small hen door which could be raised and secured on a short length of chain.

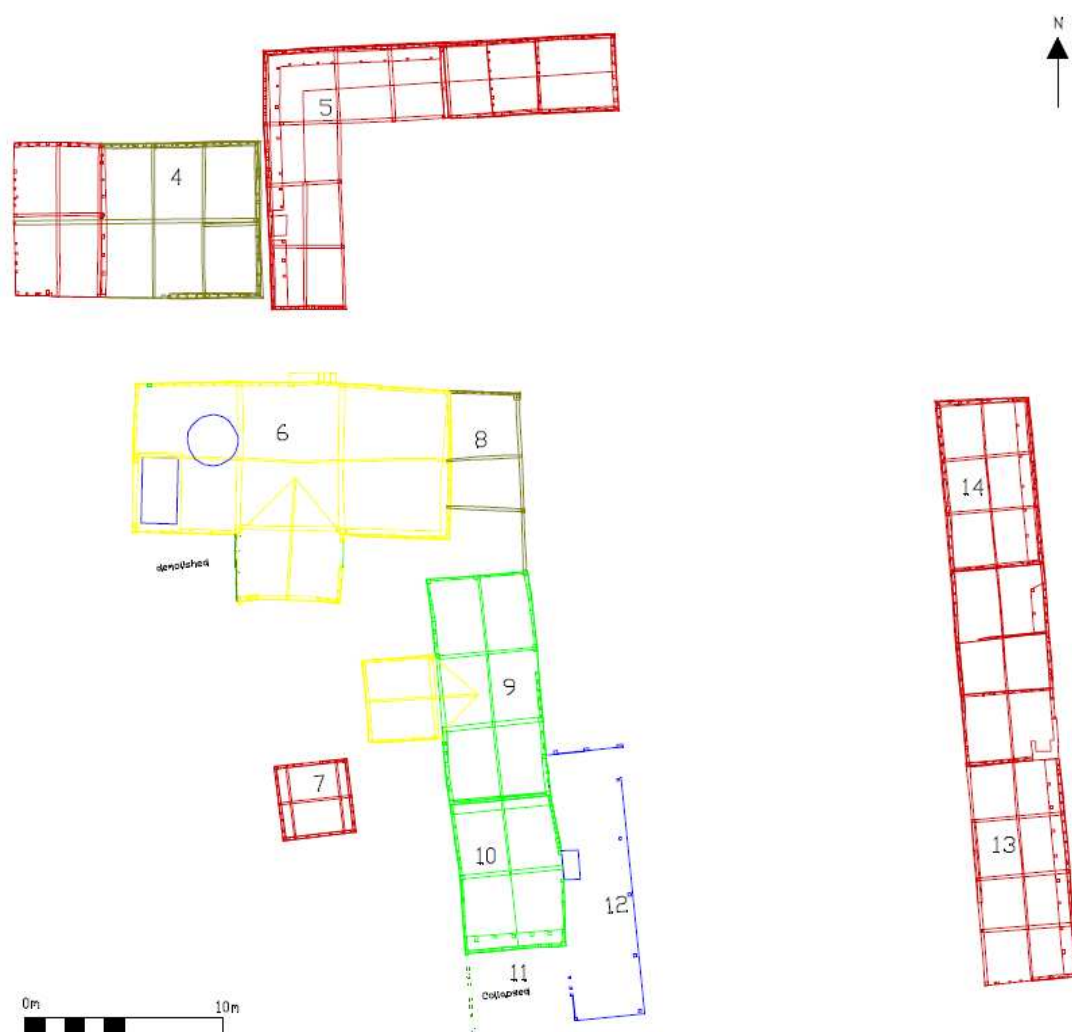
**Figure 31: Principal building phases**

The buildings on the site can be assigned to four phases of construction (Fig. 31). Discounting the recent 20th-century buildings, the farm complex was formed in the 17th century and developed largely into its current form during the late 18th /early 19th centuries. The farmyard continued in active use up until recent times; the buildings being regularly added to and repaired as time went by.
