**GLATTON HALL, GLATTON WAYS
GLATTON, HUNTINGDON**

**DESK-BASED ASSESSMENT
AND
HISTORIC BUILDING RECORD**

Report no: 2018/124

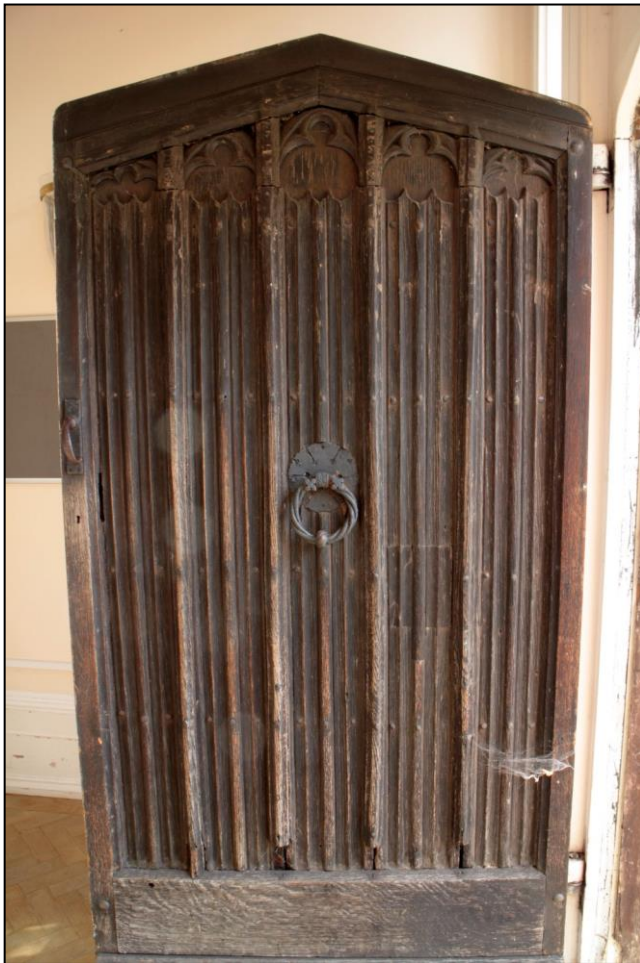
Image 5: Main entrance door
External face of door with detail of
door knocker below

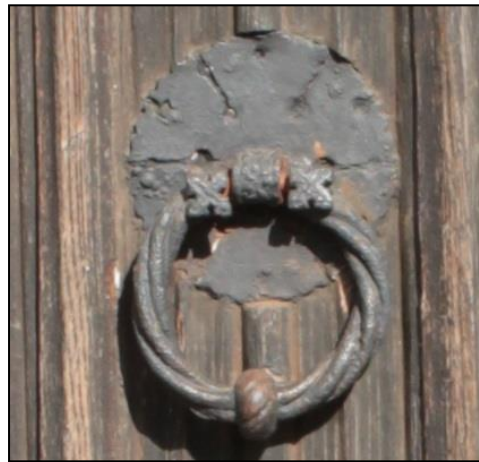
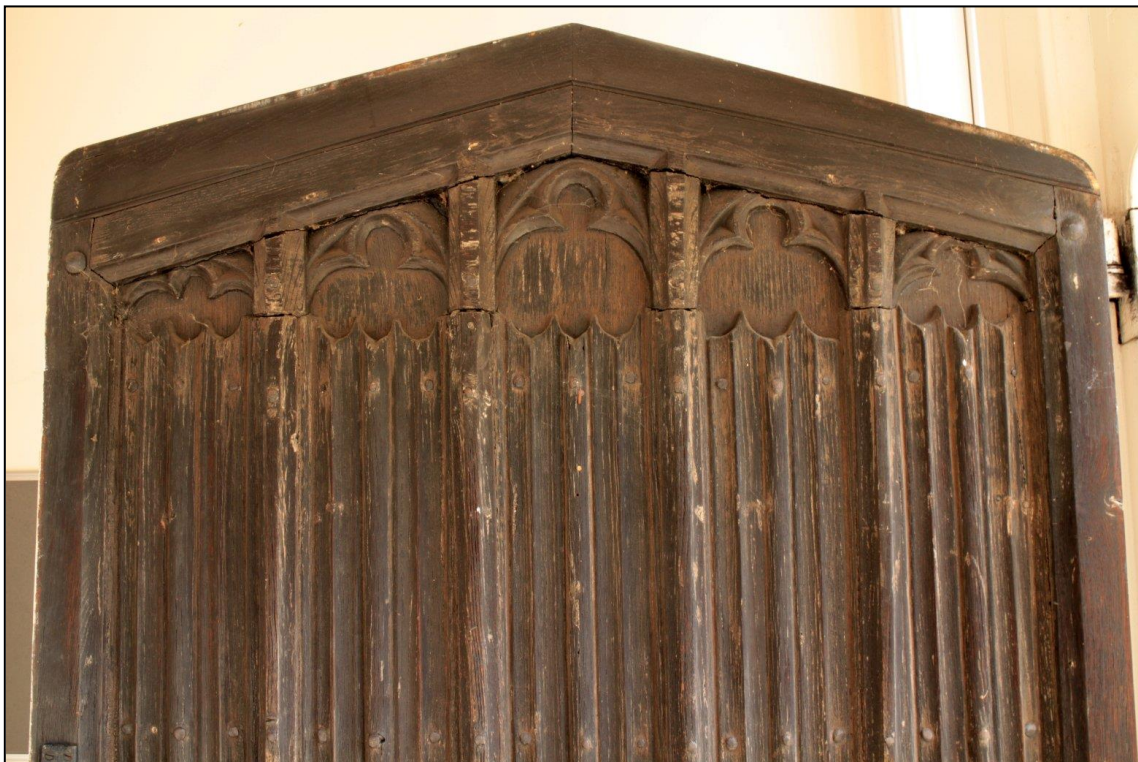
Image 6: Main entrance door: detail of decoration

Image showing details of decoration and framing

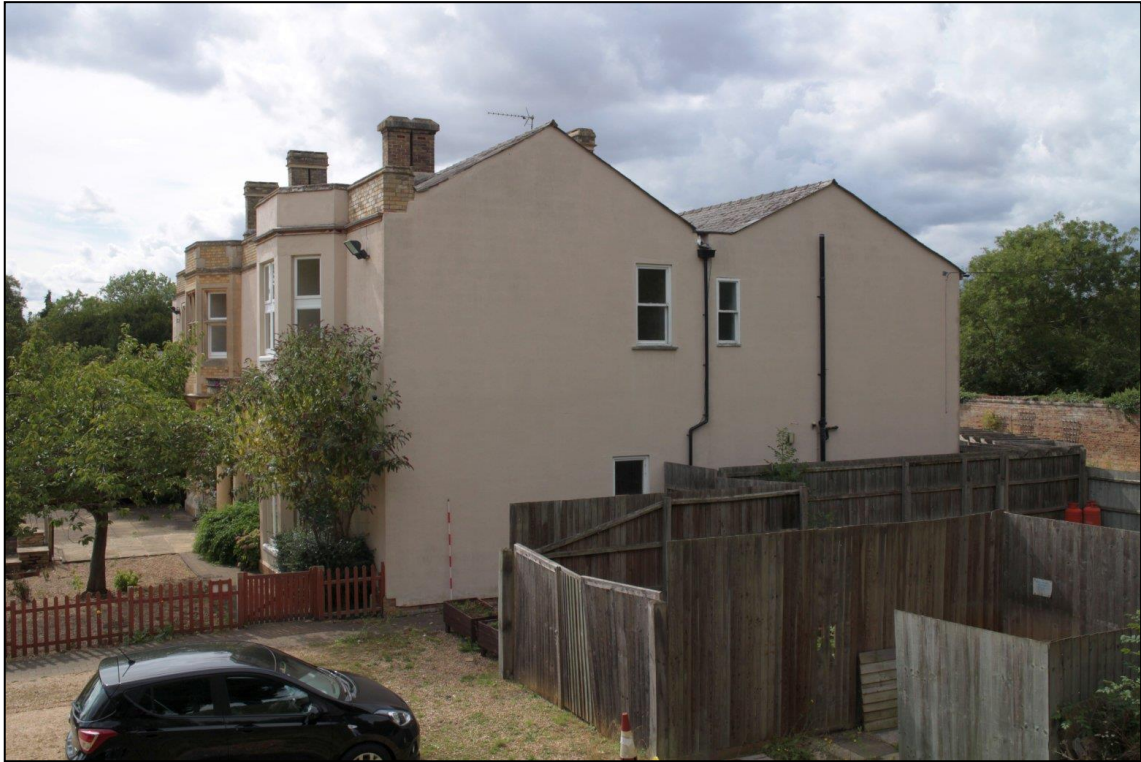
Image 7: East elevation

View of building from top of bank at east side of garden

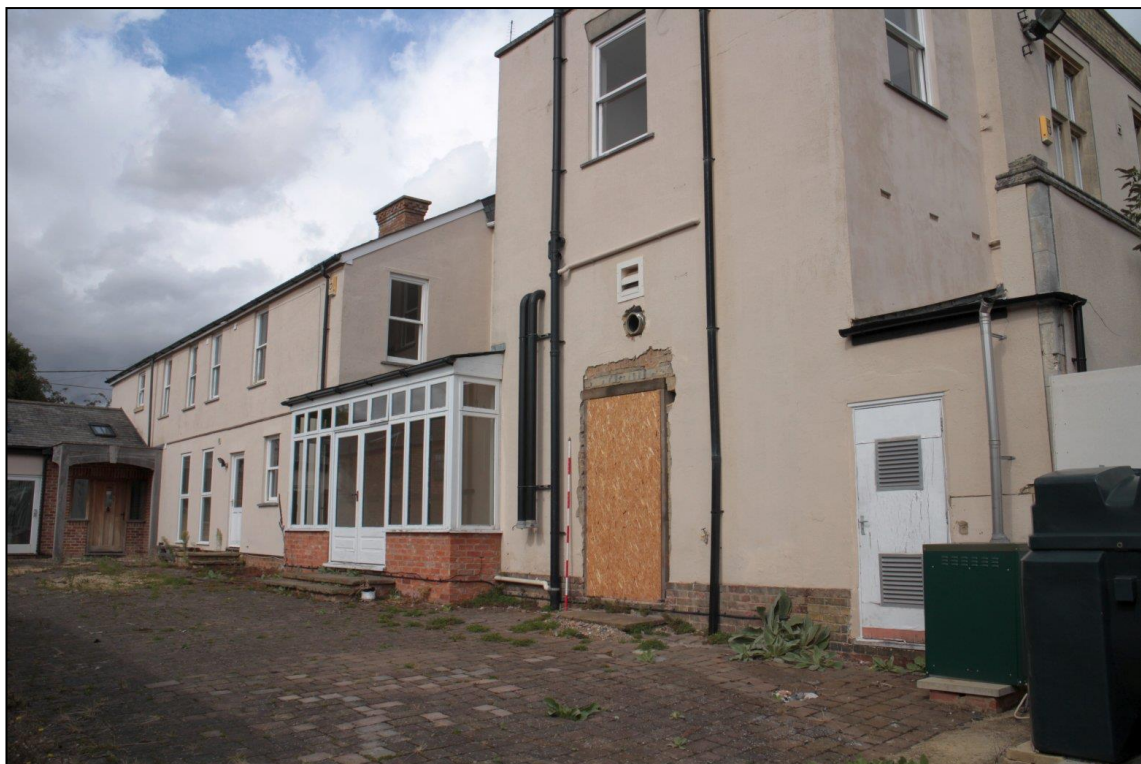
Image 8: West elevation

Looking north-east from yard area with the end of the front range in the left foreground with a modern conservatory and rear range to the left

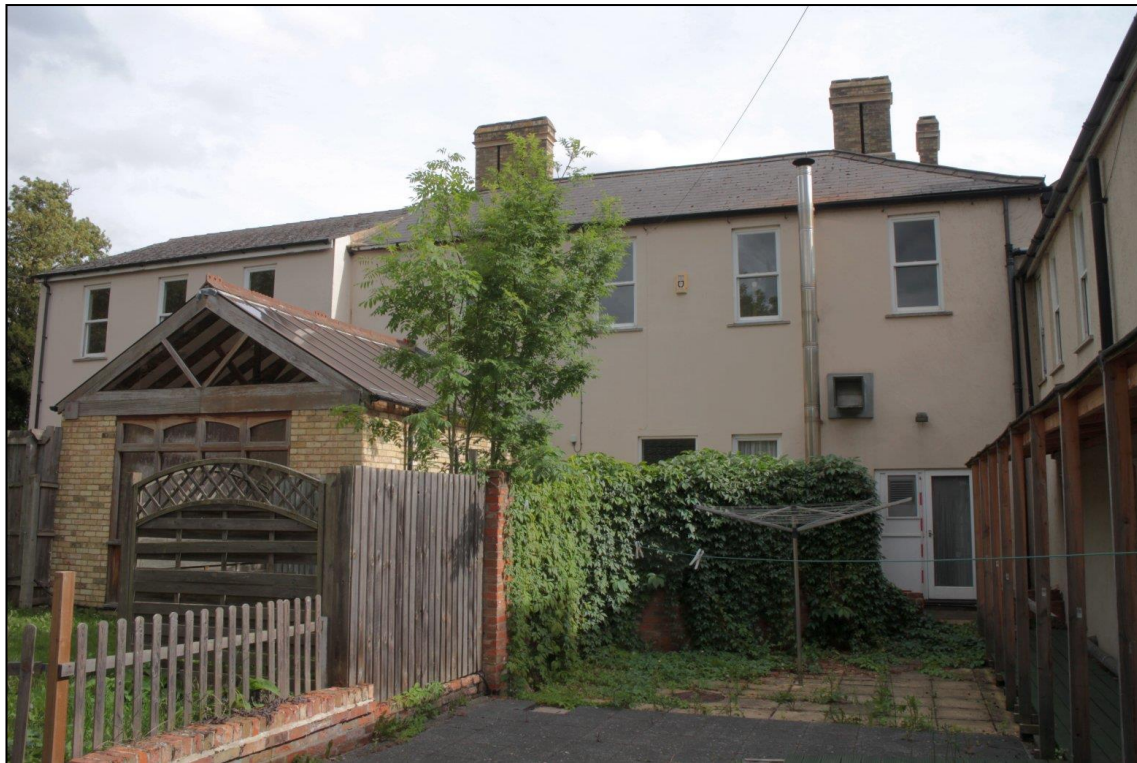
Image 9: North elevation

Looking south-east from position next to rear range

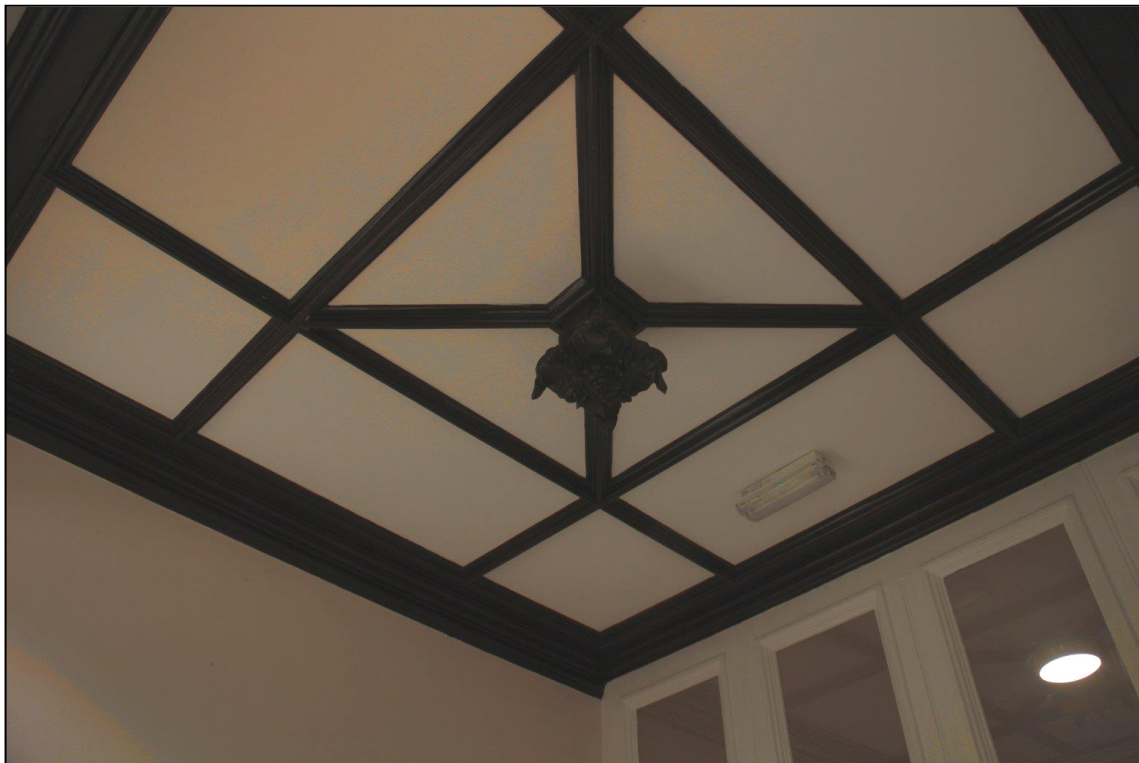
Image 14: Lobby ceiling

Looking north-west showing panelled ceiling with inset showing detail of carved central boss

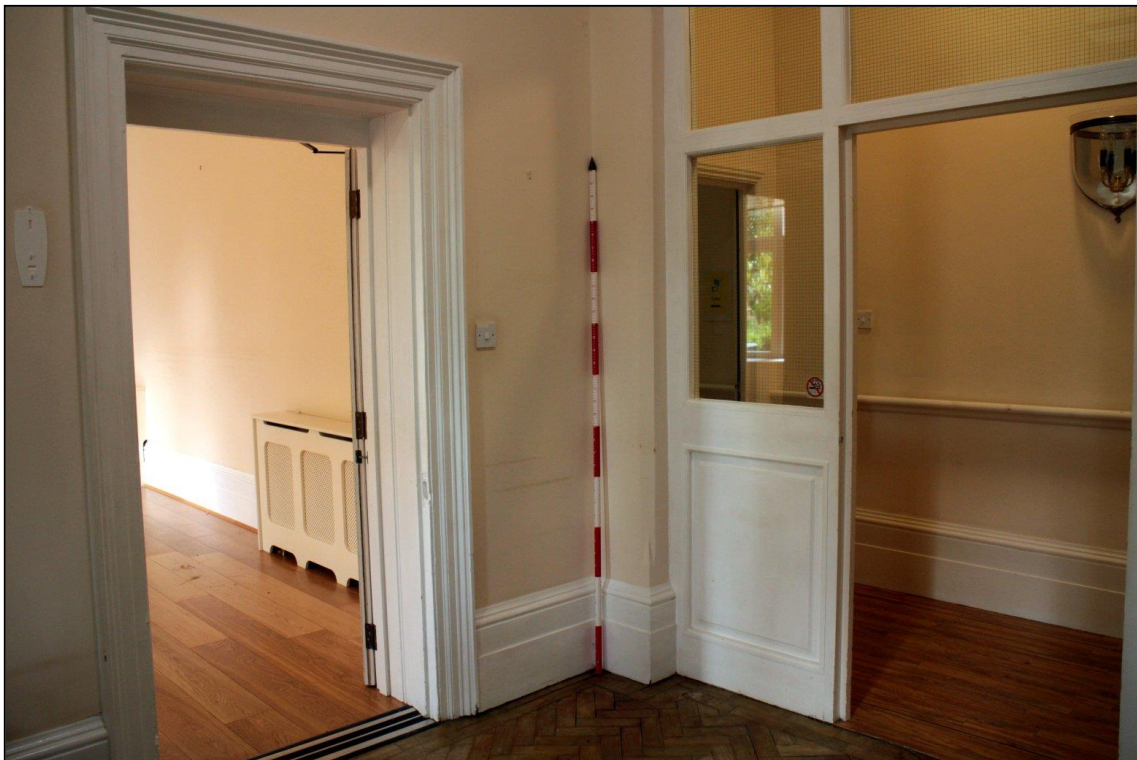
Image 16: Reception

Looking north-west showing 19th door case at left to sitting room (scale 2m)

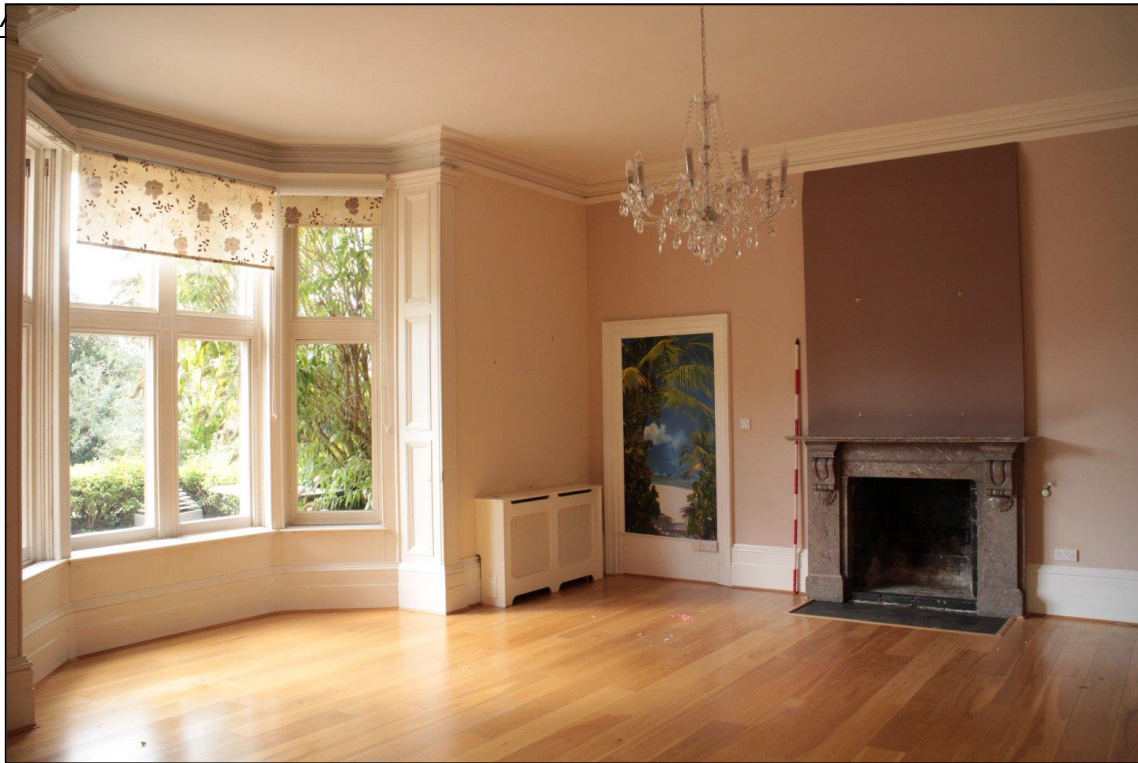
Image 18: Sitting Room

The sitting room is accessed by door in its north-east corner, off the reception room (Image 18). The door case has an architrave moulding with two angular ogee mouldings separated by a flat field and dates from the 19th-century. The frame has been modified with additional timber on the inner edge to fit a slightly smaller modern six-panel door. A blocked doorway in the south-west corner of the room has the same type of architrave moulding.

Looking south-west showing left-to-right: bay window, Blocked door and fireplace

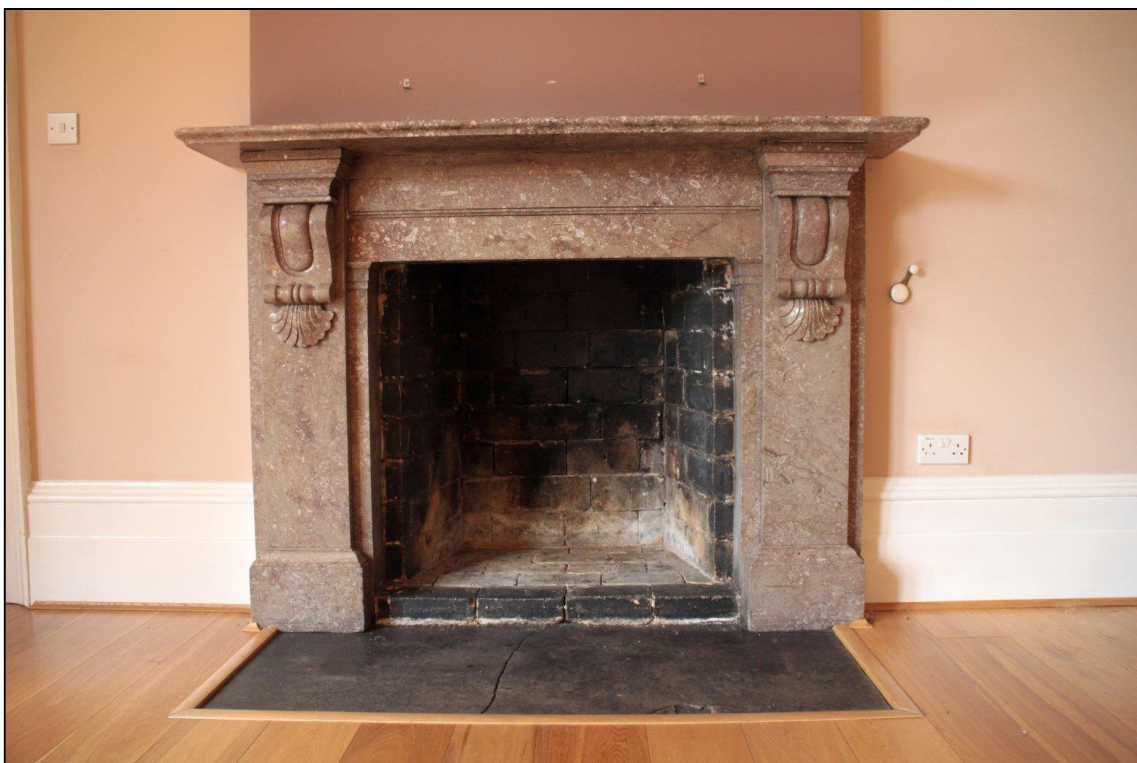
Image 19: Sitting Room: detail showing fireplace

A fireplace in the centre of the west wall is made from polished fossil 'marble', probably Derby Fossil, a Carboniferous limestone (Image 19). The fireplace dates from the mid to late 19th-century.

Polished fossil 'marble' fireplace with carved brackets

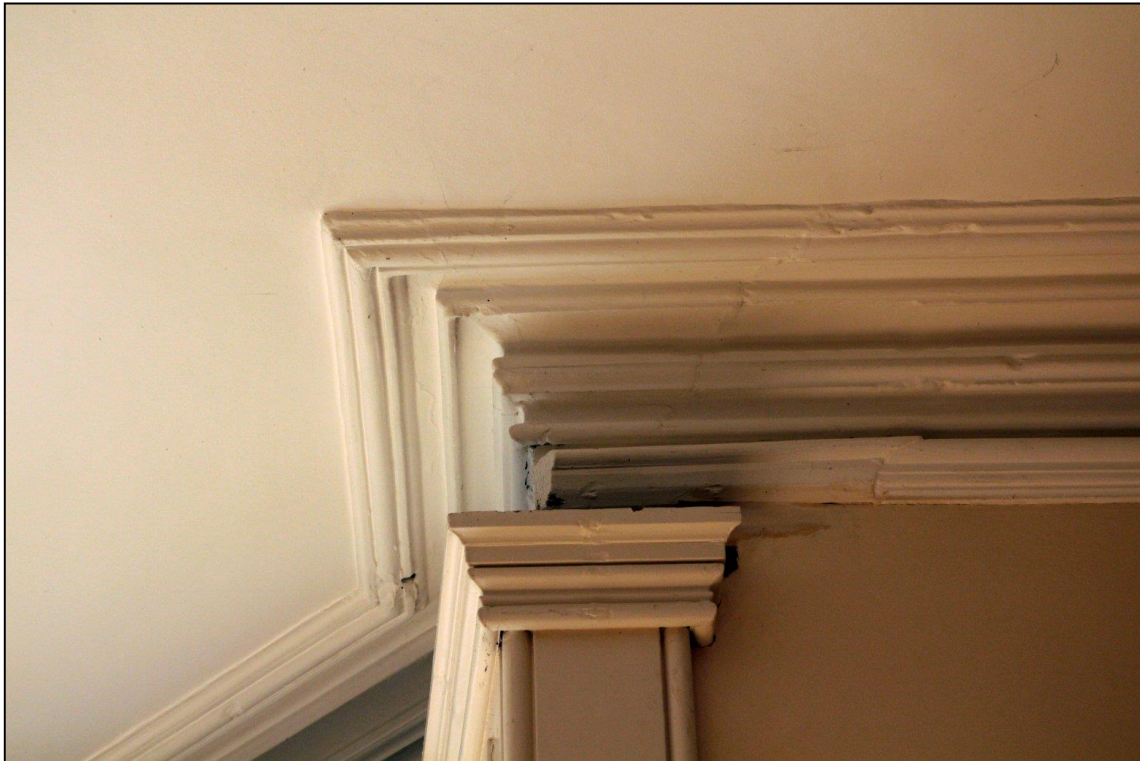
Image 20: Sitting Room: detail of cornice

The ceiling has a cornice which is a complex moulding made up from series of small elements separated by hollows (Image 20). It differs from the usual pattern of 18th and 19th cornice mouldings based on classical entablatures. The complex and irregular character of the design suggests a 19th rather than an 18th-century date for this feature.

Shows cornice at left hand side of bay window with smaller moulding for window below

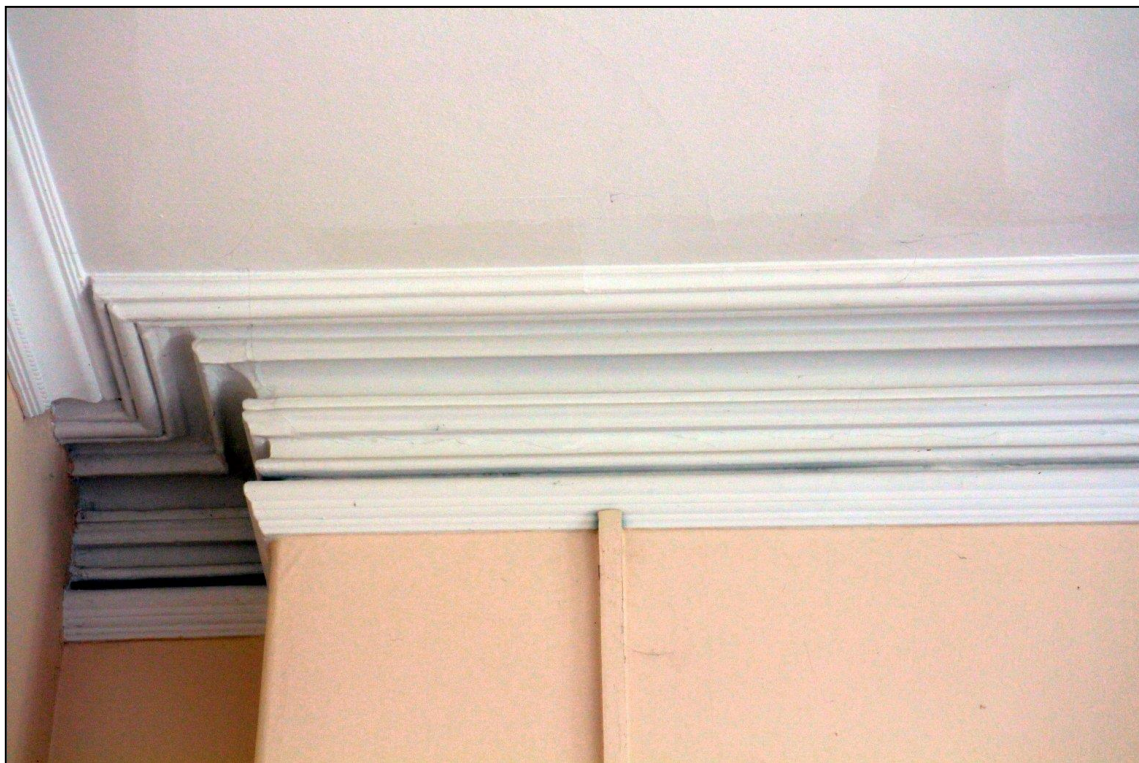
Image 21: Bedroom 18: detail of cornice

Shows cornice at north end of east wall with smaller modern cornice on stud wall partition showing in top-left corner of image

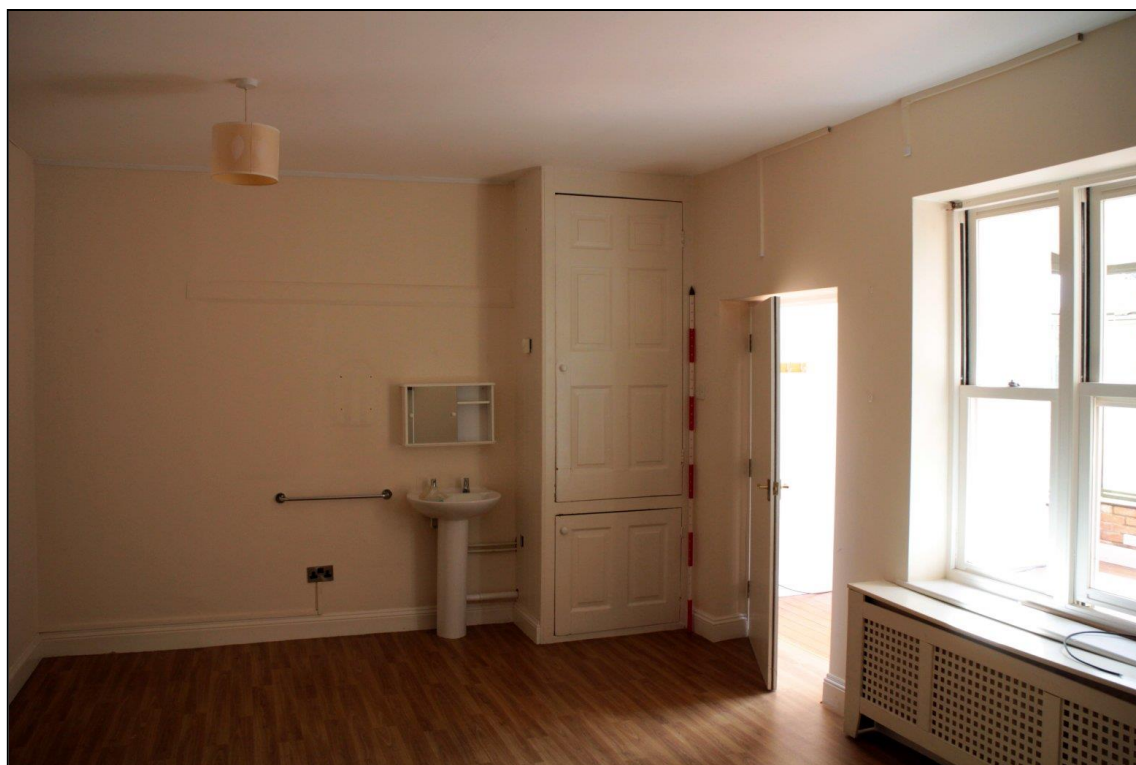
Image 23: Room 20

Looking south showing fitted 19th century cupboard in south-west corner of room

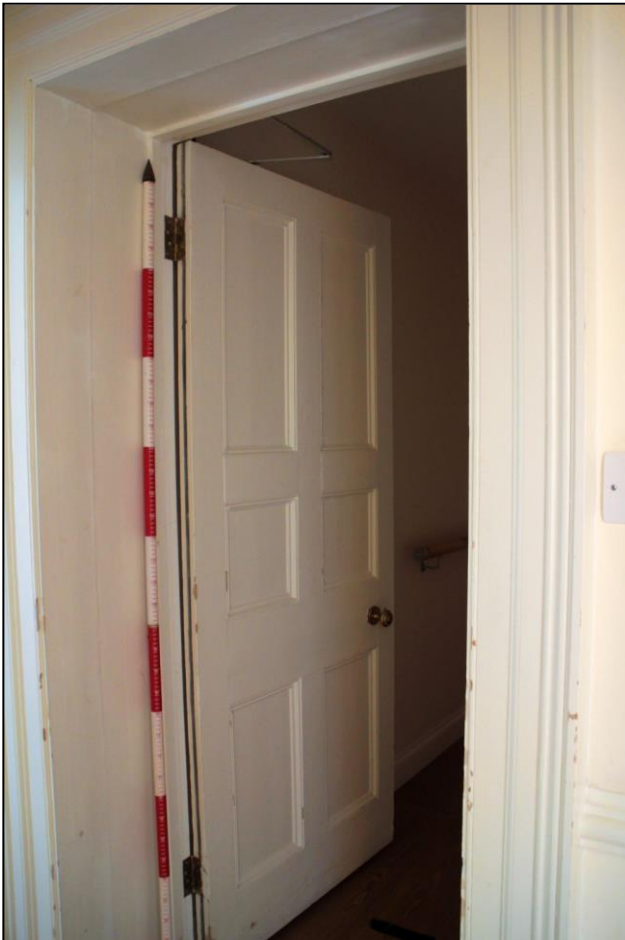
This north-south aligned corridor is located next to the east side of Room 20 (Image 24). It is accessed at its south end by a door off the former room which has been subdivided to form Bedrooms 18 and 19. The door opening has a characteristic 19th architrave moulding and it contains a 19th century six-panel door with plain panels.

Image 24: Corridor adjacent to Room 20
Shows 19th century door case and six-panel door

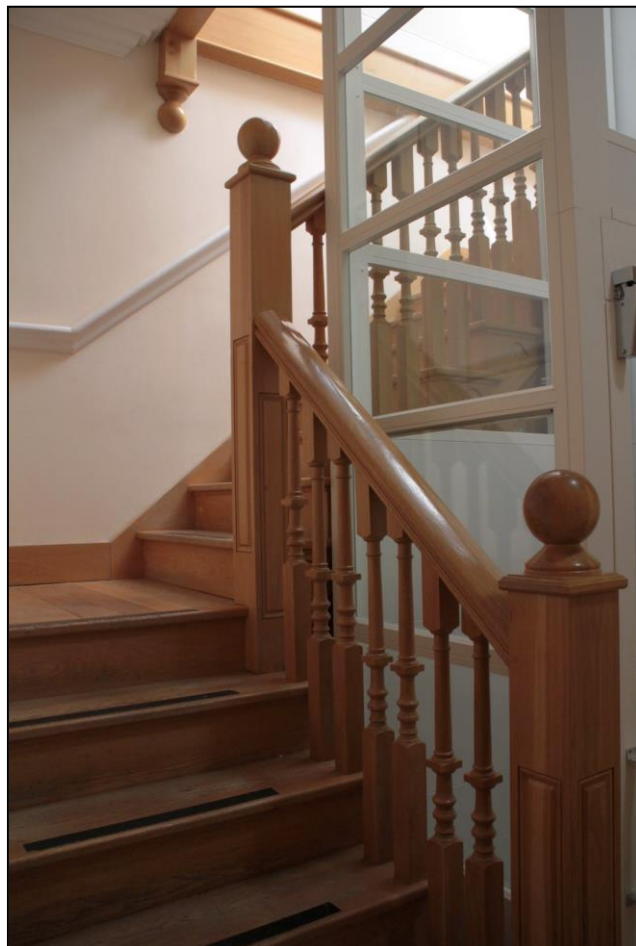
The stairs and lift located on the north side of the main corridor are modern (Image 25). The stair is an open stair with quarter landings in polished beech wood. The glass-sided lift occupies the stairwell.

Image 25: Stairs and lift
Looking north-east showing lowest flight of steps and west side of lift

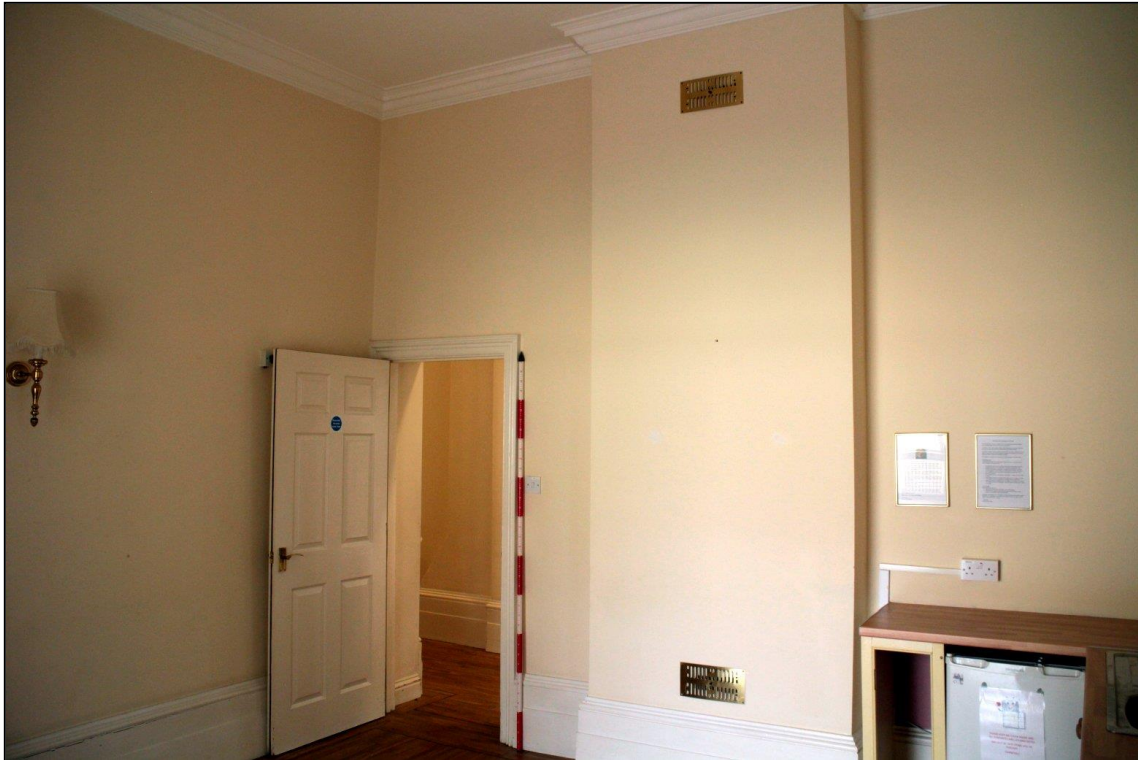
Image 26: Dining Room

The dining room is located in the north-east corner of the 19th-century core of the building (Image 26). It is accessed off the main corridor and is linked to a modern conservatory on the north side of the building.

Looking south-east showing door off main corridor and chimney breast on south wall

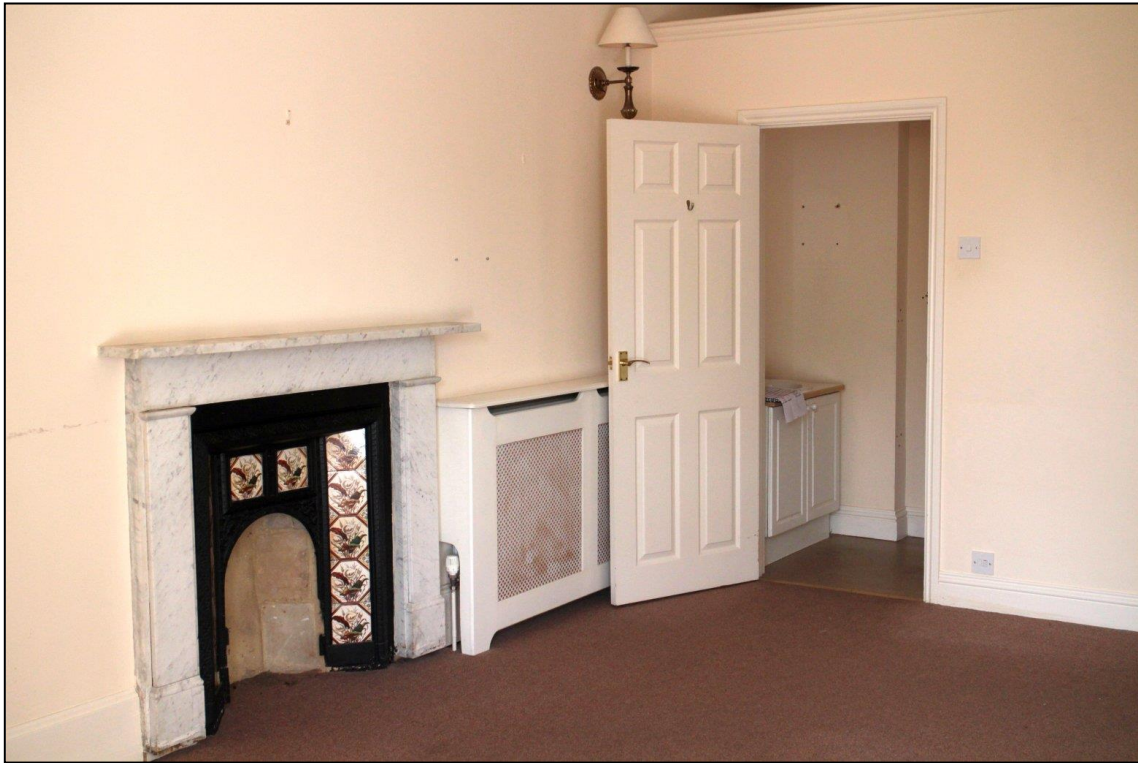
Image 28: Bedroom 6

A fireplace in Bedroom 6 has a plain marble surround with a late 19th-century cast iron grate with tile decoration (Image 28). The rooms have high ceilings with a simple classical style cornice which is modern as it extends along the modern stud wall between Bedrooms 6 and 7.

Looking north-west showing fireplace with modern partition in background

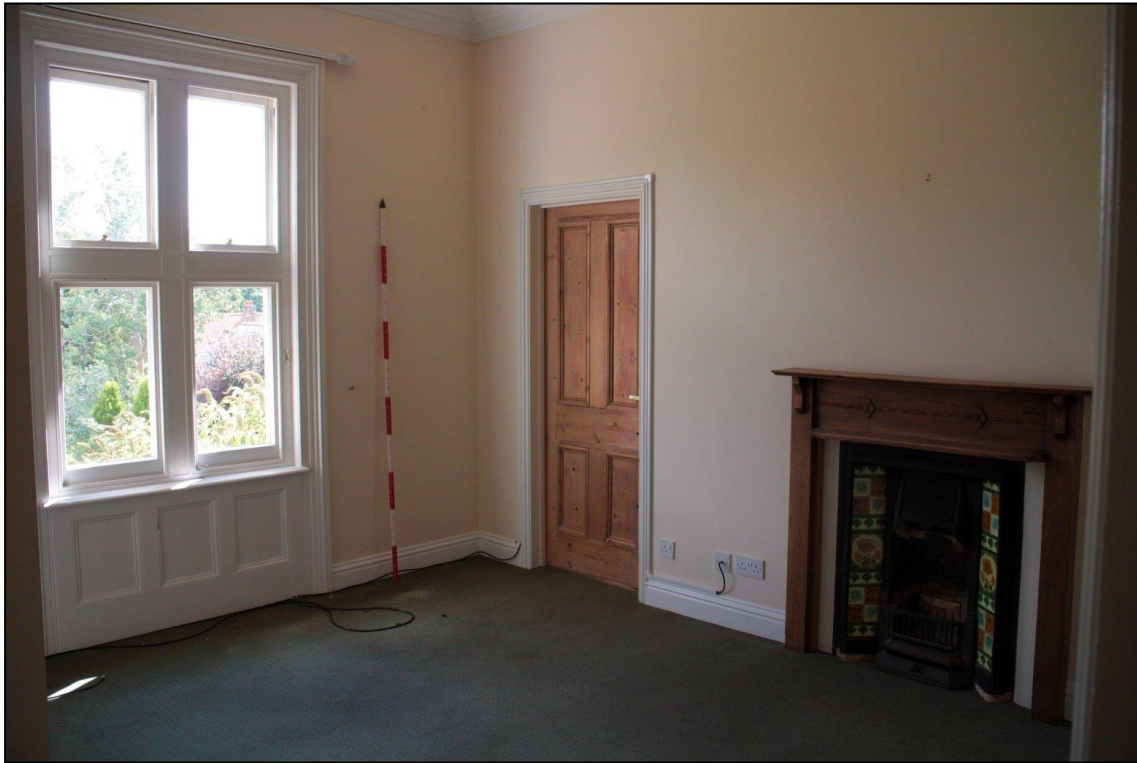
Image 37: Bedroom 16

Bedrooms 16 and 17 have been created by subdividing a single space with a stud wall partition (Images 37 & 38). The rooms have a simple classical cornice moulding which follows the line of the modern stud wall partition. In the west end of Bedroom 17 is a late-19th century cast iron fireplace with tiled side panels with a wood surround in a simple arts and crafts style (Image 39). The doors to the en-suites in Bedrooms 16 and 17 are reused four-panel pine doors (c.C19th-early C20th) set in modern door frames.

Looking south-west showing window and door to en-suite (scale 2m)
