**PRIORY CHURCH OF ST PETER
DUNSTABLE**

**ARCHAEOLOGICAL INVESTIGATION
AND REPORTING**

Project: SPD1642

Document: 2010/96
Version 1.0

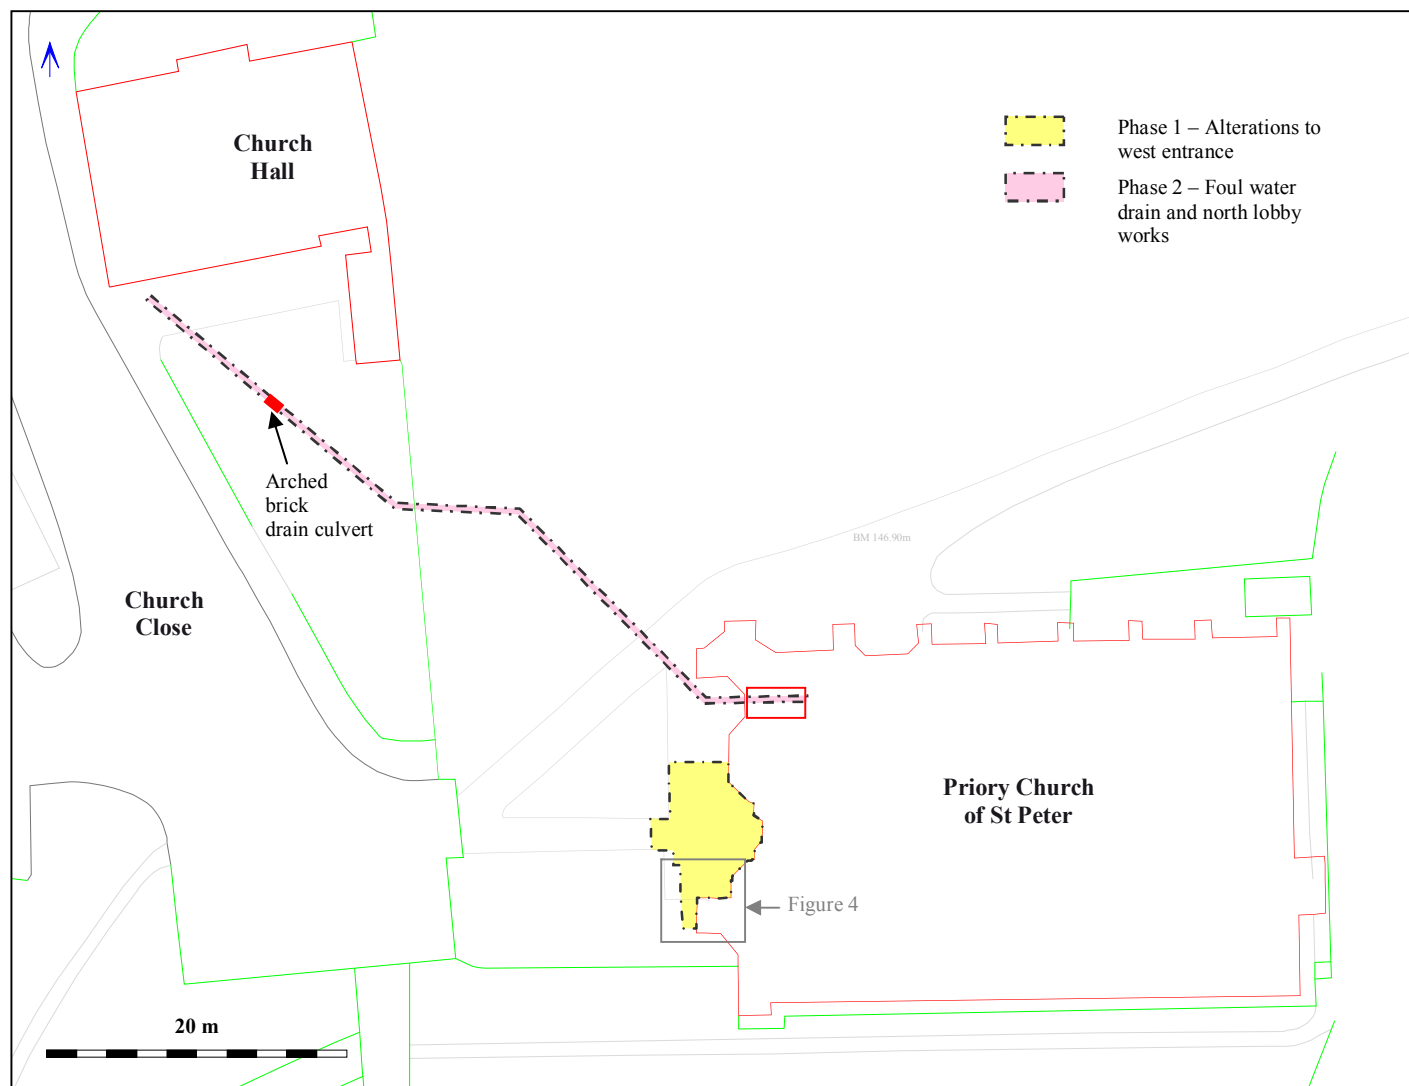
Figure 2: Areas of groundworks subject to investigation (Phases 1 and 2)

Outside the priory grounds, halfway between the churchyard wall and the Church Hall, the top of an arched brick drain or culvert was revealed 0.30m below the modern ground surface (Figure 2).
