# TOWN CLOSE, CARTMEL, CUMBRIA

Heritage Assessment

March 2019

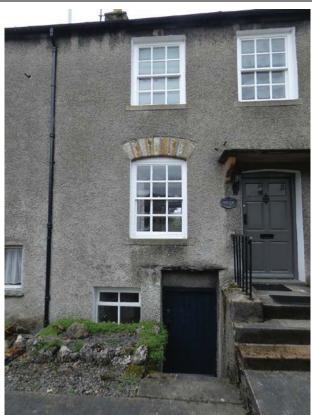
4.2.2 **East external elevation:** this is broadly symmetrical and based around a central doorway with a flat stone canopy on stone corbels with railings attached below leading down a short flight of steps to the yard (Plate 9). The door has four fielded panels and two lights in the top. To the south is a further flight of steps leading down to a second doorway at cellar level with a plank and batten door and a small four-light window to the south (Plate 10). The main elevation has two windows on the ground floor each with a stone voussoir arch and 12-light sash casements and there are three windows on the first floor all with sash casements in the same style. All of the windows have square sills probably formed of render.

Plate 9 (left): The east external elevation, viewed from the east Plate 10 (right): The south side of the east external elevation, viewed from the east

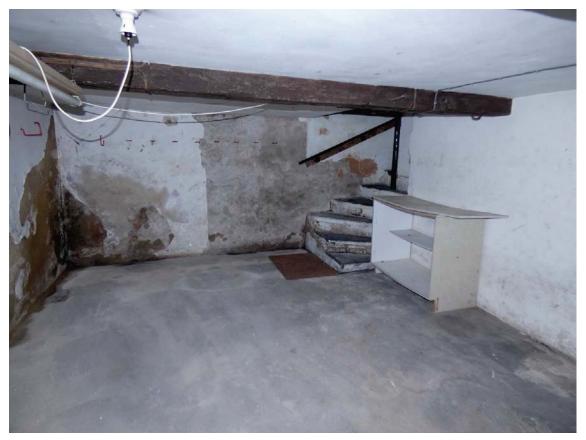
4.3.1 *Cellar:* this is split into two sections north and south by a masonry wall, which has a doorway on the east side with a re-used six panel door (Plate 11). On the east side of the north half there is an alcove that was perhaps formerly a doorway, while in the south-east corner there is a doorway to the exterior with plank and batten door and there is a stoneware sink set in the south-east corner below a small four-light window (Plate 12). To the south there is a chimney breast with no evident fireplace. On the west side is a stone staircase leading up to the ground floor (Plate 13). The beams supporting the ceiling are all hand-finished and some are clearly re-used.

Plate 13: Stairs on the west side of the cellar, viewed from the east

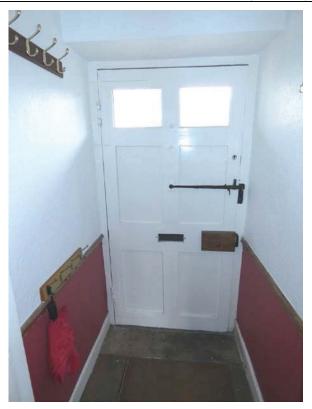
Plate 15 (right): Front doorway within the porch in the living room, viewed from the west

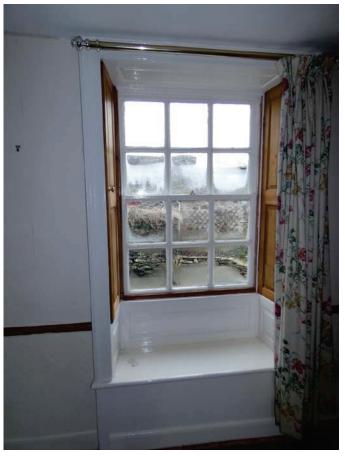
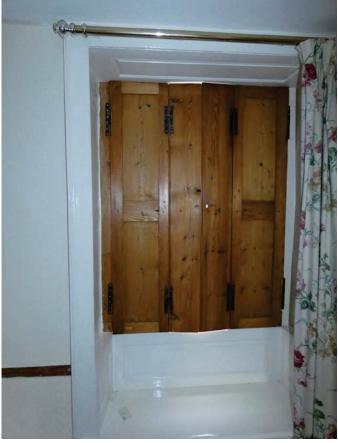
Plate 16 (left): Window in the east elevation of the living room, viewed from the west Plate 17 (right): Window in the east elevation of the living room with shutters closed, viewed from the west

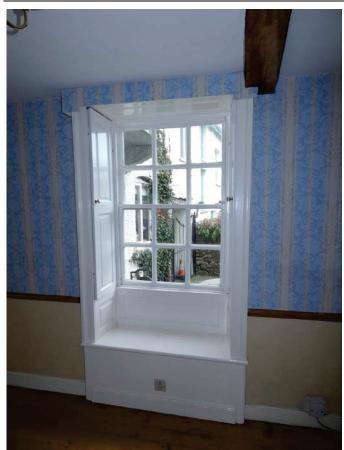
4.3.2 The kitchen has been extensively modernised with fitted units against most of the wall space. There is a window on the west side with a two-light uPVC casement and a doorway to the south of this leading to the cellar with an early door with two raised panels and L-shaped hinges (Plate 21). The parlour to the east is fairly plain. There is filled section in the floorboards against the north side, presumably denoting the location of a hearth for a fireplace (Plate 22), and a window to the east in the same style as that in the living room but with the shutters still painted (Plate 23 and Plate 24).

Plate 23 (left): Window on the east side of the parlour, viewed from the west

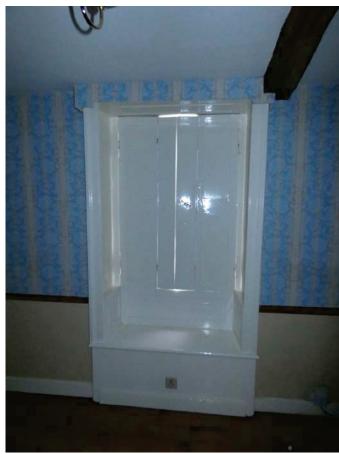
Plate 24 (right): Window on the east side of the parlour with the shutters closed, viewed from the west

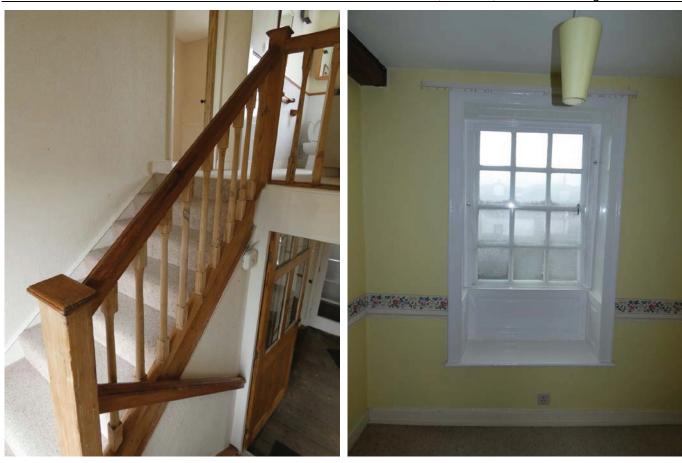
4.3.3 First floor: this is also sub-divided into three main rooms with a landing off the west side connecting to the stairs within which is a hatch to the attic that was not accessible at the time of the site visit. The stairs are lit by a tall window of six lights while the stairs have a stripped timber banister with a moulded handrail with square newels with flat tops and turned balusters (Plate 25). The majority of the rooms are finished with carpets and finished with plaster and wall paper and a moulded dado rail and beaded skirting board in the two bedrooms at either end. Within the southern bedroom the north elevation is a plain stud partition with a doorway on the west side with a door with six raised panels that has been stripped and has modern hinges. The east elevation has a window with a 12-light sliding sash casement and a window seat with fielded panelling around (Plate 26). The south elevation has a chimney breast on the south side but no obvious fireplace (Plate 27), while the west has a window with a modern six-light hinged casement (Plate 28). There is a hand-finished beam along the north side of the room. The central bathroom is modernised and finished with tiles, with a window with a 12-light sliding sash casement to the east and doorway with a six-panel door to the west. The northern bedroom is largely plain, but has windows in the west and east elevations as per those in the southern bedroom and a doorway to the south with six panels that have been stripped of paint. There is single beam against the south elevation, which is hand-finished and scored for plaster (Plate 29).

Plate 25 (left): Staircase on the west side of the building, viewed from the south-west Plate 26 (right): Window in the east elevation of the southern bedroom, viewed from the west

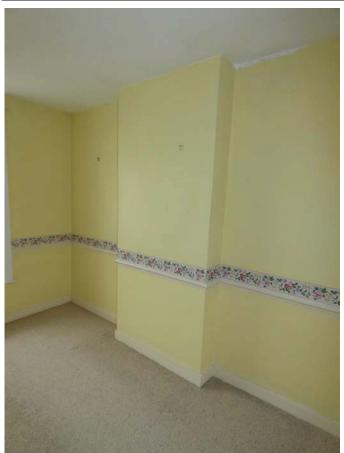
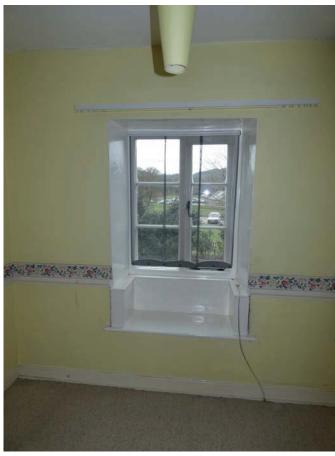
Plate 27 (left): Chimney breast on the south side of the southern bedroom, viewed from the north-west Plate 28 (right): Window in the west elevation of the southern bedroom, viewed from the east
