PRIORY CHURCH OF ST MARY AND ST MICHAEL, CARTMEL, CUMBRIA

Archaeological Assessment

Client: PCC Cartmel Priory

March 2023

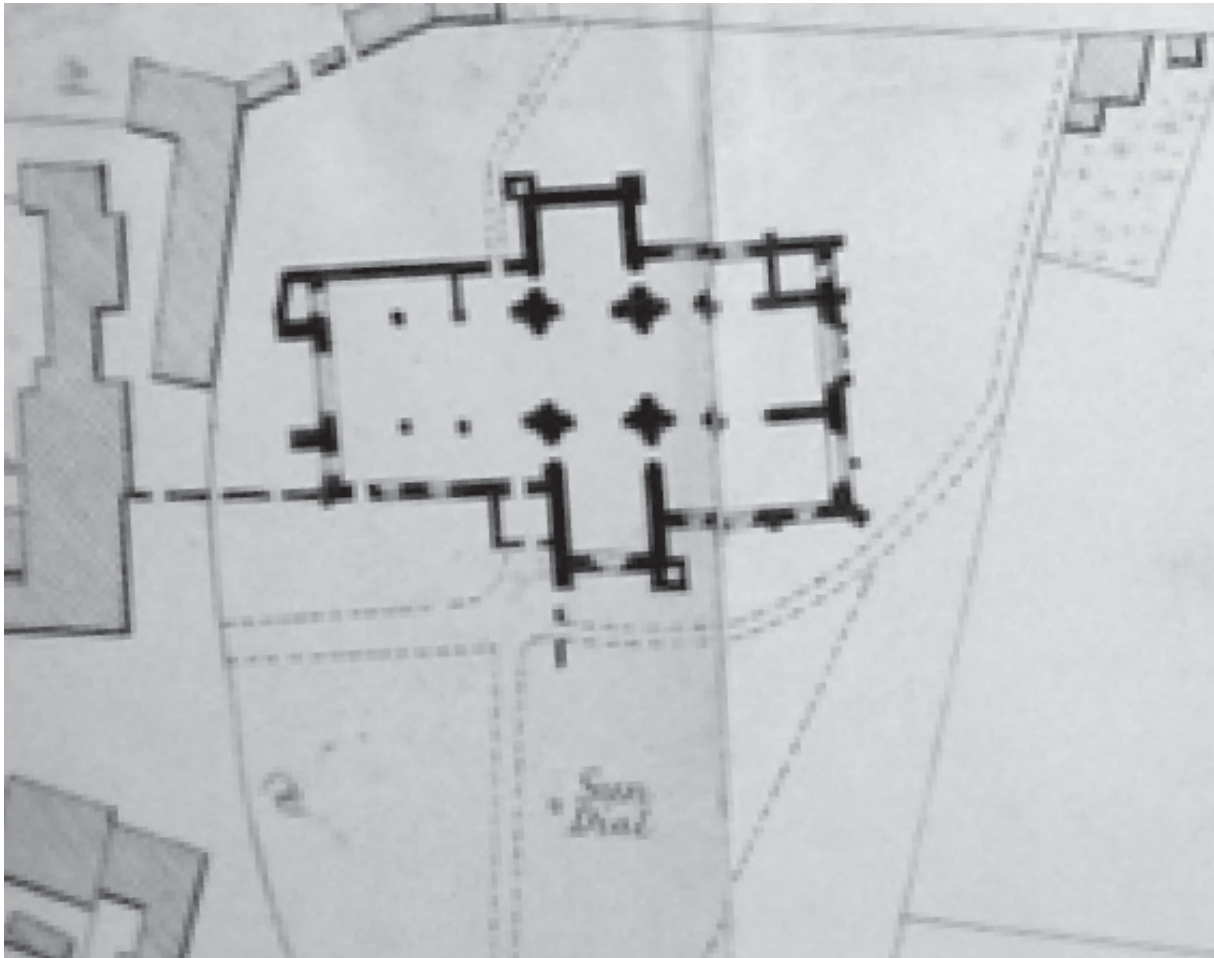
Plate 1: Extract from Ffoliott's plan of 1854

3.4.2 **Ffoliott, 1854:** this is the earliest plan to show the interior of the church and although it is uncertain how accurate it is it seems to show the interior arrangement of the building in a way that compares well with later plans and was produced before the substantial alterations of the late 19th century were carried out (Plate 1). While limited in detail this is of interest in terms of the north side of the nave as it appears to show a short section of wall running from the north wall and joining one of the arcade columns to the south. A door on the east side of the north wall of the nave is also shown as being in existence at this time.

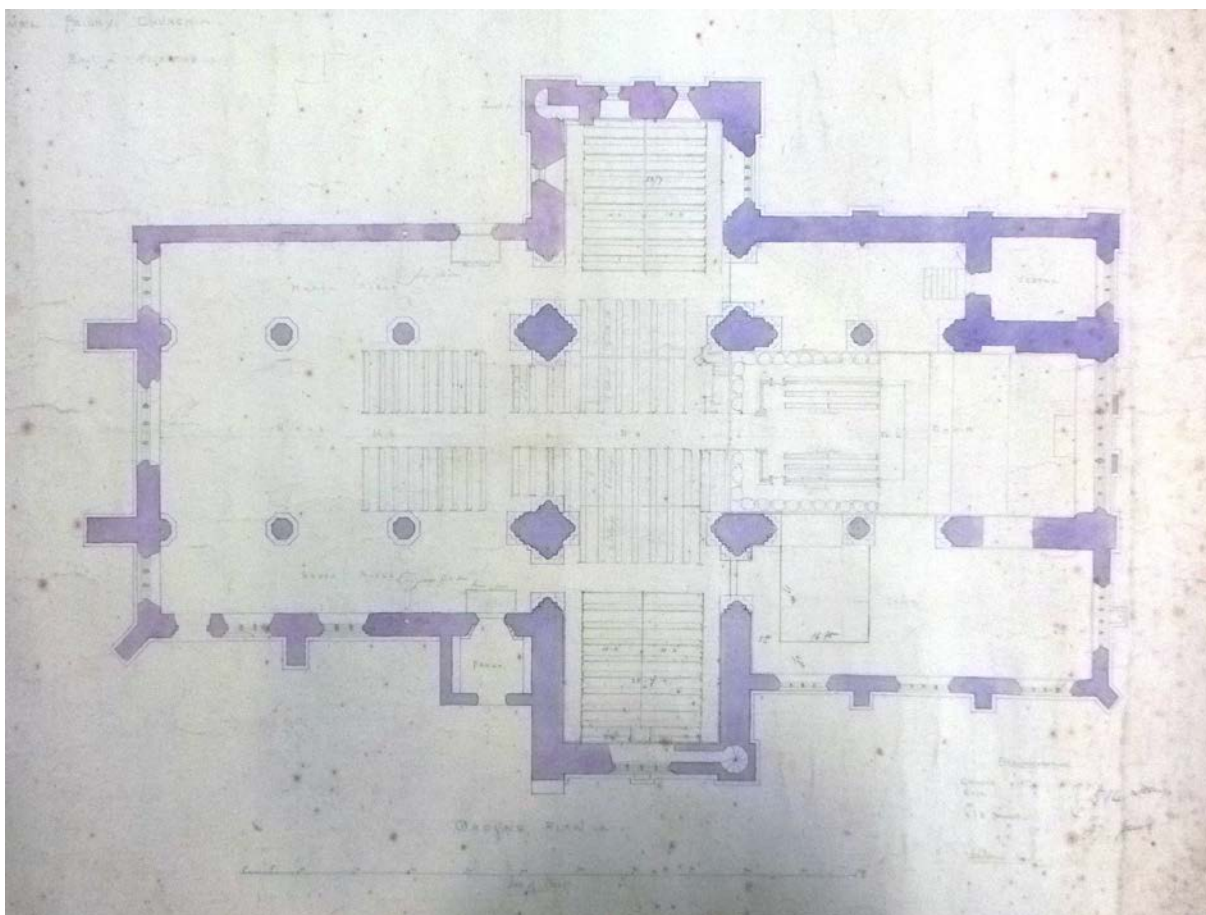
Plate 2: The plan of 1863

3.4.3 **Plan, 1863:** a plan was also produced for the restoration of the church carried out in 1863 (CAC(K) WPR/89/4/3/10 1863). This too shows an existing doorway on the east side of the north wall of the nave, but to the west of it there is an obvious flue built into the wall thickness and a dashed line connecting it to a circular structure labelled 'Large gile stove' (Plate 2).

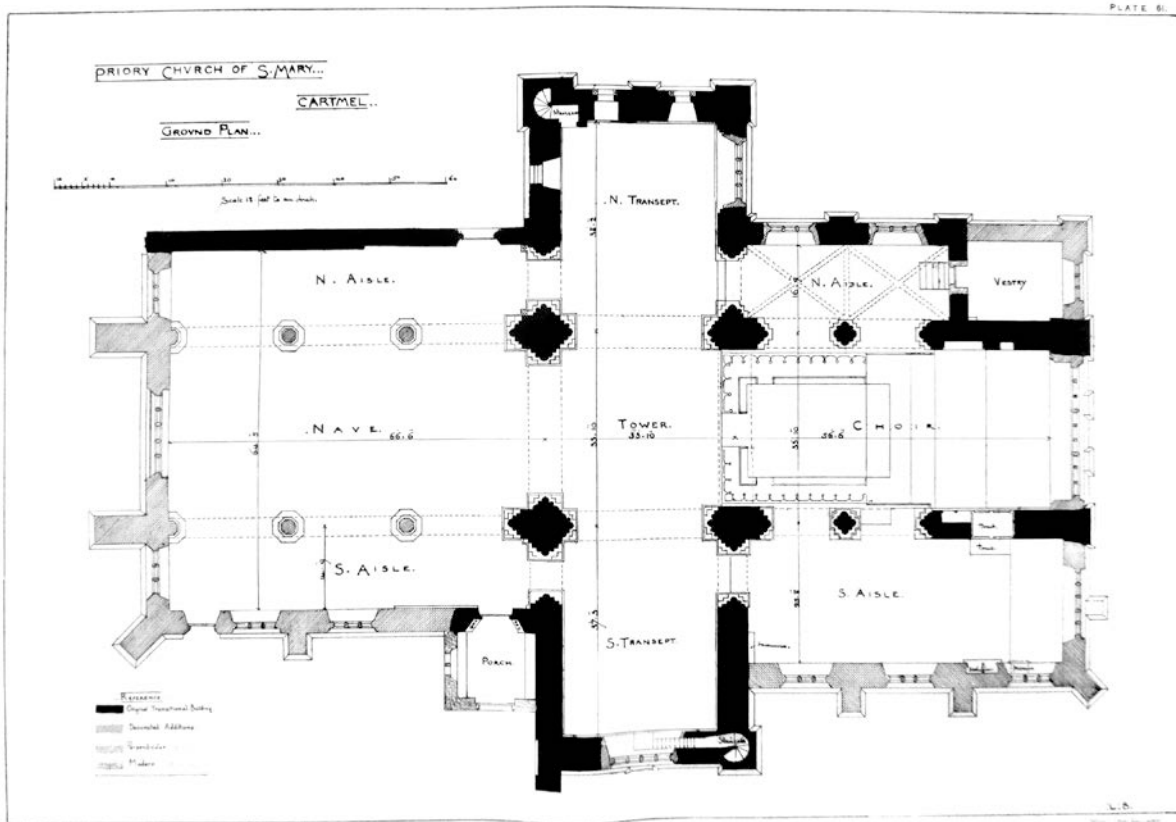
Plate 3: The plan of 1876-1879

3.4.4 **Plan and elevation, 1876-1879:** a series of architectural drawings were produced in the late 1870s (CAC(K) WPR/89/4/6/5 1876-1879). The plan is apparently the first one to show the suggested phasing of the building, with the north wall of the nave suggested as belonging to the '*Original Transitional Building*' phase (Plate 3). It is also apparently the first plan to show the step on the internal face of the wall. Unusually, there is also an associated view of the north exterior elevation, which shows details such as the doorway on the east side, the string course and the row of projecting corbels, which proves they were present at that time (Plate 4).

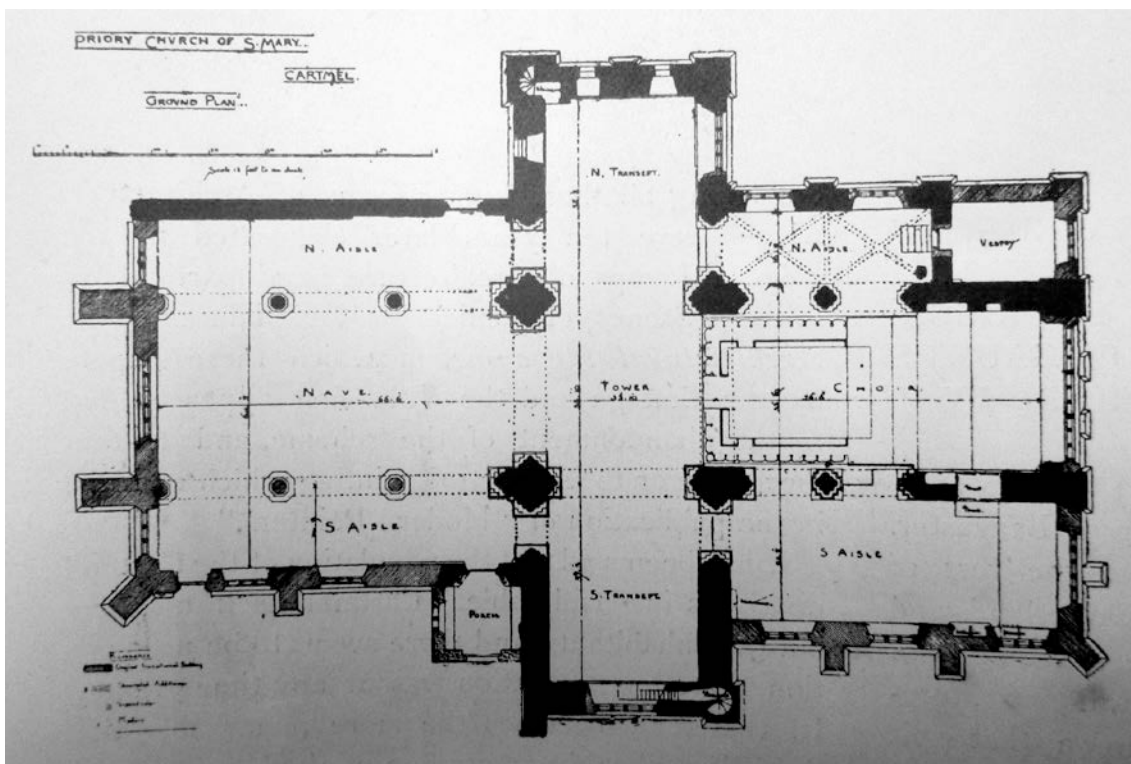
Plate 5: Early 20th century plan

3.4.5 **Plan and elevation, early 20th century:** this is a set of undated but probably early 20th century drawings, probably based on the preceding ones, but also including a cross-section that shows the south face of the north wall of the nave (CAC(B) BDX/828/1/3/80 20th century). However, neither shows any additional information of note (Plate 5 and Plate 6).

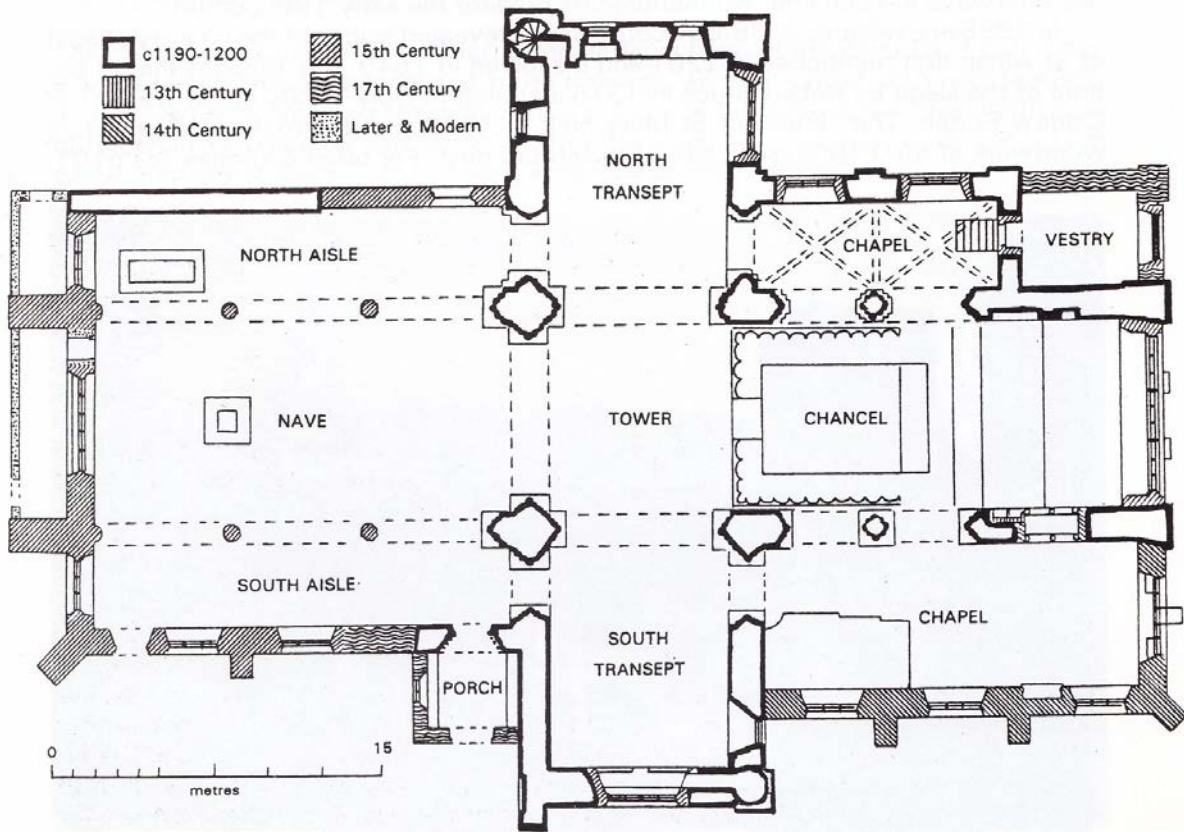
Plate 7: Salter's plan of 1998

3.4.6 **Plan, 1998:** a more recent plan of the church was produced by Salter (1998, 36) and included proposed phasing. This suggests that the area to the east of the step in the north wall of the nave is a later phase than the west end, 15th century rather than c1190-1200 (Plate 7). However, the reasoning behind this is not clear.
