FORMER PRESBYTERIAN CHURCH, SCHOOL STREET, BARROW-IN-FURNESS, CUMBRIA

Archaeological Building Recording

Client: Barrow Borough
Council

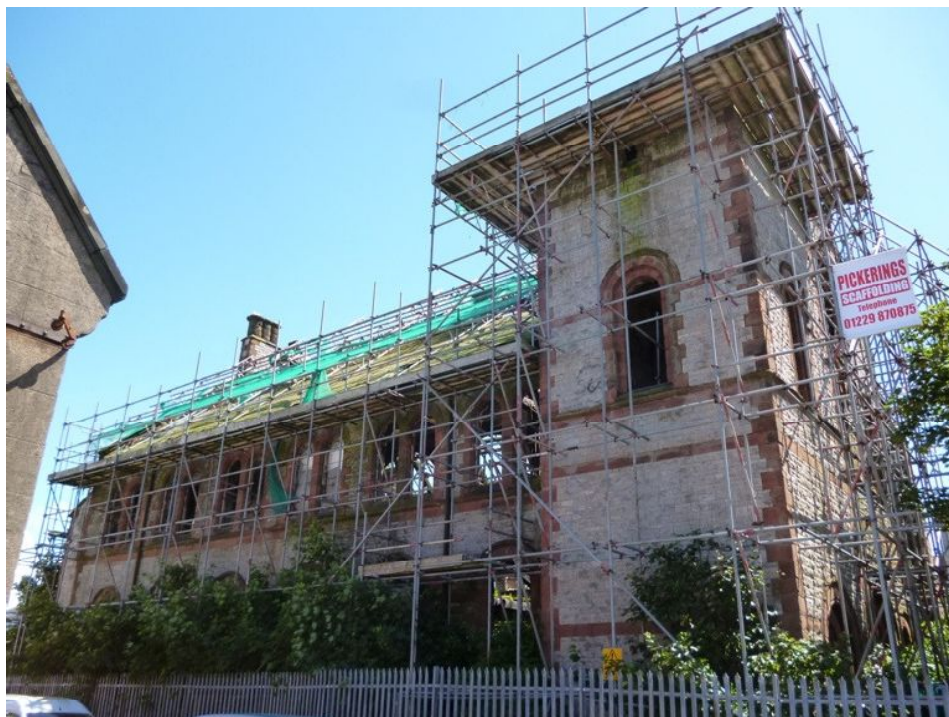
Plate 26 (right): General view of north-west external elevation

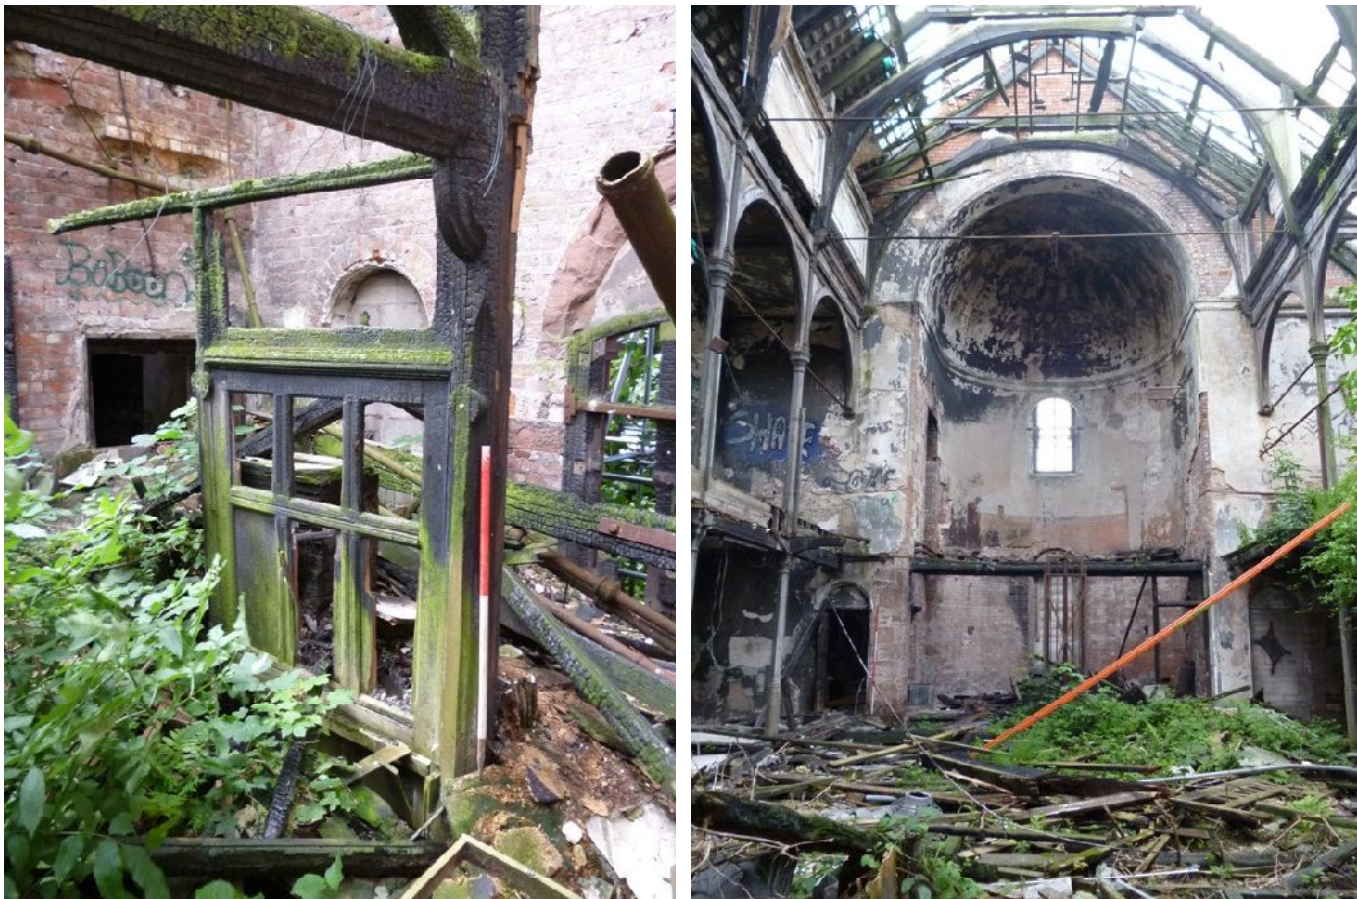
Plate 31 (left): Surviving section of stud wall at south-west end of Room G1

Plate 32 (right): General view of north-east elevation, Room G1

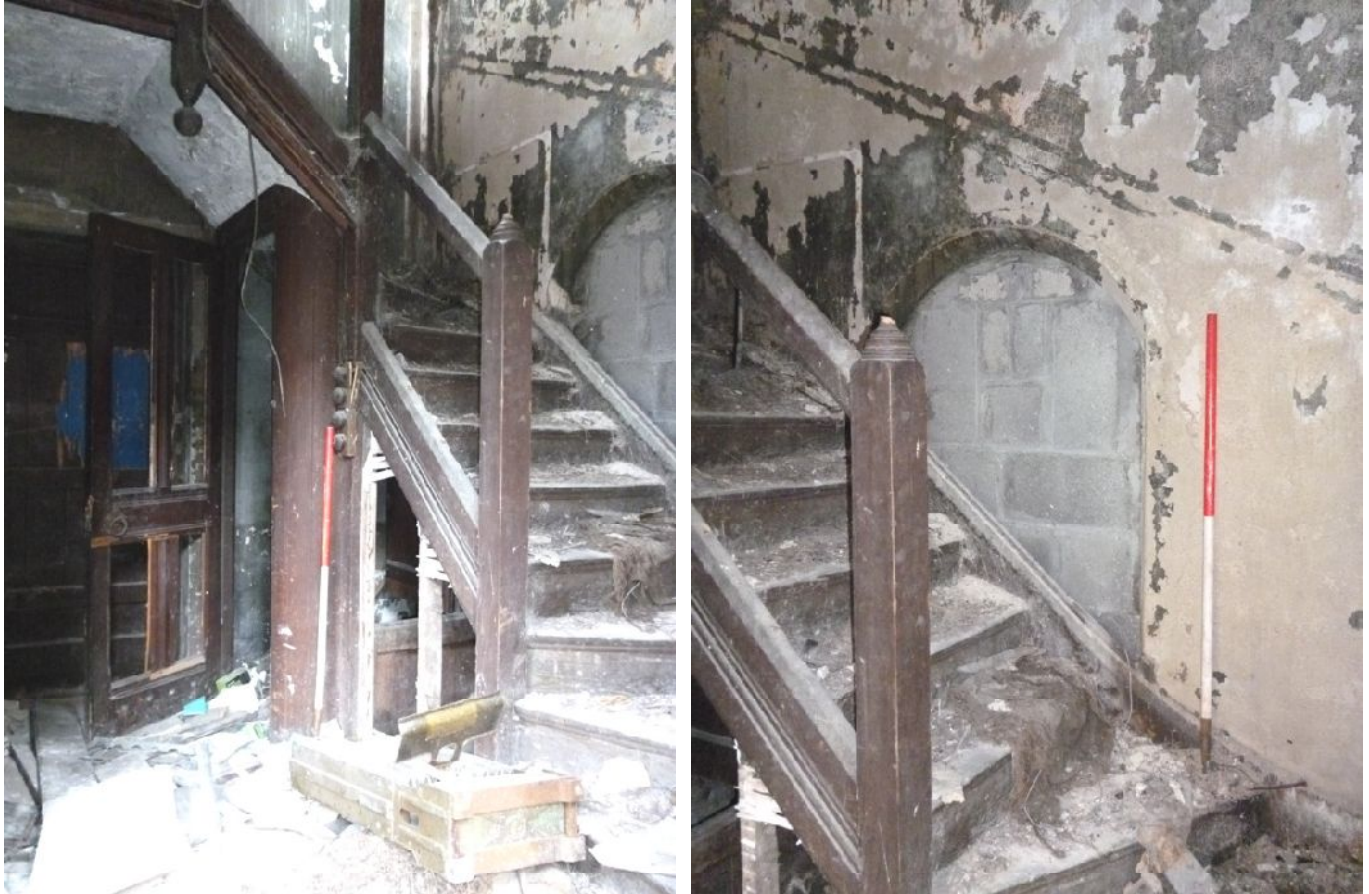
Plate 35 (left): Staircase in Room G2

Plate 36 (right): Detail of window behind stairs

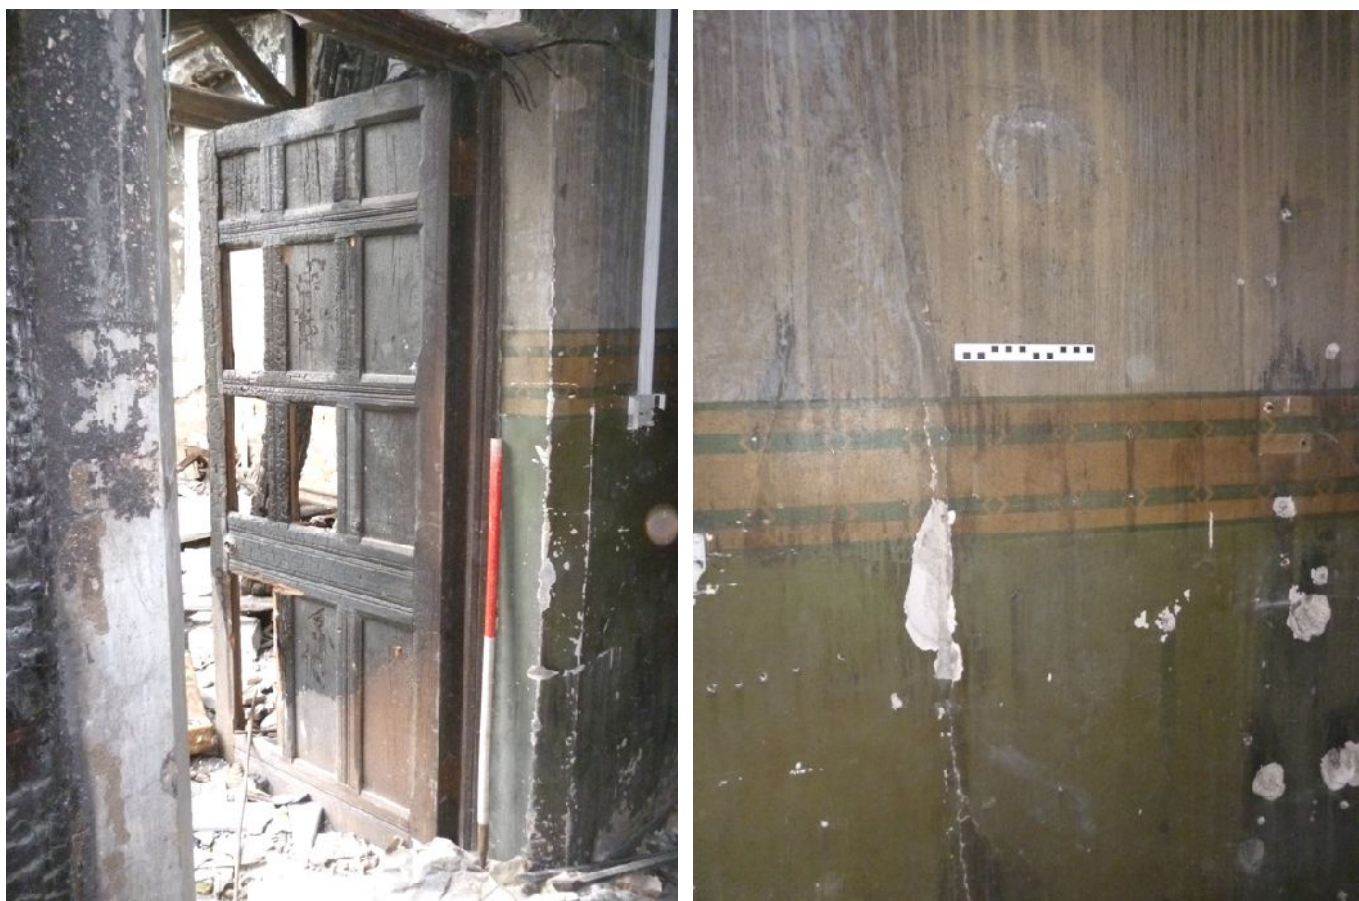
Plate 37 (left): Door in south-west elevation, Room G2

Plate 38 (right): Paint scheme on the south-west elevation, Room G2

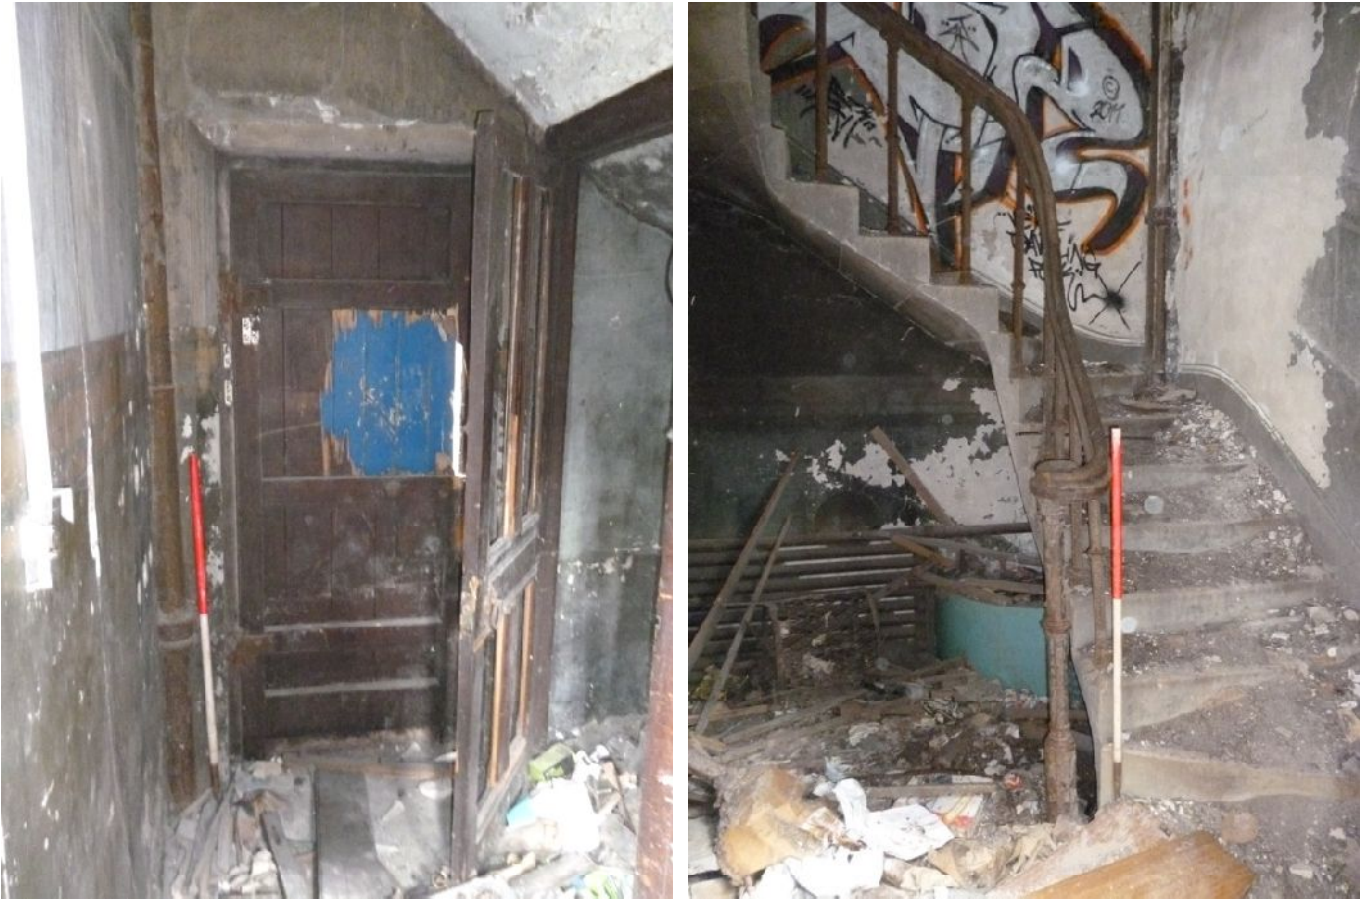
Plate 39 (left): Door in north-west elevation, Room G2

Plate 40 (right): Stairs in Room G3

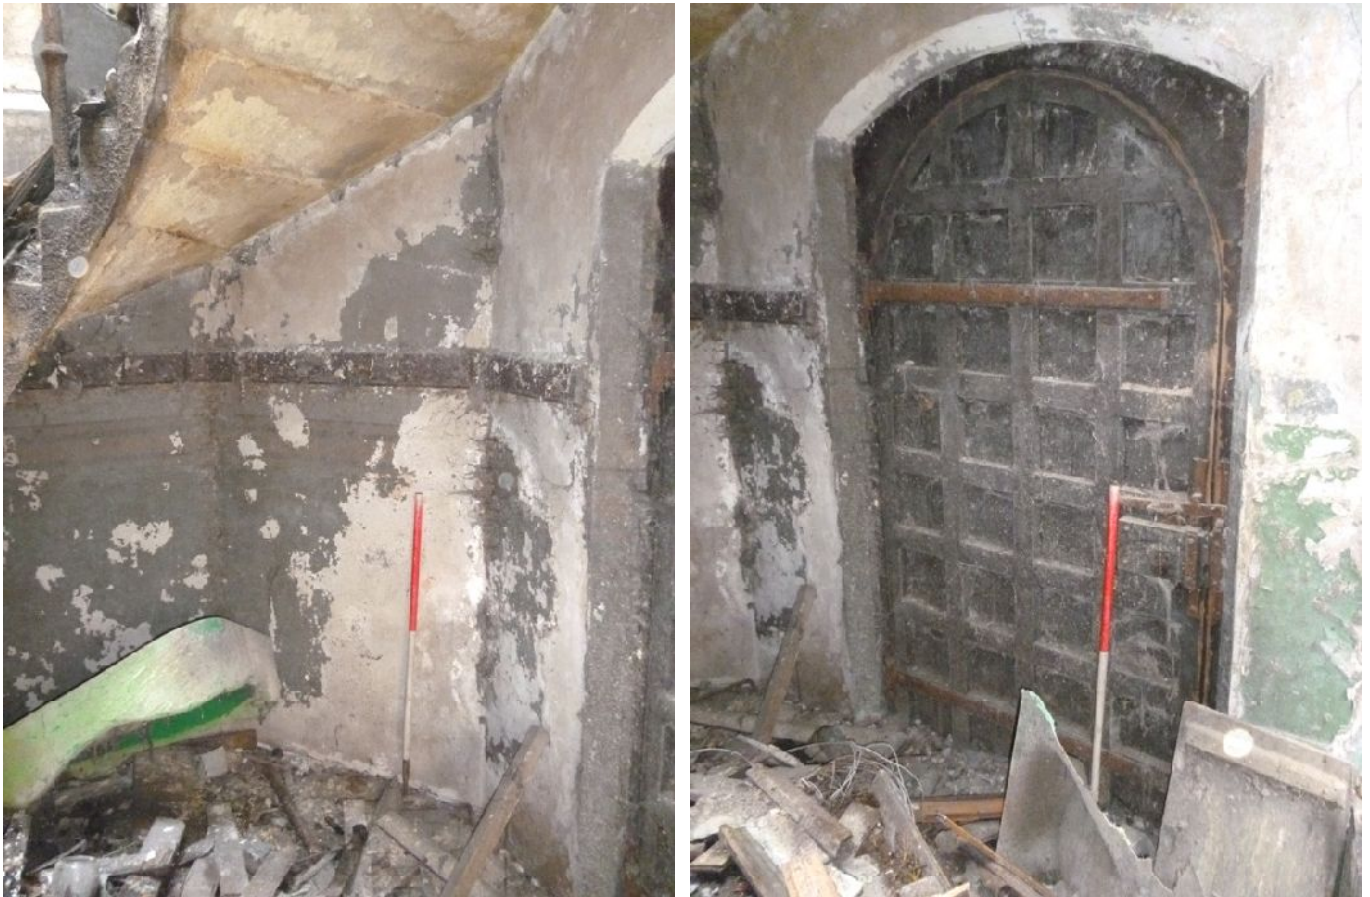
Plate 45 (left): Timber bracket forming coat hook around south corner of Room G4

Plate 46 (right): Door in south-west elevation of Room G4

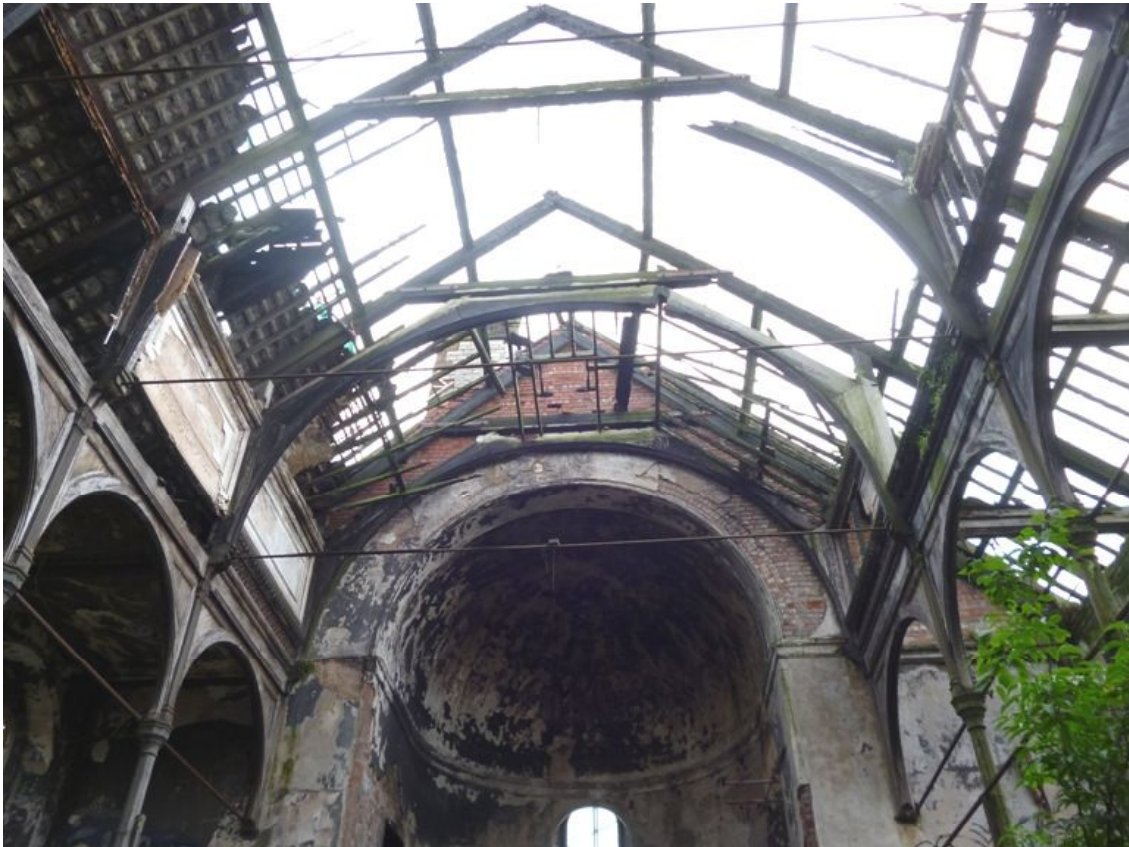
Plate 56: Typical roof trusses, Room F1

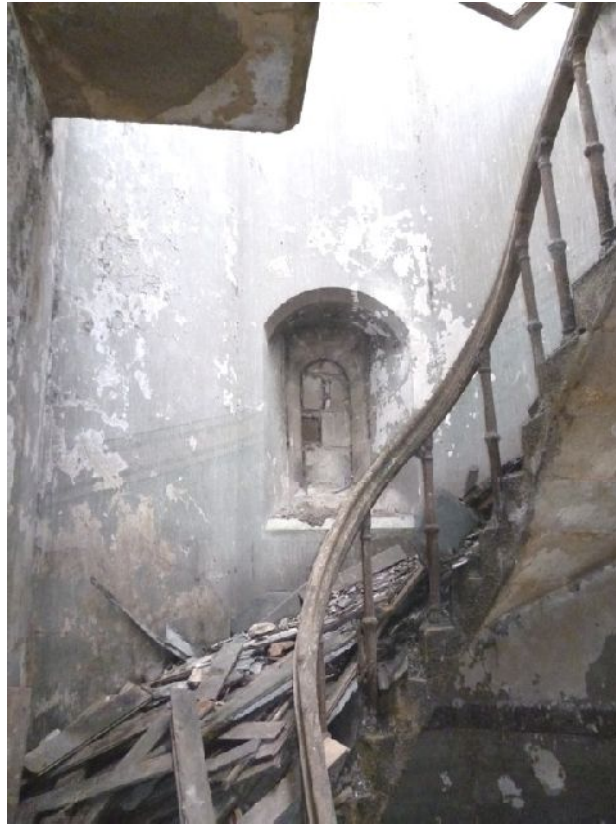
4.3.14 **First floor, Room 4:** this is the upper floor of the east tower. It is largely choked with debris, making access difficult, but the ashlar yellow sandstone staircase with cast iron balusters and turned timber hand rail, as per the floor below, continue to this level. The ceiling is missing as the roof has been largely removed leaving only elements of its structure remaining. The walls are finished with plaster, with remnants of the paint scheme (as per the floor below) and moulded skirting visible. There is a small mid-level window on the south-east side with a round head (Plate 61) and on the top floor there are three larger windows, one in each face of the tower, again with round heads. There is a doorway on the north-east side leading onto the gallery with parts of its chamfered frame remaining.

Plate 61: Small window in south-east elevation of Room F4
