'GRANGE LIDO', GRANGE-OVER-SANDS, CUMBRIA

Archaeological Building Recording

Client: NPS North West Ltd

March 2013

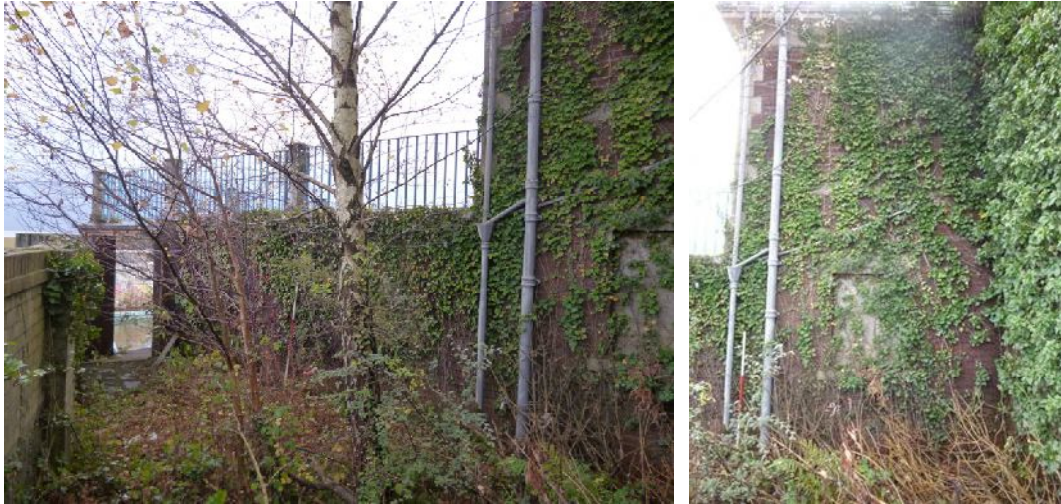
4.2.1 **North Building, North Elevation:** the north elevation is lower on the east side where it is topped by the walkway (Plate 26) with plain concrete pillars with iron fencing between, which are continued by a column at the east end and the opening has a moulded band over. There is a single small window in the low section on the west side, with a concrete sill and lintel incorporated into the band above. It is two storeys to the west, with a single ground floor window with a concrete sill and lintel (Plate 27) and string course over and moulded eaves band. It returns to the north where it is obscured by ivy, before it returns to the west again. Here there are two windows on the first floor (Plate 28) and one on the ground with concrete sills and lintels.

Plate 26 (left): East end of the north elevation of the north building

Plate 27 (right): Central window on the north elevation of the north building

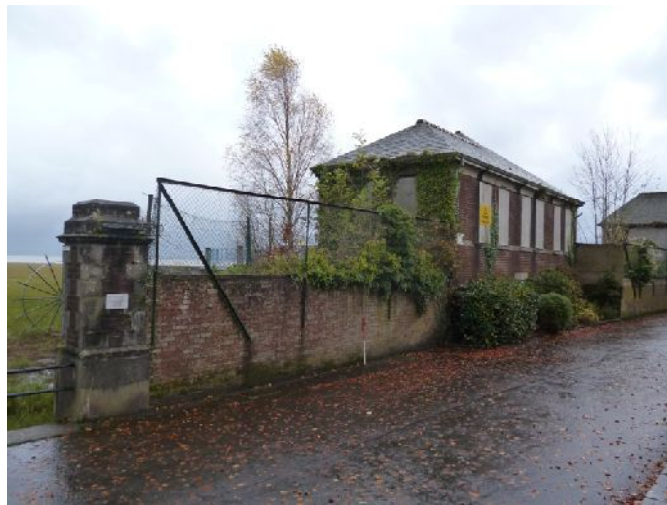
Plate 28: Oblique view of the upper floor of the north elevation and west elevation of the north building

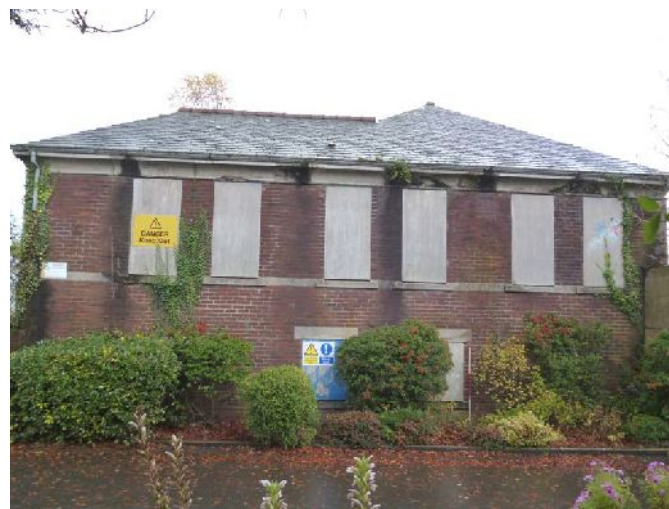
4.2.4 **North Building, West Elevation:** the west elevation is extended to the north and south by a brick boundary wall, the north end extending to a pillar at the corner, which is constructed from ashlar concrete and brick topped with plain coping. The rest of the wall is constructed from plain brick topped with mesh fencing. The wall to the south is brick probably of a different type to those in the building itself, topped with concrete blocks and mesh. The building proper has two ground floor windows, with concrete sills and lintels, and six first floor windows and has concrete quoins at each end. The sills of the first floor windows form part of the string course, the lintels form part of a moulded eaves band, and the elevation is topped with a moulded iron gutter.

Plate 35: West elevation of the north building

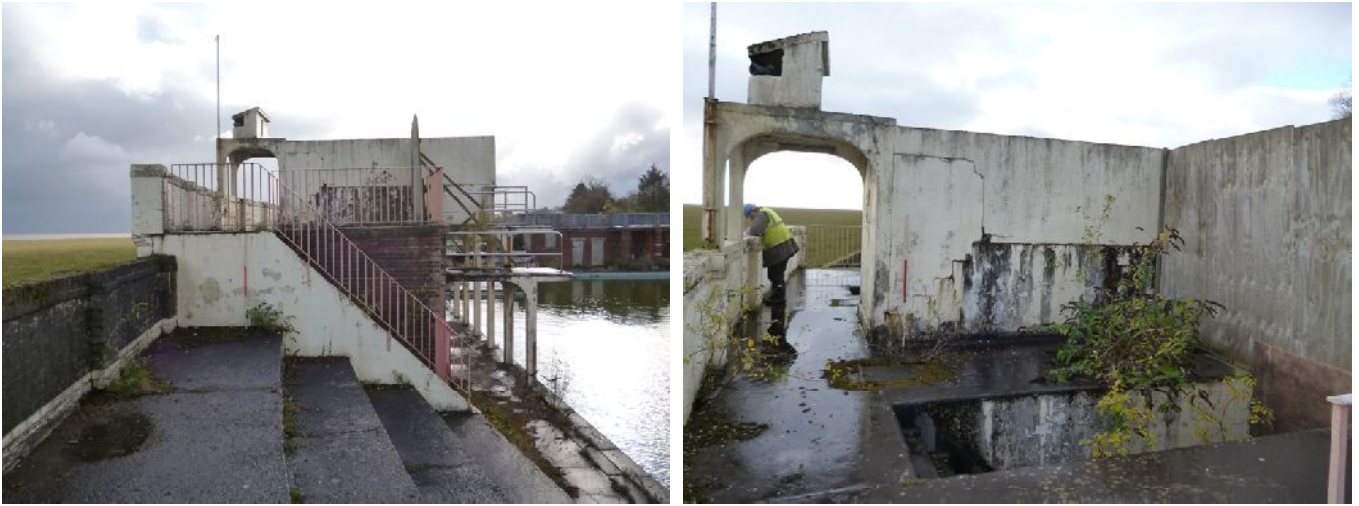
4.2.5 **East Building, North Elevation:** this building gives access to the diving boards and pump house (Plate 36 and Plate 37). The north elevation essentially mirrors the south elevation (see Section 4.2.7 below).

Plate 36 (left): North elevation of the east building

Plate 37 (right): North elevation of the east building at first floor level

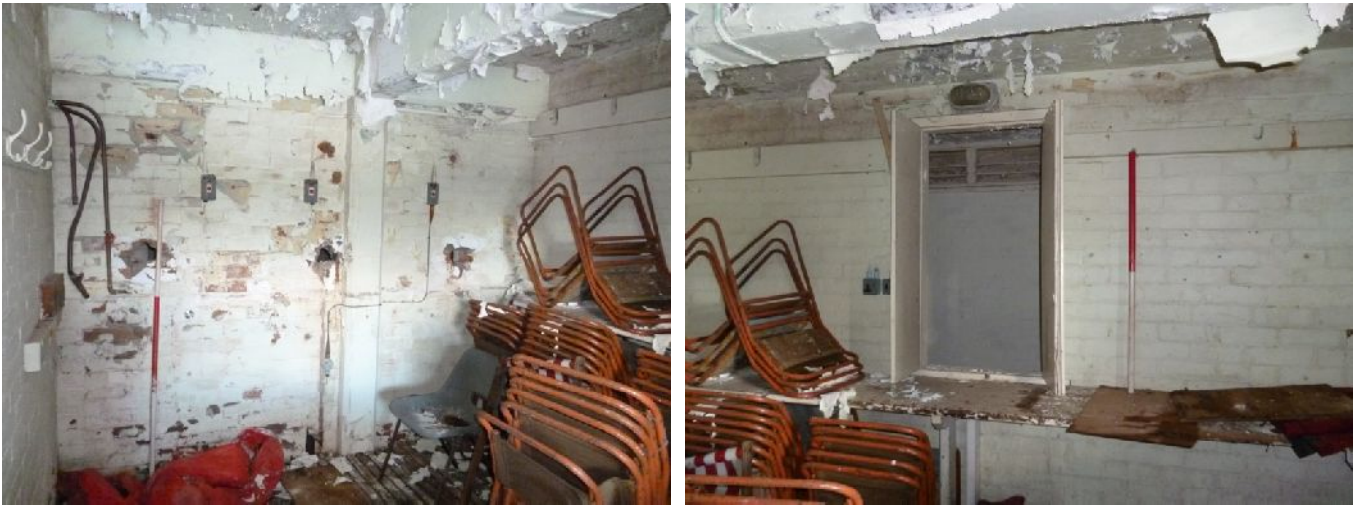
Plate 133 (left): South elevation of South Building, Ground Floor Room 5

Plate 134 (right): West elevation of South Building, Ground Floor Room 5

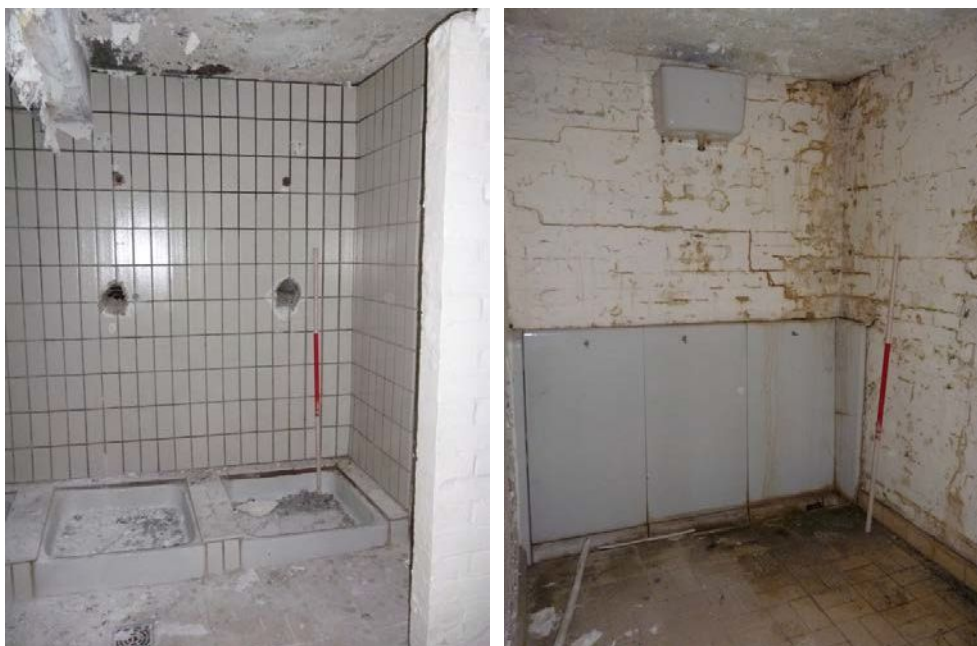
Plate 141 (left): Showers at the east end of the north elevation in South Building, Ground Floor Room 6

Plate 142 (right): Urinal at the south end of the east elevation in South Building, Ground Floor Room 6

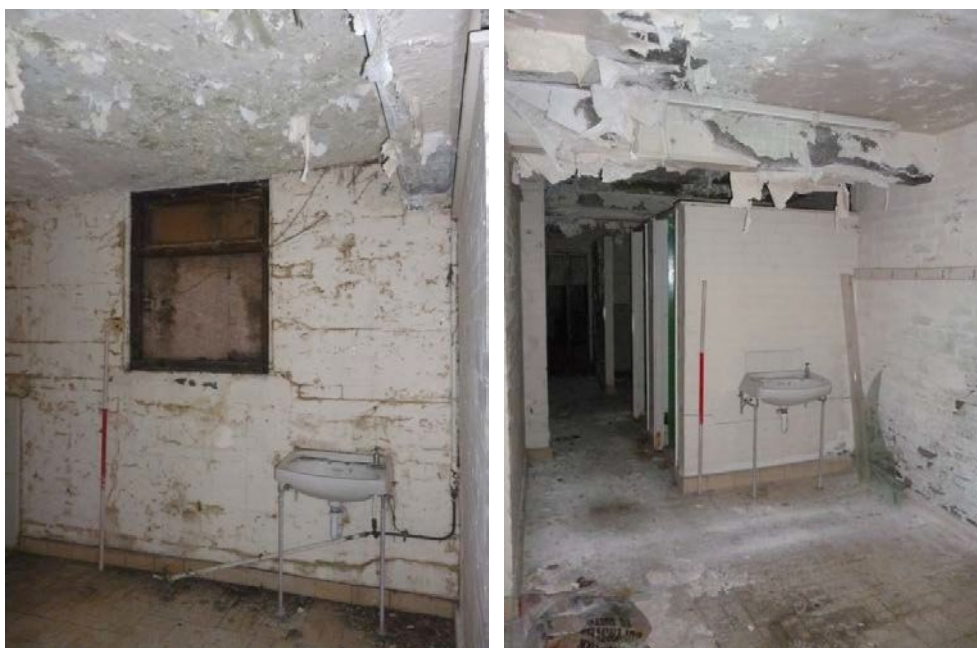
Plate 143 (left): Window at the east end of the south elevation in South Building, Ground Floor Room 6

Plate 144 (right): Toilet cubicles against the south elevation in South Building, Ground Floor Room 6

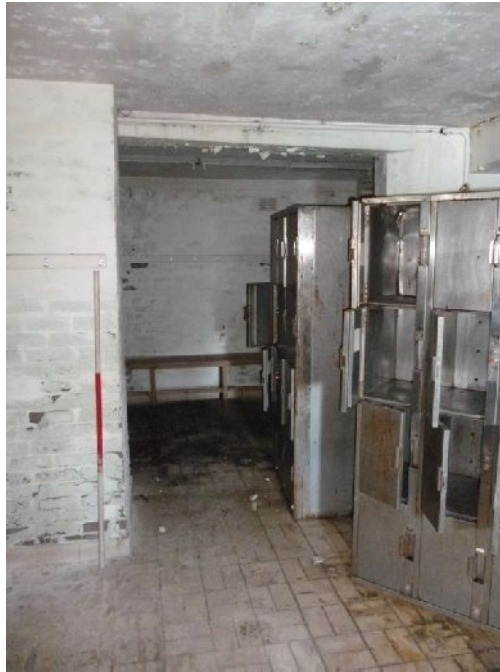
Plate 145: Opening to South Building, Ground Floor Room 7, from Ground Floor Room 6

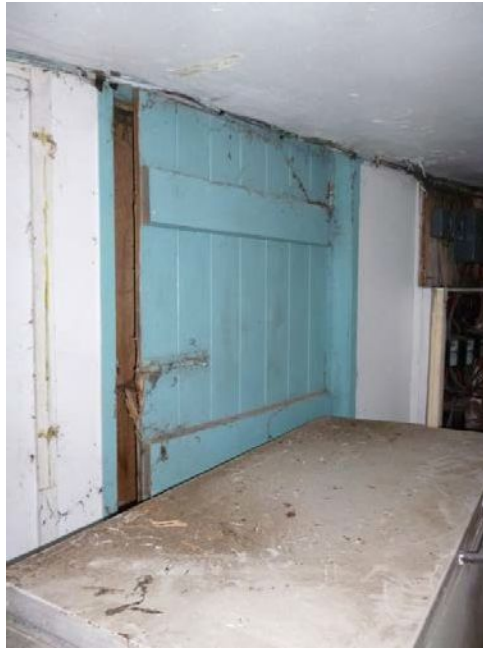
Plate 151: Plank and batten door in the west elevation of South Building, Ground Floor Room 9

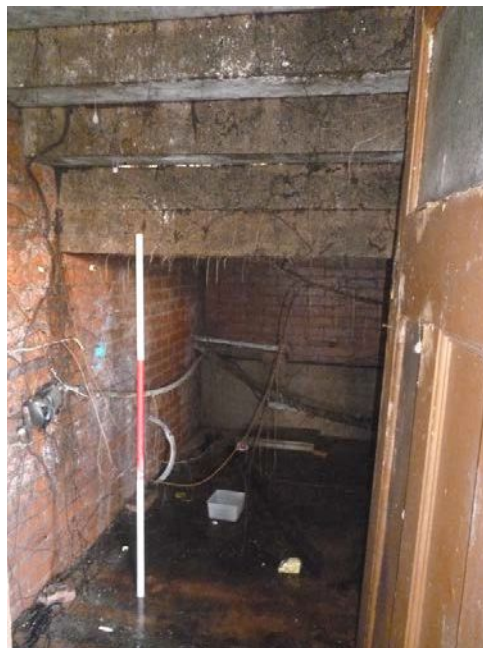
Plate 152: South Building, Ground Floor Room 10

4.3.21 Room 10 comprised the area below the stairs and has a concrete floor and the ceiling is formed by the concrete beams of steps and concrete slabs (Plate 152). The walls are exposed brick. The north and south elevations are plain but have cables attached – one junction box to the south is burnt out and labelled 'LUCY OXFORD', another at the north is labelled 'JOHN[?] PHILLIPS LTD LONDON 853'. The east elevation has a three-panel door with ovolo-moulding and the top is glazed. The west elevation has a concrete plinth.

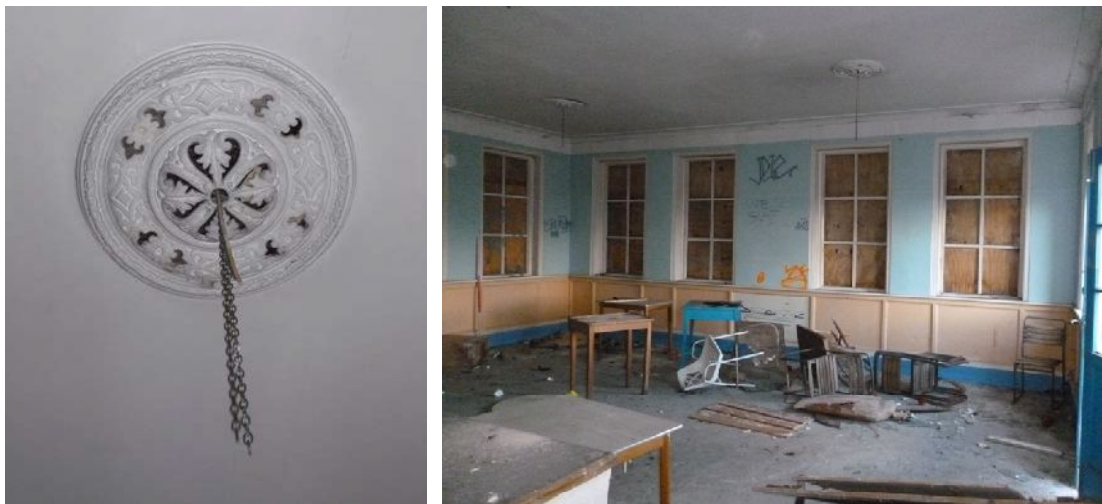
Plate 153 (left): Ceiling rose in South Building, First Floor Room 1

Plate 154 (right): North elevation of South Building, First Floor Room 1

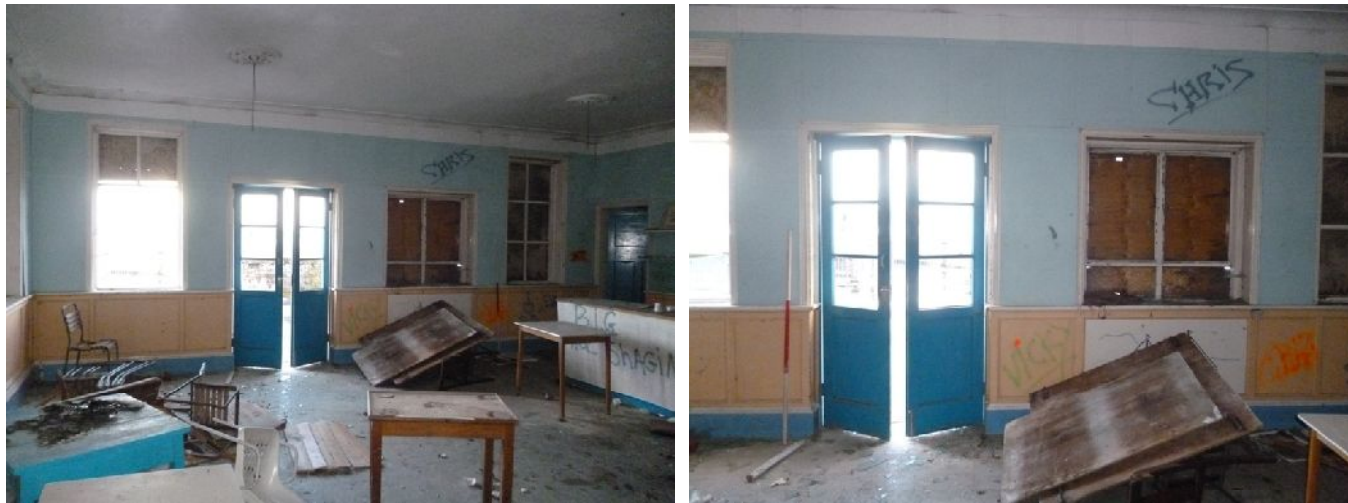
Plate 155 (left): East elevation of South Building, First Floor Room 1

Plate 156 (right): Detail of the east elevation of South Building, First Floor Room 1

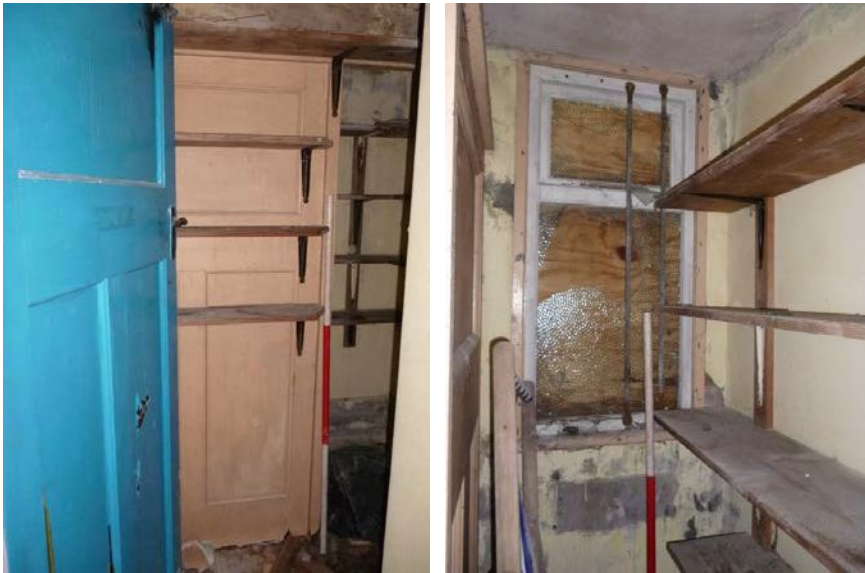
Plate 161 (left): Partition in South Building, First Floor Room 2

Plate 162 (right): Window in the east elevation of South Building, First Floor Room 2

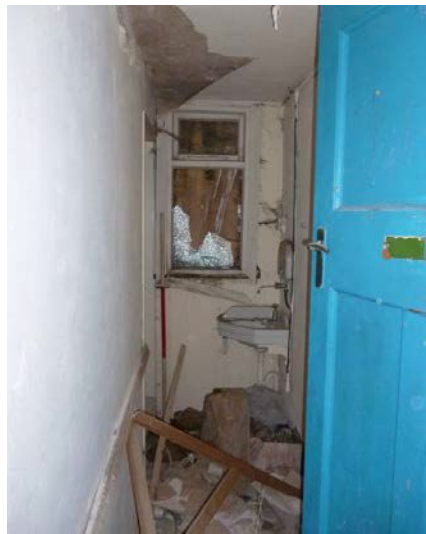
Plate 163: Window in the south elevation of South Building, First Floor Room 3

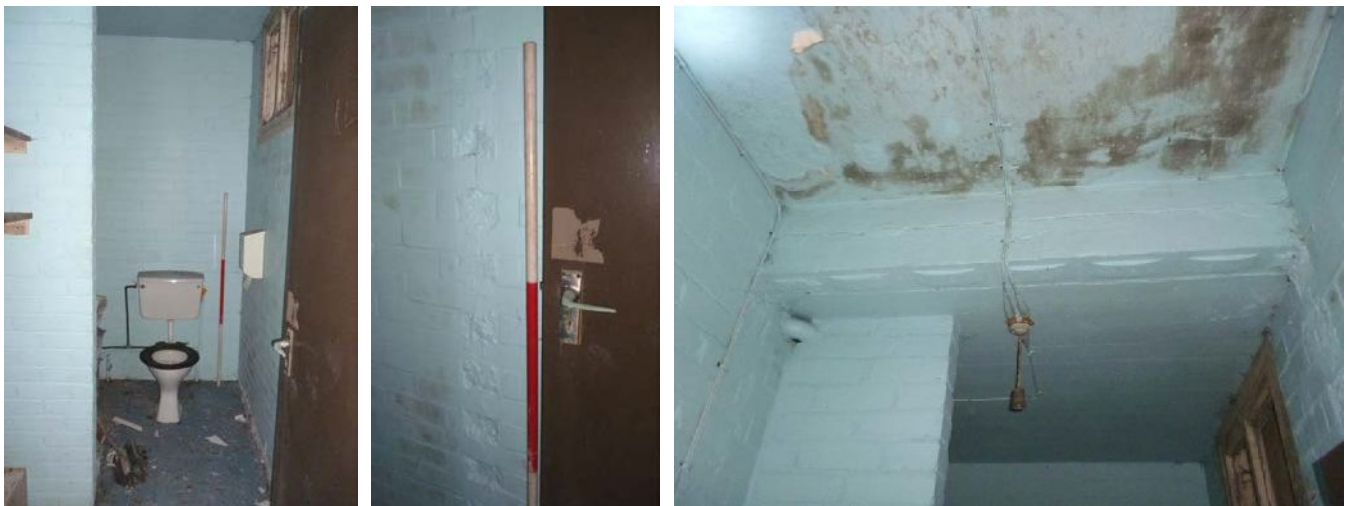
4.3.29 Room 3 is to the east of two toilets and to the south of Room 2, accessed via a door to the east. The walls are painted brick, vinyl covering the floor, and it has a painted concrete roof. It is lower on the north side, perhaps because of the stairs. There is a scar of bricks visible, line of wall above. The north elevation is plain and has a toilet attached (Plate 186). The east elevation has a high level two-light timber casement window and the scar of where the wall went across, matching the line in the ceiling (see Plate 187 and Plate 188). The south elevation has a doorway with a single light over a plain door with a plain surround. The west elevation has shelves and coat hooks to the south, over the scar of the wall, and a stub wall projecting to the east. There is a high two-light fixed casement window to the north below which is a sink 'TWYFORDS' on an iron stand.

Plate 186 (left): Toilet against the north elevation of West Building, Ground Floor Room 3

Plate 187 (centre): Wall scar in West Building, Ground Floor Room 3

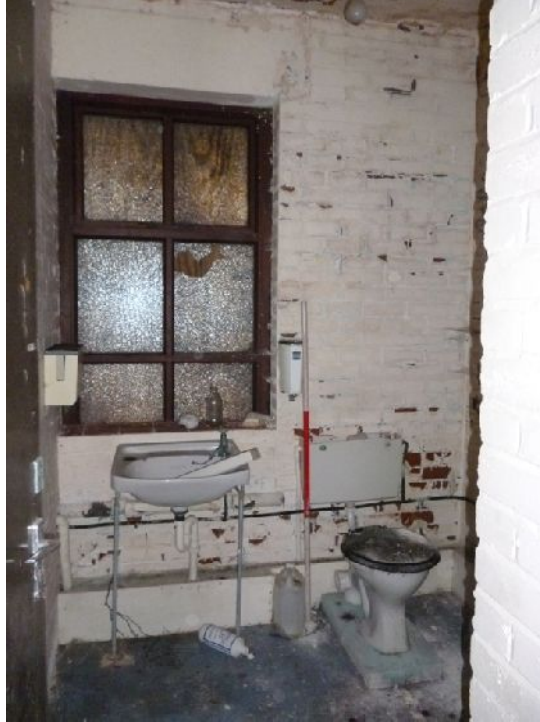
4.3.30 Room 4 is to the west of Room 3 and also a toilet with a vinyl floor and a painted concrete ceiling (Plate 189). The walls are painted brick. The north elevation has boxing along the base but is otherwise plain. It returns to the south on the east side through a door to this room to door into Room 2. The door and surround are plain with a single light over. There is a doorway in the east elevation with a plain surround but no door. The elevation returns to the west to form the south elevation. The through door to this room has a plain door and surround with a single light over. The south elevation is plain. The west

elevation has a six-light hinged casement window on the south side and a sink on an iron stand and a toilet attached. The window also has a red tile sill and concrete lintel and there is boxing along the base of the wall.

Plate 189: West elevation of West Building, Ground Floor Room 4
