OXENDALE HALL BARN, OSBALDESTON, LANCASHIRE

Archaeological Building Recording and Watching Brief

Client: Belmore Holdings Ltd

December 2017

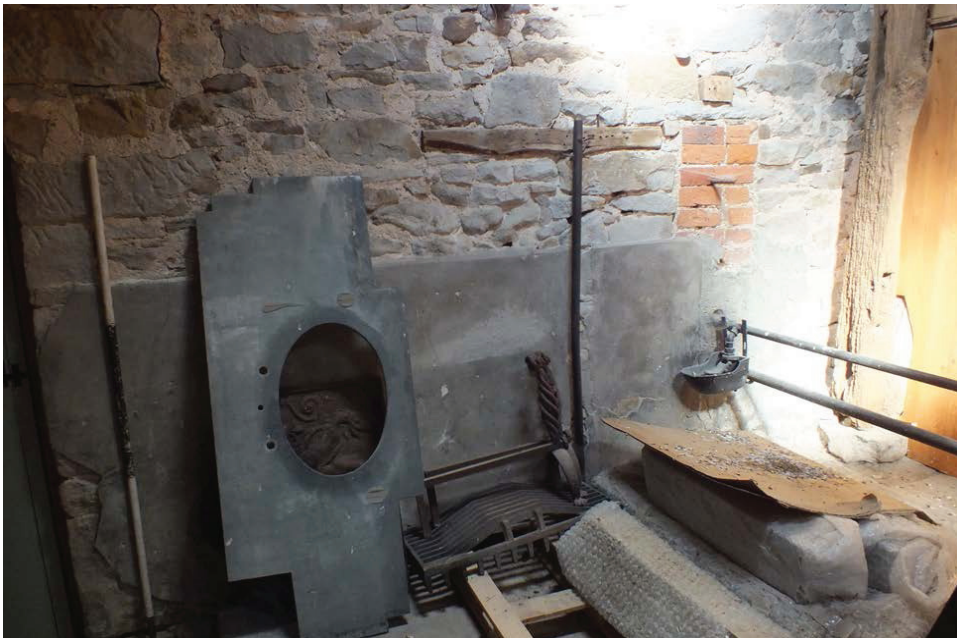
Plate 89 (left): North elevation of Room 4

4.3.9 The north elevation has a concrete skim over the lower part (Plate 89). The doorway on the west side has a stone lintel, with some evident rebuild/repointing above that, and there are quoins on its east side (Plate 87). To the east there is a piece of timber set into the wall, then a blocked vent, filled with handmade brick, with a stone lintel (Plate 89). There are four timber battens/planks attached high on the east side and a plastic pipe through the wall. Electric cable in ducting is also attached and iron tether post, which is attached to a timber batten set into the wall. The east elevation has a large post at the north end, which is the only complete post of the original timber frame on this side (Plate 90). There are slots for braces to the east and also for a brace to the rail above and for the horizontal piece to the south. The north end of the east elevation comprises planks set between posts and rail (as per Room 2; see Plate 91 to Plate 96). The lower part is modern timber with earlier timbers above, with the ends of half trusses meeting the central rail. Four of the earlier early posts remain, not including the complete one at the north end, only the two of which, to the south have surviving angled braces at the top (see Plate 94 to Plate 96; Figure 3) but all have slots for these and the horizontal beam between and hall have been sawn off at about the point where they meet the later horizontal rail. The wall plate above is been jointed with a face-halved scarf joint and is evidently dropping at the south end where it meets the stone wall (Figure 3). There are numerous slots in the underside of the wall plate, further demonstrating the presence of a doorway matching the wagon door in the east side of Room 1. There are three doorways at high level in the planking (e.g. Plate 96), with 20th century hinges and latches, and a double door in the fourth bay, with modern hinges and latch (Plate 94). The southernmost post is boxed in at the base behind further modern planking (Plate 96). The south end of the elevation is stone, but the wall plate continues into this (Plate 99), so the original building was presumably longer, extending further to the south. There is a doorway (to Room 3) on the north side of the stone section, which has clearly been rebuilt, especially around the timber lintel and quoins (Plate 98 and Plate 99) To the south is a row of three openings with machine-cut lintels and sills (Plate 99 and Plate 100), which are overlong to accommodate beaded plank and batten sliding doors.

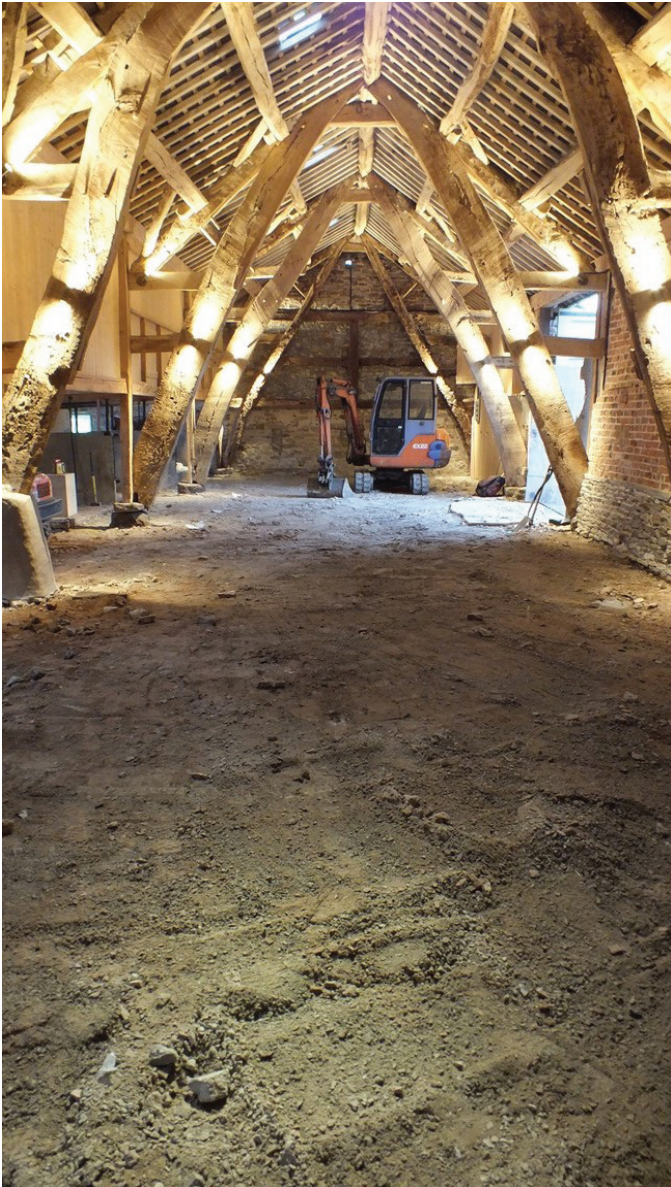
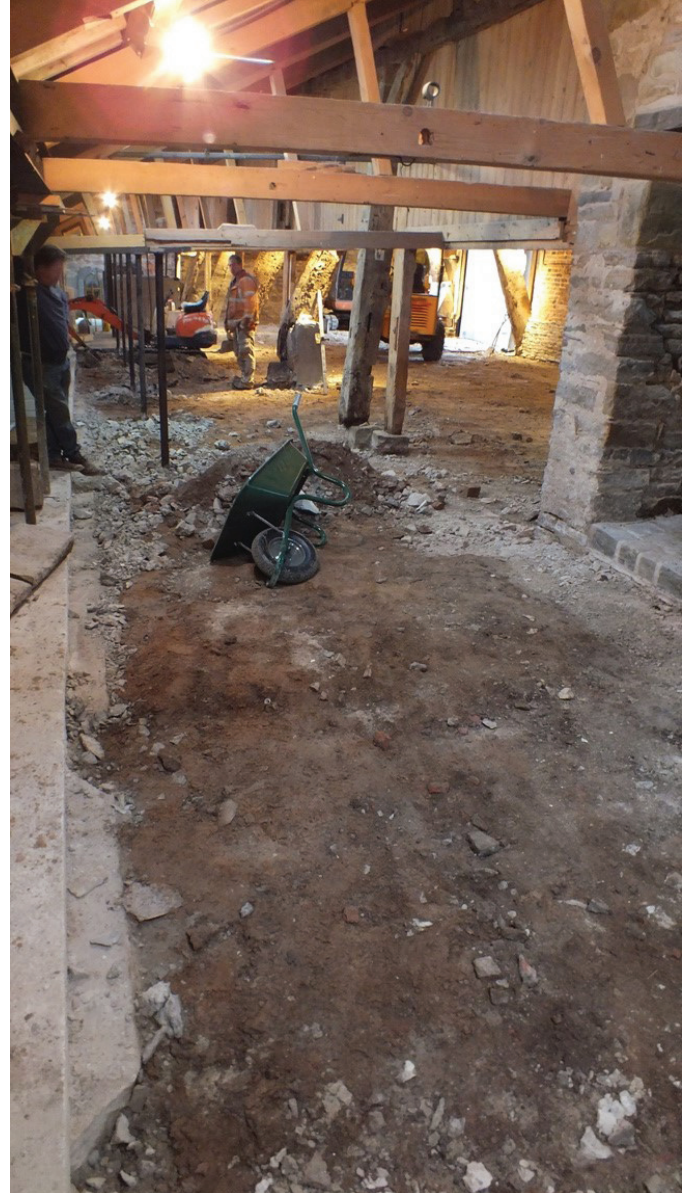
5.1.1 **Interior:** following the lifting of the stone flag floor in Room 2 and parts of the brick and concrete floor in Room 4 all subsequent groundwork was monitored by an archaeologist until the underlying natural deposits were encountered across the site (Figure 6; Plate 104 and Plate 105).

Plate 104 (left): Room 2 after the removal of the stone flag floor

Plate 105 (right): Room 4 after the removal of some of the concrete and red brick floor

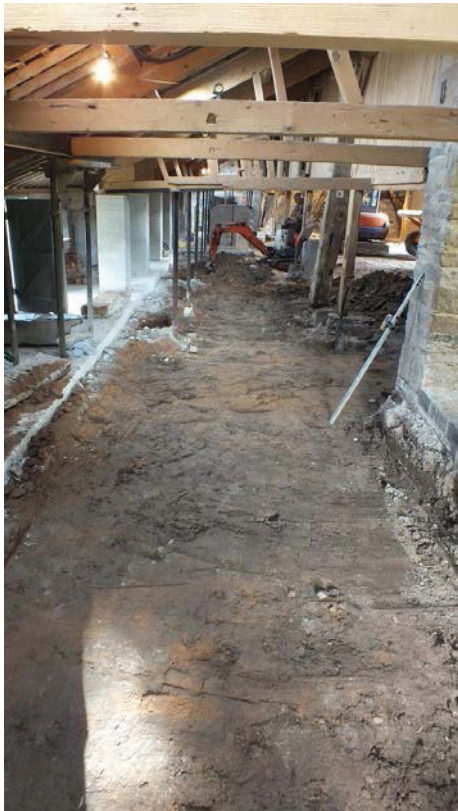
5.1.2 Below the brick and concrete flooring in Room 4 there was a thin layer of light orange sand (**100**) on top of a hard, dark grey-brown clay (**111**) (Plate 106 to Plate 108). This sand was probably brought in as bedding material below the red brick floor, most notably to the north end of the room beyond the line of Room 3 (Plate 106), although a patch of firmer light orange sand was noted in line with the north end of Room 3 in Room 4. In contrast, Room 2 had a coarse, light grey angular gravel (**101**), c0.06m thick on top of the clay natural, although this again was probably some sort of bedding material for the stone flag floor. The underlying clay 'natural' layer was very firm and had very few inclusions. It was noted to be a lighter brown to the north end of Room 2, but it still contained very few inclusions.

Plate 108 (left): General view of Room 4 after excavation to the underlying natural (111)

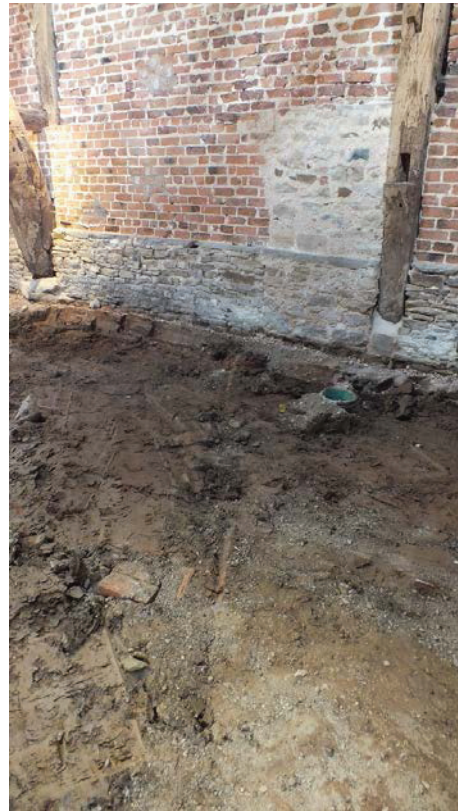
Plate 109 (right): North-east/south-west aligned drain cut, Bay4/5, and loose bricks below Truss 5, Room 2

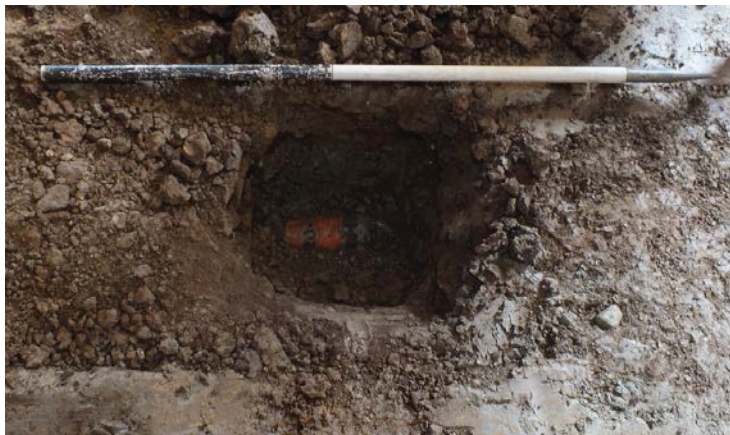
Plate 113: Drain pipe wrapped in plastic at the base of the wide drain cut in Room 2

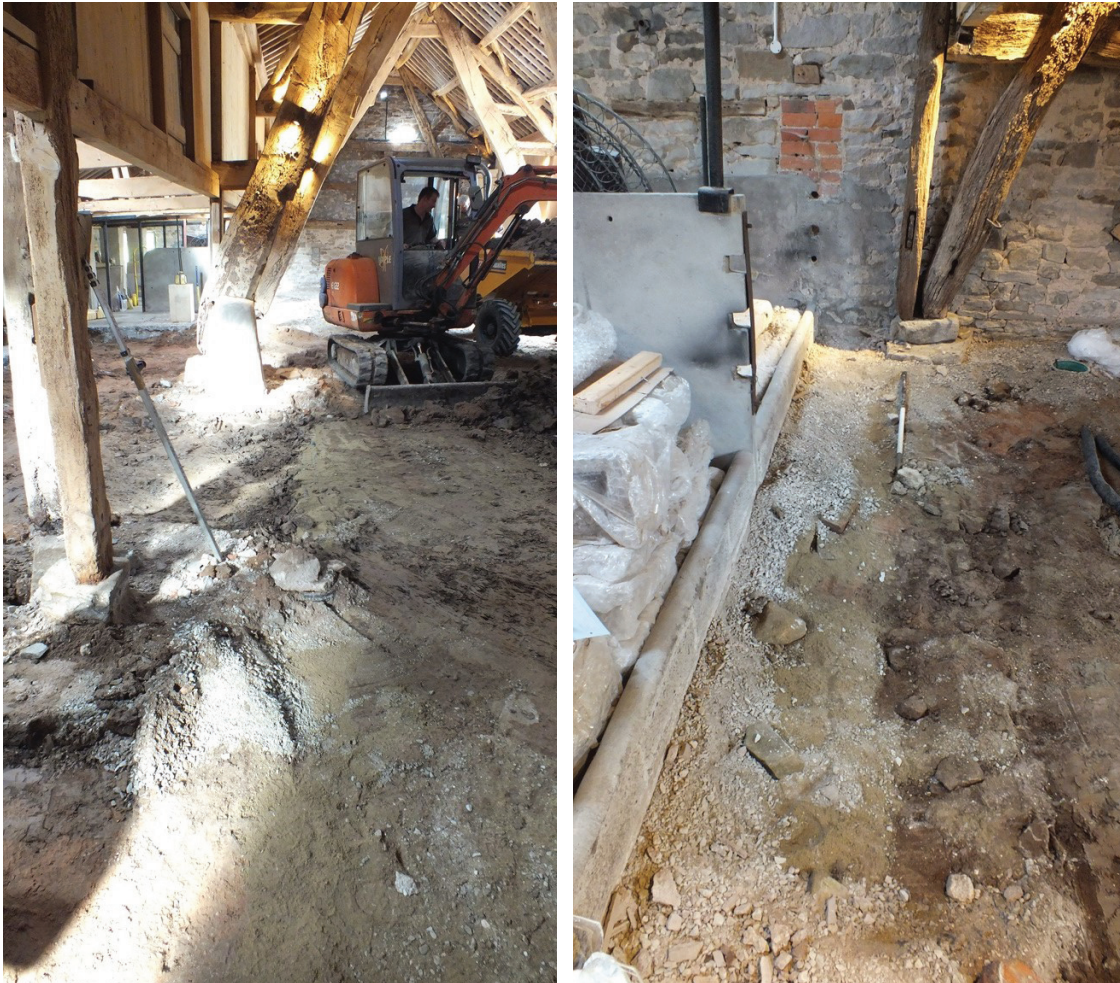
5.1.4 Electric cabling for the floor lights in Room 2 was housed in plastic ducts between each light fitting (the ducts and one of the recesses are just visible to the right in Plate 115). The ducts were in a light yellowish brown, coarse, sand-filled cut (the sandy fill is visible up the centre of Plate 114), forming a loop around the outside of Room 2 with an additional east/west section along the line of Truss 2 at the north end. This east/west section of the trench for the electric cable ducts cut across the wider section of the drain in Room 2 (that the electric cable ducts cut the wider drain cut is apparent on the right-hand side of Plate 117), but to the south end of the room it appeared that the narrower sections of the drain cut across the sandy backfilled trench for the electric cable ducts.

5.1.5 At the north end of Room 4 there was what may have been the remains of a stone floor (**104**; Plate 115), comprising some sub-angular stones or possibly stone setts, which was not apparent elsewhere. This appeared to underlie a coarse sandy deposit similar to that backfilling the trench for the electric cable ducts in Room 2; however, such a small amount remained or was uncovered in this small strip at the north end of Room 4 to the west of the north end of Room 2 that it was a little unclear if these stones did indeed form a surface.

Plate 114 (left): View along the trench for the electric cables connecting the recessed flood lights along the west side of Room 2

Plate 115 (right): Possible stone flooring (104) at the north end of Room 2

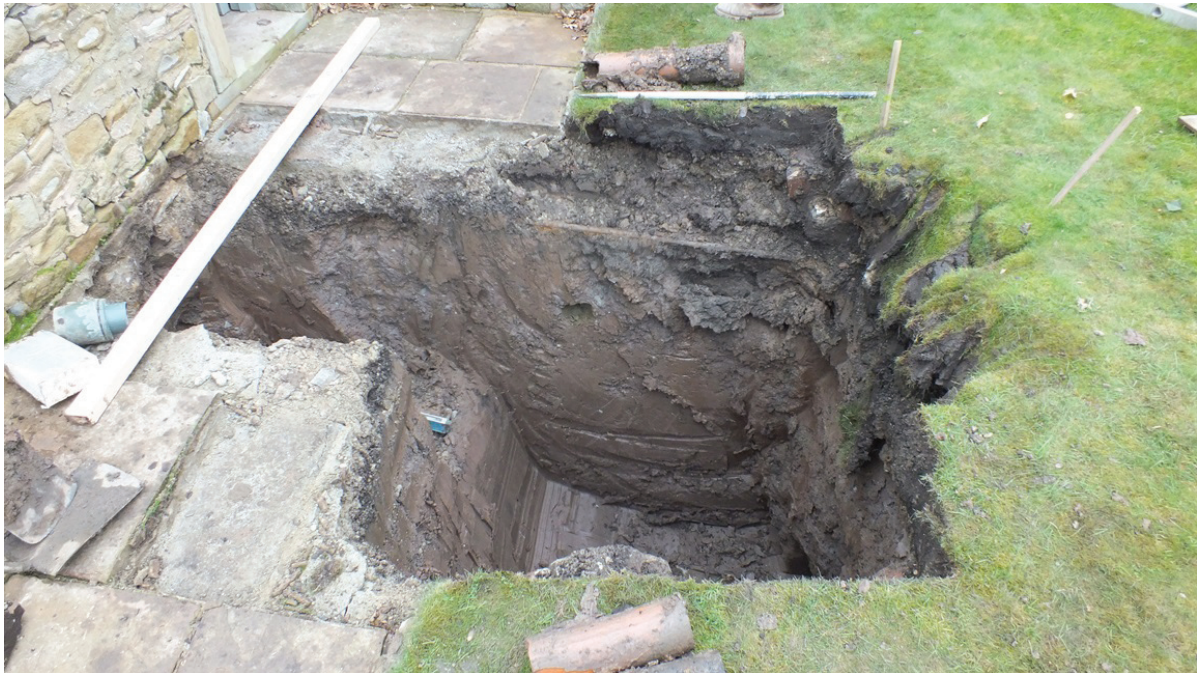
5.1.9 The area excavated across the edge of the path and into the lawn to the south was approximately 2m wide overall, however, a metal pipe was exposed c0.25m in from the east side, below the concrete and gravel, preventing further excavation against this edge (Figure 7; Plate 121). To the west of the pipe an area approximately 1.6m by 1.4m was excavated to a much greater depth. The south edge of the trench was determined by the route of an existing service trench (there were various cables noted across the lawn), the route of which was established between manhole covers visible on the surface. A gravel deposit was noted to the south end of the trench, which was probably in place above the existing services. The rubble layer (**113**) extended to the west edge and there was some plastic sheeting below it in section to the west side of the trench (Plate 122). There was also some flexible plastic piping below that above the older ceramic drain to the east, which possibly patched or reconnected to the older pipe at some stage, but it was now apparently redundant. The clay natural (**111**) was overcut here as elsewhere. The deeper section was excavated to a maximum depth of c2.4m to 2.5m below the level of the lawn to accommodate the new tank. No finds were present.

Plate 121: West-facing section of the trench excavated to the south of the barn
