SEASCALE MILL, SEASCALE, CUMBRIA

Archaeological Building Recording

Client: John Coward Architects

February 2018

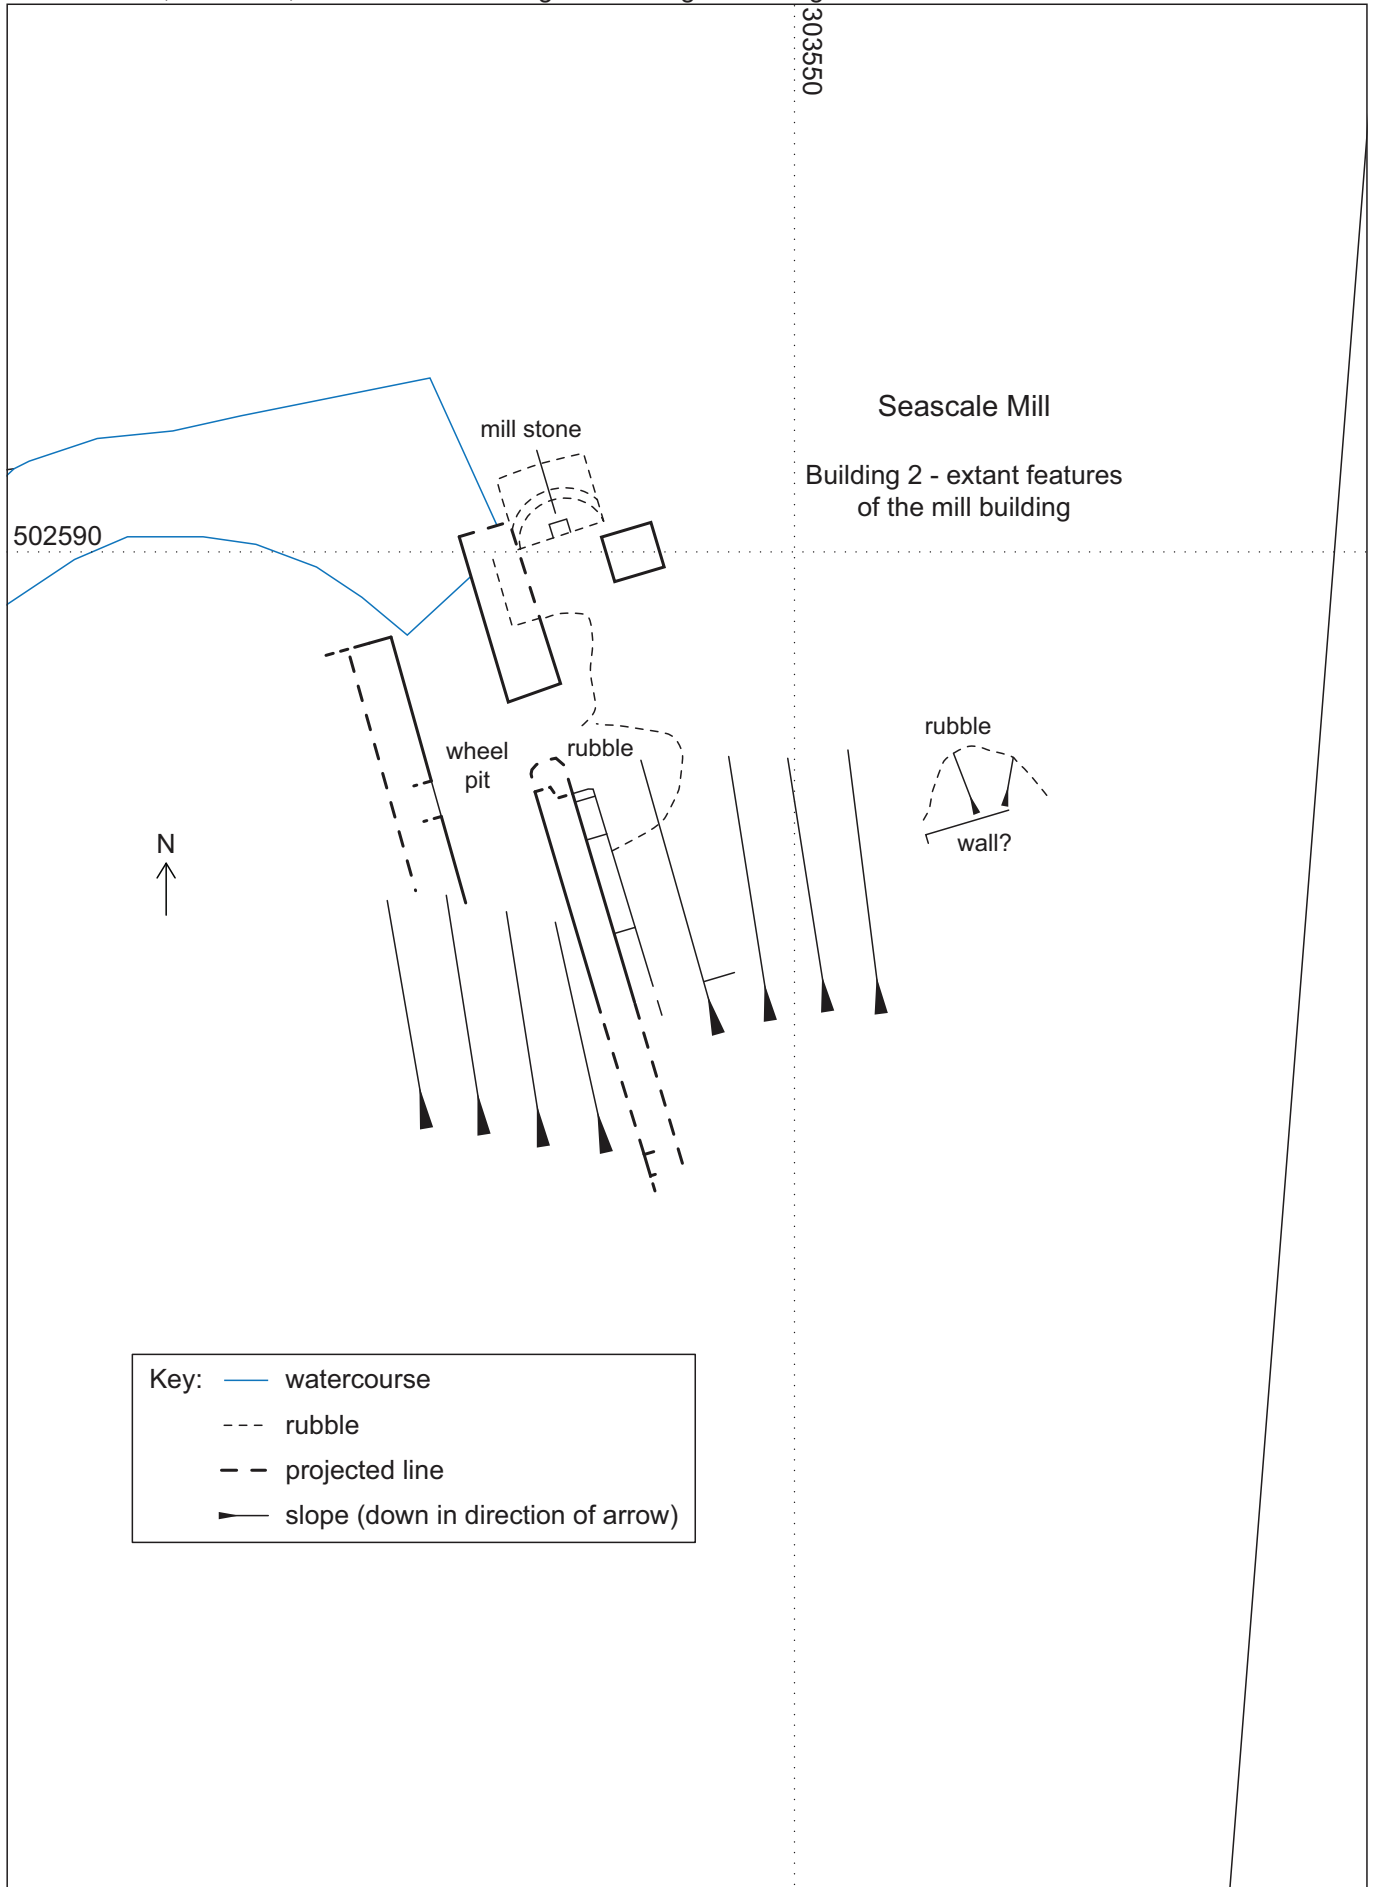
Figure 4: Plan of extant features of Building 2

essentially its present condition. Building 2, however, still had a roof and even some doorways at this time, and has rapidly decayed in the last 30 years.
