SEA VIEW FARM, RINGSTONES LANE, LOWGILL, LANCASHIRE

Archaeological Building Recording

June 2018

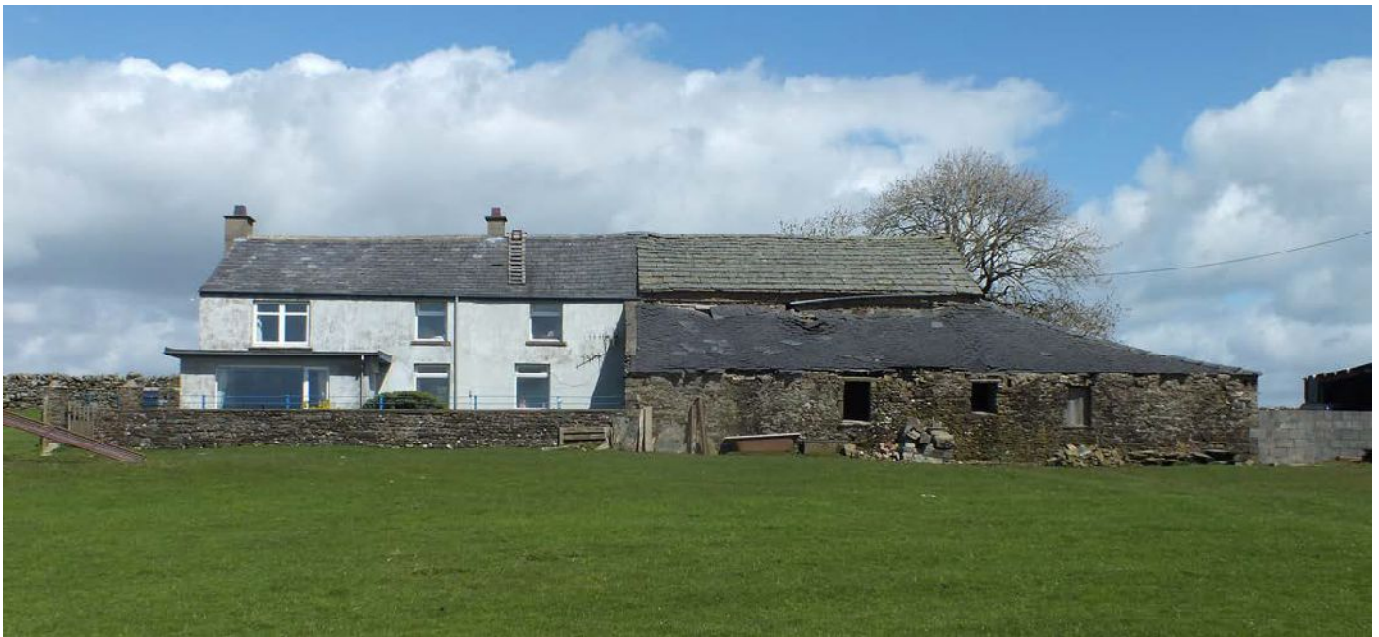
4.1.1 The site comprises an L-shaped shippon (Barns 1 and 2) around the south-west and south-east ends of an earlier barn (Barn 3) with a house at the north-west end (Plate 6 and Plate 7; Figure 1). The shippon is divided into two internally, in line with the end of the earlier barn (Barn 3). The room to the south-west side of Barn 3 is referred to throughout as Barn 1 and the room to the south-east is Barn 2 (Figure 3). Barn 3 is split over two floors with timber haylofts to the north-west and south-east ends.

Plate 6: General view of the barns and house from the south-west

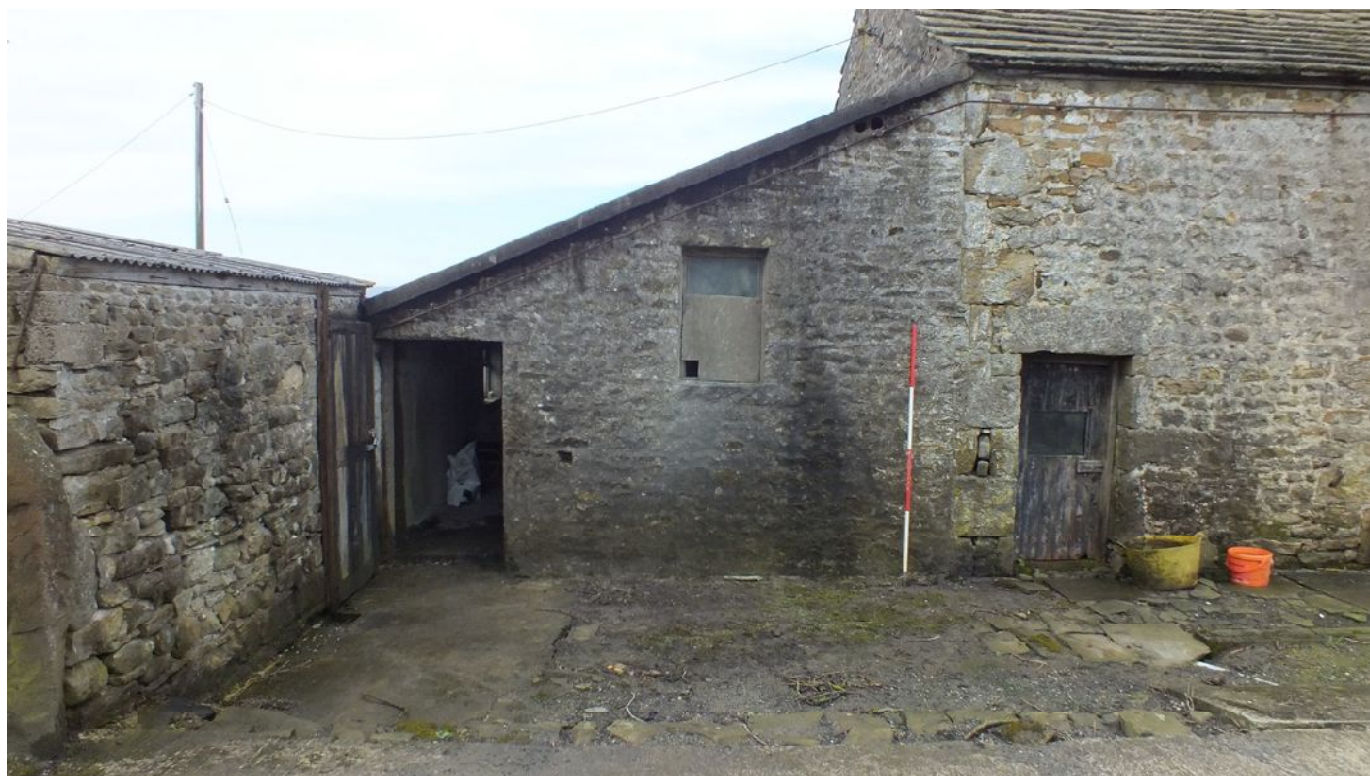
4.2.1 **North-east elevation:** the north-east elevation of Barn 2 is stone-built and the roofline rises from south-east to north-west where it butts the quoins at the south-east corner of Barn 3 (Plate 8 and Plate 9; Figure 2). The south-east end is butted and over-built by a modern redbrick structure, the roof of which slopes down to the north-west over the east corner of the shippon (Barn 2). The outshut has a single window set within a wider aperture, which is partially infilled to the north-west side (Plate 10). The doorway to the shippon (Barn 2) at the south-west end has a concrete lintel and there are possibly quoins in the jambs, but a lot of the stonework on this side is obscured by concrete render. There is a timber doorframe and a timber lintel internally, but no door. The high-level window to the north-west has a stone lintel and sill and timber surround. It was originally a three-light casement, but the bottom two are broken and boarded over. The top of this side of the shippon has a concrete skim and squared concrete edge to the corrugated sheeting. Barn 3 is also stone built, with large dressed quoins in the jambs of both doors (Plate 11; Figure 2). The stonework is mostly exposed with the white lime mortar showing, although there is some concrete render over the top in places. The plank and batten door to the south-east end of Barn 3 has a heavy stone lintel and timber surround and a mid-height frosted light (Plate 12). The central wagon door is a modern timber board door. The stone arch above is covered by board and obscured by concrete render behind that. The north-west end of Barn 3 overlaps the roof of the house and is slightly taller than the building to the north at the gutter line. Internally, it appears to butt the house, but this relationship is unclear outside where it is painted over. The roof of Barn 3 is stone flags and there is some repointing below the roofline.

Plate 8: North-east external elevation (Barn 2)

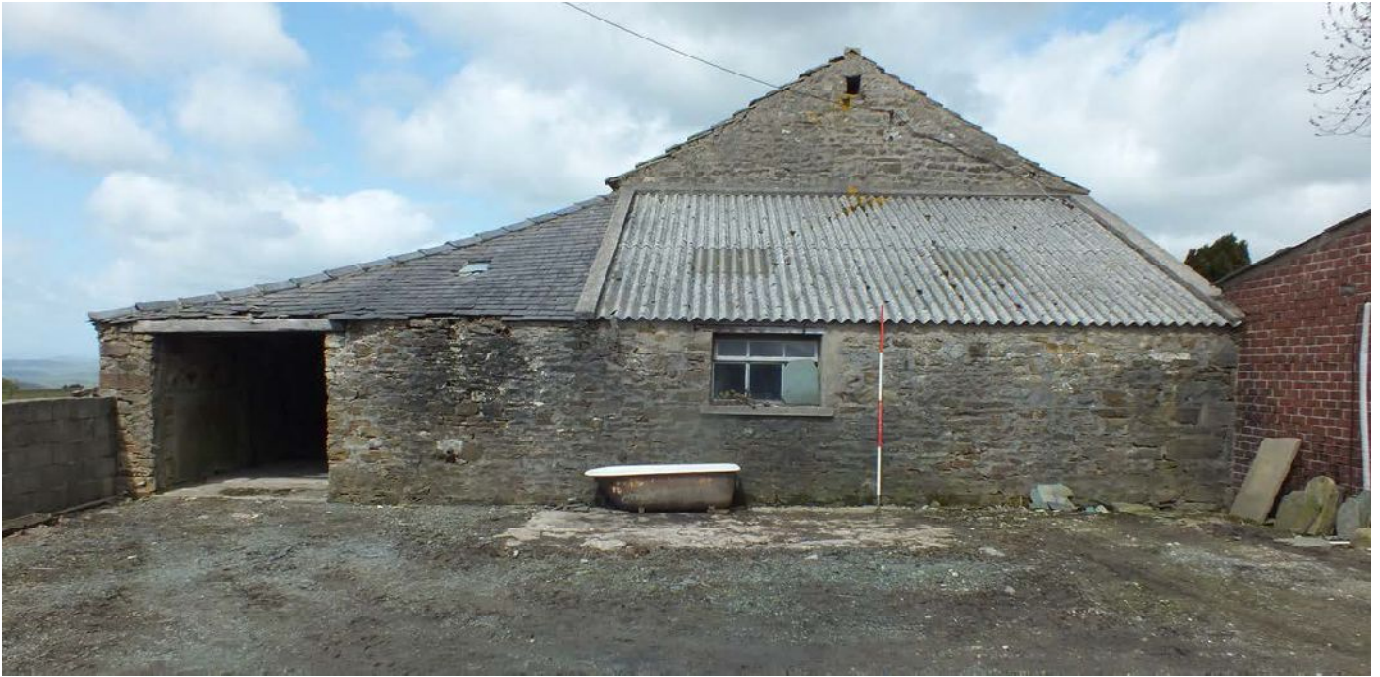
4.2.2 **South-east elevation:** the roof is slate above Barn 1 to the south-west and corrugated sheeting above Barn 2 to the north-east end (Plate 13). There is a frosted glass skylight to the south-west above Barn 1 and concrete edging to the corrugated sheeting on Barn 2. The stonework of the south-east end of Barn 3 is visible behind, although it is partially concrete rendered over. Barn 3 to the rear has a central owl hole at the top, with a stone lintel and sill, and a stone finial capping the stone flags on the roof. The shippon wall is stone-built and concrete with some re-pointing, especially to the north-east end. The wall is continuous across Barns 1 and 2 and there are quoins at both ends of the elevation (Figure 2). There is a wide wagon doorway to the south-west end (to Barn 1) with a heavy timber lintel and remnants of a timber surround but no door (Plate 14). The roughly central window to the north-east has a thin timber lintel and concrete sill (Plate 15). The window is top-opening, with a hinged casement (three-over-three) and timber surround. The north-east end of the elevation is butted and partially obscured by a modern redbrick structure with a sloping corrugated sheet roof (Plate 16).

Plate 13: South-east external elevations of the barns

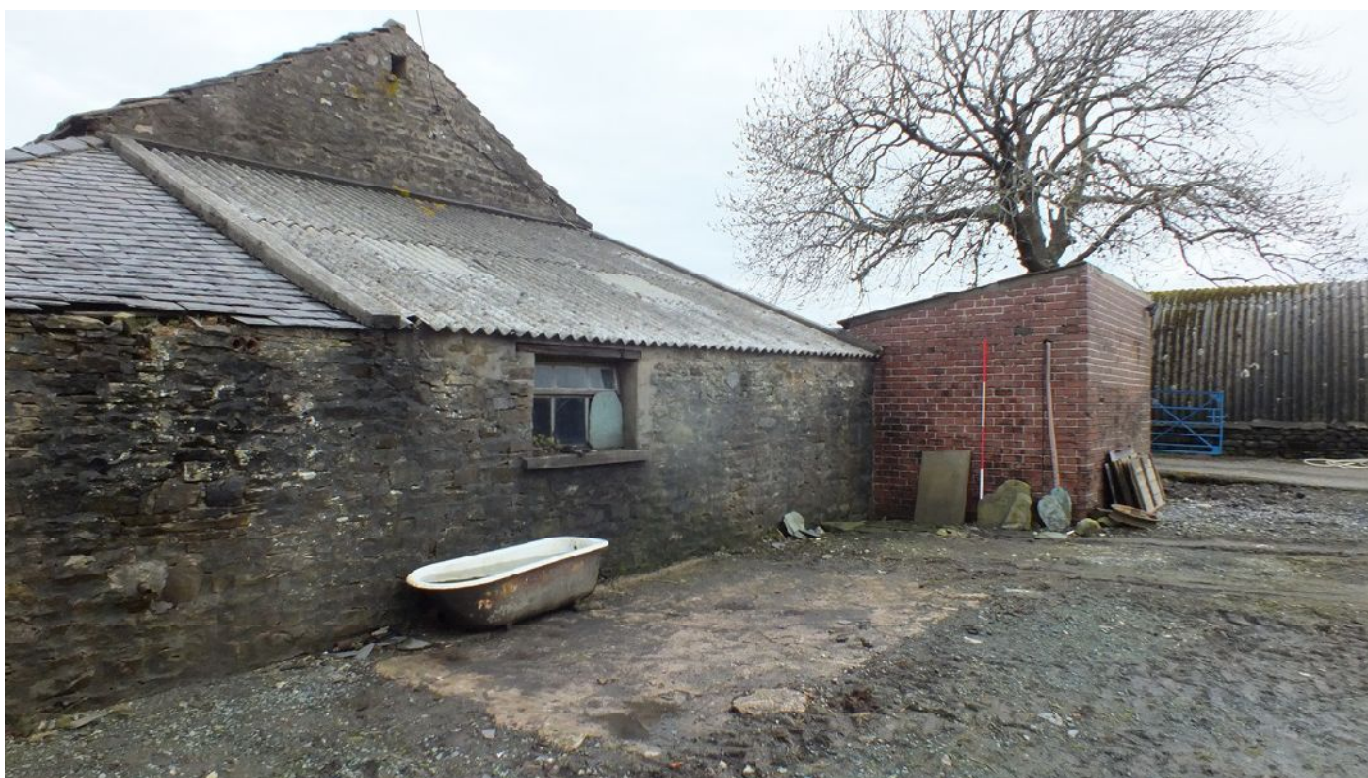
Plate 16: Outshut against the south-east external elevation of Barn 2

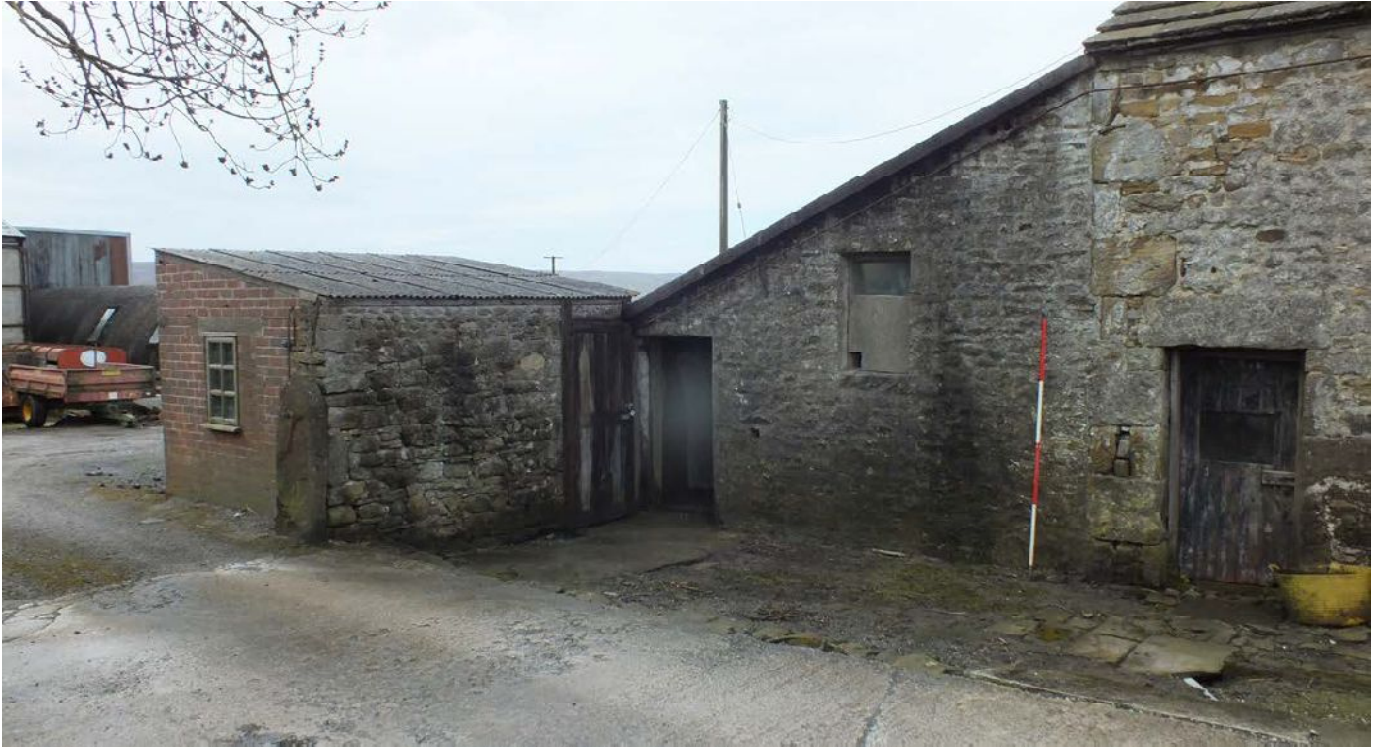
4.2.4 **North-west elevation:** the outshut is visible to the north-east side of the house from the north-west. A stone wall extends from the east corner of Barn 2 to form its north-west elevation and the corrugated sheet roof is visible above (Figure 2; Plate 21 and Plate 22). The lintel of the door to the outshut overlaps the shippon (Barn 2) to the south-west. Internally, this wall is skimmed with concrete. The gutter line of Barn 3 is slightly taller than that of the house on both sides and the stone roof of Barn 3 overlaps the slates on the roof of the house on the north-east side. The pitch of roof of Barn 3 is slightly shallower than that of the house as the overall height of the roofs is approximately the same. The space above the line of the roof of the house to the barn roof is concrete rendered over. The north-west

Plate 21: Outshut to the east side of the barns

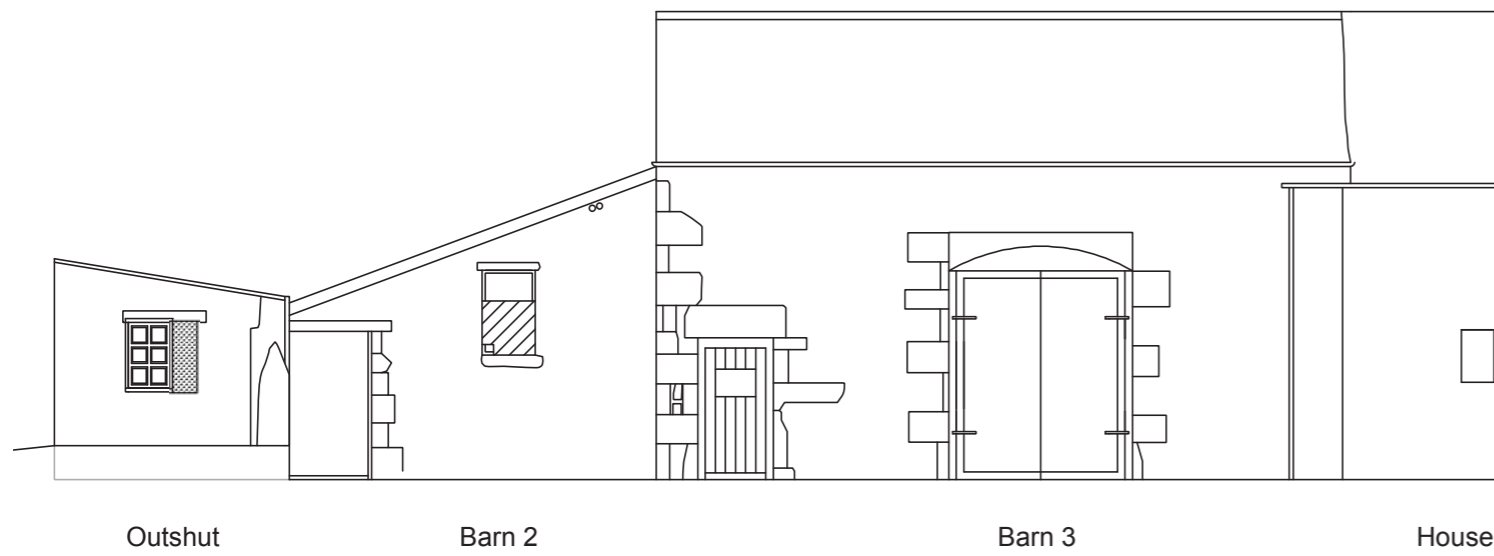
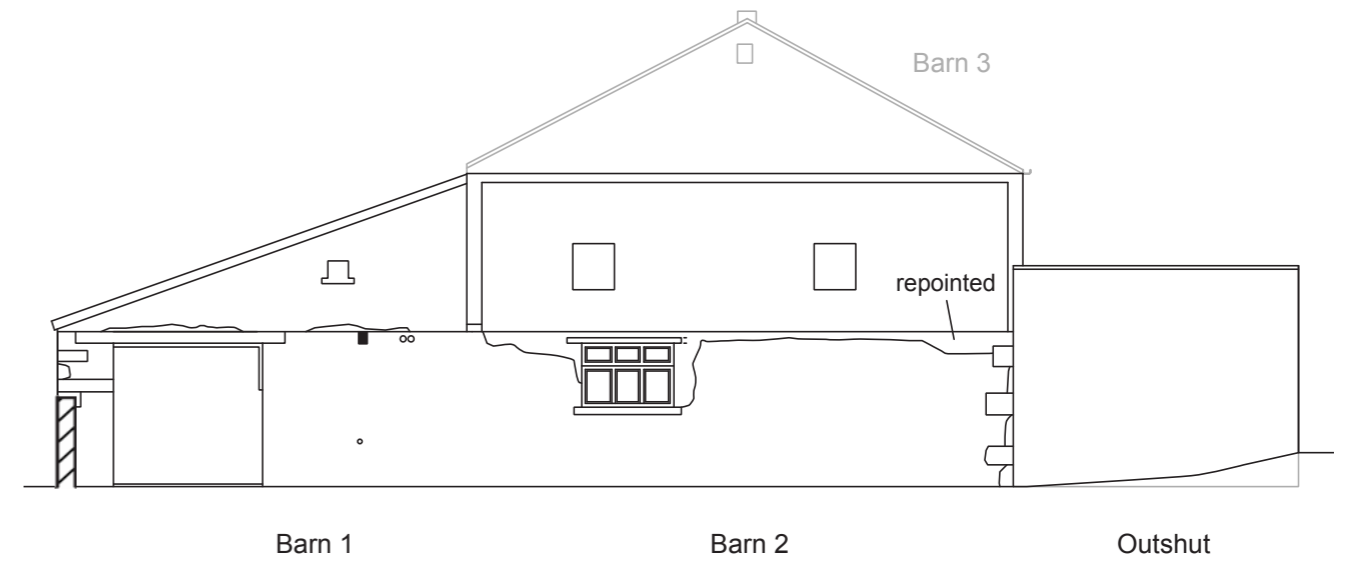
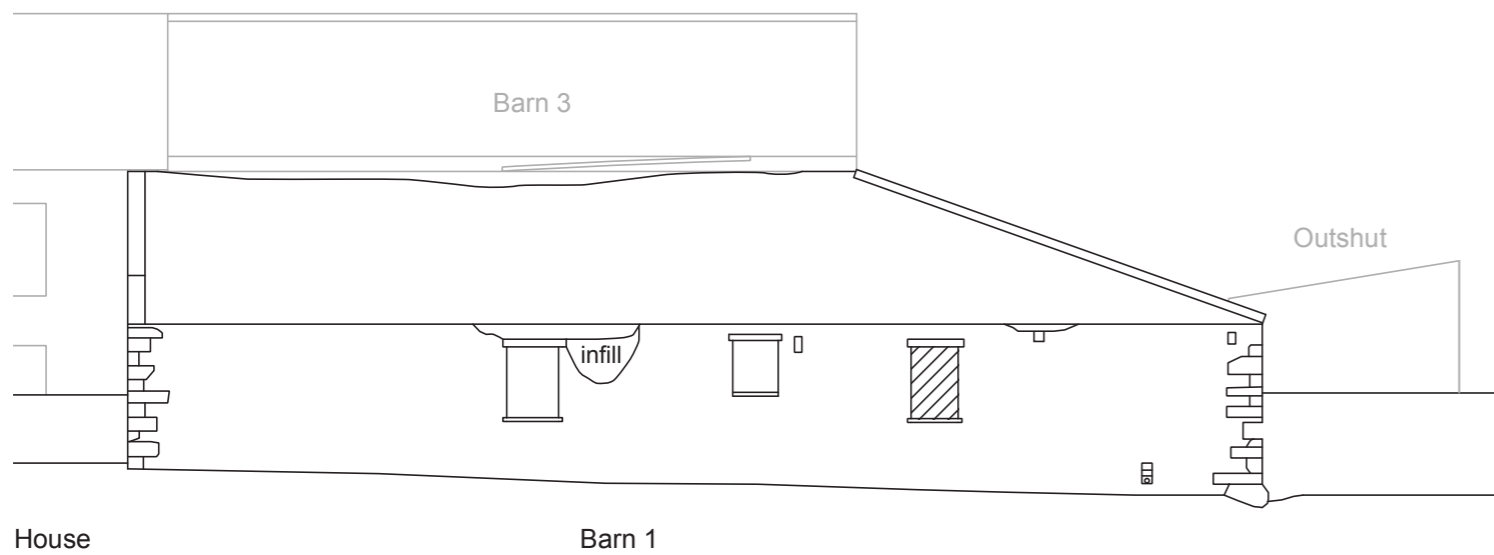
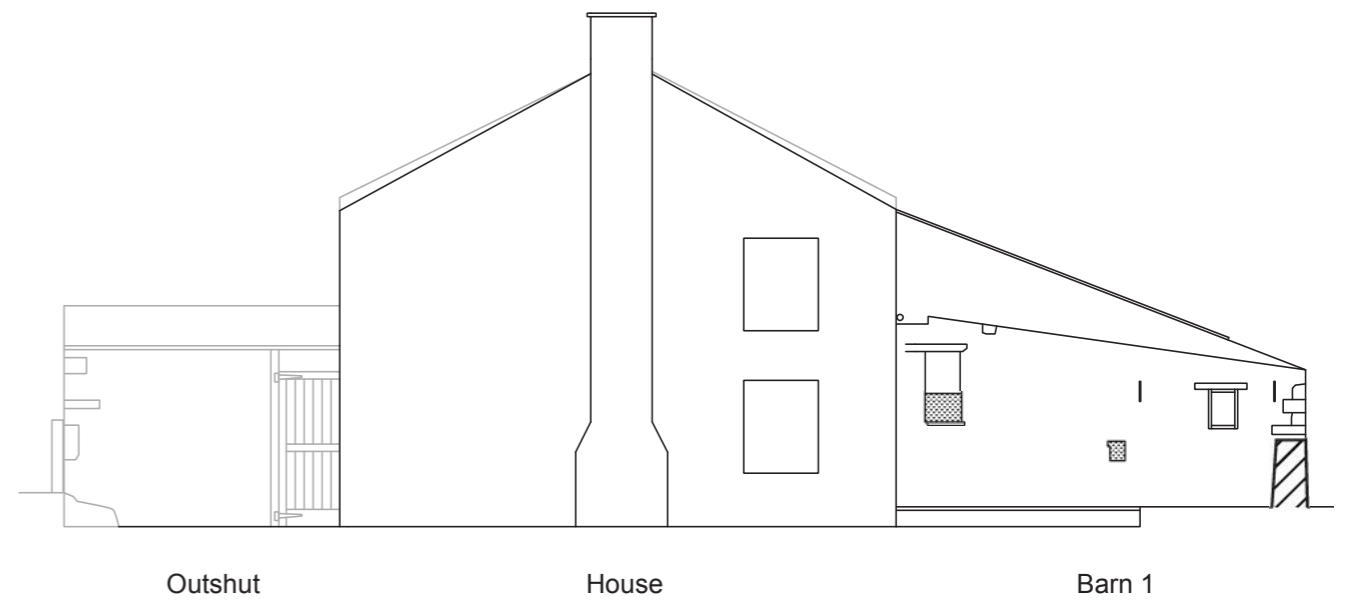
Figure 2: External elevations

4.2.3 **South-west elevation:** the south-west elevation is entirely stone-built with quoins at both ends (Plate 17; Figure 2). The slate roof of this end of the shippon (Barn 1) has a concrete edge to the north-west end and ridge tiles to the south-east at the corner. Barn 3 is visible above with a concrete skim and stone roof above. The shippon (Barn 1) extends slightly beyond Barn 3 to the north-west and parts of the roof of the shippon (Barn 1) and some of the stonework has collapsed, notably along the top at the front

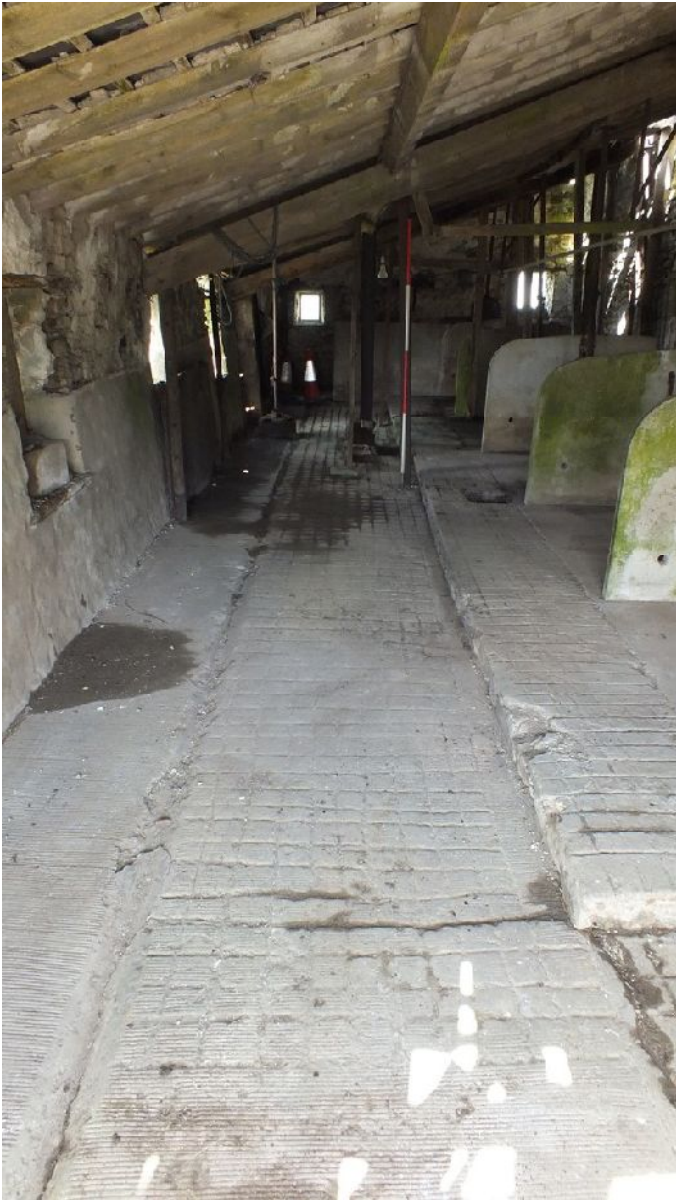
Plate 26 (left): Gridded concrete in the dung channel along the south-west side of Barn 1

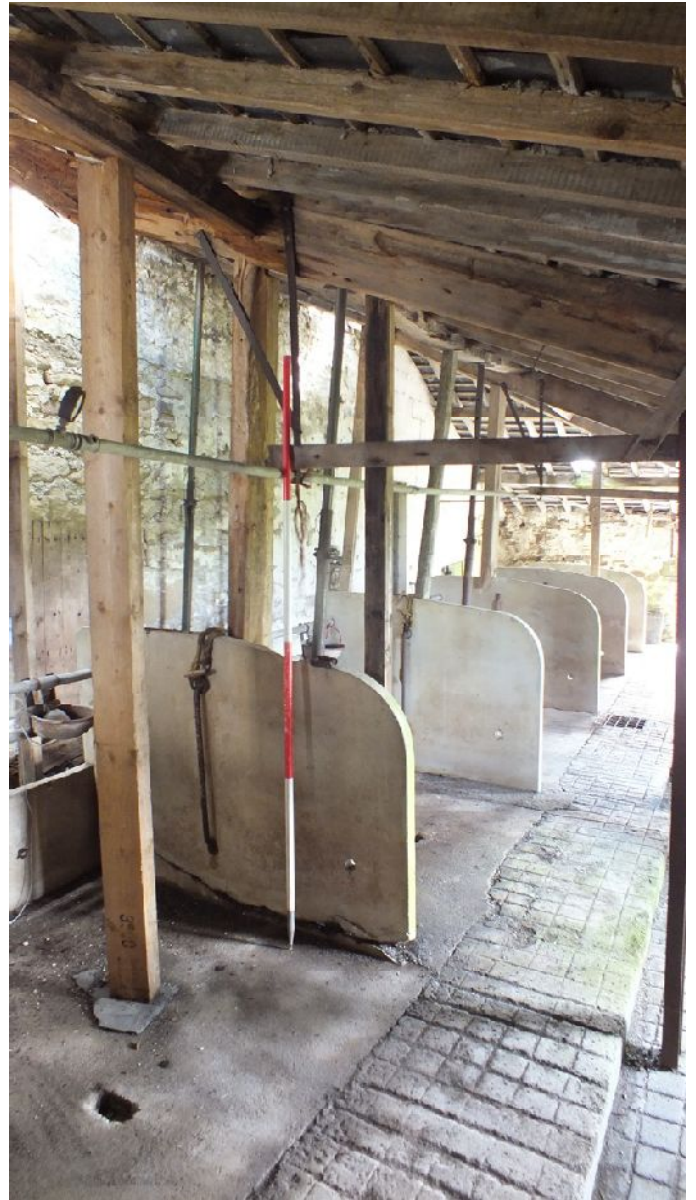
4.3.1 **Barn 1:** Barn 1 comprises a large rectangular room, aligned north-west/south-east to the south-west side of Barns 2 and 3 (Figure 3). The mono-pitched roof slopes upwards towards the side of the other two barns (Figure 5) and the machine-cut timbers and slates are exposed (Plate 25). The roof is supported by two timber beams, aligned north-east/south-west, so the barn is effectively split into three bays from south-west to north-east. There are several metal props and additional timber and I-beam supports in place at the north-west end of the room in particular. The floor is a mix of grid-pattern and plain concrete, with a feed passage along the north-east side and a lower dung channel to the south-west side (Plate 26); both the feed passage and concrete stalls are raised relative to the dung channel. There are five stalls with troughs and tethering posts (Plate 27) and a low, modern redbrick wall partition at the north-west end of the most northerly stall.

Plate 27 (right): General view of the stalls in Barn 1

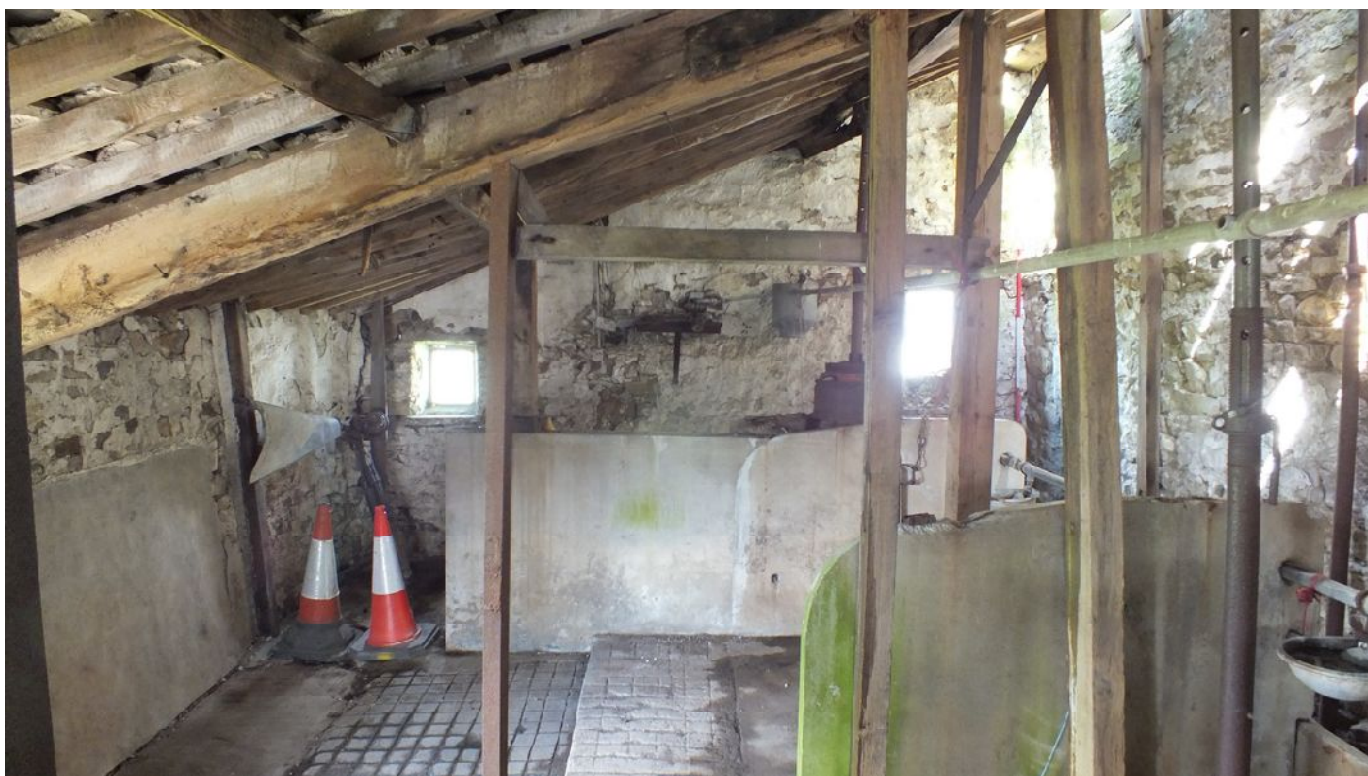
Plate 28: Low redbrick partition wall at the north-west end of Barn 1

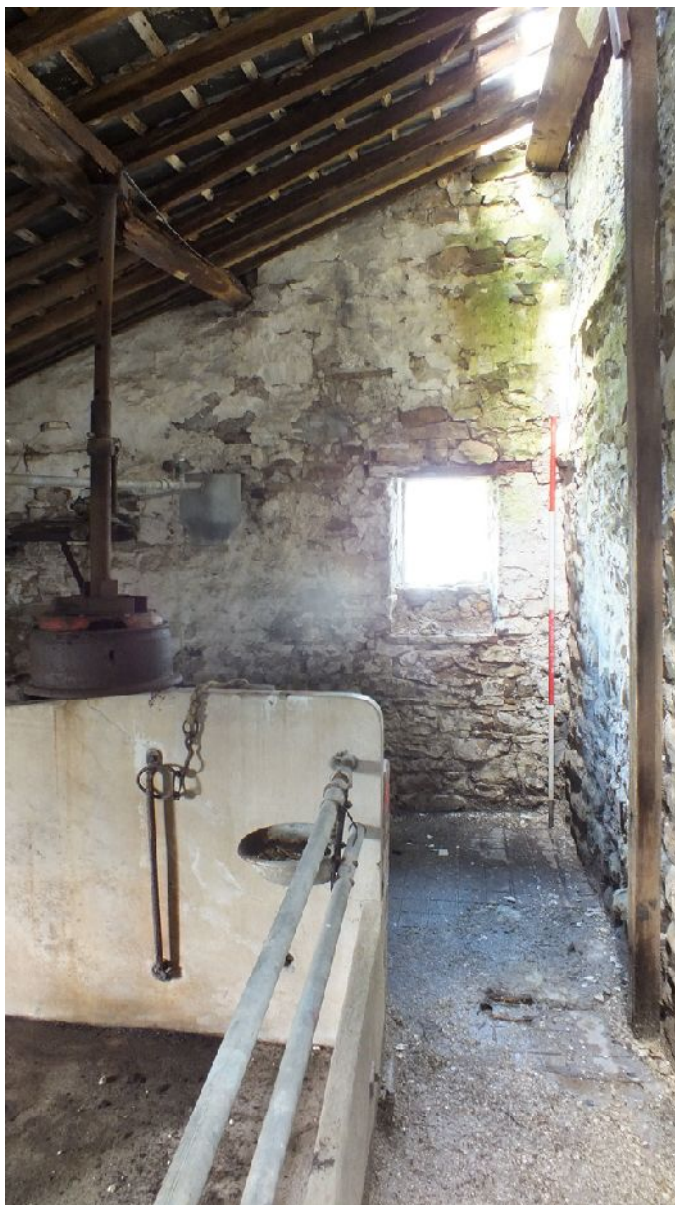
4.3.2 The north-west elevation is mostly exposed stone with some white plaster remaining (Plate 29). There are two window openings, both with stone sills and lintels (Plate 29). The one to the south-west has a single-light timber casement (fixed) (Plate 29) and the other is part blocked with stone and has no window frame (Plate 30).

Plate 30: North-east end of the north-west internal elevation

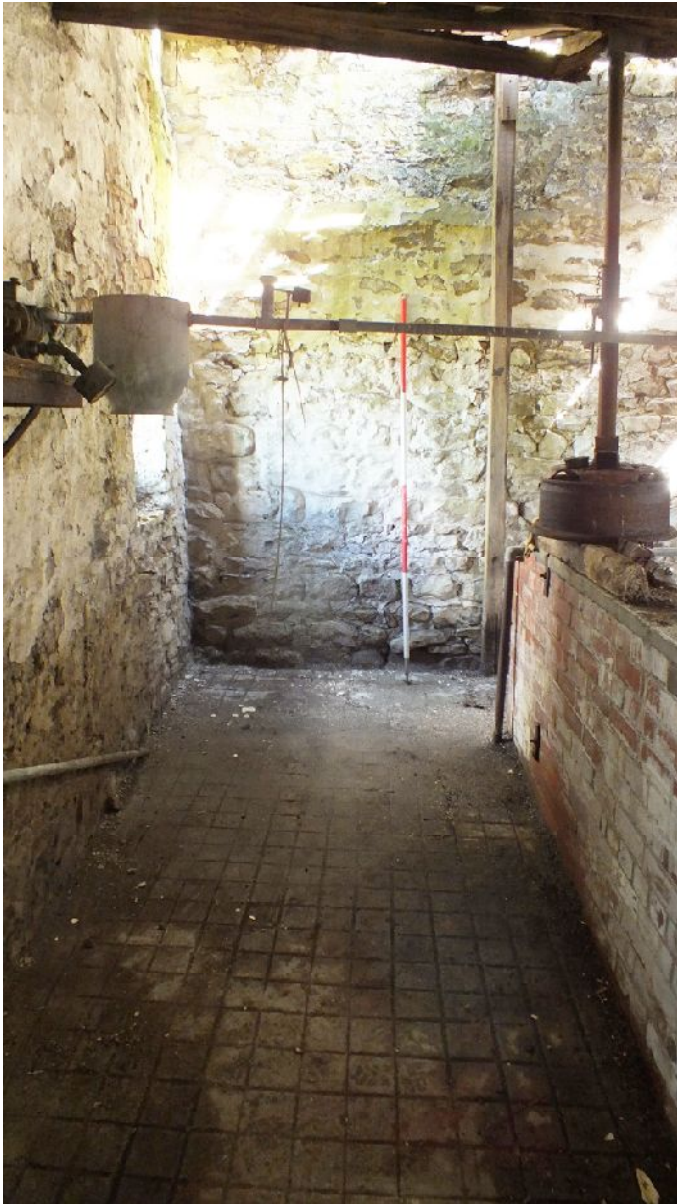
4.3.3 The north-west end of the north-east elevation is stone and white plaster (Plate 31 and Plate 32). This section corresponds to the original outside wall of the earlier barn (Barn 3) before the addition of the L-shaped shippon (Barns 1 and 2). The feed passage runs along this side of the room (Plate 33). The old plank door to Barn 3 has a stone surround with chamfered quoins in the jambs and a stone lintel (Plate 34). The alcove to the south-east of that has a stone sill but the lintel is obscured. There is a prominent ridge along the north-east elevation at a high level, which probably corresponds to the original height of the shippon (Barn 1). The raised section is obvious on the north-west external elevation (see *Section 4.2.4* above). The end of the earlier barn (Barn 3) has quoins and some brick infill and the elevation to the south-east of that steps back to the north-east and is finished with concrete blocks (Plate 35 and Plate 36). The plank and batten stable door against the end of Barn 3 has a timber surround and concrete lintel (Plate 37). The concrete blocks are painted white, with a small area of concrete skim past the gate to the trough at the south-east end. The door at the south-east end has a timber lintel and a plank and batten door with long strap hinges (Plate 38).

Plate 31 (left): North-west end of the north-east internal elevation of Barn 1

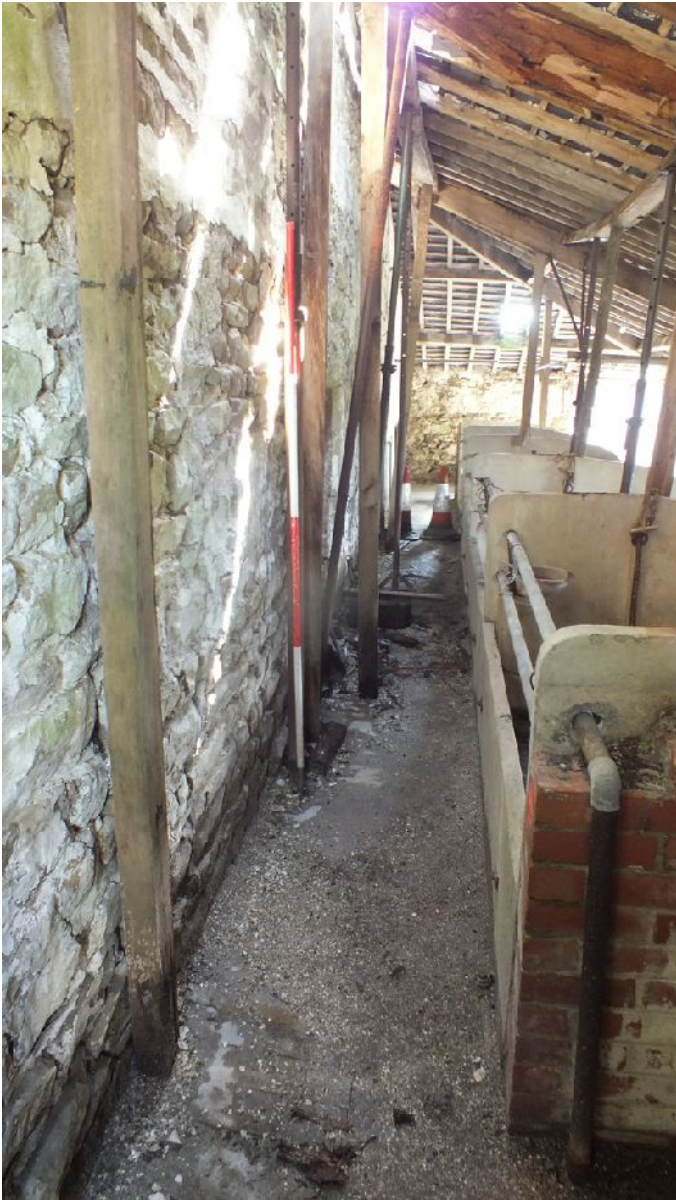
Plate 33 (left): Feed passage along the north-east side of Barn 1
