# FORMER TOLL HOUSE, DALTONGATE, ULVERSTON, CUMBRIA

## Archaeological Building Recording

June 2021

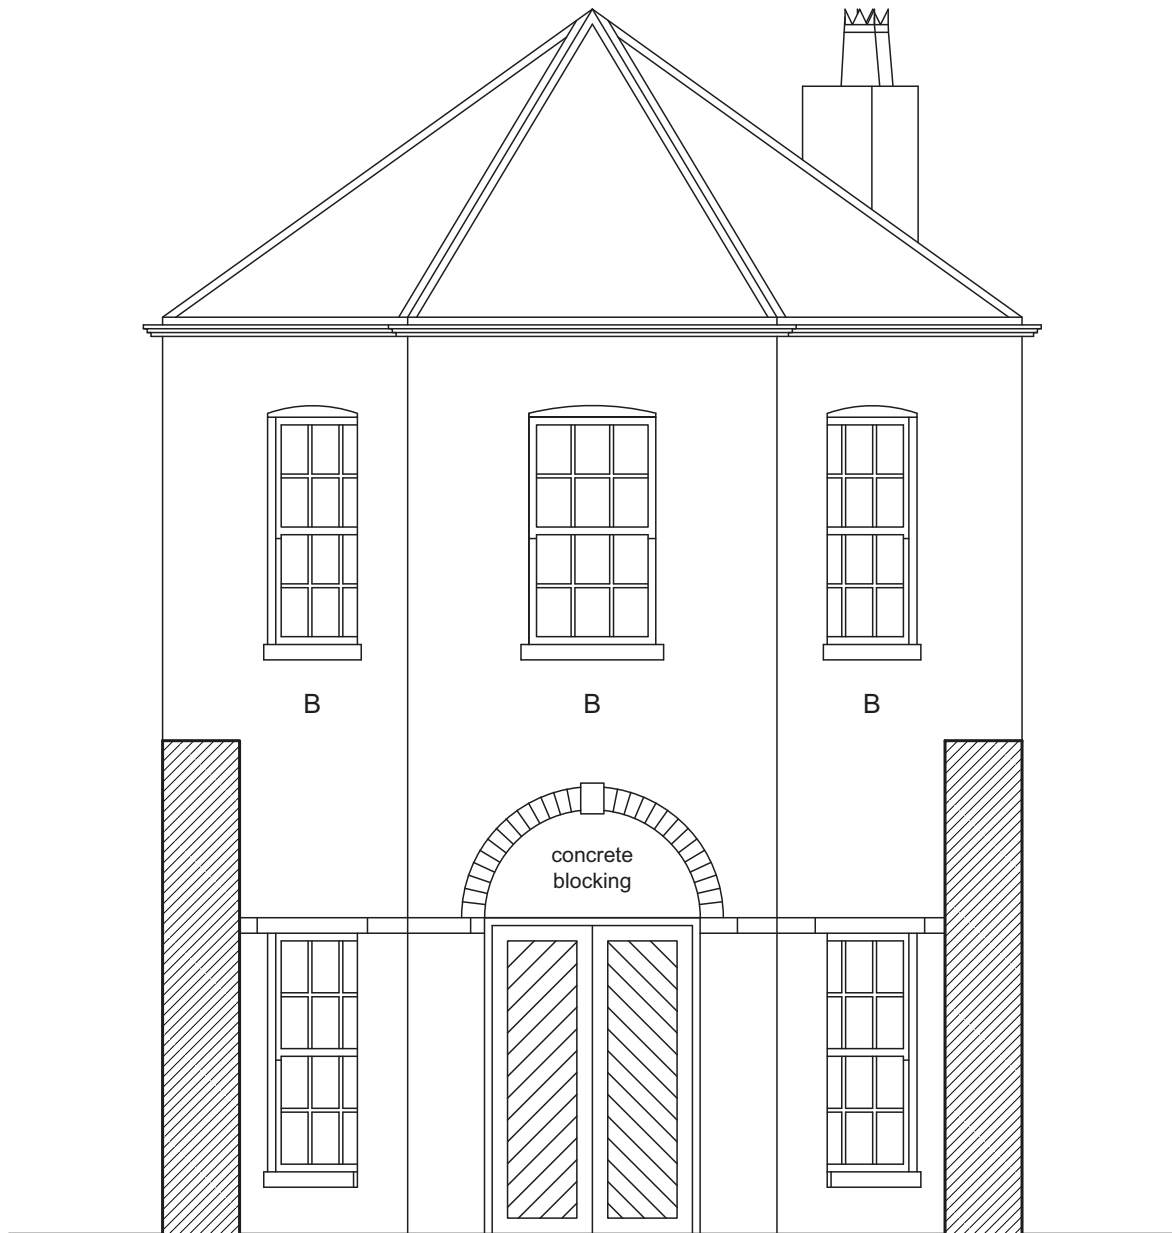
Figure 2: North-east external elevation

**4.2.3 North-east external elevation:** this is the front and comprises three sides of the hexagonal plan. The ground floor has a central doorway with a semi-circular arch over constructed from voussoir stone with a projecting key stone (Plate 16). The space below is now filled and finished with a rough skim of concrete. There is a double door below of fairly recent plank and batten construction with fairly plain diagonally-set planks and modern handles. A stone string course forms the lintel of a pair of flanking windows, both of which have concrete render over the jambs and 12 light (six over six) sliding sash casements with horns. The first floor is of brick construction but largely finished with a painted coat of what is probably thick limewash. There are three windows, one per face, all in the same style as those on the ground floor but with flat brick arches. The north-west window is blind or blocked and the casement painted onto the shallow reveal and the tall boundary wall adjoins the north-west side (Plate 17).

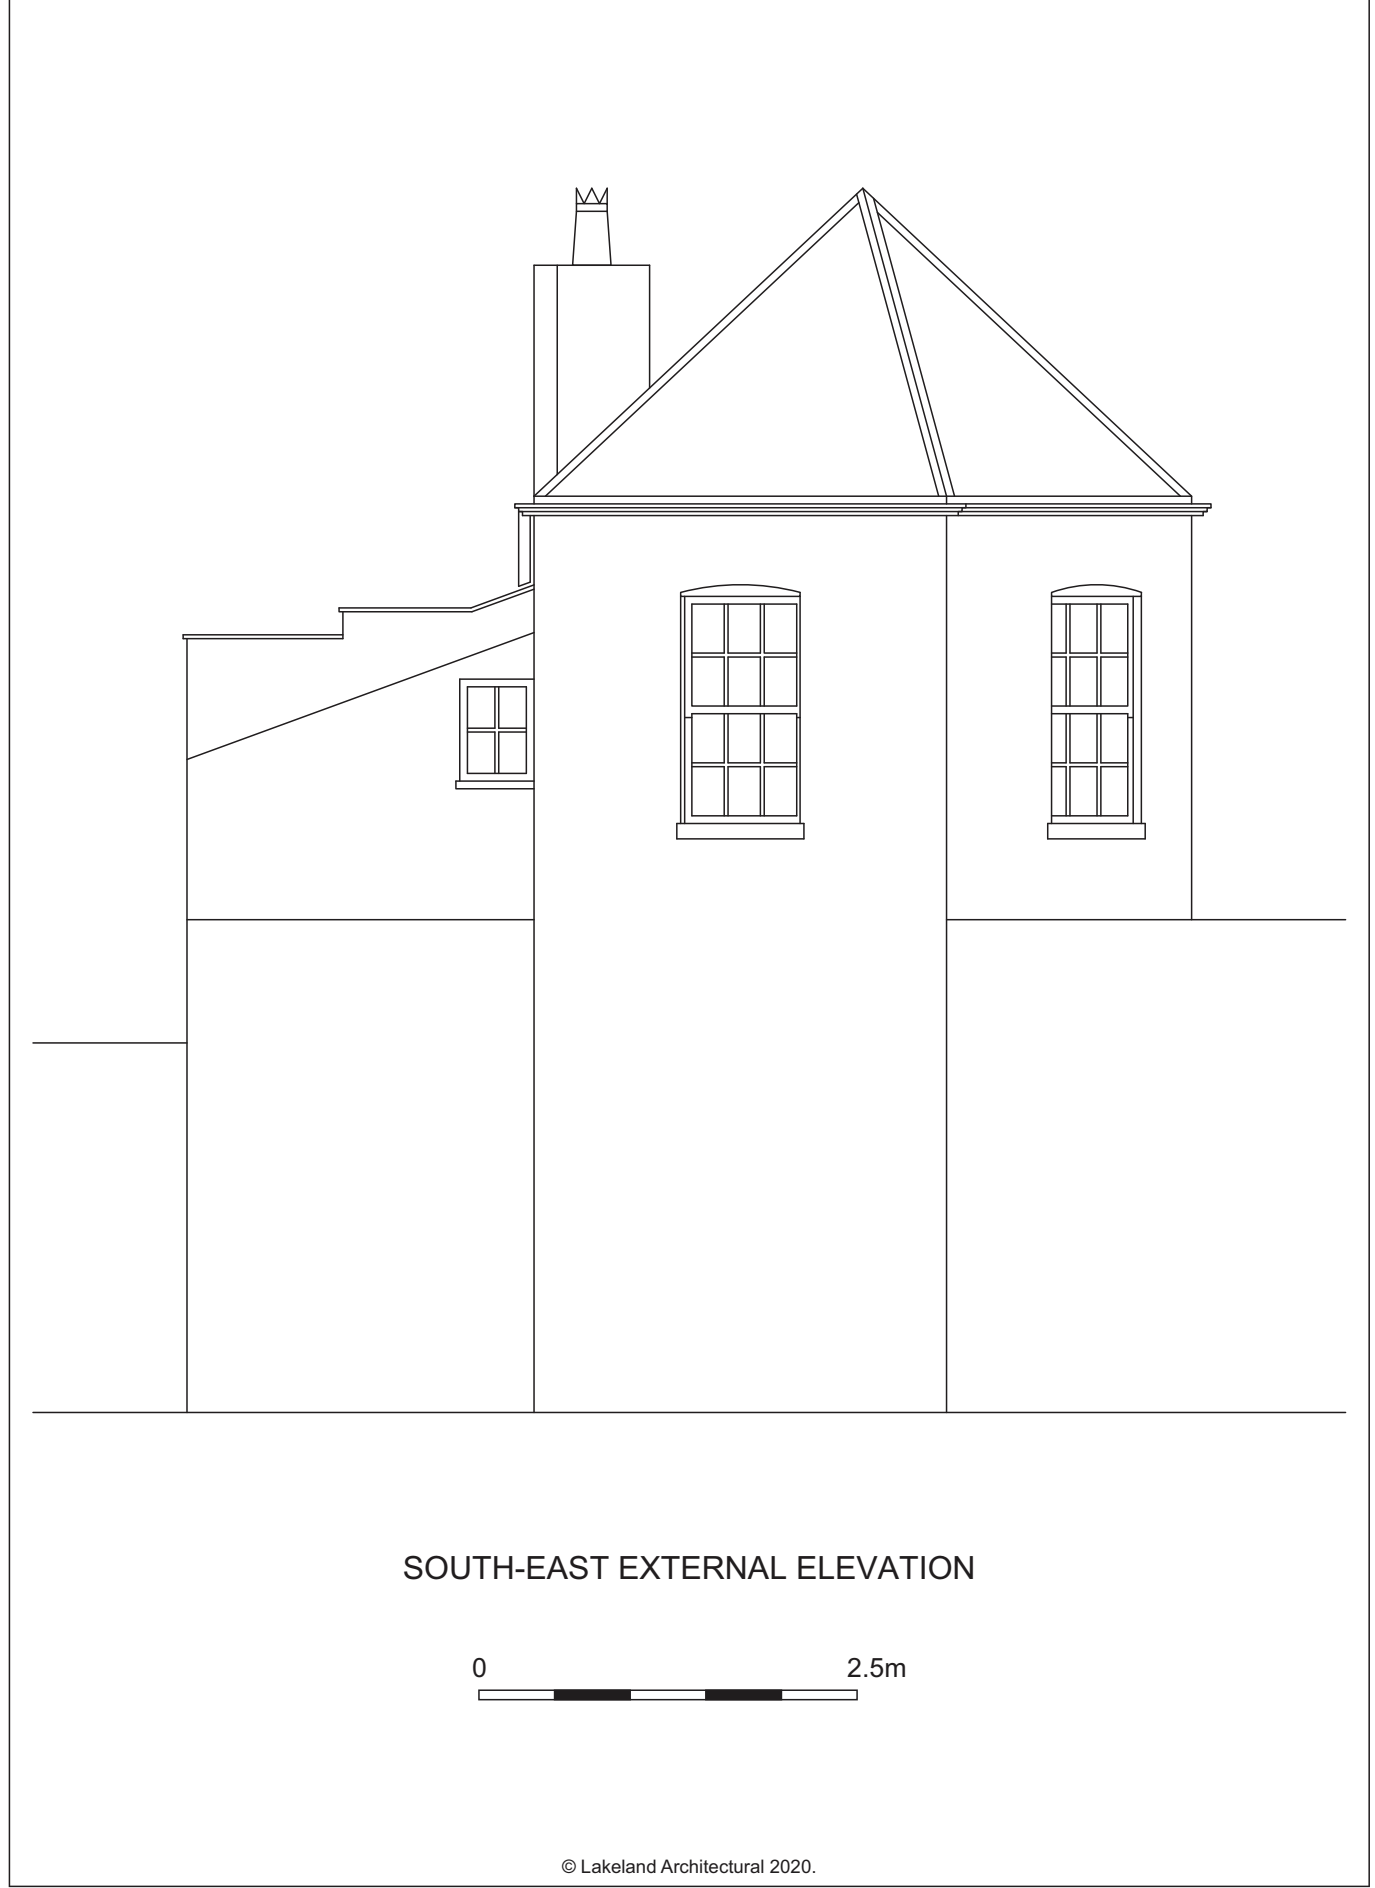
SOUTH-EAST EXTERNAL ELEVATION

**4.2.4 South-east external elevation:** this was not accessible due to the adjoining property but was evidently exposed brick at first floor level (Plate 11), with a single window as per those to the north-east. It is continued by the side of the triangular section to the rear of the building, which has a small four-light window with a fixed casement at first floor level and is finished with smooth painted render.

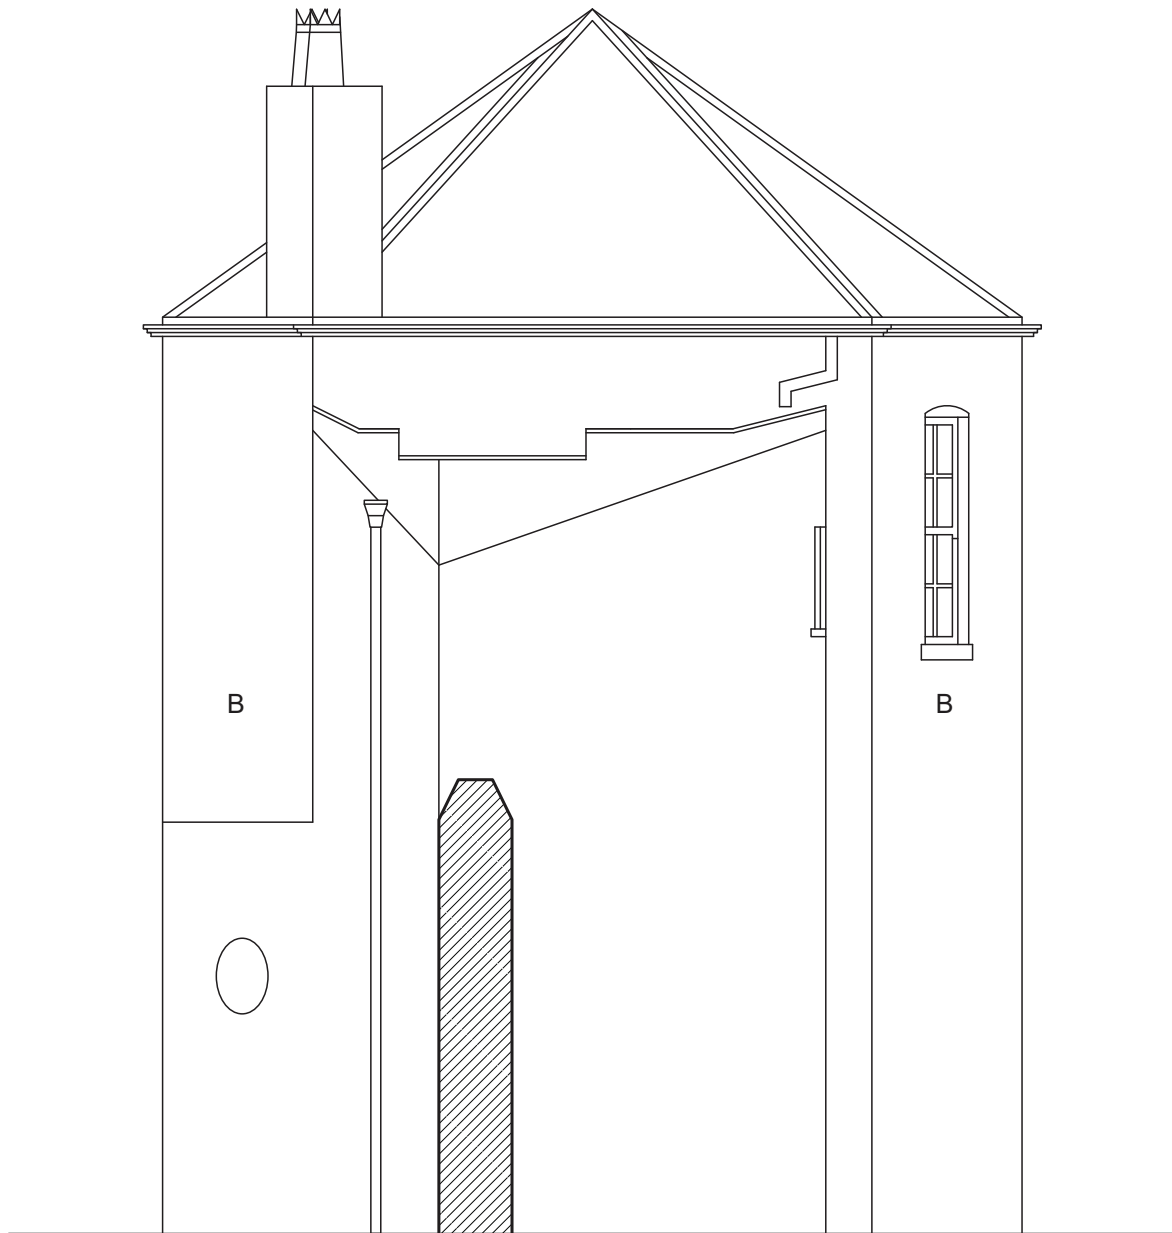
Figure 4: South-west external elevation

4.2.1 **South-west external elevation:** this is partly obscured by an adjoining boundary wall and not fully accessible due to the adjoining property's yard (Plate 11). The projecting triangular section has flag stones along the top of a parapet above the roof proper, which incorporates a lead gutter connecting to a downpipe into the street. There are roughly dressed quoins at the corner of the triangular section and an early, probably lead, downpipe from the moulded iron gutter along the main part of the roof.
