SINKFALL FARM, RAKESMOOR LANE, BARROW-IN-FURNESS, CUMBRIA

Archaeological Building Recording

Client: Brian Armistead

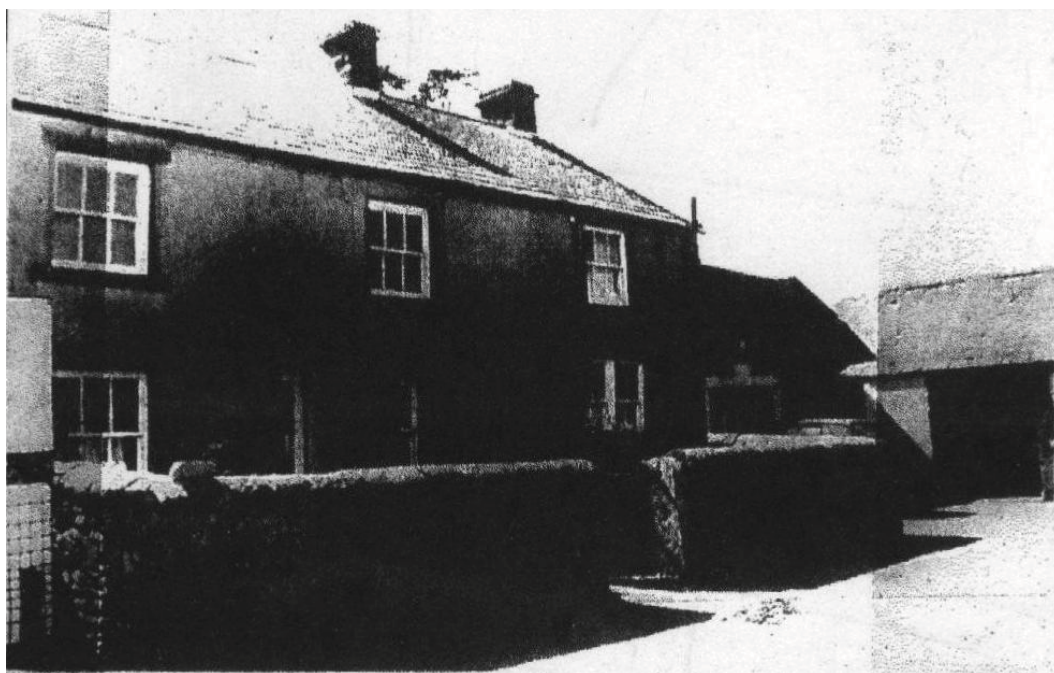
Plate 1: Photograph of Sinkfall Farm c1990 (after Evans 1990)

5.2.8 **Undated:** at some point a building in the location of the current Building 2 was added to the north end of the farmhouse range. It would appear from the map evidence that there has always been a building in the location of Building 2, although with the earliest maps it is always difficult to be sure of the accuracy and scale of what is depicted. The addition of Building 3, the 'paddy house' appears to have occurred by the first Ordnance Survey edition of 1850, and it would seem that for a period of time it was the most northerly building in the farmhouse range. This is suggested by the fact that it had a ground floor window and a doorway to the upper floor, these were often served by an external ladder. When the current Building 2 was added it seems that a modern staircase was introduced to permit access between the two buildings, the staircase also allowed access to a second floor room above the main farmhouse which clearly illustrates all these buildings were part of the farmhouse by this point. It is probable that an earlier lean-to existed in the area of Building 2 as it does appear that some construction features on all the Ordnance Survey maps available, as well as in the photograph from c1990 (Evans 1990, 14; Plate 1).

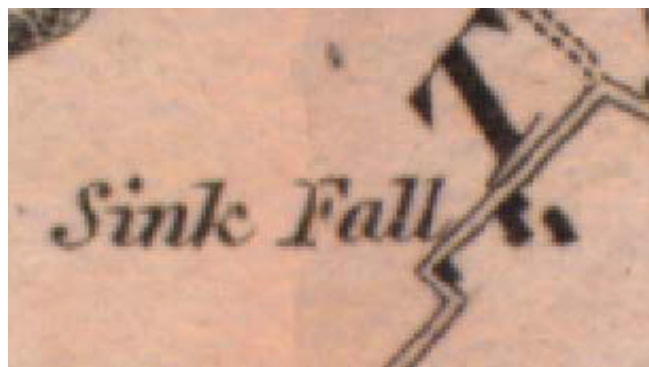
Plate 2: Extract from Hennet's map of 1830

3.3.1 **Hennet 1830:** although Hennet's map is not very detailed (Plate 2), the outline of the buildings is similar to the later Ordnance Survey maps.

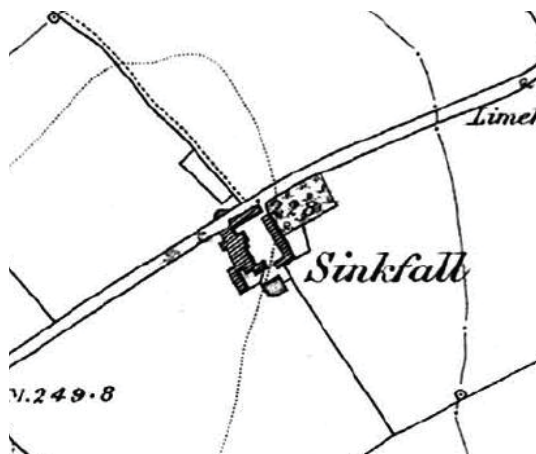
Plate 3: (left) Ordnance Survey map of 1850

3.3.2 **Ordnance Survey 1850 and 1889:** these maps although forty years apart show no discernable change to the farm buildings (Plate 3 and Plate 4). They comprise a main range orientated approximately north/south evidently with numerous outshuts, and associated outbuildings attached at either end plus a detached building to the east.

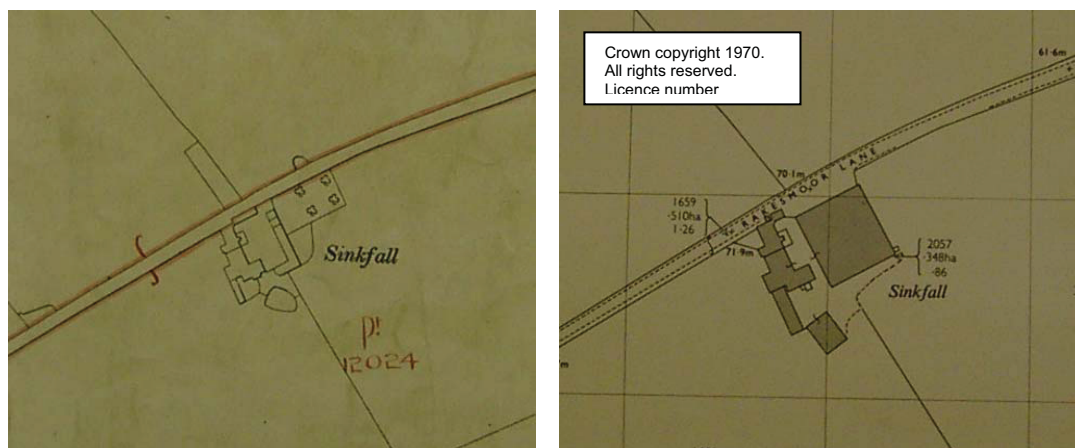
3.3.3 **Ordnance Survey 1913:** this is the map showing details of the land valuation tax of 1910, although these were unfortunately not available (Plate 5). The red numbers refer to the owners of the property; unfortunately the records for this map could not be located. Again, the farm appears unchanged.

3.3.4 **Ordnance Survey 1970:** this map shows that there have by this date been some noticeable changes at the site (Plate 6). While the main farmhouse has remained largely unchanged, the outbuildings on the north side have been altered. In addition, a new outbuilding has been constructed to the south and a large building has been constructed to the east, replacing the buildings that previously stood in this area.

Plate 5: (left) Ordnance Survey map of 1913 with land valuation details

Plate 6: (right) Ordnance Survey map of 1970

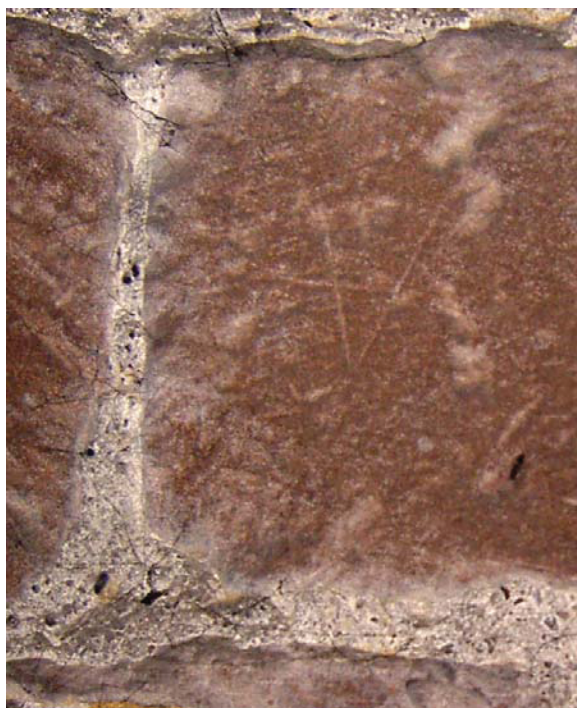
Plate 17: (left) Mason's mark on west elevation of Building 9, within loft of Building 10

4.2.21 **East elevation:** the north end of this elevation has been knocked down due to fire damage (Plate 15). It appeared from the lack of quoins at the south ends of Building 4 and the wall stub remaining at the junction with Building 4 that one continuous wall formed the entire range of the original farmhouse (Building 4) and threshing barn Building 6/9). There was pedestrian doorway into the north part of this barn (Building 6) which has a substantial red sandstone lintel with a chamfered underside, this had been re-used and inserted into the blockwork construction of this part of the elevation. Above this doorway were the remains of a window which comprised the southern jamb and red sandstone sill which was chamfered on the upper edge of its face (Plate 16). South of the pedestrian doorway was a wagon door that may have originally been the entrance to the threshing floor as it had an opposing door of a similar width on the west elevation. This access led into the part of the barn that is Building 9 and this has been divided off from Building 6 internally by a concrete block wall. The part of the original elevation into which this door was set has been entirely re-built as it has been widened and raised in height to facilitate access for more modern farm machinery. A concrete lintel has been added above the doorway which is keyed into the blockwork partition on the north side of the doorway. South of the wagon doorway the original elevation has been preserved although much of it has become obscured by the addition of Building 10. Inside Building 10 there was a pedestrian doorway into Building 9, this appeared to be an original entrance for the south-east corner of the main barn. The jambs of the doorway were well faced and there was a large oak lintel over the doorway which was roughly squared. Within the hayloft of Building 10 more of the southern part of the eastern elevation of Building 9 could be seen, and in this area two mason's marks were recorded in the red sandstone (Plate 17 and Plate 18).

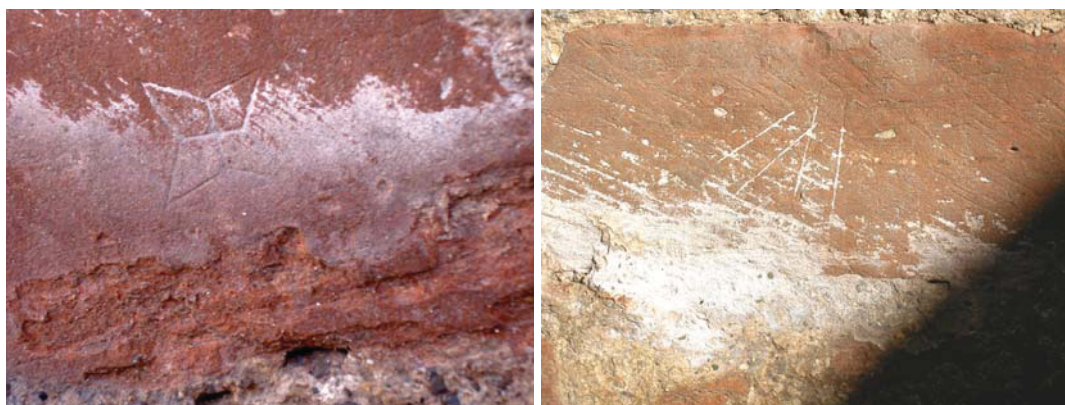
Plate 21: (left) Mason's mark on west elevation of Building 9

Plate 22: (right) Mason's mark on west elevation of Building 9

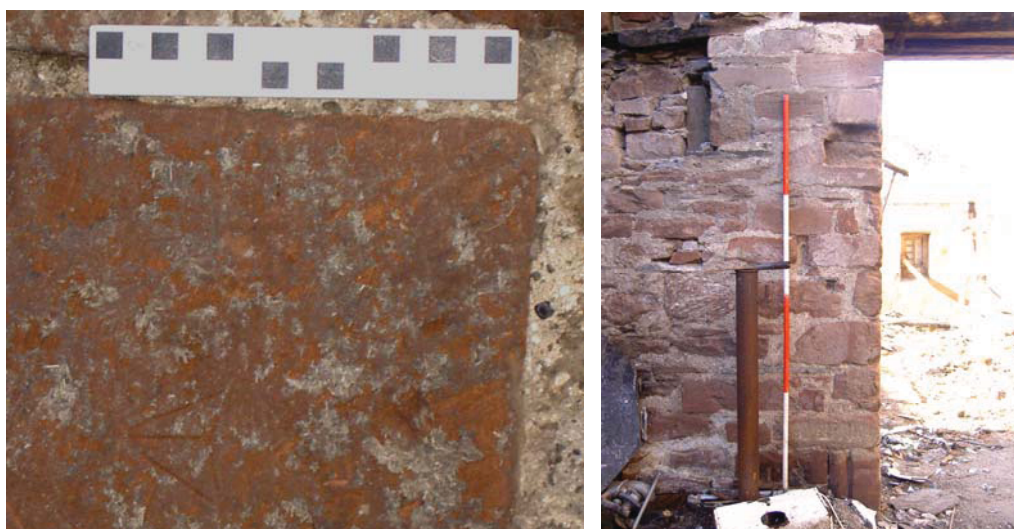
Plate 38: Masons mark south of West doorway, Building 9

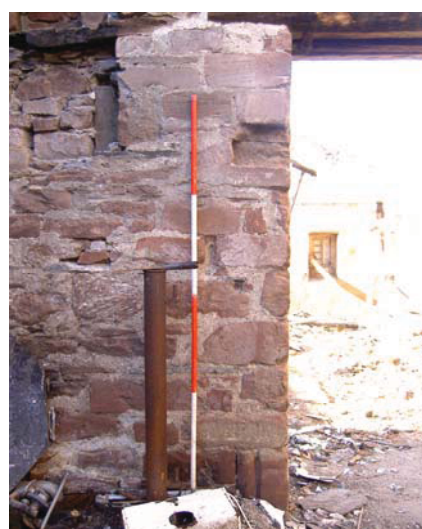
Plate 39: South side of West wagon doorway, Building 9
